FATAL FACTS

No. 8775-018

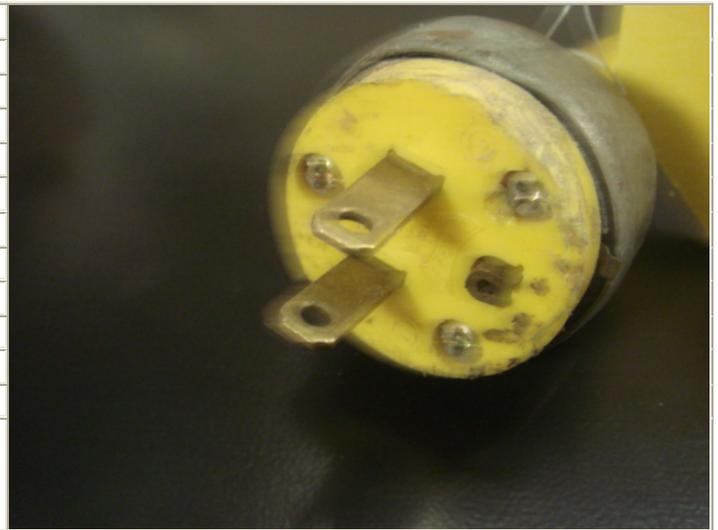
The employee was working underneath a house repairing a leak when he was electrocuted. An extension cord splitter with a missing grounding pin was being used.

An extension cord splitter with a missing grounding pin was being used. The employer was cited for not inspecting electrical equipment for defects and for using equipment without proper grounding.

The recommendation for preventing this type of accident was to provide all employees with safety training, to include electrical safety.
