FATAL FACTS

No. 8775-028

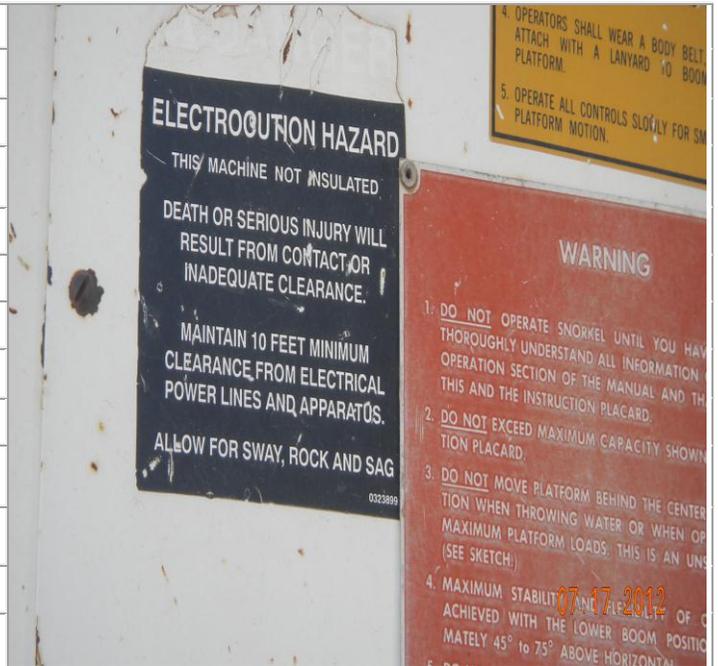
A utility pole had been rejected by an engineer, so the employer was erecting a replacement structure near the rejected pole. While lifting the employee in a lift bucket, the employee came in contact with a live wire. The employee died 15 days later from delayed medical complications due to electrocution. A second employee was hospitalized for treatment of burns to fingers and chest.

The investigation resulted in the issuance of two serious citations. The first citation was for permitting employees to approach a conductive object without an approved insulating handle – 29 CFR 1926.950(c)(1). The second citation was for not grounding aerial lift trucks when working near energized lines – 29 CFR 1926.952(b)(2).

The recommendations made by OHSB were to ground aerial lift trucks when working near energized lines and to always provide proper clearance from energized lines.
