List of Compliance Concerns

Facility Name: Snuffy's Tackle Shop		Facility Number: 29671		Phone:	
Facility Address: #1 State Road 103			City: Quemado		Zip Code: 87829
Owner Name: SBV Enterprises, Inc.		Owner Number: 76372		Phone:	
Owner Address: PO Box 538		City: Quemado	State: New Mexico		Zip Code: 87829
Operator Name: Same as Owner					Phone:
Operator Address:		City:	State: New Mexico		Zip Code:

Warning of Significant Compliance Concerns

Inspection Type: Compliance	Case Number: 3098	Inspection Start Time: 10:12:00 AM	Date: 21-Mar-17
------------------------------------	--------------------------	------------------------------------	-----------------

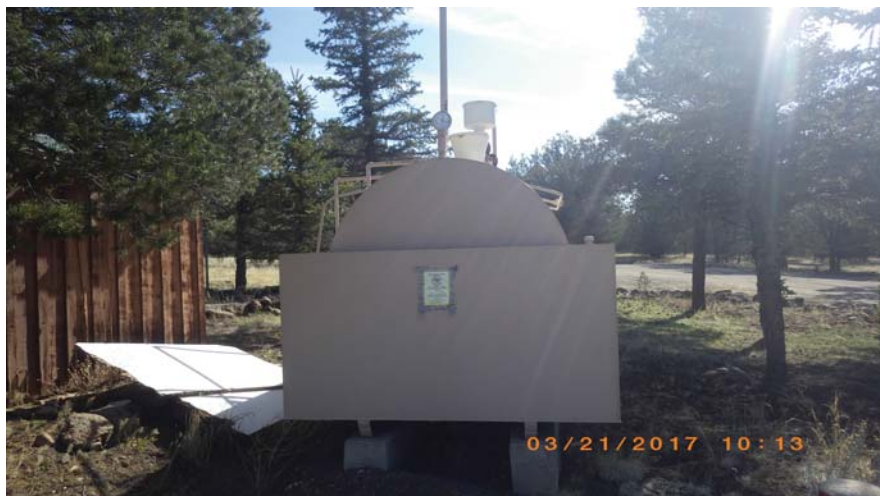
Picture Number: USER2643

Picture taken while facing east and looking at the AST at this facility.

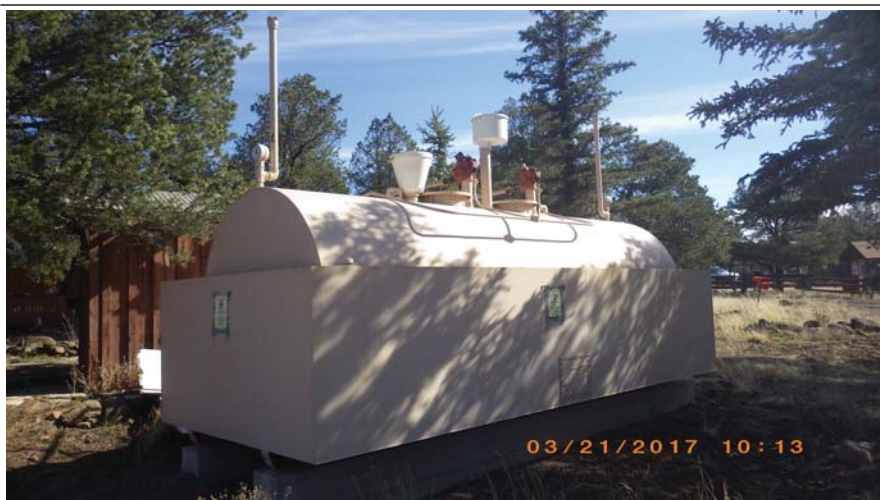
Picture Number: USER2644

Picture taken while facing NE and looking at the AST at this facility.

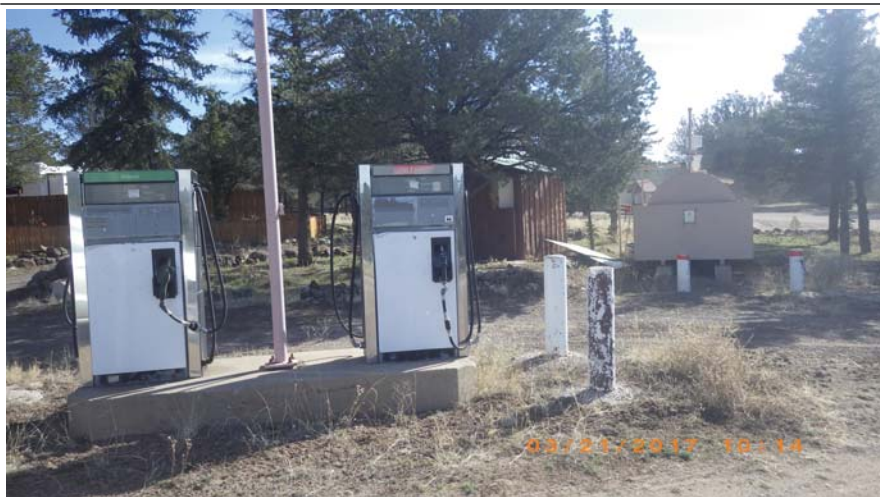
Picture Number: USER2645

Picture taken while facing east and looking at the dispensers.
