## List of Compliance Concerns

**Warning of Significant Compliance Concerns**

<b>Inspection Type: Compliance</b>	<b>Case Number: 2570</b>	Inspection Start Time: 10:45:00 AM	Date: 27-Feb-14
------------------------------------	--------------------------	------------------------------------	-----------------

**Re: Enforcement Recommendation Josie's Country Market (FID 54493)**

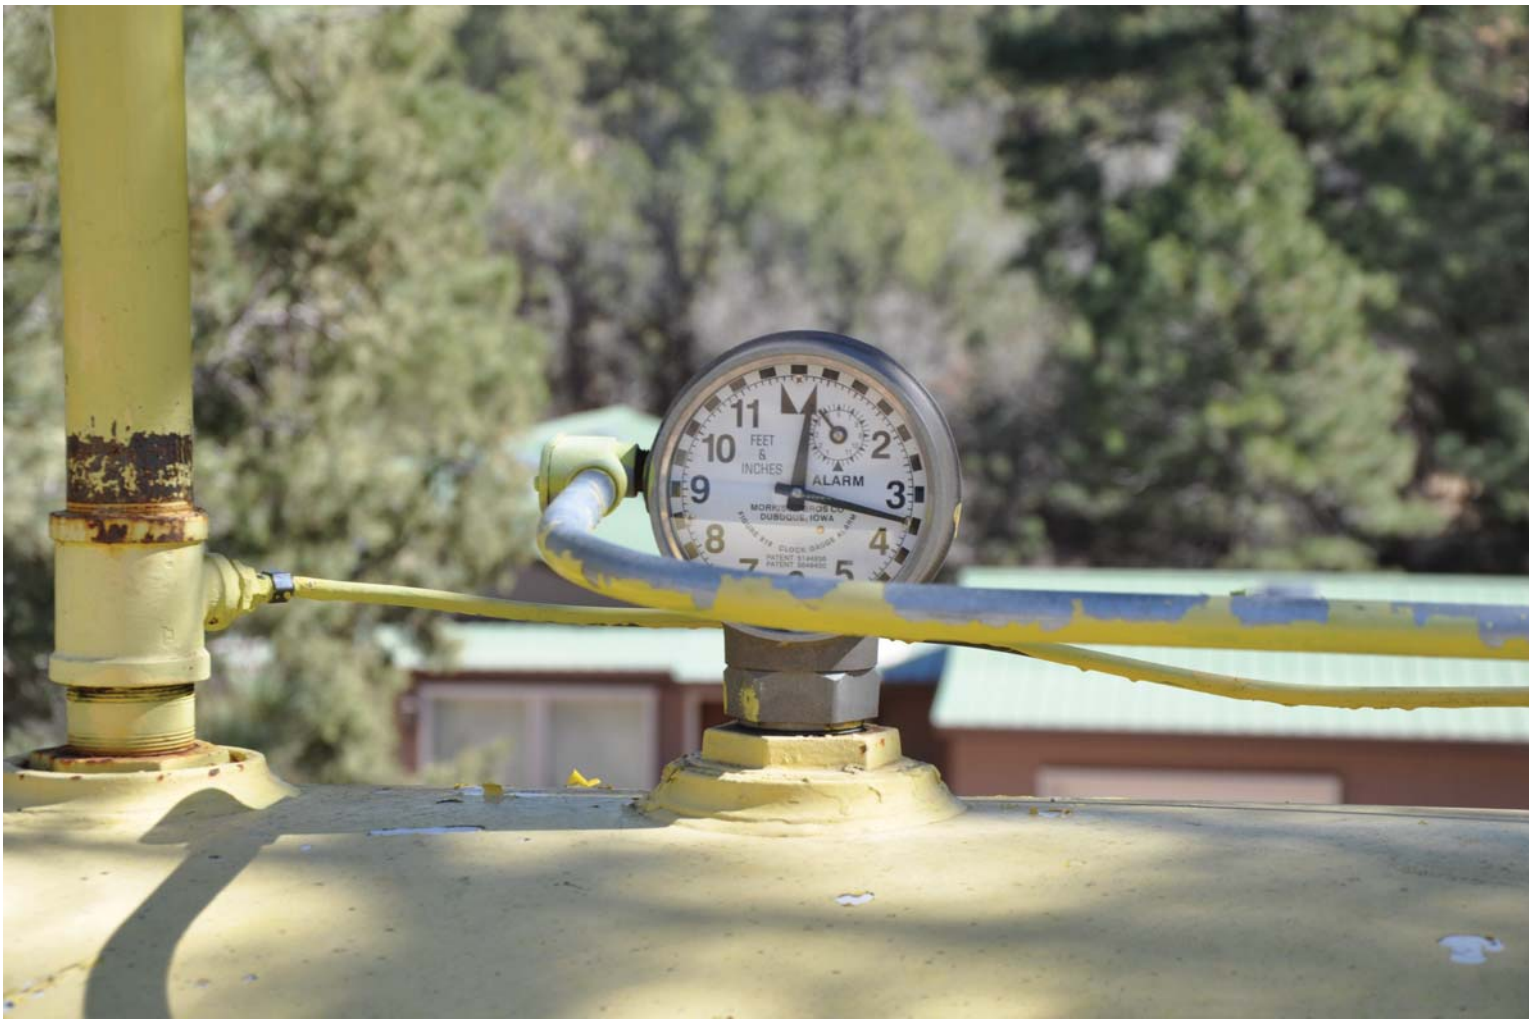
Facility Name: Josie's Country Market Facility Number: 54493 Photograph Number: DSC\_0100

3) Unleaded compartment appears to contain 3&1/2 inches of fuel and diesel compartment appears to contain about 5&1/2 inches of fuel. Tank is not being monitored monthly as required. (Violation of 20.5.6.10.A NMAC - Level B)

Description:  
Picture taken while facing east and looking at the gauge on the Unleaded compartment of the tank which indicates about 3 & 1/2 inches of product remaining.

6) Tanks and piping will be required to be integrity tested prior to a return to service.

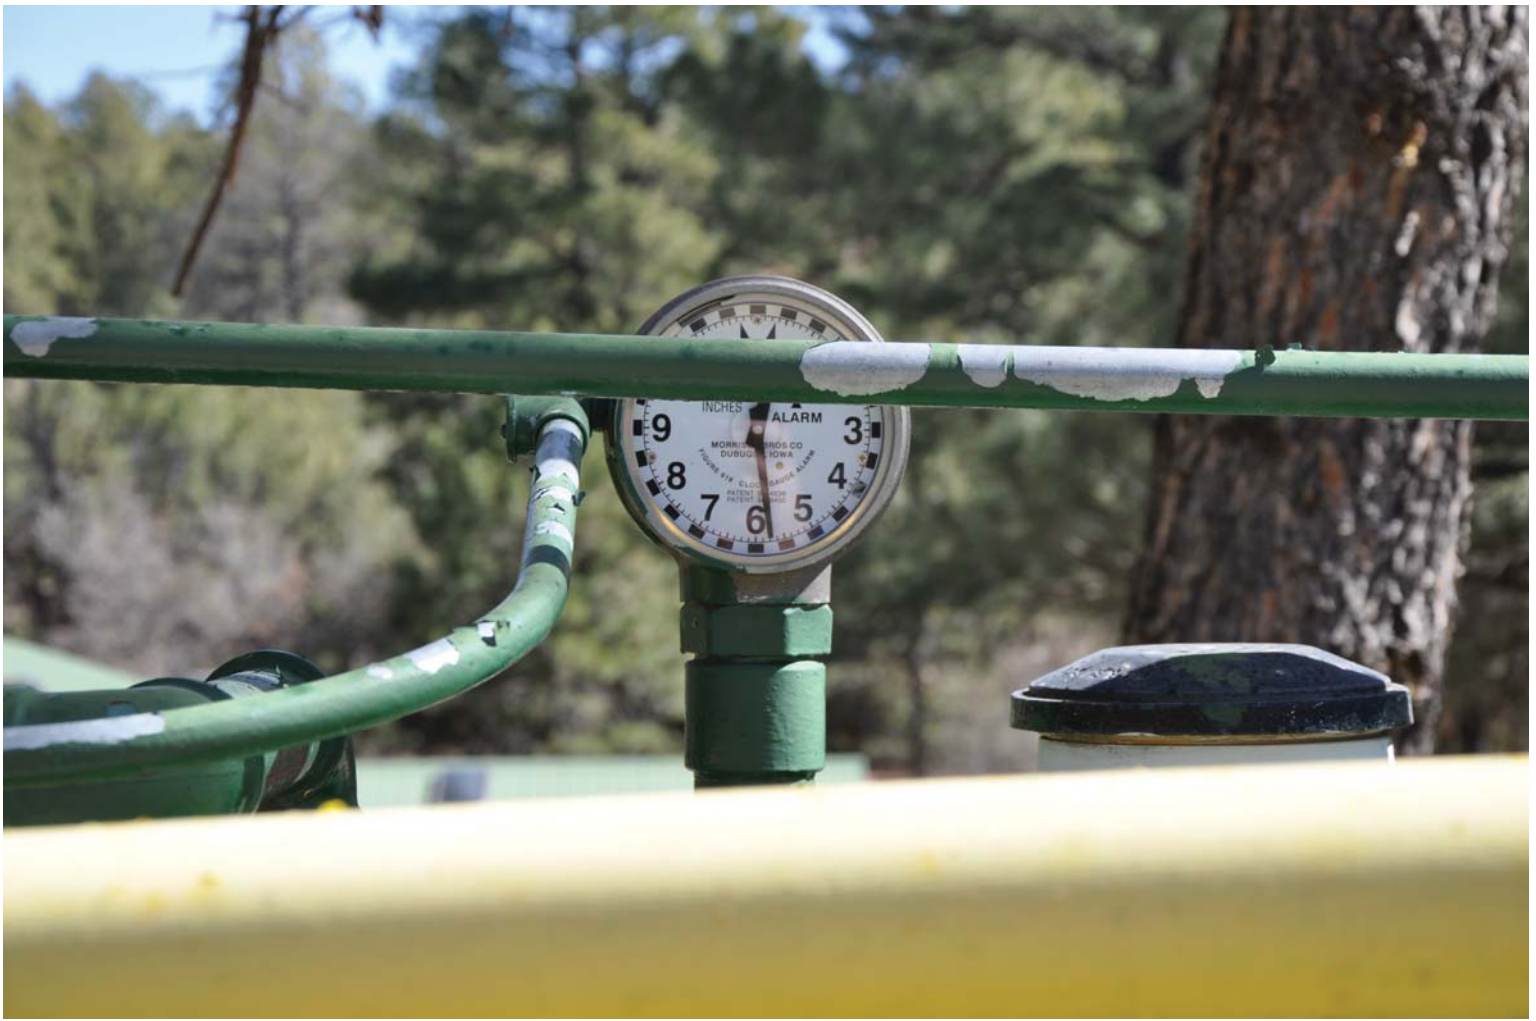
Facility Name: Josie's Country Market Facility Number: 54493 Photograph Number: DSC\_0102

Description:  
Picture taken while facing east and looking at the gauge on the diesel compartment of the tank which indicated there is almost 6 inches of product in this compartment.

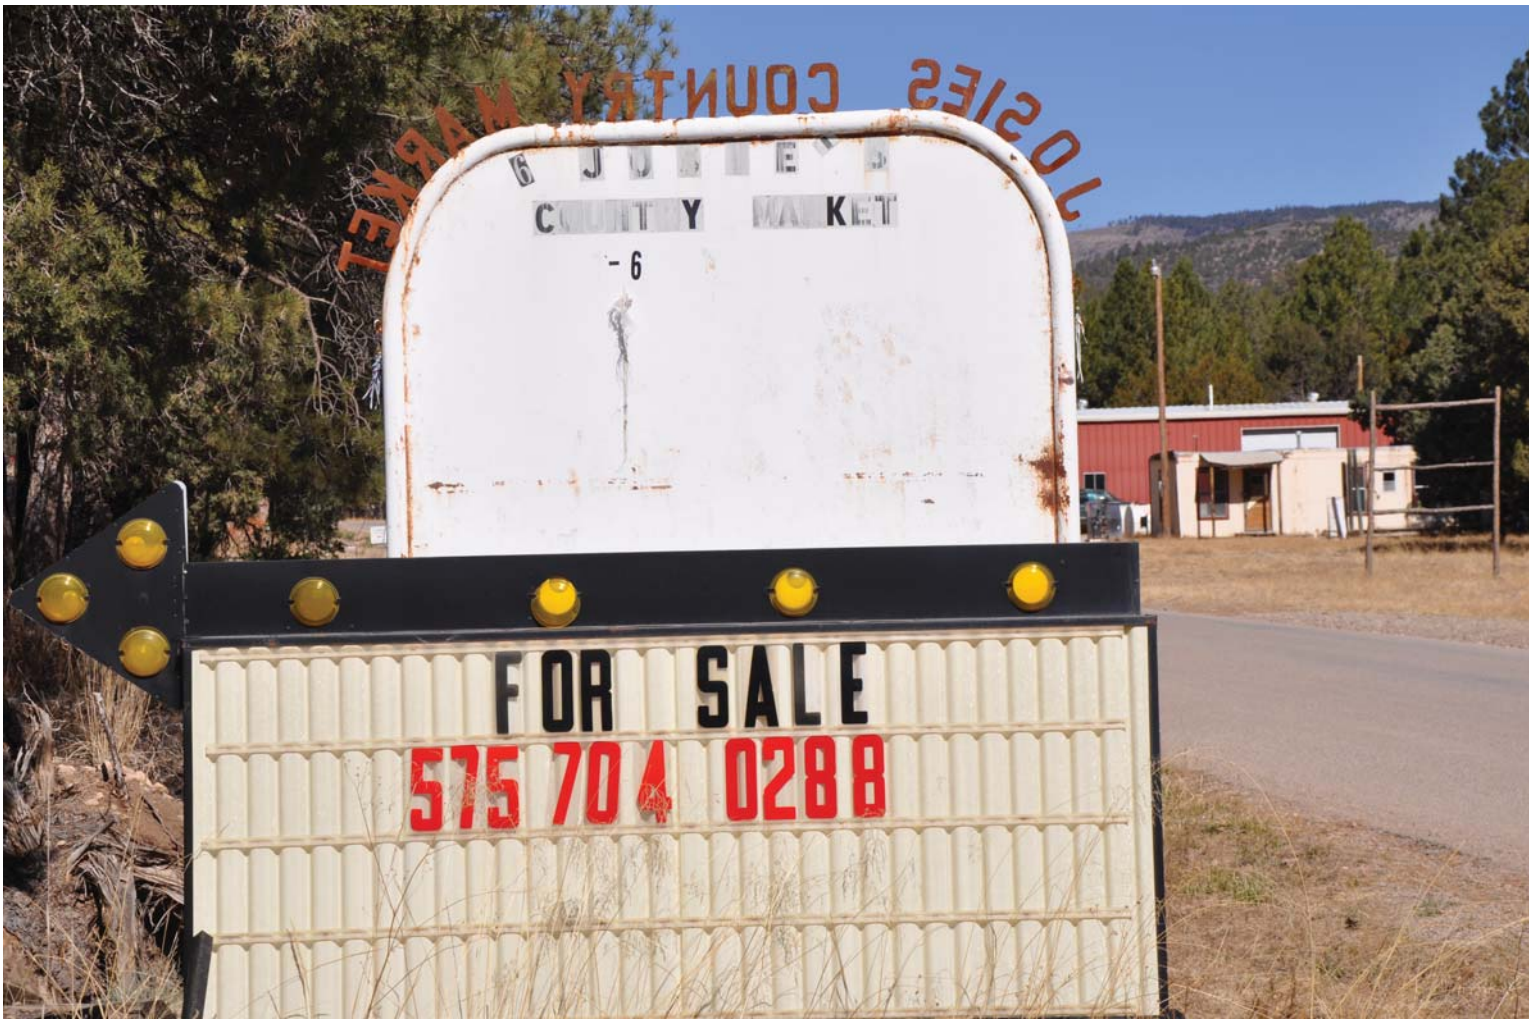
Facility Name: Josie's Country Market Facility Number: 54493 Photograph Number: DSC\_0105

1) Inspection notice and records request was mailed to last known address of owner which was returned by US Postal Service. A new address was on the expired forward request, the new address is 505 E. Crockett Rd, Lovington, NM 88260. Owner failed to update contact information with Dept. which is violation of 20.5.2.16 NMAC.

Description:  
Picture taken while facing NNW and looking at the sign beside the entrance which gives a Lovington, NM area phone number to call for interest in this facility.
