NEW MEXICO
ENVIRONMENT DEPARTMENT

Surface Water Quality Bureau

Re: **Major Municipal; SIC 4952; NPDES Compliance Evaluation Inspection; Bloomfield
Wastewater Treatment Plant; NM0020770; May 23, 2012**

City of Bloomfield WWTP
NPDES Permit Number NM0020770
Compliance Evaluation Inspection
23 May 2012
Page 1 of 7

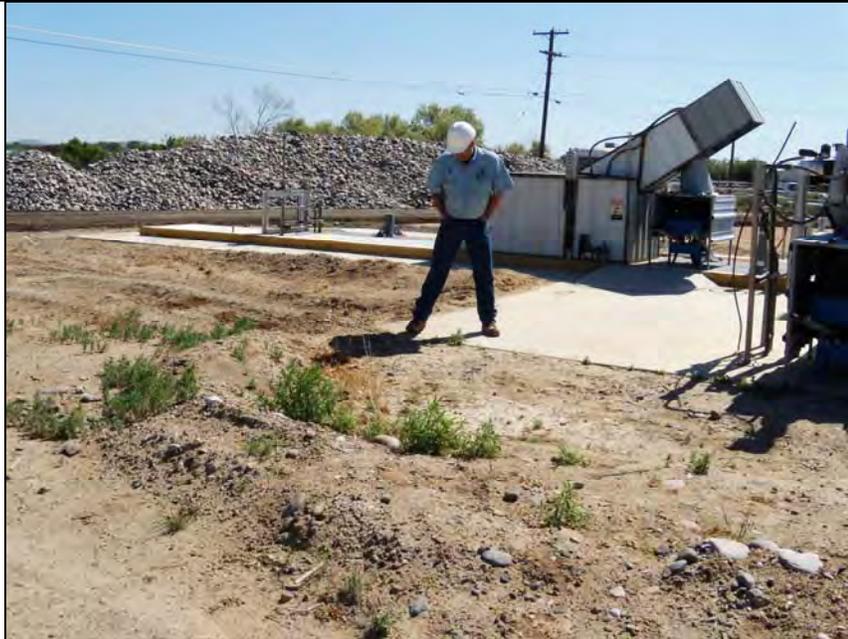
1. Head works berm - During a previous inspection, it was noted that there is no containment at the head works where the grit chamber screw pump dumps waste into a wheel barrow or hopper. The need for containment is twofold: 1. Prevention of the raw sewage and solids from spreading on the bare ground and potentially contaminating ground water by seeping in. Ground water is hydrologically connected with the San Juan River in this location; 2. To prevent raw sewage from running off into surface water. Since the time of the last inspection, operators have put mounds of earth around the grit removal area. This is successful at preventing normal weather surface run off. However the solids and raw sewage are still able to seep into the ground. Staining was visible on the ground in this area, indicating that liquids have indeed been allowed to pool and soak into the ground. The berms and platform where influent grit is handled should be made of impermeable material such as concrete.

Subject: Head works - The earthen berm is permeable and raw sewage is still allowed to make contact with bare ground - potentially contaminating groundwater. The reason for berms and containment is to prevent the raw sewage from coming into direct contact with the bare ground. A hydrologic link between ground water and the San Juan River exists in this location.

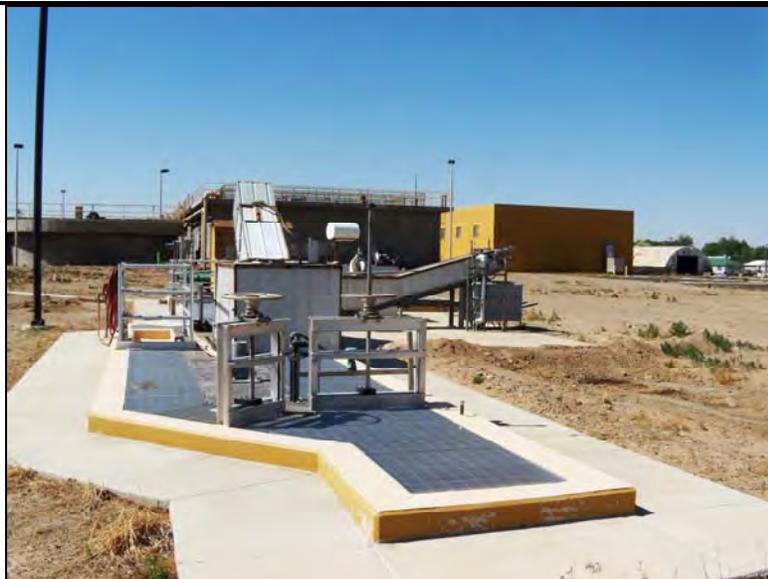
Subject: Head works,- including mechanical and manual bar screens. Grit removal and primary aeration in the grit chamber.

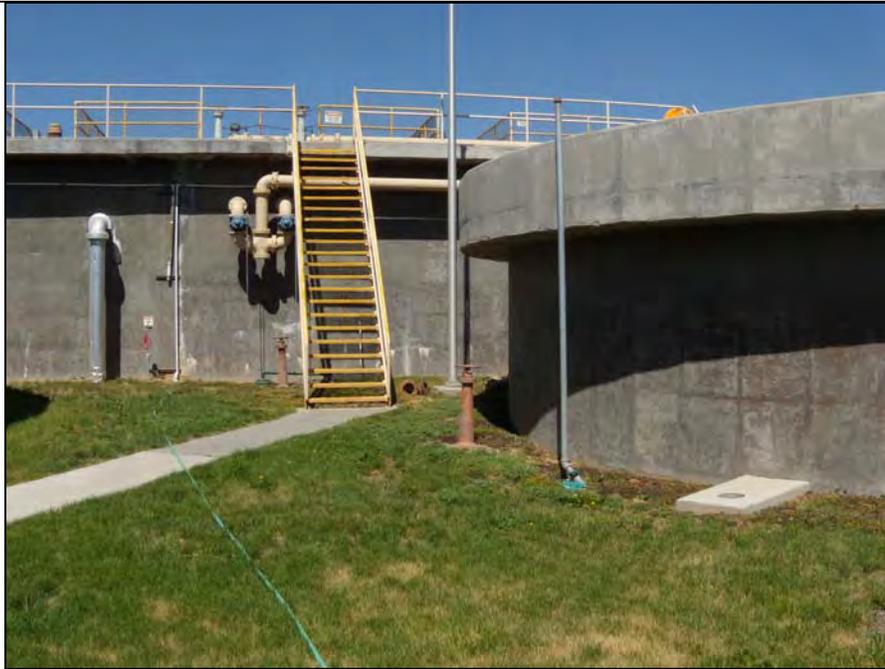
Subject: Above Ground Aeration Basins and Secondary Clarifier

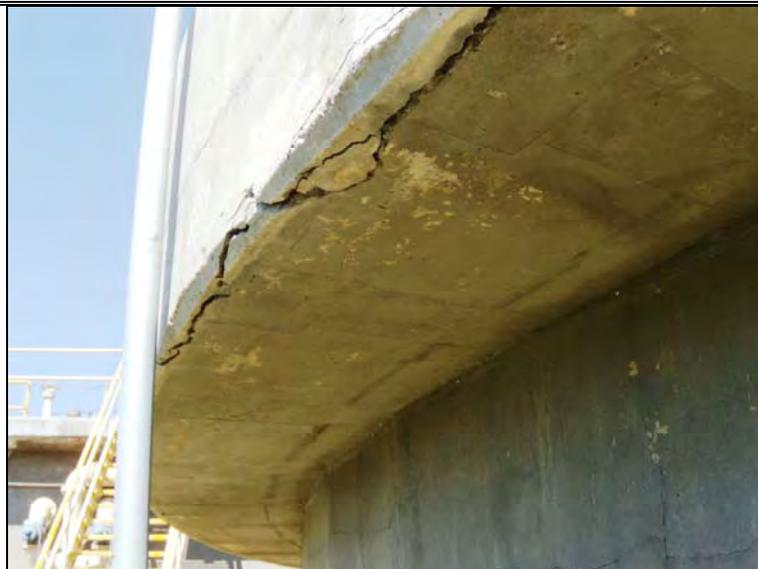
5. Concrete cracks - This WWTP was built in 1978. New head works were built and put on line approximately 5 years ago. Throughout the WWTP there are indications of failing concrete, including cracks throughout all the treatment units including the secondary clarifiers. Inside the

basins the concrete is pitted and crumbling from the many years of exposure to the caustic wastewater. Metal parts and water works are showing signs of rusting throughout.

Subject: Secondary Clarifier Cement Condition - extensive cracks and aging noted throughout the WWTP. The plant was built in 1978 and has exceeded the expected life of the treatment systems by nearly 15 years.

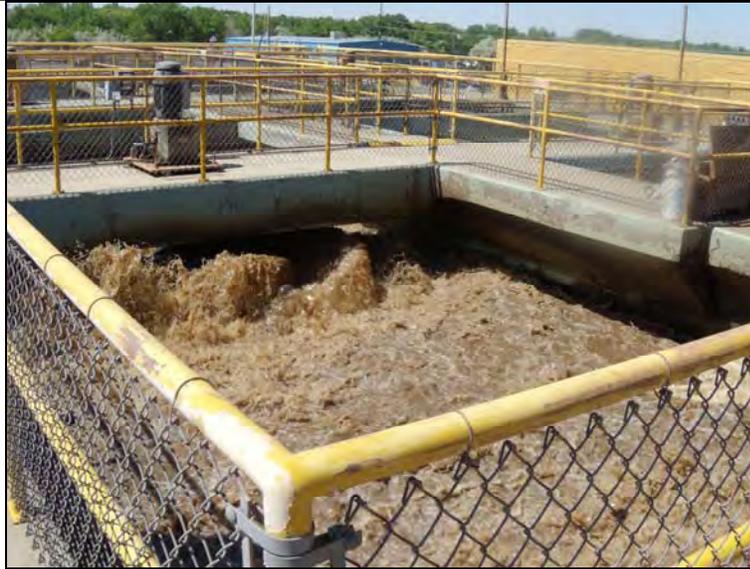
2. Aeration Basins - The parallel aeration basins have surface aerators that mix approximately the top six feet of the chambers. The paddles cause a great deal of turbulence and frequent splash over. Regardless of the highly turbulent surface these aerators create, the lower 2/3 of each basin does not receive adequate and reliable aeration and mixing, causing anoxic and potentially even septic conditions. The color of the basins was an unhealthy milk brown - indicating old solids and less than optimal aerobic treatment.

Subject: Aeration Basin with surface aerators. The aeration occurs in the top approximately six feet of the basins. Incomplete mixing is occurring in the basins. The lower portions of the basin are likely to be anaerobic.

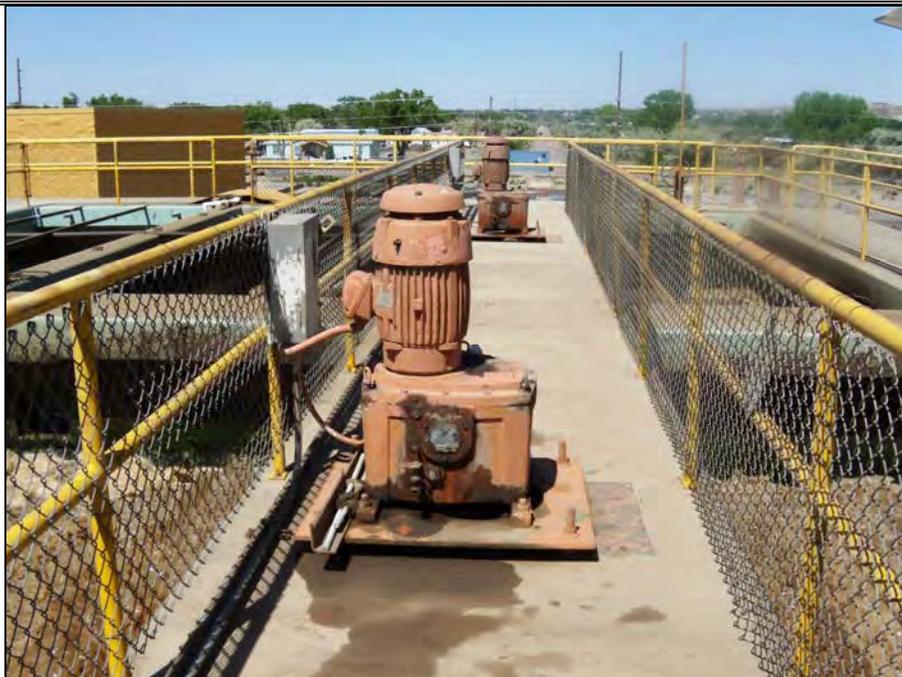
6. Aging treatment units and obsolete treatment units - The motors for the aeration basin paddle aerators are heavily worn, rusting and leaking oil.

Subject: Drive motor for surface aerator paddles. Note these motors are very worn and are leaking oil that could potentially reach the basins.

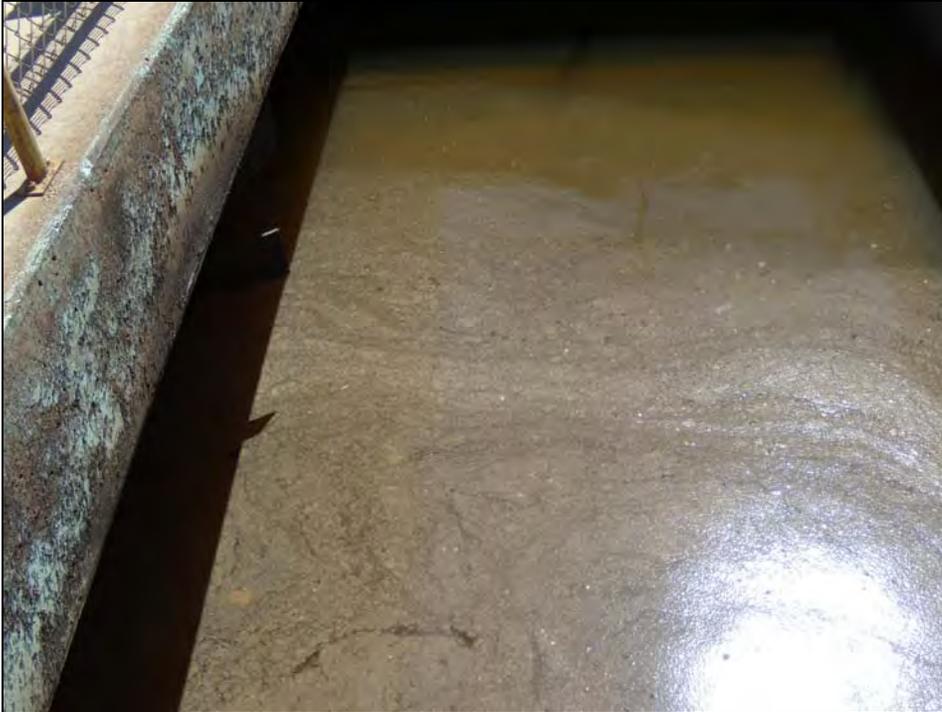
3. Aerobic digester / sludge thickener - This basin was septic. There was no indication of any aerobic activity in the basin. The odor from the basin was indicative of a septic condition and was evident more than several hundred yards outside the boundary of the WWTP property. The Clean Water Act does not regulate odors. However odors can be an indicator of how well a treatment plant is or is not operating. The rate of solids removal should be increased.

Subject: Anaerobic Digest / Sludge Thickener was septic. Note also the concrete is deteriorating along the sidewalls of this treatment unit built in 1978.

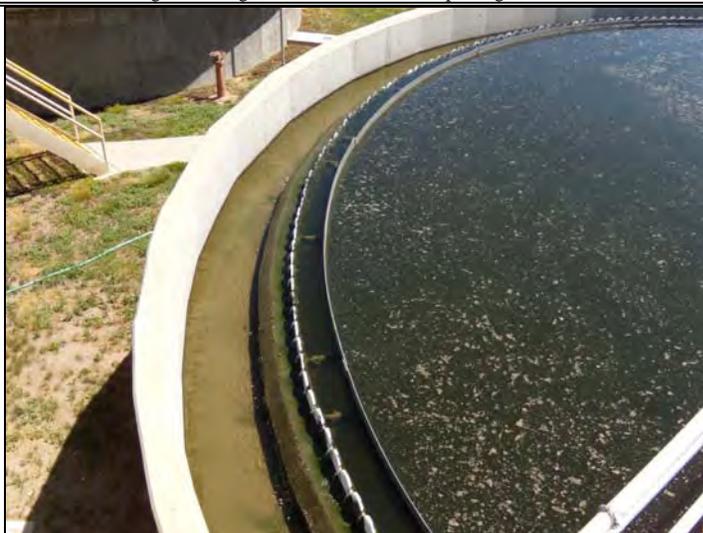
The weirs have been replaced on the secondary clarifiers and this is helpful at reducing floating solids from being sent to the chlorine contact chamber. However, floating solids are still getting through.

Subject: Secondary Clarifier. New weirs were recently install to assist in preventing excess solids from being sent to the chlorine contact chamber. Note however that some amount of sedimentary material is in bottom of the outer ring, indicating that some solids are still passing over the weirs.

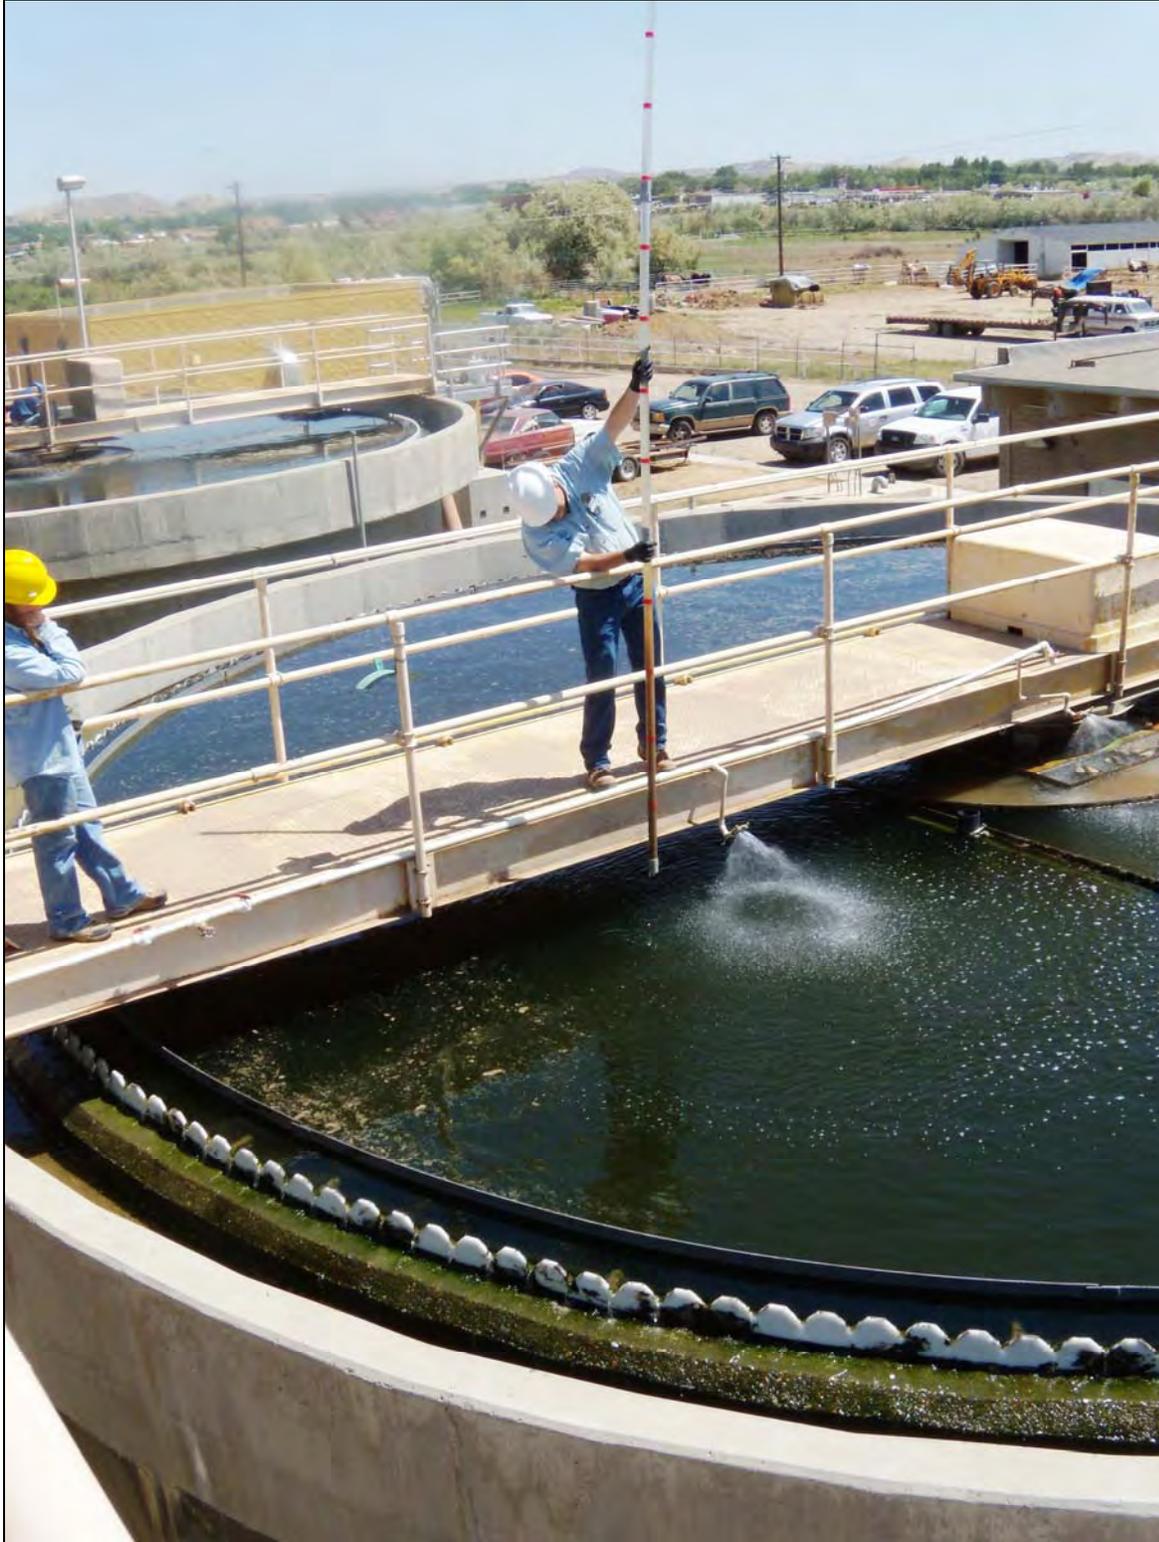
4. Secondary Clarifiers - The sludge blanket was 4 feet deep and throughout the rest of the column solids were thinly dispersed. - Solids in the column indicate too many solids in basin and old solids - rising flock - pin flock also indicate old solids. The rate of solids wasting should be increased.

Subject: Secondary Clarifier (South) The sludge blanket was 4 feet and dispersed solids in the water column above. To improve effluent quality, an increase of solids wasting may be advisable. The floating solids in this unit also indicate older solids and less effective biological treatment in the aeration basins.

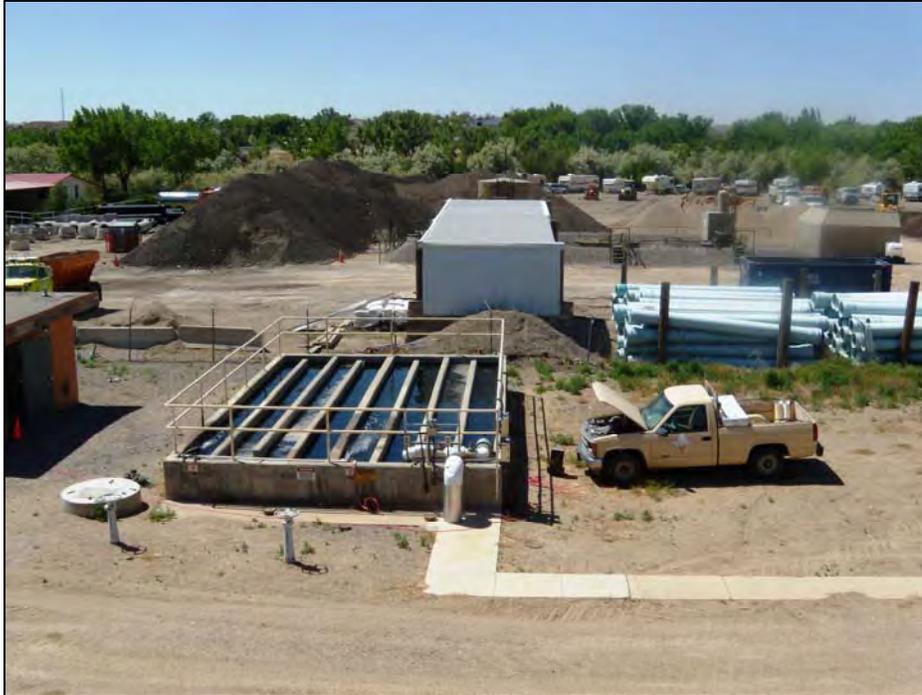
Subject: Chlorine Contact Chamber - Two parallel units.

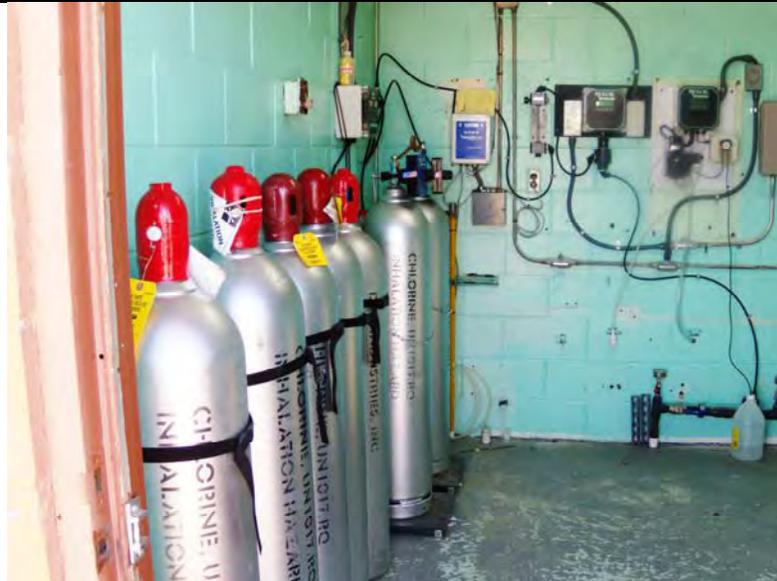
Subject: Chlorine gas used for disinfection in the Chlorine Contact Chamber. Dosing is flow dependent.

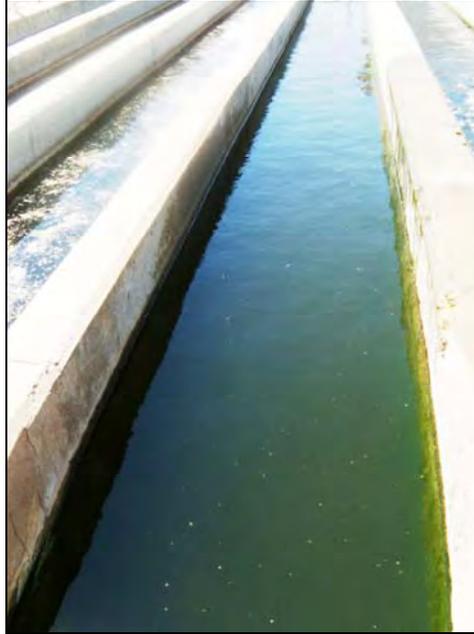
9. Chlorine Contact Chamber - The serpentine chlorine contact chambers were very turbid. Floating solids were observed in the chamber. Operators have installed a surface baffle to catch floating solids before they reach the effluent discharge point. However because floating solids are visible throughout the water column, the surface baffles are only partially effective at removing all of it. Operator indicated that at one time they installed additional screens at the end of the chlorine contact chambers to catch the solids but the screens became clogged to quickly for the operator to keep up with cleaning it, and the screens were removed. This is a repeat finding.

Subject: Chlorine Contact chamber - very turbid water and floating solids are visible through the water column that is eventually being released to the San Juan River .

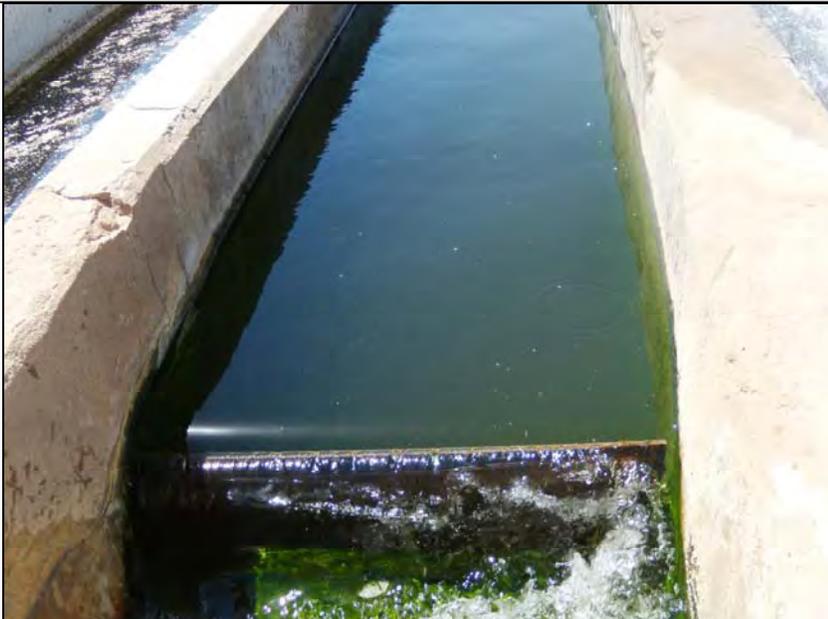
Subject: Chlorine Contact Chamber - again floating solids are visible and are being released.

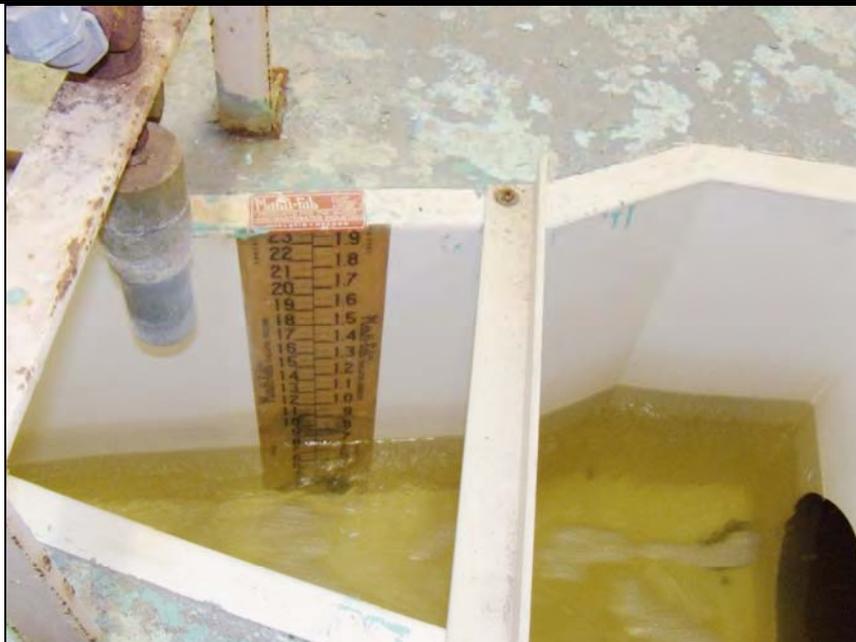
Effluent flow measurements are not accurate to within a 10% margin of error as required by the permit. The margin of error is 27%.

Subject: Effluent Flow Meter. Staff Gauge and Ultrasonic Totalizer. Effluent water is turbid greenish-brown. The channel design for the lead to the Parshall flume is too short and causes turbulence that could be adversely impacting the accuracy of the flow measurements.

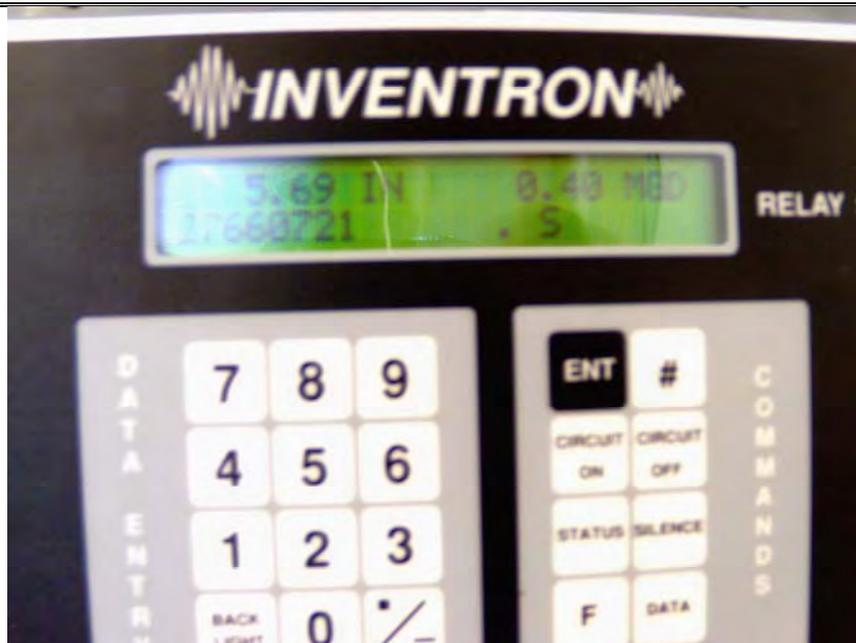
Subject: Effluent Flow Meter Ultrasonic read out.

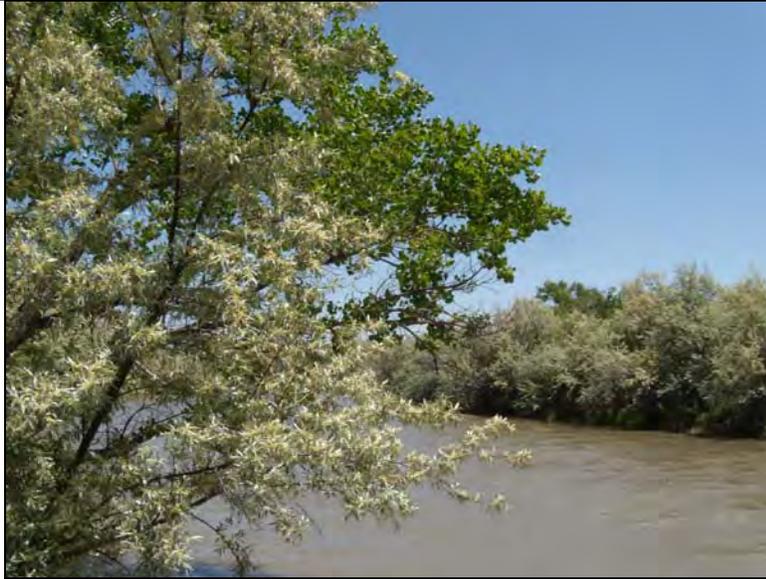
Subject: Outfall pipe at th San Juan River is below the water surface because of the high flow of the river at the time the photo was taken.

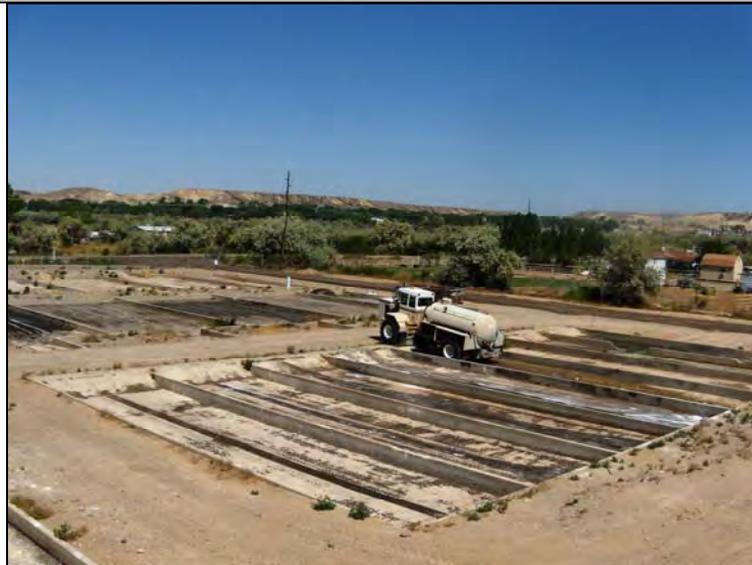
Subject: Sludge Drying Beds. Septage hauler releasing contents into bed designated for septage. The septage beds are not plumbed so that liquids go to the head works.

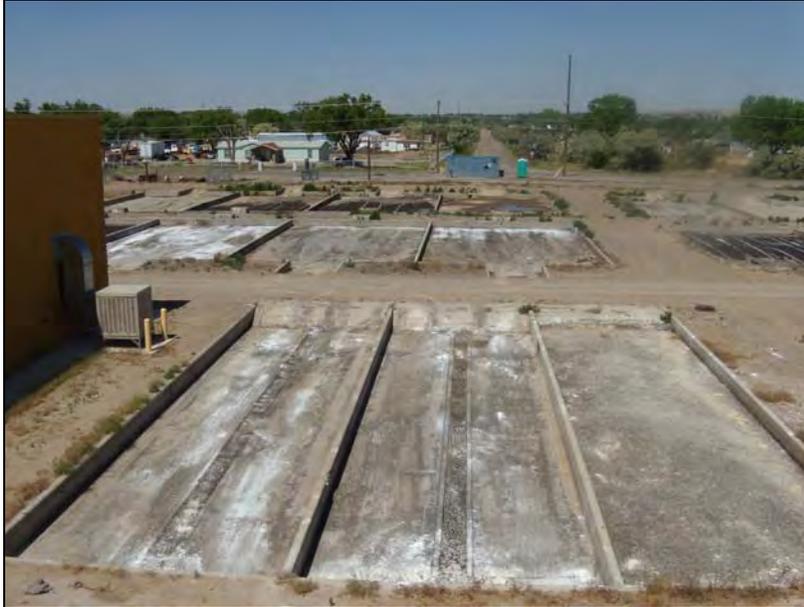
Subject: Drying beds. The white substance is Lime used as an odor reduction treatment.

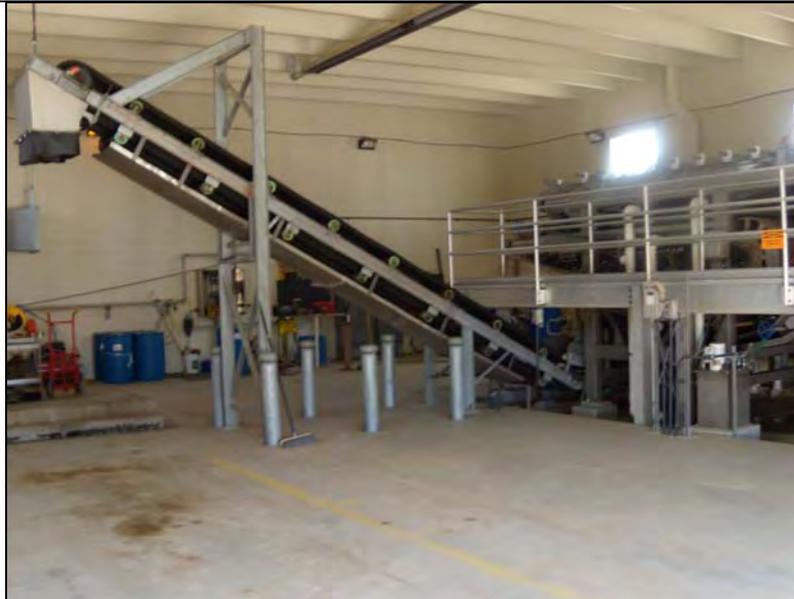
Subject: Sludge Processing - Belt press to dewater solids and conveyor belt to move sludge to dump trucks for transport to sludge drying beds.

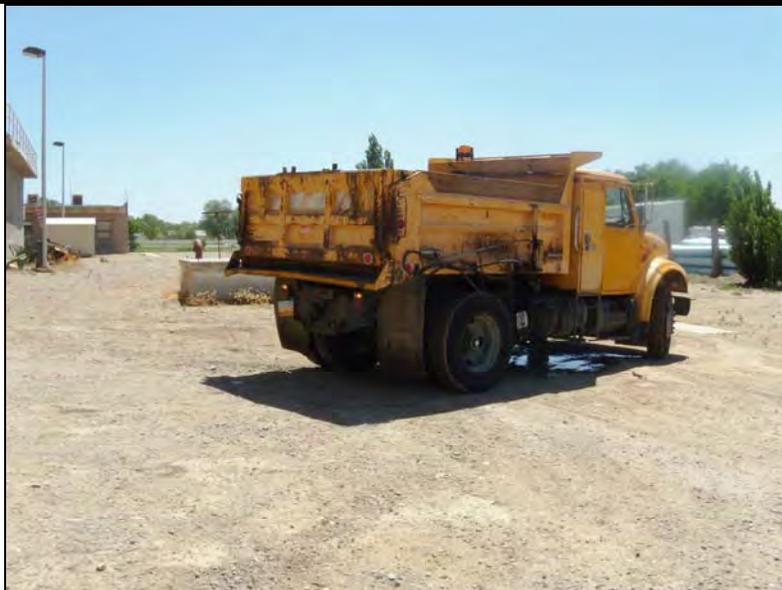
Subject: Dump Truck for hauling sludge.

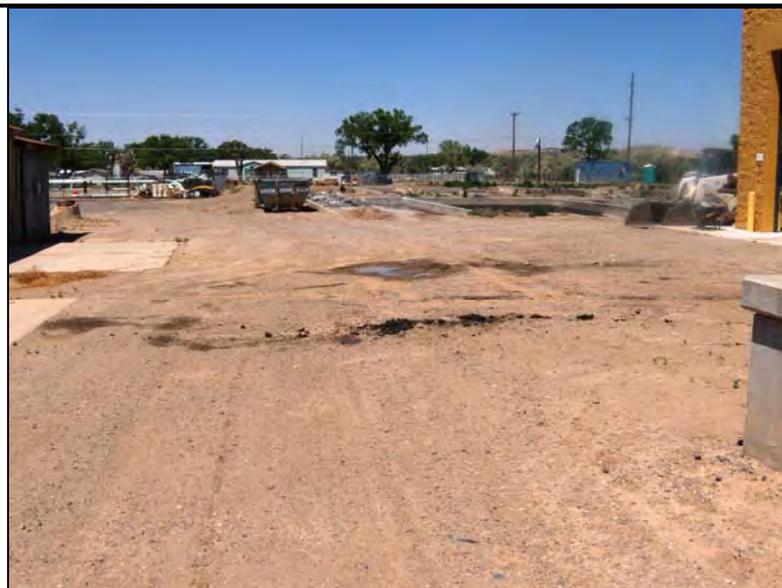
7. Sludge dump truck cleaning on bare ground - Outside the building where the solids belt press is located, pools of water and sludge were observed. According to operators, the dump truck used to haul the sludge from the belt press to the sludge drying beds was recently washed there. All efforts must be made to contain and prevent liquid waste and sludge from coming into contact with the bare ground. Cleaning of the dump truck should be in a contained area such as the cement lined sludge drying beds. Due to the close proximity to the San Juan River and to the high ground water table, a hydrological link exists between the two. This area could also wash off to the river during a rain storm.

Subject: Dump trucks that haul sludge are washed on the bare ground leaving sludge and liquid wash water. The wash water can soak into and potentially contaminate groundwater, and the solids can also cause contamination.

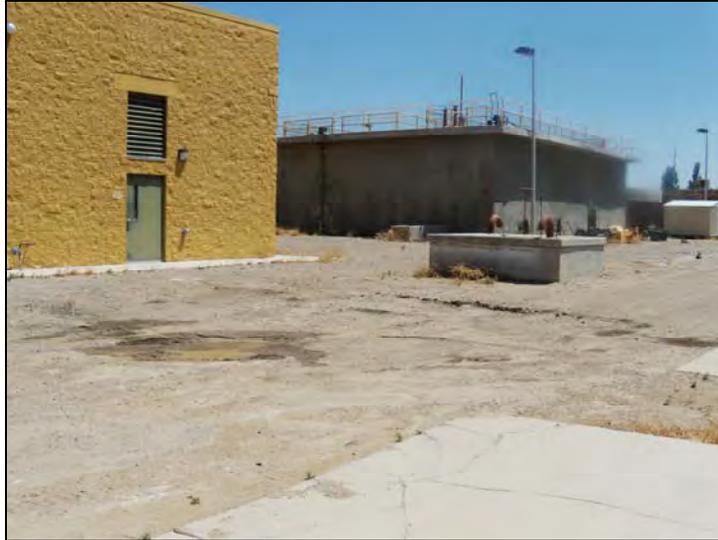
Subject: This photo also show liquid wash water and spilled sludge on bare ground. Dump Trucks should be washed in contained areas.
