Re: Major Municipal; SIC 4952; Compliance Evaluation Inspection; Artesia Wastewater Treatment Plant;  
NPDES Permit No. NM0022268; July 23, 2014

### NPDES Compliance Inspection Report

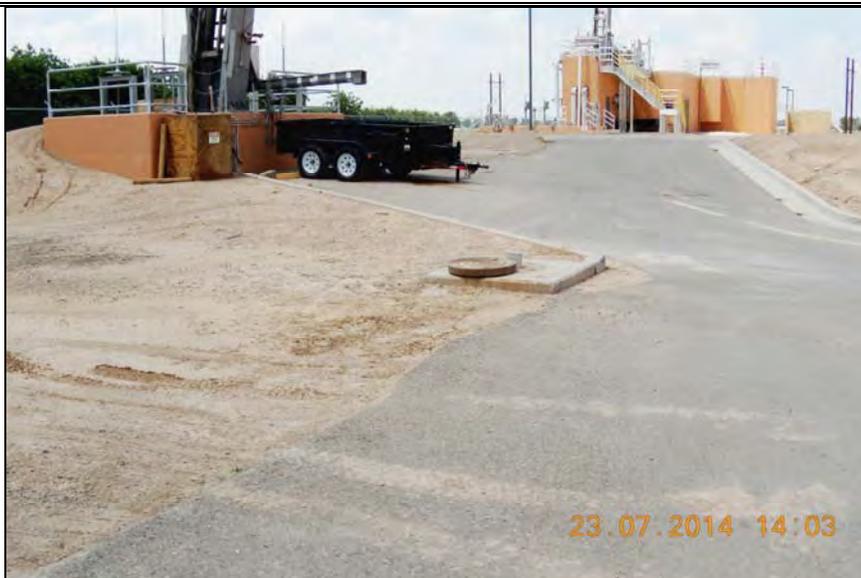
Subject: Headworks has two mechanical bar screens. The first in the foreground is ahead of the influent pumps – lift station. Large solids and rags were interfering with the lift station so this lower bar screen was installed to address that problem.. The second headworks are in the background. The septage receiving station is immediately ahead of this lower barscreen.

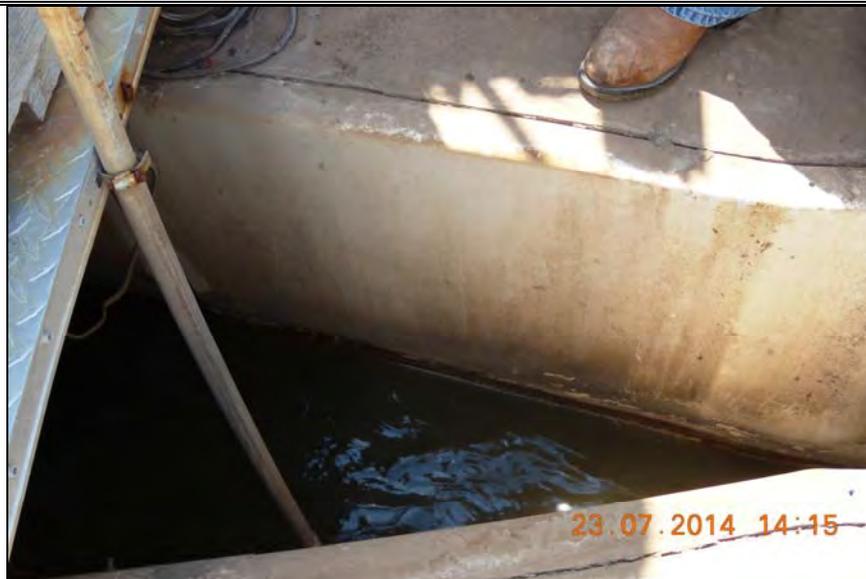
Subject: Influent Parshall Flume. Flow measurement is taken at this location.

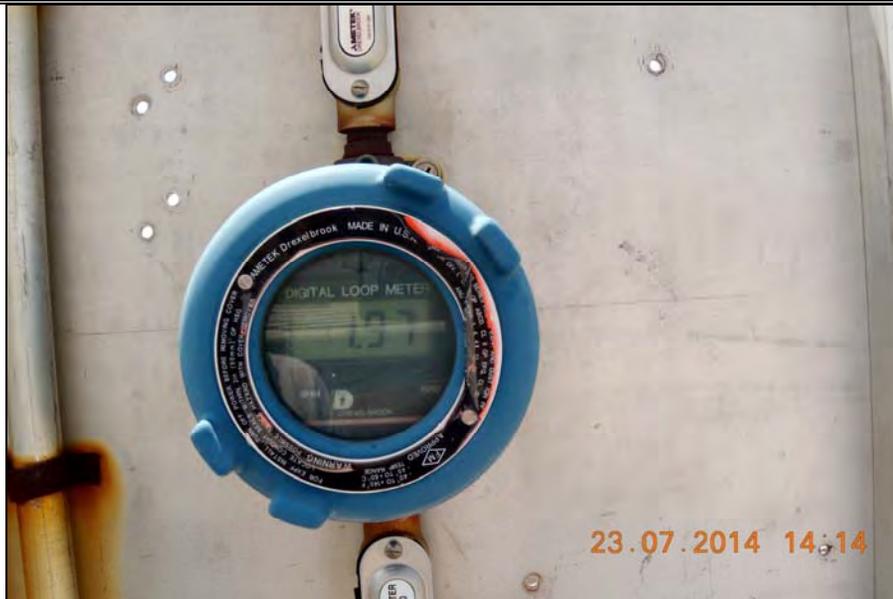
Subject: Influent flow measurement with a Drexelbrook meter – at the time this photo was taken the instantaneous influent flow was 1.97 Million Gallons Per Day (MGD). The influent meter is used for NPDES and Ground Water Discharge Permit reporting.

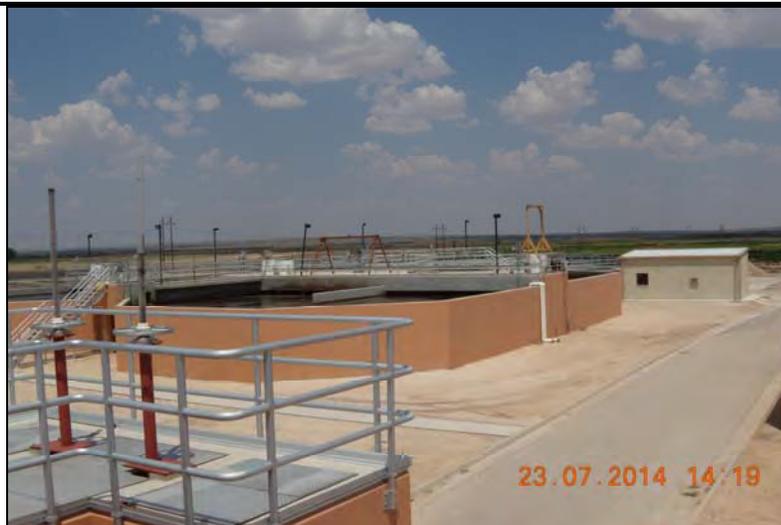
2. Past the influent bar screens and grit removal system, the splitter box gate is improperly designed. Operators could not effectively control the flow of wastewater to the separate aeration basins. Therefore one basin always received a higher portion of the flow than the other. A piece of equipment, an actuator valve replacement, to regulate the flow and improve controls, was on order. At the time of this report being written, the actuator has been installed and operators are more able to control an even split of the raw wastewater to each basin.

Subject: The Splitter box for influent flow was not working properly at the time of the inspection. Operators were unable to control the an even flow to all basins. A replacement piece of equipment, the actuator, was on order. As of the date this report was written, the replacement actuator has been installed, and operators have better control of flows throughout the treatment works. In the distance are the South aeration basins.

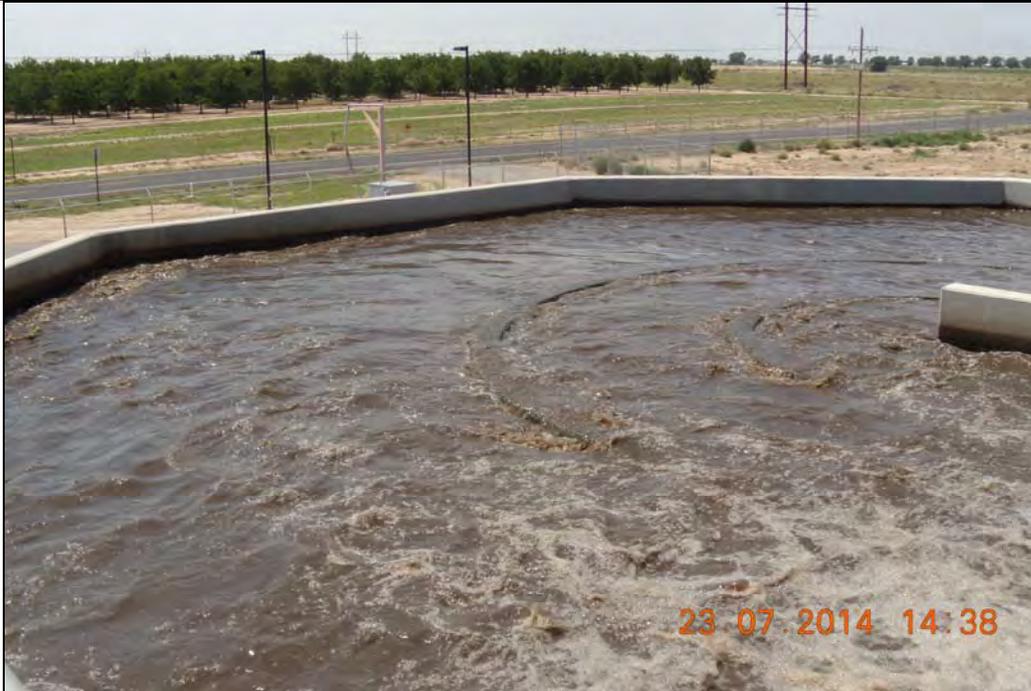
3. The Mixed Liquor Suspended Solids (MLSS) concentration were lower than is typical for this type of treatment system. The north basin concentrations were 1700 mg/L and the south basin concentrations were 1,400 mg/L. Operators indicated that because of the low food to mass ratio (F/M ratio) coming into the treatment plant, they were compensating by limiting the volume of solids being wasted. If this is not managed carefully, the microbial populations typically found in older solids in a basin become less effective in the activated sludge treatment process. The operators are monitoring the microbial populations under a microscope on a weekly basis or more often when needed. The F/M ratio coming into the WWTP is very low as a result of the high volume of industrial waste the facility is accepting from the Navajo Refinery.

Subject: North basin is very dark. Similar to finding in the January 2013 inspection, there is a higher than normal volume being held in the basin. Solids are retained for longer periods than other similar treatment systems, possibly due to the highly dilute influent from the industrial contributor, the Navajo Refinery.

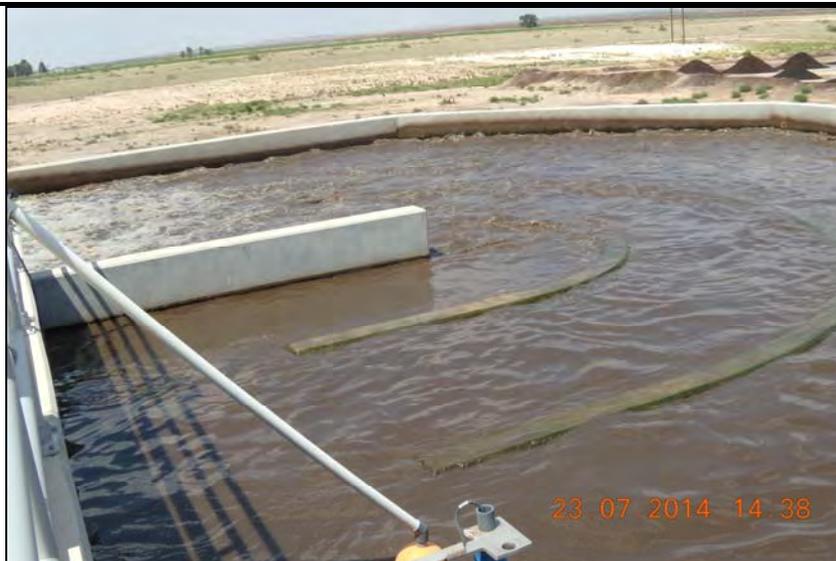
Subject: Aeration basin and anoxic zone. A Dissolved Oxygen (DO) meter is seen in the foreground. According to Operators, the DO meters are old and unreliable.

6. The Dissolved Oxygen (DO) meters in the oxidation ditches were out of order at the time of the inspection. These meters are an important part of monitoring for operational controls. It is advisable for the permittee to either repair or replace the meters.

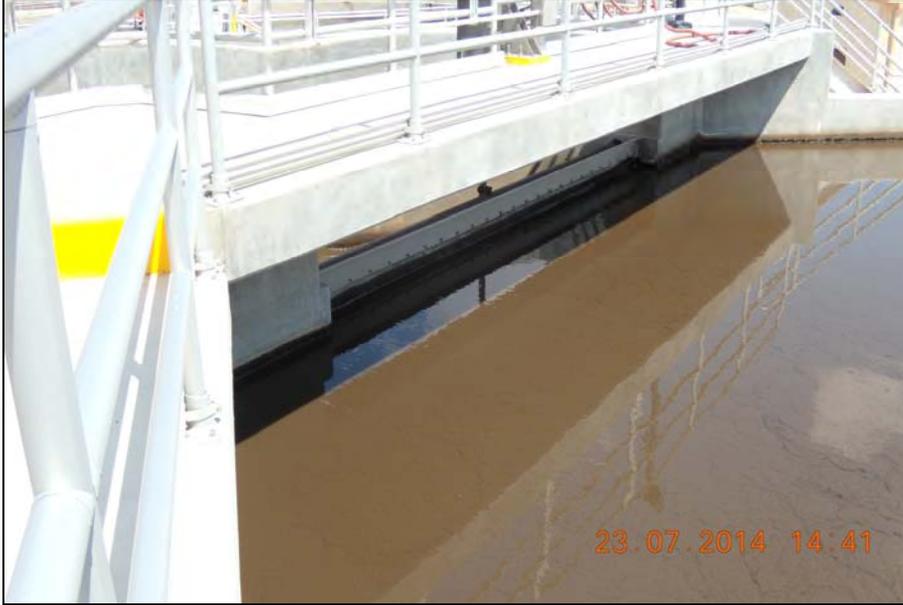
4. Flock shearing was noted in the aeration basins. This is an indication of interference with the optimal activated sludge process. The cause is not specifically identified in this report, however this condition is consistent with an interference occurring from unknown substances in the influent and improper mixing.

Subject: North aeration basin in the settling phase. There is some flock sheer noted in the basin.

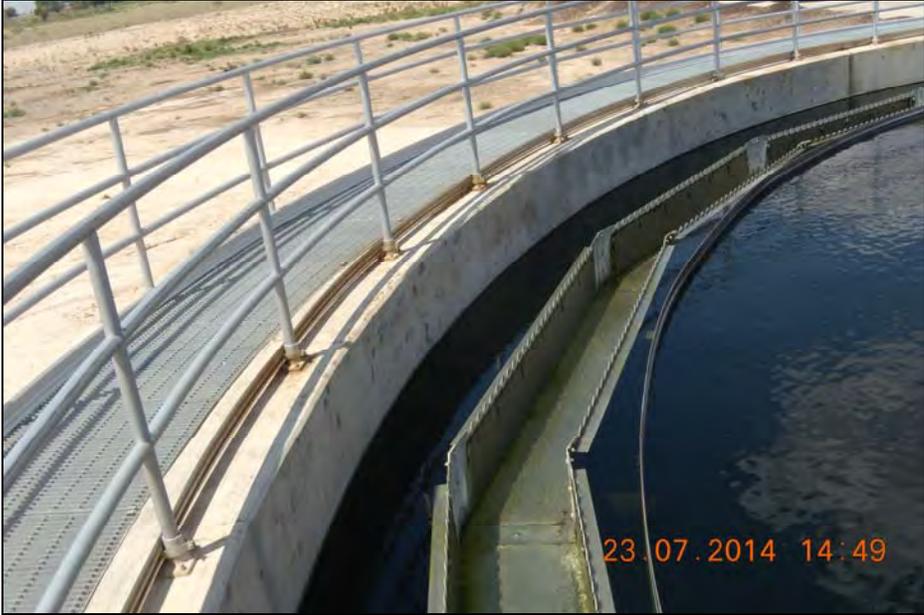
<b>NMED/SWQB Official Photograph Log Photo # 17</b>		
Photographer: B. Cooney	Date: 23 July 2014	Time: 14:49 Hours
City/County: Artesia/ Eddy County		State: New Mexico
Location: Artesia WWTP		
Subject: Secondary Clarifier weirs were clean and free of algae and debris. There was not evidence of older solids floating up from the blanket at the bottom of the basin. This is an improvement from the conditions of this unit observed during the January 2013 NMED inspection.

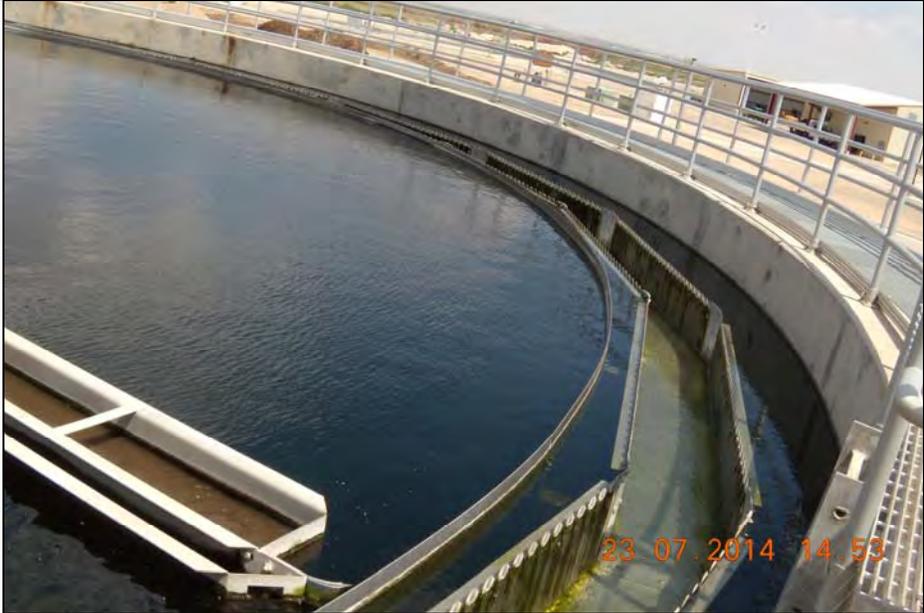
5. Some floating solids and pinfloc were observed in the secondary clarifier, which were being sent with the decant to the next treatment process, ultraviolet disinfection.

<b>NMED/SWQB Official Photograph Log Photo # 18</b>		
Photographer: B. Cooney	Date: 23 July 2014	Time: 14:53 Hours
City/County: Artesia/ Eddy County		State: New Mexico
Location: Artesia WWTP		
Subject: Another view of the Secondary Clarifier shows the weirs in the other direction and around the other side of the basin are also clean and for the most part free of debris and there is an even flow throughout. A slight amount of floating solids does appear near the sweeper arm and does escape the unit with the decant.

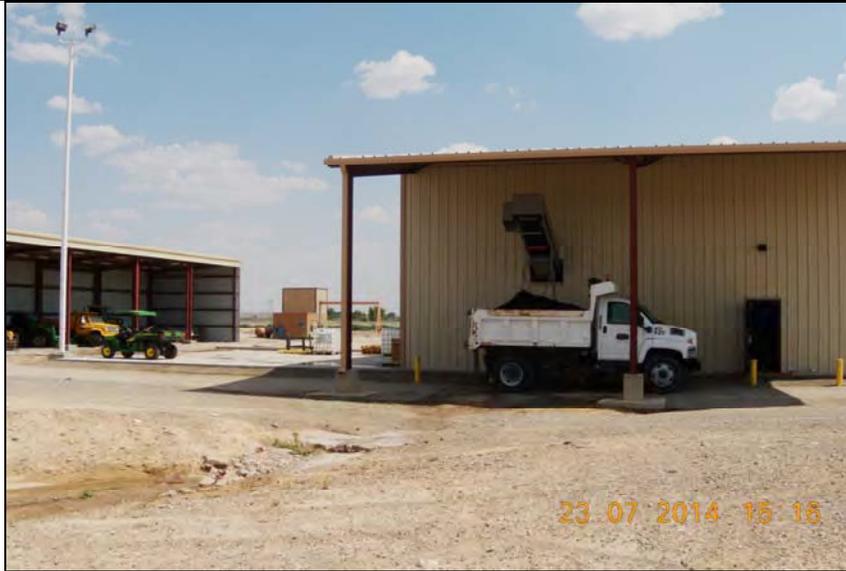
12. A drainage canal through the property to an outside area off-property was observed. The drainage canal goes to a playa lake outside the fenced area and towards the Pecos River. This was noted in the previous reports.

Subject: The larger building is where the sludge belt press is housed and hauling truck area. Visible in this photo is also a drainage area directly from the belt press building that is channelized to flow off the property to a playa lake.

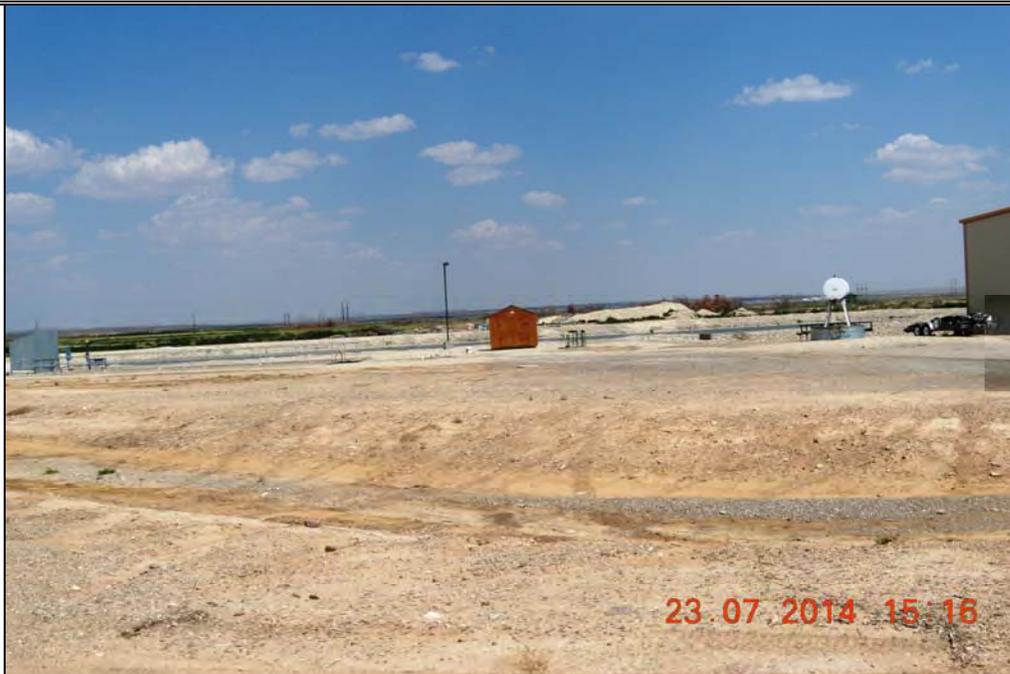
Subject: Continuing from the previous photo; visible in this photo is also a drainage area directly from the belt press building that is channelized to flow off the property to a playa lake.

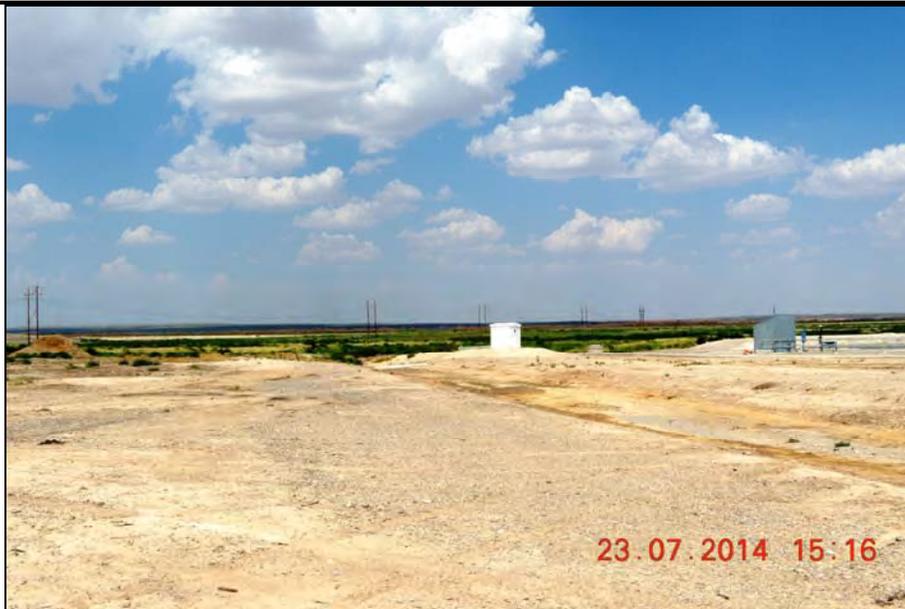
Subject: Continuing from the previous photo; visible in this photo is also a drainage area directly from the belt press building that is channelized to flow off the property to a playa lake.

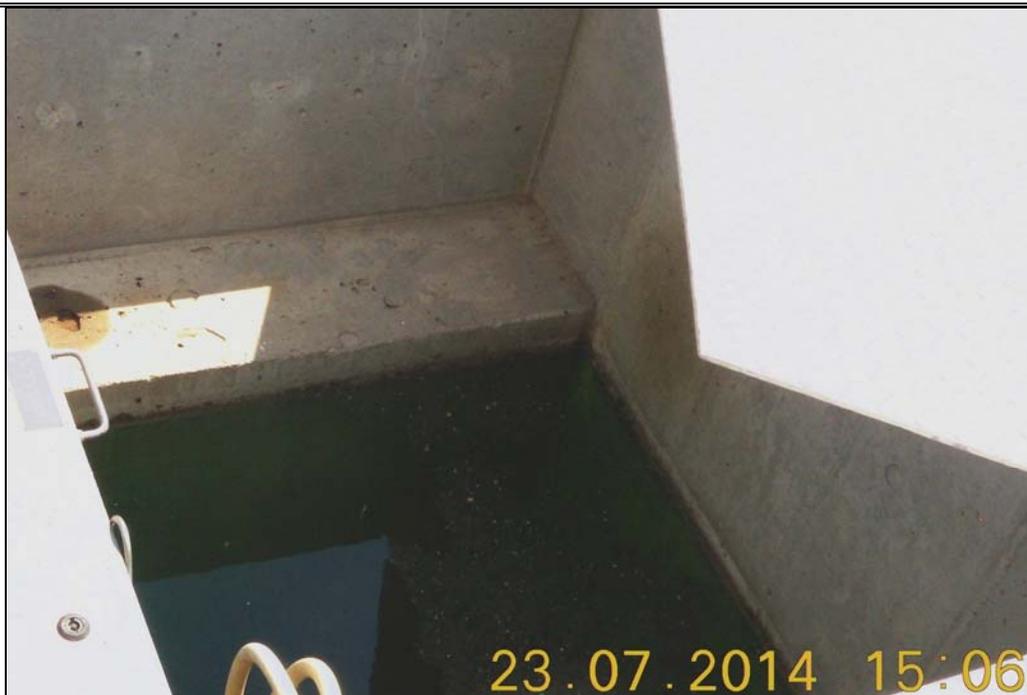
2. Floating solids were noted at the ultraviolet disinfection basin, and slight amounts were also observed making it through the outfall.

Subject: Treated wastewater entering the Ultraviolet Disinfection Unit has floating solids present.

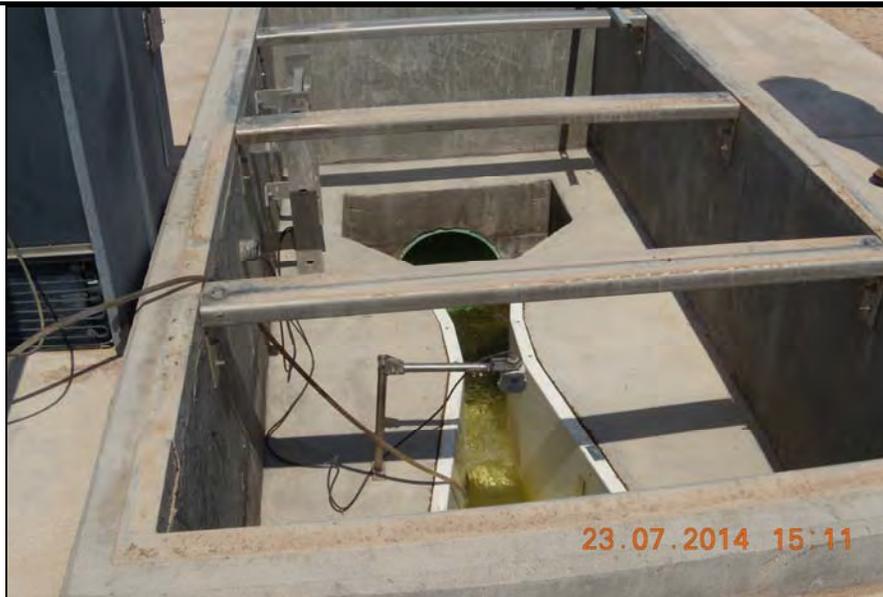
1. The effluent flow meter is improperly installed. The meter cannot be used for flow measurements. Influent flow is being used for reporting. This is a repeat finding. Engineers for the facility met with NMED on July 30, 2014 to discuss plans for improving the effluent meter design so that the problem may be corrected. As of the date this report is written, changes have not been made.

Subject: Effluent Parshall Flume – There is considerable turbulence due to the design of the pipe out of the flume area that is causing back flow into the flow monitoring area. A smooth laminar flow is necessary for accurate flow reading. This flow meter location cannot be verified to meet the requirement of being within 10% of the actual flow. IN part, the cause of the problem is that during the construction of the Plant, a change was made to the engineering design from the original plans, creating the hydraulic back up.

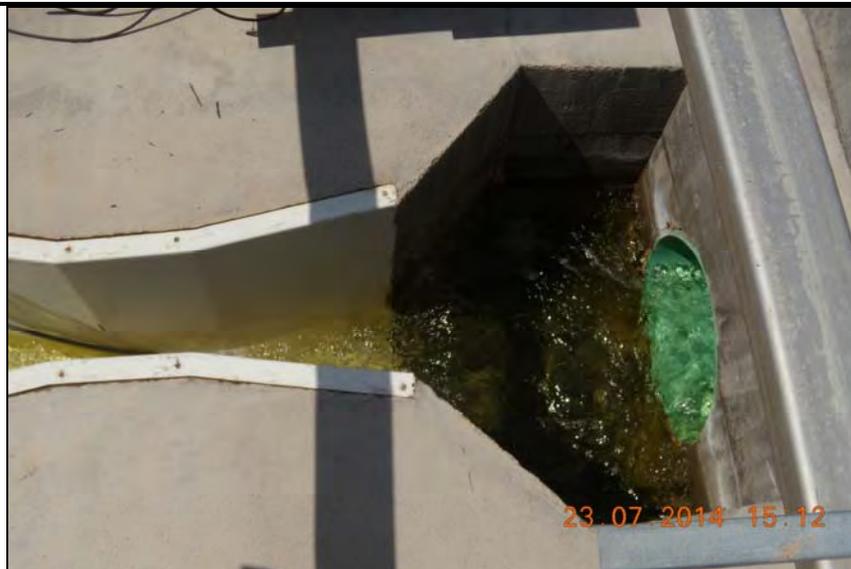
Subject: Another view: Effluent Parshall Flume – There is considerable turbulence due to the design of the pipe out of the flume area that is causing back flow into the flow monitoring area. A smooth laminar flow is necessary for accurate flow reading. This flow meter location cannot be verified to meet the requirement of being within 10% of the actual flow. During the plant construction the engineering design was changed, causing improper hydraulic head, resulting back up flows from the effluent pipe.

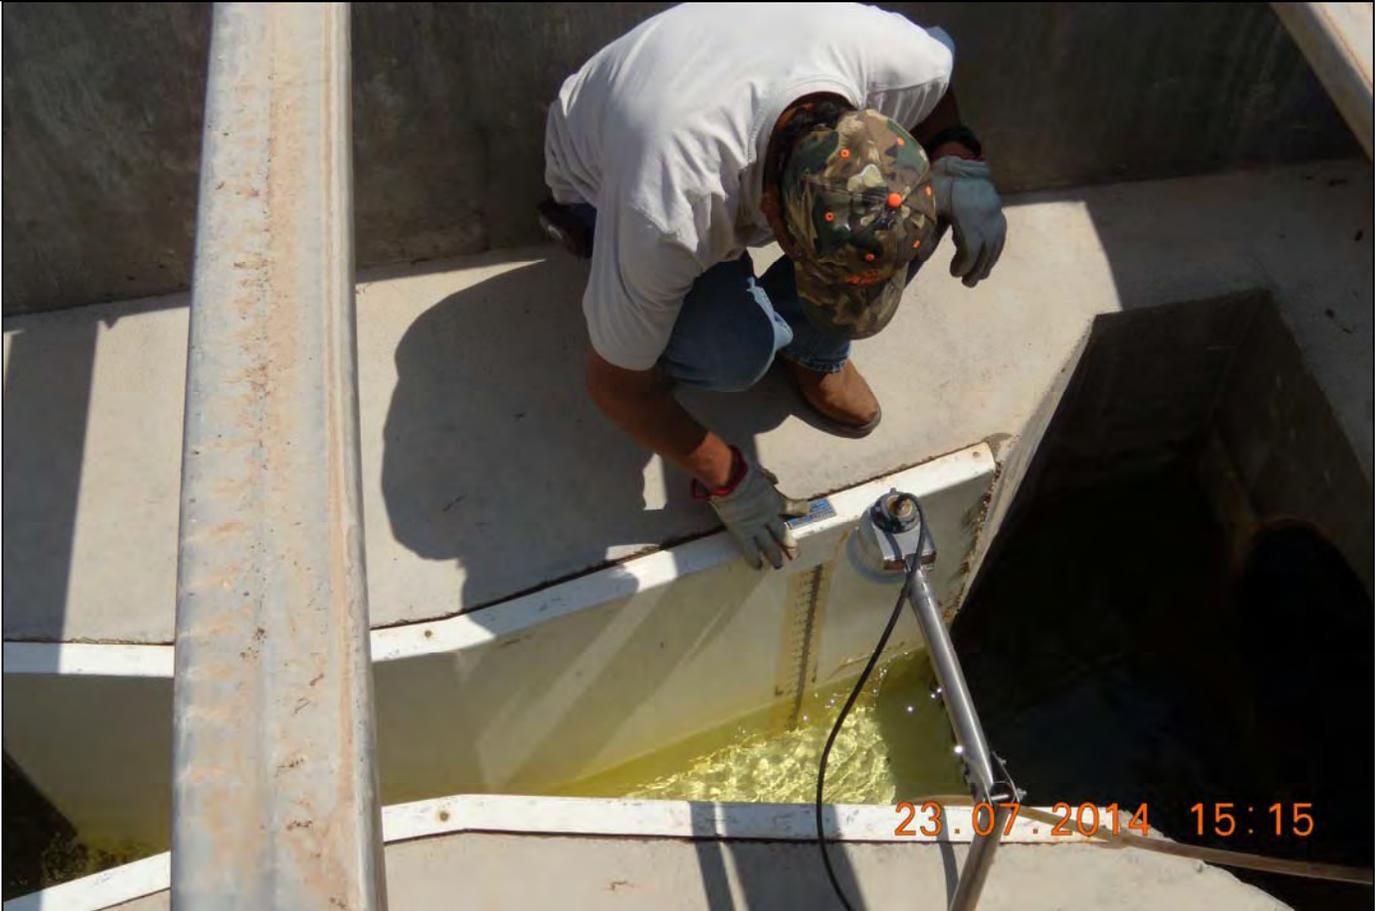
Subject: Effluent Parshall Flume – There is considerable turbulence due to the design of the pipe out of the flume area that is causing back flow into the flow monitoring area. A smooth laminar flow is necessary for accurate flow reading. This flow meter location cannot be verified to meet the requirement of being within 10% of the actual flow.

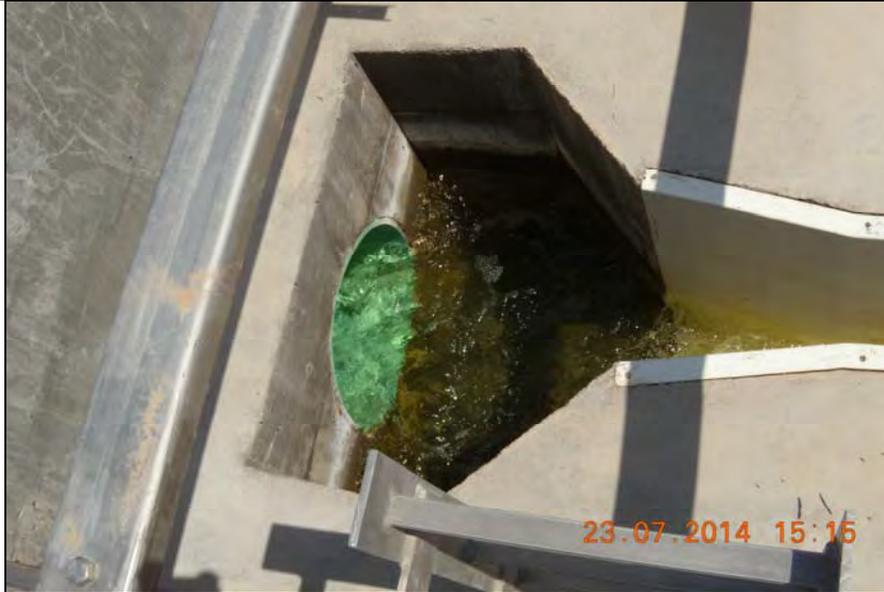
Subject: Effluent Parshall Flume – There is considerable turbulence due to the design of the pipe out of the flume area that is causing back flow into the flow monitoring area. A smooth laminar flow is necessary for accurate flow reading. This flow meter location cannot be verified to meet the requirement of being within 10% of the actual flow.

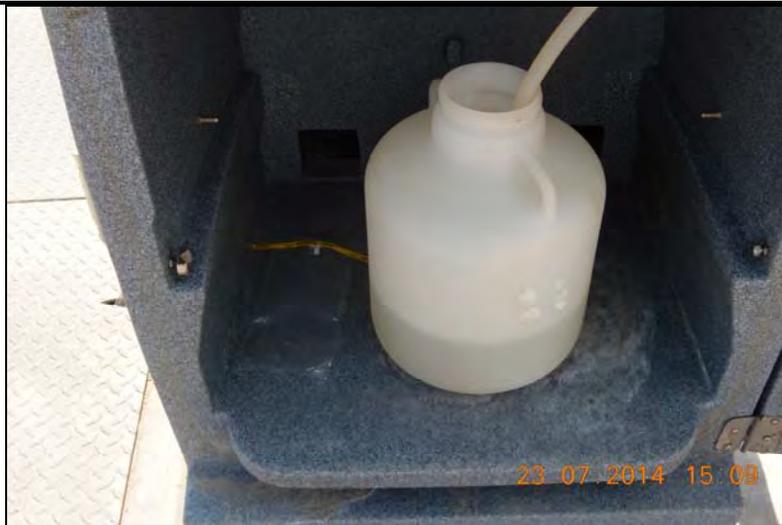
Subject: The ISCO Composite Sampler at the effluent. This sampler has a digital thermometer. There was not a backup thermometer in the sample chamber at the time of the inspection.

1. The ISCO composite sampler at the effluent weir was observed. There was no back up thermometer in the sampling chamber. The unit's digital thermometer read 4.7 degrees centigrade. It is advisable for quality assurance purposes to have a back up mercury thermometer as well.
2. There were no other adverse findings in the records or for laboratory procedures.

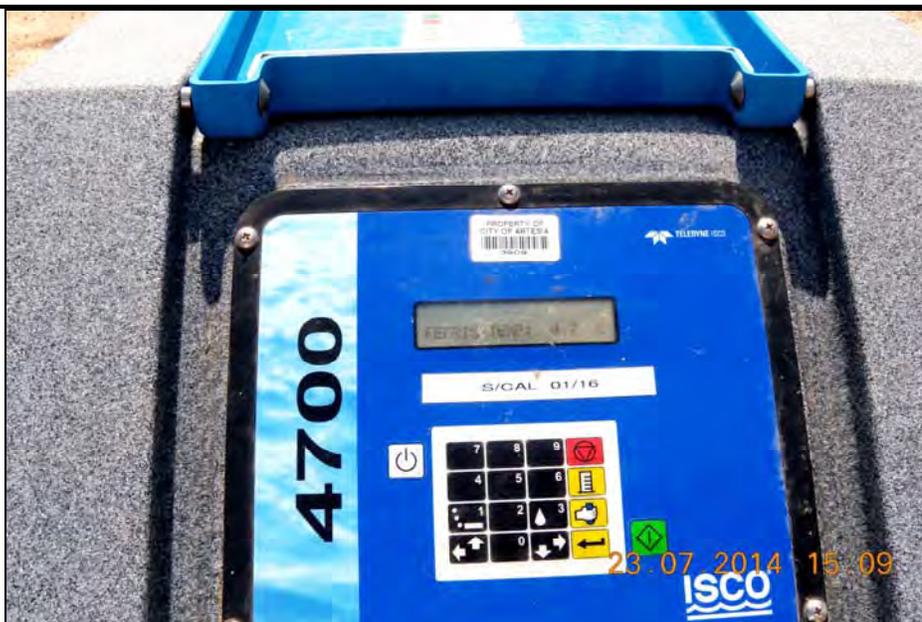
Subject: The ISCO Composite Sampler at the effluent. This sampler has a digital thermometer. There was not a backup thermometer in the sample chamber at the time of the inspection. The digital reading was 4.7 degrees centigrade.
