## NEW MEXICO ENVIRONMENT DEPARTMENT

**Re: Chevron Mining, Inc. (CMI), Questa Mine; Major Individual Permit; SIC 1061; NPDES Reconnaissance Inspections; NM0022306; June 2 and July 13, 2016**

**NPDES Compliance Inspection Report**

**Chevron Mining Inc. - Questa Mine  
NPDES Permit No. NM0022306  
Reconnaissance Inspections  
June 2, 2016 and July 13, 2016**

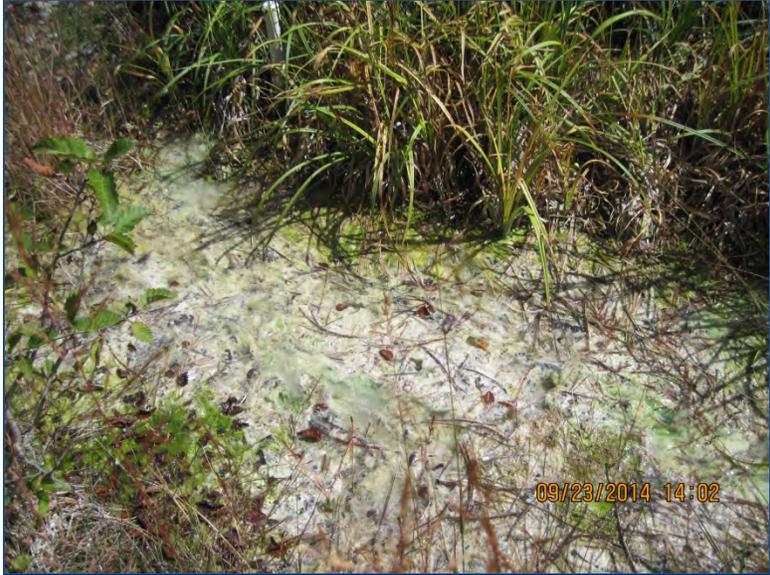
<b>NMED/SWQB Official Photograph Log Photo # 2 of 2014 CEI Report</b>		
Photographer: Erin S. Trujillo	Date: 09/23/2014	Time: 1402 hours
City/County: East of Questa / Taos County		State: New Mexico
Location: CMI Questa Mine, Spring 39 Seepage Interception System Area		
Subject: Visible white precipitate and surface water at Spring 39 Seepage Interception System.

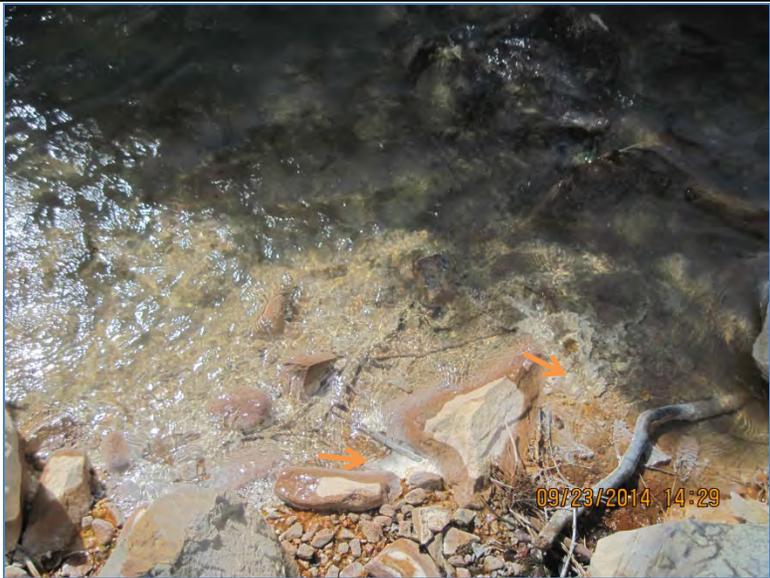
<b>NMED/SWQB Official Photograph Log Photo # 4 of 2014 CEI Report</b>		
Photographer: Erin S. Trujillo	Date: 09/23/2014	Time: 1429 hours
City/County: East of Questa / Taos County		State: New Mexico
Location: CMI Questa Mine, Adjacent to Spring 13 Seepage Interception System Area, Along bank of Red River		
Subject: Arrows point to examples of visible white precipitate in Red River.

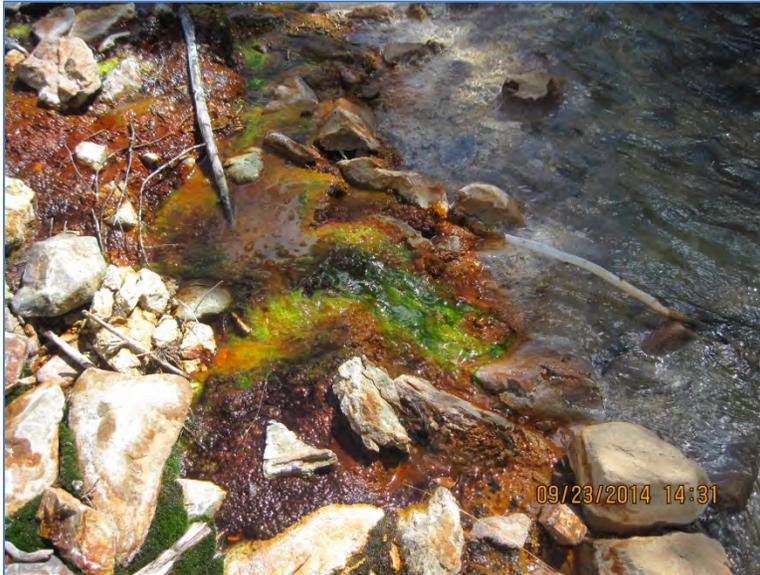
<b>NMED/SWQB Official Photograph Log Photo # 5 of 2014 CEI Report</b>		
Photographer: Erin S. Trujillo	Date: 09/23/2014	Time: 1431 hours
City/County: East of Questa / Taos County		State: New Mexico
Location: CMI Questa Mine, Downstream of Spring 13 Seepage Interception System Area		
Subject: Example of red (rusty in color) slimy deposits, possibly iron bacteria at seep along bank of Red River. Green algal growth mat at seep may be from increased nutrients (nitrogen and phosphorus).

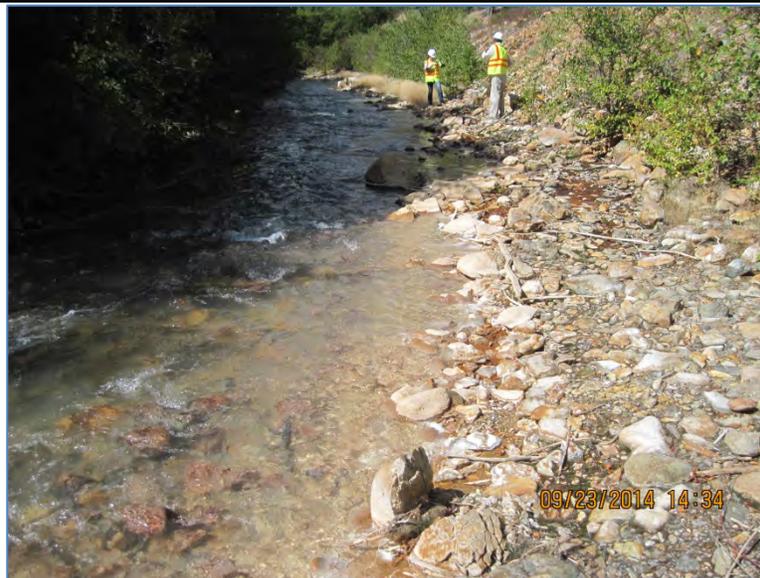
<b>NMED/SWQB Official Photograph Log Photo # 7 of 2014 CEI Report</b>		
Photographer: Erin S. Trujillo	Date: 09/23/2014	Time: 1434 hours
City/County: East of Questa / Taos County		State: New Mexico
Location: CMI Questa Mine, Downstream of Spring 13 Seepage Interception System Area.		
Subject: Looking downstream at Red River.

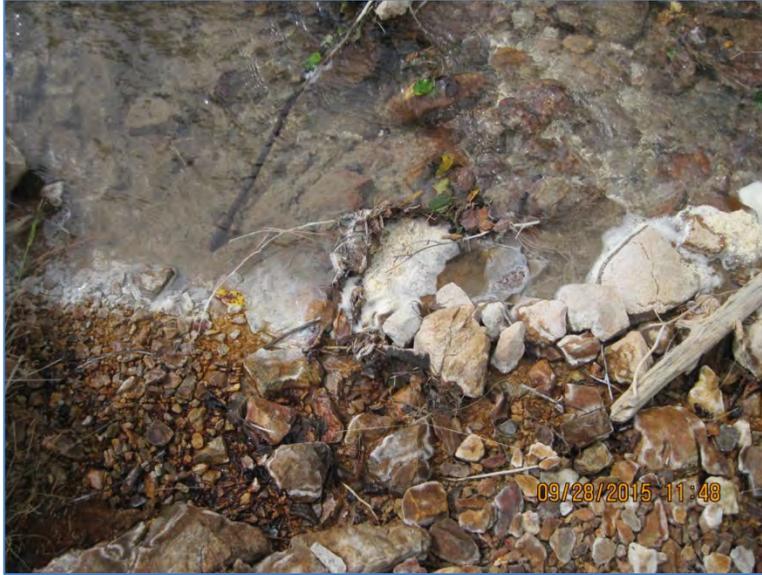
<b>NMED/SWQB          Official Photograph Log          Photo # 3 of 2015 CEI Report</b>		
Photographer: Erin S. Trujillo	Date: 09/28/2015	Time: 1148 hours
City/County: East of Questa / Taos County		State: New Mexico
Location: CMI Questa Mine, Downstream of Spring 13 Seepage Interception System Area, North bank of Red River		
Subject: Examples of visible white precipitate and white with brown foam along water's edge of Red River. A brown color on this type of foam is an indicator that the source is not from man-made commercial detergents.

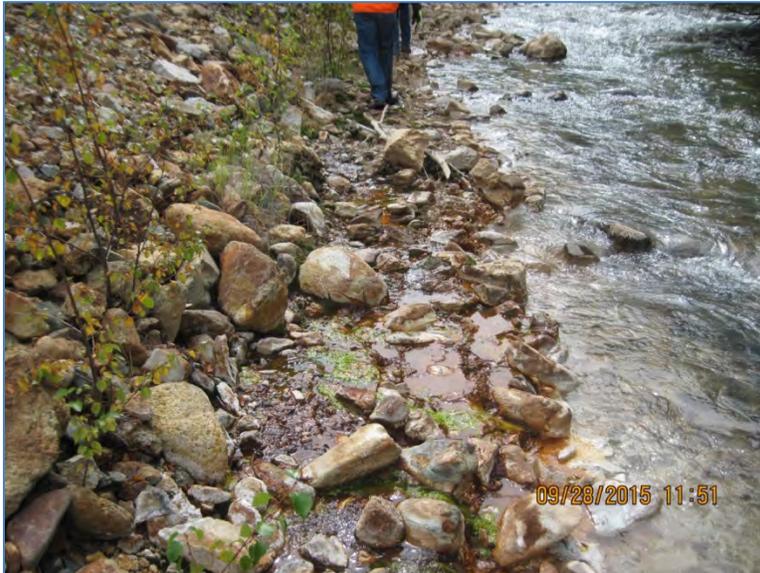
<b>NMED/SWQB          Official Photograph Log          Photo # 4 of 2015 CEI Report</b>		
Photographer: Erin S. Trujillo	Date: 09/28/2015	Time: 1151 hours
City/County: East of Questa / Taos County		State: New Mexico
Location: CMI Questa Mine, Downstream of Spring 13 Seepage Interception System Area, Along north bank		
Subject: Looking upstream (generally east), example of red (rusty in color) slimy deposits, possibly iron bacteria; and green algal growth mats at seep along bank of Red River. Algal growth may be from increased nutrients (nitrogen and phosphorus).

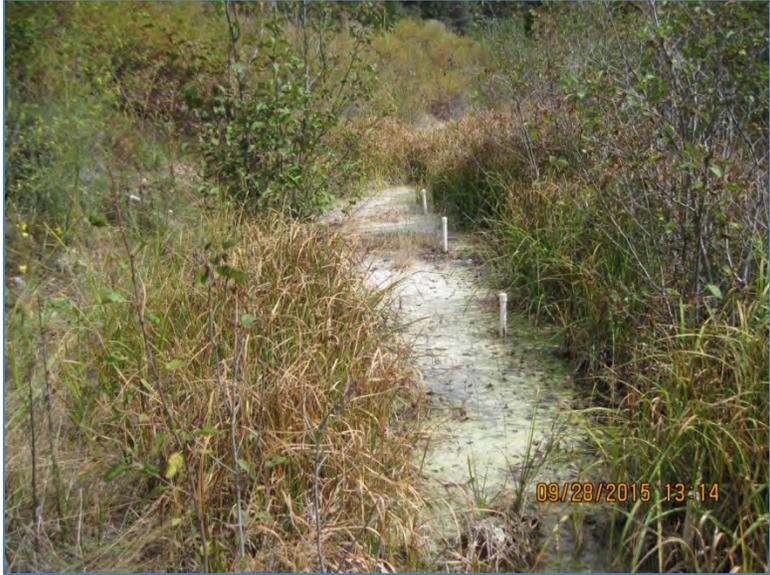
<b>NMED/SWQB          Official Photograph Log          Photo # 5 of 2015 CEI Report</b>		
Photographer: Erin S. Trujillo	Date: 09/28/2015	Time: 1314 hours
City/County: East of Questa / Taos County		State: New Mexico
Location: CMI Questa Mine, Spring 39 Seepage Interception System Area		
Subject: Visible white precipitates (aluminum hydroxide) on surface water, and PVC pipe for trench system at Spring 39 Seepage Interception System.

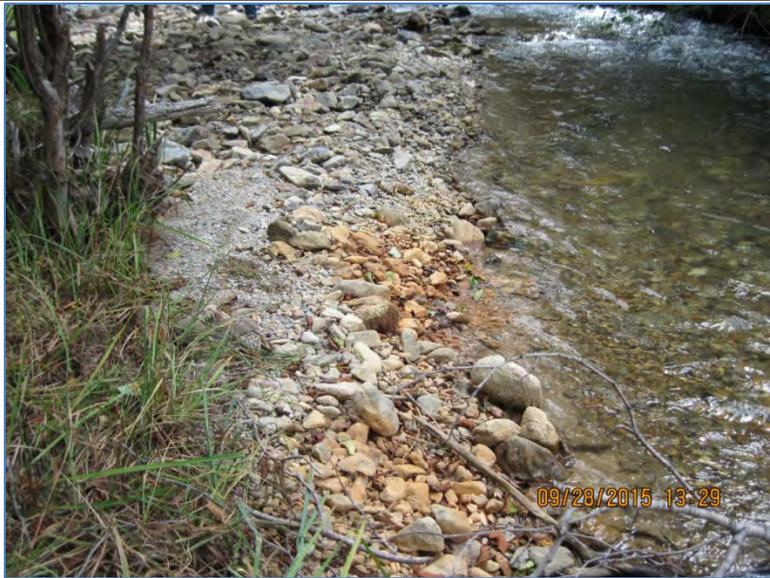
<b>NMED/SWQB          Official Photograph Log          Photo # 6 of 2015 CEI Report</b>		
Photographer: Erin S. Trujillo	Date: 09/28/2015	Time: 1329 hours
City/County: East of Questa / Taos County		State: New Mexico
Location: North bank of Red River, Approximately one mile east of CMI Questa Mine Boundary		
Subject: Looking upstream (generally east), dry red, rusty in color, deposits along north bank of Red River.

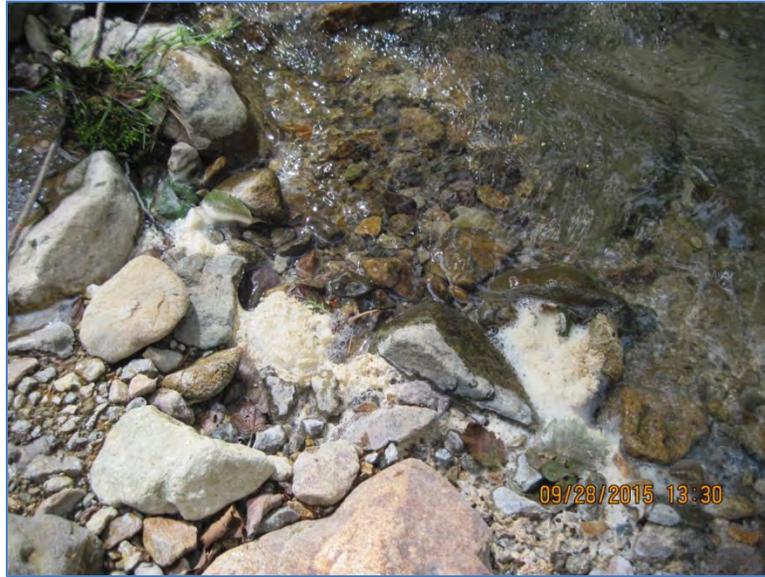
**NMED/SWQB  
Official Photograph Log  
Photo # 7 of 2015 CEI Report**

Photographer: Erin S. Trujillo	Date: 09/28/2015	Time: 1330 hours
City/County: East of Questa / Taos County	State: New Mexico	
Location: North bank of Red River, Approximately one mile east and upstream of CMI Questa Mine Boundary		
Subject: White with brown foam along north bank of Red River. A brown color on this type of foam is an indicator that the source is not from man-made commercial detergents.

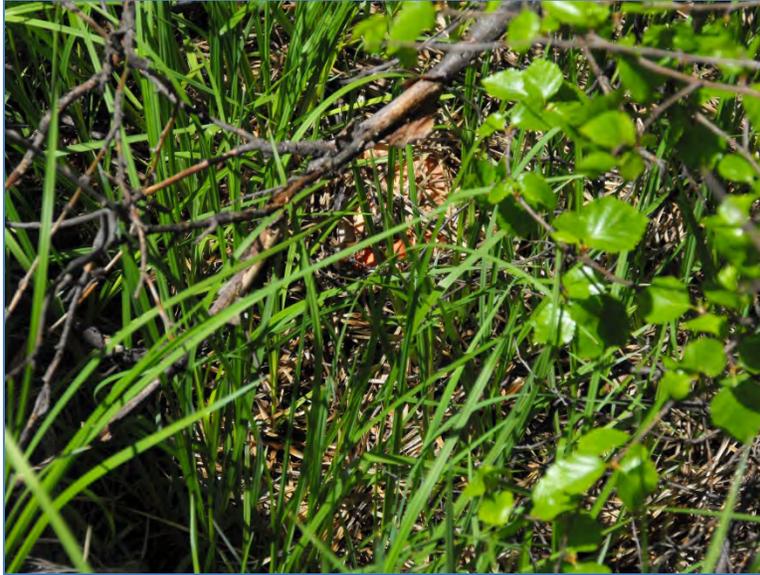
<b>NMED/SWQB Official Photograph Log Photo # 1</b>		
Photographer: Daniel Valenta	Date: 06/02/2016 (013)	Time: 1119 hours
City/County: East of Questa / Taos County		State: New Mexico
Location: Red River Floodplain, Approximately one mile east and upstream of CMI Questa Mine Boundary		
Subject: Red (rusty in color) deposits, possibly iron bacteria in floodplain.

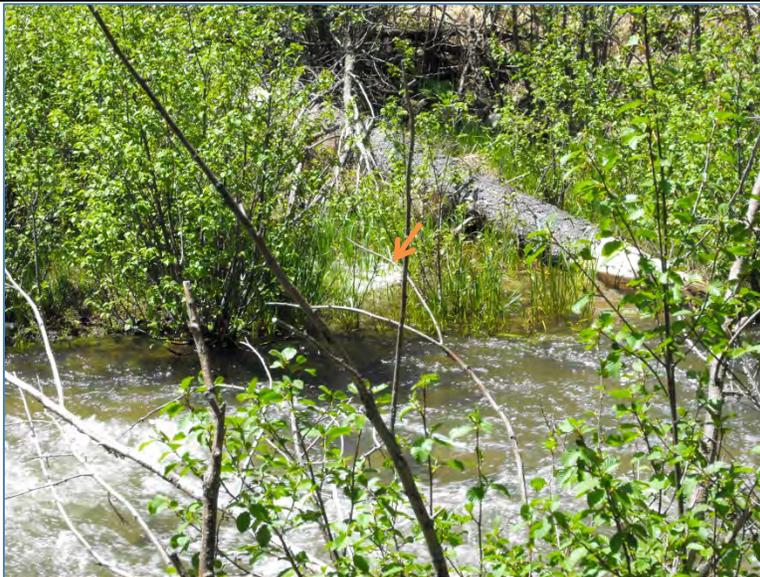
<b>NMED/SWQB Official Photograph Log Photo # 2</b>		
Photographer: Daniel Valenta	Date: 06/02/2016 (016)	Time: 1120 hours
City/County: East of Questa / Taos County		State: New Mexico
Location: From north bank of Red River, Approximately one mile east and upstream of CMI Questa Mine Boundary		
Subject: Arrow points to what appeared to be white foam, possibly aluminum hydroxide precipitates, on opposite stream bank.

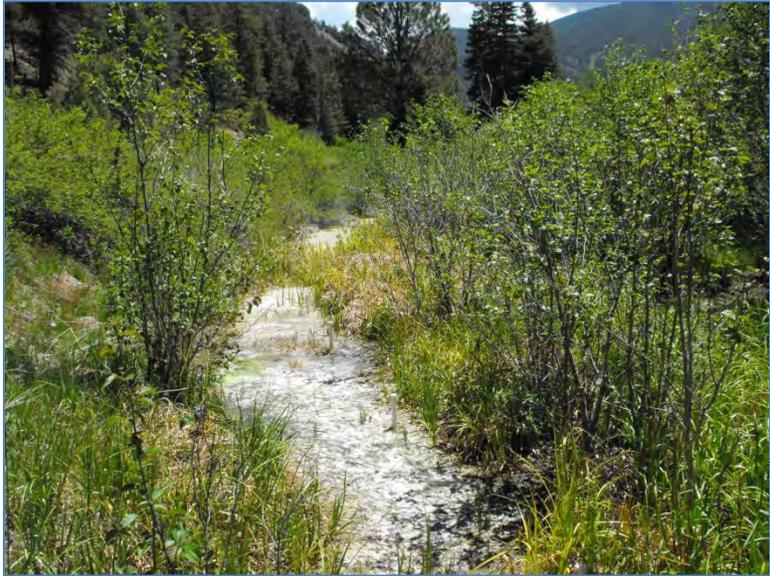
<b>NMED/SWQB Official Photograph Log Photo # 3</b>		
Photographer: Daniel Valenta	Date: 06/02/2016 (055)	Time: 1200 hours
City/County: East of Questa / Taos County		State: New Mexico
Location: CMI Questa Mine, Spring 39 Seepage Interception System Area		
Subject: Flowing water and floating visible white precipitates (aluminum hydroxide), and PVC pipe for trench system. See similar observations in Photo # 2 of 2014 CEI Report and Photo #5 of 2015 CEI Report above. Near location shown in 07/13/2016 Photo #13 below.

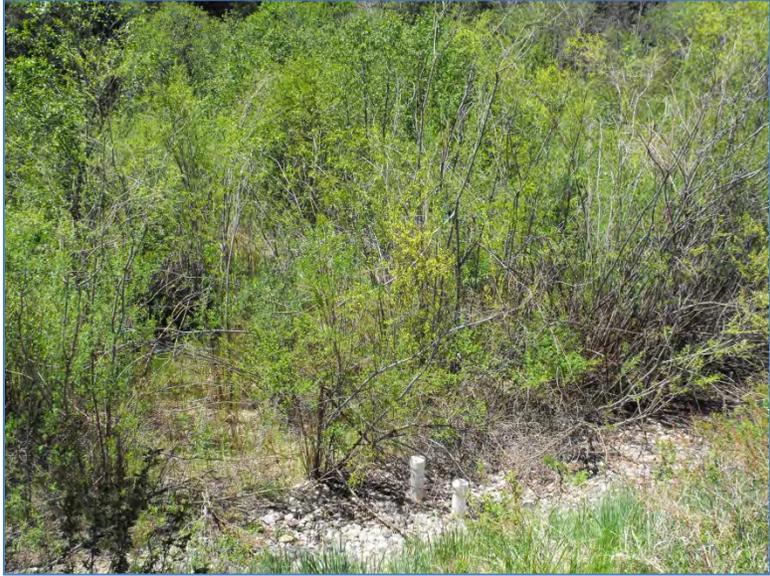
<b>NMED/SWQB Official Photograph Log Photo # 4</b>		
Photographer: Daniel Valenta	Date: 06/02/2016 (059)	Time: 1203 hours
City/County: East of Questa / Taos County		State: New Mexico
Location: CMI Questa Mine, Spring 39 Seepage Interception System Area		
Subject: Upper Spring 39 Seepage Interception System Area was dry at ground surface.

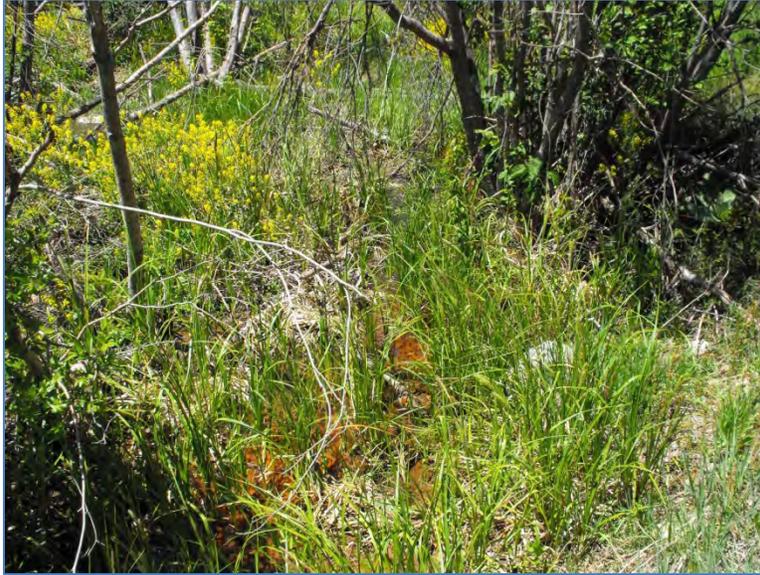
<b>NMED/SWQB Official Photograph Log Photo # 5</b>		
Photographer: Daniel Valenta	Date: 06/02/2016 (066)	Time: 1212 hours
City/County: East of Questa / Taos County		State: New Mexico
Location: CMI Questa Mine, Near Spring 39 Seepage Interception System Area		
Subject: Red (rusty in color) slimy deposits, possibly iron bacteria, in floodplain between Spring 39 and Red River. Similar observations upstream of CMI Questa Mine Boundary were observed as shown in 06/02/2016 Photo # 1 above.

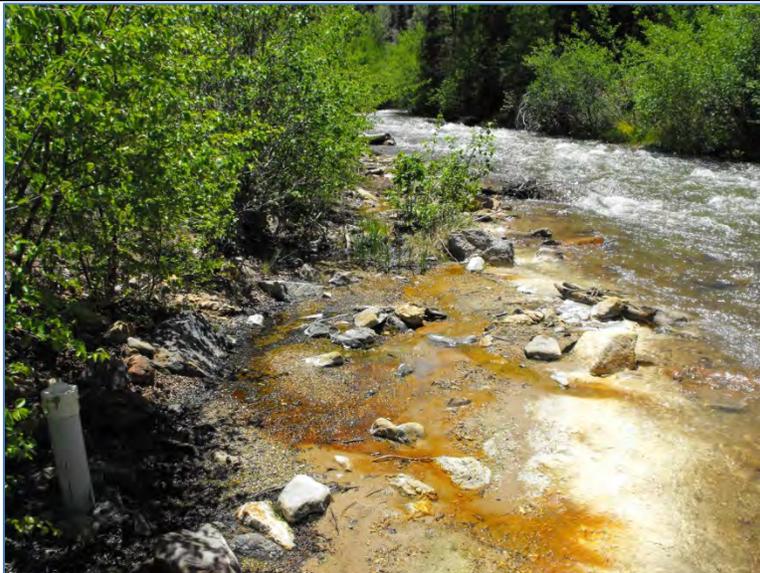
<b>NMED/SWQB Official Photograph Log Photo # 6</b>		
Photographer: Daniel Valenta	Date: 06/02/2016 (080)	Time: 1245 hours
City/County: East of Questa / Taos County		State: New Mexico
Location: CMI Questa Mine, Near Spring 13 Seepage Interception System Area, Along north bank of Red River		
Subject: Looking upstream, example of red (rusty in color) slimy deposits, possibly iron bacteria at seep along bank of Red River. PVC pipe is cleanout for Spring 13 seepage interception system. Near location shown in 07/13/2016 Photos #11 and 12 below.

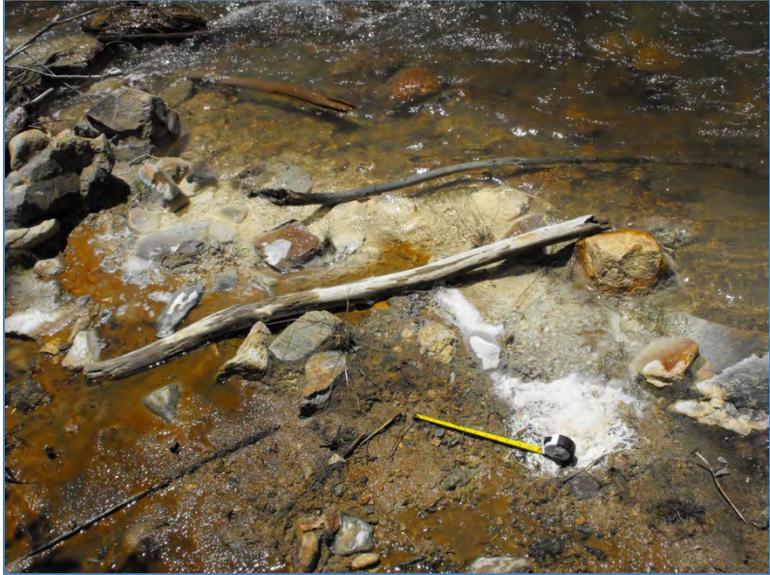
<b>NMED/SWQB          Official Photograph Log          Photo # 7</b>		
Photographer: Daniel Valenta	Date: 06/02/2016 (090)	Time: 1248 hours
City/County: East of Questa / Taos County		State: New Mexico
Location: CMI Questa Mine, Near Spring 13 Seepage Interception System Area, North bank of Red River		
Subject: Example of aluminum precipitates and red (rusty in color) slimy deposits, possibly iron bacteria at waters edge. Similar observations shown in Photo #3 of 2014 CEI Report.

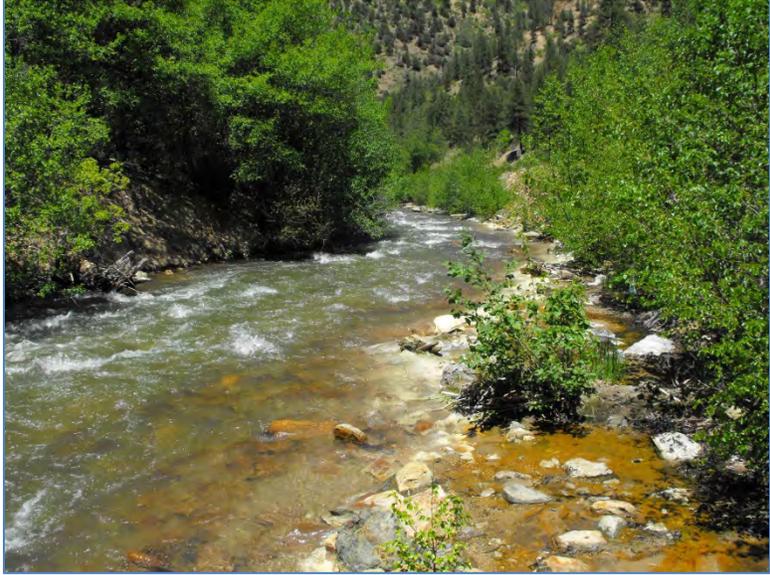
<b>NMED/SWQB          Official Photograph Log          Photo # 8</b>		
Photographer: Daniel Valenta	Date: 06/02/2016 (093)	Time: 1250 hours
City/County: East of Questa / Taos County		State: New Mexico
Location: CMI Questa Mine, Near Spring 13 Seepage Interception System Area, Along bank of Red River		
Subject: Looking downstream at Red River. Near location shown in Photo # 7 of 2014 CEI Report above.

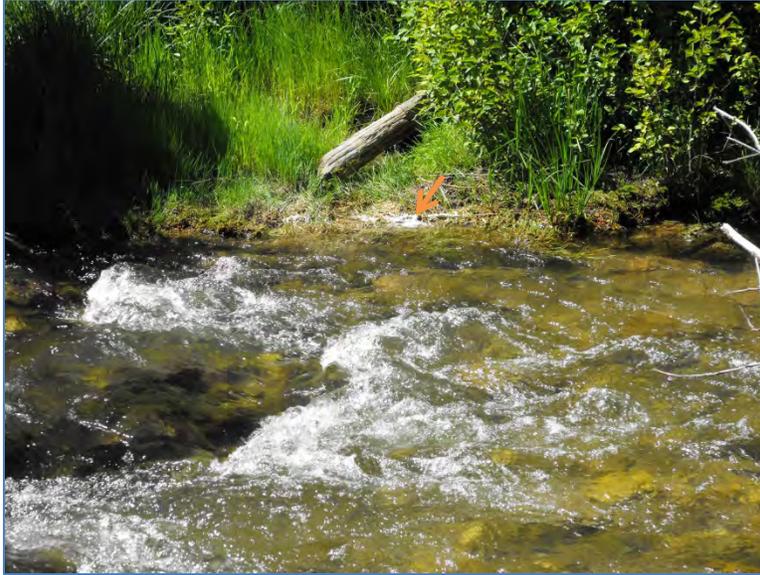
<b>NMED/SWQB          Official Photograph Log          Photo # 9</b>		
Photographer: Daniel Valenta	Date: 07/13/2016 (010)	Time: 1032 hours
City/County: East of Questa / Taos County		State: New Mexico
Location: Red River, Approximately one mile east and upstream of CMI Questa Mine Boundary		
Subject: Arrow points to what appeared to be white foam, possibly aluminum hydroxide precipitates, on opposite stream bank. Similar observations were made on 06/02/2016 (see Photo #2 above)

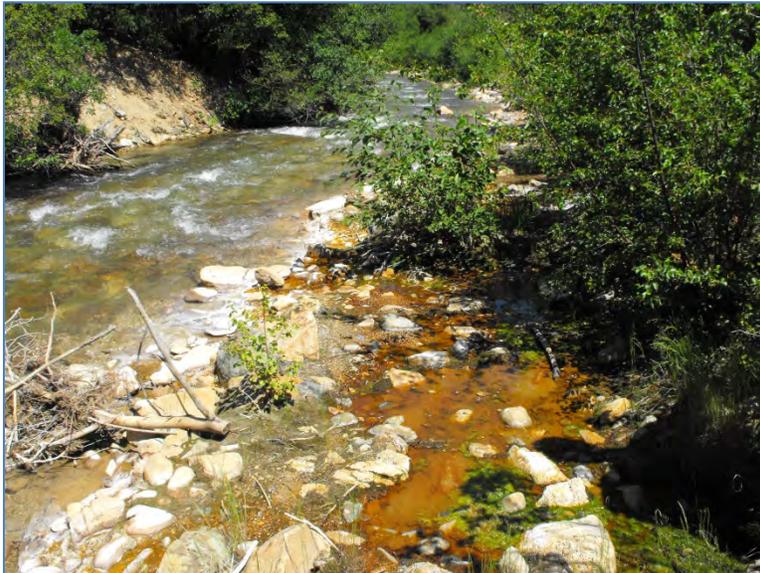
<b>NMED/SWQB          Official Photograph Log          Photo # 10</b>		
Photographer: Daniel Valenta	Date: 07/13/2016 (032)	Time: 1125 hours
City/County: East of Questa / Taos County		State: New Mexico
Location: CMI Questa Mine, Near Spring 13 Seepage Interception System Area, Along bank of Red River		
Subject: Looking downstream at Red River at red (rusty in color) slimy deposits and green algal growth mats at waters edge. Near location shown in Photo # 7 of 2014 CEI Report and 06/02/2016 Photo #8 above.

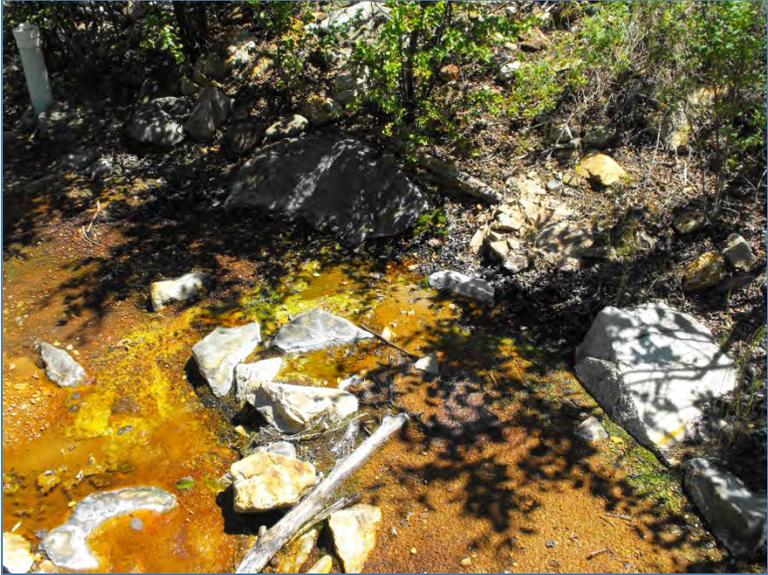
<b>NMED/SWQB Official Photograph Log Photo # 11</b>		
Photographer: Daniel Valenta	Date: 07/13/2016 (034)	Time: 1125 hours
City/County: East of Questa / Taos County		State: New Mexico
Location: CMI Questa Mine, Near Spring 13 Seepage Interception System Area, North bank of Red River		
Subject: Red (rusty in color) slimy deposits and green algal growth mats at seep.

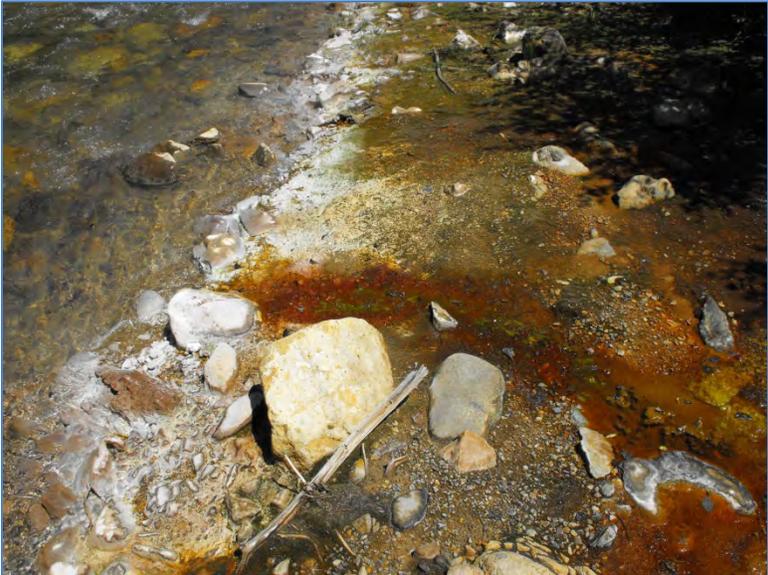
<b>NMED/SWQB Official Photograph Log Photo # 12</b>		
Photographer: Daniel Valenta	Date: 07/13/2016 (034)	Time: 1125 hours
City/County: East of Questa / Taos County		State: New Mexico
Location: CMI Questa Mine, Near Spring 13 Seepage Interception System Area, Along bank of Red River		
Subject: Flow from seep shown in photo above entering Red River.

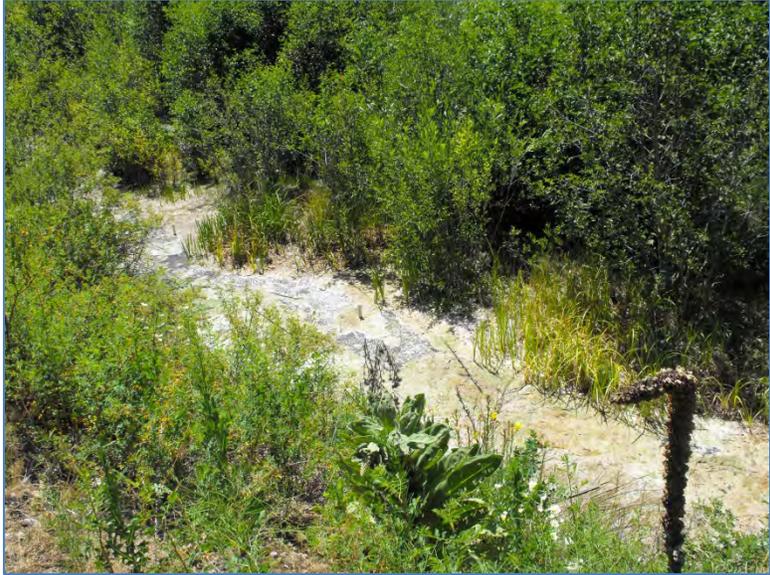
<b>NMED/SWQB          Official Photograph Log          Photo # 13</b>		
Photographer: Daniel Valenta	Date: 07/13/16 (041)	Time: 1135 hours
City/County: East of Questa / Taos County		State: New Mexico
Location: CMI Questa Mine, Spring 39 Seepage Interception System Area		
Subject: Looking from roadway embankment, flowing and floating visible white precipitates (aluminum hydroxide), and PVC pipe for trench system at Spring 39 Seepage Interception System. Near location shown in Photo #3 above.

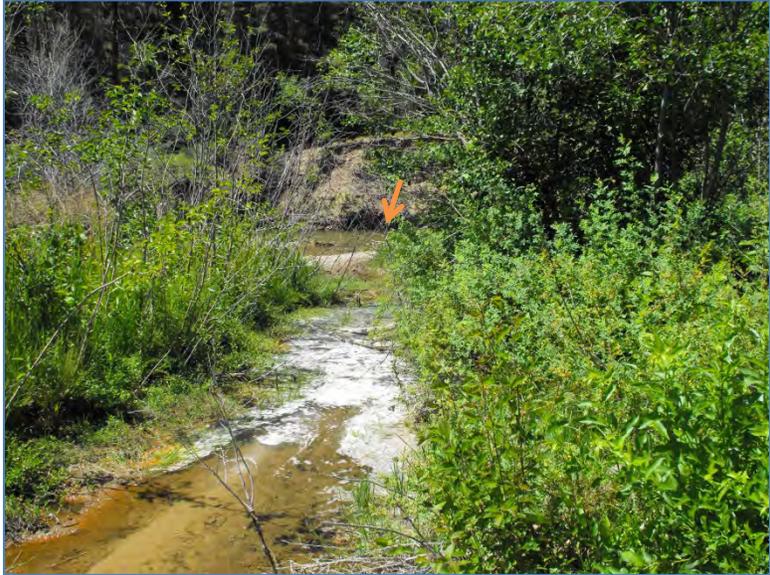
<b>NMED/SWQB          Official Photograph Log          Photo # 14</b>		
Photographer: Daniel Valenta	Date: 07/13/2016 (042)	Time: 1137 hours
City/County: East of Questa / Taos County		State: New Mexico
Location: CMI Questa Mine, Near Spring 39 Seepage Interception System Area		
Subject: Visible white precipitate flowing in channel downstream of Spring 39 Seepage Interception System toward Red River. Arrow points to Red River in photo background.
