Re: **Minor Municipal; SIC 4952; NPDES Compliance Evaluation Inspection; Abiquiu MDWCA; NM0024830; June 26, 2012**

NPDES Compliance Inspection Report

**Compliance Evaluation Inspection
Abiquiu Wastewater Treatment Facility
NPDES Permit No. NM0024830
June 26, 2012**

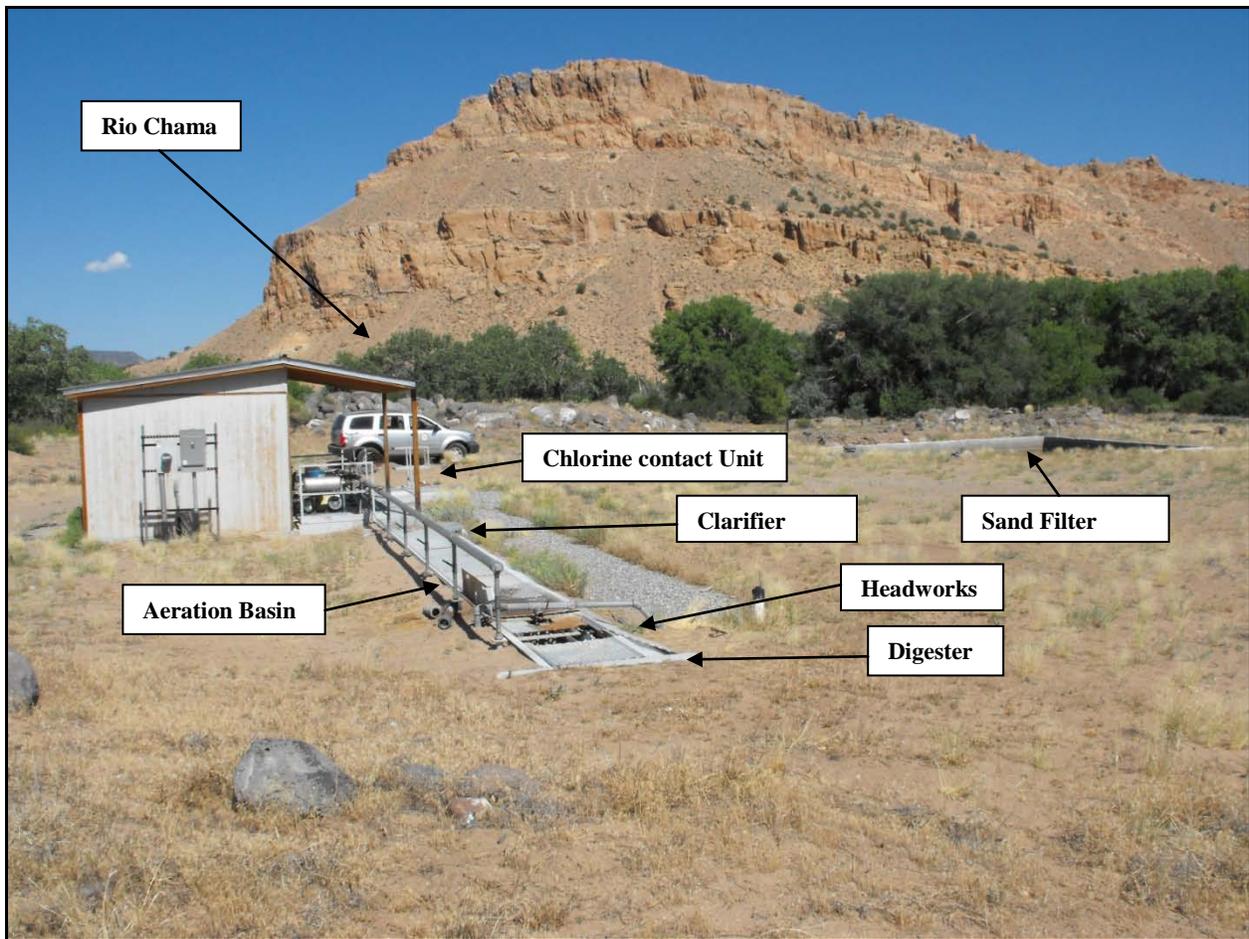
Photo # 1

Photographer: Daniel Valenta	Date: 6/26/2012	Time: 1005
City/County: Abiquiu/ Rio Arriba		
Location: Behind the store located at 21196 U.S. 84 Abiquiu, NM 87510, facing west.		
Subject: Waste Water Treatment facility in Abiquiu, New Mexico

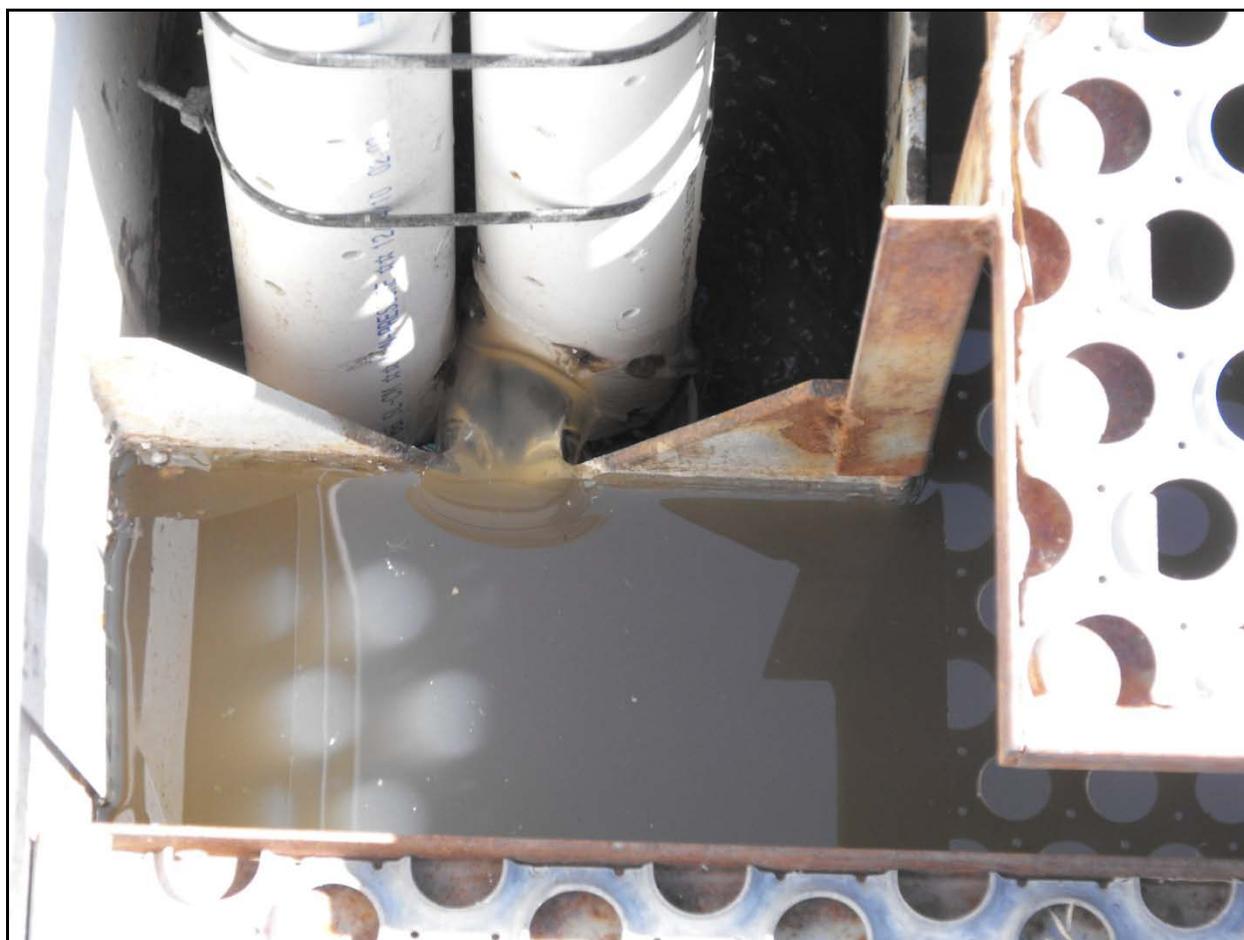
Photo #2

The chlorine contact chamber consists of metal baffles with staggered slots that extend to the base of the unit that serve to increase the detention time of effluent. After passing through the final slot, the effluent flows over a V-notch weir and into a smaller basin where PVC pipes with holes have been installed. Dechlorination tablets are put in the tubes. At the bottom of the basin is the outlet, the plant does not appear to be designed for dechlorination and the present system improvised (see photo 2).

- The facility does not appear to be designed for dechlorination. To complete this task two PVC pipes filled with dechlorination tablets have been placed in the downside chamber where flow is measured. Only the effluent entering the holes drilled into the PVC pipes contacts the dechlorination tablets, (see photo 2). The effluent drains from the chamber at the bottom thus there is no standing contact pool.

- Column 1. First a sample was taken at the v-notch weir (see photo 2). This sample determines the TRC level of chlorine introduced into the water for disinfection.

Photographer: Daniel Valenta	Date: 6/26/2012	Time: 1020
City/County: Abiquiu/ Rio Arriba		
Location: Behind the store located at 21196 U.S. 84 Abiquiu, NM 87510, facing north.		
Subject: V-notch flow measurement, effluent flowing onto PCV pipes with dechlorination tablets. Effluent then exits at the bottom of the chamber to discharge to river or sand filter.

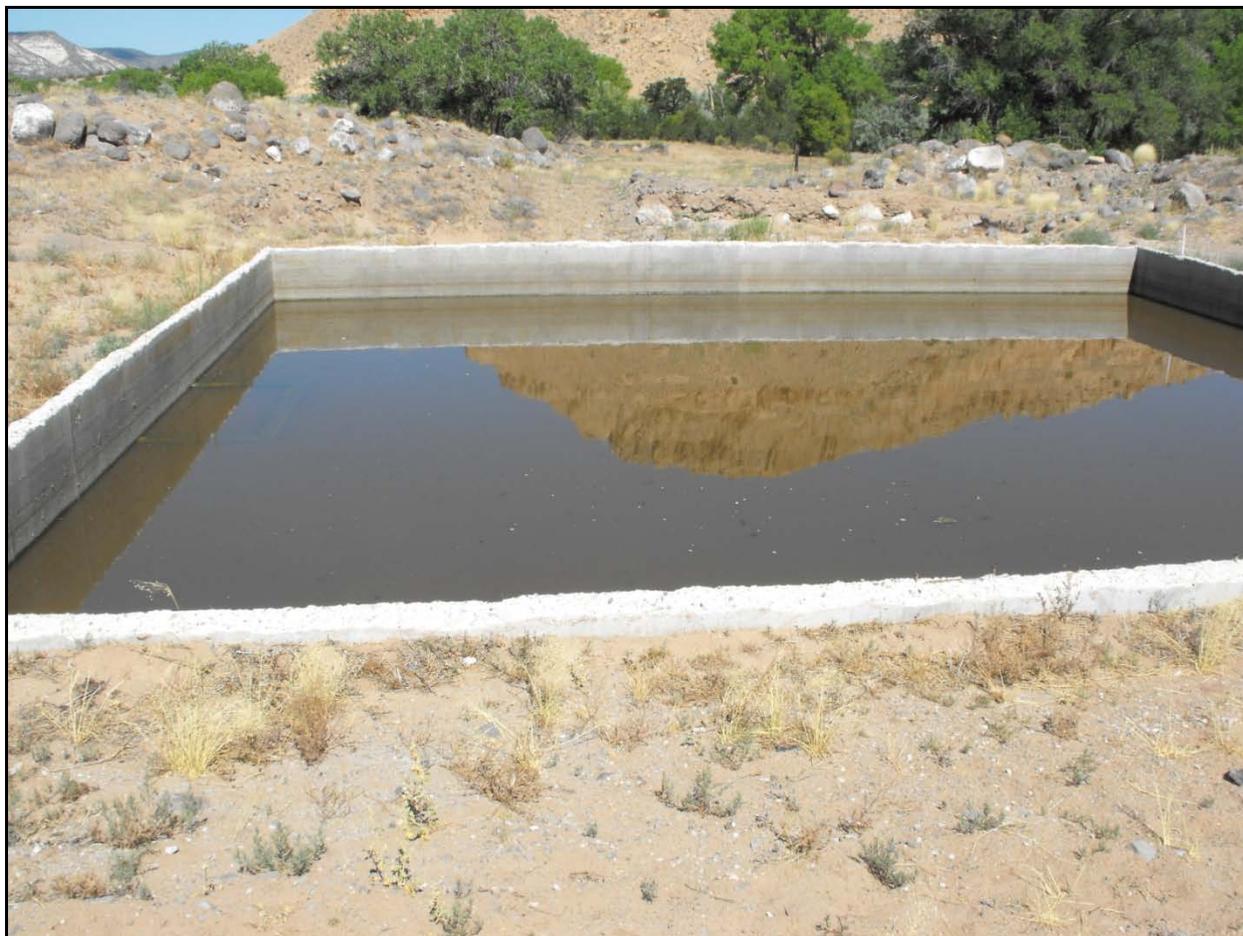
Photo # 3

- A sand filter is the final treatment phase of the facility. At the present time the sand filter has become clogged and does not drain. It is now filled with standing water, (see photo 3). The sand filter has been bypassed and thus a pipe carries the effluent approximately 640 ft to discharge to the Rio Chama.

Photographer: Daniel Valenta	Date: 6/26/2012	Time: 1026
City/County: Abiquiu/ Rio Arriba		
Location: Behind the store located at 21196 U.S. 84 Abiquiu, NM 87510, facing west.		
Subject: Sand filter unit, has stopped draining and effluent sits stagnate.

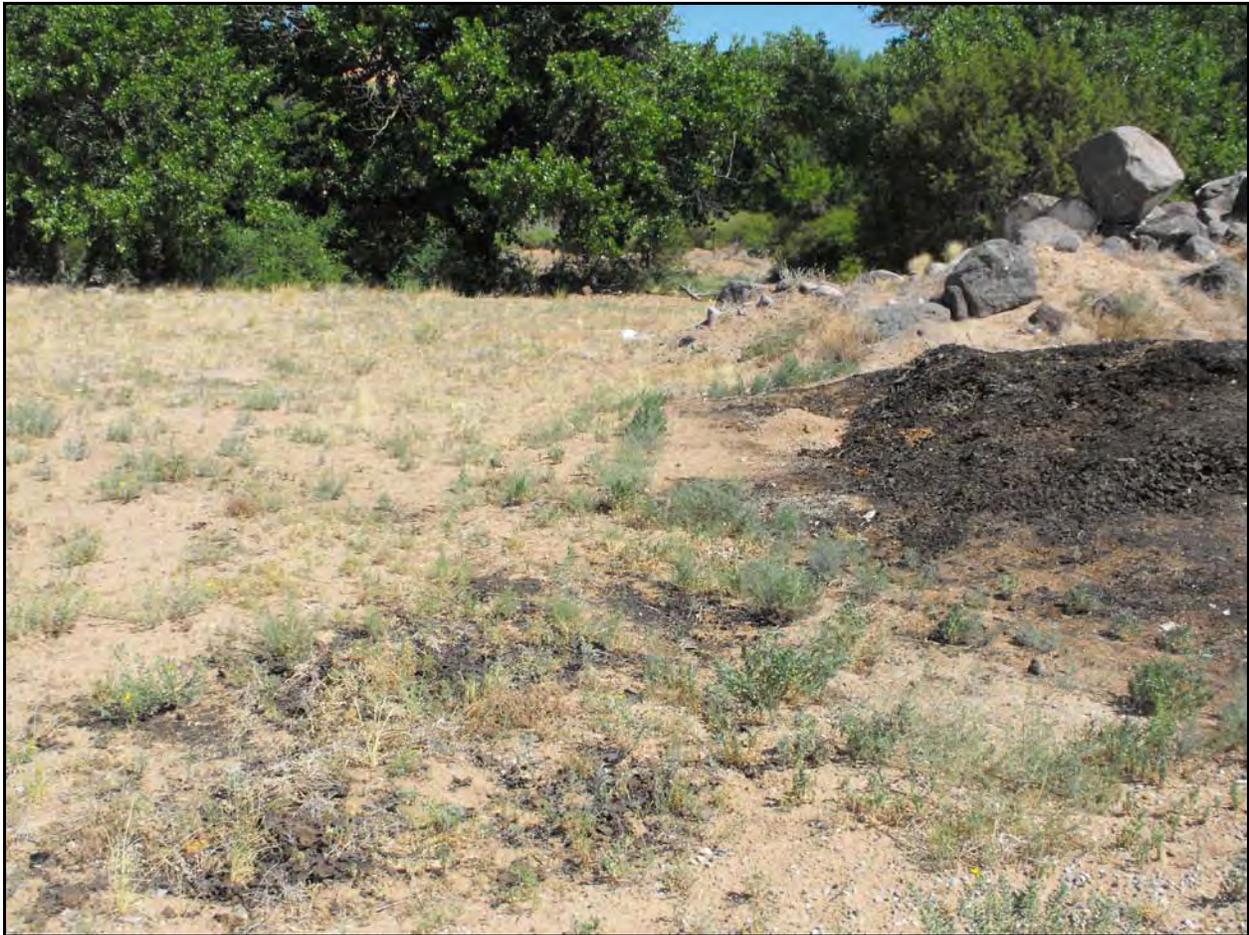
Photo #4

Solids from the digester are pumped to one of two drying beds. Both beds have underdrains and the collected wastewater is pumped to the headworks. On the day of the inspection piles of sludge were placed on bare soil with no controls to prevent storm water or groundwater contamination. Sludge has been stockpiled onsite this way for years (see photo 4).

Photographer: Daniel Valenta	Date: 6/26/2012	Time: 1033
City/County: Abiquiu/ Rio Arriba		
Location: Behind the store located at 21196 U.S. 84 Abiquiu, NM 87510, facing north.		
Subject: Sludge from drying beds, left in piles around the containment area.

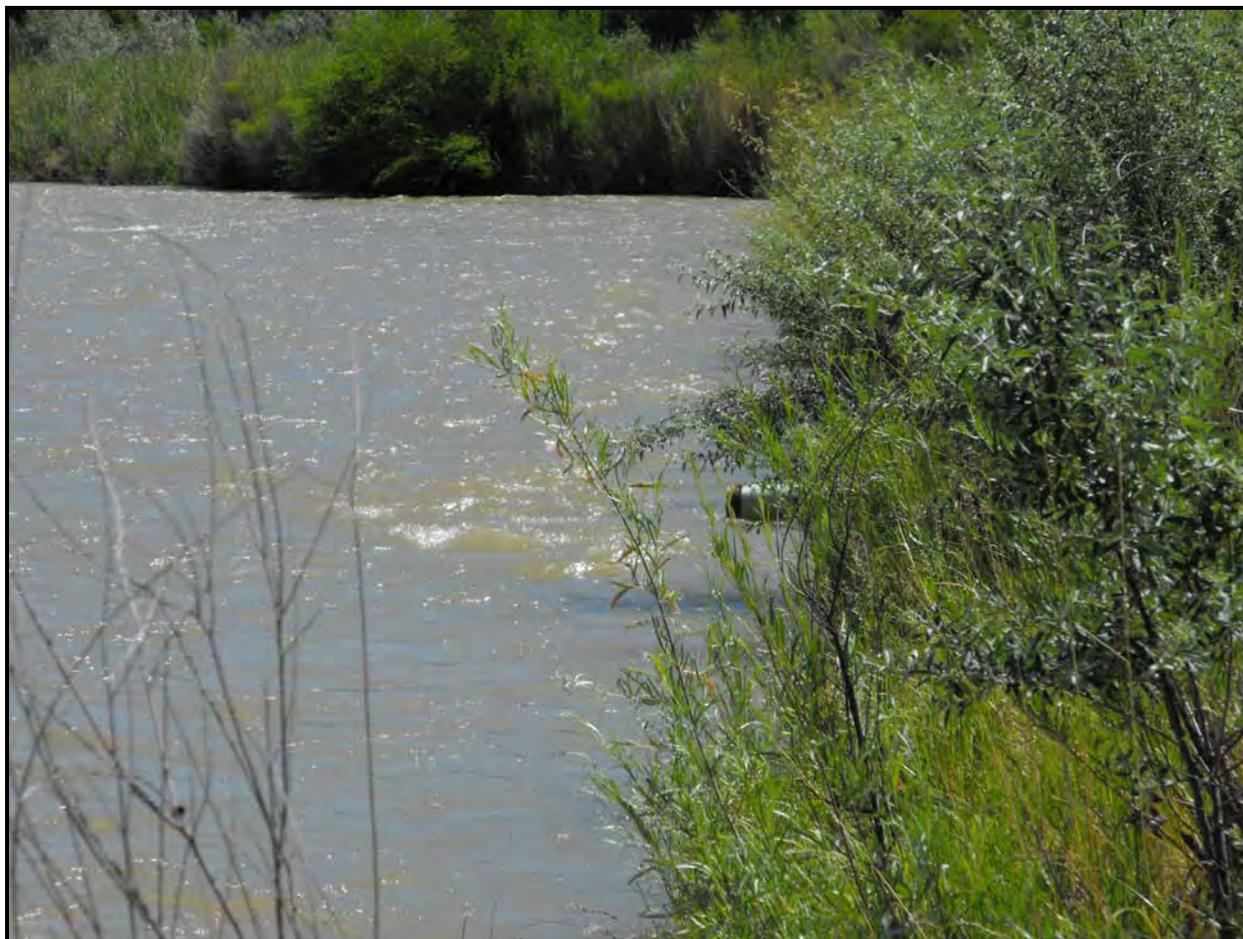
Photo # 5

RECEIVING WATER OBSERVATIONS: **Discharge outfall into river could not be observed due to high water level. Effluent at the v-notch weir appeared to be cloudy with some pin flock discharging to outfall.**

Photographer: Daniel Valenta	Date: 6/26/2012	Time: 1047
City/County: Abiquiu/ Rio Arriba		
Location: Behind the store located at 21196 U.S. 84 Abiquiu, NM 87510, facing northwest.		
Subject: Discharge outfall into the Rio Chama.
