Re: Rio Grande Resources Mount Taylor Mine; Major; Individual Permit; SIC 1094: NPDES Compliance Evaluation Inspection; NPDES # NM0028100; February 26, 2014

NPDES Compliance Inspection Report

**Compliance Evaluation Inspection
Rio Grande Resources/Mt. Taylor Mine
February 26, 2014
NM0028100**

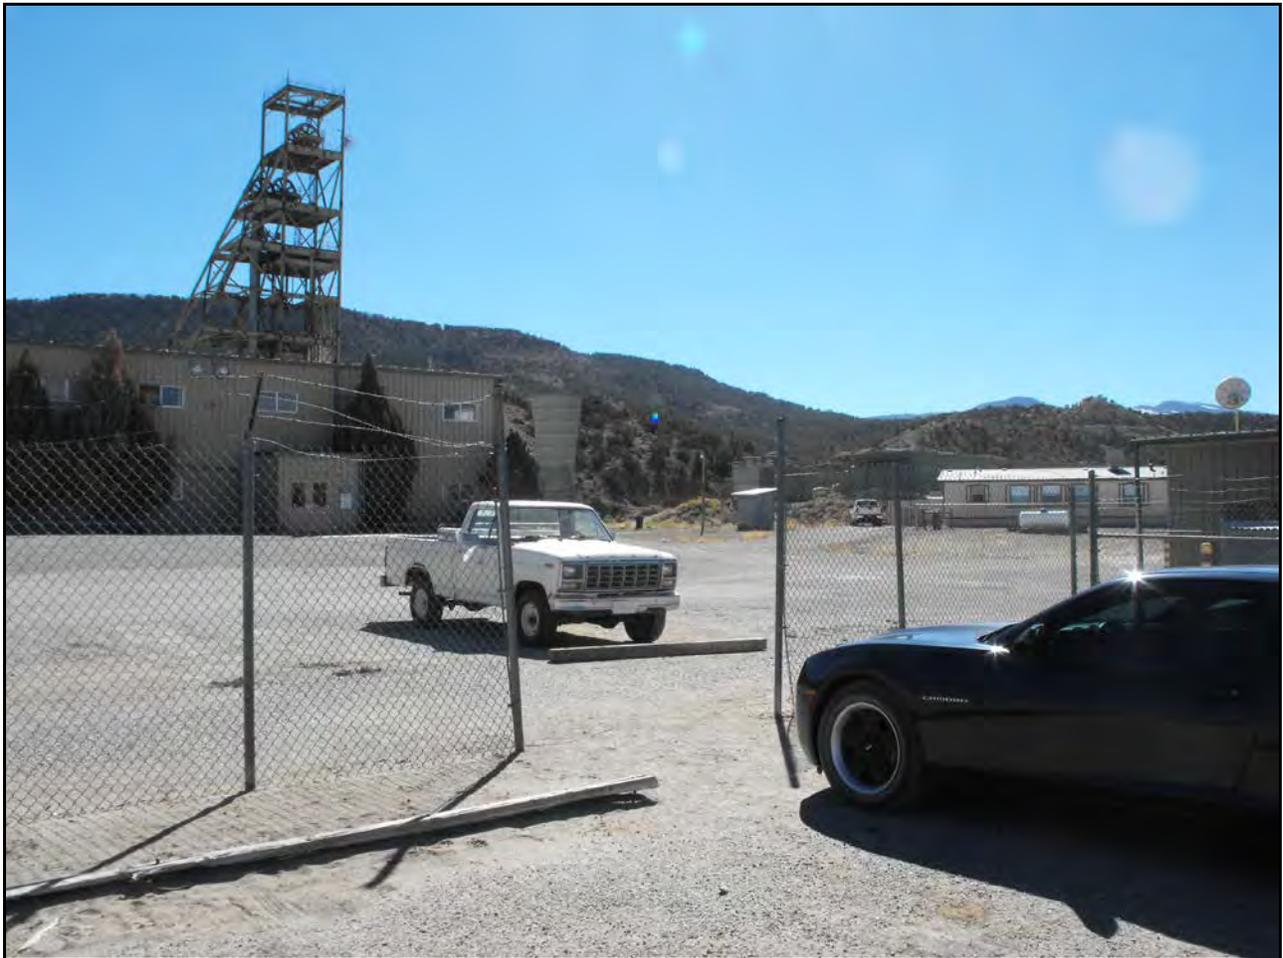
Photo # 1

Photographer: Daniel Valenta	Date: 2/26/2014	Time: 1053 hours
City/County: Mount Taylor Mine, 23 miles north of Milan/Cibola County		
Location: Rio Grande Mount Taylor Mine, facing east.		
Subject: Entrance to mine property.

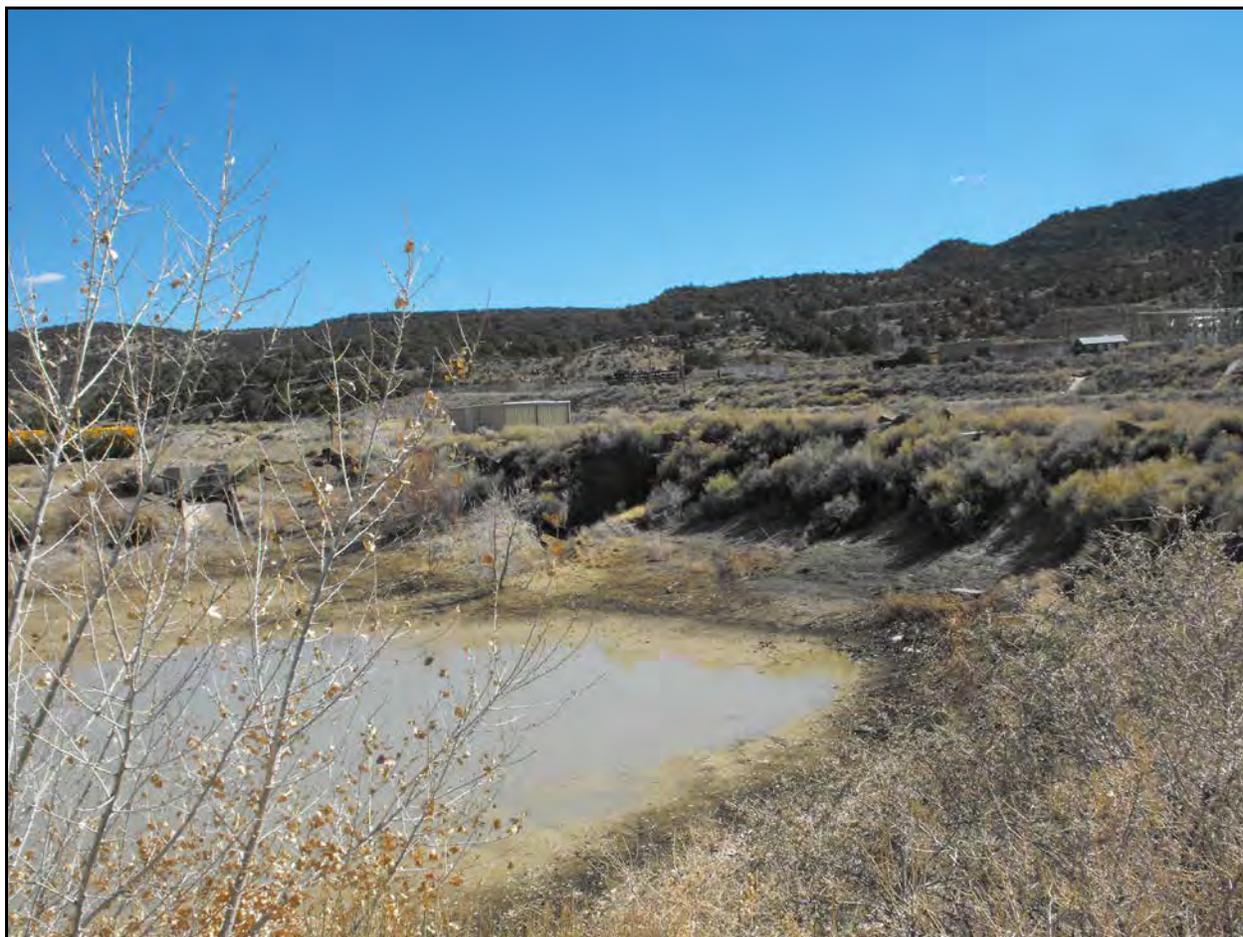
Photo # 2

Photographer: Daniel Valenta	Date: 2/26/2014	Time: 1121 hours
City/County: Mount Taylor Mine, 23 miles north of Milan/Cibola County		
Location: Rio Grande Mount Taylor Mine, facing east.		
Subject: Stormwater from the plant flows to settling pond.

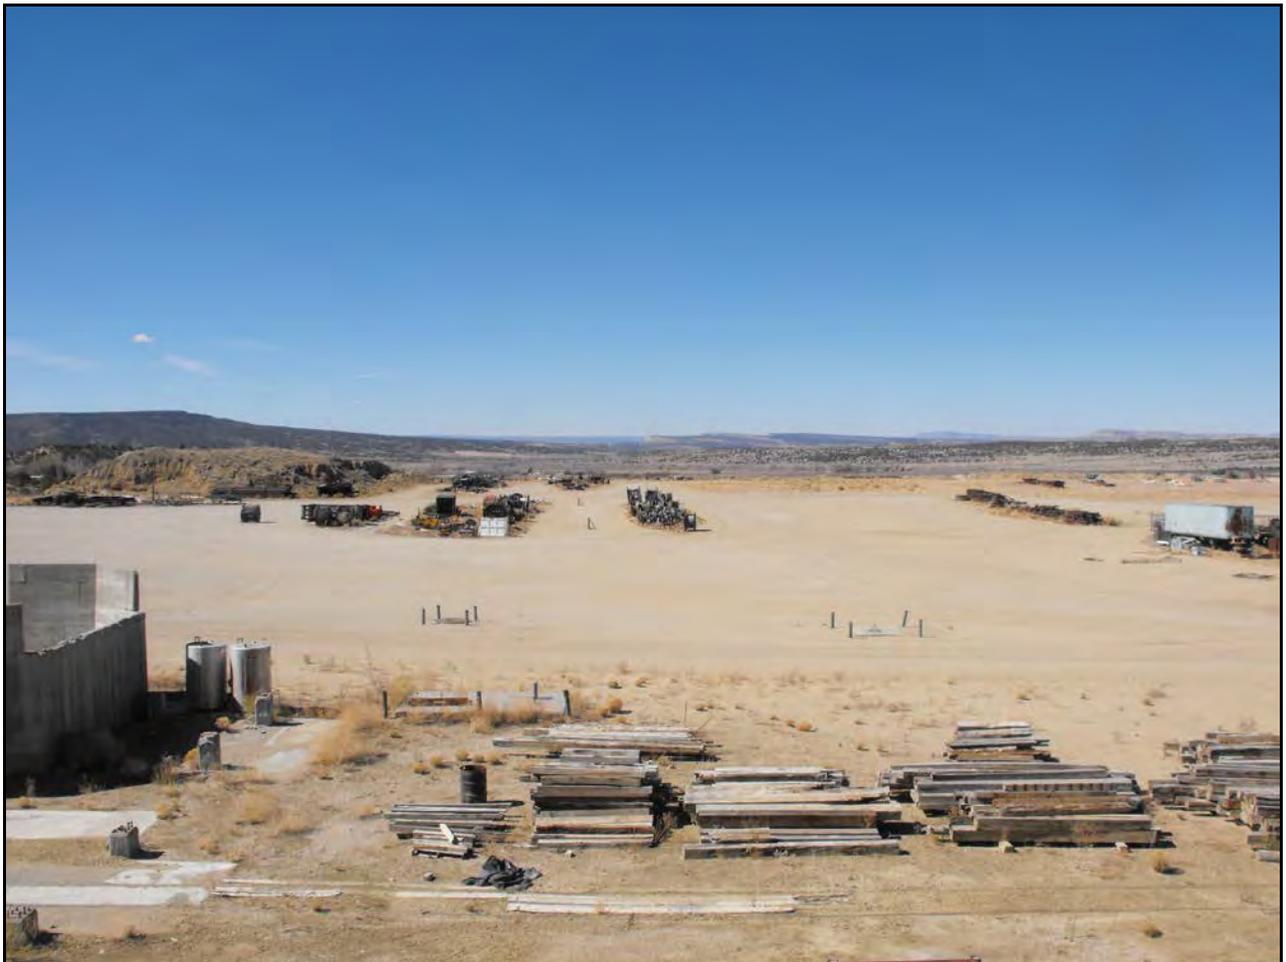
Photo # 3

Photographer: Daniel Valenta	Date: 2/26/2014	Time: 1156 hours
City/County: Mount Taylor Mine, 23 miles north of Milan/Cibola County		
Location: Rio Grande Mount Taylor Mine, facing west.		
Subject: Material storage area.

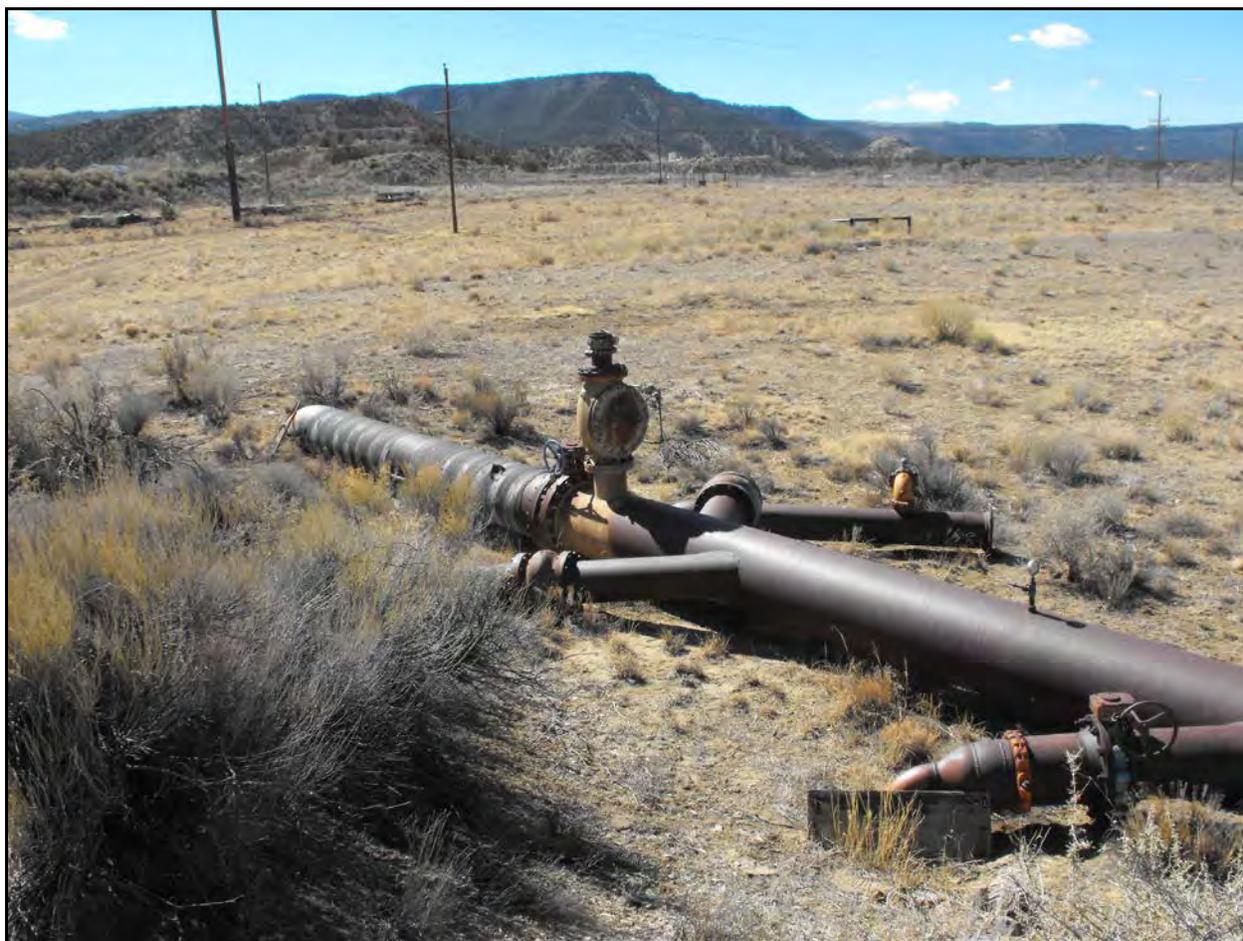
Photo # 4

Photographer: Daniel Valenta	Date: 2/26/2014	Time: 1121 hours
City/County: Mount Taylor Mine, 23 miles north of Milan/Cibola County		
Location: Rio Grande Mount Taylor Mine, facing east.		
Subject: The facility would discharge through a 24-inch steel pipe that runs approximately 4.5 miles north to outfall 001. This is the beginning of the discharge line.

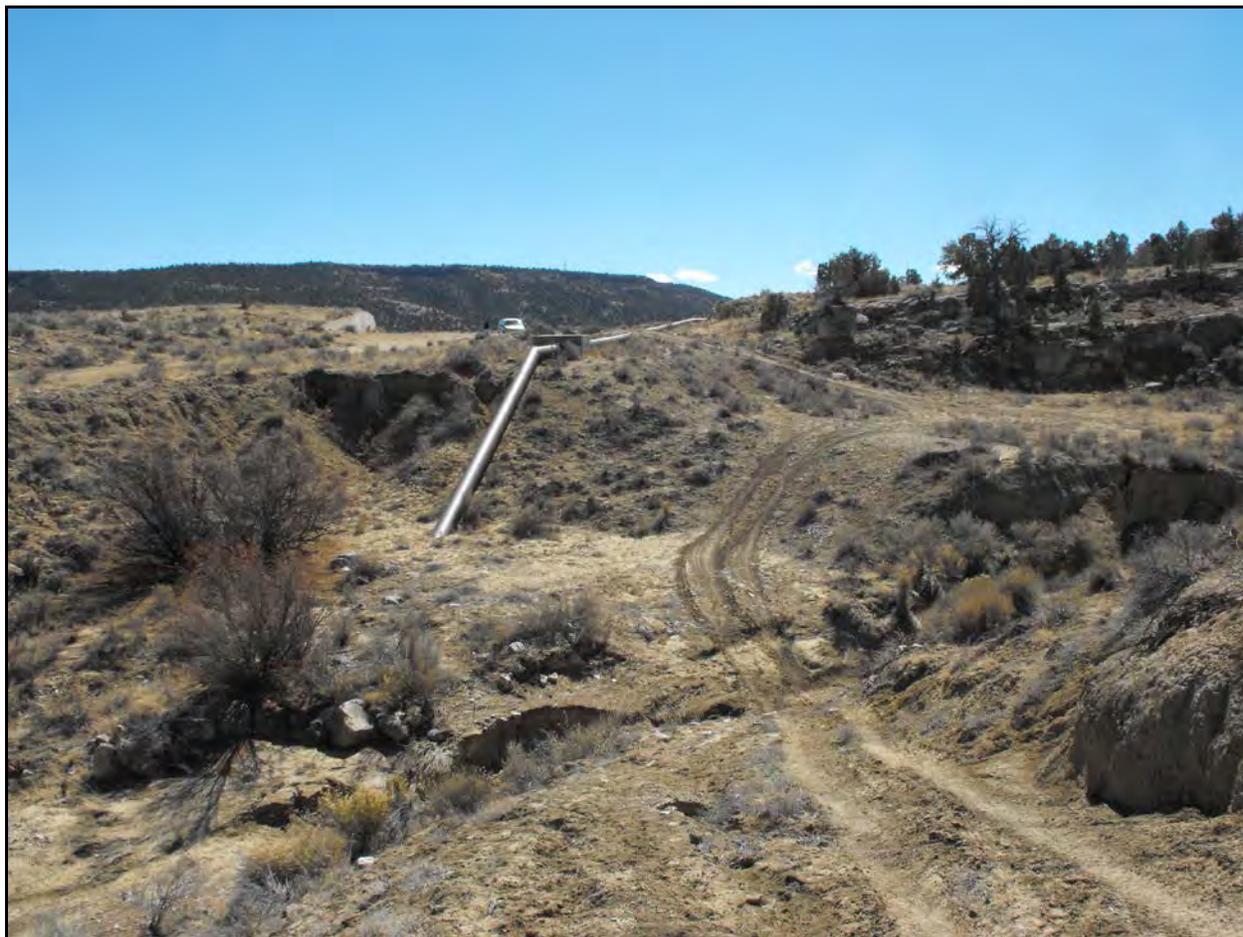
Photo # 5

Photographer: Daniel Valenta	Date: 2/26/2014	Time: 1245 hours
City/County: Mount Taylor Mine, 23 miles north of Milan/Cibola County		
Location: Rio Grande Mount Taylor Mine discharge line, facing south.		
Subject: Discharge line enters the unnamed tributary that flows to San Miguel Creek.
