NEW MEXICO ENVIRONMENT DEPARTMENT

Re: **Resurrection Mining, LLC Rio Puerco Uranium Mine; Major Non-Municipal, SIC 1094,
NPDES Compliance Evaluation Inspection, NM0028169, August 6, 2015**

**Compliance Evaluation Inspection
Resurrection Mining LLC – Rio Puerco Mine
NPDES Permit #NM0028169, August 6, 2015**

Further Explanations

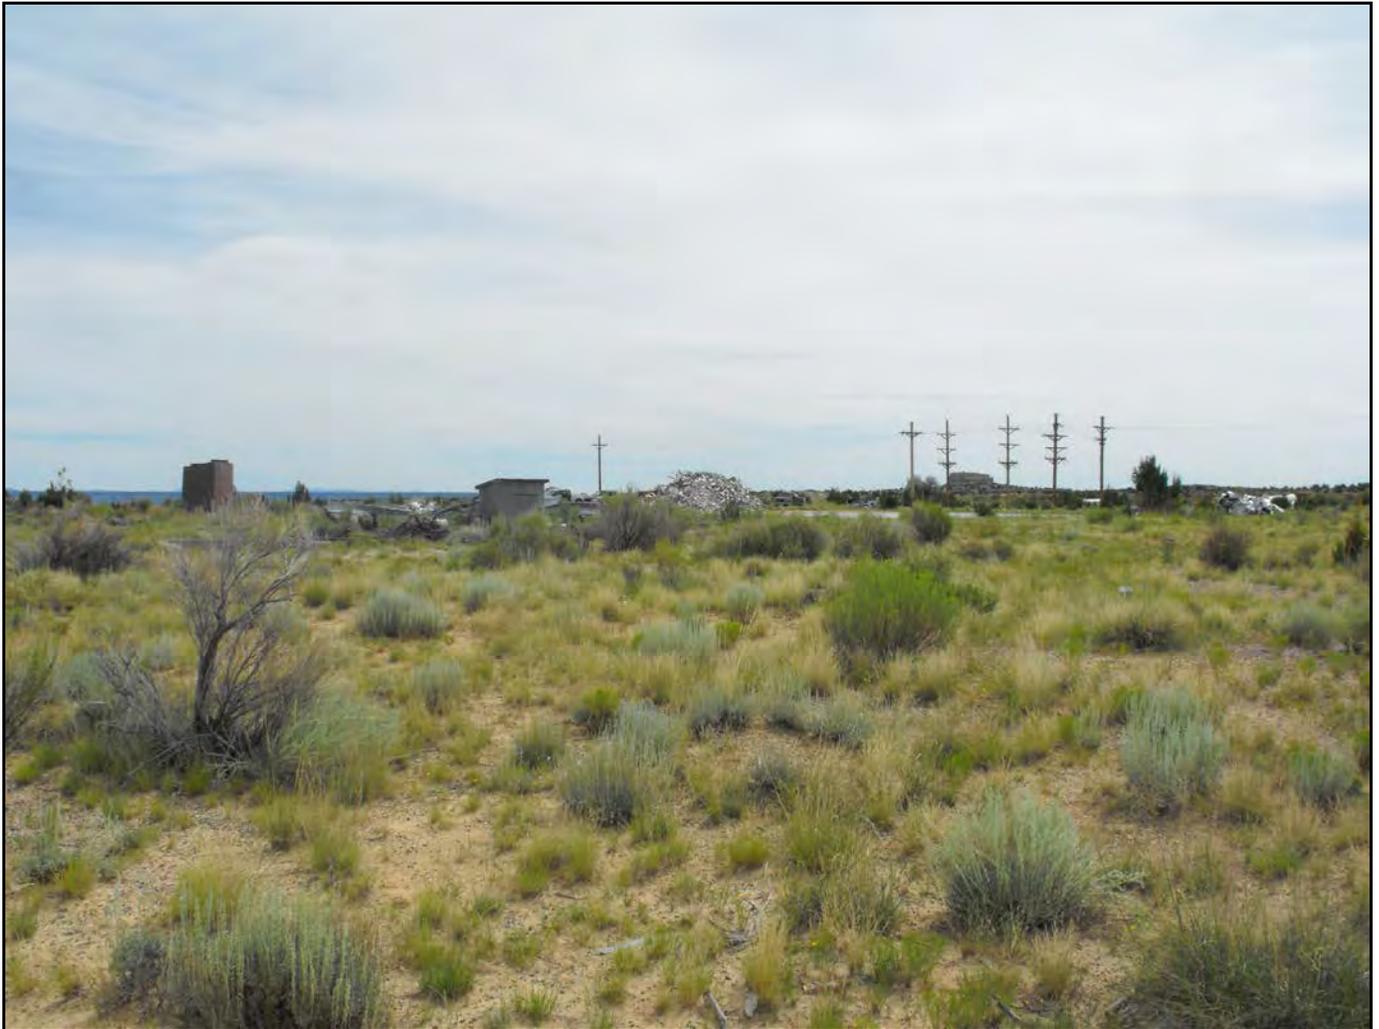
Photo # 1

- The large metal building and other smaller structures have been demolished and all sellable metal material removed from the area. Only a pile of waste material remains at the site from the structures, (see photo 1).
- The main shaft entrance is covered by a welded iron plate. The WWTP has been stripped and only the water filled underground chambers remain, (see photo 2).
- The treatment lagoons liners are degraded with what appears to be rainwater ponded in the bottom. The ponds would have to fill before any discharge could occur at Outfall 001, (see photo 3).

Photographer: Daniel Valenta	Date: August 6, 2015	Time: 1108 hours
City/County: Approximately eight miles south of Marquez, NM		
Location: Resurrection Mine formerly the Uranium King Mine, facing northeast.		
Subject: The mine facility buildings have been torn down with the metal salvaged.

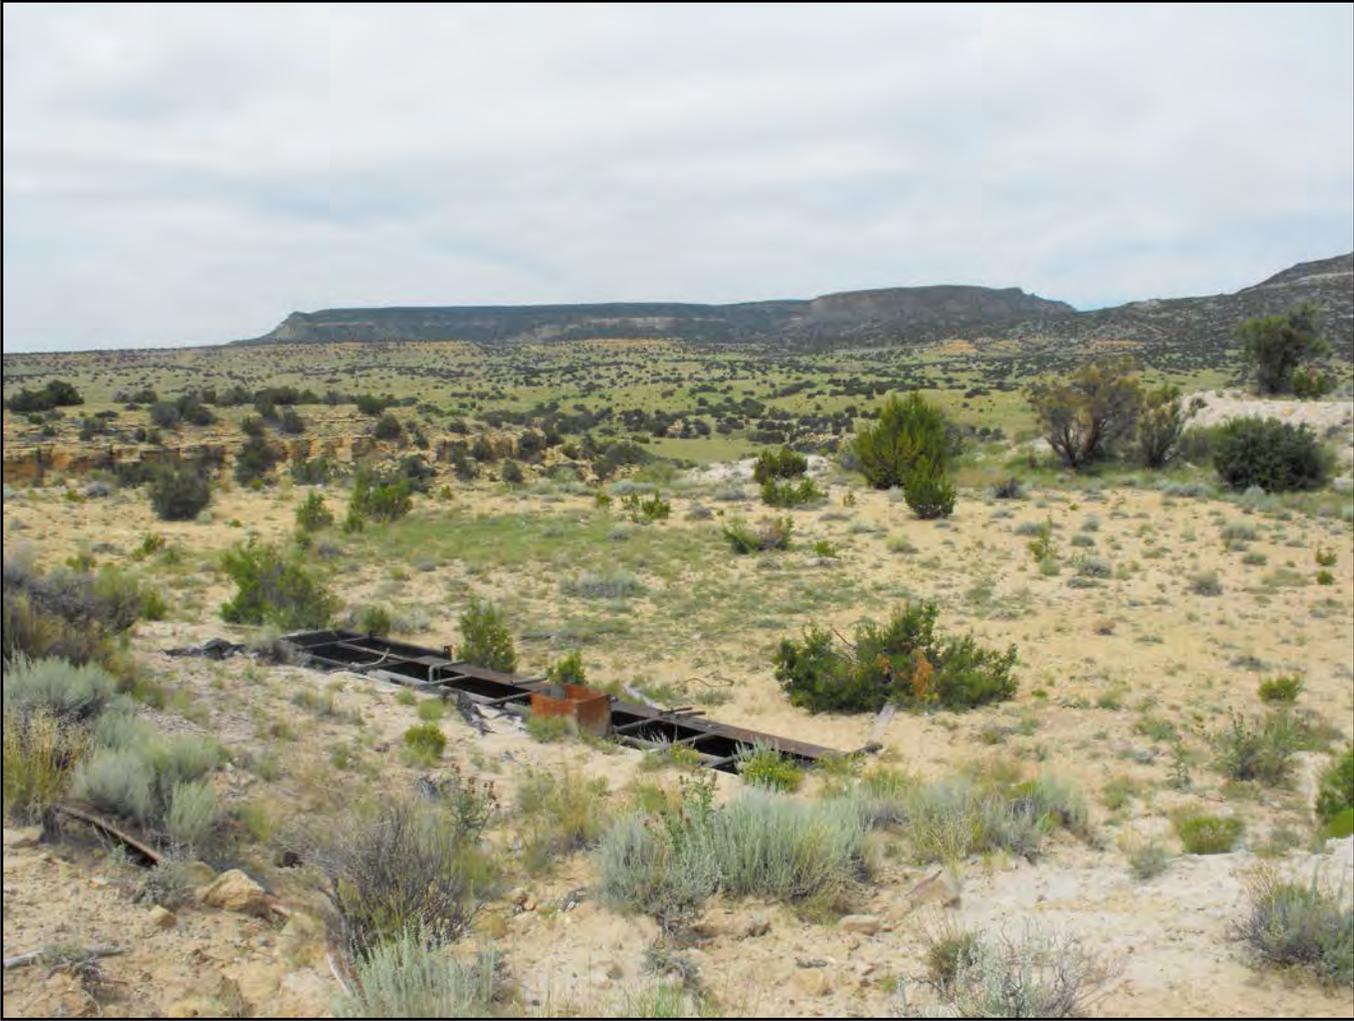
Photo # 2

Photographer: Daniel Valenta	Date: August 6, 2015	Time: 1108 hours
City/County: Approximately eight miles south of Marquee, NM		
Location: Resurrection Mine formerly the Uranium King Mine, facing southwest.		
Subject: Waste water treatment package plant, just the underground treatment tanks remain.

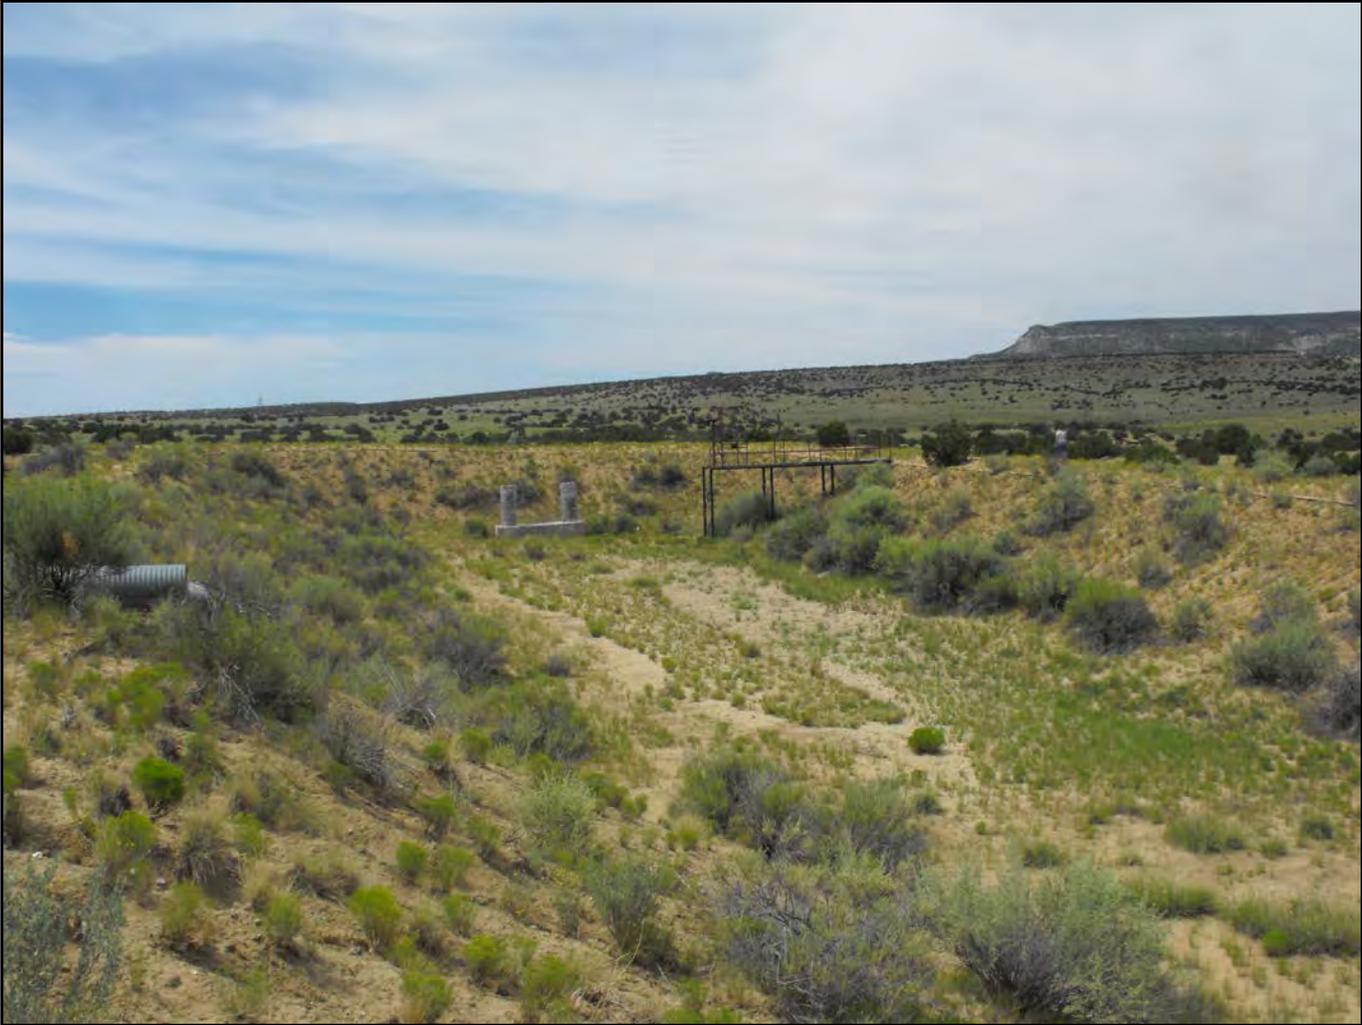
Photo # 3

Photographer: Daniel Valenta	Date: August 6, 2015	Time: 1149 hours
City/County: Approximately eight miles south of Marquez, NM		
Location: Resurrection Mine formerly the Uranium King Mine, facing southwest.		
Subject: Final treatment lagoon before discharge to Outfall 001.

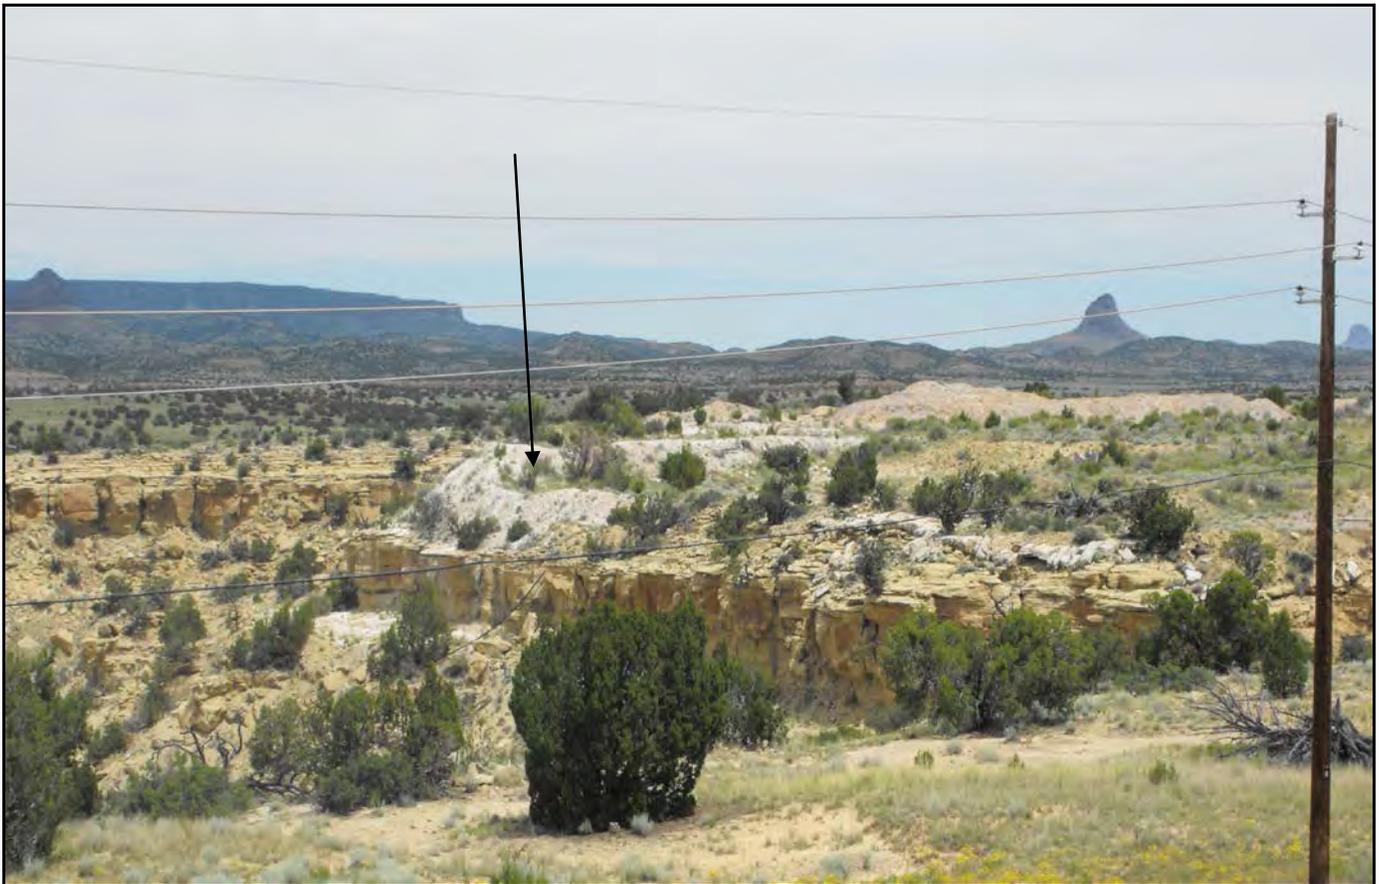
Photo # 4

- There are piles of soil stored next to the mine site. Per the December 7, 2000 letter to NMED, see attached, “these are only spoil piles and contain only minimal background uranium content”. In reviewing the file record no soil sampling data was found. Some of these materials appear to be spilling over the edge into the canyon below, (see photo 4). This erosion and mobilization of the spoil piles is noted in the October 31, 2000 Reconnaissance Inspection, the April 13, 2007 CEI, and the August 24, 2012 CEI.

Photographer: Daniel Valenta	Date: August 6, 2015	Time: 1200 hours
City/County: Approximately eight miles south of Marqueez, NM		
Location: Resurrection Mine formerly the Uranium King Mine, facing northwest.		
Subject: Spoil piles from the mine appear to be eroding into the canyon below.
