NEW MEXICO ENVIRONMENT DEPARTMENT

Re: Major Municipal; SIC 4952; Compliance Evaluation Inspection; CRRUA Sunland Park
Wastewater Treatment Plant; NPDES Permit No. NM0029483; November 20, 2014

NPDES Compliance Inspection Report

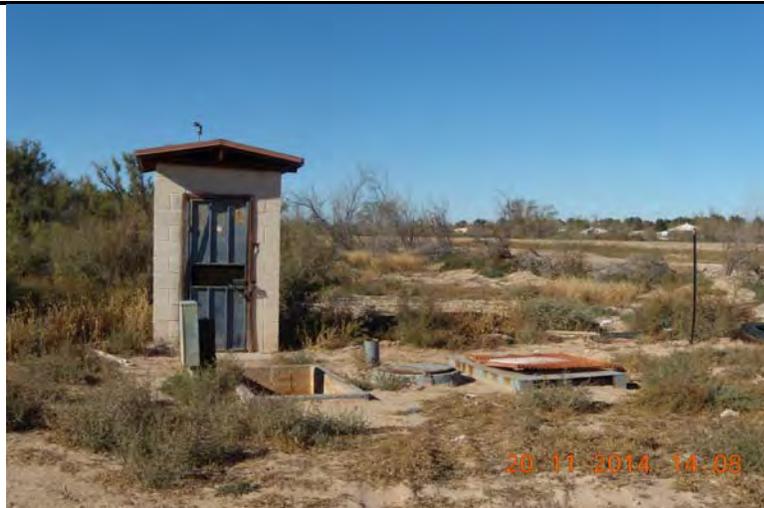
Location: CRRUA Sunland Park Wastewater Treatment Plant - Dias Lago Lift Station

Subject: Dias Lago Lift Station – no backup power and no alarm system.

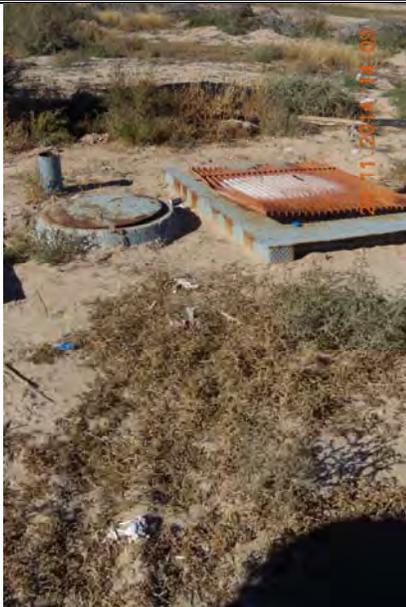
Location: CRRUA Sunland Park Wastewater Treatment Plant - Dias Lago Lift Station

Subject: Dias Lago Lift Station – there is litter blown in around the area. There is also indication of overflows from in the debris on the ground.

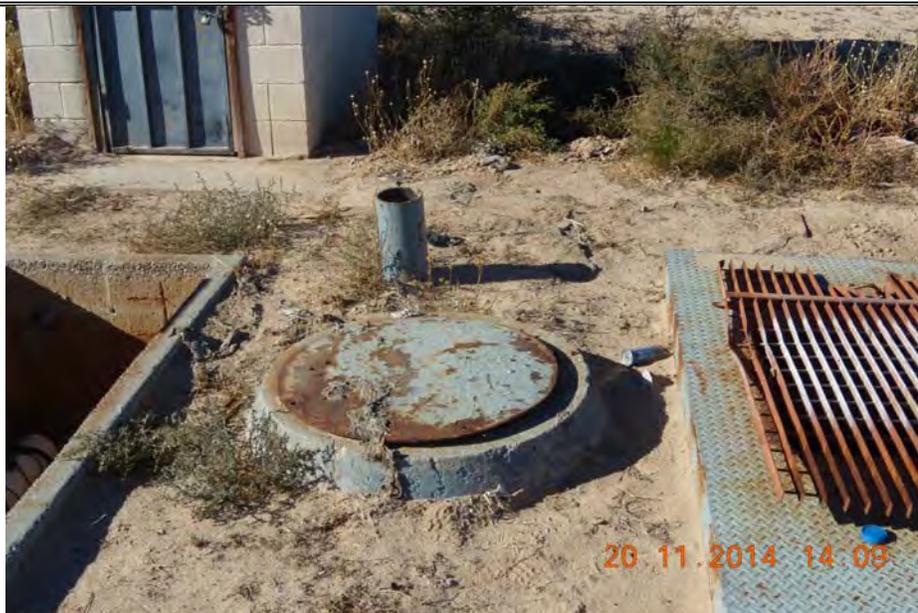
Location: - CRRUA Sunland Park Wastewater Treatment Plant - Dias Lago Lift Station

Subject: Dias Lago Lift Station – there is litter blown in around the area. There is also indication of overflows from in the debris on the ground.

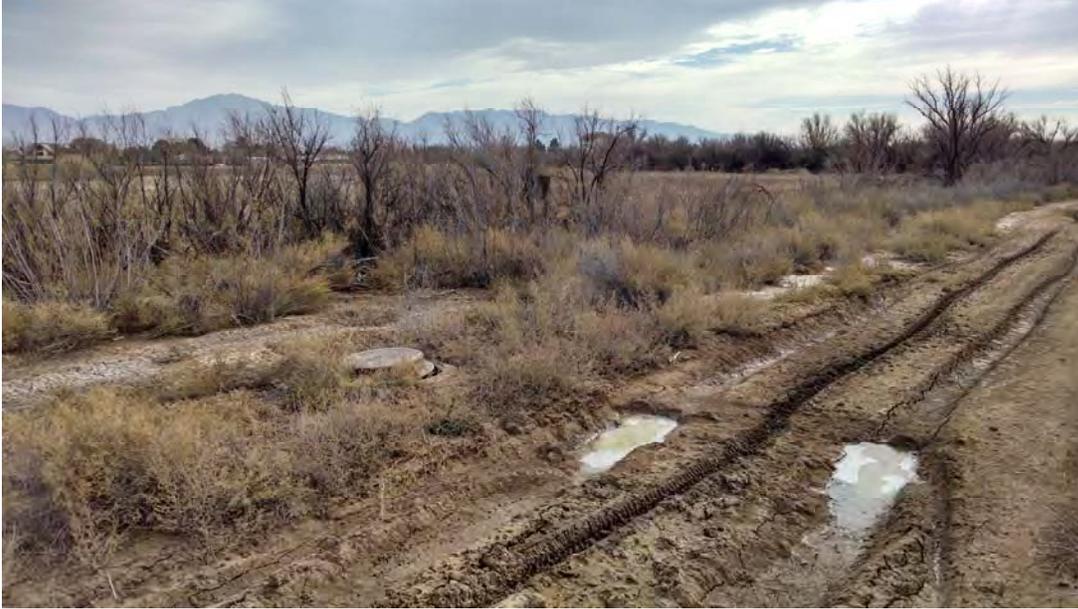
Location: CRRUA Sunland Park Wastewater Treatment Plant - Man hole - near Santa Teresa (in Sunland Park, NM) Dias Lago spill

Subject: Man hole Dias Lago spill.

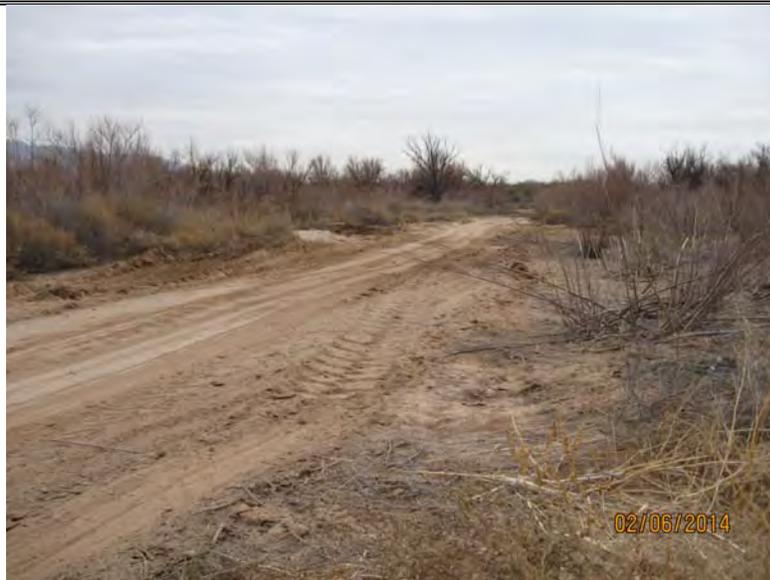
Location: CRRUA Sunland Park Wastewater Treatment Plant - Man hole - near Santa Teresa (in Sunland Park, NM) Dias Lago spill

Subject: Man hole - Dias Lago spill cleanup completed and road graded on February 6, 2014

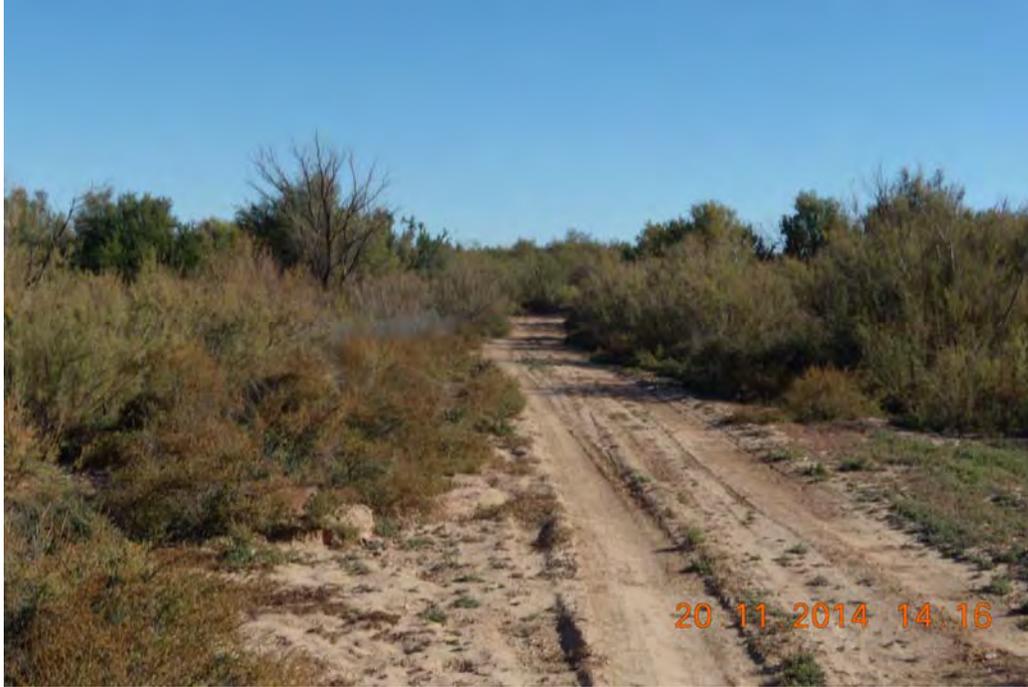
Location: CRRUA Sunland Park Wastewater Treatment Plant - Dias Lago manhole

Subject: Manhole - Dias Lago – Ten months after the sewer overflow, the area has been cleaned and is free of any apparent sewage debris.

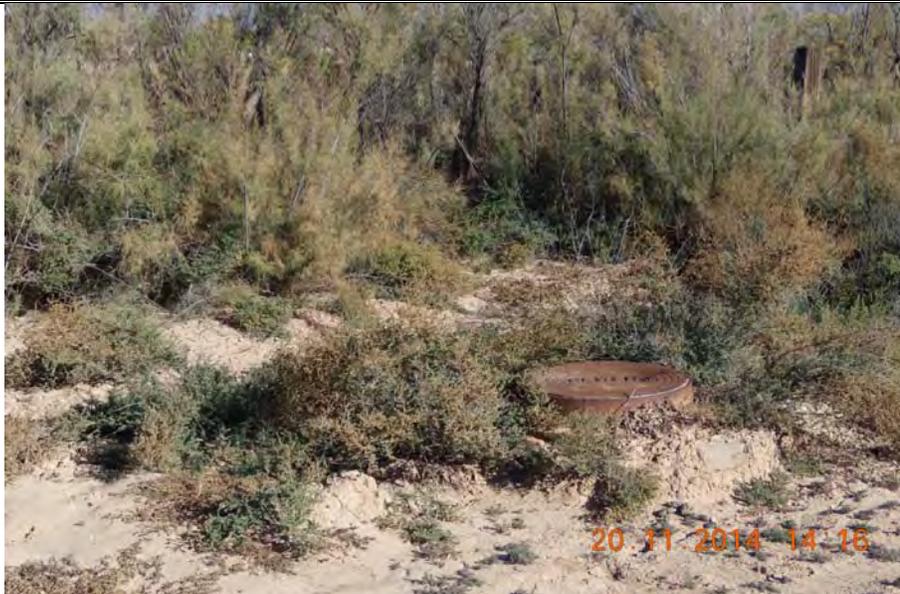
Location: CRRUA Sunland Park Wastewater Treatment Plant - Dias Lago manhole

Subject: Another view - Dias Lago – Ten months after the sewer overflow, the area has been cleaned and is free of any apparent sewage debris.

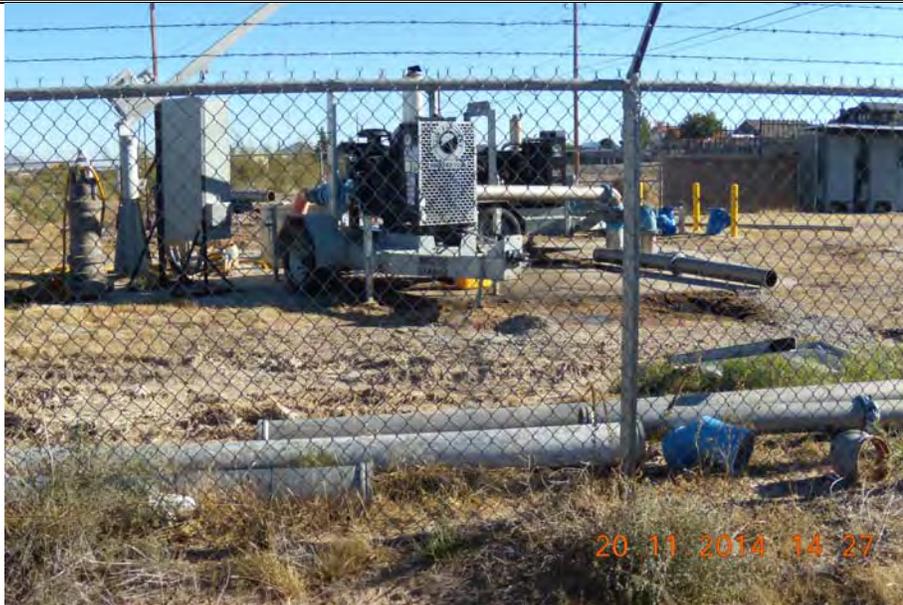
Location: CRRUA Sunland Park Wastewater Treatment Plant - Santa Teresa Lift Station

Subject: Santa Teresa Lift Station – Generators, and lines are being worked on. Oil and sewage is pooling on the ground.

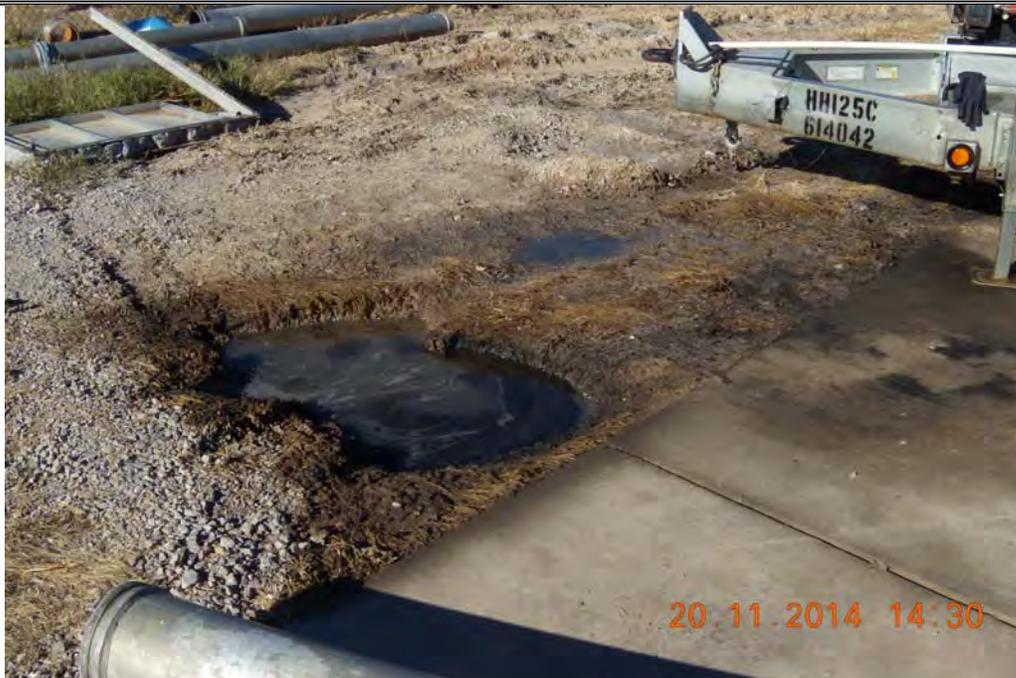
Location: CRRUA Sunland Park Wastewater Treatment Plant - Santa Teresa Lift Station

Subject: Santa Teresa Lift Station – Generators, and lines are being worked on. Oil and sewage is pooling on the ground.

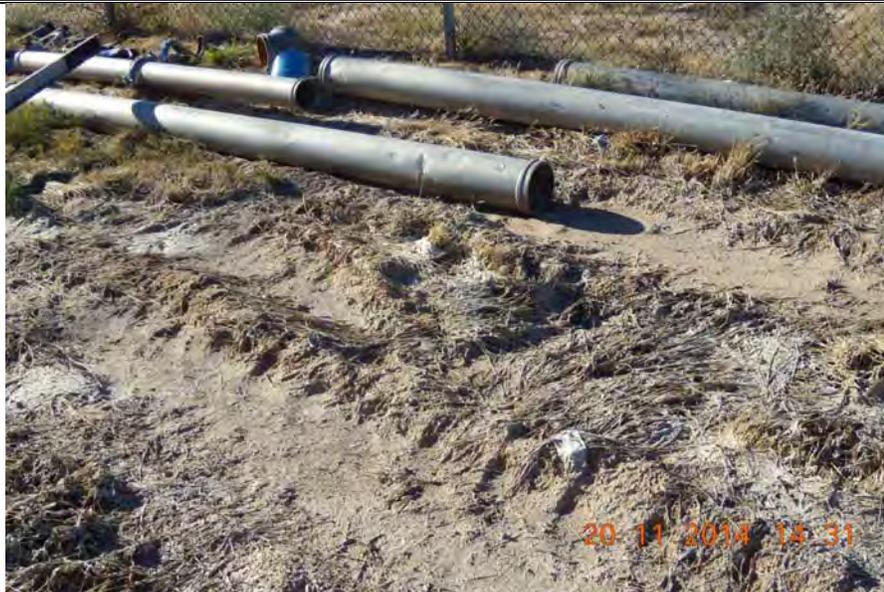
Location: CRRUA Sunland Park Wastewater Treatment Plant - Santa Teresa Lift Station

Subject: Santa Teresa Lift Station – Indications of sewage run off from the site.

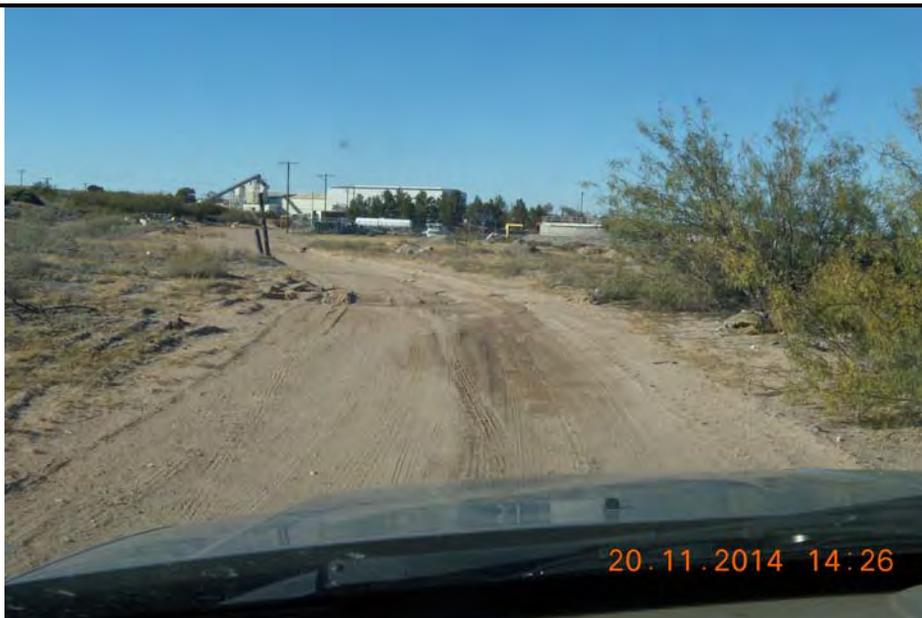
Location: CRRUA Sunland Park Wastewater Treatment Plant - Santa Teresa Lift Station

Subject: Santa Teresa Lift Station – Indications of sewage run off from the site. The road and area from the lift station was saturated in a channel of what appears to be sewage runoff.

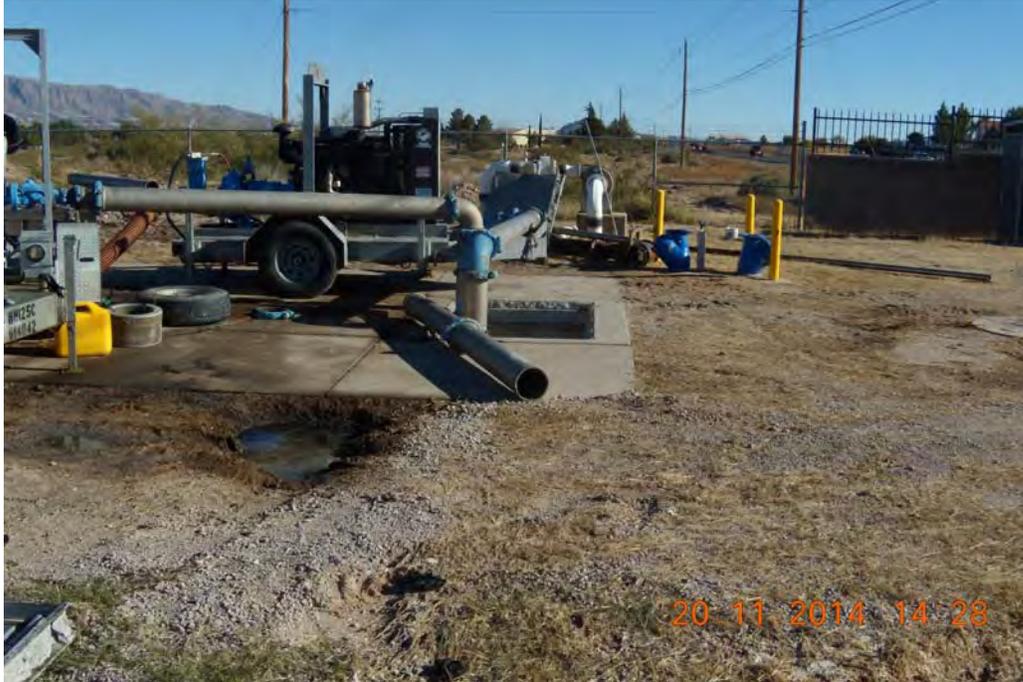
Location: CRRUA Sunland Park Wastewater Treatment Plant - Santa Teresa Lift Station

Subject: Another view of Santa Teresa Lift Station – Generators, and lines are being worked on. Oil and sewage is pooling on the ground.

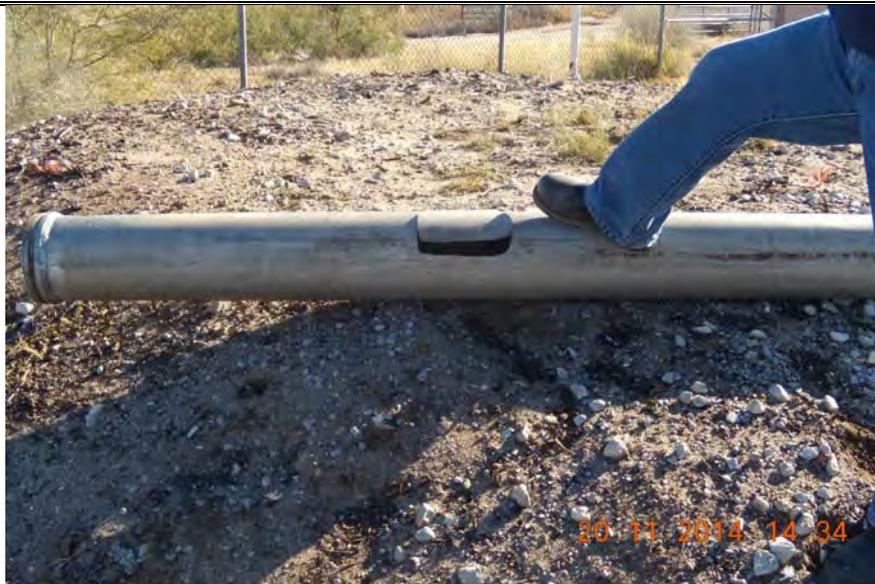
Location: CRRUA Sunland Park Wastewater Treatment Plant - Santa Teresa Lift Station

Subject: A damaged Sewer line pipe at the Santa Teresa lift station is being replaced.

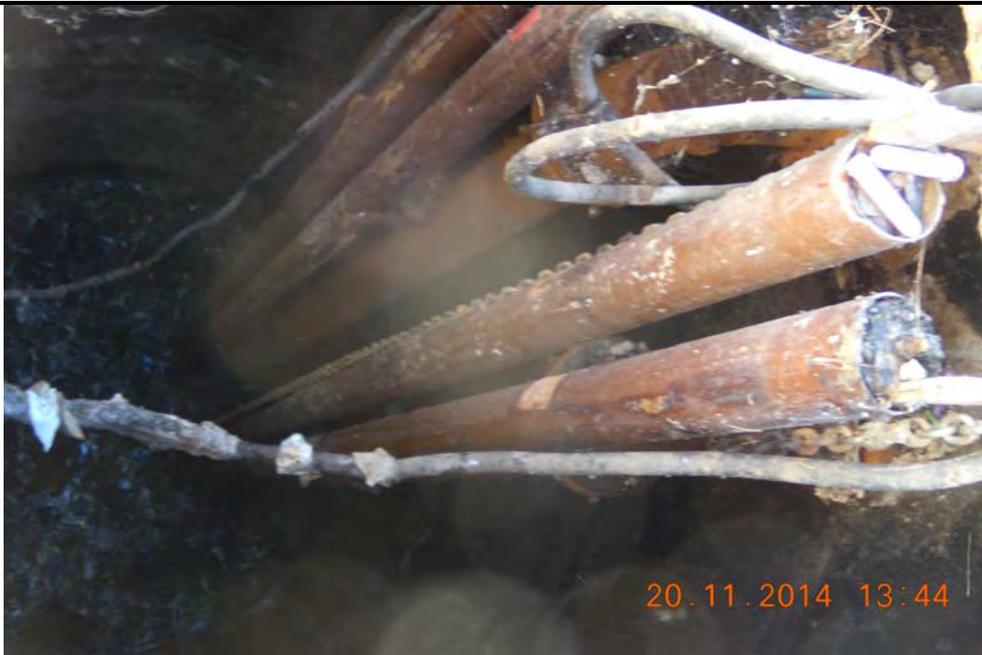
Location: CRRUA Sunland Park Wastewater Treatment Plant - Racetrack lift station.

Subject: Lift station, the high level of debris on top of the pump casing indicates overflows have occurred.

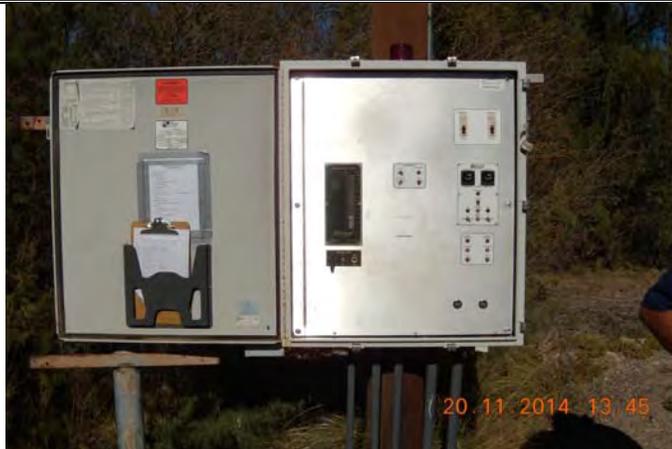
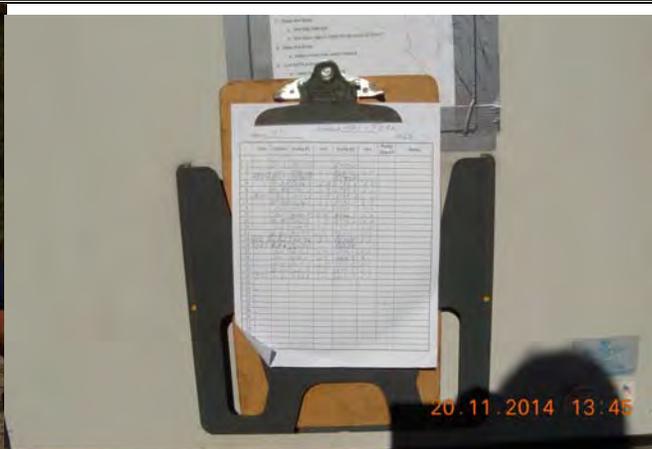
Location: CRRUA Sunland Park Wastewater Treatment Plant - Race track lift station

4. ADEQUATE ALARM SYSTEM FOR POWER OR EQUIPMENT FAILURES AVAILABLE. Lift station alarm system was not functioning at time of Inspection.

Subject: Lift station and daily logs up to date. However the alarm could not be turned on to check to see if it is operational.

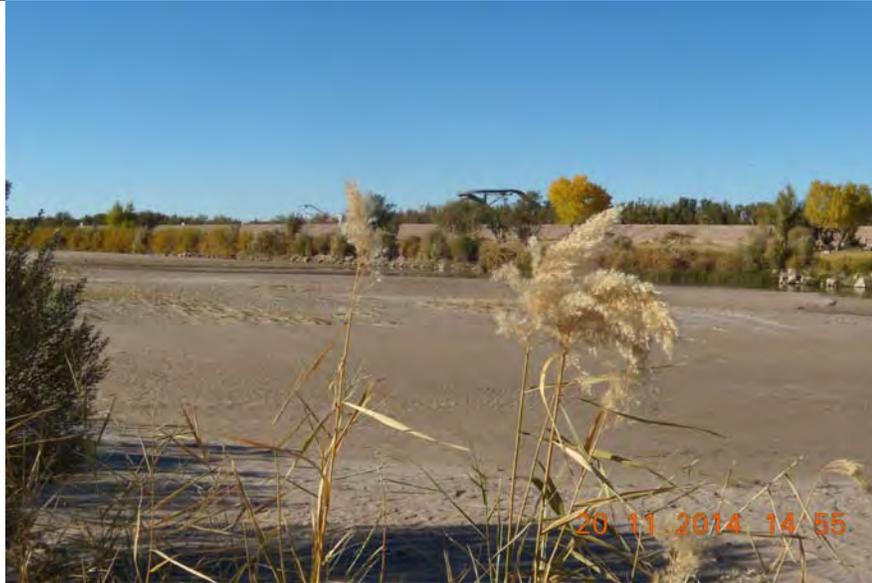
Location: CRRUA Sunland Park Wastewater Treatment Plant - Outfall to the Rio Grande

Subject: Upstream of the outfall, the bankside where the discharge is located is dry. There is water flowing on the other side of the river bed from another source upstream.

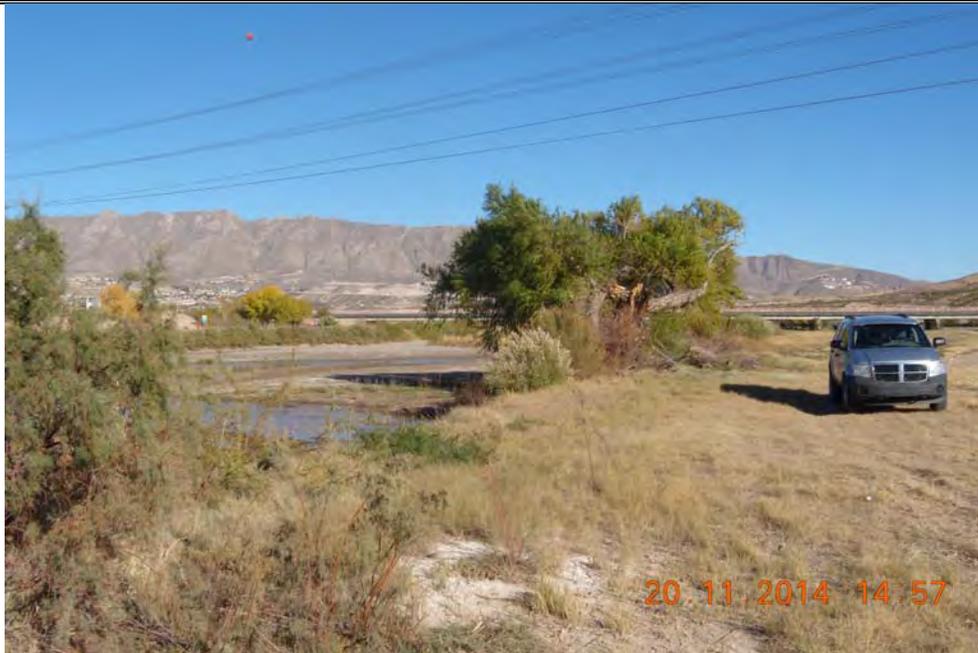
Location: CRRUA Sunland Park Wastewater Treatment Plant - Outfall to the Rio Grande

Subject: At the outfall, and below, the river is flowing and dominated by the volume from the effluent.

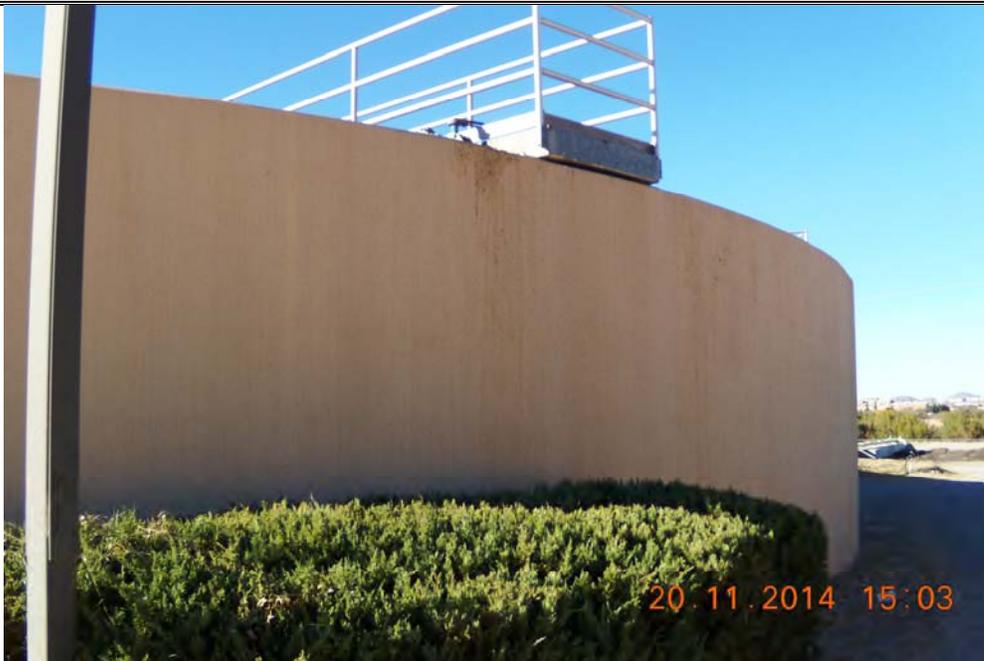
15. Evidence of Hydraulic overload – overflows from the aeration basin. Though the plant design is at 2.0 MGD, and flows recorded are less than that at 7 day averages of 1.53 MGD, overflows from the aeration basins indicate both overloading of solids and overloading of total wastewater volume (see attached photos). This facility cannot accept and effectively treat any high volumes of wastewater in its current condition.

Subject: Outside wall of the aeration basin has splash over of sewage/foam/solids. This is an indication of overloading in the basin.

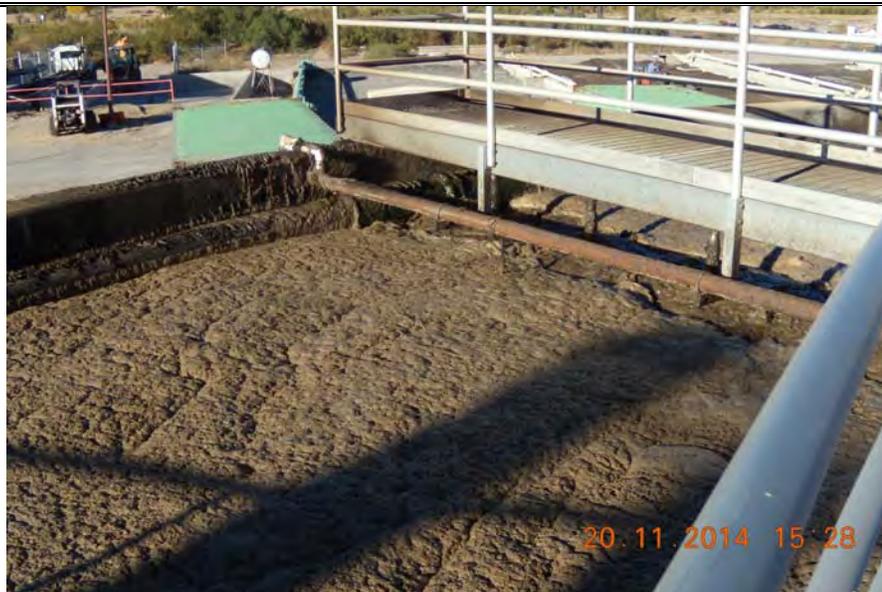
Subject: Basin where splash over the walls have occurred. Note the heavy foam layer and high volume in the basin relative to the freeboard above, less than two feet from the height of the sewage in treatment and the top of the basin walls.

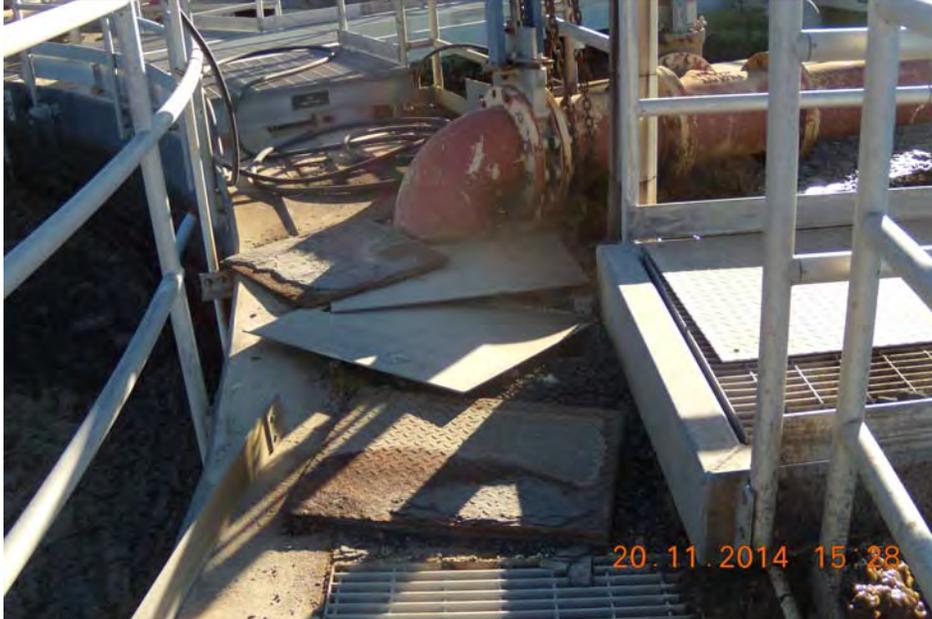
Subject: Walkway at the top of the basins are damaged and show sewage over flows to the walkway. The boards are covering the area.

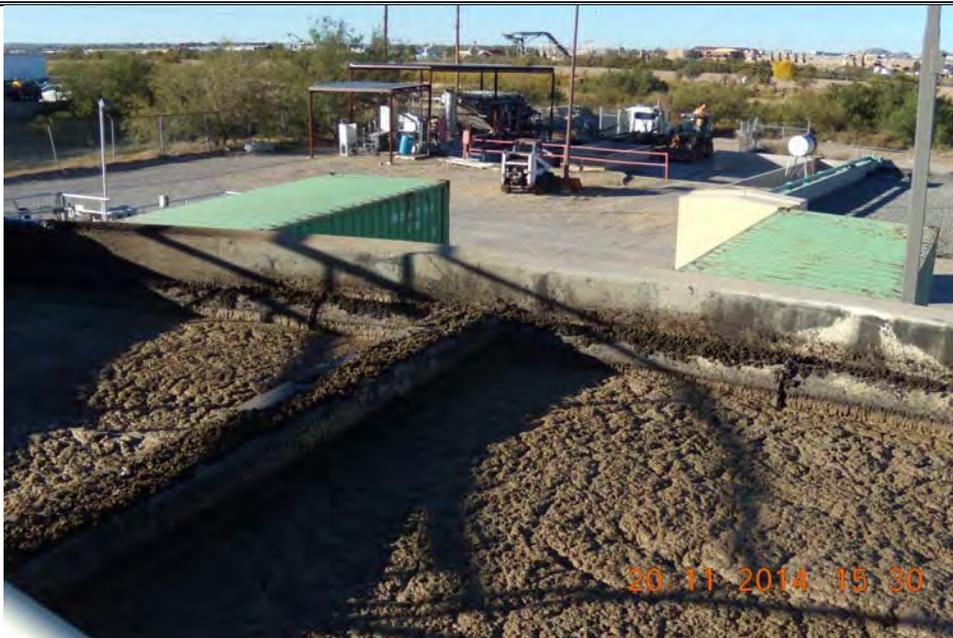
Subject: Another view of the heavy foam and solids load in the basins. Note the high marks on the wall, less than a foot from the top and some areas of staining show another area the basin has overflowed. – In the distance is the solids belt press and drying beds area.

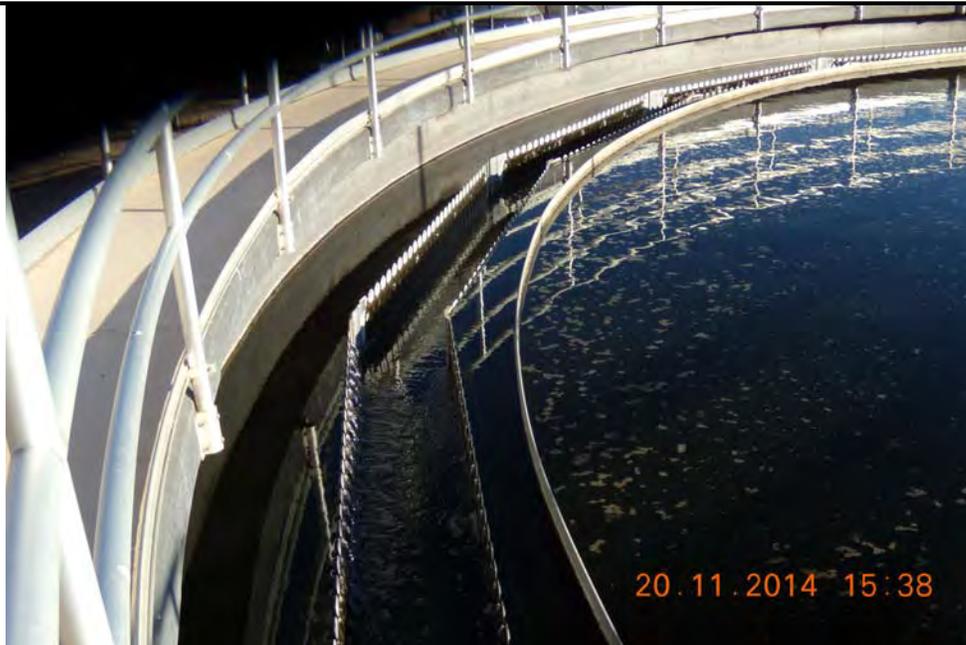
14. Final Clarifiers had a small amount of floating solids that indicate older sludge and inadequate wasting of solids (see attached photo). The clarifier weirs were clean and free of algae and collected solids. An operator was cleaning the weirs the day of the inspection.

Subject: Secondary Clarifier weirs were clean and free of debris. There is some indication of uneven levels of the weirs causing some short circuiting. The basin had some floating solids indicating old solids and inadequate amount of wasting of solids from the unit.

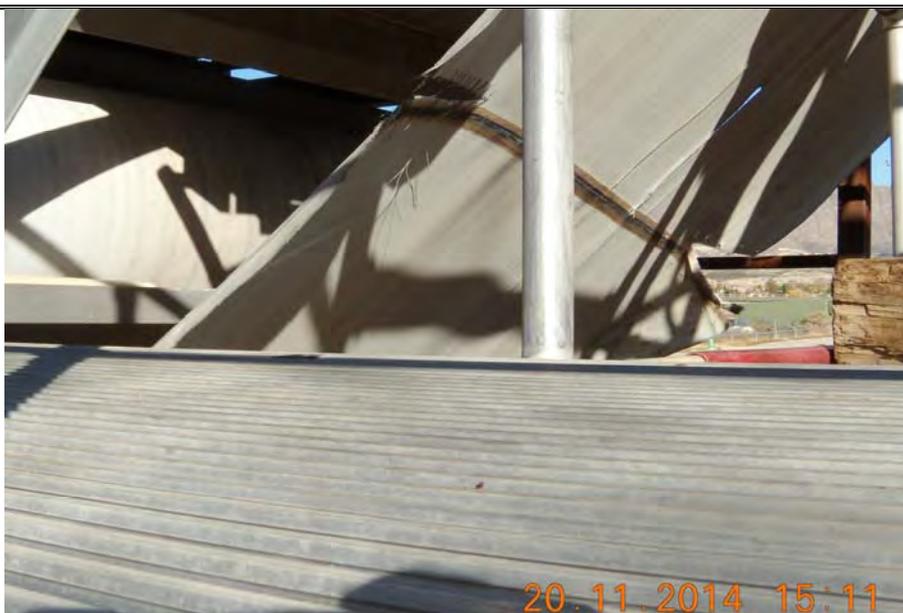
1. The DMRs for the sludge monitoring for January 2014 have the wrong year dated on them.
2. Sludge handling equipment is out of operation. The sludge dewatering belt press is torn and broken. This is adding to the entire WWTP being overloaded with solids. This condition if not corrected is likely to result in reduced effluent quality.

Subject: Belt Press – The solids belt press and drying beds area. Numerous rips and tears are present in the belt. Some areas have been sewn in an attempt to repair it.

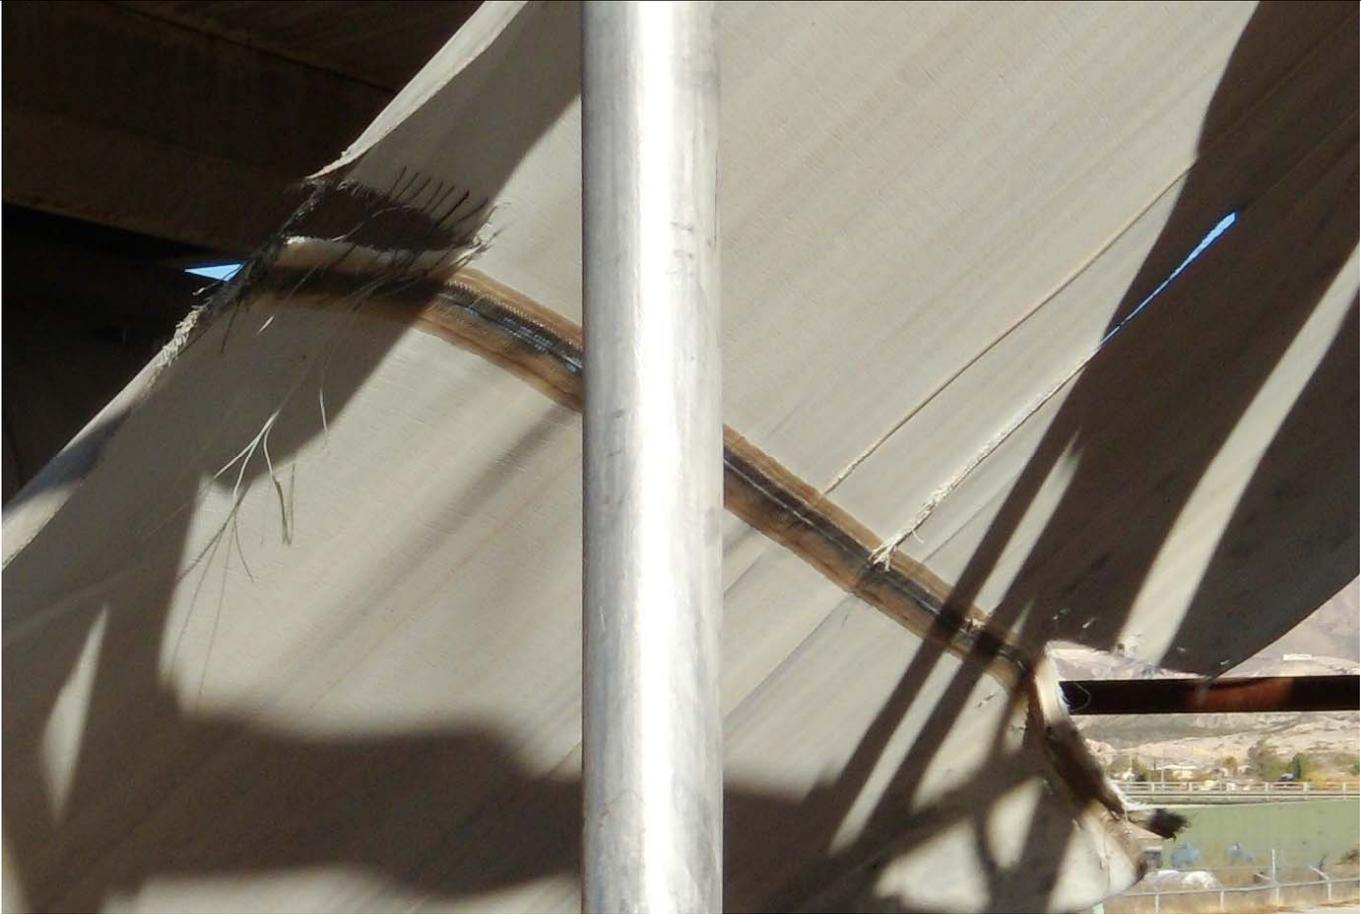
Subject: The solids belt press and drying beds area. Closer view of the Belt Press – Numerous rips and tears are present in the belt. Some areas have been sewn in an attempt to repair it.

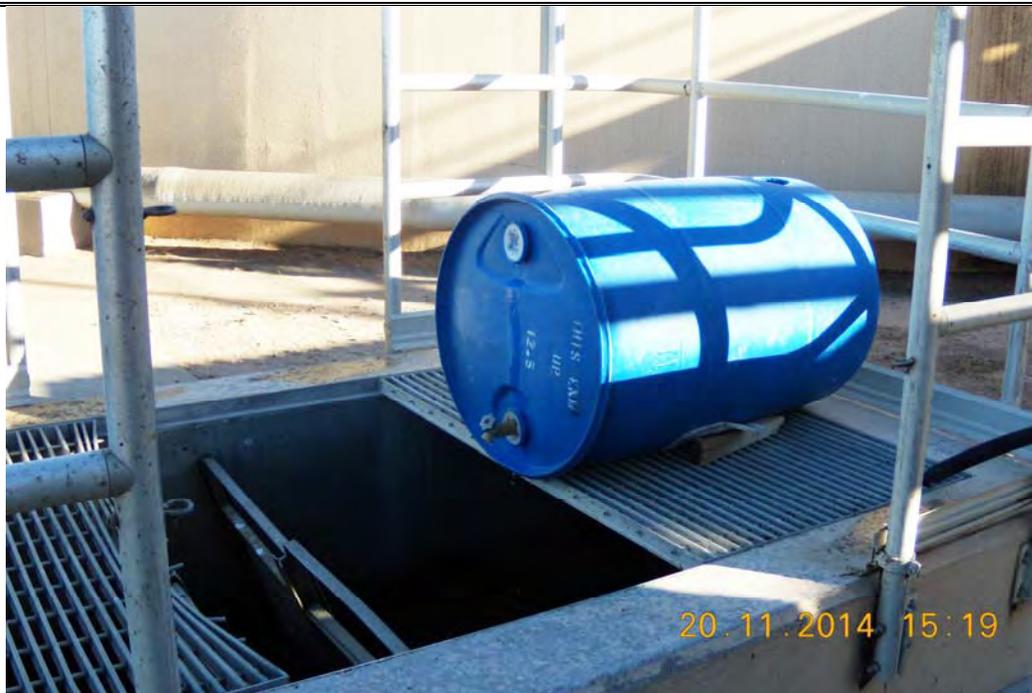
Subject: Sodium Hypochlorite Barrel dripping into the UV disinfection treatment system.

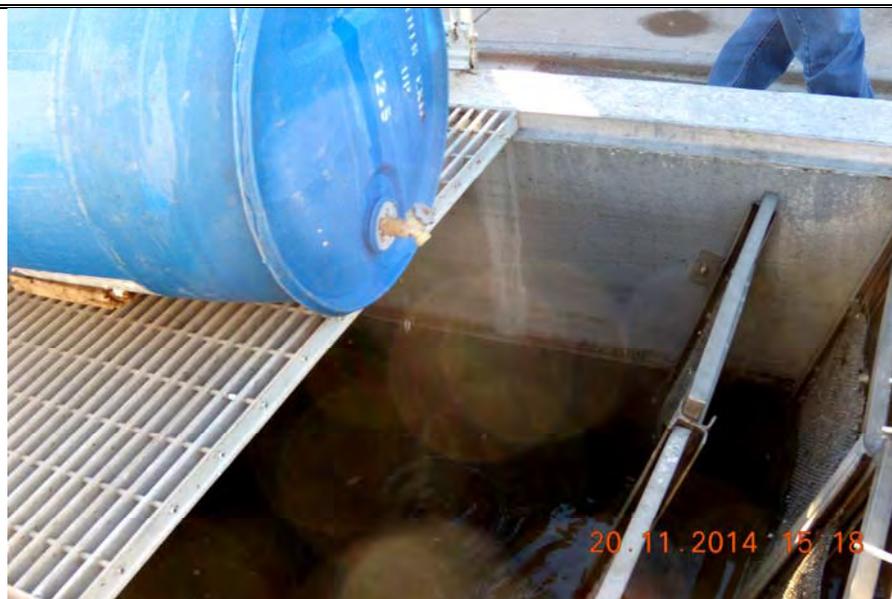
Subject: Sodium Hypochlorite Barrel dripping into the UV disinfection treatment system.
