NEW MEXICO ENVIRONMENT DEPARTMENT

Re: Minor Municipal; SIC 4952; Compliance Evaluation Inspection; CRRUA Santa Teresa Wastewater Treatment Plant; NPDES Permit No. NM0030201; February 25, 2015

NPDES Compliance Inspection Report

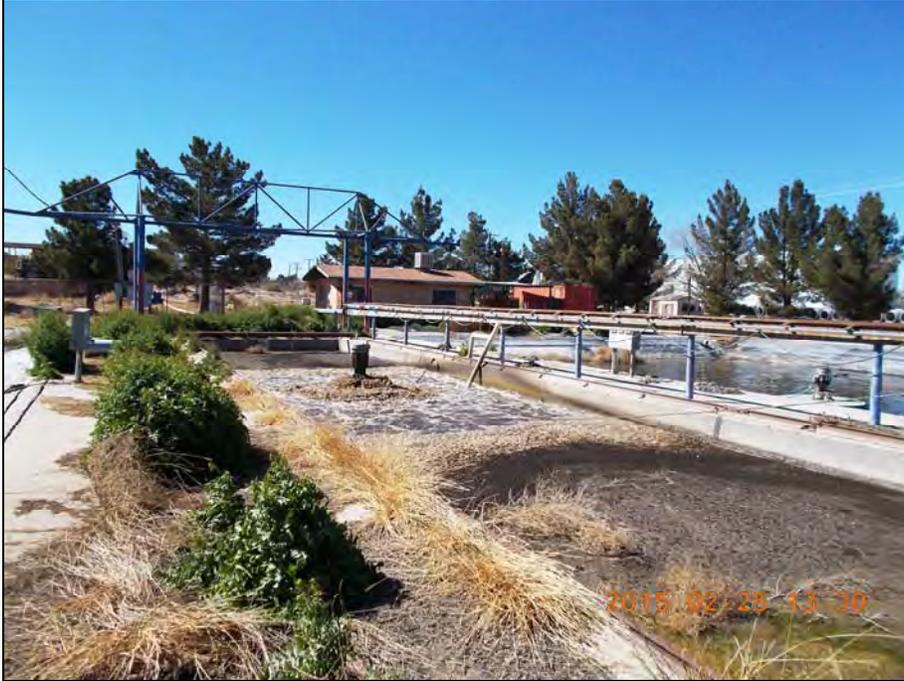
NMED/SWQB
Official Photograph Log
Photo #3

Subject: Package plant at WWTP influent flow enters the small package plant that is heavily loaded with solids, and only one aerators working. There is evidence of overflows from the basin is seen in the debris on the ground. Overgrown vegetation has not been removed. General maintenance is lacking at this facility.

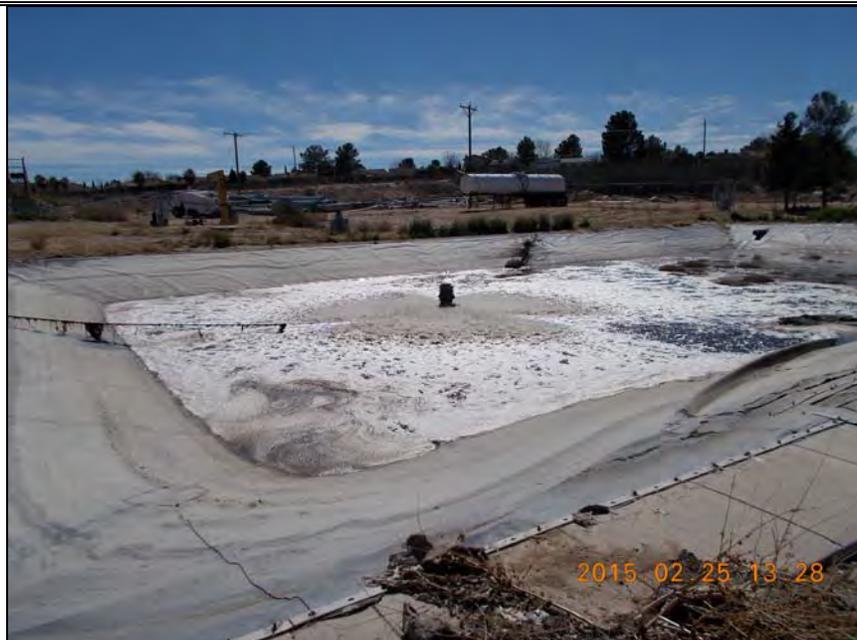
NMED/SWQB
Official Photograph Log
Photo #4

Subject: From the package plant, flow is split to two aerated ponds. East Pond: one aerator is working, solids are visible throughout the basins, foam is also an indication of solids overloading. Debris visible at the bottom of the photo shows an area of overflow from the aeration basin of the package plant.

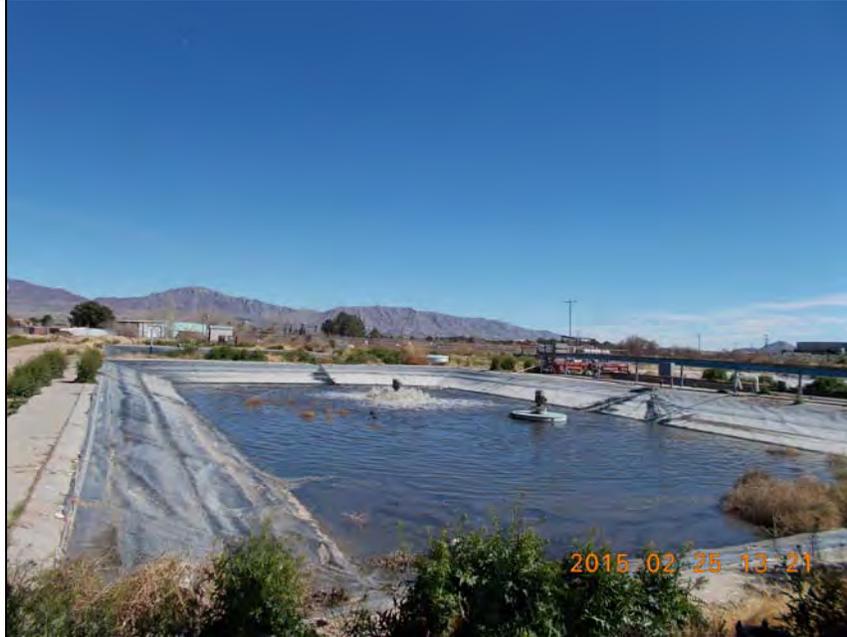
NMED/SWQB
Official Photograph Log
Photo # 5

Subject: West aerated pond flowing the aeration basins. Only one aerator is operational. Note the worn liner. Solids can be seen throughout the basin indicating overloading and inadequate solids removal.

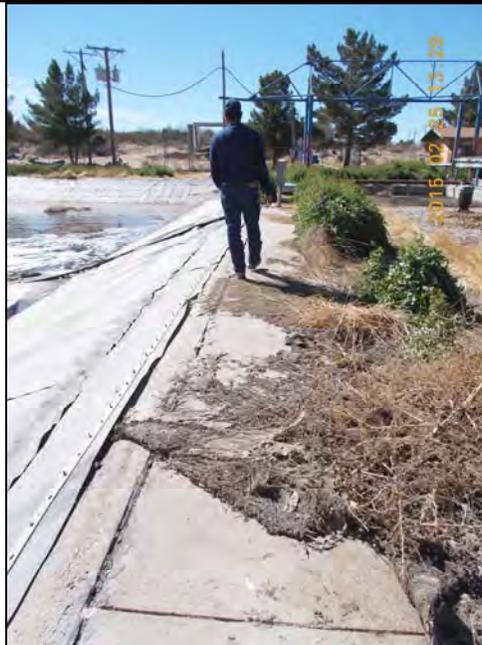
NMED/SWQB
Official Photograph Log
Photo # 6

Subject: Evidence of overflow from the basins is noted by the debris on the ground.

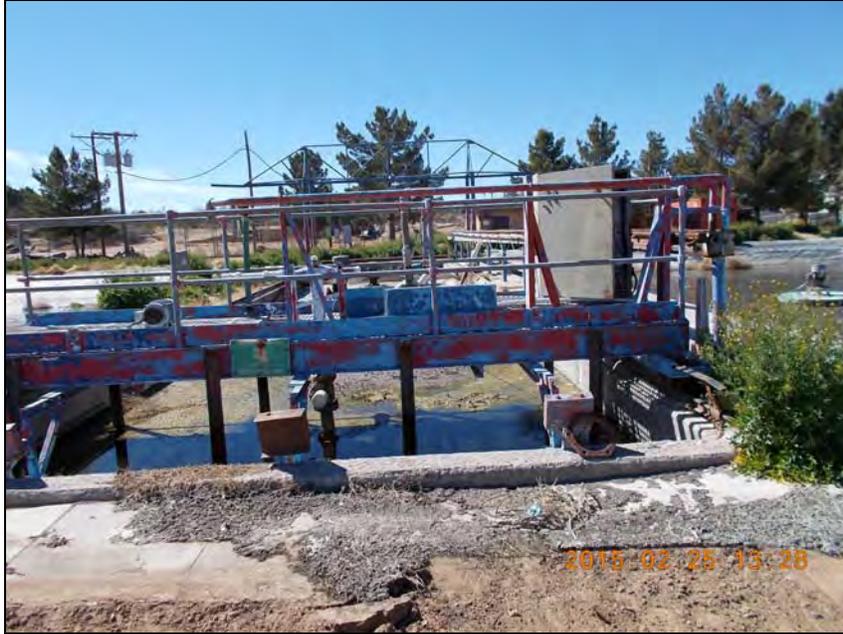
NMED/SWQB
Official Photograph Log
Photo # 7

Subject: Another view of evidence from basin overflows is noted by the debris on the ground.

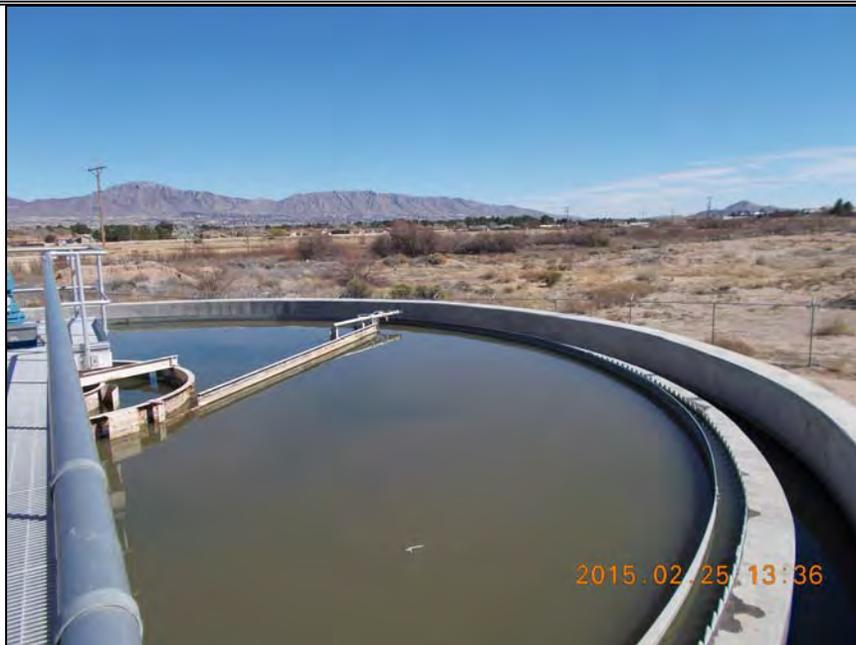
NMED/SWQB
Official Photograph Log
Photo # 8

14. *Final Clarifiers had a small amount of floating solids that indicate older sludge and inadequate wasting of solids (see attached photo). The clarifier weirs were clean and free of algae and collected solids. An operator was cleaning the weirs the day of the inspection*

Subject: Secondary clarifier has visible solids in the basin.

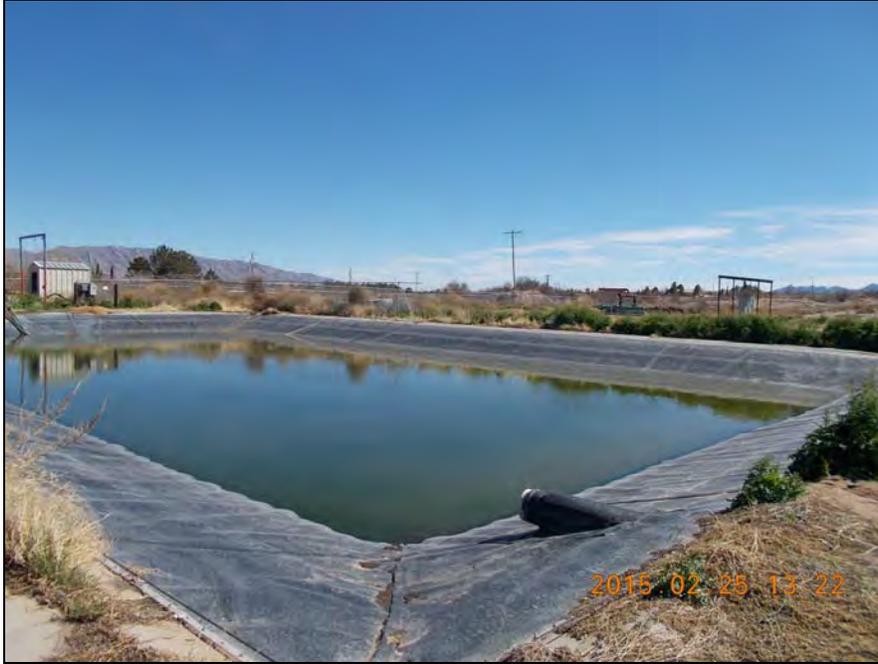
NMED/SWQB
Official Photograph Log
Photo # 9

Subject: The final pond that was formerly used as a chlorine contact basin has visible sold. From this basin, flow is sent to the View Point Lift Station for transport to the City of Sunland Park WWTP.

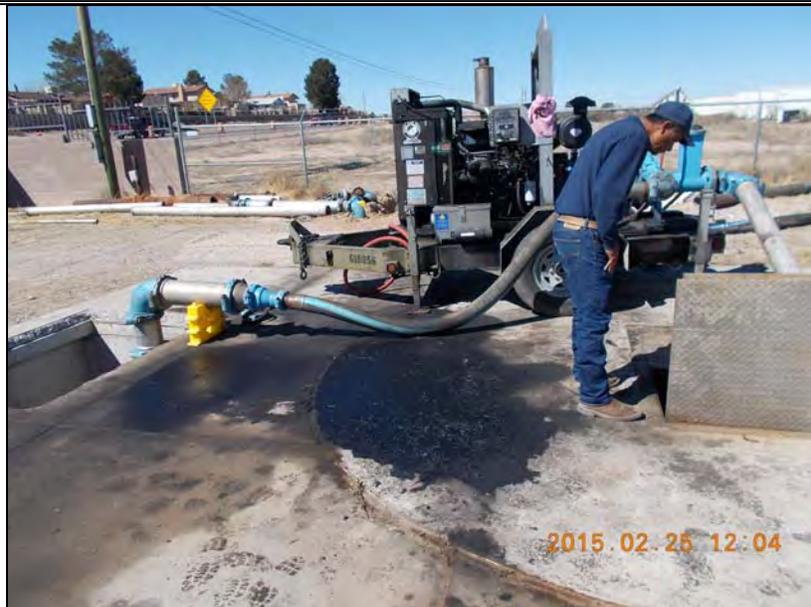
NMED/SWQB
Official Photograph Log
Photo #10

Subject: View Point Lift Station temporary mobile pumps are being used. Oil and gas spills on the ground.

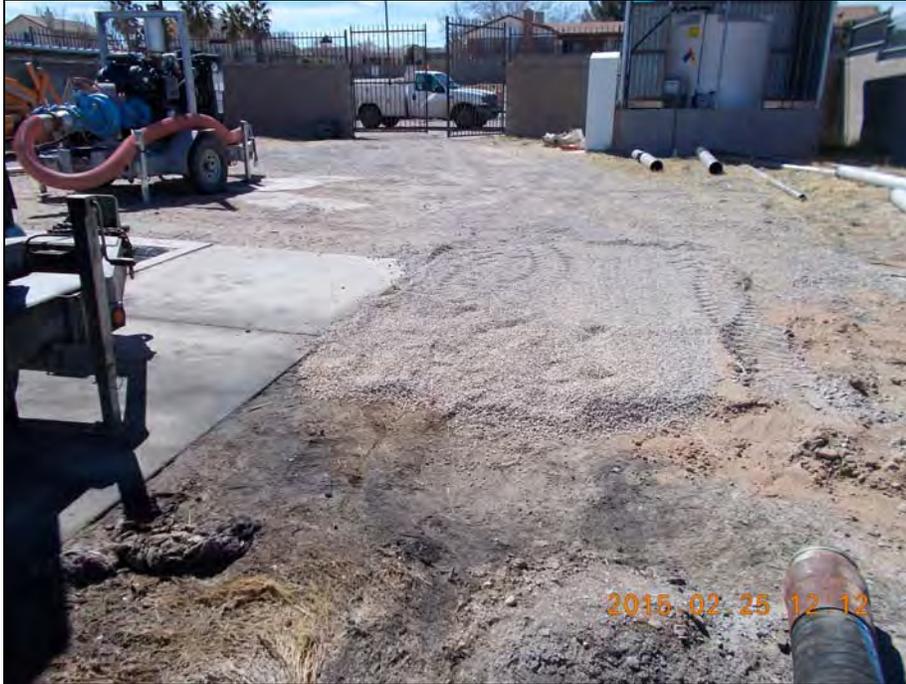
NMED/SWQB
Official Photograph Log
Photo # 11

Subject: View Point Lift Station temporary mobile pumps are being used. Oil and gas spills on the ground. The area of gravel was noted in the inspection of the City of Sunland Park WWTP conducted by NMED on November 20, 2015. The area had raw sewage, grease and oil spilled on the ground. It was not removed nor cleaned up. It was simply covered by gravel. The contaminants may still affect ground water.

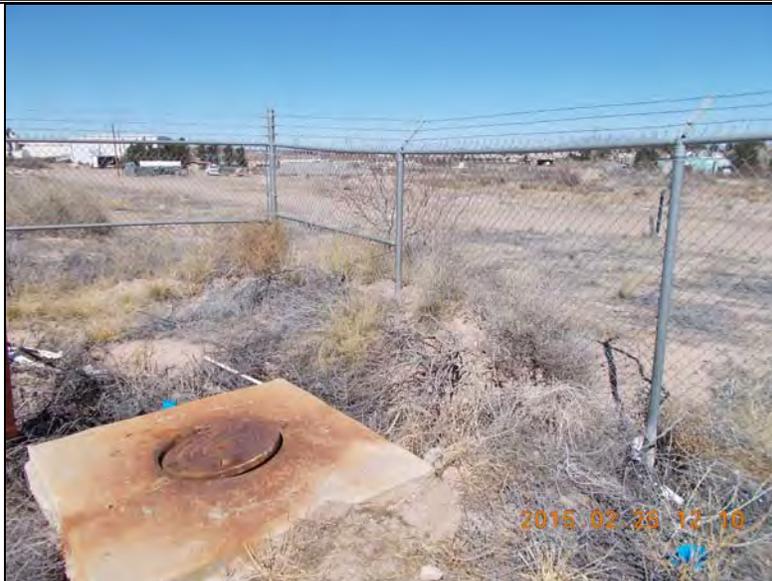
NMED/SWQB
Official Photograph Log
Photo # 12

Subject: View Point Lift Station temporary mobile pumps are being used. Oil and gas spills on the ground. The area of gravel was noted in the inspection of the City of Sunland Park WWTP conducted by NMED on November 20, 2015. The area had raw sewage on the ground. It was not removed nor cleaned up.

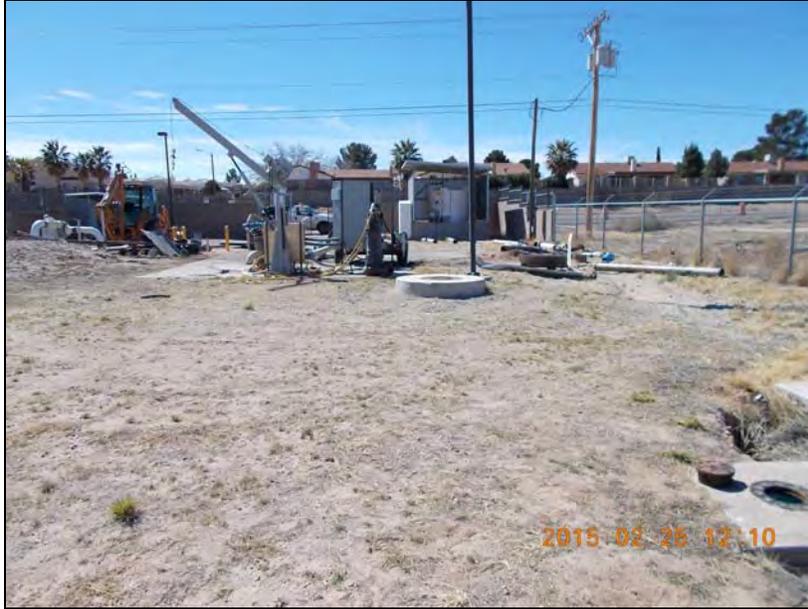
NMED/SWQB
Official Photograph Log
Photo # 13

Subject: Another wider area photo of the View Point Lift Station. A chlorine tank in the back is used for odor control and dosing directly into the sewer line.

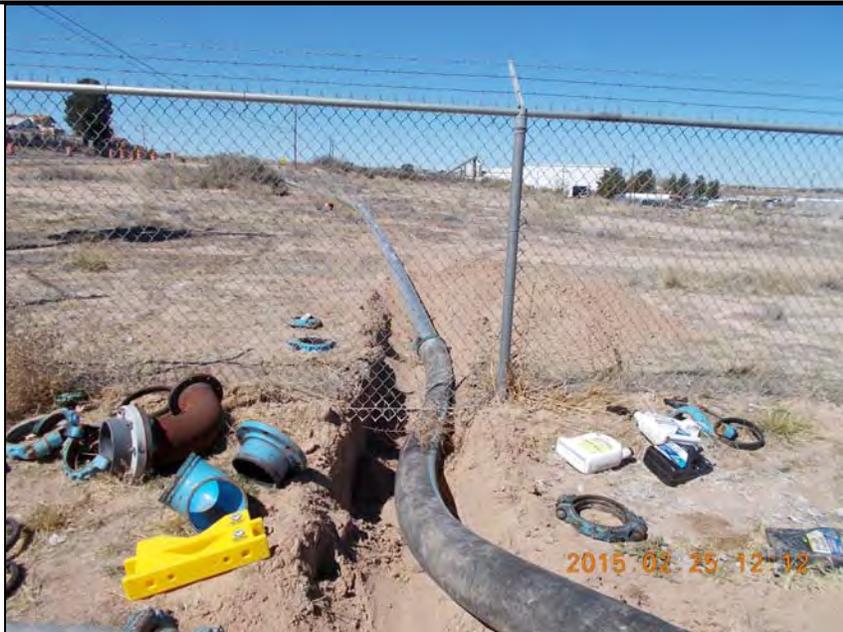
NMED/SWQB
Official Photograph Log
Photo # 14

Subject: From a man hole on McNutt road, a temporary line is in place to handle the flow. The manhole is where flow is split to either enter the Santa Teresa – Sunland Park North plant or to be sent directly to the Sunland Park plant approximately 7 miles away. This manhole is scheduled for rehabilitation.

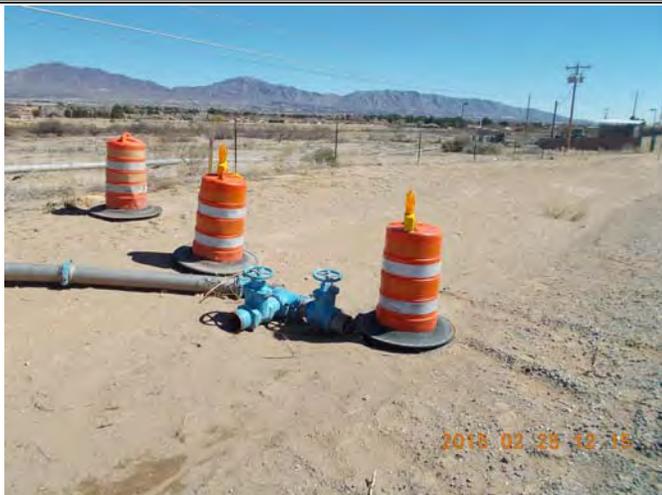
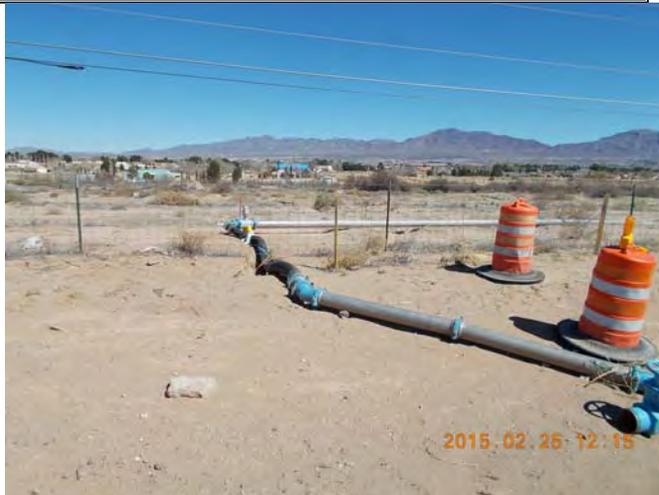
NMED/SWQB
Official Photograph Log
Photo #15 & 16

Subject: Another view from a man hole on McNutt road, a temporary line is in place to handle the flow. The manhole is where flow is split to either enter the Santa Teresa – Sunland Park North plant or to be sent directly to the Sunland Park plant approximately 7 miles away. This manhole is scheduled for rehabilitation.

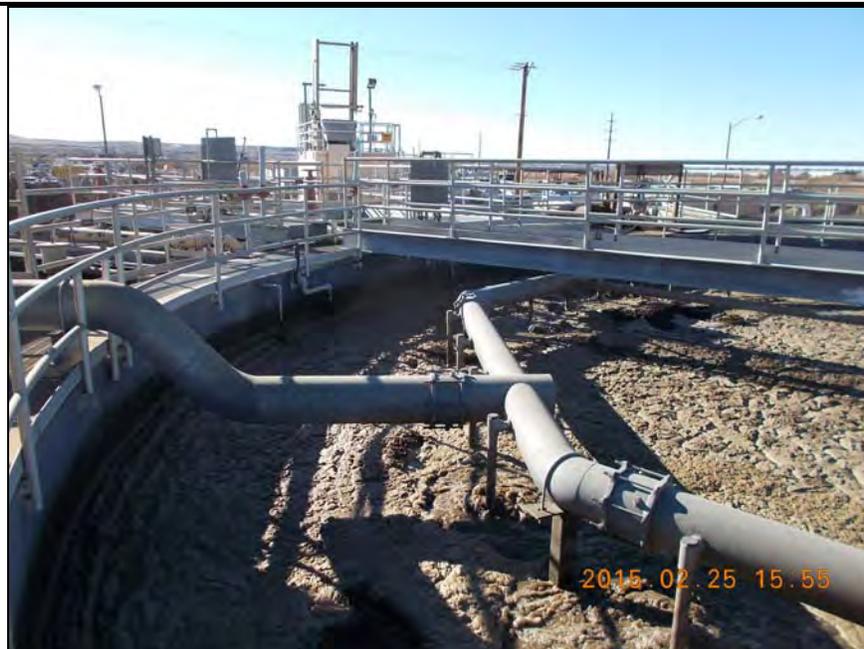
NMED/SWQB
Official Photograph Log
Photo # 17

Subject: A walk through of the Sunland Park Plant shows the aeration basins are in the same condition as found in the inspection done by NMED on November 20, 2014. The basins remain heavily overloaded with solids and foam.

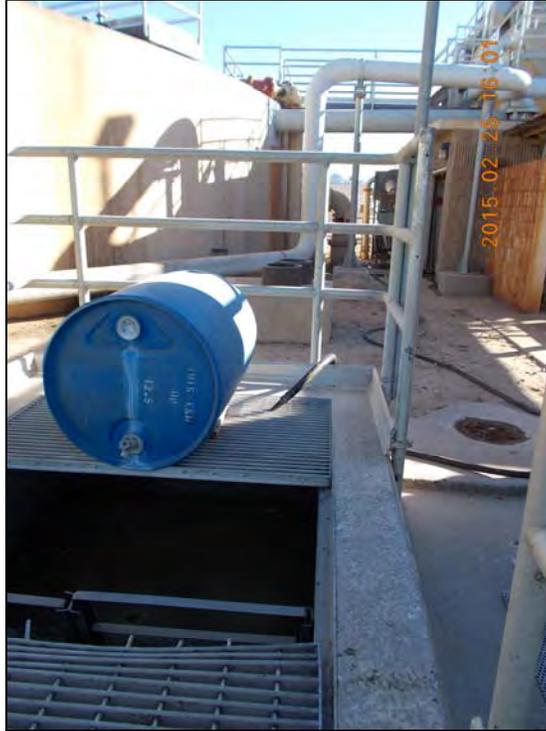
NMED/SWQB
Official Photograph Log
Photo # 18

Subject: A walk through of the Sunland Park Plant shows the aeration basins are in the same condition as found in the inspection done by NMED on November 20, 2014. A barrel of liquid chlorine is dripping into the effluent channel and ultraviolet disinfection channel. There is not enough contact time and no de-chlorination in place at this location. Repairs must be made to the ultraviolet system to achieve appropriate disinfection of effluent.

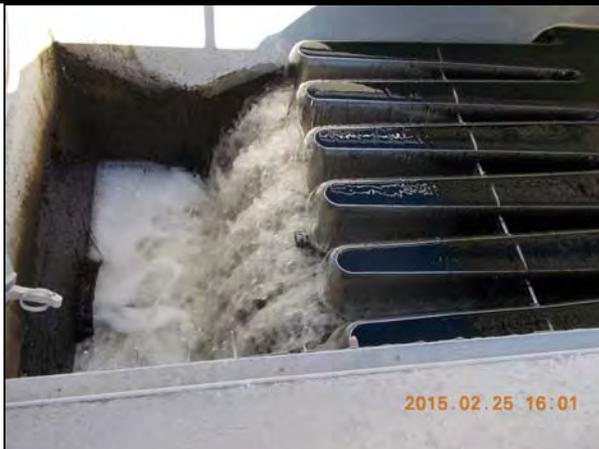
NMED/SWQB
Official Photograph Log
Photo # 19

Subject: A walk through of the Sunland Park Plant shows the aeration basins are in the same condition as found in the inspection done by NMED on November 20, 2014. Effluent following the ultraviolet disinfection system. The effluent was a slight greenish color and foamy. Repairs must be made to the ultraviolet system to achieve appropriate disinfection of effluent.

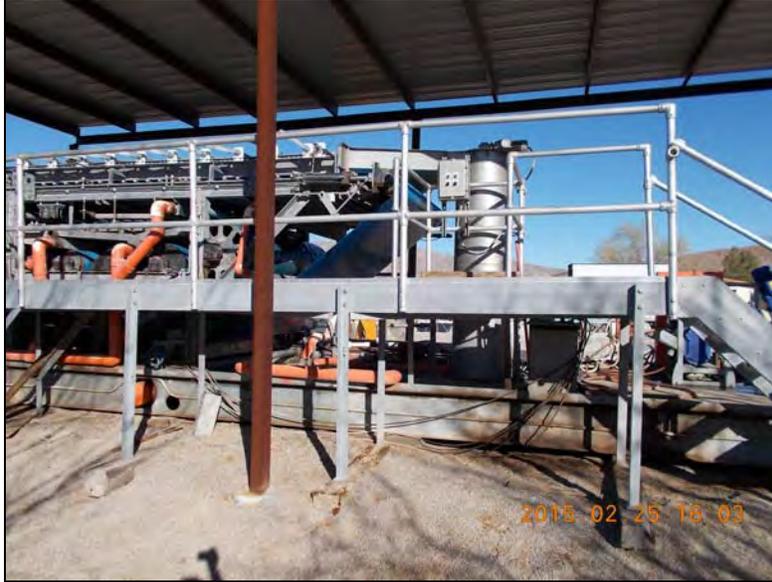
NMED/SWQB
Official Photograph Log
Photo # 20

Subject: A walk through of the Sunland Park Plant shows the aeration basins are in the same condition as found in the inspection done by NMED on November 20, 2014. The solids dewatering belt press has been repaired and increased solids wasting is taking place. Though the plant is still heavily overloaded with solids.

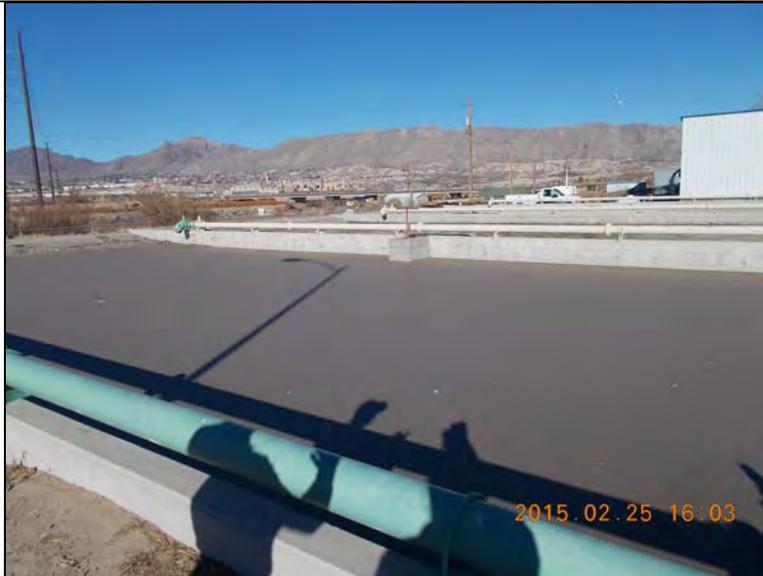
NMED/SWQB
Official Photograph Log
Photo # 21

Subject: Subject: A walk through of the Sunland Park Plant shows the aeration basins are in the same condition as found in the inspection done by NMED on November 20, 2014. The solids dewatering belt press has been repaired and increased solids wasting is taking place. Though the plant is still heavily overloaded with solids. In addition to dewatering by belt press, solids are being sent to the drying beds in greater volumes than noted in the previous inspection.

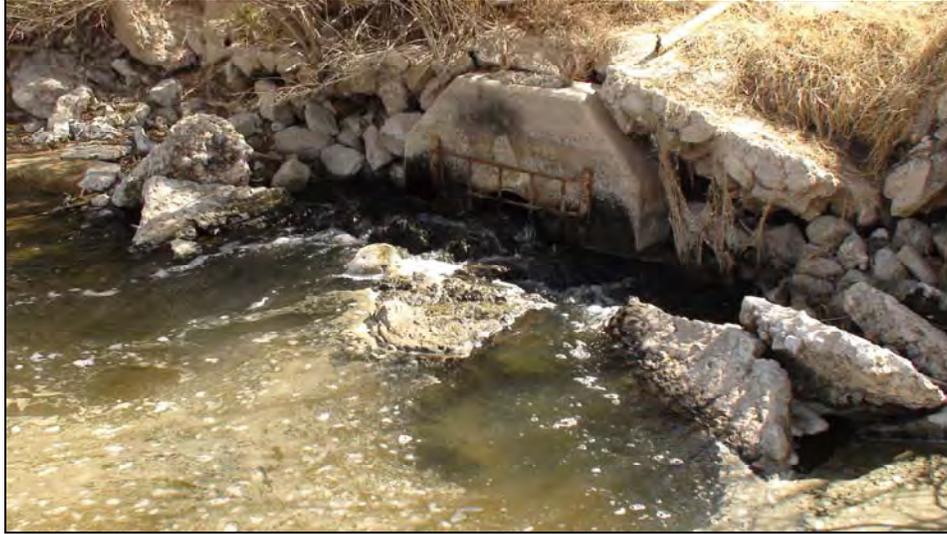
**NMED/SWQB
Official Photograph Log
Photo # 22**

Subject: Complaint of Sewage Discharge to Rio Grande from Sunland Park WWTP NM0029483, the final discharge point for the Santa Teresa WWTP. Note the brown/grey foam, floating solids and turbidity being discharged to the Rio Grande. The discharge appears to be untreated sewage due to poor operations and maintenance at the Sunland Park WWTP. The complainant also noted a strong sewage odor from the discharge.

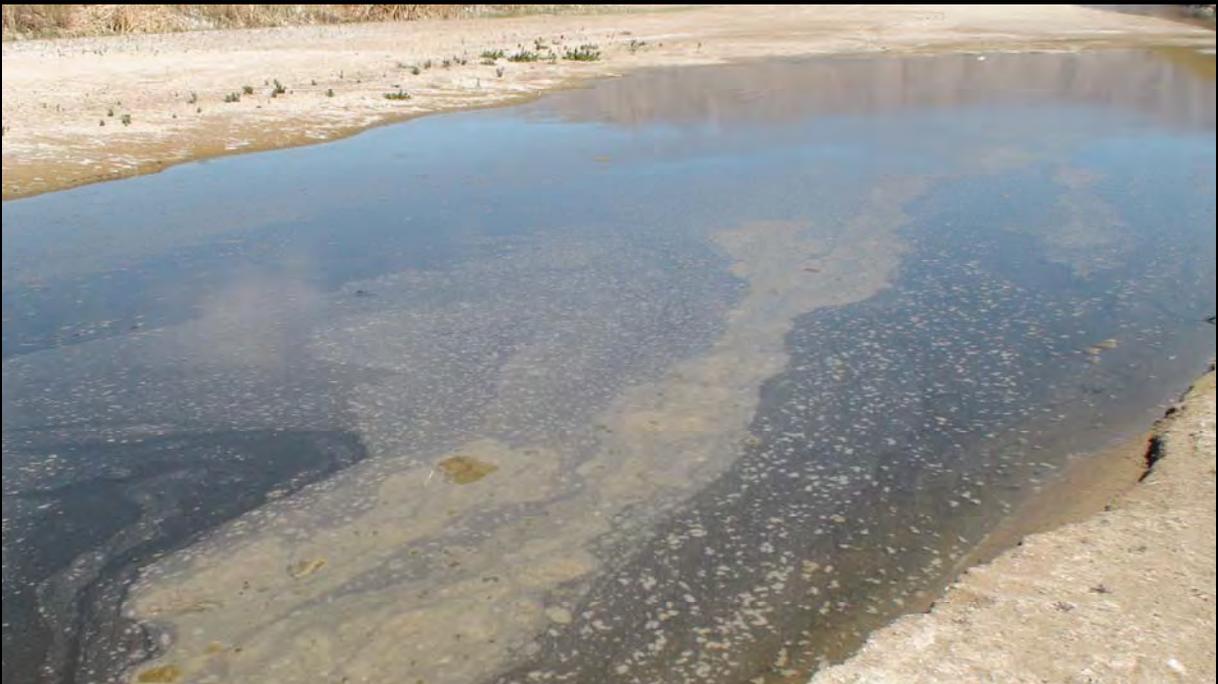
**NMED/SWQB
Official Photograph Log
Photo # 23**

Subject: Another view; Complaint of Sewage Discharge to Rio Grande from Sunland Park WWTP NM0029483, the final discharge point for the Santa Teresa WWTP. Note the brown/grey foam, floating solids and turbidity being discharged to the Rio Grande. The discharge appears to be untreated sewage due to poor operations and maintenance at the Sunland Park WWTP. The complainant also noted a strong sewage odor from the discharge.

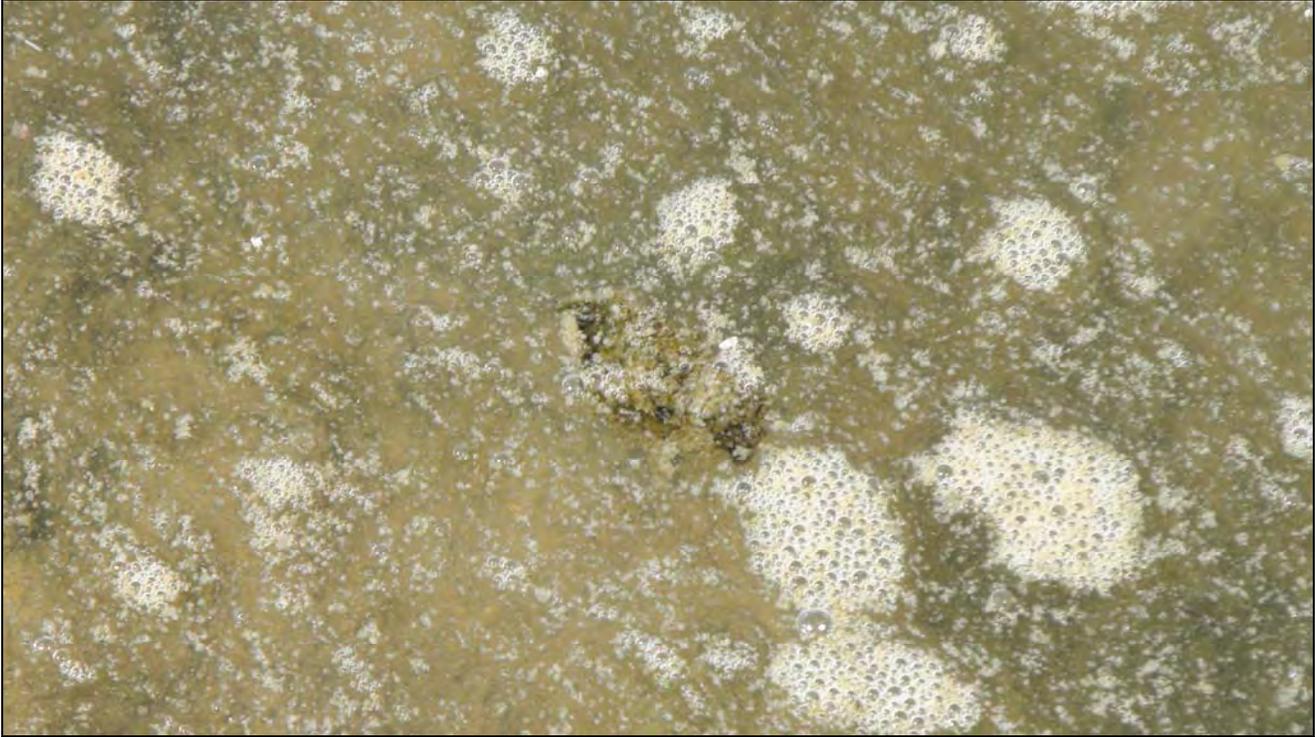
NMED/SWQB
Official Photograph Log
Photo # 24

Subject: Another view; Complaint of Sewage Discharge to Rio Grande from Sunland Park WWTP NM0029483, the final discharge point for the Santa Teresa WWTP. Note the brown/grey foam, floating solids and turbidity being discharged to the Rio Grande. The discharge appears to be untreated sewage due to poor operations and maintenance at the Sunland Park WWTP. The complainant also noted a strong sewage odor from the discharge.

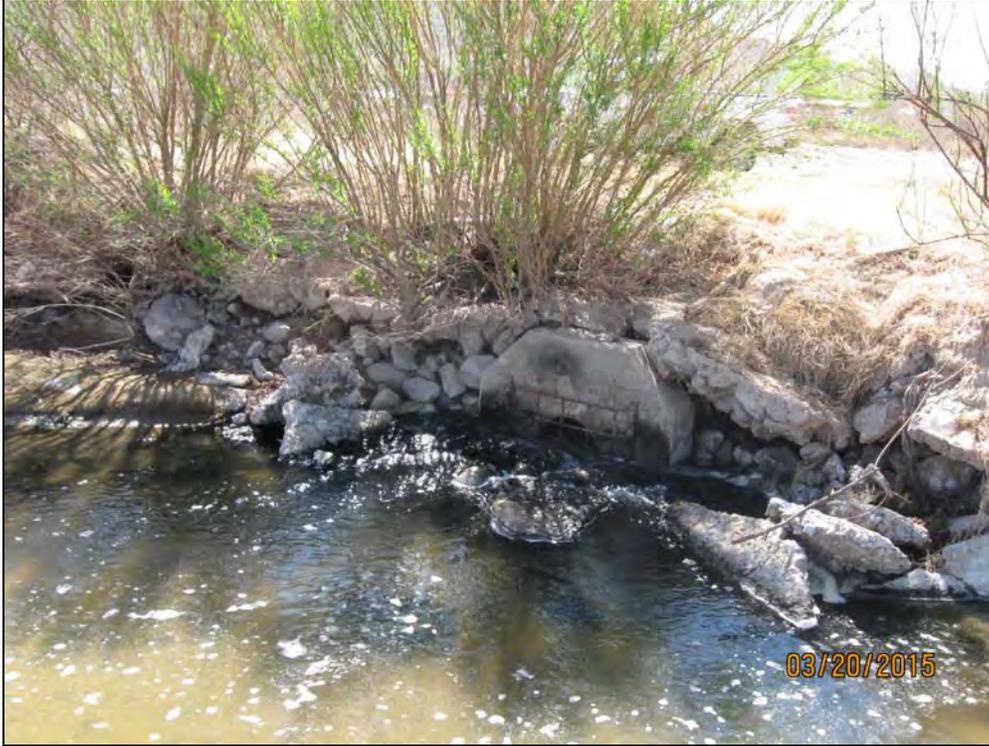
NMED/SWQB
Official Photograph Log
Photo # 25

Subject: Effluent discharge nine days after the complaint by the IBWC of raw sewage being discharged. Foam is observed and some degree of turbidity appears to be present.

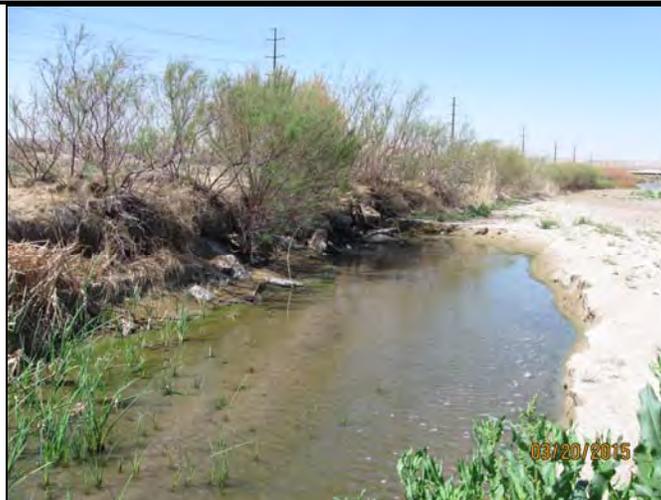
NMED/SWQB
Official Photograph Log
Photo # 26

Subject: Looking upstream from the effluent discharge nine days after the complaint by the IBWC of raw sewage being discharged. Foam is observed and some degree of turbidity appears to be present.

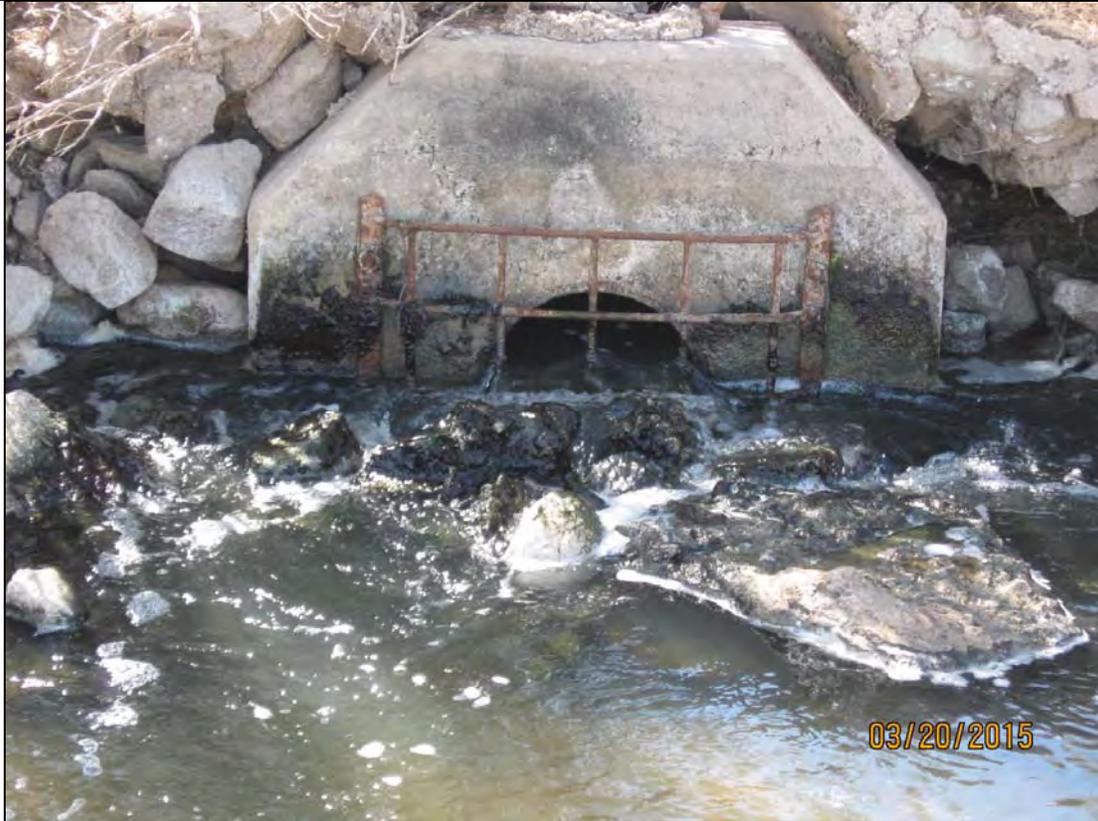
NMED/SWQB
Official Photograph Log
Photo # 27

Subject: Effluent discharge nine days after the complaint by the IBWC of raw sewage being discharged. Foam is observed and some degree of turbidity appears to be present.
