**Re: EXPO New Mexico, CAFO; SIC 5093; NPDES Compliance Evaluation Inspection; NMG010068;
December 17, 2013**

NPDES Compliance Inspection Report

**NPDES Compliance Inspection
EXPO New Mexico/The Downs at Albuquerque
December 17, 2013
Further Explanations**

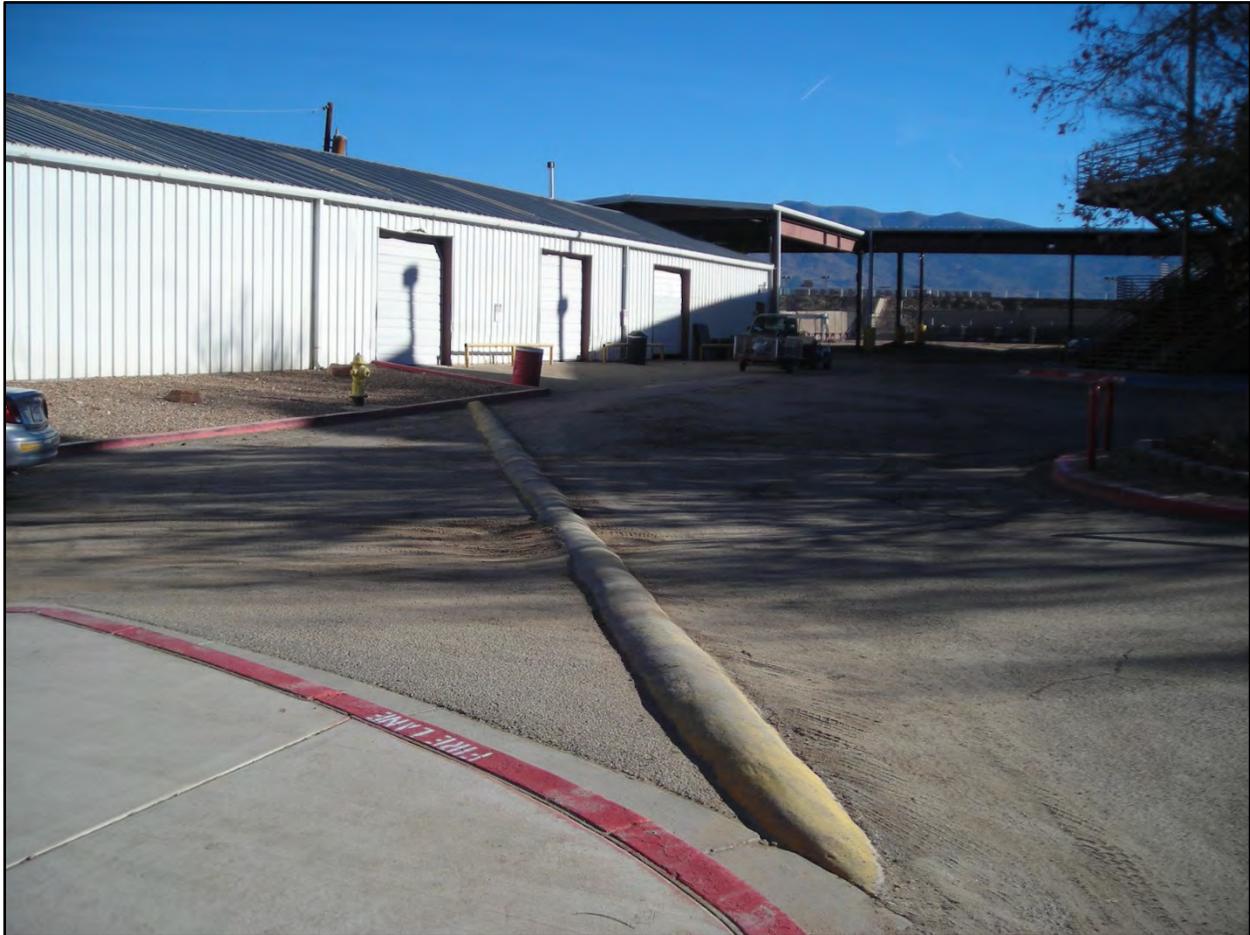
NMED Photolog
Photo #1

Historically there has been a complex infrastructure situation at this facility. EXPO NM is located in the middle of the city of Albuquerque on land owned by the State of New Mexico. In 1982, an easement was granted to allow the city to install flood control/stormwater infrastructure at this site on state land. This infrastructure drains approximately 2.6 square miles of the neighborhoods that directly border EXPO NM to the East. The drainage from this area is sent to a large sectionalized storm surge pond located at the east end of EXPO NM. An outlet from this pond was constructed to connect it to the existing storm drain system constructed in the 1950s. This subsurface outlet pipe crosses the north end of EXPO NM, through the area where the animals are stabled. Since the prior inspection, EXPO has sealed off the five drop inlets into this stormwater pipe by installing corrugated steel underneath the inlets in conjunction with a strong plastic pond liner material, and then paved over the inlet with asphalt. EXPO has also installed berms to divert runoff from the MS4 area of the facility away from the CAFO area. Please see photos # 1 & 7.

Photographer:	Sarah Holcomb	Date:	12-17-2013
Location:	EXPO New Mexico, Albuquerque, Bernalillo County, NM		
Description:	Water diversion structure/berm installed to divert stormwater run-on away from the CAFO area of the facility.

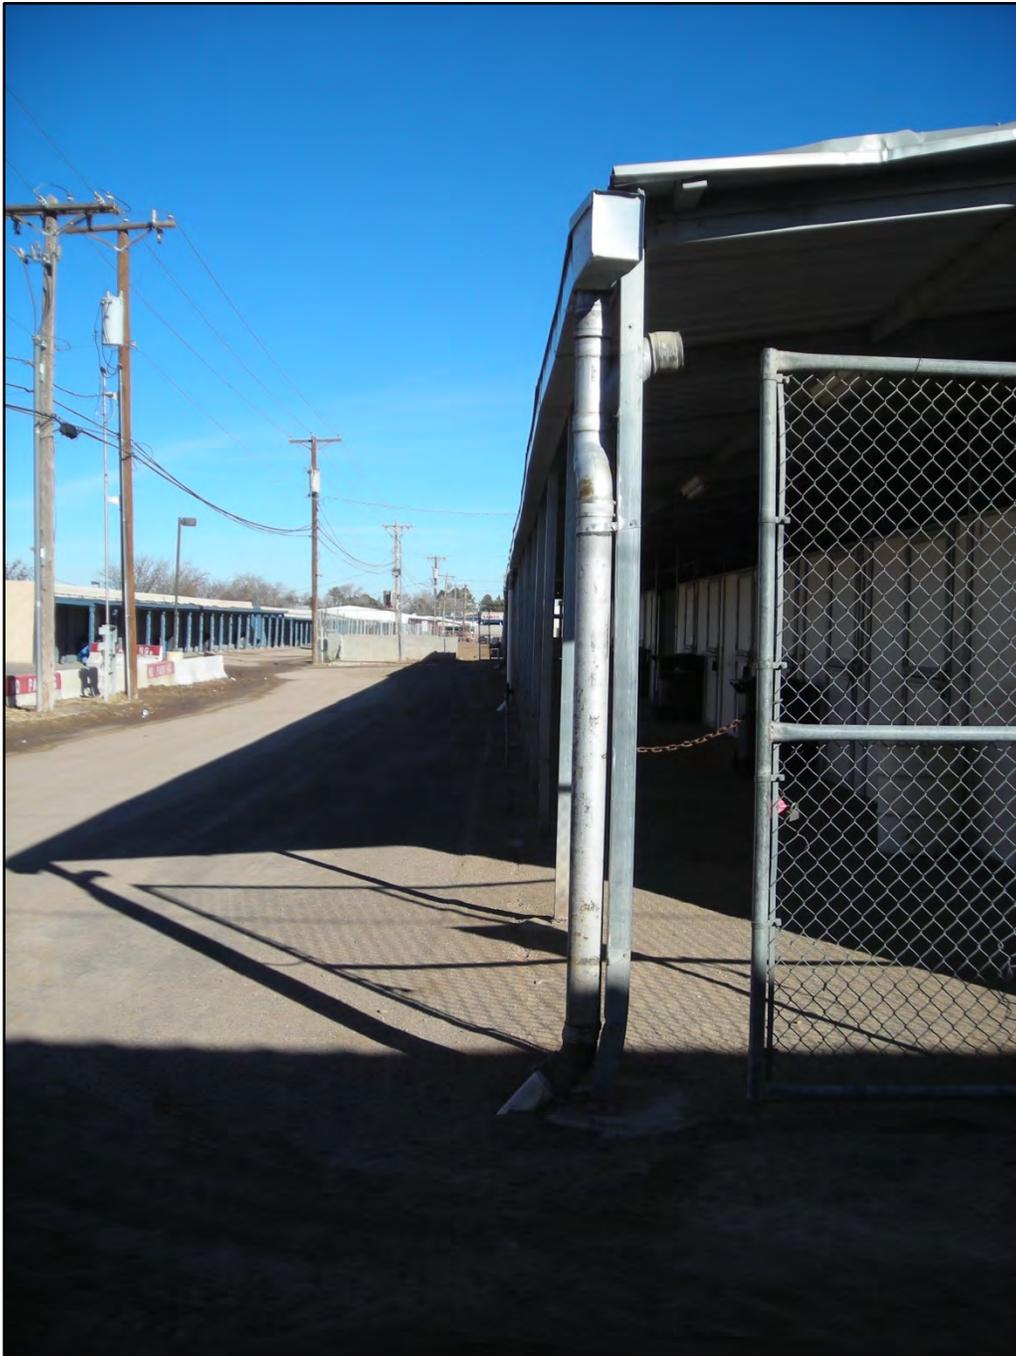
NMED Photolog
Photo #2

The roof runoff from the stall/barn area of the CAFO has been disconnected from the production area. Please see photo #2-3. This clean runoff has been directed, via underground pipe, into the storm surge pond side of the new engineered dam. Please see photo #14, indicator #3.

Photographer:	Sarah Holcomb	Date:	12-17-2013
Location:	EXPO New Mexico, Albuquerque, Bernalillo County, NM		
Description:	Uncontaminated roof runoff has been disconnected and is directly diverted into the City of Albuquerque's stormwater system. The downspouts are directly connected to the city storm sewer.

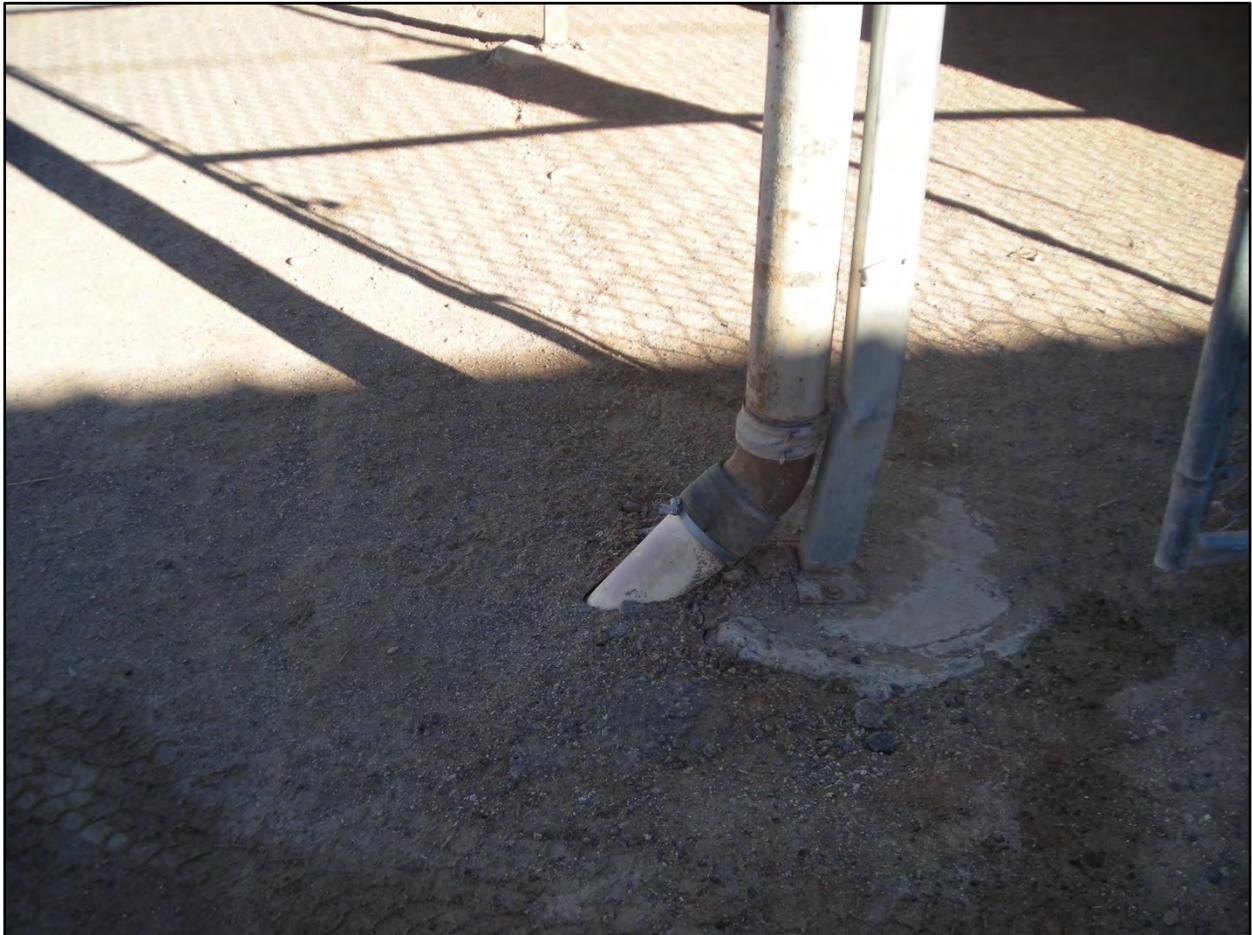
NMED Photolog
Photo #3

Photographer:	Sarah Holcomb	Date:	12-17-2013
Location:	EXPO New Mexico, Albuquerque, Bernalillo County, NM		
Description:	Uncontaminated roof runoff has been disconnected and is directly diverted into the City of Albuquerque's stormwater system. The downspouts are directly connected to the city storm sewer.

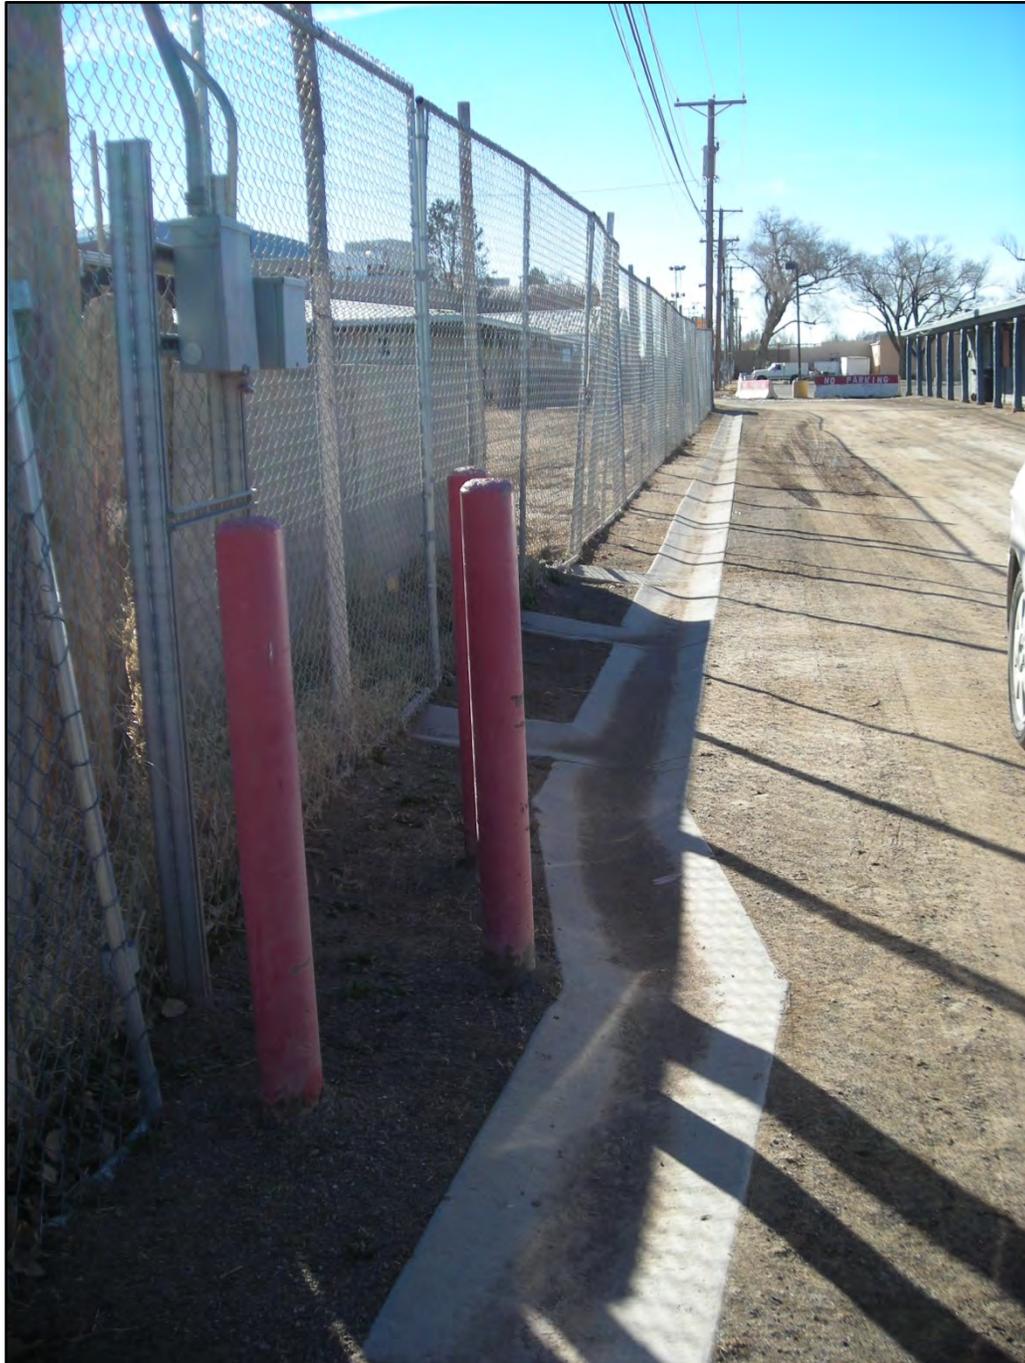
NMED Photolog
Photo #4

There are numerous wash racks located around the stabling facilities. Discharges from the wash racks located around the stabling area are now directed through a new conveyance system (please see photos #4-6) to a pretreatment system. This pretreatment system provides primary treatment (settling) of the wastewater before discharging the waste to the Albuquerque Bernalillo County Water Utility Authority's (ABCWUA) sanitary sewer system. EXPO NM holds an NPDES pretreatment permit with the ABCWUA for discharge of this wastewater to their system. The pretreatment system consists of two chambers. The first chamber (800 gallons) provides the primary treatment/settling, after which the flow is directed to a sump. Solids collected from the settling basin are disposed of at a Bernalillo County transfer station near Tijeras, NM. The sump (800 gallons) is operated via a float valve and automatic pump. The pump has a rainwater detection device, which allows the system to shut off in the event of rainfall, enabling the ABCWUA to avoid collecting rainwater into their system. Please see photos #10-12.

Photographer:	Sarah Holcomb	Date:	12-17-2013
Location:	EXPO New Mexico, Albuquerque, Bernalillo County, NM		
Description:	A new culvert/drainage system has been installed to convey the wastewater from horse washing to the treatment system. This channelizes the water and efficiently conveys it through the facility. All of the horse wash racks are connected to this conveyance.

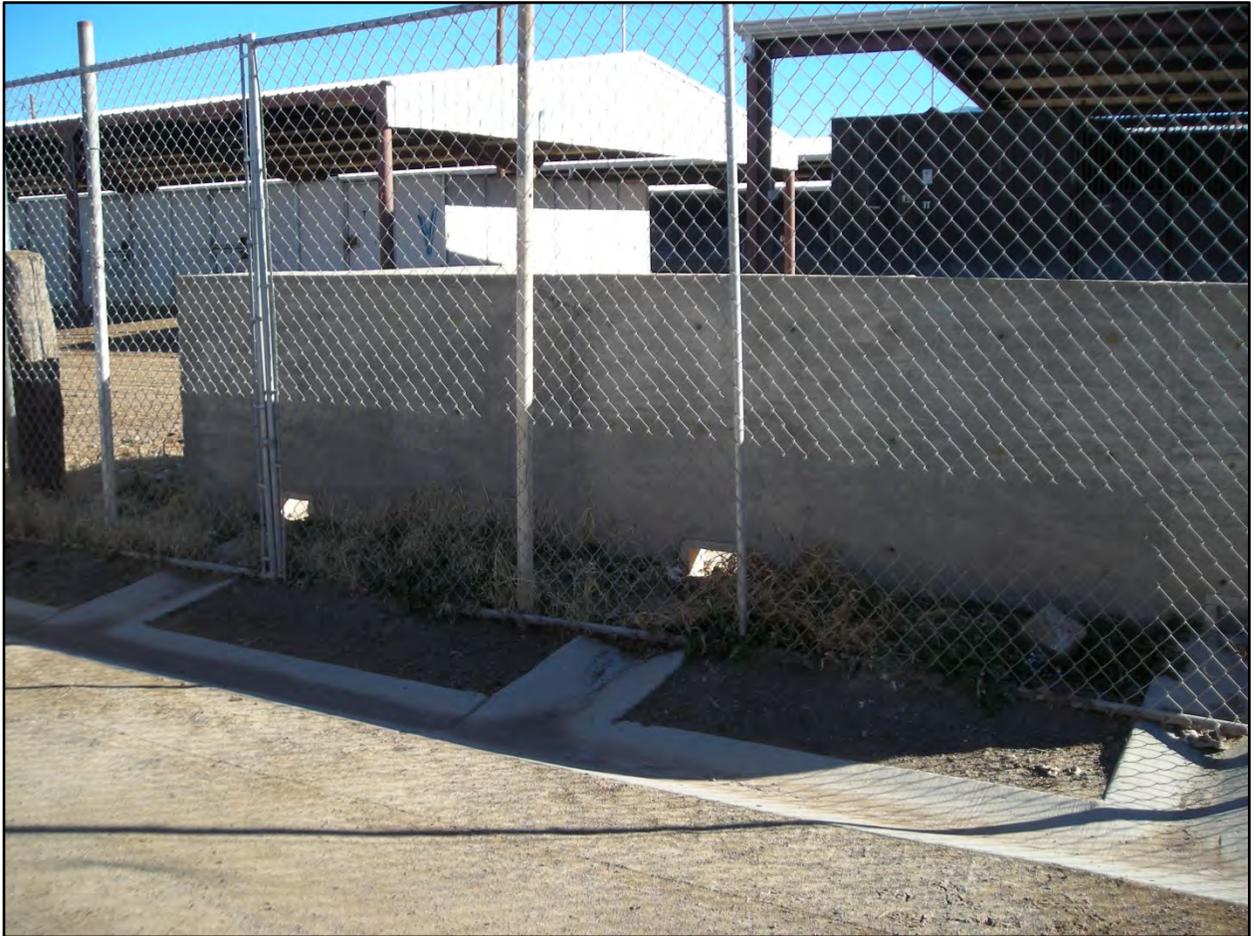
NMED Photolog
Photo #5

Photographer:	Sarah Holcomb	Date:	12-17-2013
Location:	EXPO New Mexico, Albuquerque, Bernalillo County, NM		
Description:	The horse wash racks are directly connected to the new conveyance.

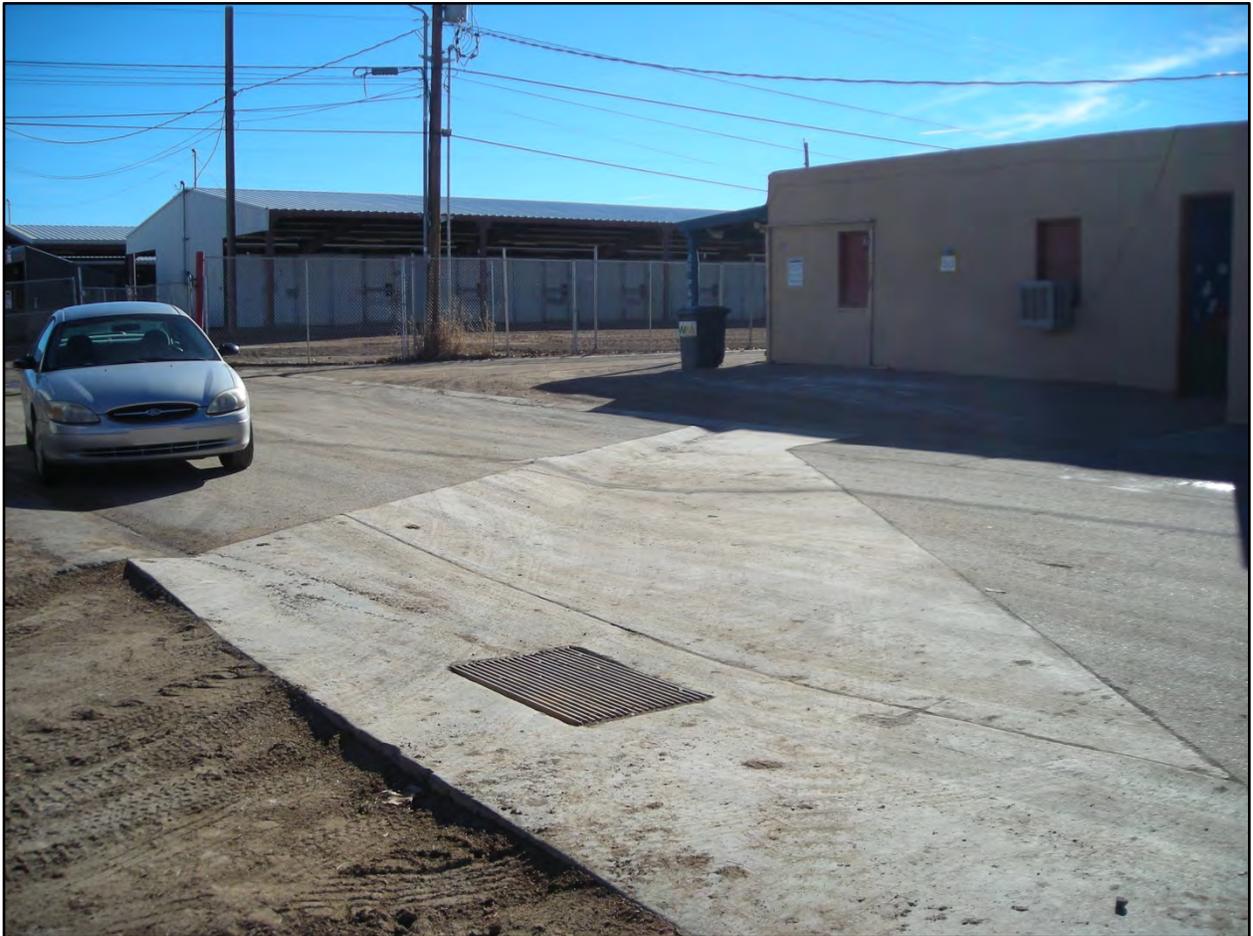
NMED Photolog
Photo #6

Photographer:	Sarah Holcomb	Date:	12-17-2013
Location:	EXPO New Mexico, Albuquerque, Bernalillo County, NM		
Description:	The new conveyance system leads directly to drop inlets, which carry the wastewater to the EXPO's wastewater treatment facility.

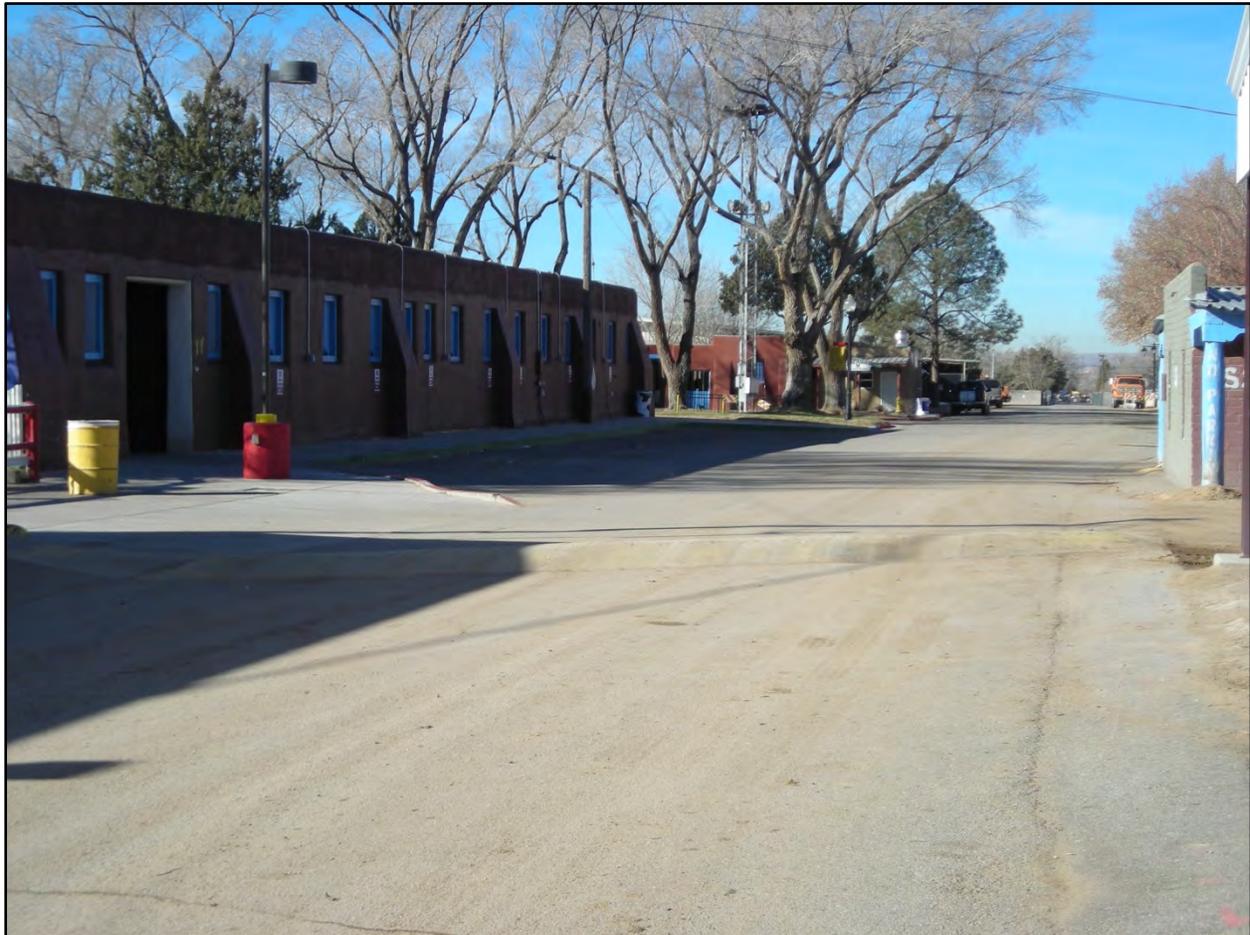
NMED Photolog
Photo #7

Photographer:	Sarah Holcomb	Date:	12-17-2013
Location:	EXPO New Mexico, Albuquerque, Bernalillo County, NM		
Description:	The second diversion structure/berm installed to divert run-on away from the CAFO portion of EXPO's facility.

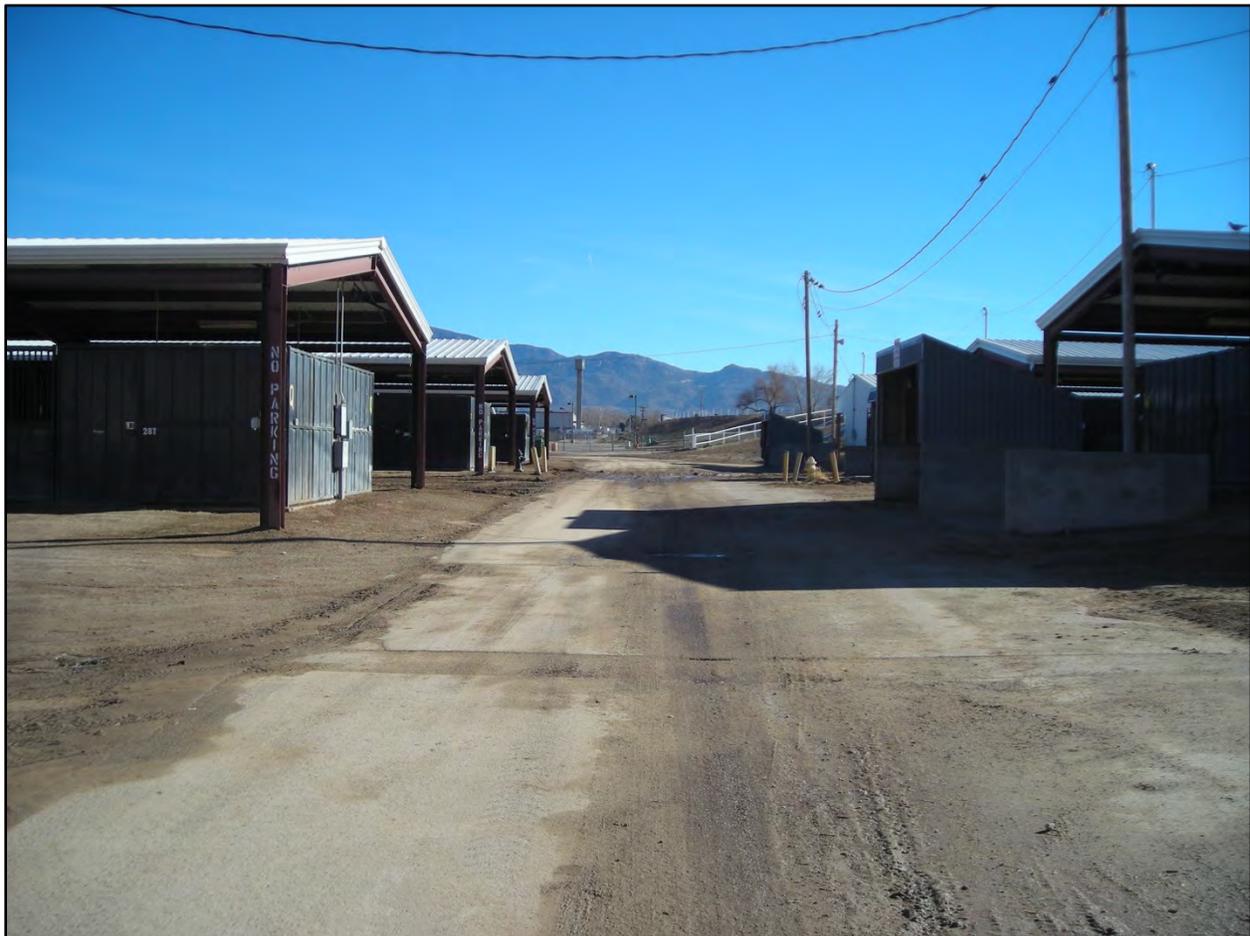
NMED Photolog
Photo #8

Photographer:	Sarah Holcomb	Date:	12-17-2013
Location:	EXPO New Mexico, Albuquerque, Bernalillo County, NM		
Description:	View of the facility's roads within the CAFO area. To the right in the far background is the facility's racetrack. This road previously contained drop inlets that carried CAFO wastewater directly to the AMAFCA storm sewers. The drop inlets have since been disconnected by installing a sheet of corrugated metal and some pond liner and then paving over the area with asphalt.

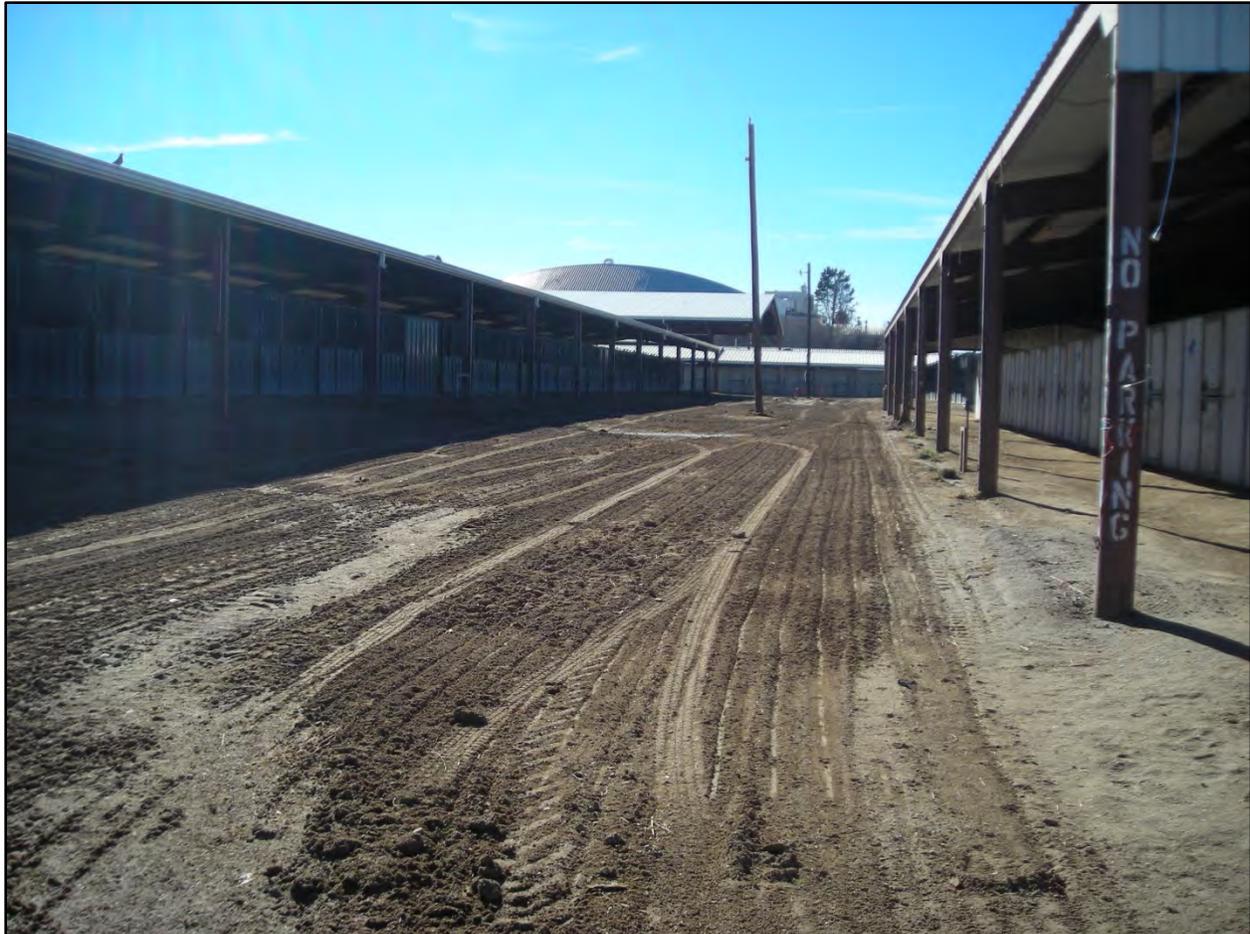
NMED Photolog
Photo #9

The facility personnel also removed compacted dirt in the barn area and refilled the area with 12-18 inches of new soil in order to promote infiltration on site. The facility also added swales and focused on improving surface grading. Please see photo #9.

Photographer:	Sarah Holcomb	Date:	12-17-2013
Location:	EXPO New Mexico, Albuquerque, Bernalillo County, NM		
Description:	In the barn areas, fresh dirt is brought in to facilitate infiltration of stormwater and to allow for proper grading to ensure that the wastewater is directed to the treatment system.

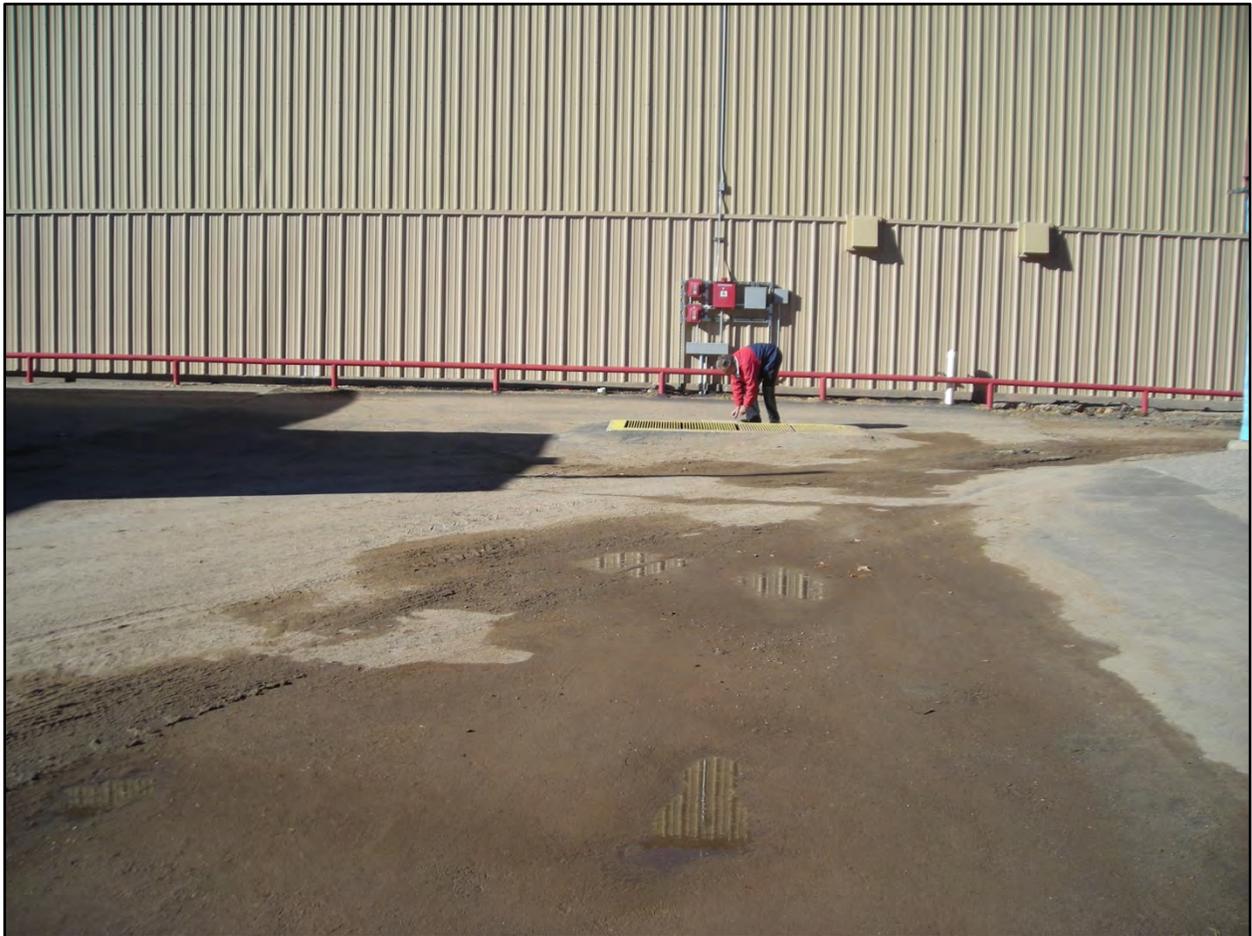
NMED Photolog
Photo #10

Photographer:	Sarah Holcomb	Date:	12-17-2013
Location:	EXPO New Mexico, Albuquerque, Bernalillo County, NM		
Description:	View of the facility's wastewater treatment system. The photographer is standing on the first grate, which contains a settling chamber and trash collection device. The wastewater is then routed to the second chamber (in the background) where it is pumped to the ABCWUA's treatment system.

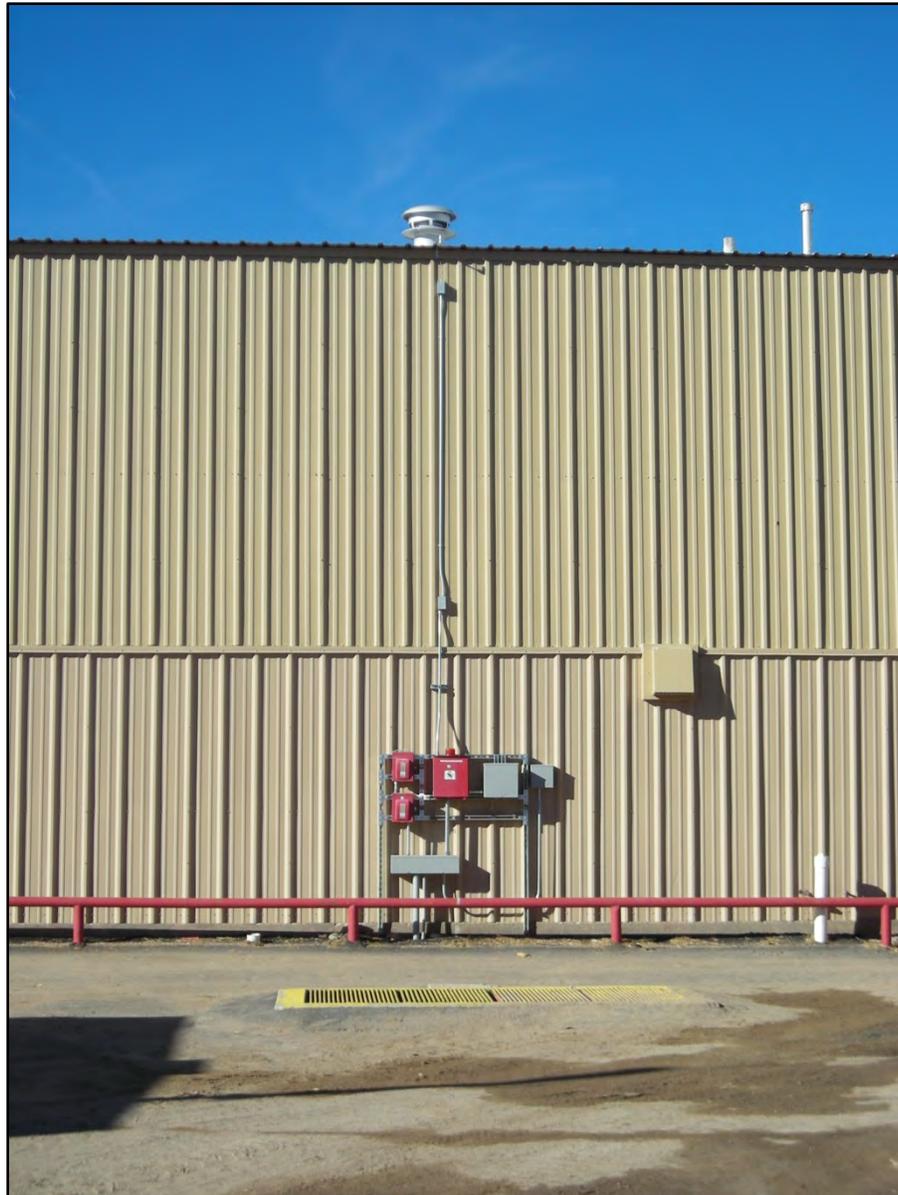
NMED Photolog
Photo #11

Photographer:	Sarah Holcomb	Date:	12-17-2013
Location:	EXPO New Mexico, Albuquerque, Bernalillo County, NM		
Description:	The facility's rain gauge, which shuts off the pump to ABCWUA's system in the event of a rain storm. This prevents inflow and infiltration into the Authority's system.

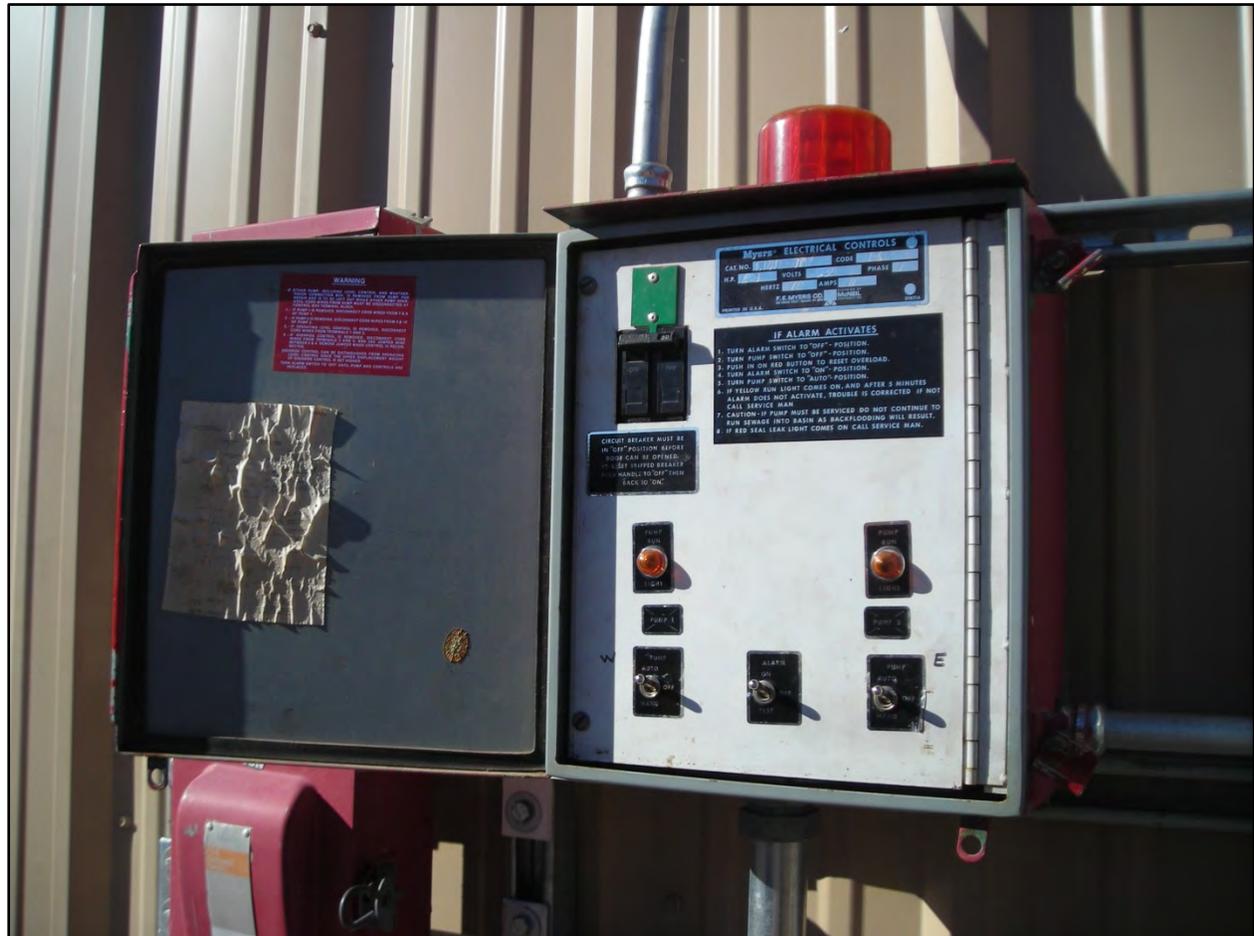
NMED Photolog
Photo #12

Photographer:	Sarah Holcomb	Date:	12-17-2013
Location:	EXPO New Mexico, Albuquerque, Bernalillo County, NM		
Description:	Rain gauge/pump panel. The system does allow for a manual override to pump even when the rain gauge has stopped the system.

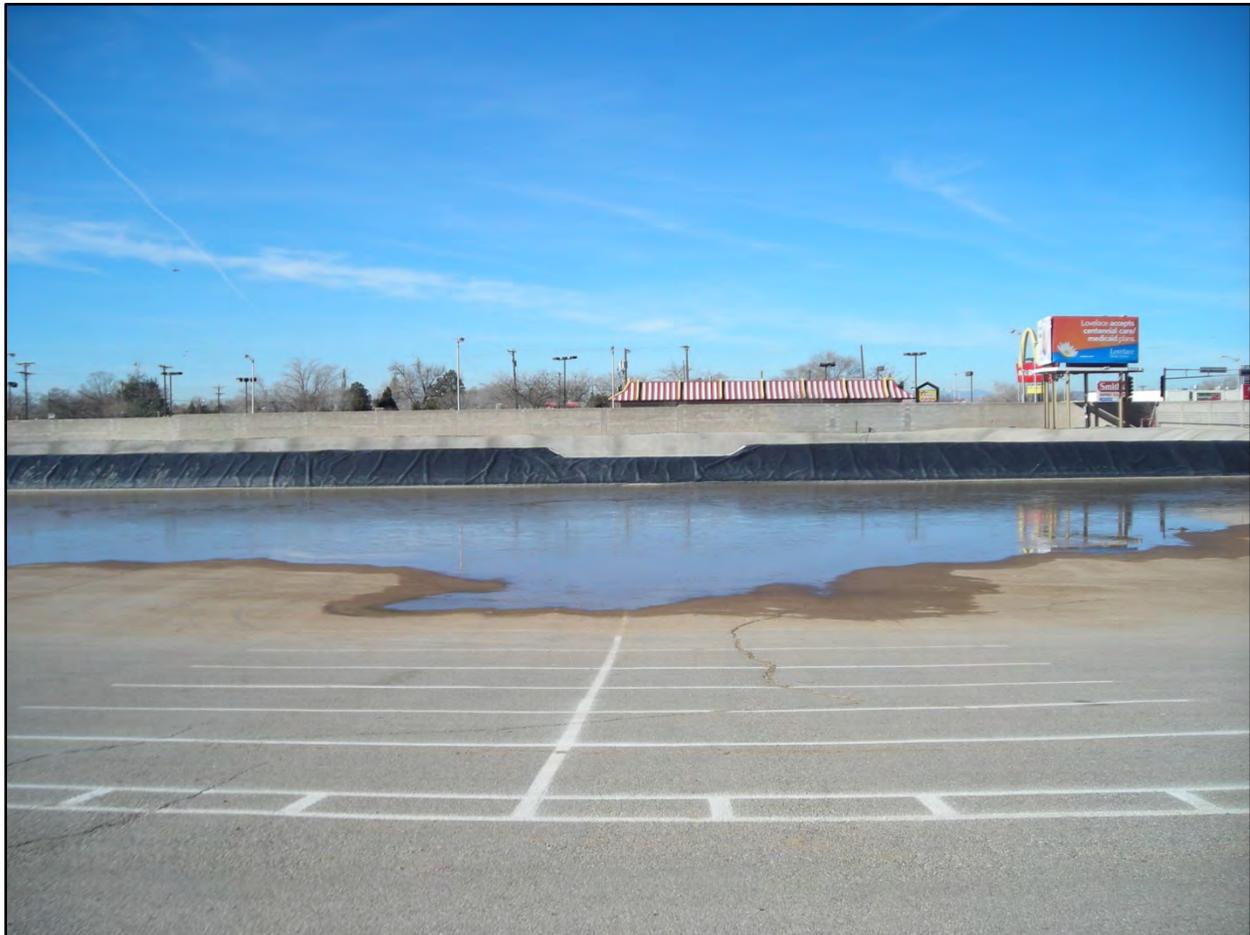
NMED Photolog
Photo #13

Photographer:	Sarah Holcomb	Date:	12-17-2013
Location:	EXPO New Mexico, Albuquerque, Bernalillo County, NM		
Description:	View of the dam to contain wastewater from the CAFO on the south side of the facility. The facility is designed with capacity to hold the 25 year/24 hour storm, plus two additional feet of freeboard to allow for subsequent storms.

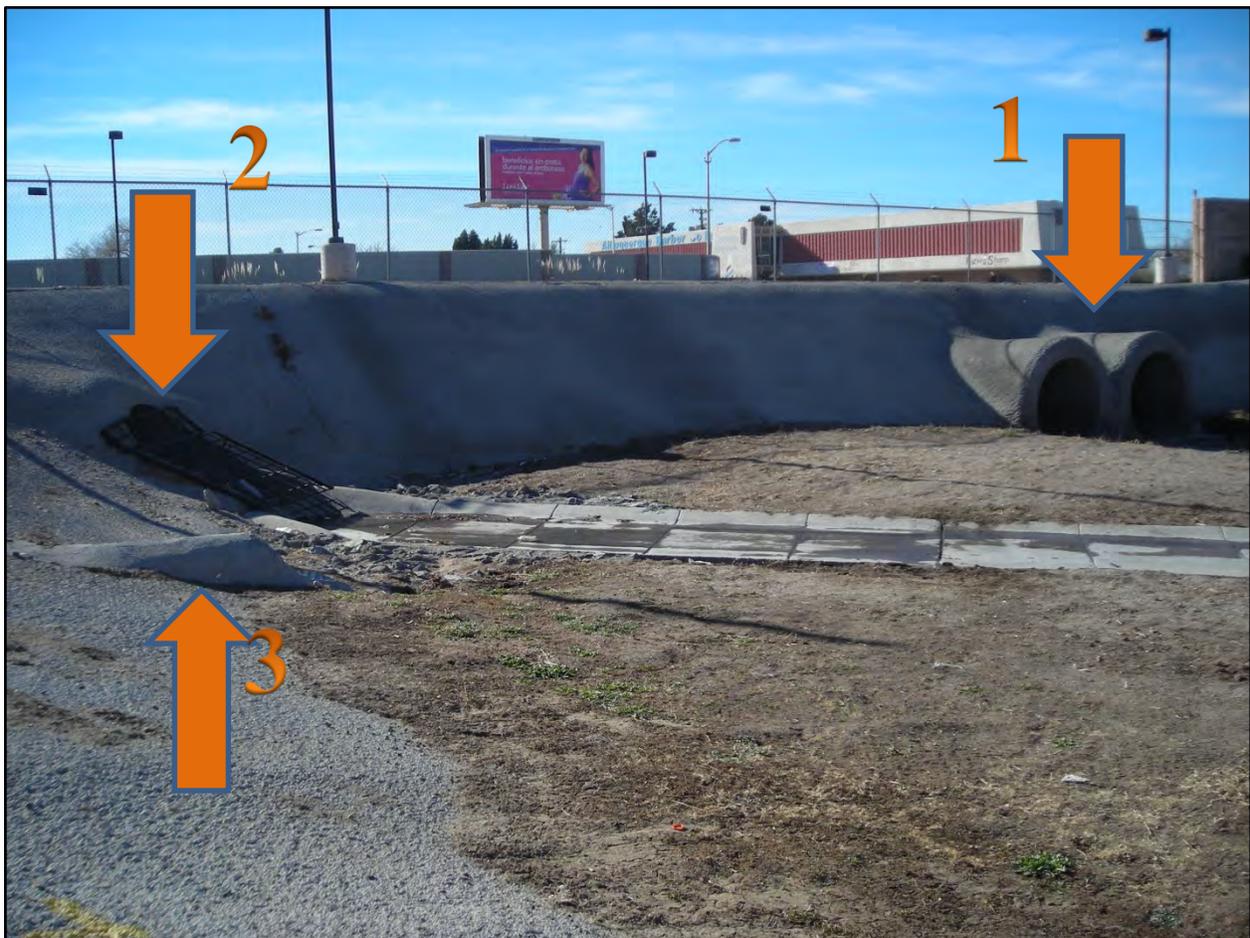
NMED Photolog
Photo #14

Photographer:	Sarah Holcomb	Date:	12-17-2013
Location:	EXPO New Mexico, Albuquerque, Bernalillo County, NM		
Description:	This is the storm surge side of the dam still used by the City of Albuquerque during storm events. The inputs are as follows: <ol style="list-style-type: none">1) These culverts are part of the 2-pond storm surge system. This in inflow from pond #1/.2) Storm flow directed from Louisiana Road, underneath the CAFO area at EXPO, and daylighting in this storm surge pond.3) This is the pipe that contains the uncontaminated roof runoff in the barn area (from the disconnected downspouts).

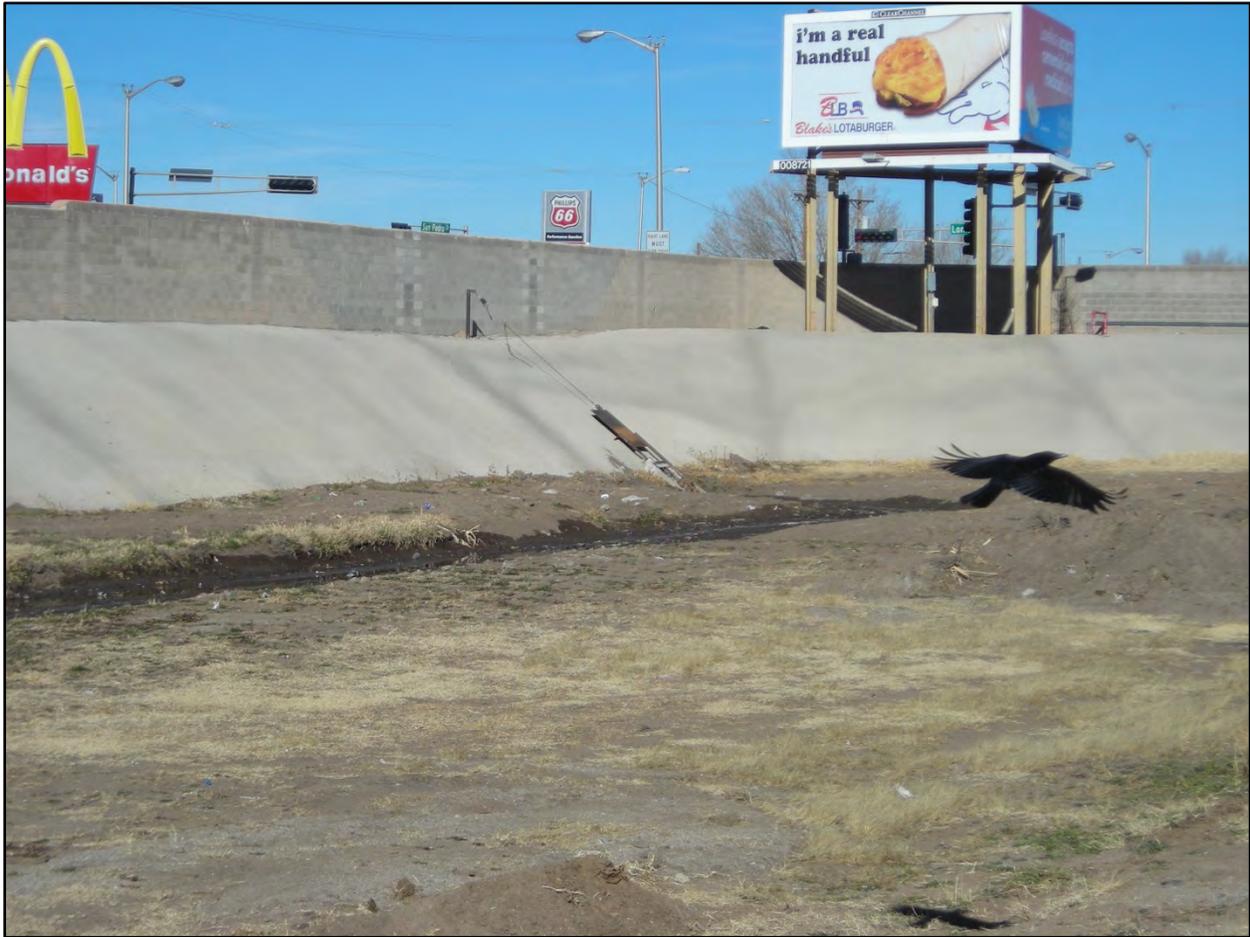
NMED Photolog
Photo #15

Photographer:	Sarah Holcomb	Date:	12-17-2013
Location:	EXPO New Mexico, Albuquerque, Bernalillo County, NM		
Description:	The outflow from the storm surge pond to the AMAFCA system.

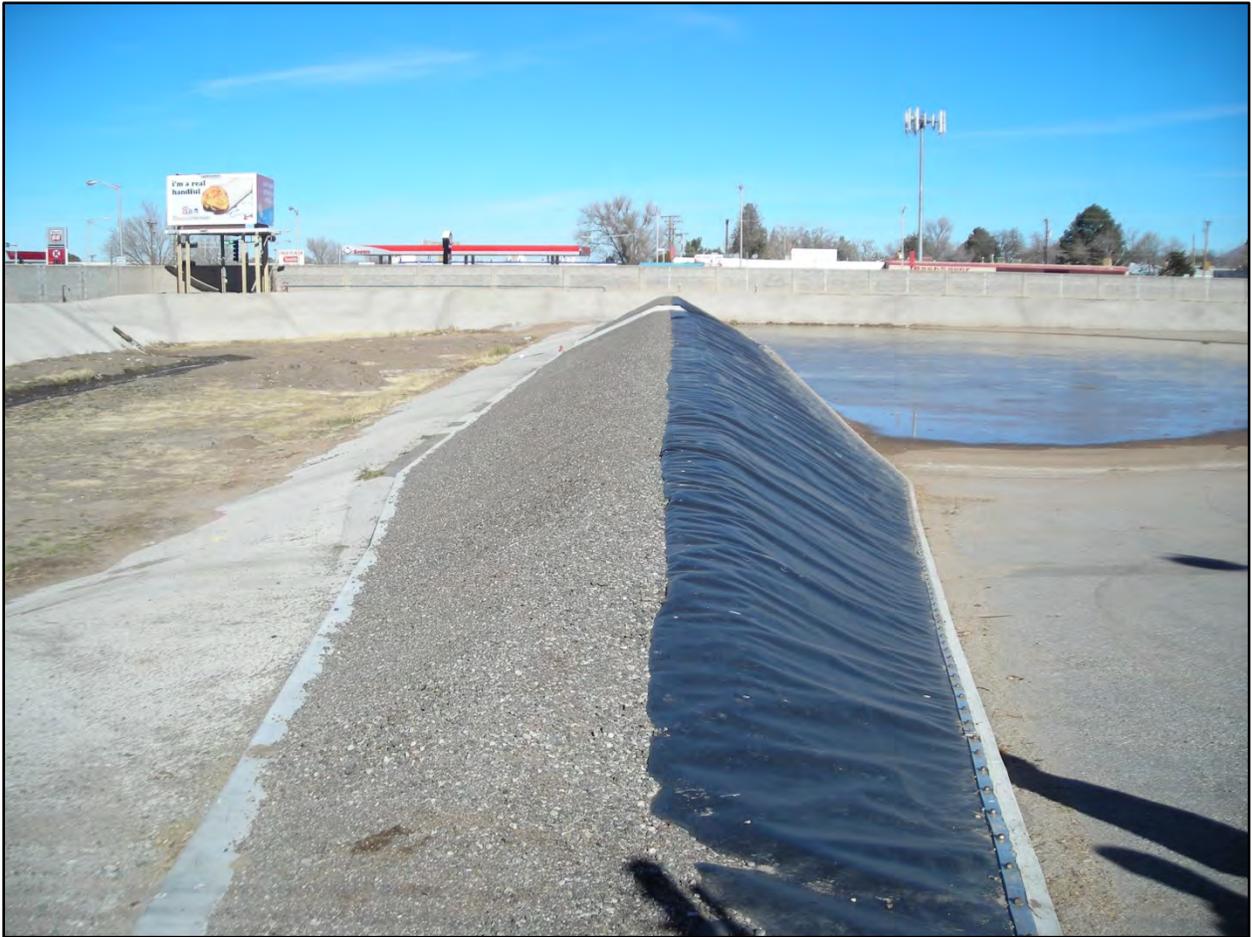
NMED Photolog
Photo #16

Photographer:	Sarah Holcomb	Date:	12-17-2013
Location:	EXPO New Mexico, Albuquerque, Bernalillo County, NM		
Description:	View of the dam. The right side is the CAFO wastewater retention area. The left side is the storm surge pond used by the City of Albuquerque.
