NEW MEXICO
ENVIRONMENT DEPARTMENT
Surface Water Quality Bureau

RE: Construction Storm Water, SIC 1611, NPDES Compliance Evaluation Inspection, Beckner Road Equities, Inc. / Las Soleras and Beckner Road Extension, NMR10GR54, August 24, 2011

NPDES Compliance Inspection Report

Beckner Road Equities, Inc.
Los Soleras and Beckner Road Extension
NPDES Tracking No. NMR10GR54
August 24, 2011

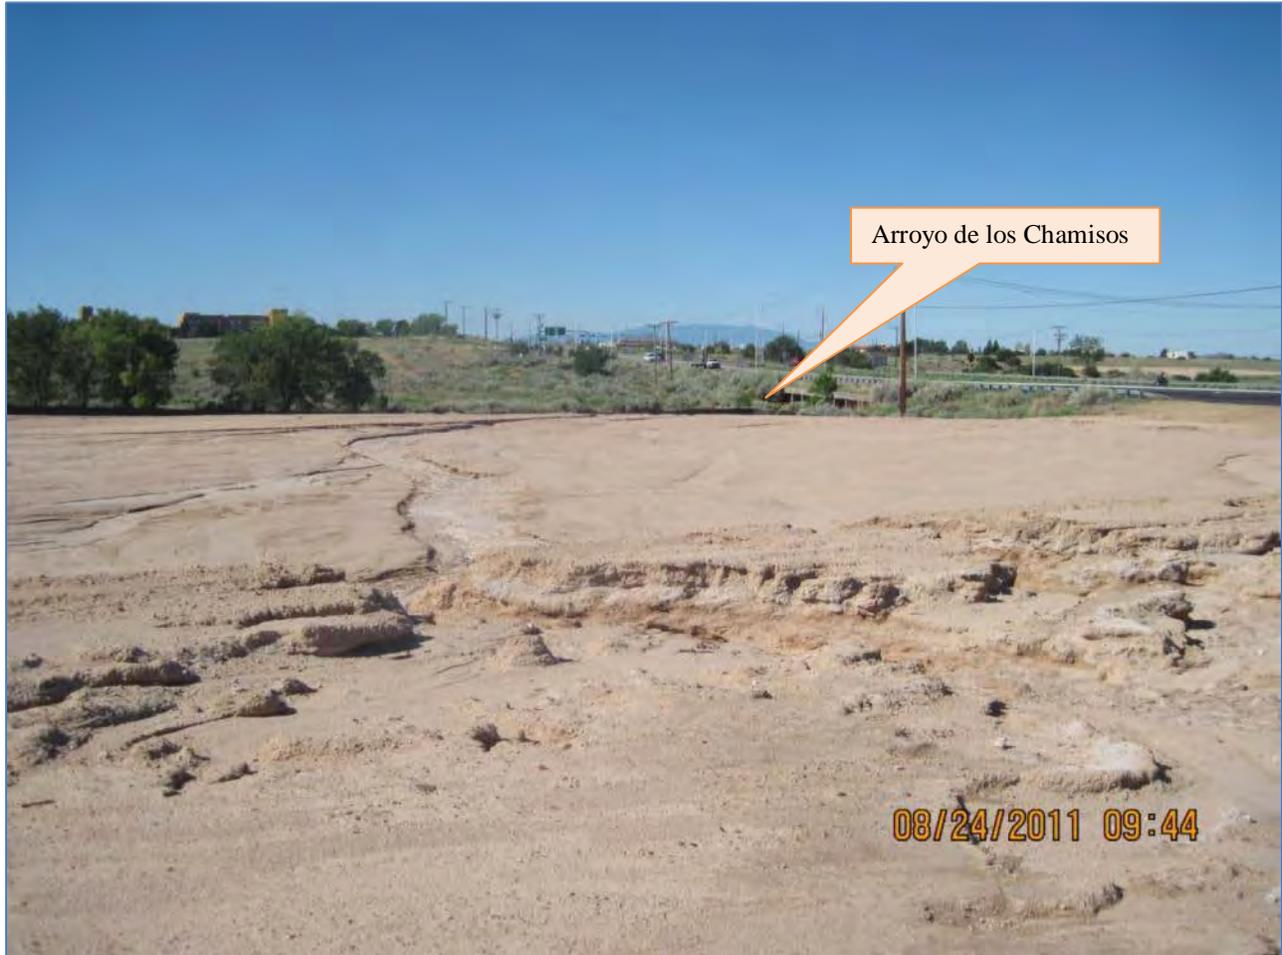
NMED/SWQB
Official Photograph Log
Photo # 1

Subject: North of road grading for Crossing at Chamiso, a retention pond had been constructed. Erosion rills in undisturbed areas and at the slopes of vegetated area directly north of the pond were observed. No erosion rills or gullies were observed leading out of the pond. Photo below shows the erosion rills and gullies south of the pond and road grading for Crossing at Chamiso leading to the Arroyo de los Chamisos stream.

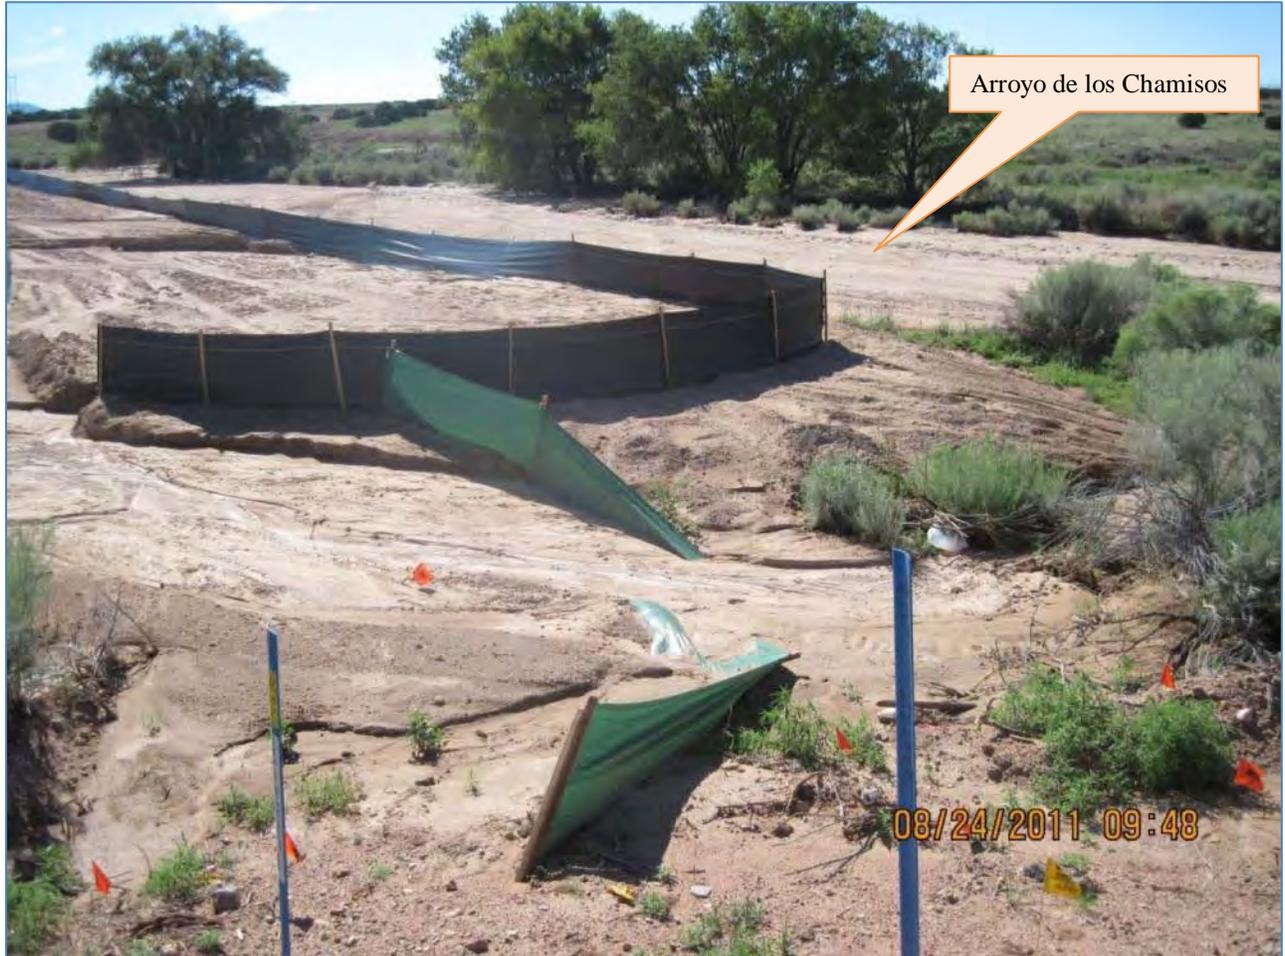
NMED/SWQB
Official Photograph Log
Photo # 2

Subject: Silt fence damage and erosion at Arroyo de los Chamisos

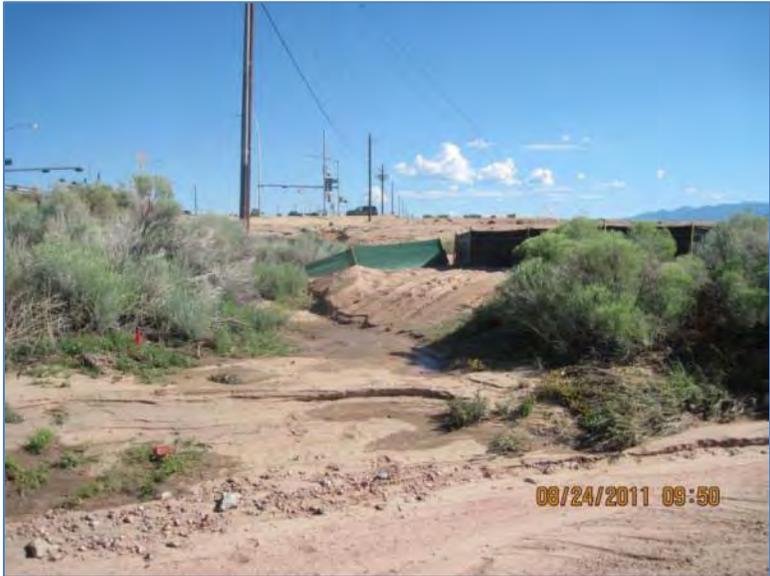
NMED/SWQB Official Photograph Log Photo # 3		
Photographer: Erin S. Trujillo	Date: 08/24/2011	Time: 0950 hours
City/County: Santa Fe / Santa Fe		State: New Mexico
Location: Las Soleras and Beckner Road Extension		
Subject: Evidence of previous discharge into stream from construction site observed from Arroyo de los Chamisos stream bed.

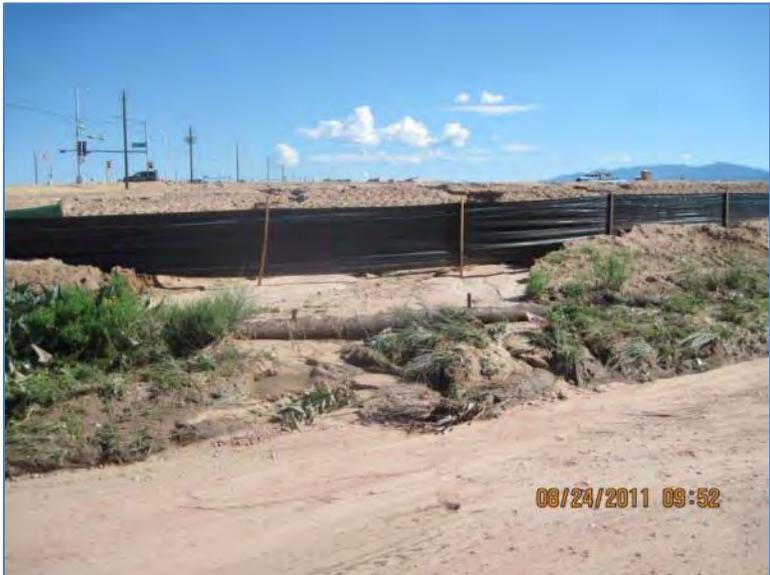
NMED/SWQB Official Photograph Log Photo # 4		
Photographer: Erin S. Trujillo	Date: 08/24/2011	Time: 0952 hours
City/County: Santa Fe / Santa Fe		State: New Mexico
Location: Las Soleras and Beckner Road Extension		
Subject: Evidence of previous discharge into stream from construction site. Example of erosion from fill area undercutting silt fence as observed from Arroyo de los Chamisos stream bed. Some sediment had accumulated behind wattle in floodplain/stream bank. Additional areas of silt fence damage and undercutting were observed upstream.

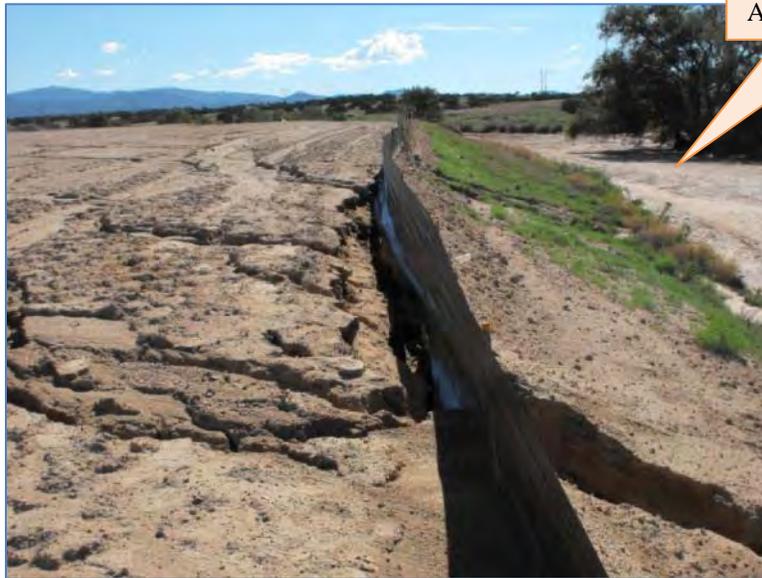
NMED/SWQB Official Photograph Log Photo # 5		
Photographer: Daniel Valenta	Date: 08/24/2011	Time: 0955 hours
City/County: Santa Fe / Santa Fe		State: New Mexico
Location: Las Soleras and Beckner Road Extension		
Subject: Erosion from fill area along silt fence and undercutting silt fence (same area shown in Photo #4).

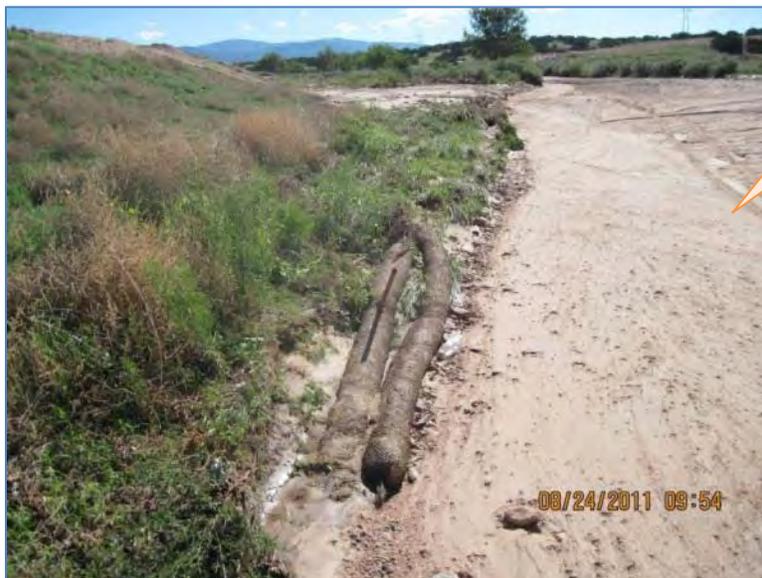
NMED/SWQB Official Photograph Log Photo # 6		
Photographer: Erin S. Trujillo	Date: 08/24/2011	Time: 0954 hours
City/County: Santa Fe / Santa Fe		State: New Mexico
Location: Las Soleras and Beckner Road Extension		
Subject: Damaged straw wattle staked at edge of stream bank. Un-staked portion of wattle most likely was moved during flow in channel.

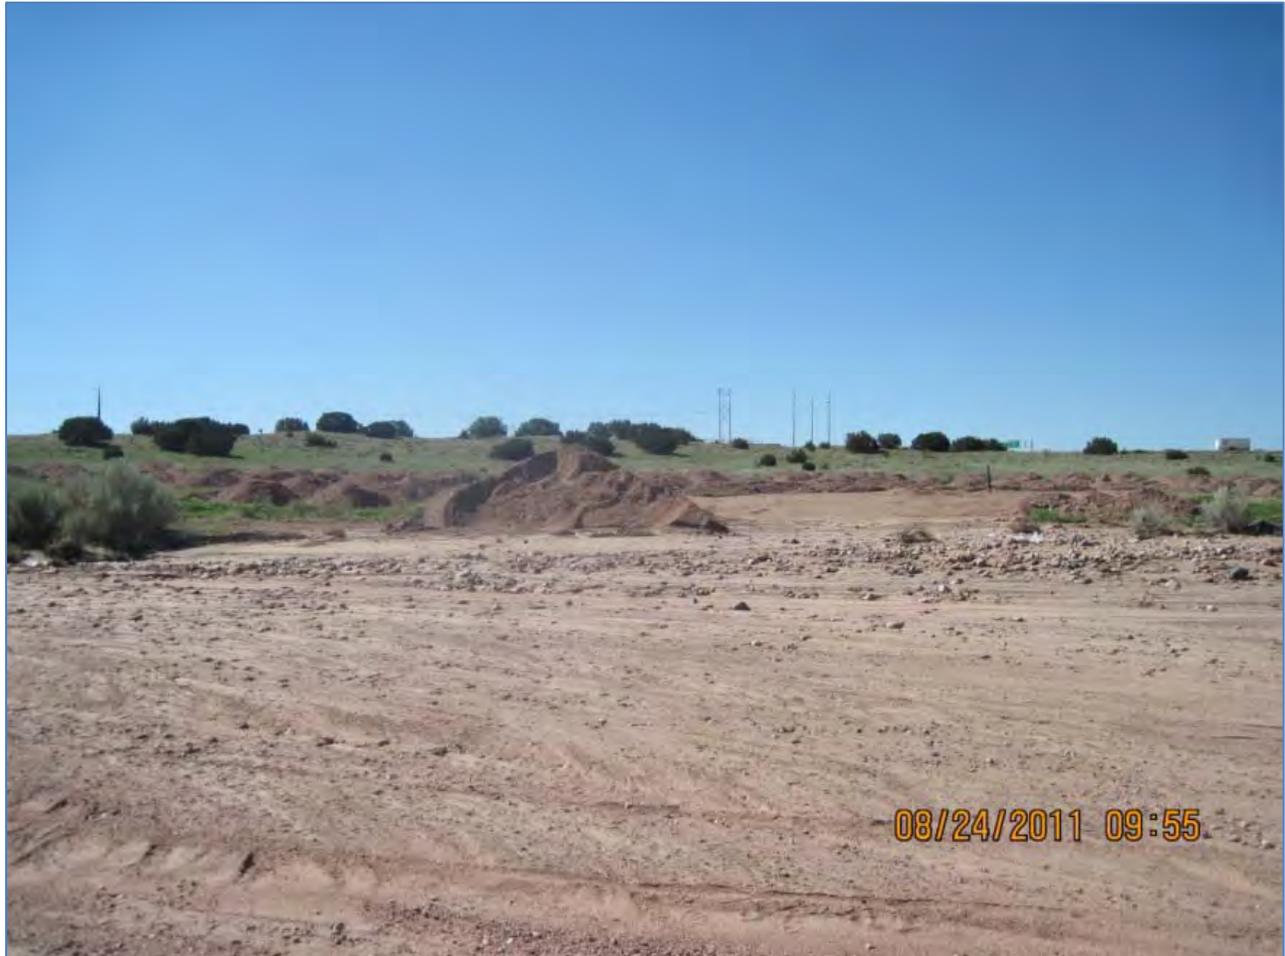
NMED/SWQB
Official Photograph Log
Photo # 7

Subject: Looking south at fill stockpiles in floodplain as observed from Arroyo de los Chamisos stream bed. No remaining BMPs were installed between fill stockpiles and stream.

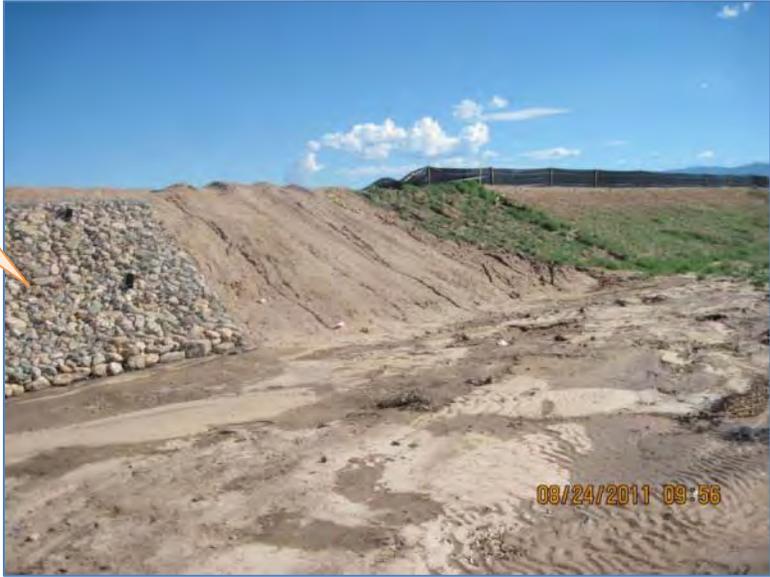
NMED/SWQB Official Photograph Log Photo # 8		
Photographer: Erin S. Trujillo	Date: 08/24/2011	Time: 0956 hours
City/County: Santa Fe / Santa Fe		State: New Mexico
Location: Las Soleras and Beckner Road Extension		
Subject: Upstream of previous photos, example of erosion rills along constructed fill/slope at gap and damaged silt fence as observed from floodplain of Arroyo de los Chamisos. Previous flows had risen above the banks of the stream in this area. Additional gap in silt fence and undercutting was observed upstream (not shown in photo).

Short segment of rip rap had been installed at buried utility line according to on-site representatives.

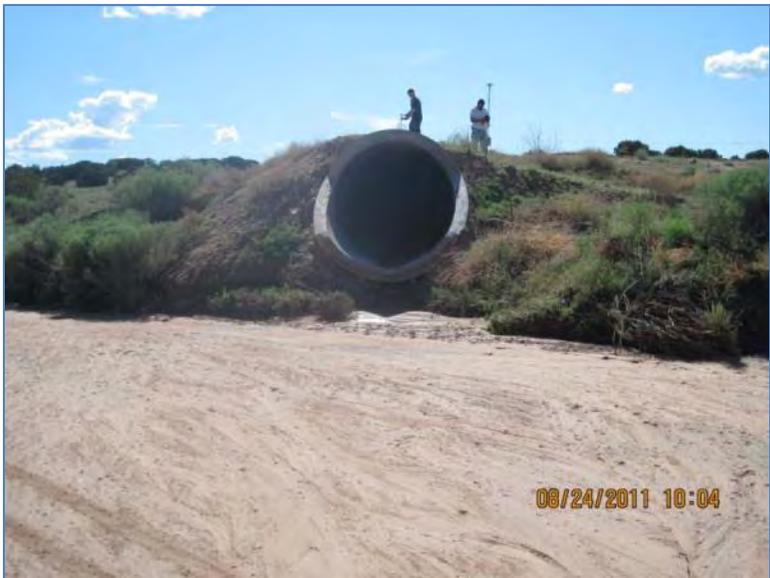
NMED/SWQB Official Photograph Log Photo # 9		
Photographer: Erin S. Trujillo	Date: 08/24/2011	Time: 1004 hours
City/County: Santa Fe / Santa Fe		State: New Mexico
Location: Las Soleras and Beckner Road Extension		
Subject: Storm sewer outfall as observed from Arroyo de los Chamisos arroyo. No outfall protection was installed. SWPPP identifies rip rap flood walls, but no other velocity dissipation or retention of flows from outfall.

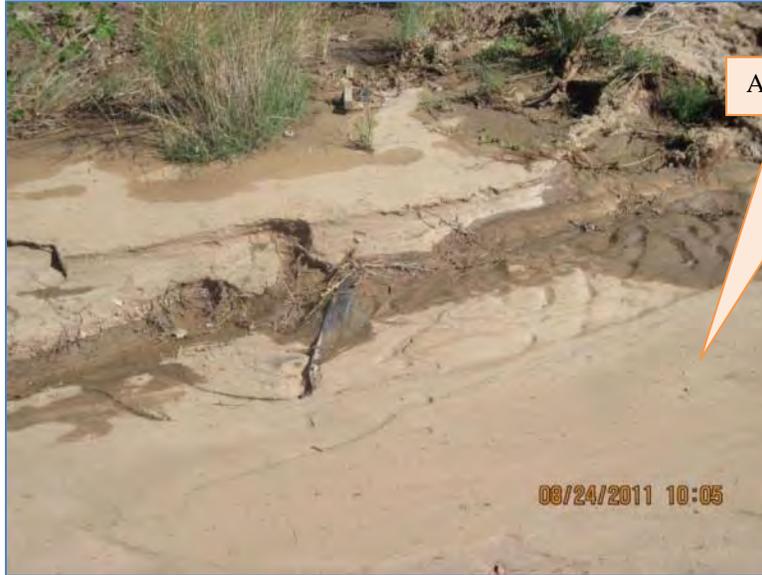
NMED/SWQB Official Photograph Log Photo # 10		
Photographer: Erin S. Trujillo	Date: 08/24/2011	Time: 1005 hours
City/County: Santa Fe / Santa Fe		State: New Mexico
Location: Las Soleras and Beckner Road Extension		
Subject: Buried silt fence in stream bed and silt fence stake on stream bank below low water crossing.

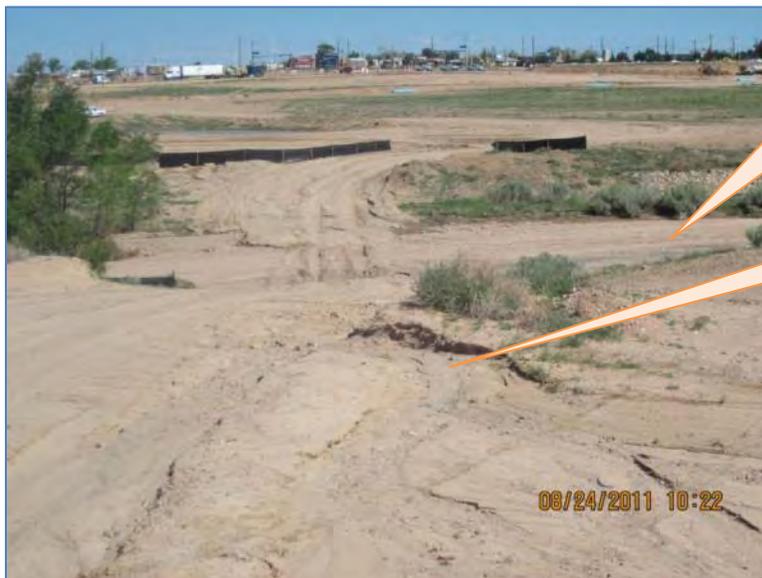
NMED/SWQB Official Photograph Log Photo # 11		
Photographer: Erin S. Trujillo	Date: 08/24/2011	Time: 1022 hours
City/County: Santa Fe / Santa Fe		State: New Mexico
Location: Las Soleras and Beckner Road Extension		
Subject: Looking north from grading for Crossing at Chamisos. Erosion from disturbed areas flows toward low water crossing. Flow along graded road was not diverted.

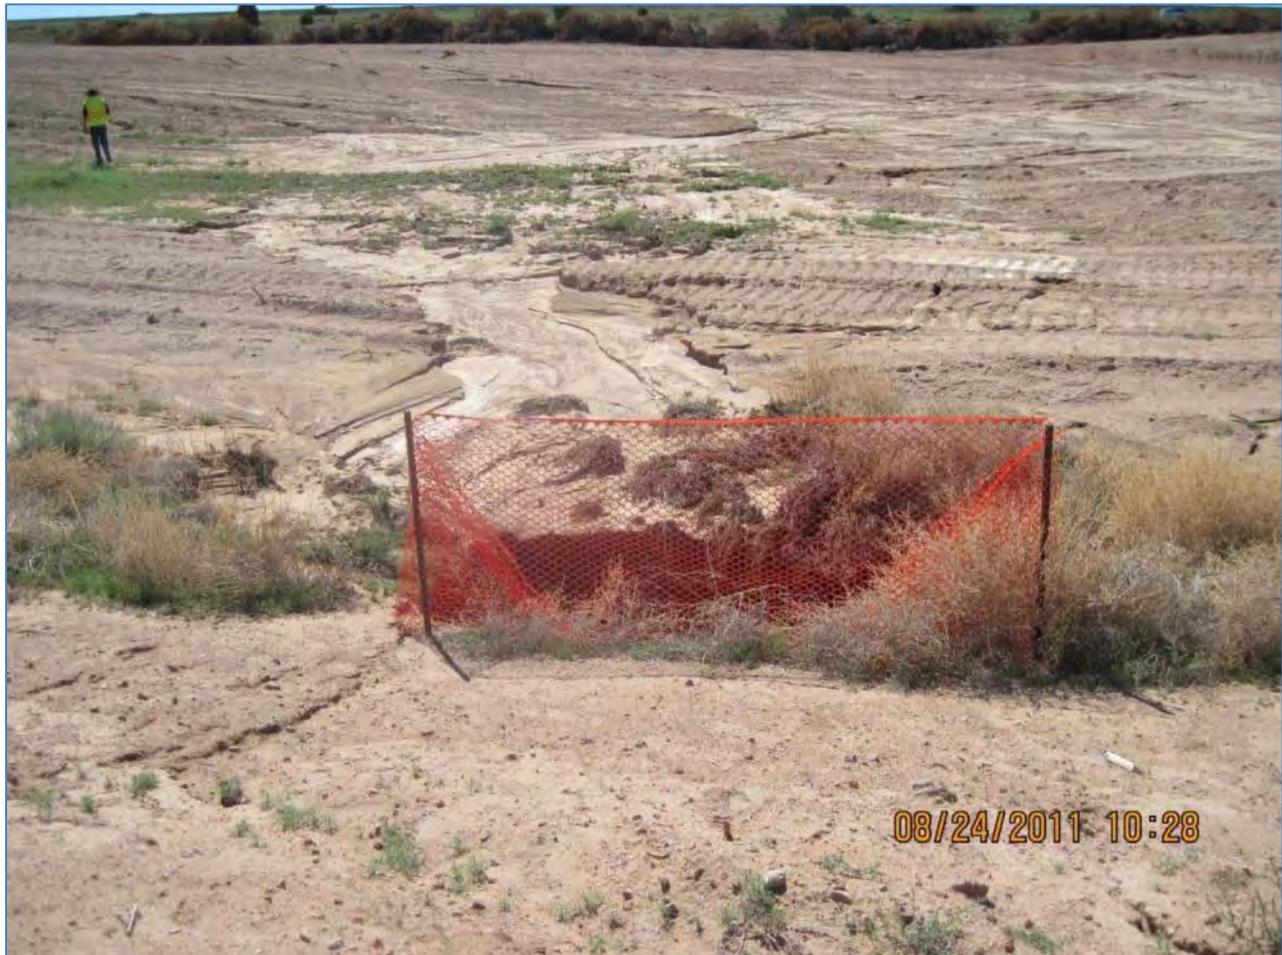
Erosion rill toward graded road and stream

Subject: Looking south from graded Beckner Road Extension, erosion in disturbed area. Tackifier was recorded to have been used in this area. Because the temporary riser pipe (planned drop inlet) for the Beckner Road Extension is missing, flow from this area discharge directly from the outfall (shown in previous photo) into Arroyo de los Chamisos. Repair of the riser is needed to prevent discharge into Arroyo de los Chamisos from this area. Re-application of tackifier and/or other control measures appears needed.

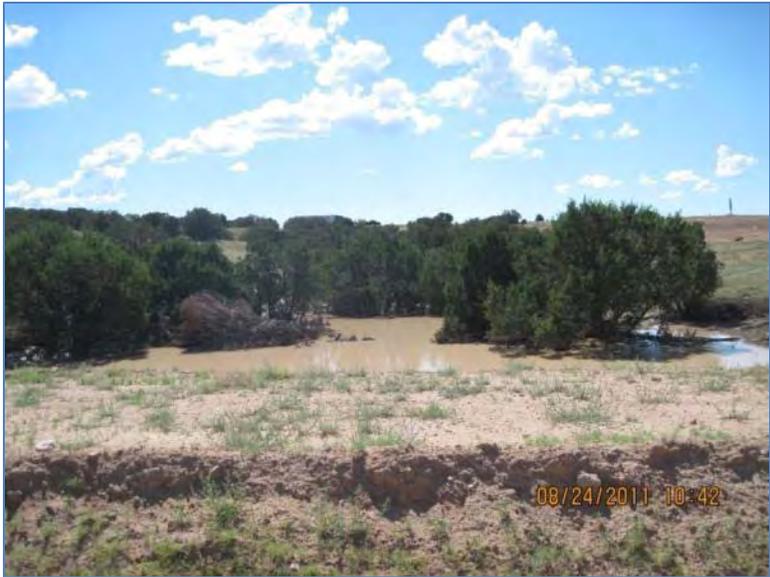
NMED/SWQB Official Photograph Log Photo # 13		
Photographer: Erin S. Trujillo	Date: 08/24/2011	Time: 1042 hours
City/County: Santa Fe / Santa Fe		State: New Mexico
Location: Las Soleras and Beckner Road Extension		
Subject: Example of water ponding in low area/drainage swale at Beckner Road fill that was shown on previous Site Map, but not current map.

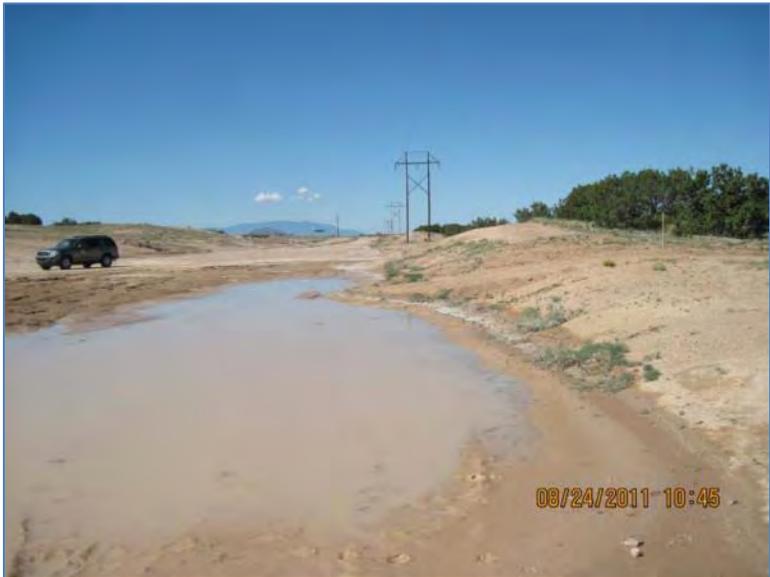
NMED/SWQB Official Photograph Log Photo # 14		
Photographer: Erin S. Trujillo	Date: 08/24/2011	Time: 1045 hours
City/County: Santa Fe / Santa Fe		State: New Mexico
Location: Las Soleras and Beckner Road Extension		
Subject: Example of water ponding at end of Beckner Road Extension (approximately 3500 feet east of construction site entrance) that was not shown on Site Maps. If intended to be control measures, then location needs to be shown on Site Maps.

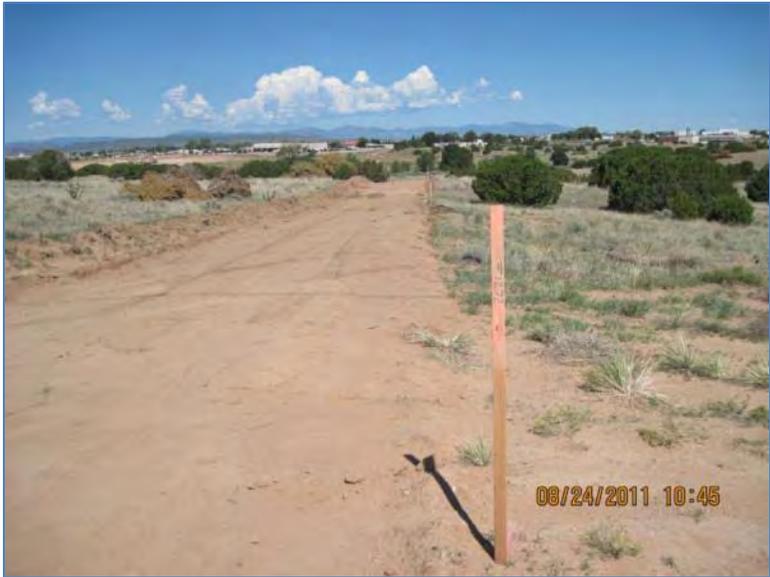
NMED/SWQB Official Photograph Log Photo # 15		
Photographer: Erin S. Trujillo	Date: 08/24/2011	Time: 1045 hours
City/County: Santa Fe / Santa Fe		State: New Mexico
Location: Las Soleras and Beckner Road Extension		
Subject: Looking north, graded and staked road approximately 3,000 feet east of construction site entrance that was not shown on Site Maps to be disturbed.

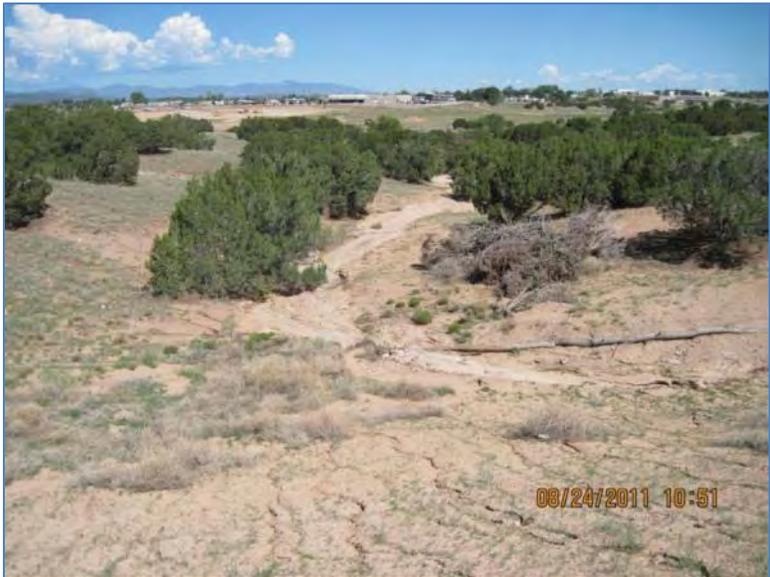
NMED/SWQB Official Photograph Log Photo # 16		
Photographer: Erin S. Trujillo	Date: 08/24/2011	Time: 1051 hours
City/County: Santa Fe / Santa Fe		State: New Mexico
Location: Las Soleras and Beckner Road Extension		
Subject: Erosion rills from Beckner Road fill slope leading toward tributary. Wattles crossing tributary do not provide erosion/sediment control measures from fill slopes.

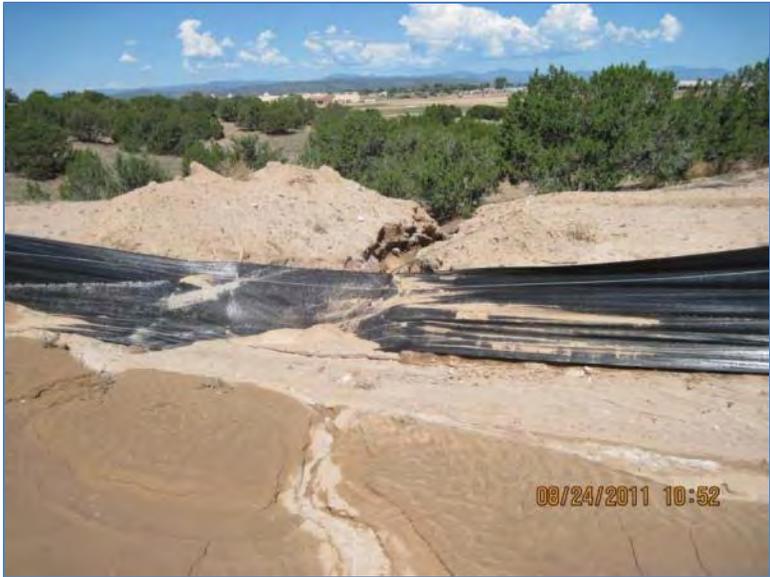
NMED/SWQB Official Photograph Log Photo # 17		
Photographer: Erin S. Trujillo	Date: 08/24/2011	Time: 1052 hours
City/County: Santa Fe / Santa Fe		State: New Mexico
Location: Las Soleras and Beckner Road Extension		
Subject: From Beckner Road above tributary shown in Photo 16, evidence of flow overtopping and damaged silt fence. Flow along Beckner Road to this low area was not shown on Site Maps.

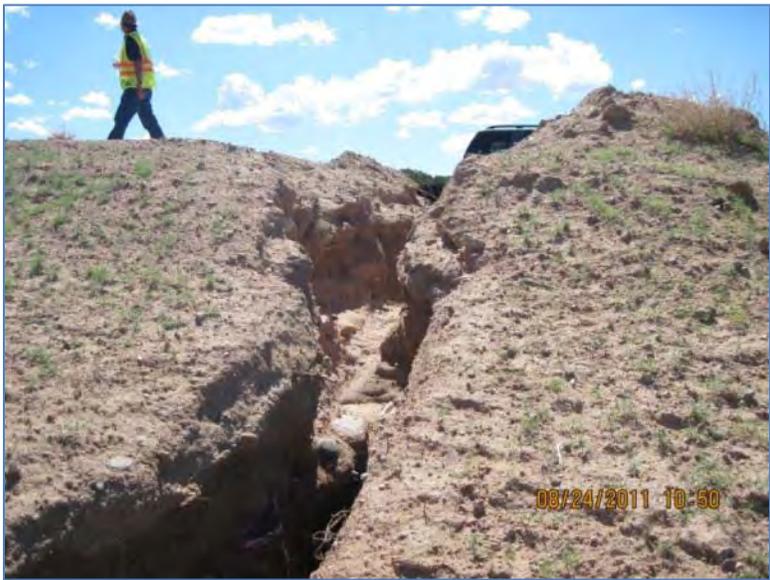
NMED/SWQB Official Photograph Log Photo # 18		
Photographer: Erin S. Trujillo	Date: 08/24/2011	Time: 1050 hours
City/County: Santa Fe / Santa Fe		State: New Mexico
Location: Las Soleras and Beckner Road Extension		
Subject: Below Beckner Road above tributary shown in Photo 16, gully from flow had formed.

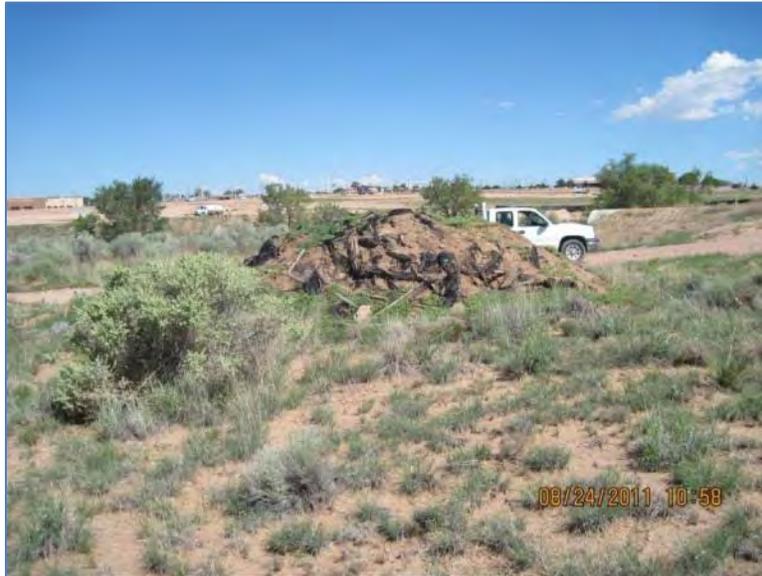
NMED/SWQB Official Photograph Log Photo # 19		
Photographer: Erin S. Trujillo	Date: 08/24/2011	Time: 1058 hours
City/County: Santa Fe / Santa Fe		State: New Mexico
Location: Las Soleras and Beckner Road Extension		
Subject: A stockpile of dirt and damaged silt fence also existed near Crossing at Chamiso. BMPs existing prior to construction were not documented in SWPPP. Damaged construction materials/controls need to be properly disposed.

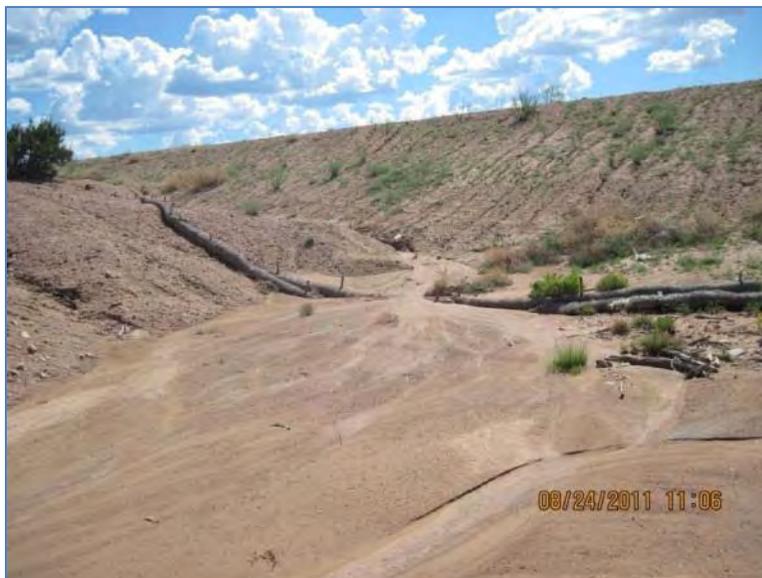
NMED/SWQB Official Photograph Log Photo # 20		
Photographer: Erin S. Trujillo	Date: 08/24/2011	Time: 1106 hours
City/County: Santa Fe / Santa Fe		State: New Mexico
Location: Las Soleras and Beckner Road Extension		
Subject: Tributary below Beckner Road fill slope east of tributary shown in Photo 16. Photo shows, buried wattle crossing stream channel and erosion rills in fill slope. Location of straw wattle does not appear to provide sediment/erosion control for fill slope.

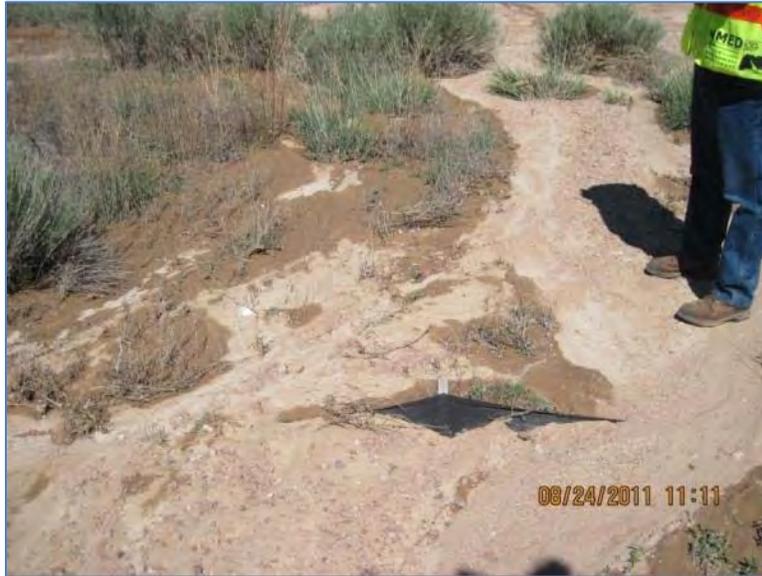
NMED/SWQB Official Photograph Log Photo # 21		
Photographer: Erin S. Trujillo	Date: 08/24/2011	Time: 1111 hours
City/County: Santa Fe / Santa Fe		State: New Mexico
Location: Las Soleras and Beckner Road Extension		
Subject: Un-maintained/damaged silt fence was located in drainage swales, across tributaries, and along access road where tributaries were interrupted along the south of Arroyo de los Chamiso stream. This example of buried silt fence was at sanitary access road may have been installed prior to construction. Although tributary channels (shown in Photo 16 and 20) are interrupted, sheet flow continued to channel at entering Arroyo de los Chamisos shown in next photo.

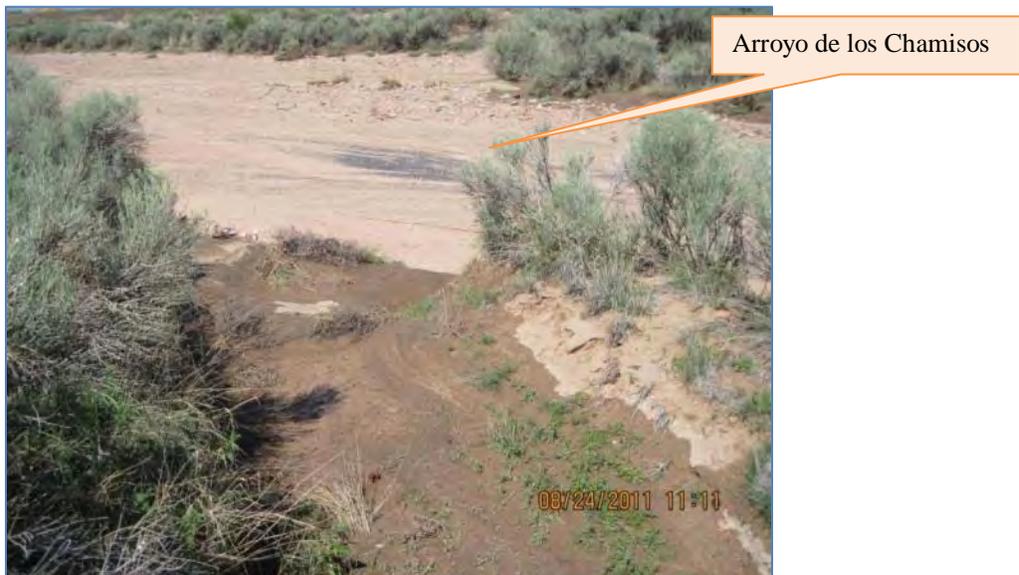
NMED/SWQB Official Photograph Log Photo # 22		
Photographer: Erin S. Trujillo	Date: 08/24/2011	Time: 1111 hours
City/County: Santa Fe / Santa Fe		State: New Mexico
Location: Las Soleras and Beckner Road Extension		
Subject: Wet soils in channel at Arroyo de los Chamisos. Evidence of tributary discharge location at Arroyo de los Chamisos downstream from Beckner Road.

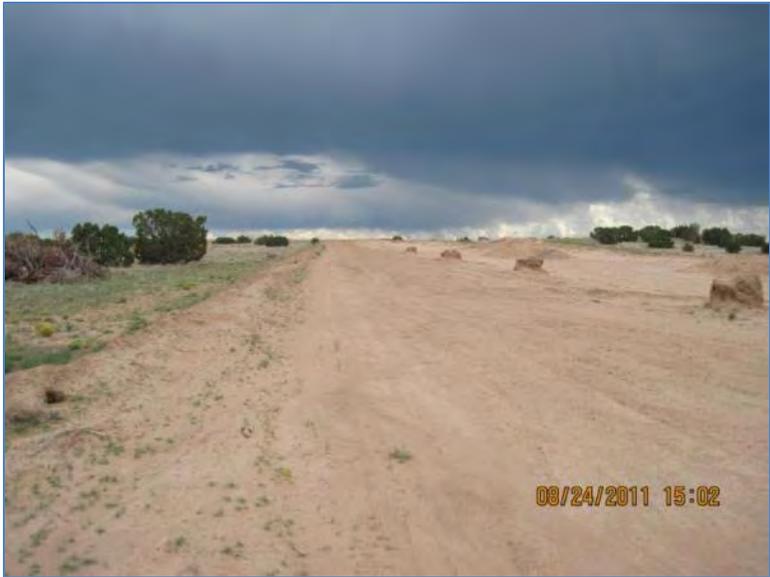
NMED/SWQB Official Photograph Log Photo # 23		
Photographer: Erin S. Trujillo	Date: 08/24/2011	Time: 1502 hours
City/County: Santa Fe / Santa Fe		State: New Mexico
Location: Las Soleras and Beckner Road Extension		
Subject: Looking south, disturbance at eastern boundary of construction and support activity based on information from on-site representatives.

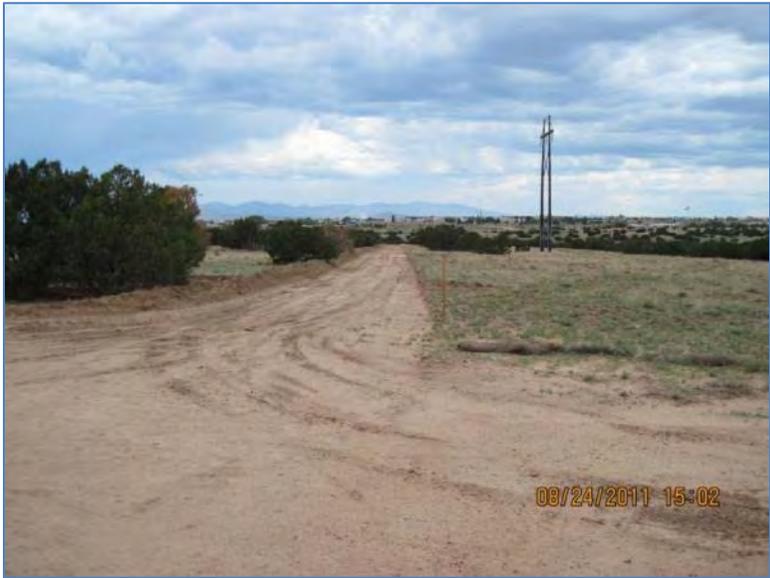
NMED/SWQB Official Photograph Log Photo # 24		
Photographer: Erin S. Trujillo	Date: 08/24/2011	Time: 1502 hours
City/County: Santa Fe / Santa Fe		State: New Mexico
Location: Las Soleras and Beckner Road Extension		
Subject: Looking north from location of previous photo, graded road, vehicle tracks and staking at eastern boundary of construction and support activity based on information from on-site representatives. Disturbance of this road not shown on Site Maps.

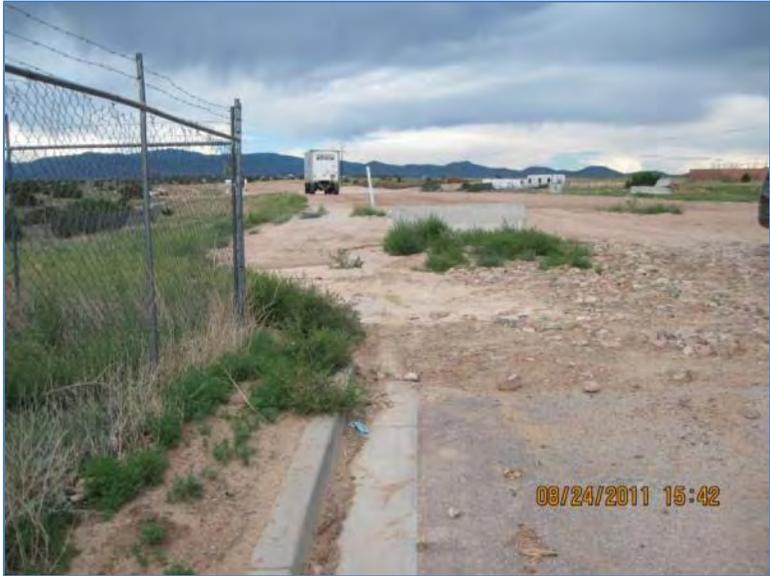
NMED/SWQB Official Photograph Log Photo # 25		
Photographer: Erin S. Trujillo	Date: 08/24/2011	Time: 1542 hours
City/County: Santa Fe / Santa Fe		State: New Mexico
Location: Las Soleras and Beckner Road Extension		
Subject: Off-site accumulated sediment from erosion around vehicle track out pad at site entrance. Paved portion of Beckner Road did not appear to have accumulated sediment from vehicle tracking on the day of this inspection, but cobble was beginning to become buried. Additional control measures and maintenance of the vehicle track out measure were needed.

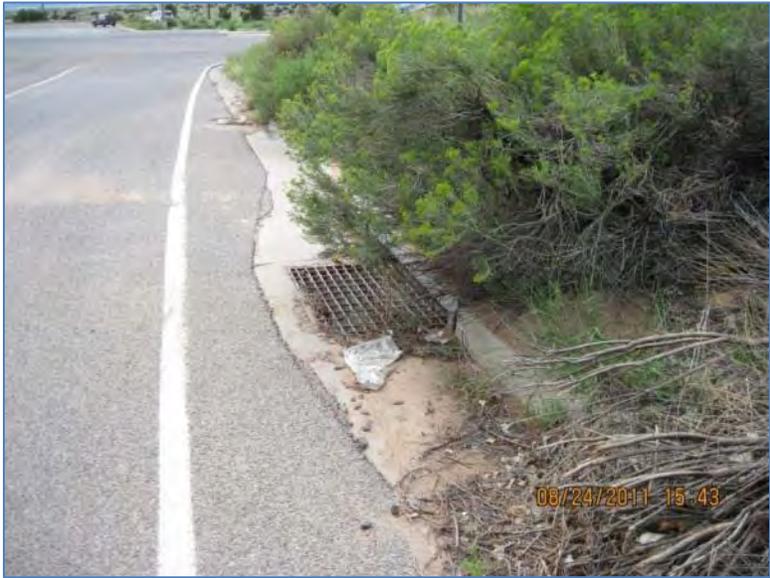
NMED/SWQB Official Photograph Log Photo # 26		
Photographer: Erin S. Trujillo	Date: 08/24/2011	Time: 1543 hours
City/County: Santa Fe / Santa Fe		State: New Mexico
Location: Las Soleras and Beckner Road Extension		
Subject: Not all off-site accumulated sediment or trash shown can be attributed to Las Soleras construction activities. Additional measures as discussed in previous photo appear needed.
