**NEW MEXICO  
ENVIRONMENT DEPARTMENT**

**Re:** Gila River Bridge FLAP 15-2(1); Minor; Construction Stormwater; SIC 1522; NPDES Compliance Evaluation; NPDES Permit NMR12AZ68; May 28, 2015

**Gila River Bridge FLAP 15-2(1)**  
**NPDES No NMR12AZ33**  
**May 28, 2015**

**NMED/SWQB  
Official Photograph Log**

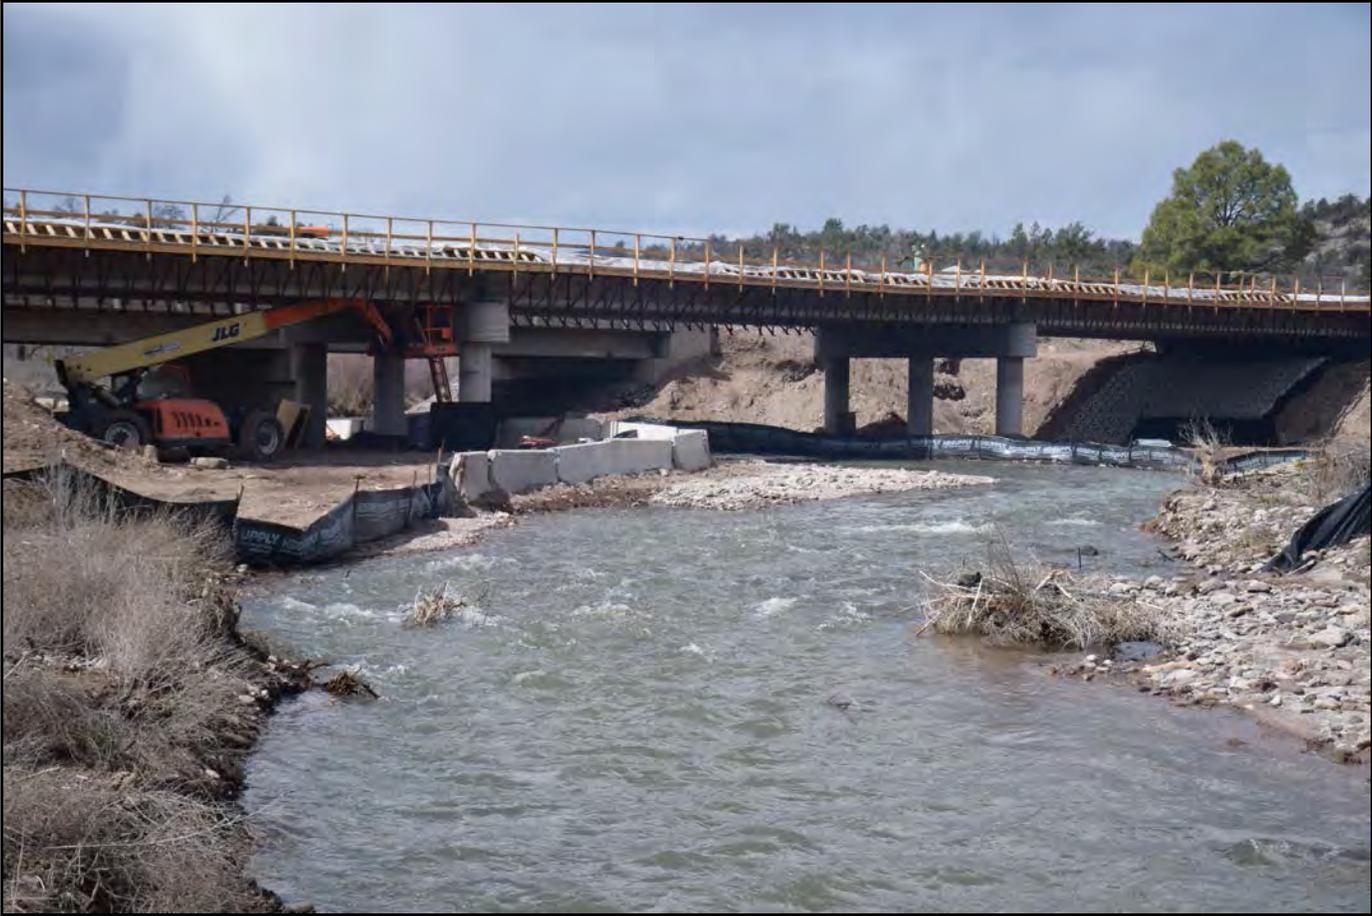
Photo # 1

Photographer: Unknown	Date: 3/4/2015	Time: 1329 hours
City/County: Approximately 44 miles north of Silver City New Mexico/Catron		
Location: New Mexico State Highway 15 in the Gila National Forest (Forest) and Heart Bar Wildlife Area,		
Subject: New bridge construction over the Gila River.

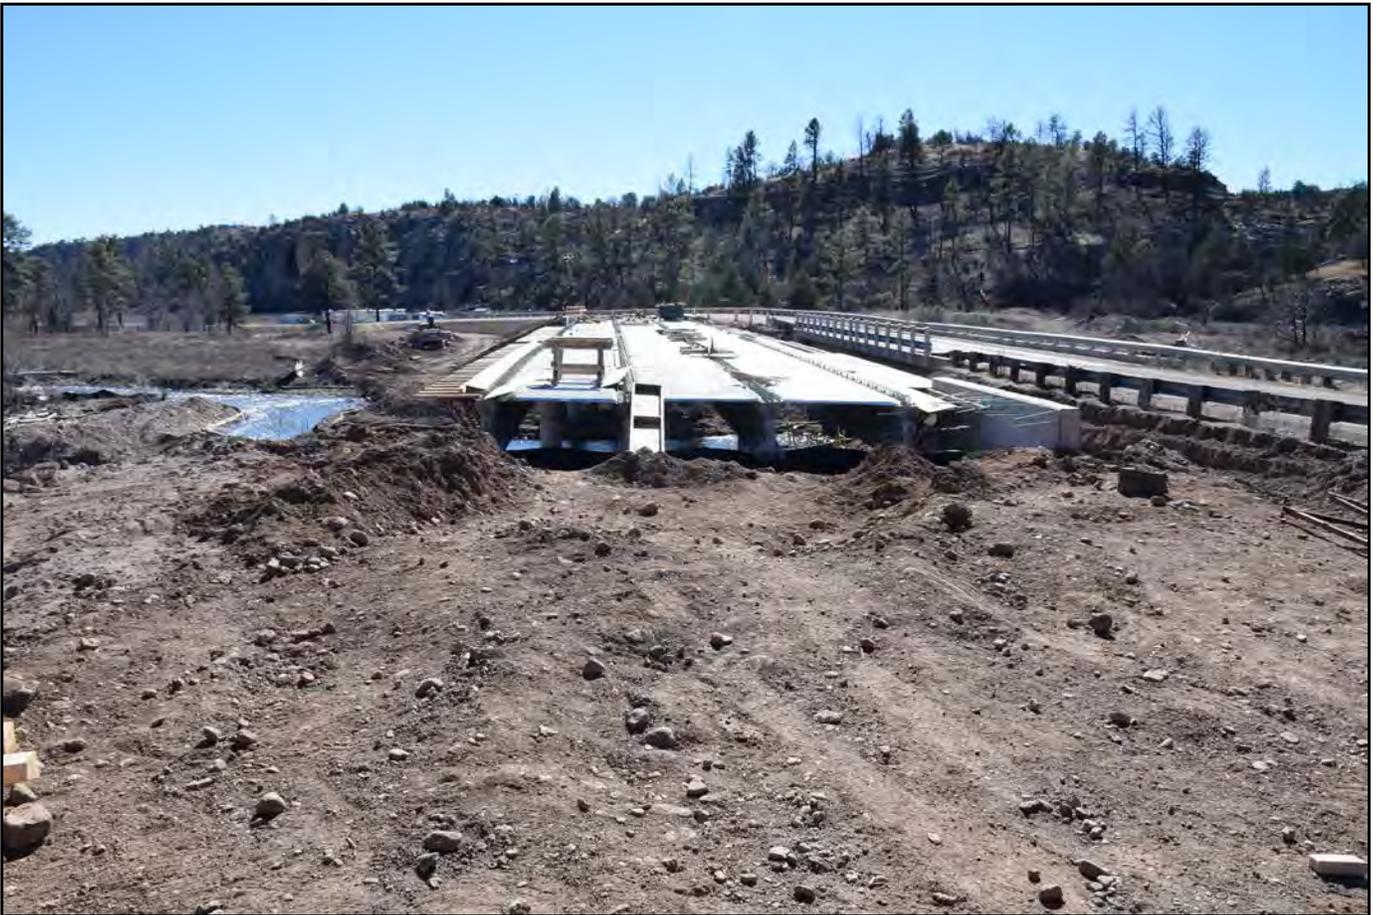
Photo # 2

Photographer: Unknown	Date: 1/23/2015	Time: 1339 hours
City/County: Approximately 44 miles north of Silver City New Mexico/Catron		
Location: New Mexico State Highway 15 in the Gila National Forest (Forest) and Heart Bar Wildlife Area,		
Subject: New bridge construction over the Gila River.

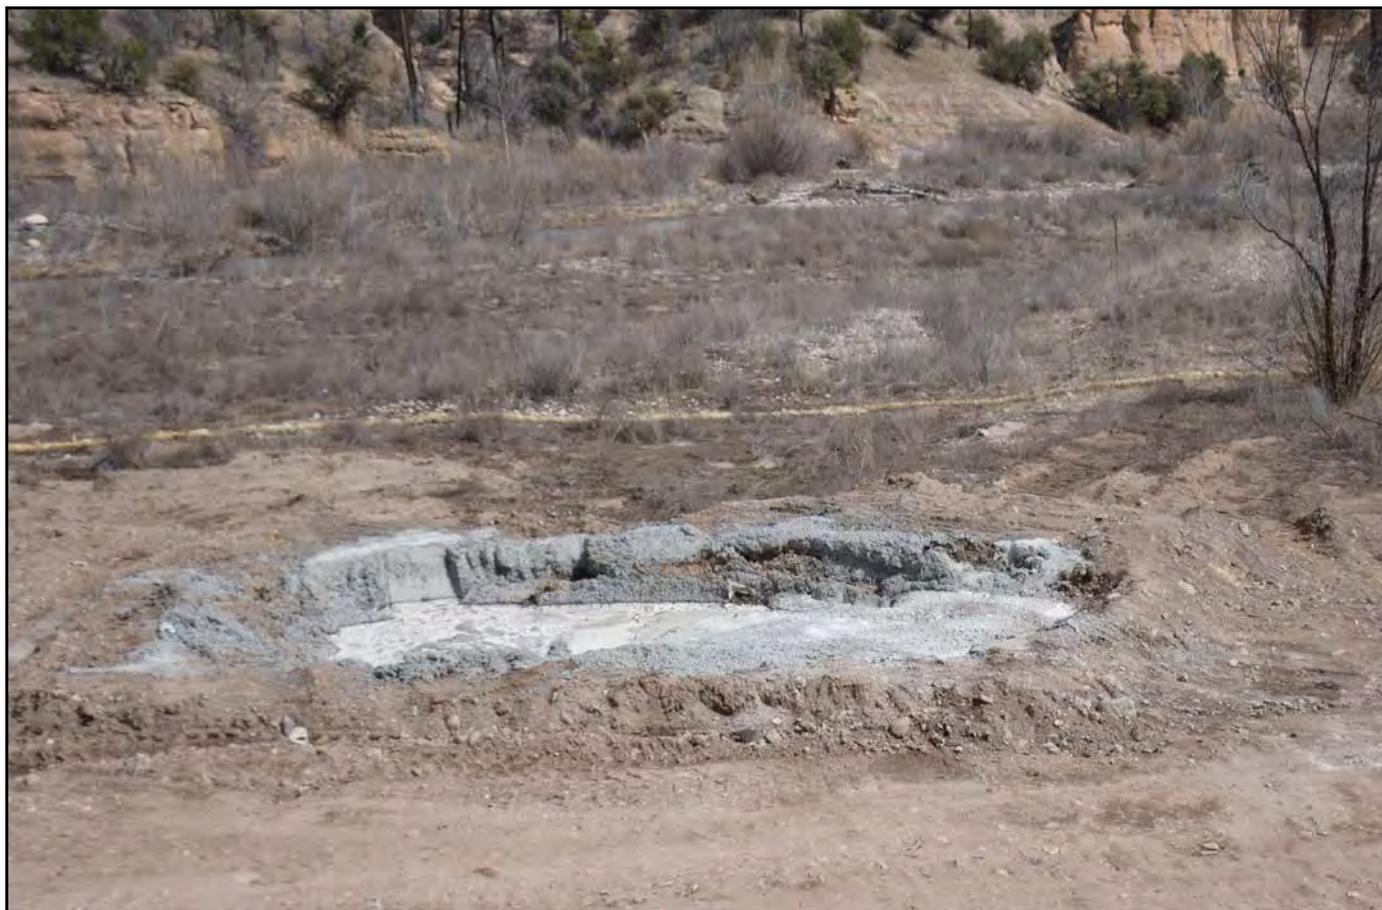
Photo # 3

2. Soil that came in contact with the hydraulic fluid was reported to be buried on site in the May 28, 2015 site visit report. Due to the small amount of spilled fluid this could have been easily taken care of as reported in the June 23, 2015 e-mail by Ted Walker, (see Attachment C).
3. Photos taken of the site on a site visit by Mr. Money on March 4, 2015, (see Photo 3). Appears to show an unlined cement clean out pit. A photo submitted June 23, 2015 via e-mail by Ted Walker shows the pit was lined. Dirt and concrete covered the liner giving the appearance of not being lined, (see Attachment D).

Photographer: Unknown	Date: 3/4/2015	Time: 1400 hours
City/County: Approximately 44 miles north of Silver City New Mexico/Catron		
Location: New Mexico State Highway 15 in the Gila National Forest (Forest) and Heart Bar Wildlife Area,		
Subject: Cement wash out, disposal area

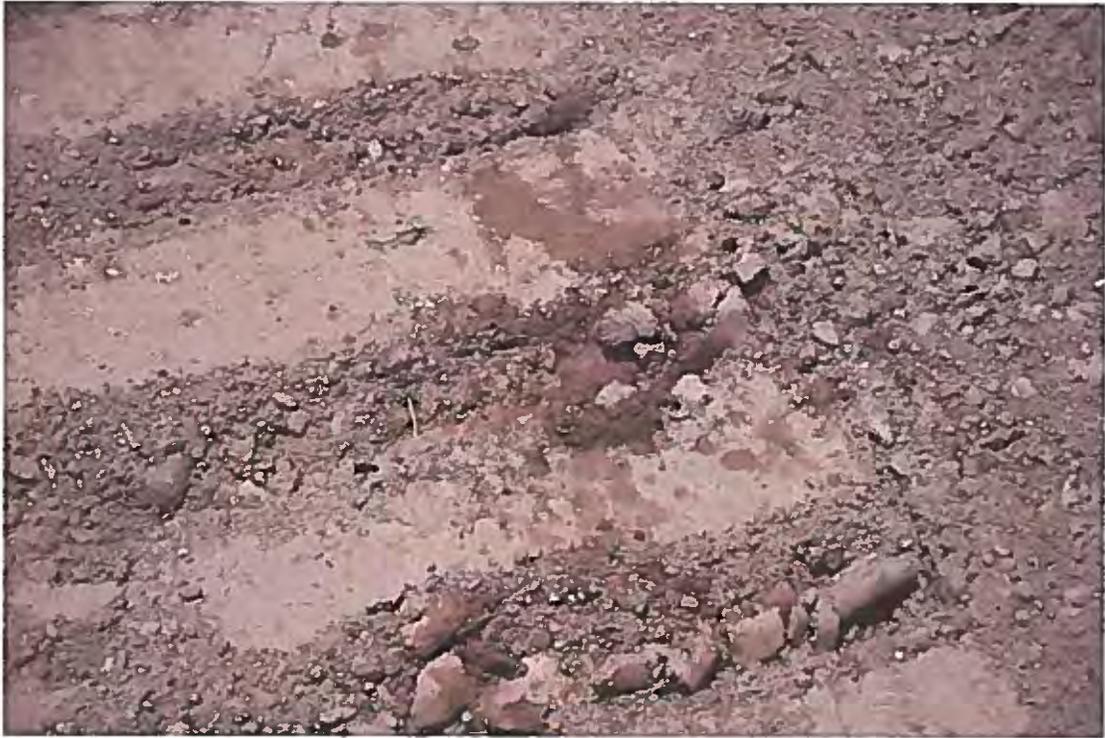
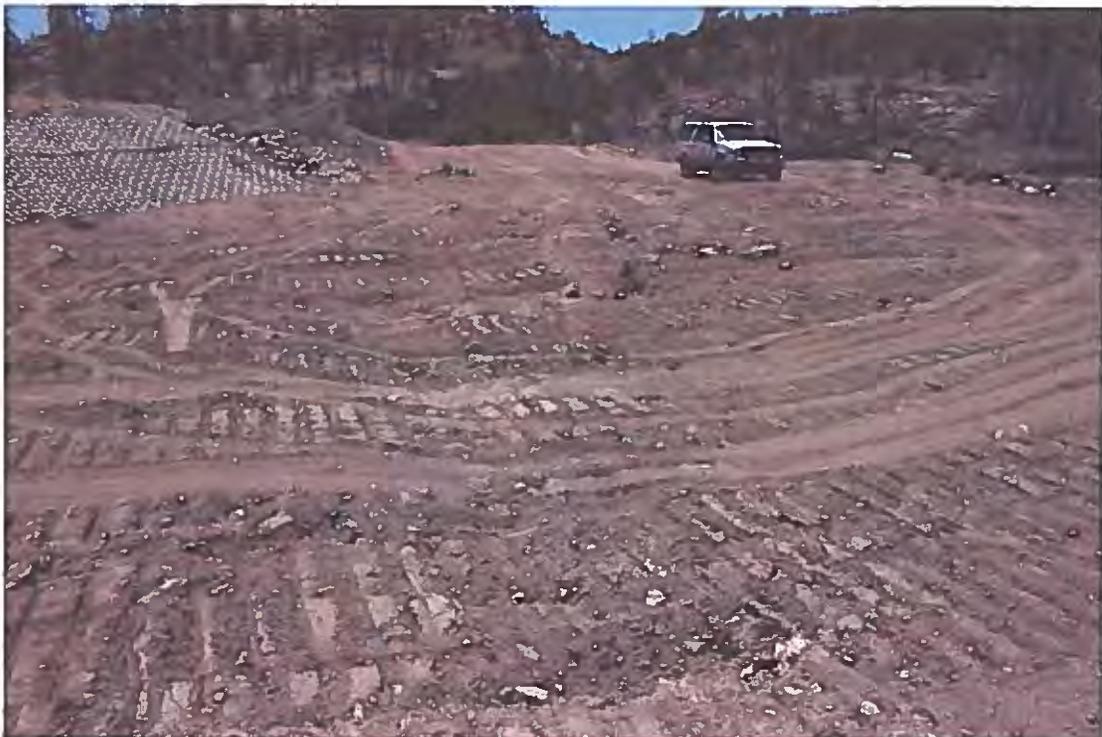
The area that Jessie Miller described is about 200 yards from equipment staging area and offices and lies within the floodplain of the West Fork of the Gila. I noted initially a set of pickup truck tracks that had recently been to the site and also the imprints left from a tracked vehicle like an excavator. Near the area Jessie described I did see several spots that had been discolored by oil. One of the construction employees said I was in the correct location, but the material had been buried approximately 10 feet deep. Another employee said she had pictures on the office computer and could send them via email. She estimated the spill at 165 gallons (described as three 55 gallon drums) I did not see oil slicks or pools on the soil, nor did the river's edge closest to the spill show any sheen from oil.

My take away impression: I believe there was definitely hydraulic oil spill and possibly a large one. I do not believe the soil was transported off-site due to the relatively long haul distance to the nearest landfill and the eye witness account of the soil being buried in-situ.

Oil contaminated soil (above) and general area of spill (below)

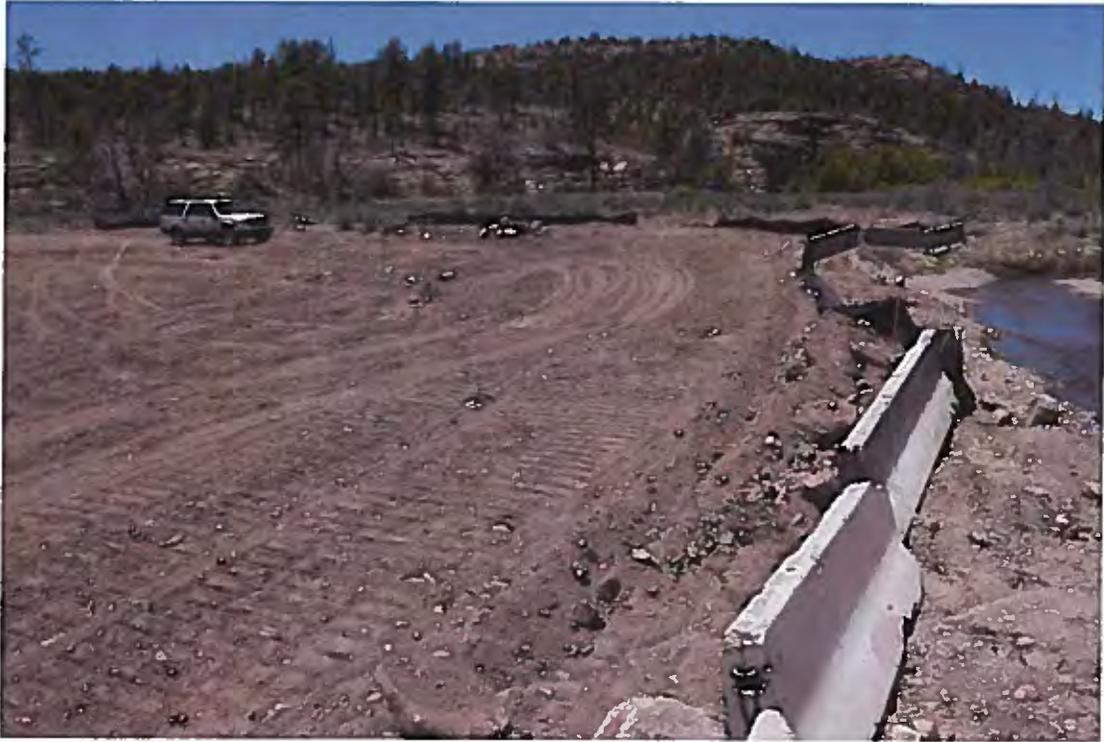
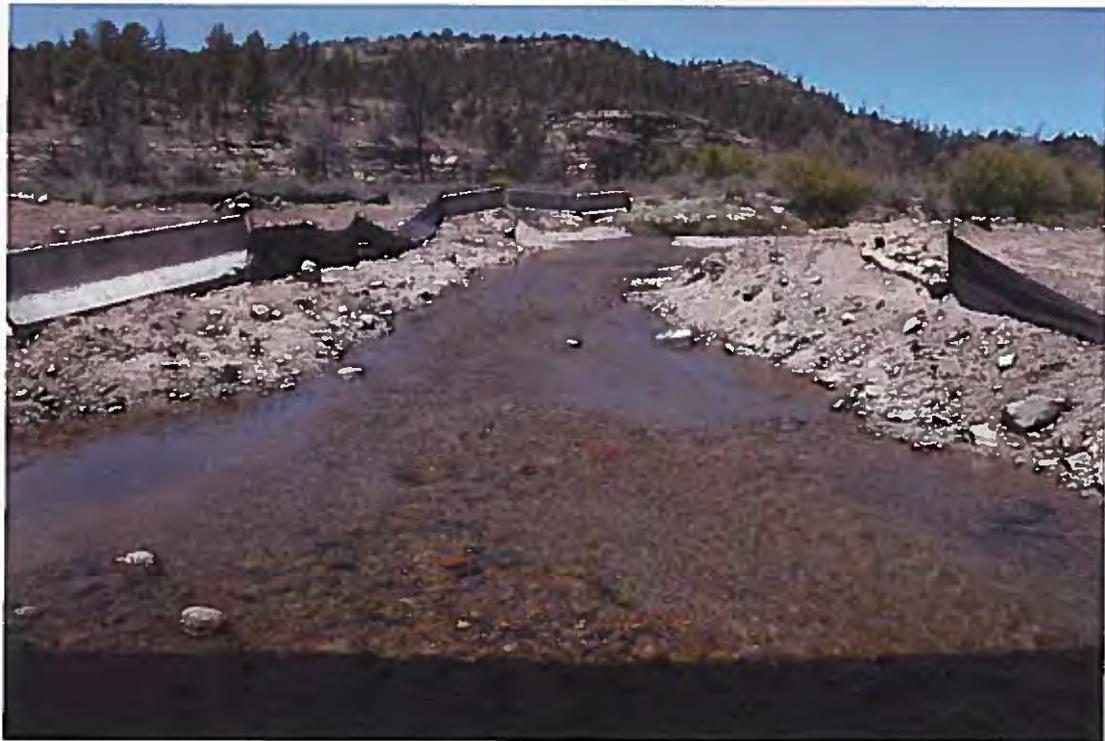
Spill area relative to the river (above) and BMPs with fill material placed in the river (below).

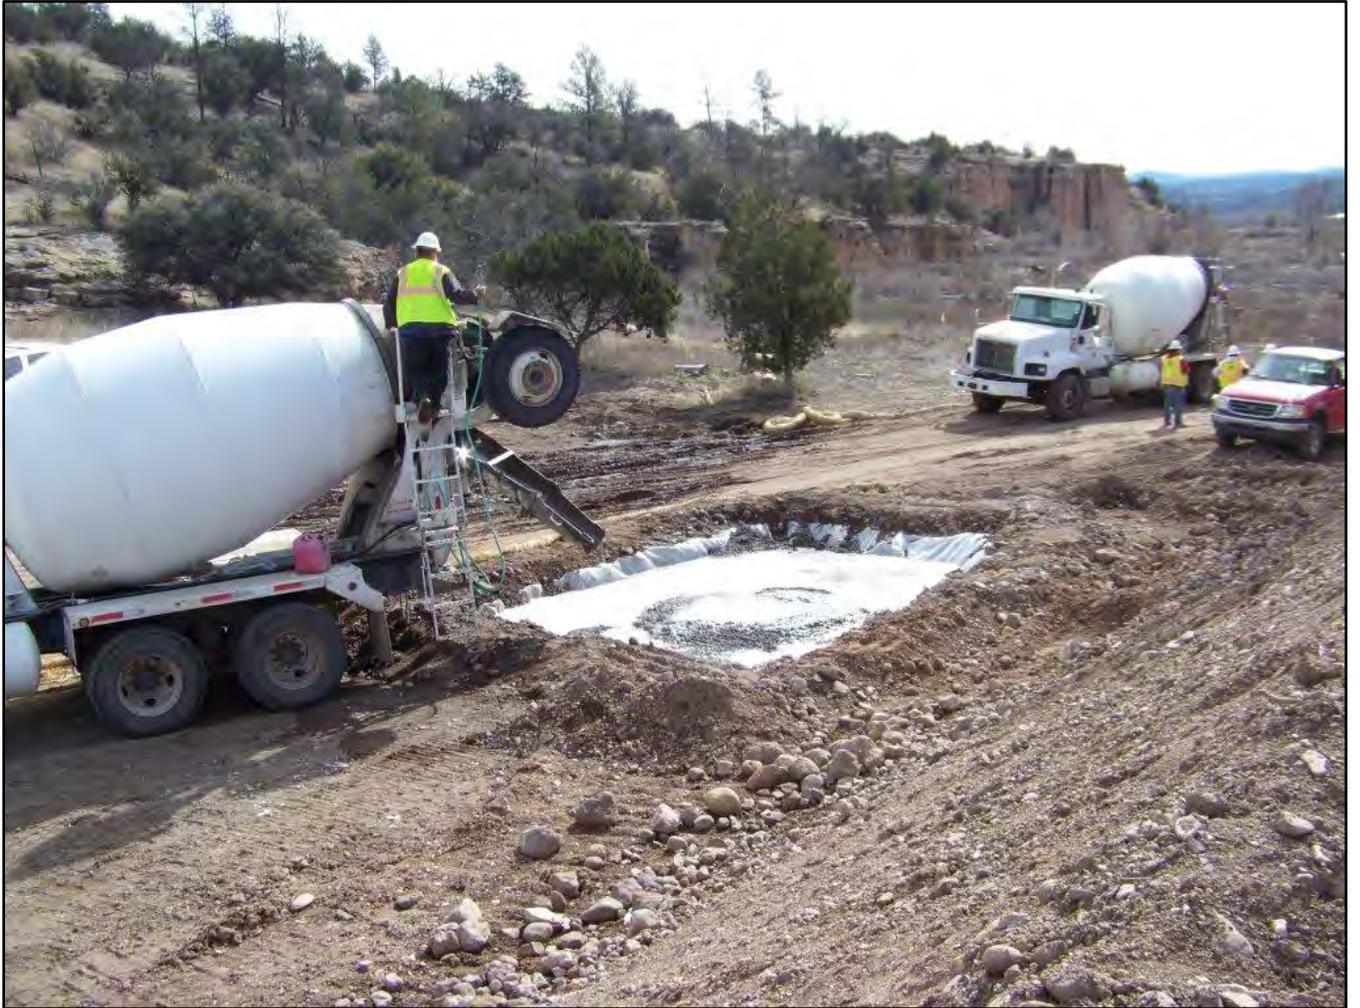
Concrete Wash Out

The visqueen was very definitely installed in the only two concrete wash out pits on the project. According to Mike Sick (Superintendent) and Robert Layne (CQC) for J-Star and Steve Short (FHWA) the pits were lined with visqueen and soil was place on top for ballast. The visqueen was buried to ballast the visqueen, so the visqueen was in place below the ballast soil.

Concrete latents and soils are cover the plastic in the picture you forwarded making the visqueen hard to identify. The onsite managers and inspectors are adamant that the visqueen was absolutely in place at both wash pits as shown in our picture attached. The attached picture seems to have been taken earlier in the progress of the project at a point prior to latents topping the visqueen.

Even in your picture you can see an uncharacteristic evenness of concrete as it splashed onto the plastic and adhered. Also, in your picture, you can even see some of the white color of visqueen where the concrete latents seem to have broken away from the visqueen lining where it was rolled on top of the pit. (See our Attached Picture)
