**NEW MEXICO
ENVIRONMENT DEPARTMENT**

Surface Water Quality Bureau

Re: Industrial Storm Water, SIC 2951, NPDES Compliance Evaluation Inspection, Blue Collar Construction Yard, NMU001851, April 3, 2013

NPDES Compliance Inspection Report

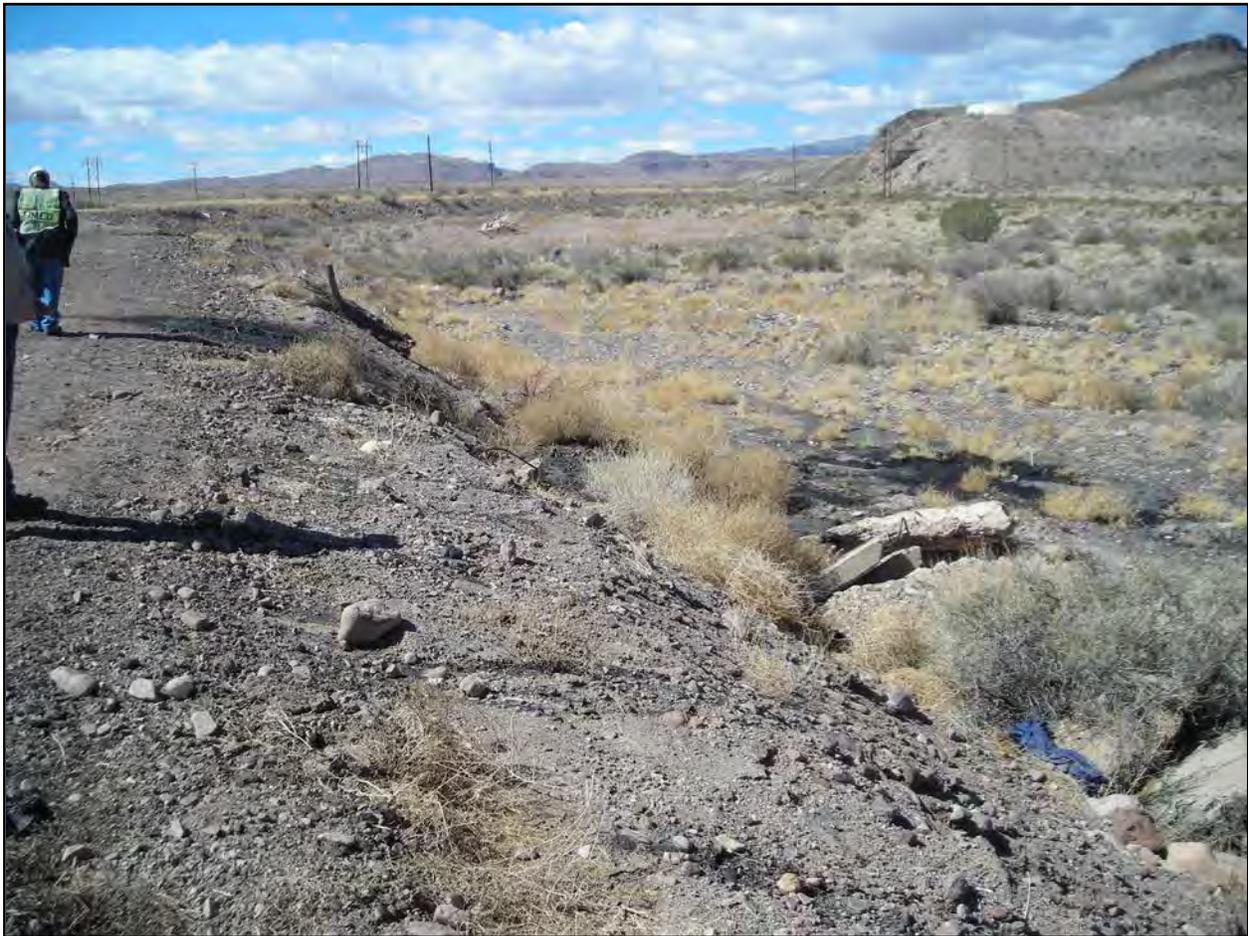
Photo # 1

Blue Collar Construction engages primarily in road construction and produces asphalt materials for that process. The materials concerned in the complaint NMED received were a raw asphalt mixture which was dumped into the adjacent arroyo and which had travelled about 300 yards from the initial dumping point (the facility representative indicated that approximately 250-300 gallons had been dumped), and an anionic asphalt emulsion (SS1H) contained in a 10,000 gallon tank onsite which had been poured out or had leaked out of the tank into a pit about 3 feet deep. The facility representative indicated that there was approximately 1,600 gallons left in the tank, which would be reused in the process. The MSDS for the asphalt emulsion is attached to this report.

On the day of the inspection, some pollutant sources observed on site that were exposed outside and could potentially come into contact with storm water included: 1) raw asphalt spilled/dumped into the Arroyo de la Matanza (please see Photo #1), 2) anionic asphalt emulsion in the pit at the south end of the site (please see Photo #5), and 3) various asphalt pieces that were distributed around the site.

Photographer: Sarah Holcomb	Date: 4-3-2013	Time: 1045 hours
City/County: Socorro, Socorro County		
Location: Blue Collar Construction yard, Arroyo de la Mantanza		
Subject: Asphalt mixture that was spilled/dumped into the Arroyo de la Mantanza.

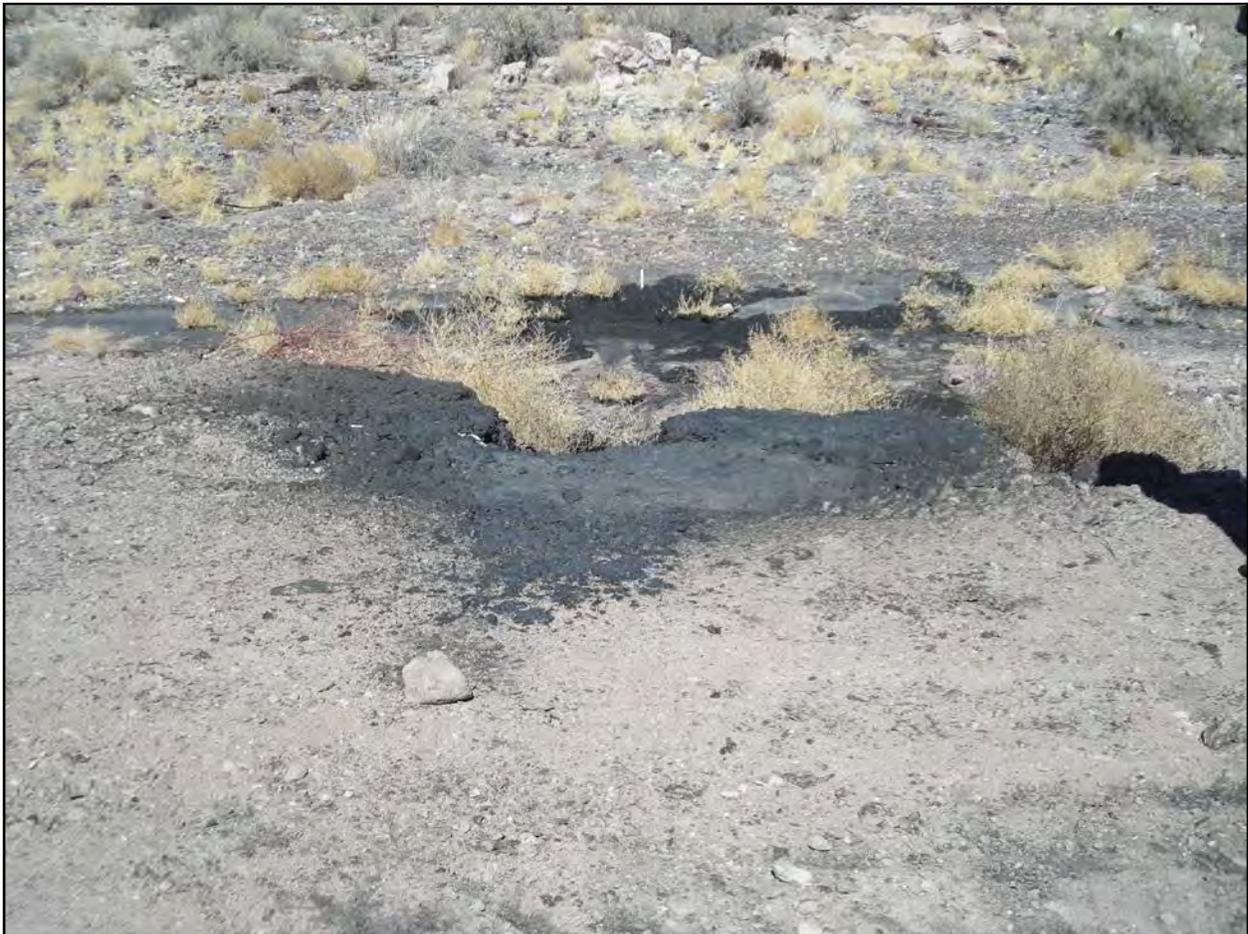
Photo # 2

Photographer: Sarah Holcomb	Date: 4-3-2013	Time: 1059 hours
City/County: Socorro, Socorro County		
Location: Blue Collar Construction yard, Arroyo de la Mantanza		
Subject: Asphalt mixture that was spilled/dumped into the Arroyo de la Mantanza.

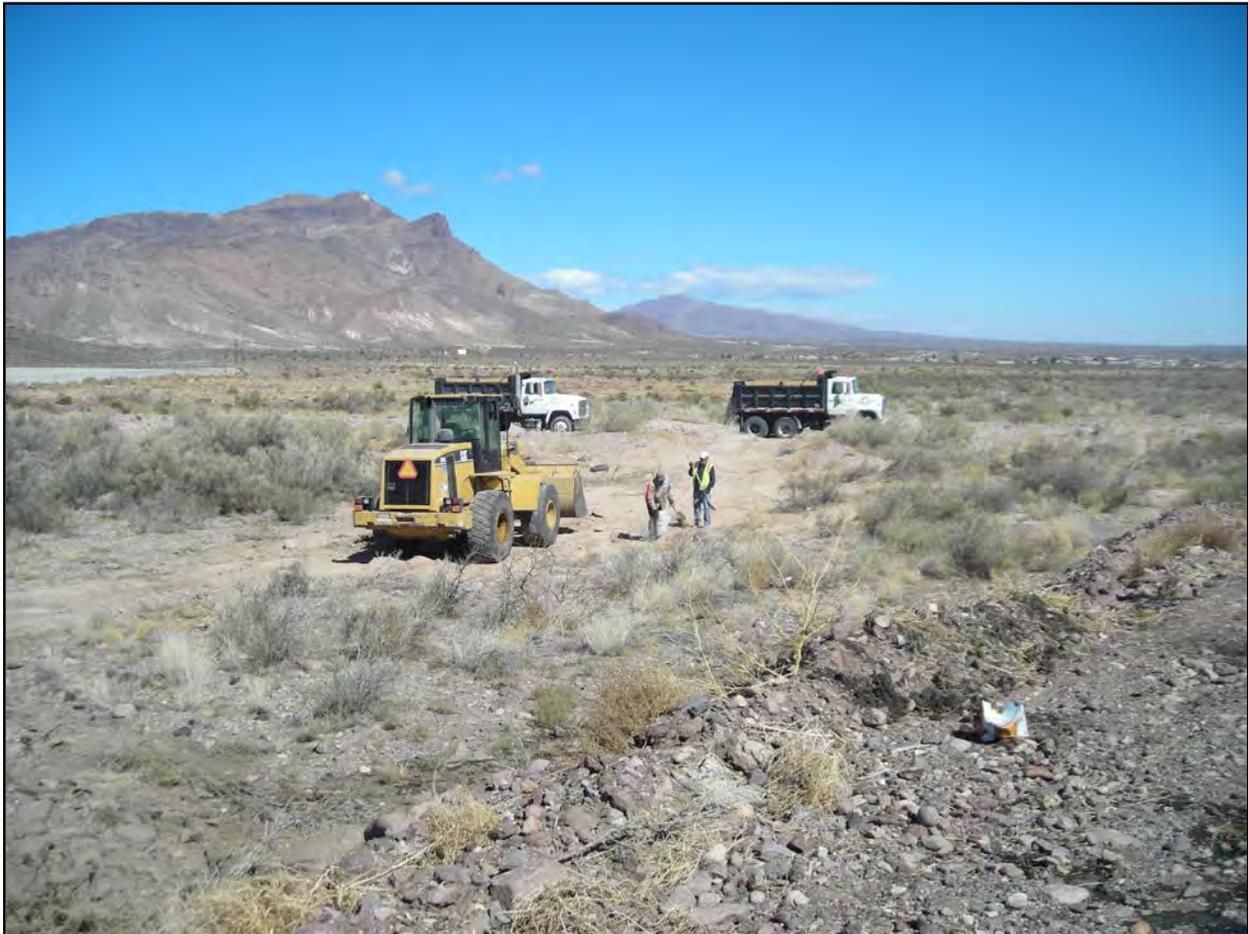
Photo # 3

Photographer: Sarah Holcomb	Date: 4-3-2013	Time: 1044 hours
City/County: Socorro, Socorro County		
Location: Blue Collar Construction yard, Arroyo de la Mantanza		
Subject: Blue Collar Construction staff cleaning up the material in the arroyo.

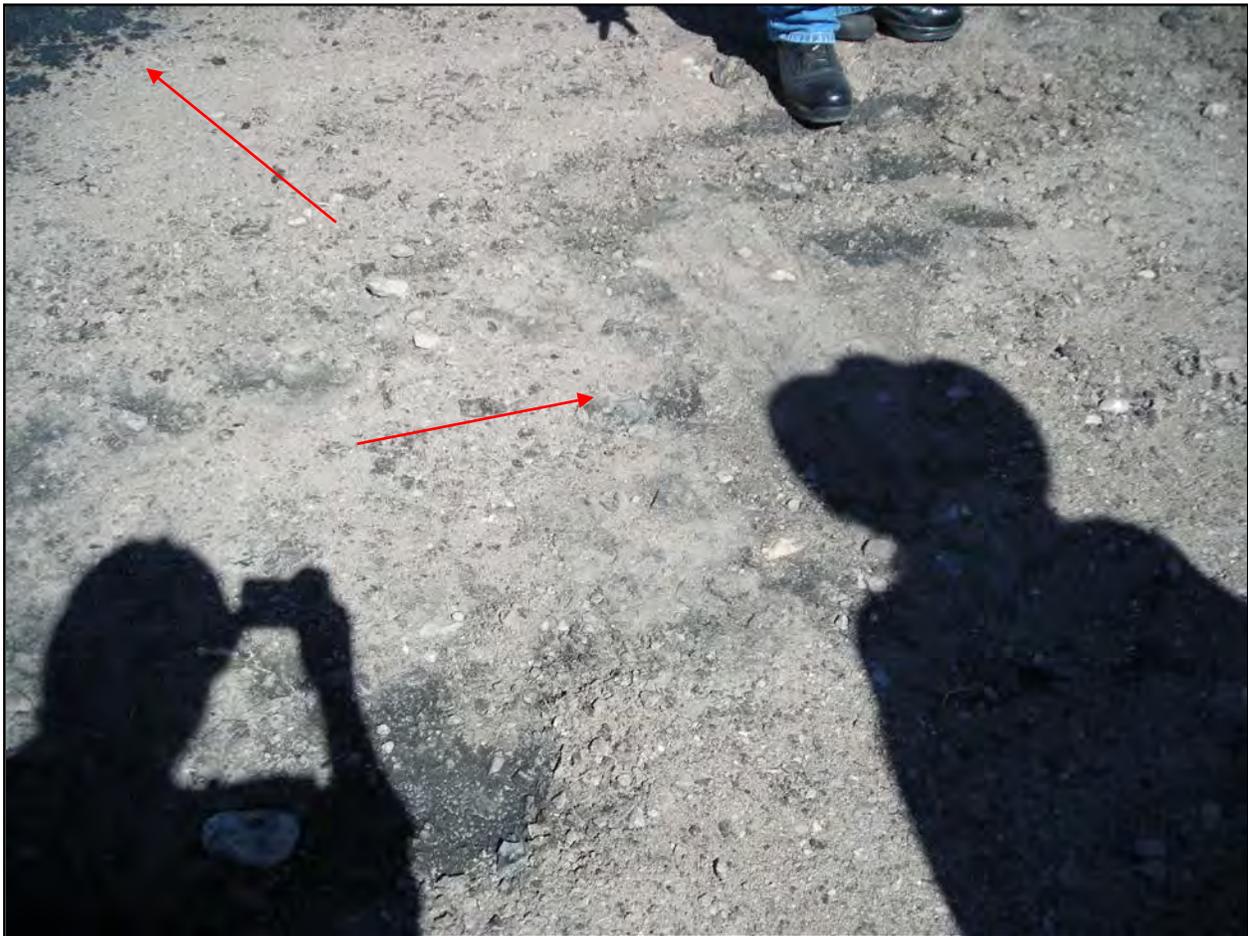
Photo # 4

Photographer: Sarah Holcomb	Date: 4-3-2013	Time: 1059 hours
City/County: Socorro, Socorro County		
Location: Blue Collar Construction yard, Arroyo de la Mantanza		
Subject: Tire tracks (indicated by arrow) showing a truck had backed up to the arroyo and dumped the material into the waterbody. Second arrow points to the asphalt area shown in Photo #2.

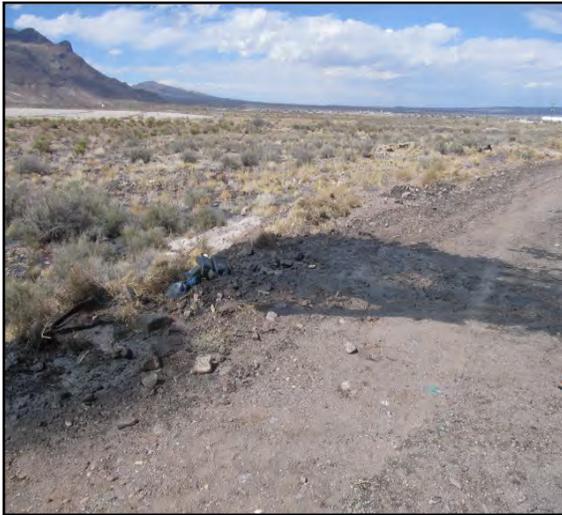
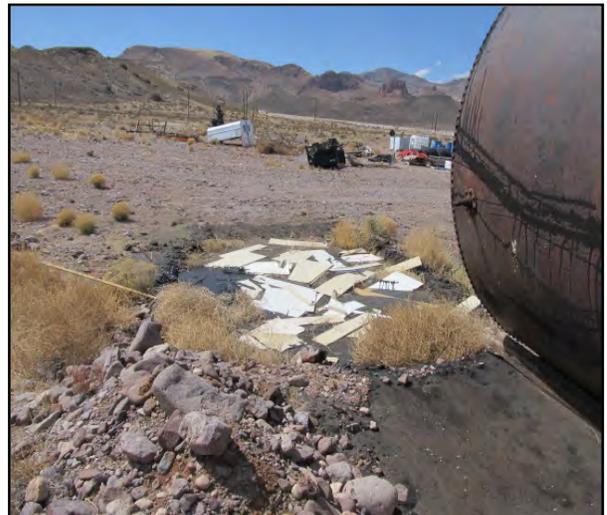
Photo # 5

Photographer: Marco Banales	Date: 4-2-2013	Time: various times
City/County: Socorro, Socorro County		
Location: Blue Collar Construction yard		
Subject: Photos taken by NMED Solid Waste Bureau staff during initial response to the complaint. This shows the 10,000 gallon tank in the south end of the yard which stored the asphalt emulsion.
