RE: Santa Fe Quill Wastewater Treatment Facility; Minor; Unpermitted Discharge; SIC 4952; NPDES Compliance Evaluation Inspection; NPDES # NMU001871; January 13, 2014

NPDES Compliance Inspection Report

Compliance Evaluation Inspection
Santa Fe Quill Wastewater Treatment Facility
NPDES Permit No. NMU001871
January 13, 2014

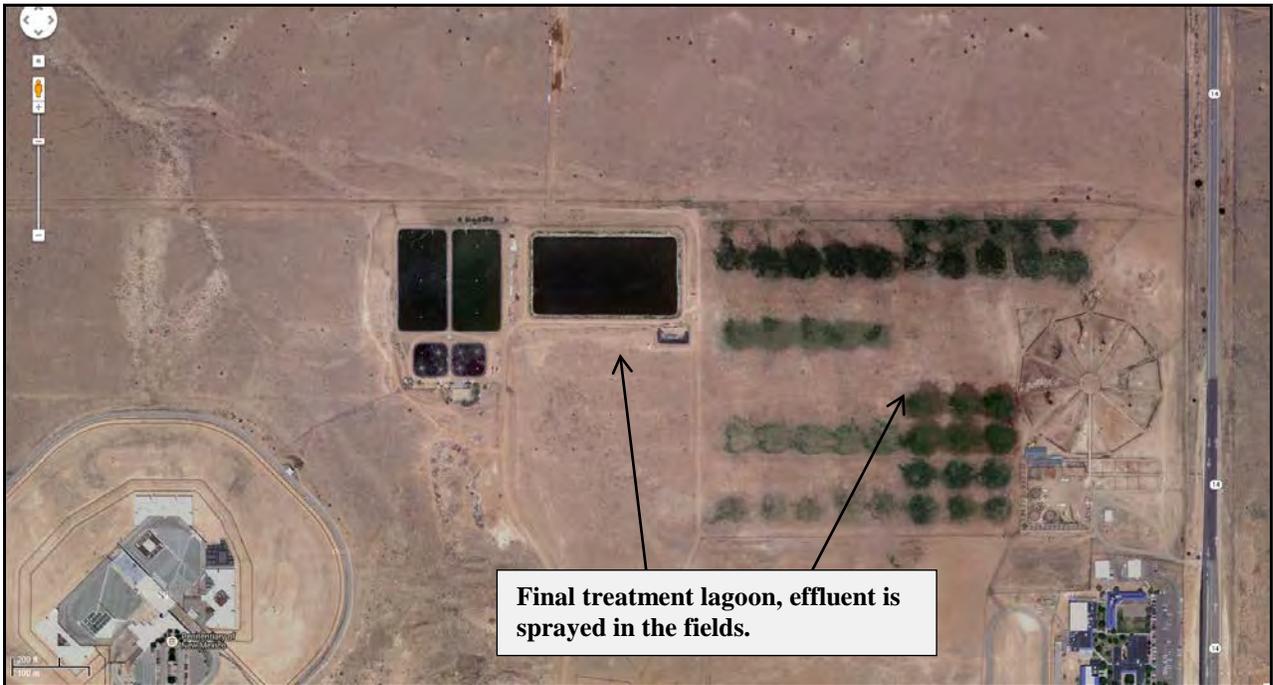
Site Overview

Wastewater is collected from various sources to be treated at the Santa Fe Quill facility. After treatment the water is pumped to the facilities effluent storage pond. The water is disposed of by spraying onto the adjacent fields (see overview 1-2). Groundwater permit DP234 is in place to monitor this activity. During the winter months the fields are frozen with no growing vegetation. To keep the facilities effluent storage pond from overflowing spraying continues. When conditions allow the effluent freezes and slowly accumulate. As the weather changes sudden melting of the frozen effluent may occur. This overwhelms the inoperative collection system at the bottom of the hill. Per the facility representative the discharge observed during the inspection was estimated to be approximately 50,000 gallons. The effluent runoff was found to extend down the arroyo approximately 0.5 miles from the point of origin.

City/County: South of Santa Fe/Santa Fe County	
Location: 43110 Hwy 14, Santa Fe, NM	
Subject: Overview of the facility. Photo taken during the summer not at the time of the inspection.

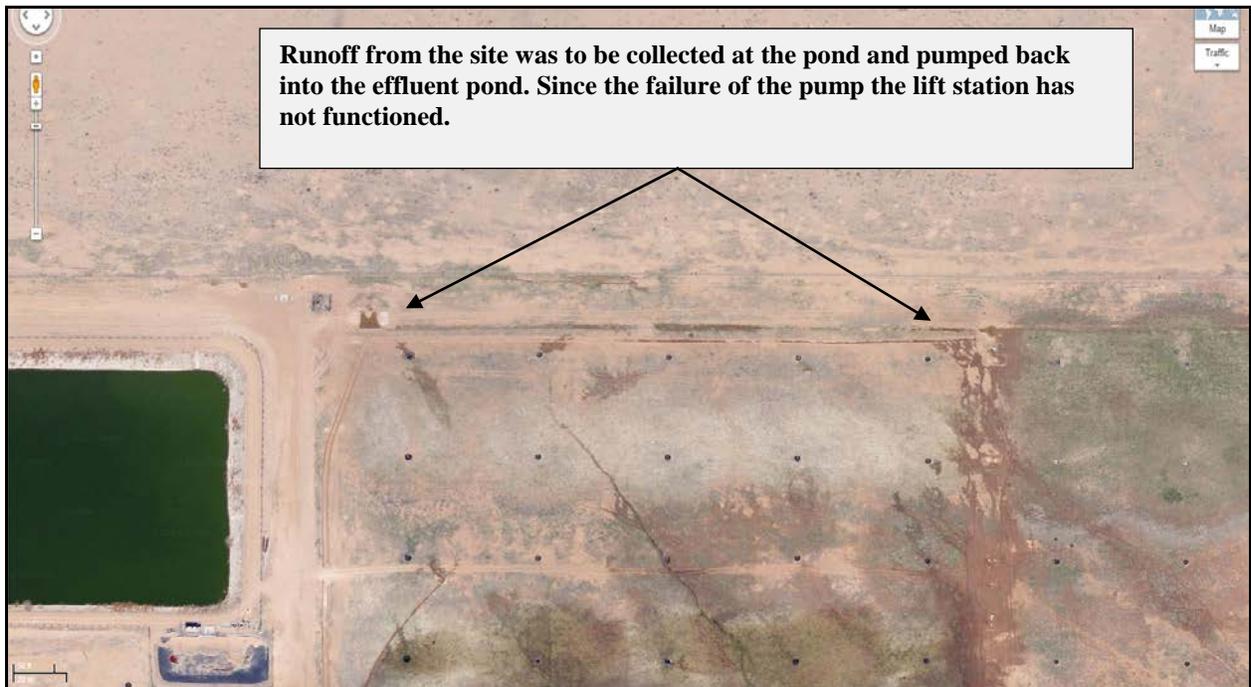
Site Overview

City/County: South of Santa Fe/Santa Fe County	
Location: 43110 Hwy 14, Santa Fe, NM	
Subject: The system was designed to collect the effluent and return it to the effluent storage lagoon.

Effluent discharged onto the field during winter months freezes and then melts and is absorbed by the soil. A small tailwater pond equipped with an automated pump system is intended to capture any effluent that is not absorbed by the soil and transfer it back to the effluent storage pond. Unfortunately, the tailwater pump and controls are non-functional, so effluent that runs off of the irrigation field is collecting in the small tailwater pond, overflowing the pond and running off the site. SFCU is in the process of repairing the tailwater pump equipment, but is proposing to implement the following corrective actions to address the current runoff problem:

1. The berm of the small tailwater pond will be improved to prevent runoff to a greater extent.
2. Effluent that collects in the tailwater pump wetwell will be transferred back to the effluent storage pond by pump or using the SFCU's Vector trailer unit.
3. Irrigation of the field will be kept to a minimum during the winter months to prevent excessive runoff as the effluent melts. This will involve the application of only enough effluent to the field to maintain the required freeboard in the effluent storage pond.

The improvements to the tailwater pond berm have already been made and SFCU is currently and will continue to remove the accumulated water in the tailwater pump wetwell and return it to the effluent storage pond. These actions have stopped the unauthorized discharge of effluent runoff from the tailwater pond.

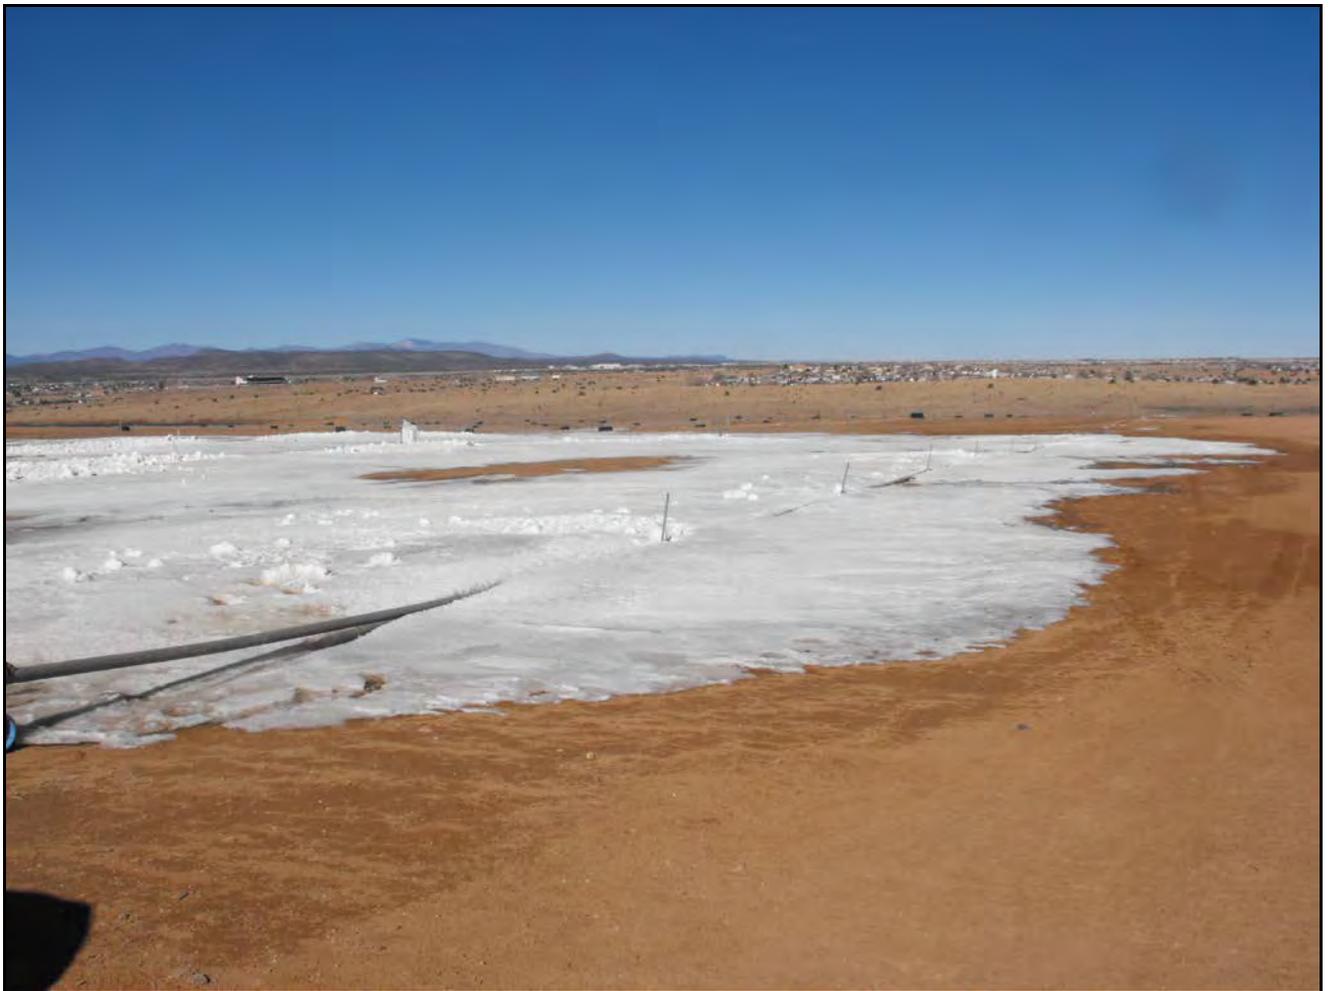
Photo # 1

Photographer: Daniel Valenta	Date: 1/13/2014	Time: 1144
City/County: South of Santa Fe/Santa Fe County		
Location: 43110 Hwy 14, Santa Fe, NM, facing northwest.		
Subject: Effluent is sprayed onto the field where it freezes and accumulates.

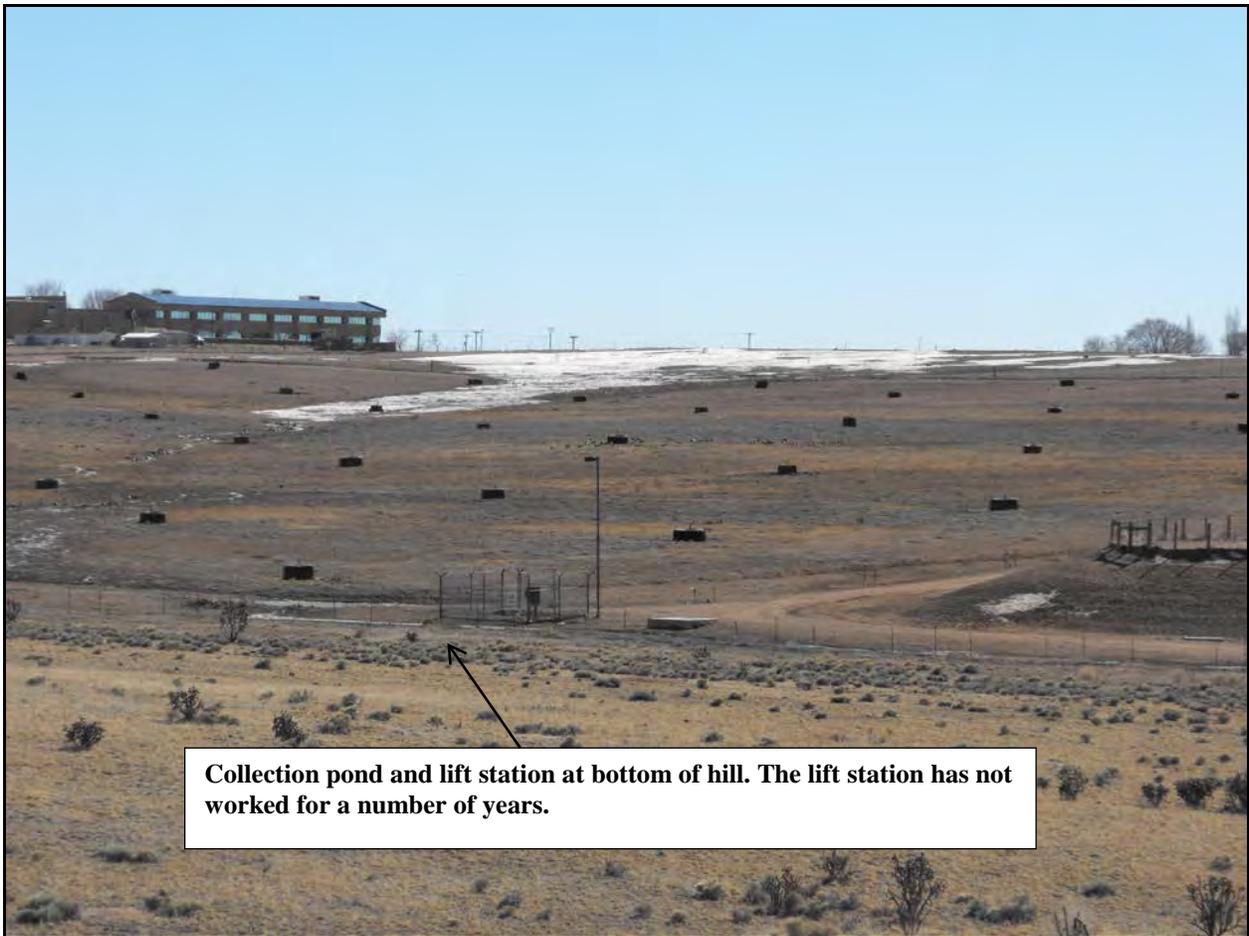
Photo # 2

The pump at the lift station to prevent this discharge was reported to be nonfunctional for the last two years. It is unknown at this time how many unpermitted discharges have occurred before this inspection when rain events or those described above have occurred. The Santa Fe County Utilities Division has submitted a report addressing the unauthorized discharge of effluent runoff to the EPA and State, see attached.

Photographer: Daniel Valenta	Date: 1/13/2014	Time: 1200
City/County: South of Santa Fe/Santa Fe County		
Location: 43110 Hwy 14, Santa Fe, NM, facing southeast.		
Subject: Effluent runs off field to the overflow collection pond and flows down the arroyo.

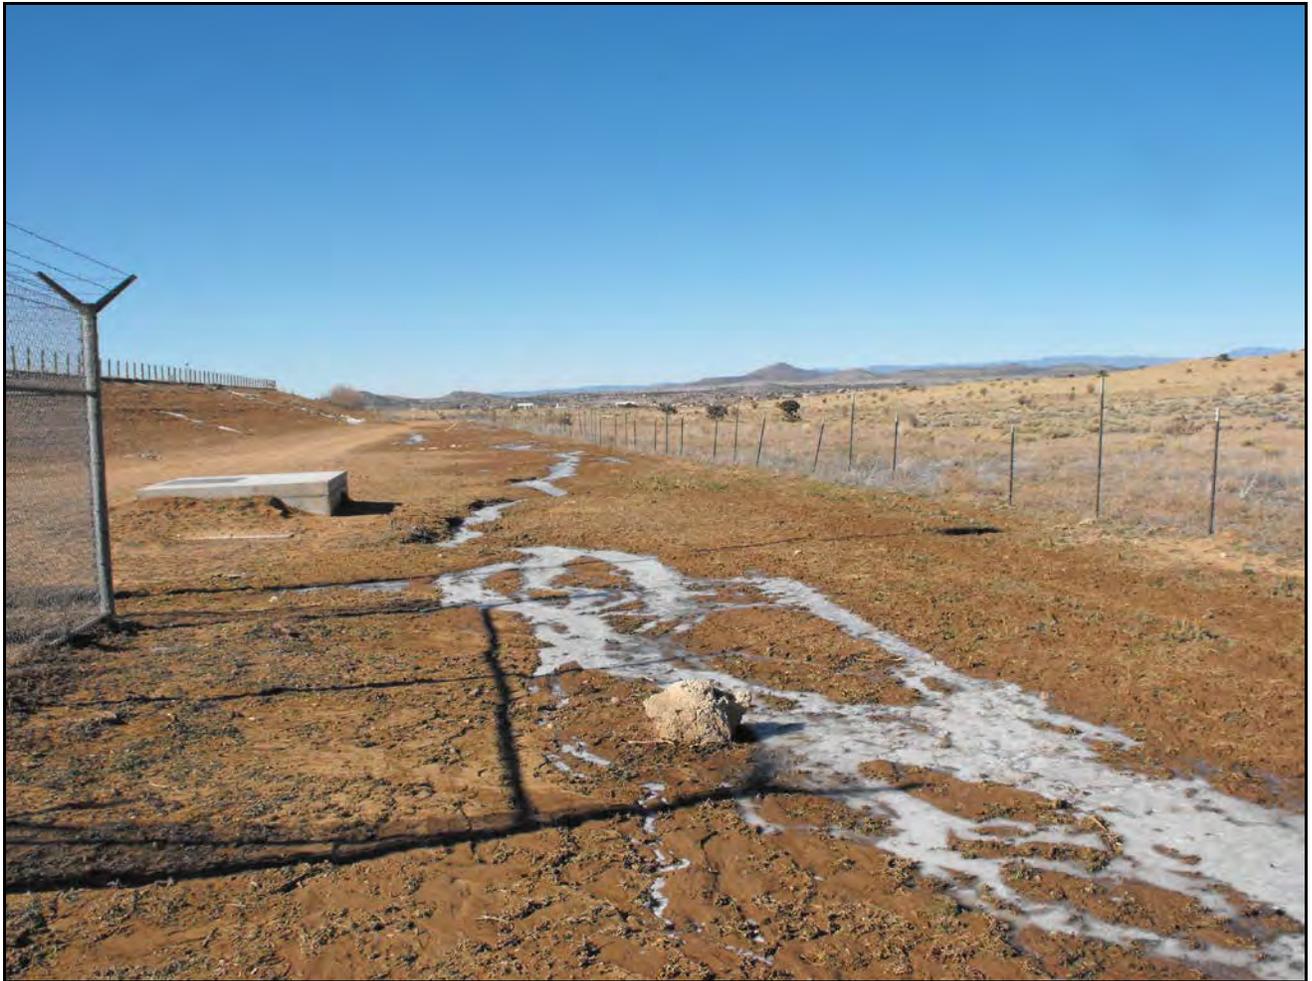
Photo # 3

Photographer: Daniel Valenta	Date: 1/13/2014	Time: 1123
City/County: South of Santa Fe/Santa Fe County		
Location: 43110 Hwy 14, Santa Fe, NM, facing west.		
Subject: Effluent discharge from collection system.

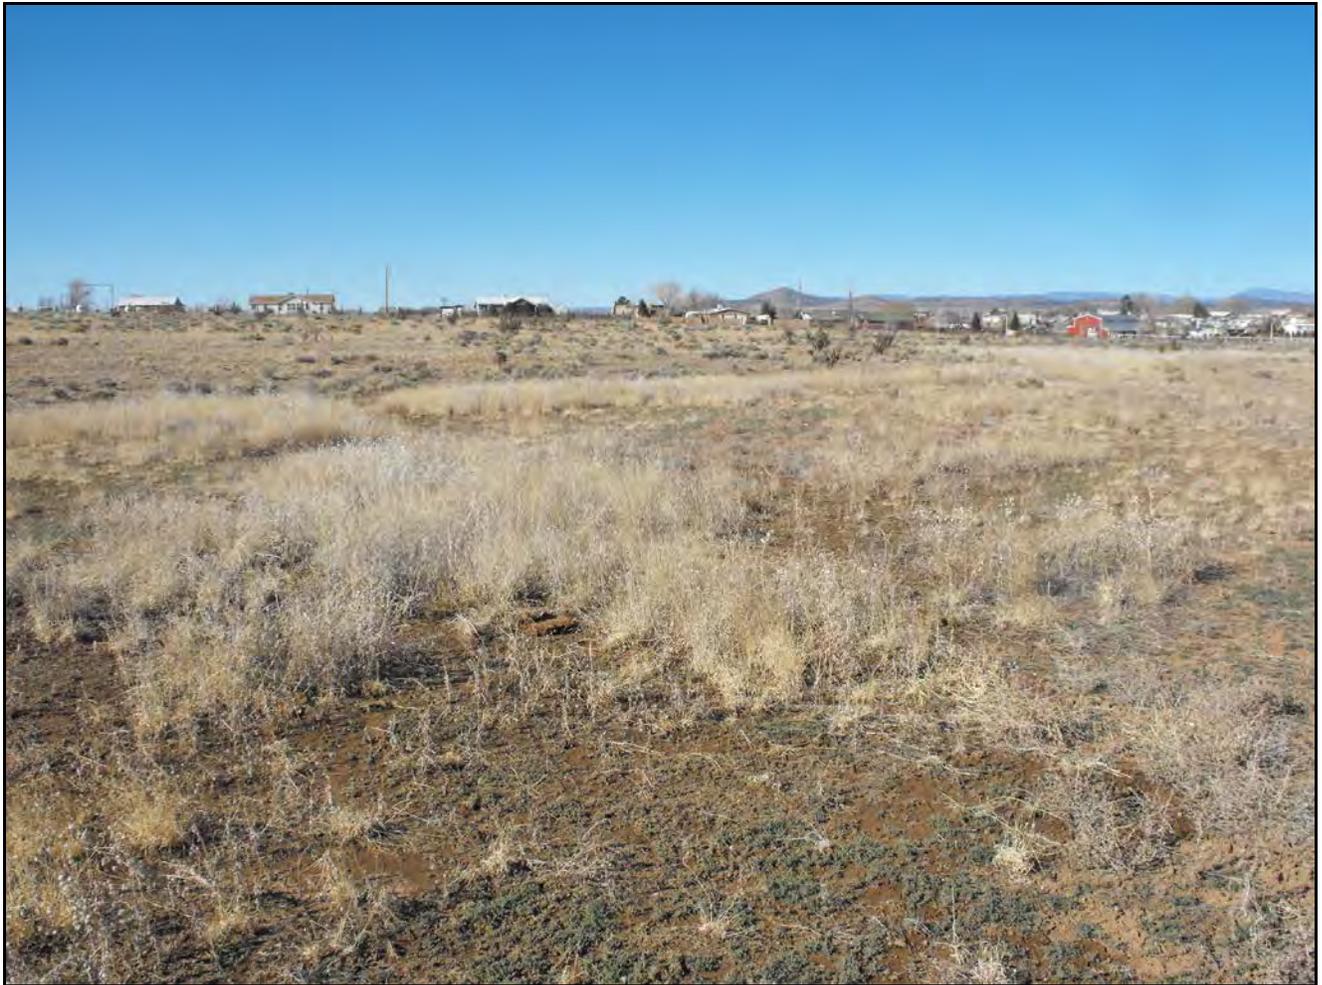
Photo # 5

Photographer: Daniel Valenta	Date: 1/13/2014	Time: 1054
City/County: South of Santa Fe/Santa Fe County		
Location: 43110 Hwy 14, Santa Fe, NM, facing west.		
Subject: Effluent flows down the arroyo towards a residential area and Cienega Creek.

down the same un-named arroyo that was previously impacted by the unauthorized sewage discharge. The effluent runoff was found to extend down the arroyo approximately 0.5 miles from its point of origin. Assuming a wetted area of approximately 80,000 square feet and an applied depth of 1" of effluent runoff over the entire wetted area, the volume of the unauthorized discharge of effluent runoff can be estimated to be approximately 50,000 gallons.
