RE: Santa Fe Quill Wastewater Treatment Facility; Minor; Unpermitted Discharge; SIC 4952; NPDES Compliance Evaluation Inspection; NPDES # NMU001871; January 23, 2014

NPDES Compliance Inspection Report

Compliance Evaluation Inspection
Santa Fe Quill Wastewater Treatment Facility
NPDES Permit No. NMU001871
January 23, 2014

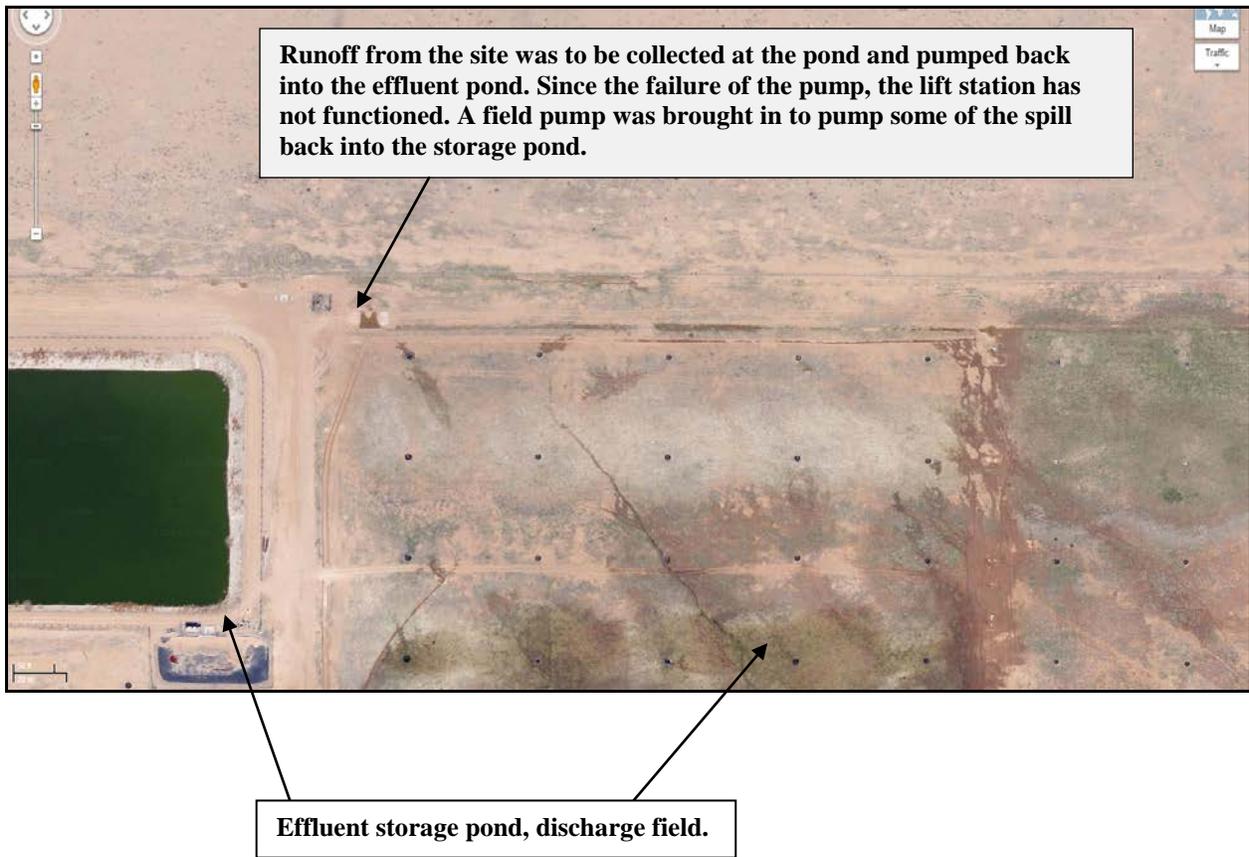
Site Overview

City/County: South of Santa Fe/Santa Fe County	
Location: 43110 Hwy 14, Santa Fe, NM	
Subject: The system was designed to collect the effluent and return it to the effluent storage lagoon.

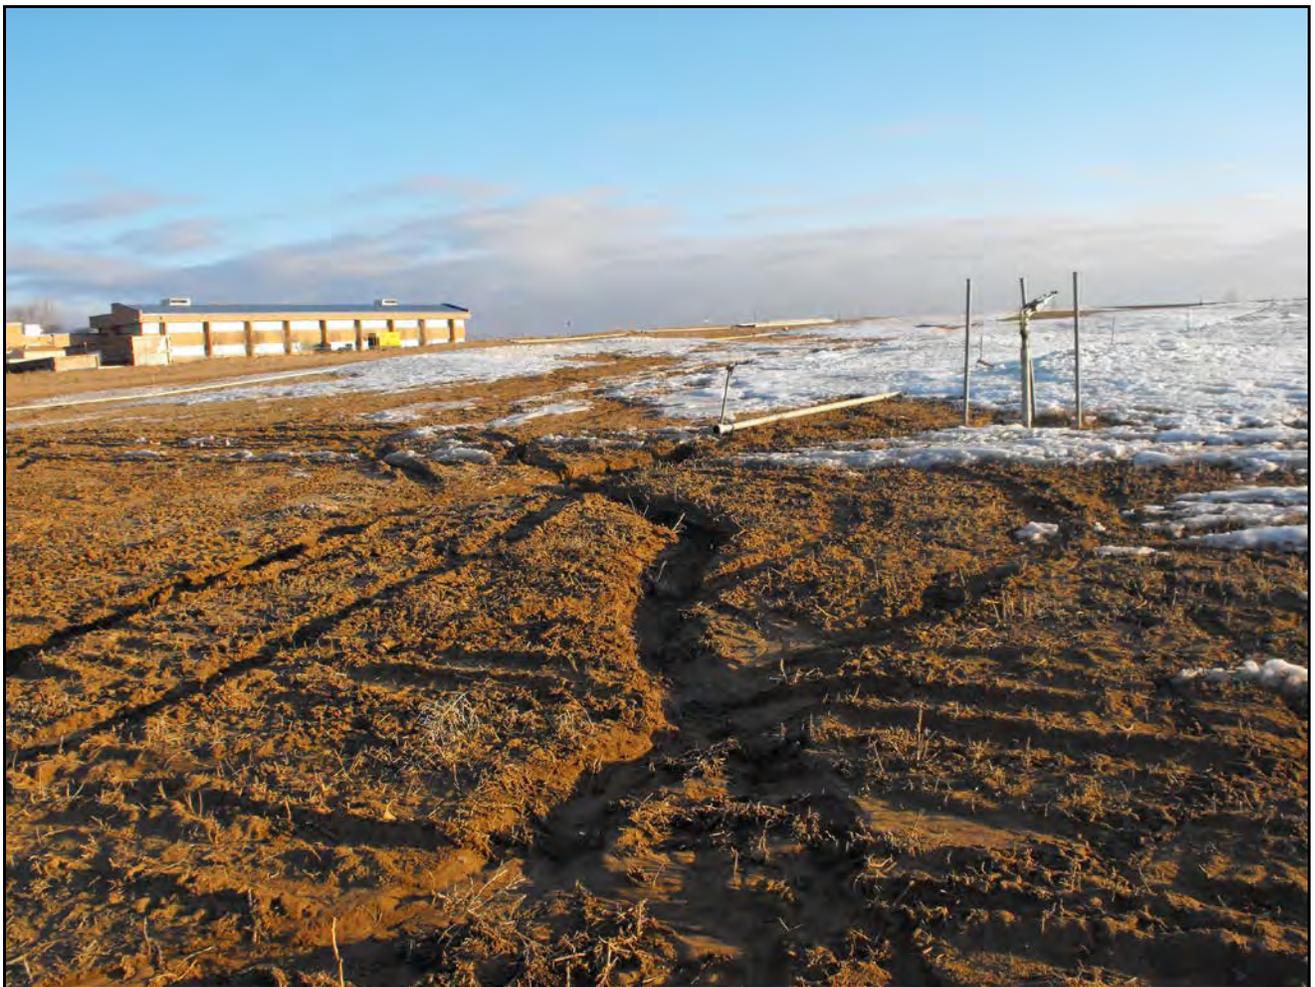
Photo # 1

Investigation into the cause of the extensive runoff revealed that one of the end-plugs on an irrigation lateral had blown out of place and was allowing an unrestricted discharge of effluent to exit the irrigation system. The total volume discharged as calculated by SFCU personnel on January 21, 2014 was 144,500 gallons (based upon meter readings) and the irrigation pump ran a total of 4.11 hrs. Of this volume, approximately 25,000 gallons was captured in the tailwater pond and transferred back to the effluent pond by trash pump and some of the effluent absorbed into the soil of the irrigation area, however; a significant volume (possibly > 100,000 gallons) ran off the site and discharged to the nearby arroyo. The area in the arroyo affected was very similar to the area affected by the unauthorized discharge observed by NMED on January 13, 2014.

After interviewing the site operators and reviewing the site it is believed that the plugging of six of the sprinkler heads caused increased pressure within the irrigation system resulting in the blow out of a single end-plug.

Photographer: Daniel Valenta	Date: 1/23/2014	Time: 1635
City/County: South of Santa Fe/Santa Fe County		
Location: 43110 Hwy 14, Santa Fe, NM, facing southeast.		
Subject: Discharge field where pipe plug was blown out allowing discharge of treated effluent.

6. SFCU is evaluating the use of wire retainers and/or thrust blocks to restrict the movement of the end-plugs. If one (or both) of these solutions proves to work well and still allow the irrigation system to be easily and fully drained, it will be implemented.

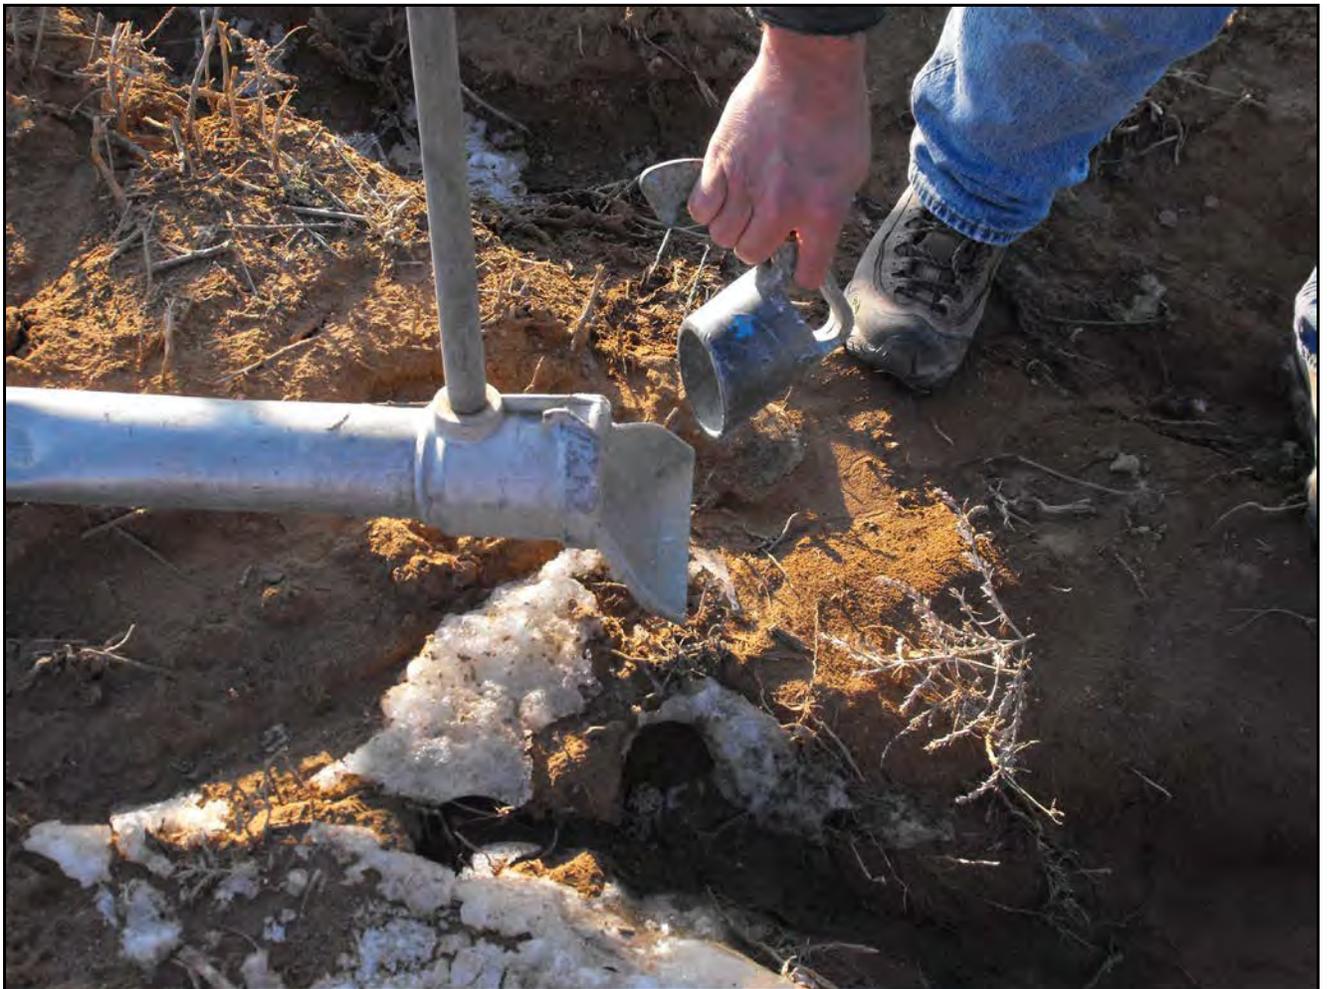
Photo # 2

Photographer: Daniel Valenta	Date: 1/23/2014	Time: 1631
City/County: South of Santa Fe/Santa Fe County		
Location: 43110 Hwy 14, Santa Fe, NM.		
Subject: The pipe is plugged with this cap, it sits inside the pipe and locks into place by the curved handle which latches onto the lip of the pipe.

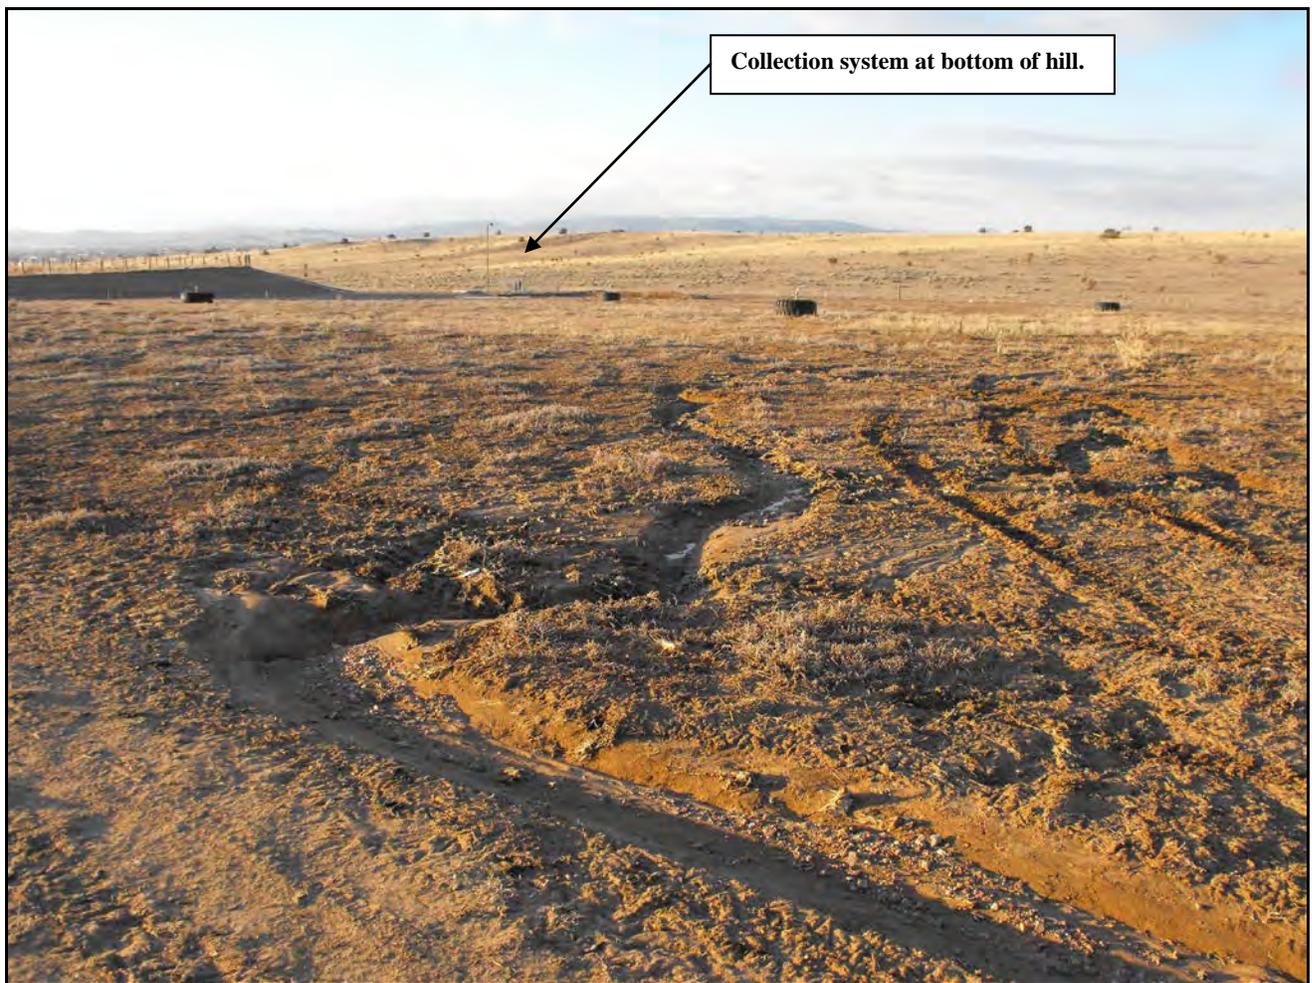
Photo # 3

Photographer: Daniel Valenta	Date: 1/23/2014	Time: 1640
City/County: South of Santa Fe/Santa Fe County		
Location: 43110 Hwy 14, Santa Fe, N.M. facing northwest.		
Subject: Downcutting from treated effluent from the blown endcap.

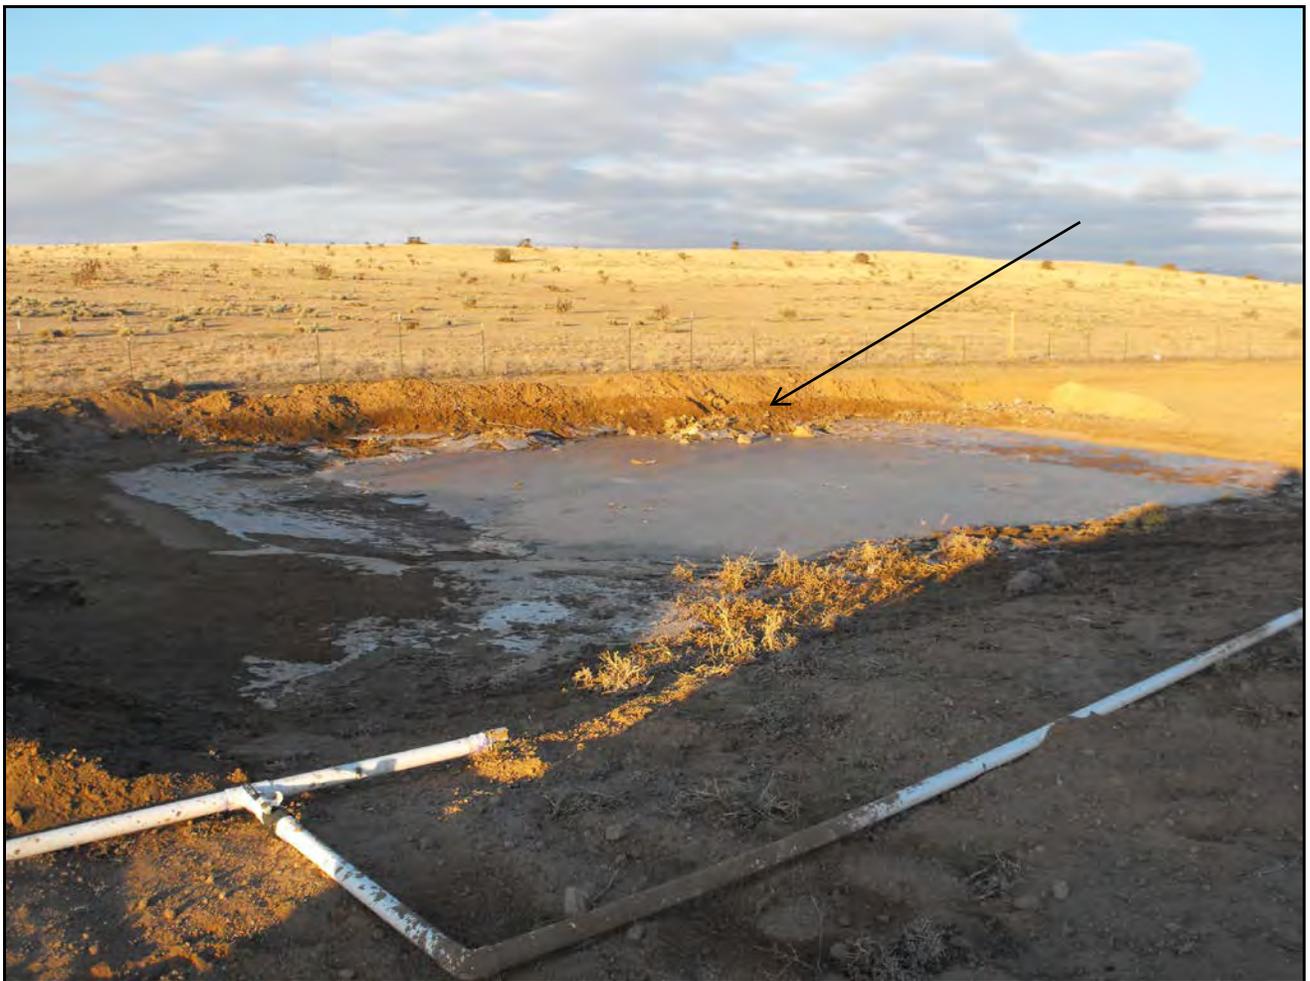
Photo # 4

Photographer: Daniel Valenta	Date: 1/23/2014	Time: 1645
City/County: South of Santa Fe/Santa Fe County		
Location: 43110 Hwy 14, Santa Fe, N.M. facing southeast.		
Subject: Collection pond filled and then overflowed, note water level mark.

1. The north and (now) west berms of the small tailwater pond have been improved to prevent runoff to a greater extent. However, please note that these berms can only control moderate amounts of runoff. A failure of the irrigation system will still cause overflow of the tailwater pond.

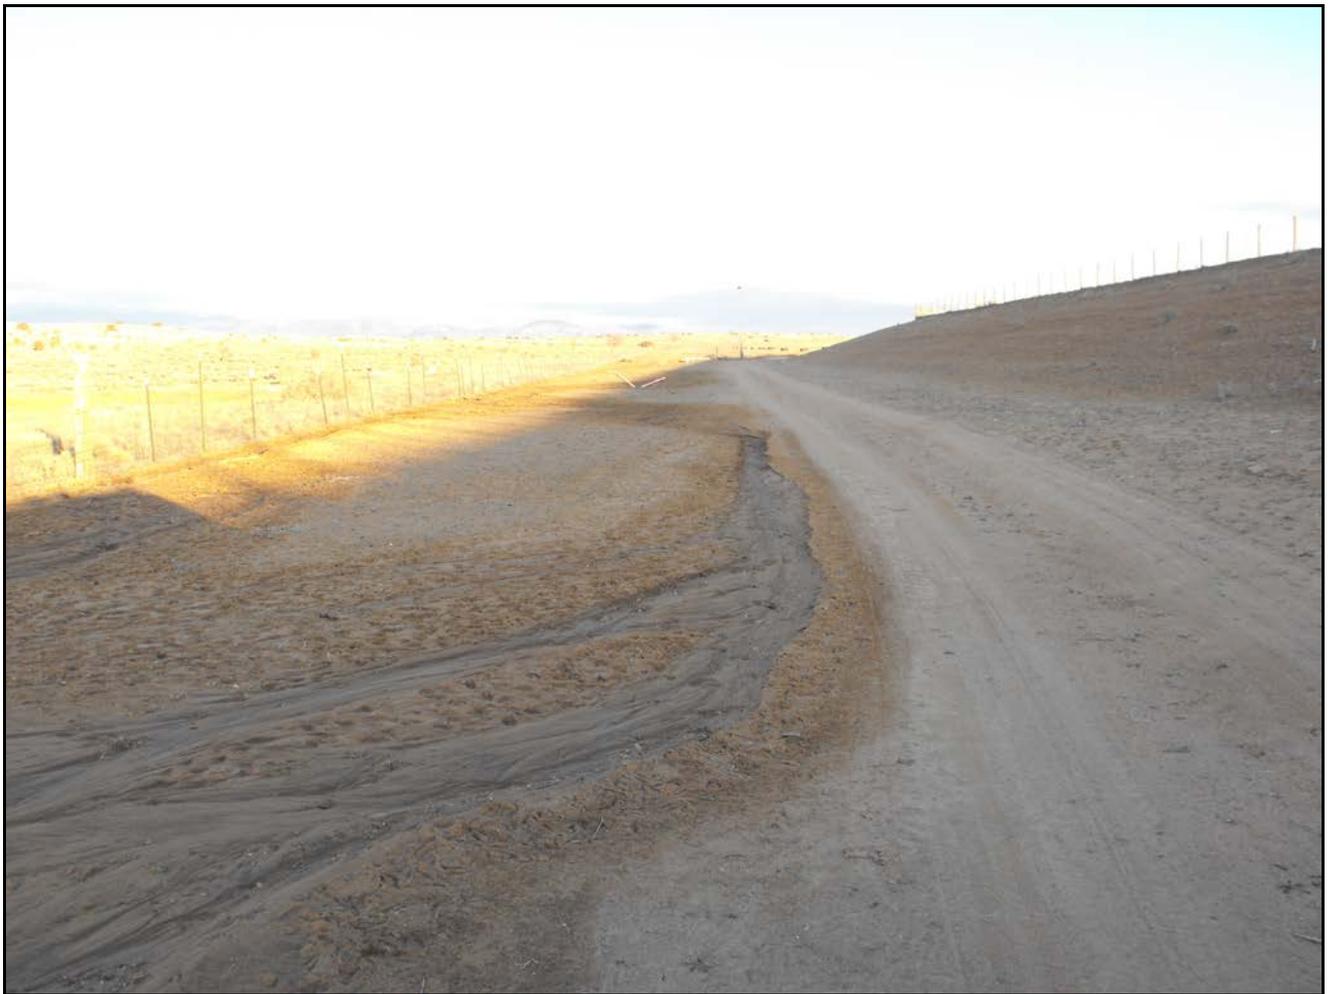
Photo # 5

Photographer: Daniel Valenta	Date: 1/23/2014	Time: 1648
City/County: South of Santa Fe/Santa Fe County		
Location: 43110 Hwy 14, Santa Fe, N.M. facing southeast.		
Subject: Effluent overtopped holding pond and continued downhill.
