**RE: Billali Mine; Minor; Unpermitted Discharge; SIC 1041; NPDES Reconnaissance Inspection;  
NPDES # NMU001879; May 13, 2014**

**Shooting Star Mining Company, LLC  
Billali Mine, New Mexico  
NPDES Tracking No. NMU001879  
Reconnaissance Inspection  
May 13, 2014**

**Further Explanations**

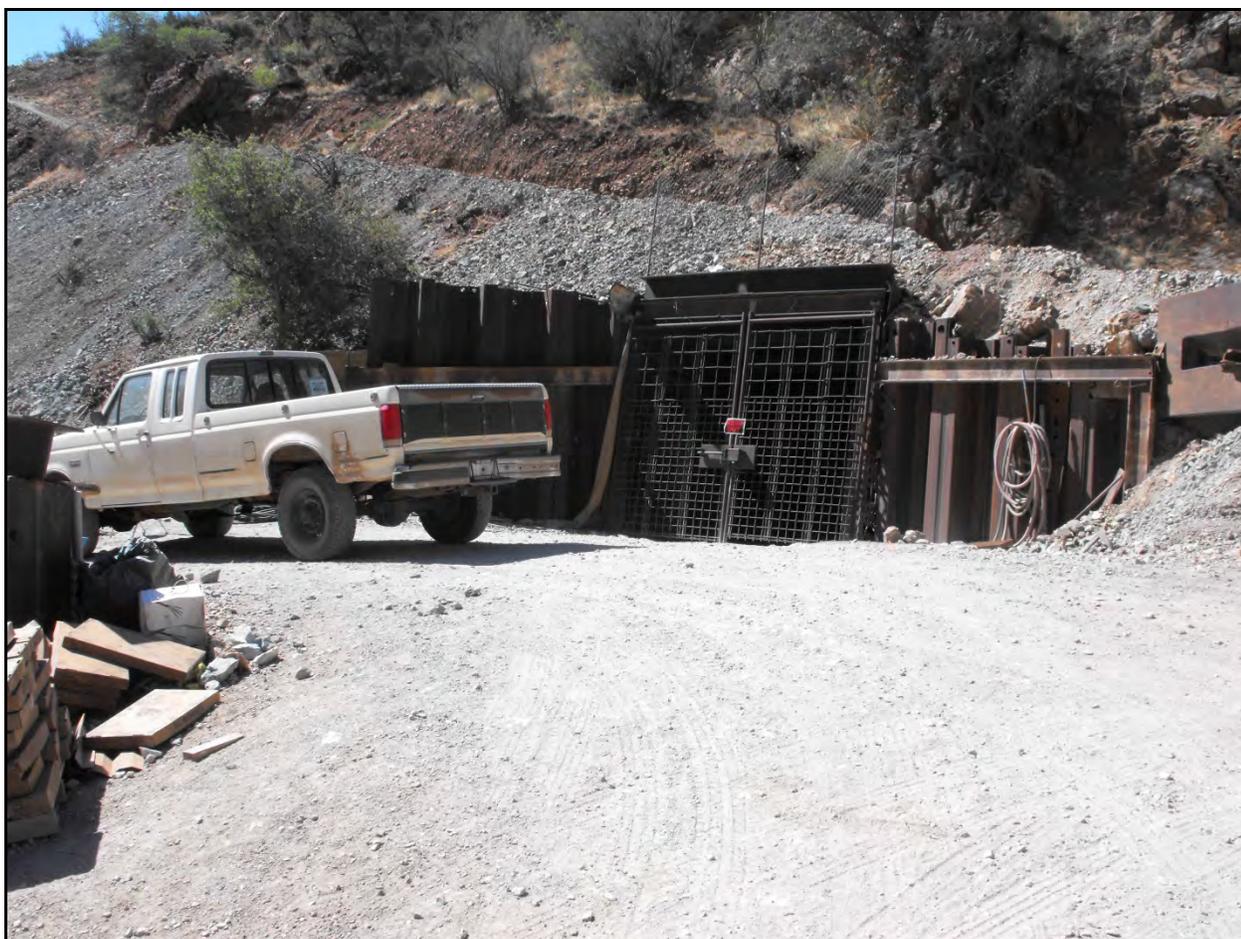
Photo # 1

Photographer: Daniel Valenta	Date: May 13, 2014	Time: 1039 hours
City/County: Monzingo Ranch/Grant County		
Location: Billali Mine, New Mexico, next to Bitter Creek road coming from Hwy 75 north of Douglas AZ.		
Subject: Entrance to the Billali mine where groundwater was pumped out to enable samples to be taken.

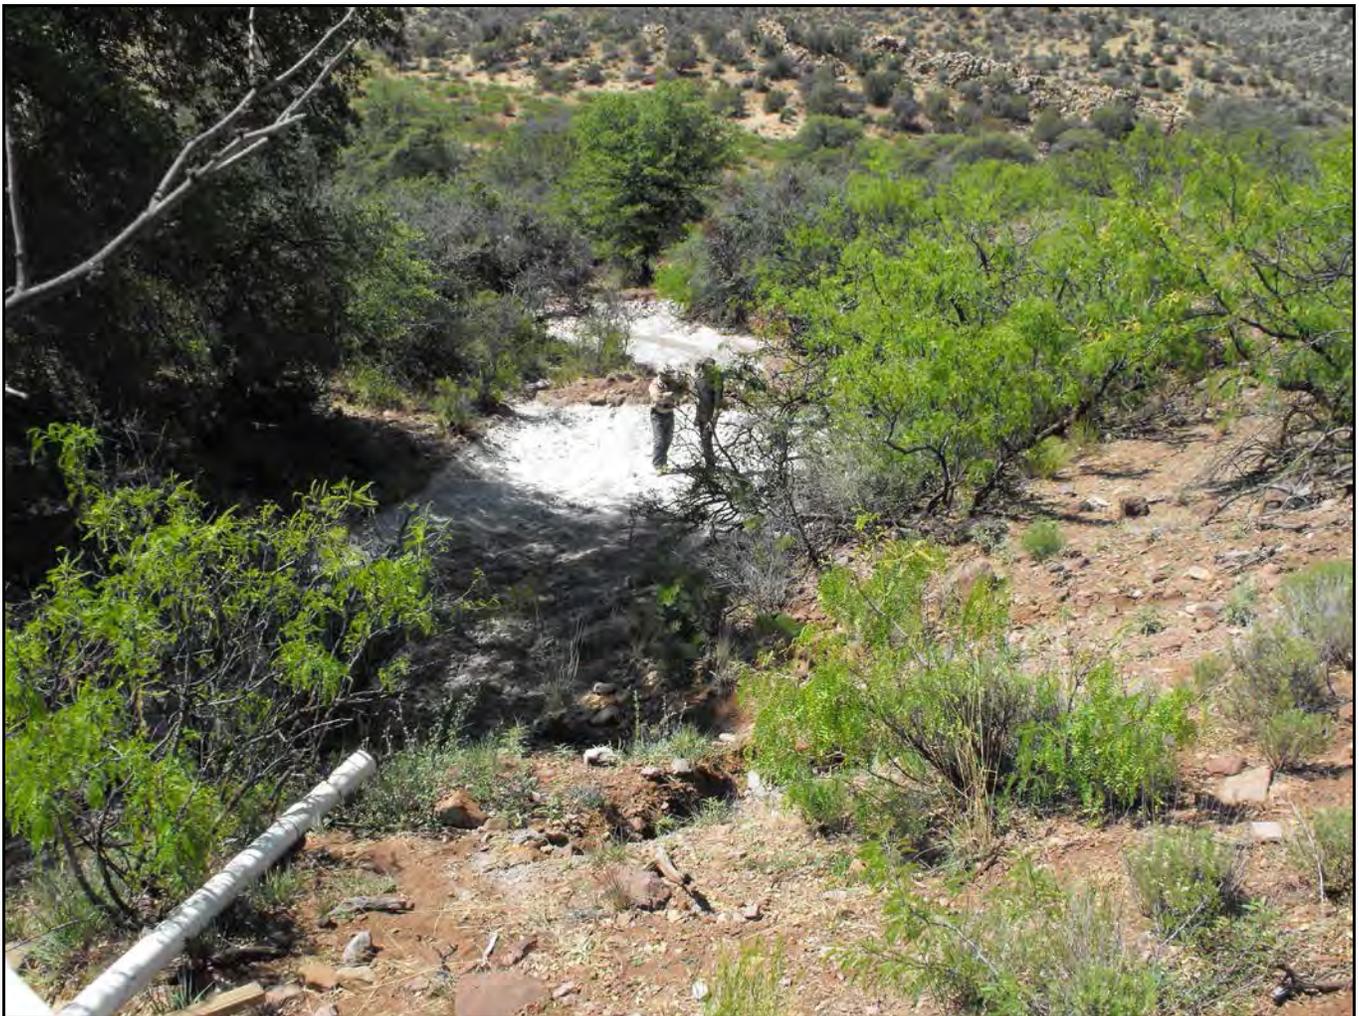
Photo # 2

Photographer: Daniel Valenta	Date: May 13, 2014	Time: 1126 hours
City/County: Monzingo Ranch/Grant County		
Location: Monzingo Ranch, New Mexico, next to Bitter Creek road coming from Hwy 75 north of Douglas AZ.		
Subject: Pipe discharges groundwater from the mine into unnamed arroyo on the Monzingo ranch, this is a tributary to Bitter creek. A series of check dams have been built to retain the water. A white residue was left as the water was absorbed into the ground.

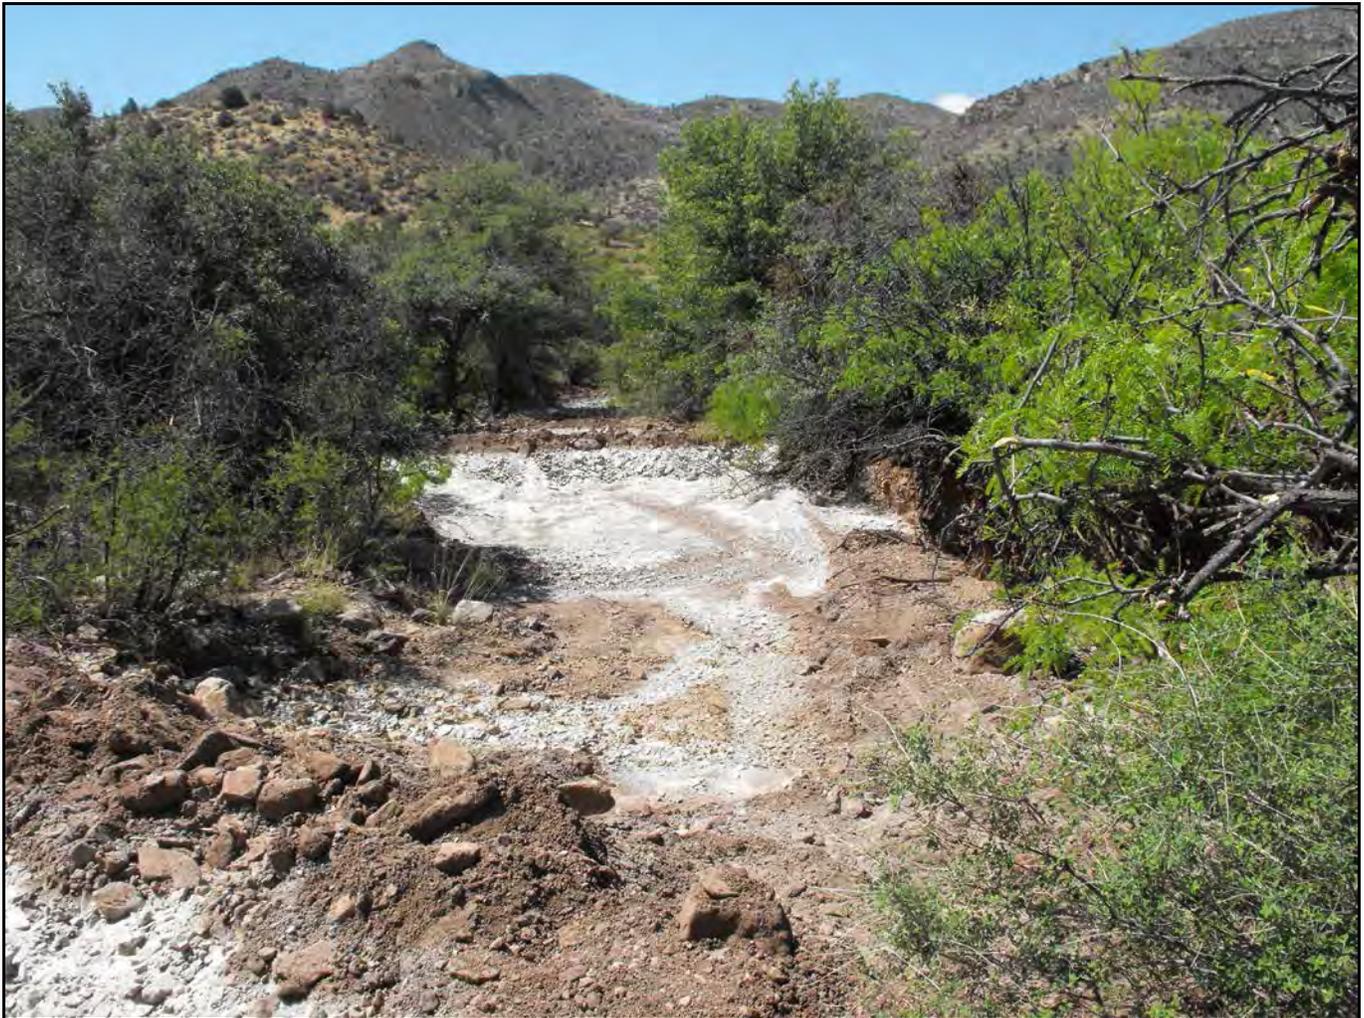
Photo # 3

Photographer: Daniel Valenta	Date: May 13, 2014	Time: 1130 hours
City/County: Monzingo Ranch/Grant County		
Location: Monzingo Ranch, New Mexico, next to Bitter Creek road coming from Hwy 75 north of Douglas AZ.		
Subject: A series of small check dams had been built to retain the water until flowing around and into the next check dam. A white residue was left on the ground as the water was absorbed into the ground.

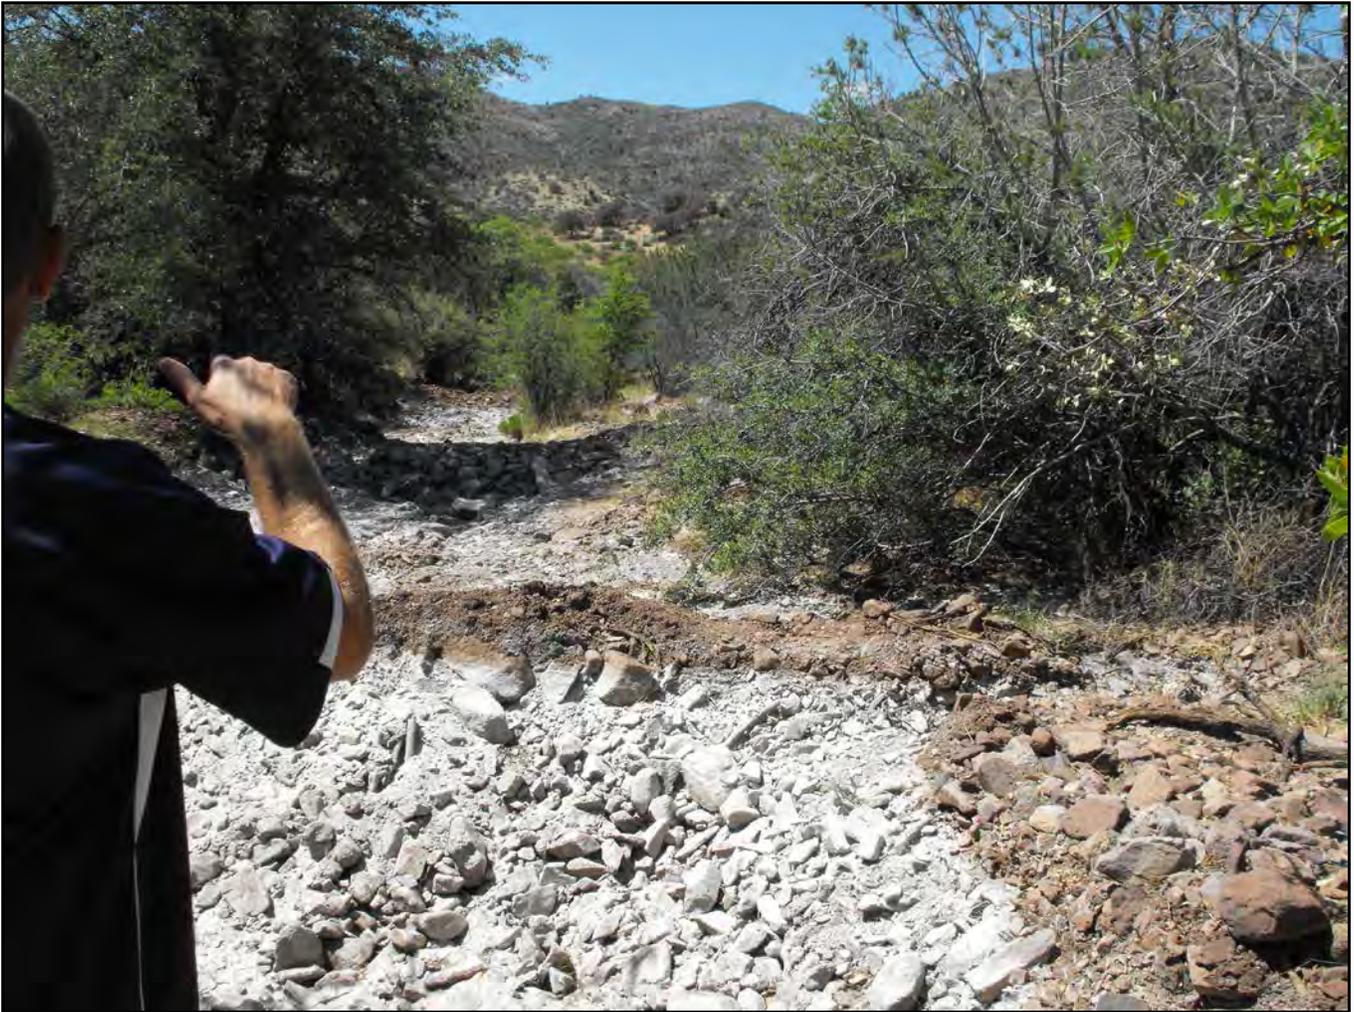
Photo # 4

Photographer: Daniel Valenta	Date: May 13, 2014	Time: 1143 hours
City/County: Monzingo Ranch/Grant County		
Location: Monzingo Ranch, New Mexico, next to Bitter Creek road coming from Hwy 75 north of Douglas AZ.		
Subject: A series of small check dams had been built to retain the water until flowing around and into the next check dam. A white residue was left on the ground as the water was absorbed into the ground.

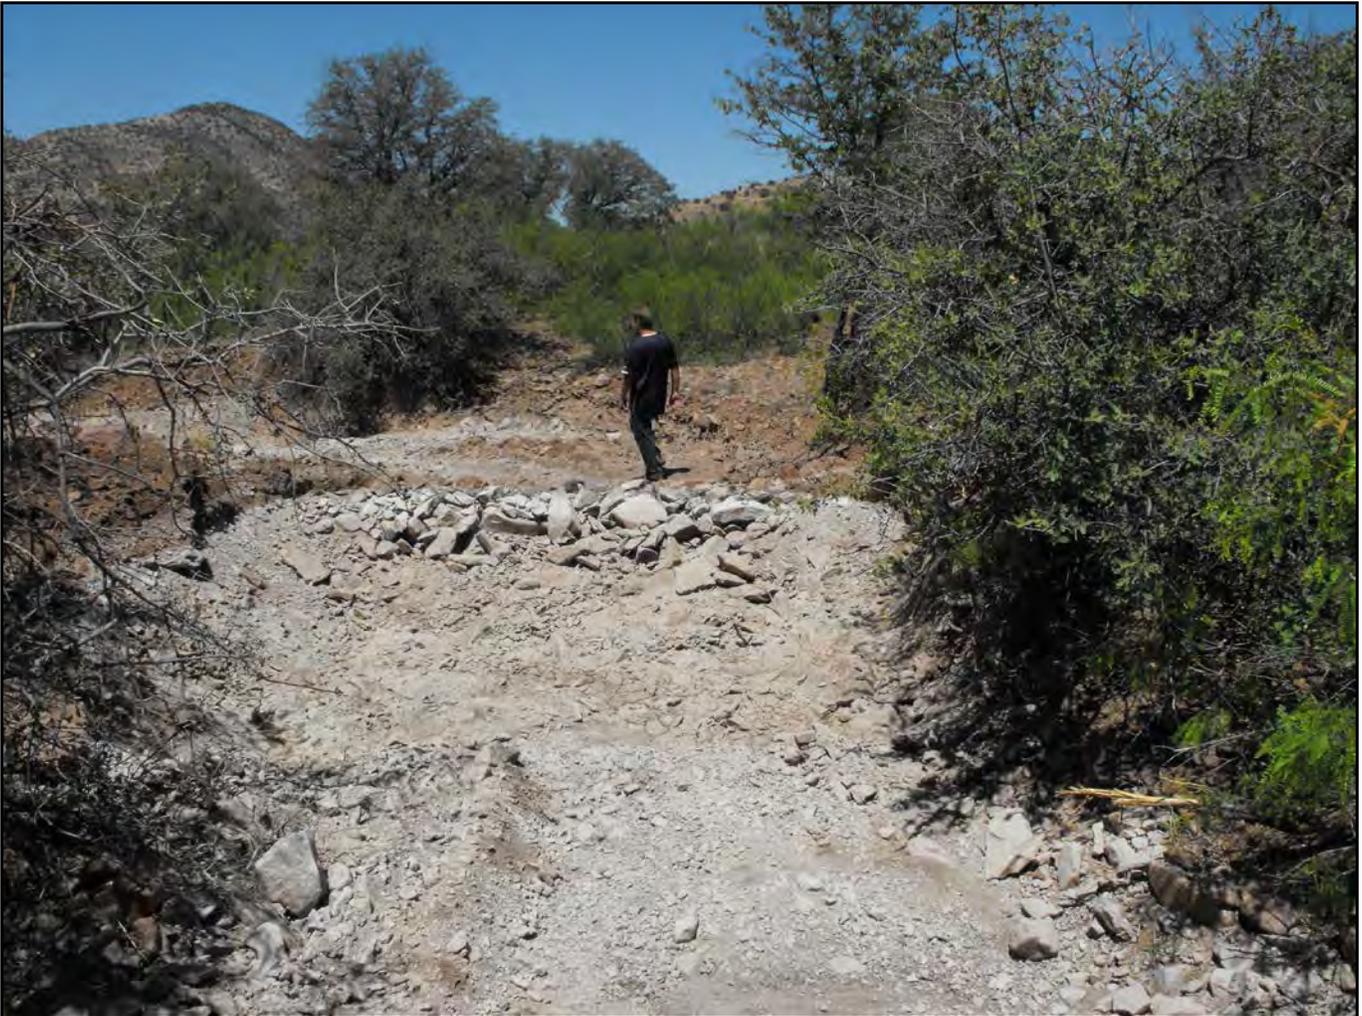
Photo # 5

Photographer: Daniel Valenta	Date: May 13, 2014	Time: 1148 hours
City/County: Monzingo Ranch/Grant County		
Location: Monzingo Ranch, New Mexico, next to Bitter Creek road coming from Hwy 75 north of Douglas AZ.		
Subject: A series of small check dams had been built to retain the water until flowing around and into the next check dam. A white residue was left on the ground as the water was absorbed into the ground.

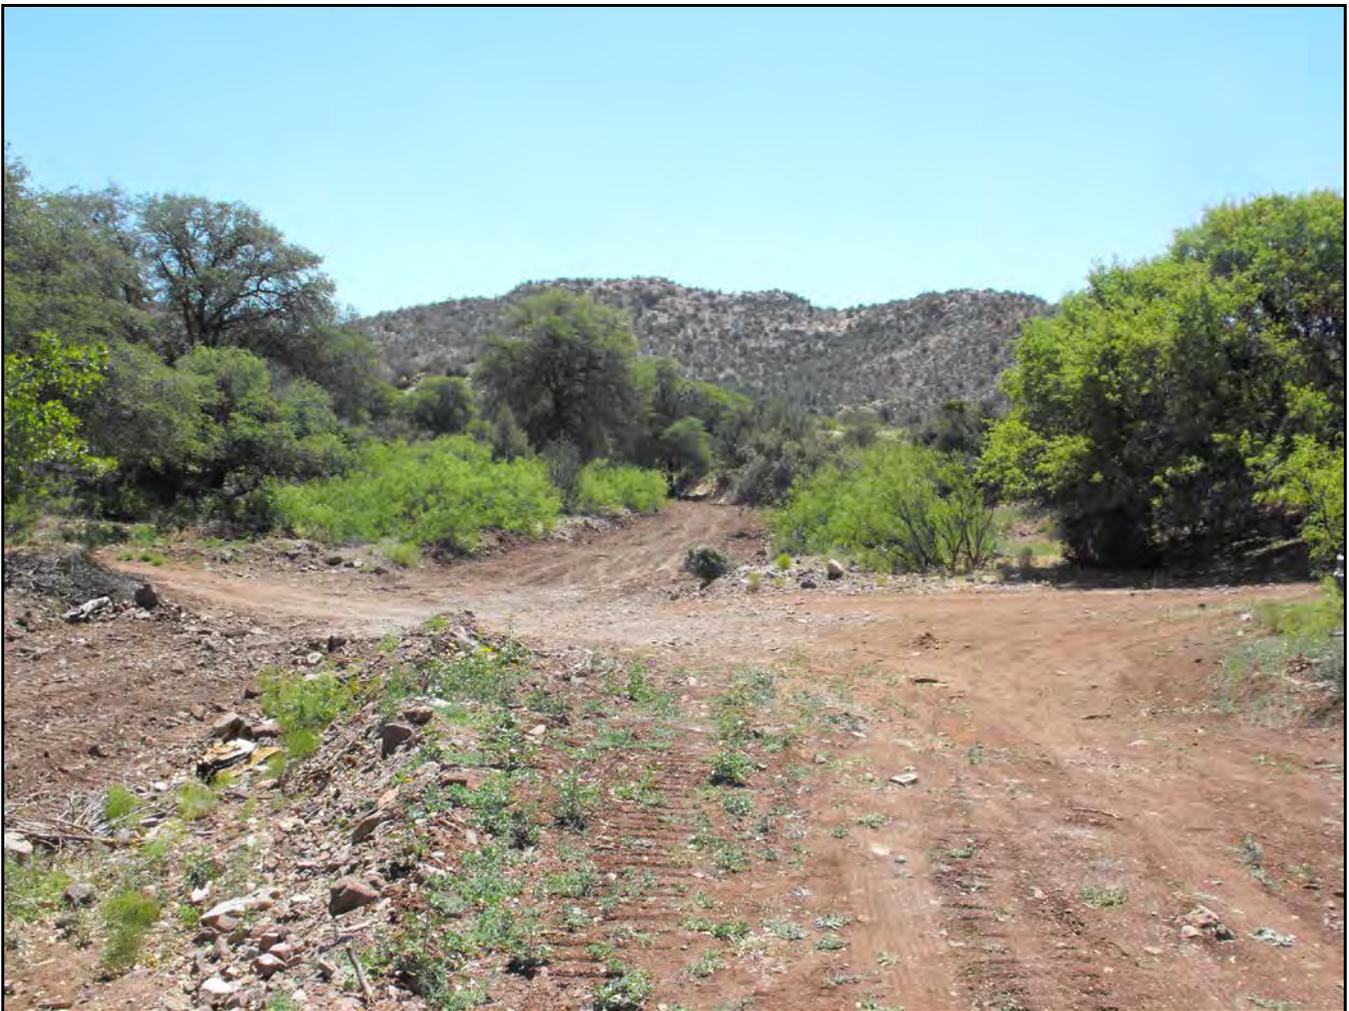
Photo # 6

Photographer: Daniel Valenta	Date: May 13, 2014	Time: 1155 hours
City/County: Monzingo Ranch/Grant County		
Location: Monzingo Ranch, New Mexico, next to Bitter Creek road coming from Hwy 75 north of Douglas AZ.		
Subject: Approximately 1,400 ft. downstream of discharge point, road to the Monzingo ranch house crosses the unnamed arroyo. Mr. Monzingo was contracted by the mine operators to level the berms in the arroyo using heavy equipment from the ranch.

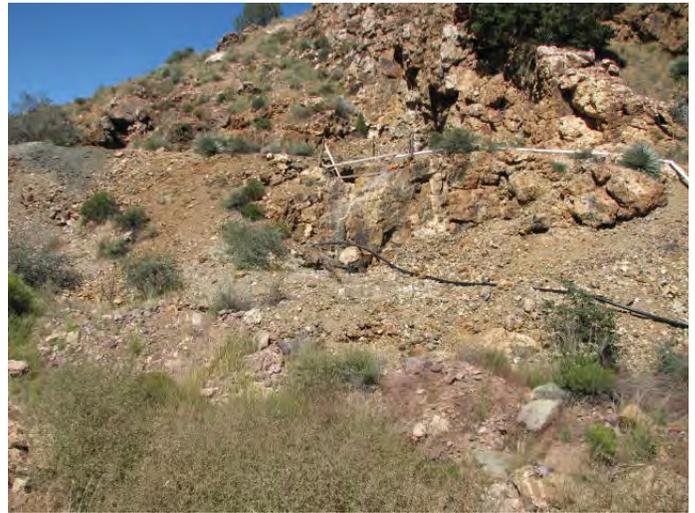
2) Note two pipe lines dumping 150 gpm into shaft

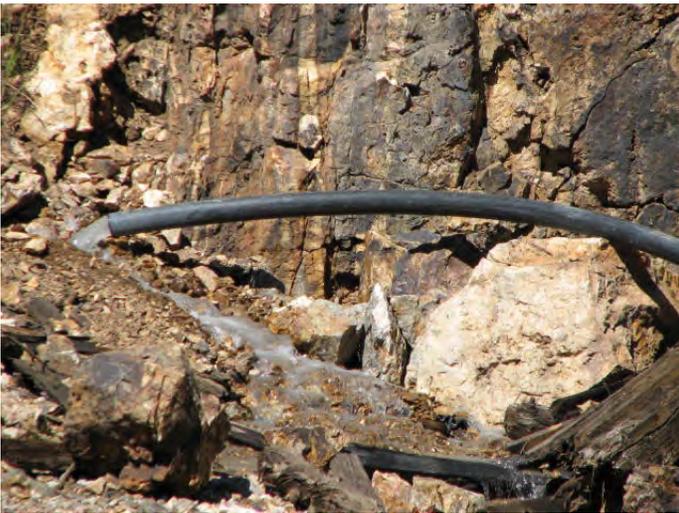
3) Lower Pipe line on this date was dumping water onto the Surface then allowing it to run back into a shaft opening

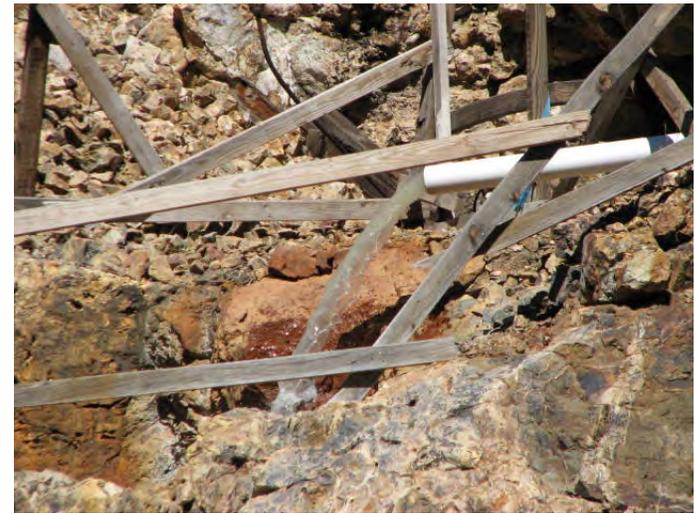
4) PVC line dumping directly into Norman King Shaft

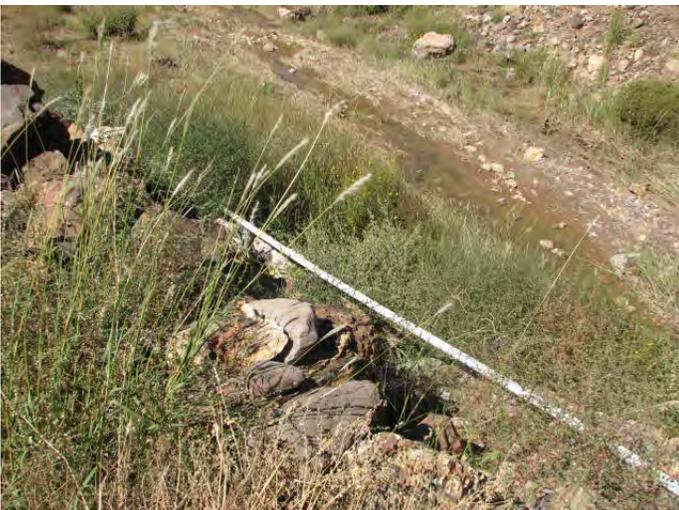
5) 1" PVC line running to 4000 gallon storage tank and it is noted that the creek bed is wet yet it has not rained recently

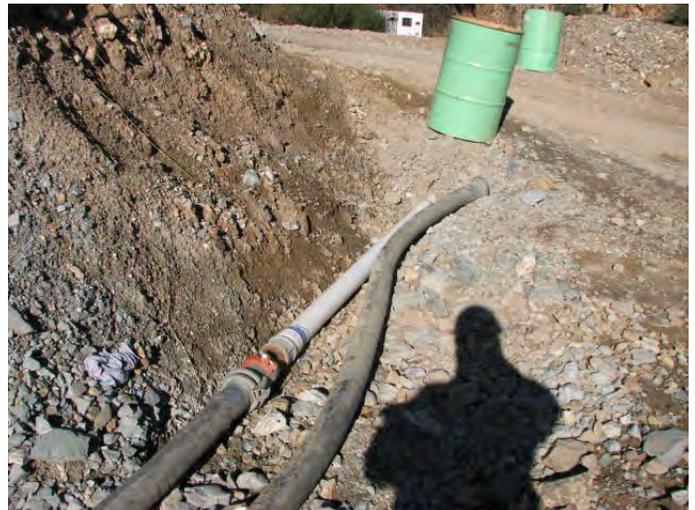
4) Earl Harrison stated they had two breaks at this location one on the PVC line, and one on the rubber line disconnected (line on the right) discharging water onto the surface

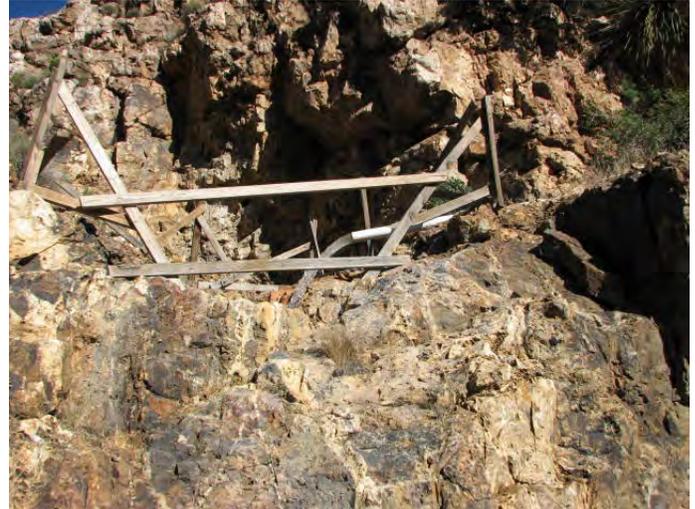
8) Point where PVC discharge line dumps into the Norman King Shaft

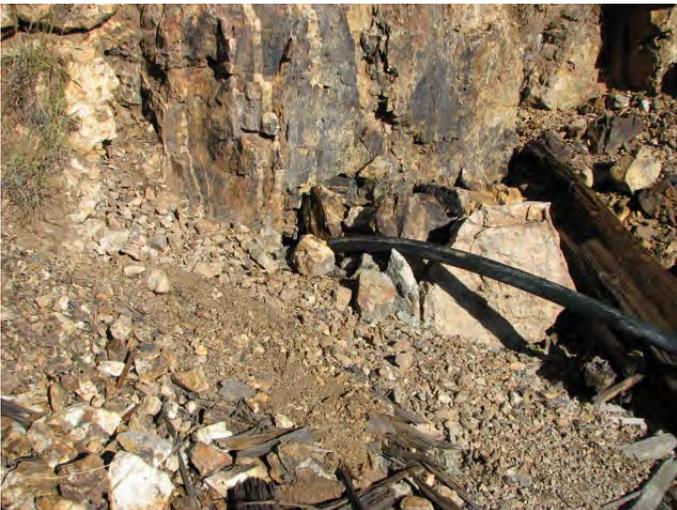
15) Point the drisco line dumps into the Norman King Shaft (this was changed from original observation because of evaporative losses when dumped on surface)

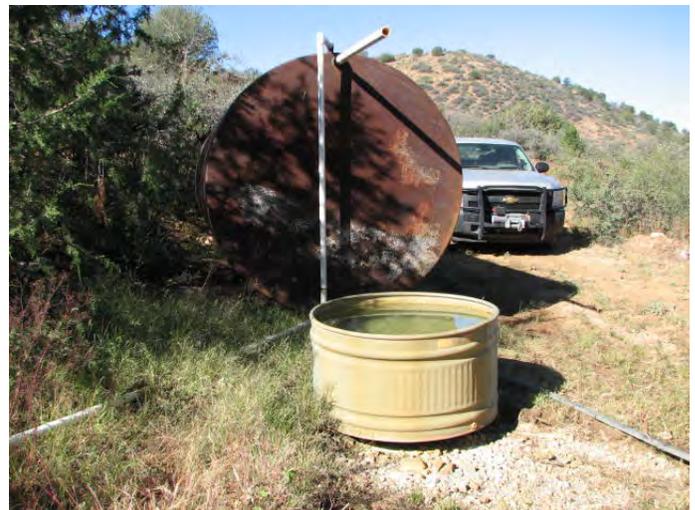
18) 4000 gallon storage tank for the rancher to water cattle From filled with water from Billali Mine Shaft (note open over flow line, line laying on the ground to the right)

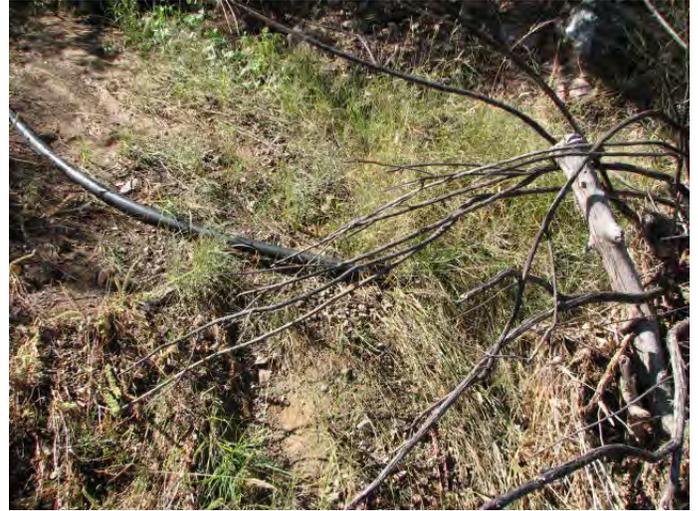
20) Line connected to valve from ranchers storage tank that was laid out down the drainage of Bitter Creek
