## NEW MEXICO ENVIRONMENT DEPARTMENT

**RE: Tri Delta Iron & Metals; Minor; Industrial Permit; SIC 5093; NPDES Compliance Evaluation Inspection; NPDES NMU001880; October 27, 2014**

### NPDES Compliance Inspection Report

**Tri Delta Iron & Metals**  
**NPDES Tracking No. NMU001880**  
**October 27, 2014**

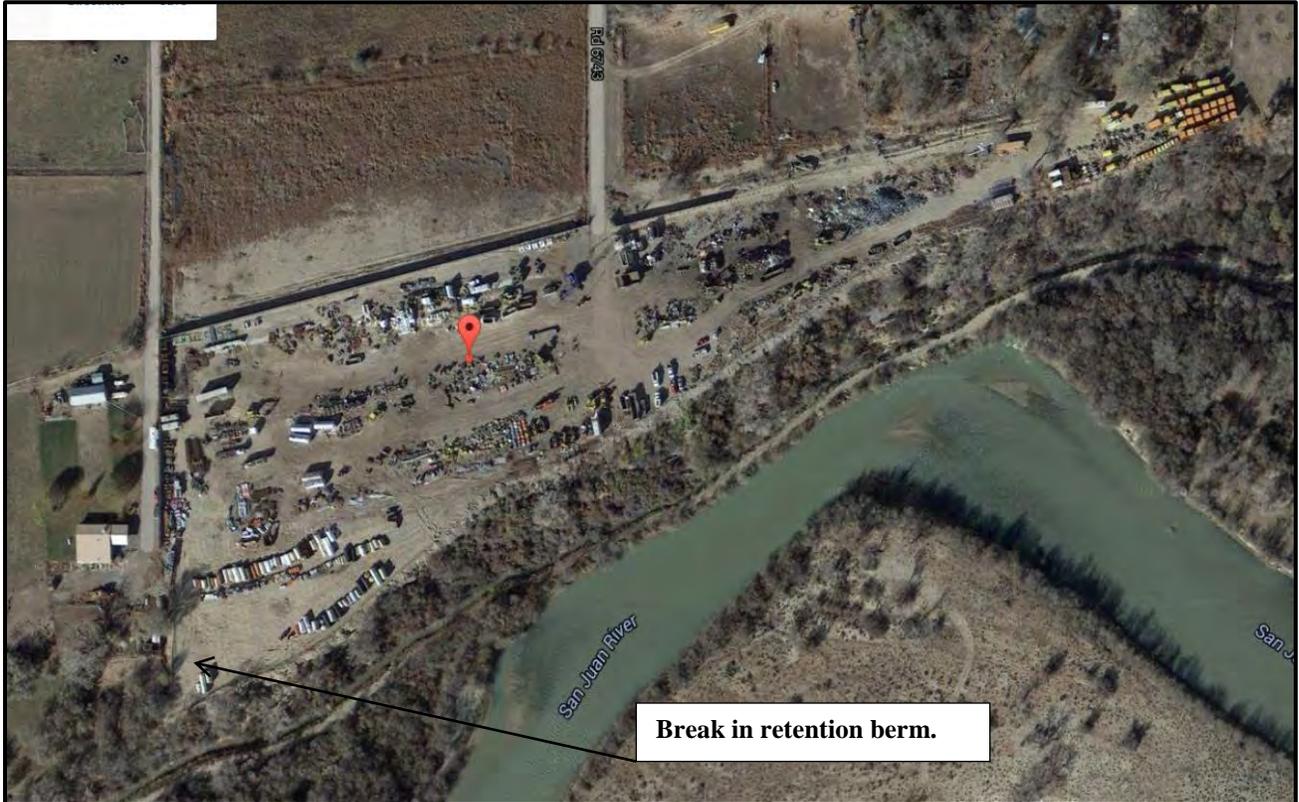
NMED/SWQB  
Overview of Site

- The dirt berm along the south edge of the facility was intact and preventing stormwater from leaving the property except for an area in the southwest corner (overview and photo 7). Here there were small erosion rills and some debris. It appeared to the Inspector that water discharging at this point was only sheet flow that fell in the vicinity and not a collection of water from across the site. It is unknown how long the berm has been breached and the amount of water the site may have discharged. However note the vegetation in this area appears to be well established.

City/County: Fruitland/San Juan	
Location: 28 County Road 6743, Fruitland, New Mexico	
Subject: Tri Delta Iron & Metal sits on the north bank of the San Juan River.

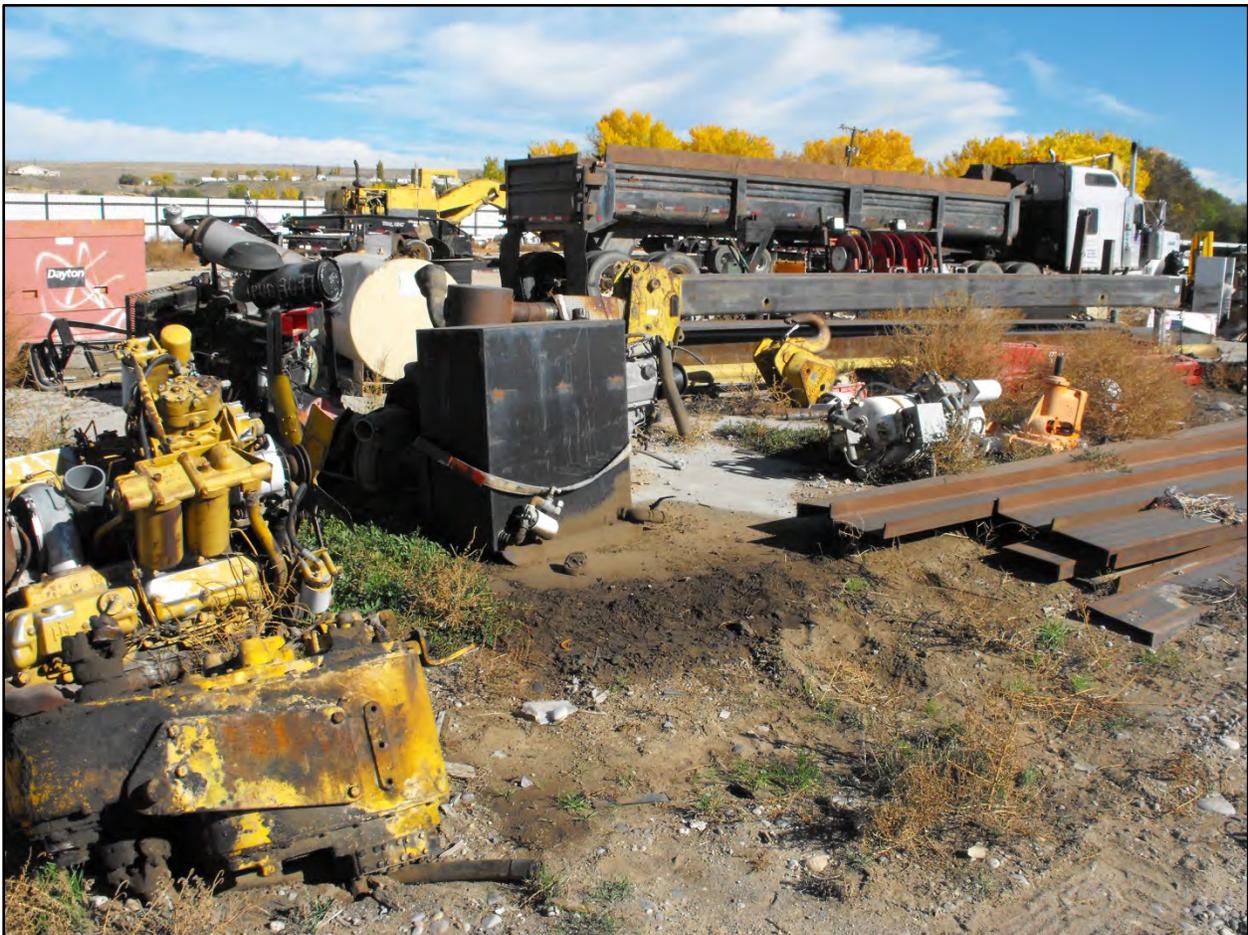
Photo # 1

Photographer: Daniel Valenta	Date: 10-27-2014	Time: 1038 hours
City/County: Fruitland/San Juan		
Location: 28 County Road 6743, Fruitland, New Mexico, facing north.		
Subject: Tri Delta Iron & Metal storage yard. Various equipment, storage tanks, engines, motors, pumps, can be found throughout the site.

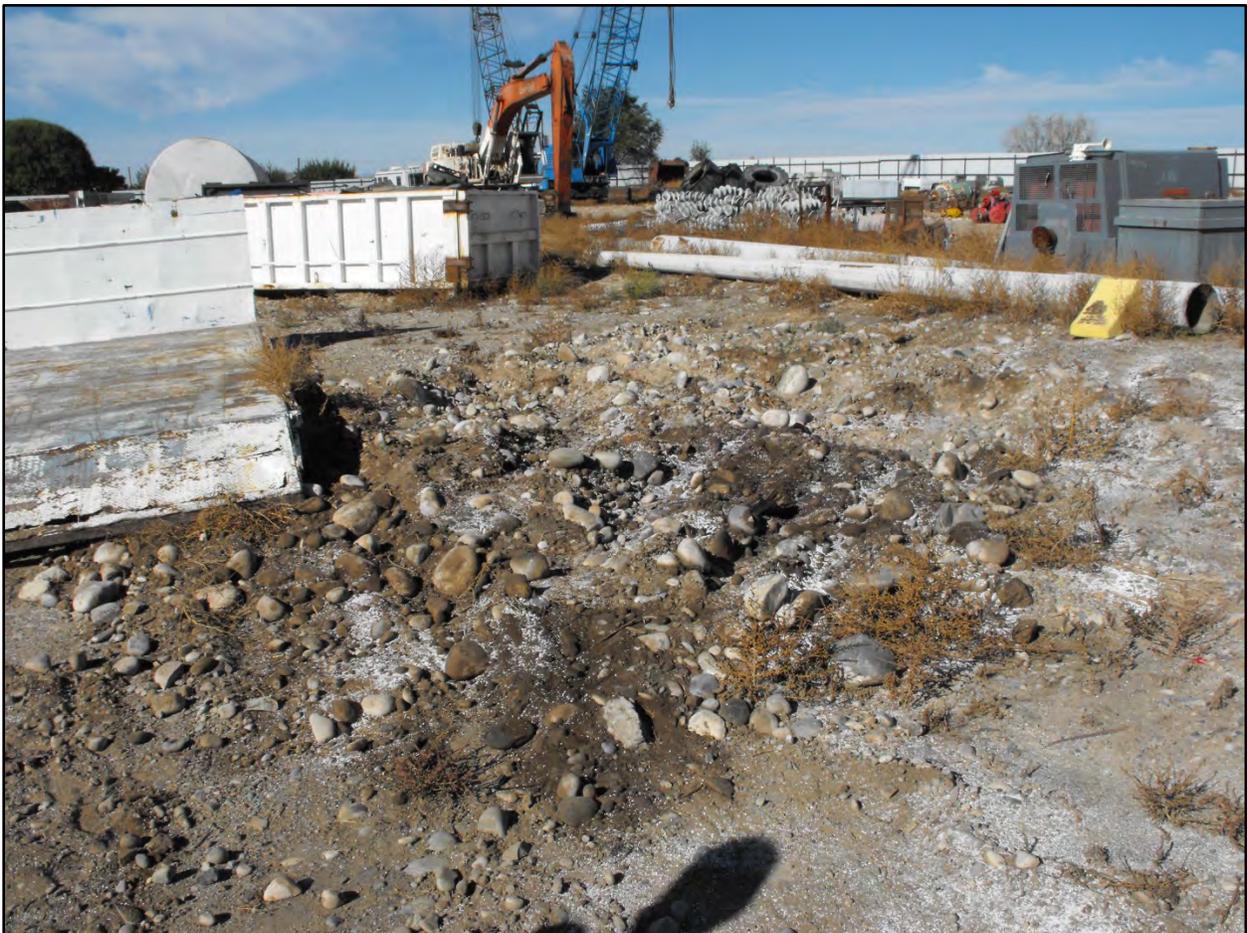
Photo # 2

- The site had typical salvage yard petroleum releases however the volume and type of fluid spilled in the disturbed areas (see photos 2&6) is unknown.

Photographer: Daniel Valenta	Date: 10-27-2014	Time: 1042 hours
City/County: Fruitland/San Juan		
Location: 28 County Road 6743, Fruitland, New Mexico, facing northeast.		
Subject: Tri Delta Iron & Metal storage yard. Battery acid was reported to have been spilled in this area. The soil has been disturbed; the white powder on the ground is washing detergent.

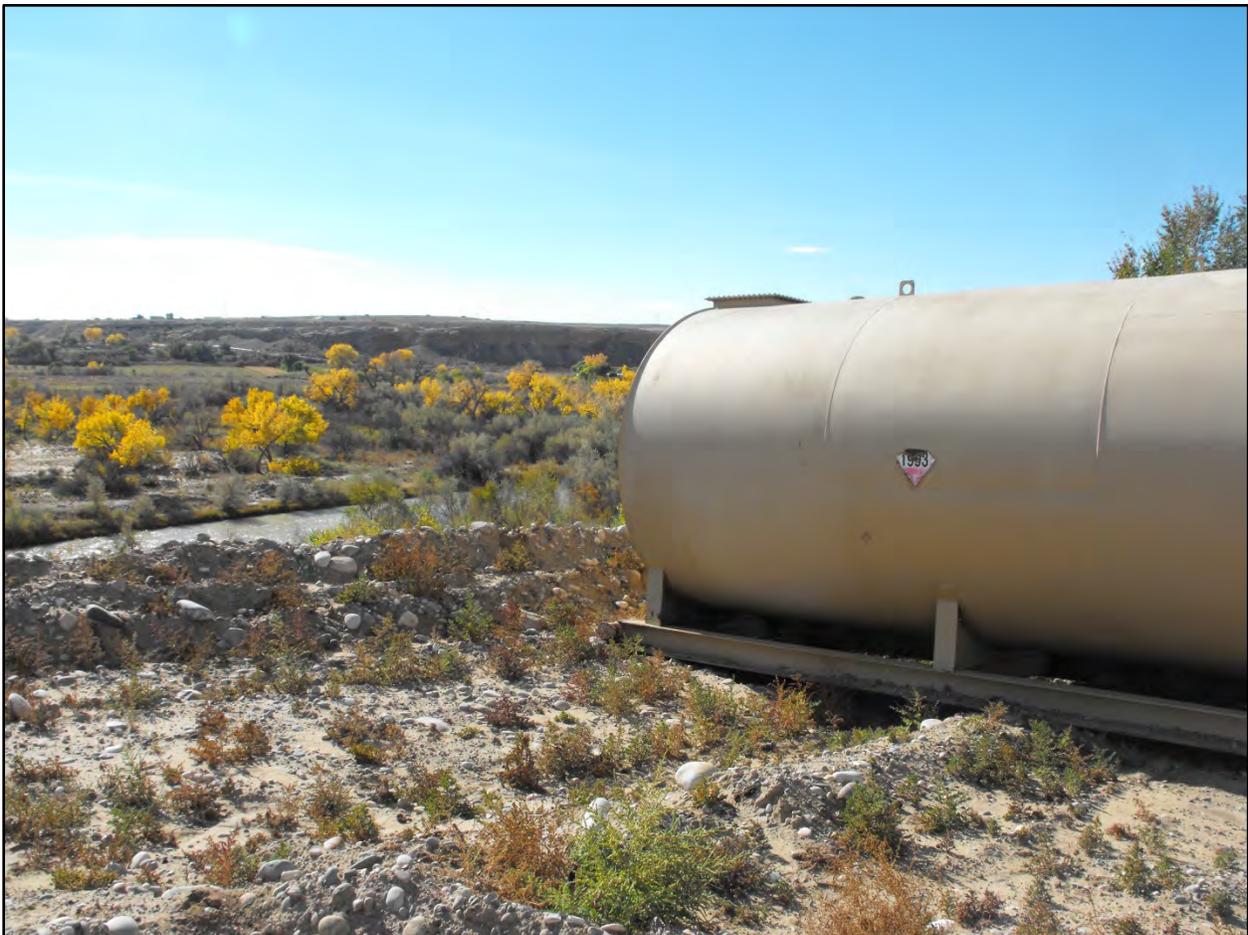
Photo # 3

Photographer: Daniel Valenta	Date: 10-27-2014	Time: 1051 hours
City/County: Fruitland/San Juan		
Location: 28 County Road 6743, Fruitland, New Mexico, facing south.		
Subject: Tri Delta Iron & Metal storage yard. Various storage tanks are scattered around the site. The San Juan River flows below the bluff.

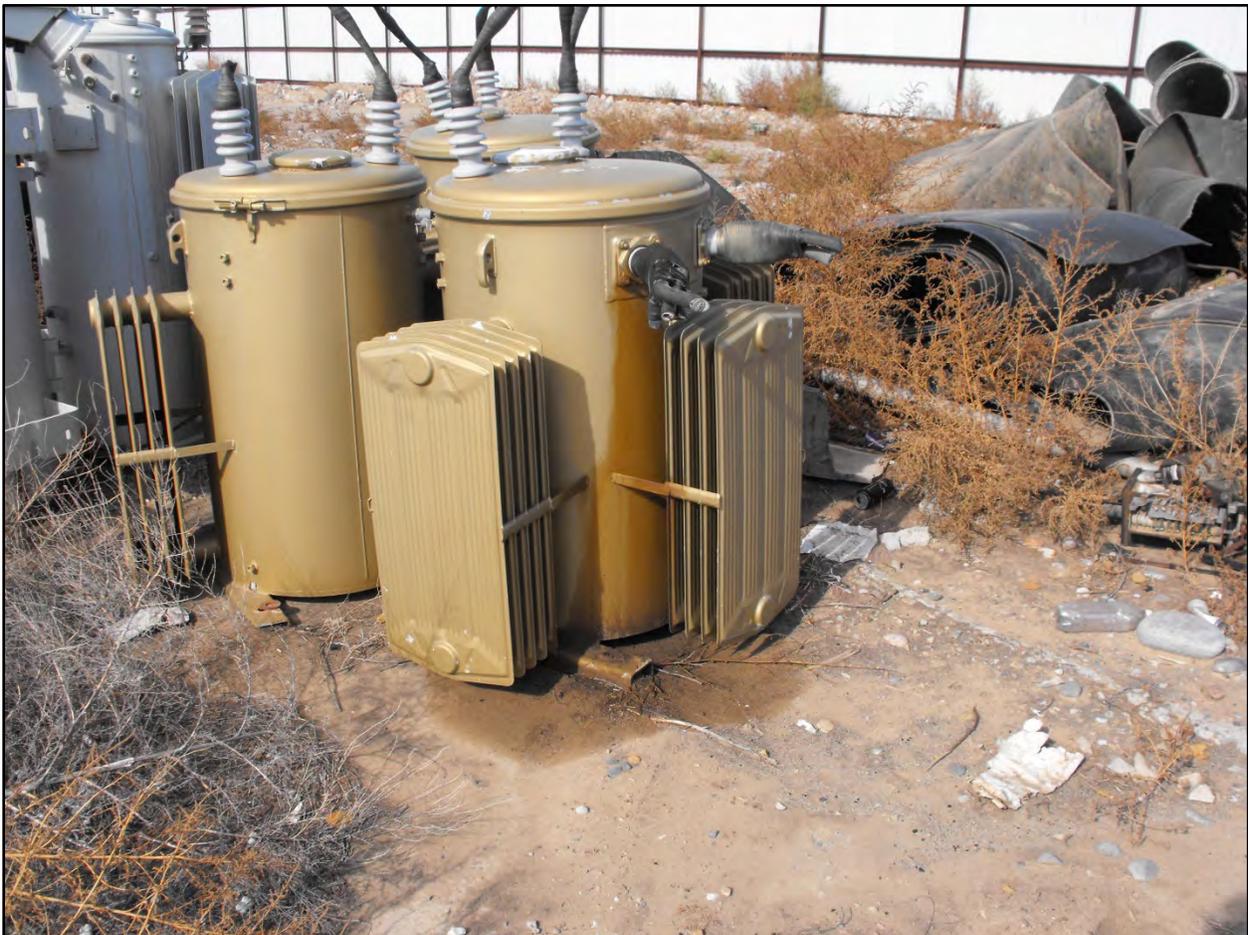
Photo # 4

Photographer: Daniel Valenta	Date: 10-27-2014	Time: 1119 hours
City/County: Fruitland/San Juan		
Location: 28 County Road 6743, Fruitland, New Mexico, facing northwest.		
Subject: Tri Delta Iron & Metal storage yard. A transformer was leaking oily material from its side. The transformer was not labeled as PCB free.

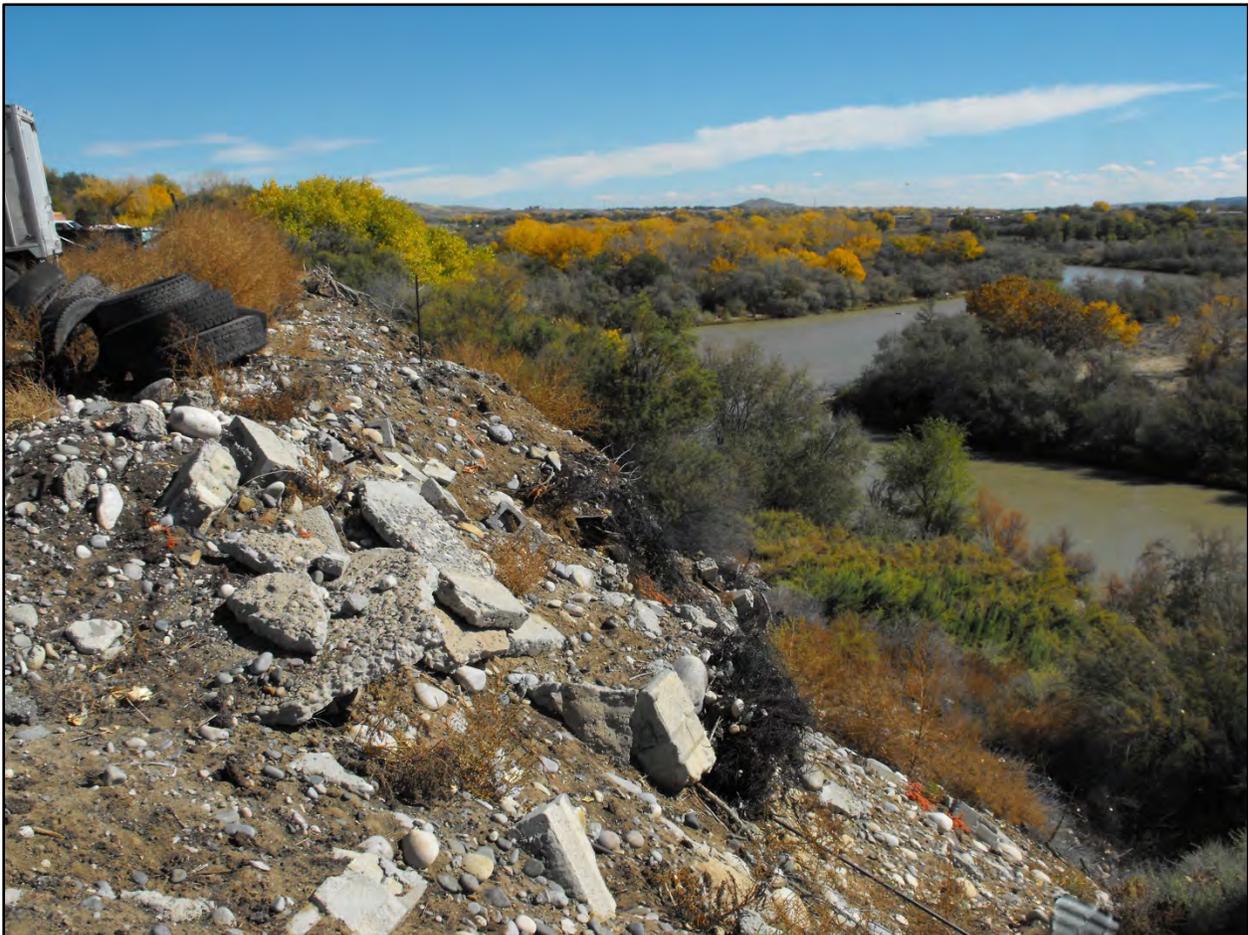
Photo # 5

Photographer: Daniel Valenta	Date: 10-27-2014	Time: 1209 hours
City/County: Fruitland/San Juan		
Location: 28 County Road 6743, Fruitland, New Mexico, east side of property, facing east.		
Subject: Tri Delta Iron & Metal storage yard. On the east side of the property there was various materials pushed over the berm, tin roofing, wire, lumber, and what appeared to be very weathered manure.

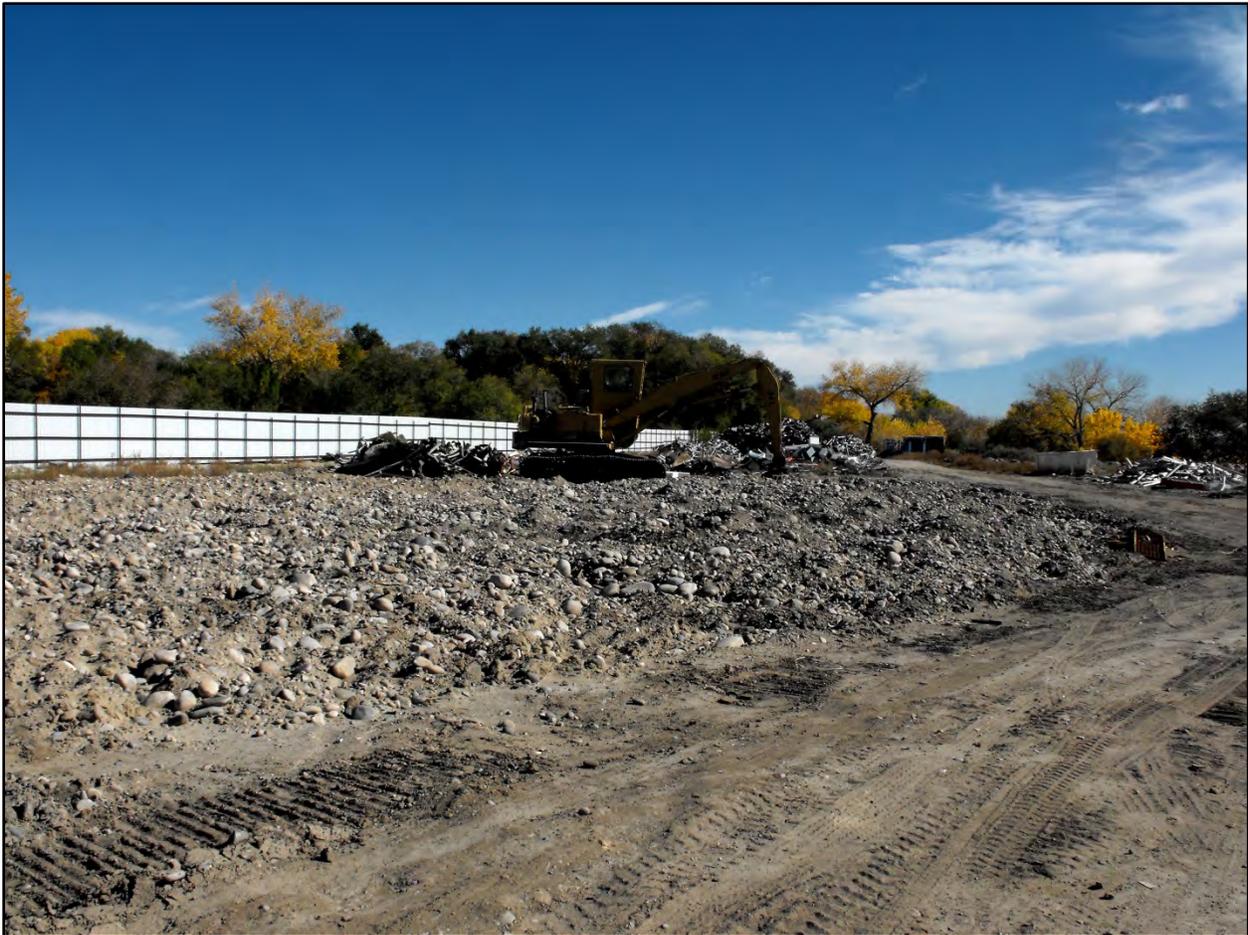
Photo # 6

Photographer: Daniel Valenta	Date: 10-27-2014	Time: 1133 hours
City/County: Fruitland/San Juan		
Location: 28 County Road 6743, Fruitland, New Mexico, east side of property, facing east.		
Subject: Tri Delta Iron & Metal storage yard. In this area various types of spills were reported to have occurred. The ground was ripped up and turned, a bioremediation additive Micro-Blaze has been spread on the ground.

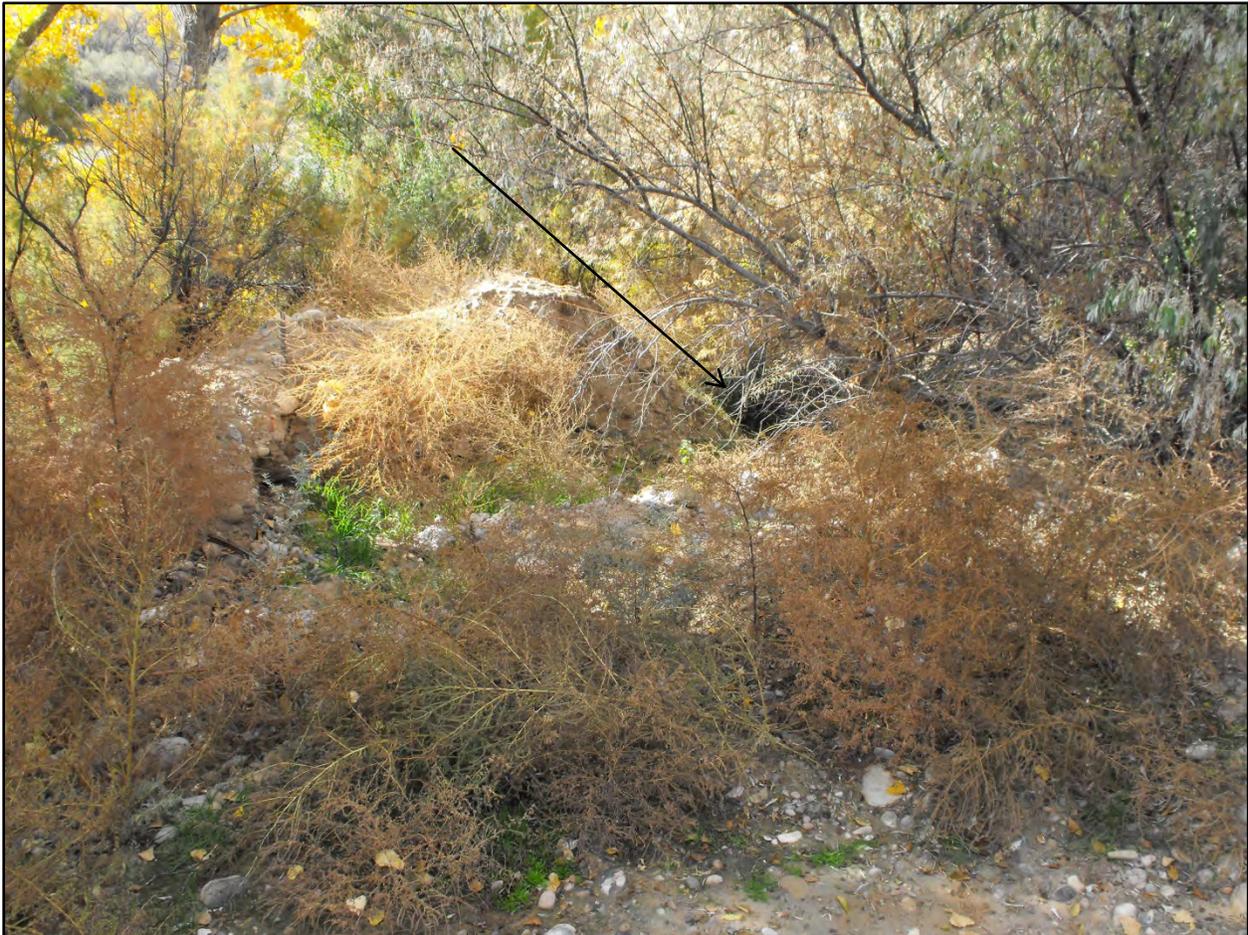
Photo # 7

Photographer: Daniel Valenta	Date: 10-27-2014	Time: 1101 hours
City/County: Fruitland/San Juan		
Location: 28 County Road 6743, Fruitland, New Mexico, east side of property, facing southeast.		
Subject: Tri Delta Iron & Metal storage yard. Retention berm breached in the southwest corner.
