RE: Robert Rivera Construction Company; Industrial Permit; SIC 1442 & 1373; NPDES Compliance Evaluation Inspection; NPDES NMU001897; July 7, 2015

**Multi-Sector General Permit
Compliance Evaluation Inspection
NPDES Permit NMU001897
Inspection Date: July 7, 2015**

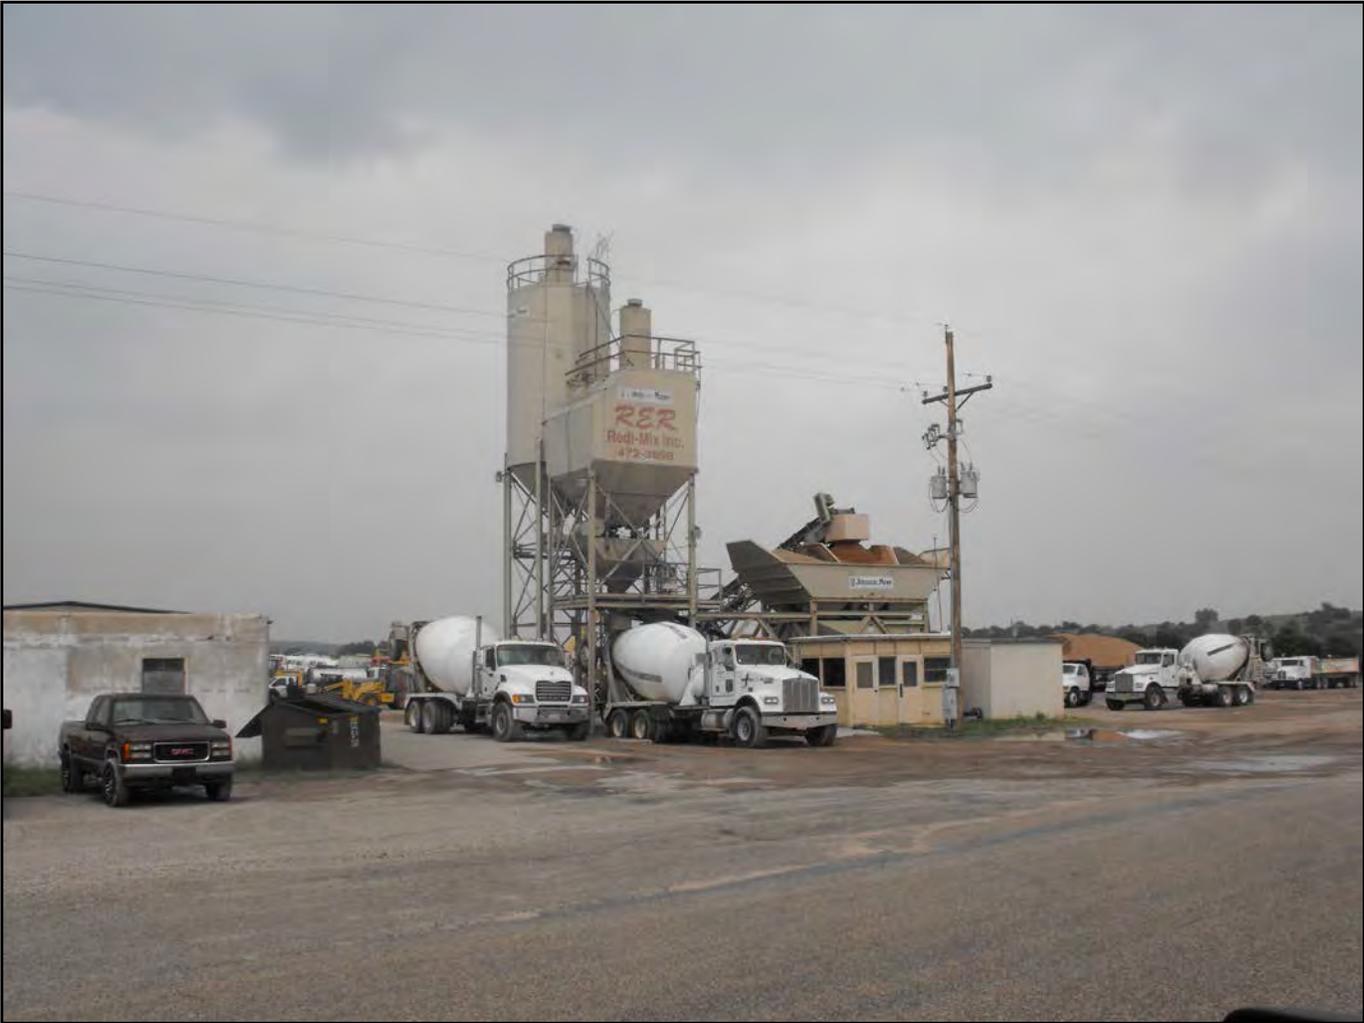
Photo # 1

Photographer: Daniel Valenta	Date: 7/7/2015	Time: 1420 hours
City/County: Santa Rosa/ Guadalupe County		
Location: 1261Rivera Road facing northeast.		
Subject: Loading operation of Robert E. Rivera Construction, Inc.

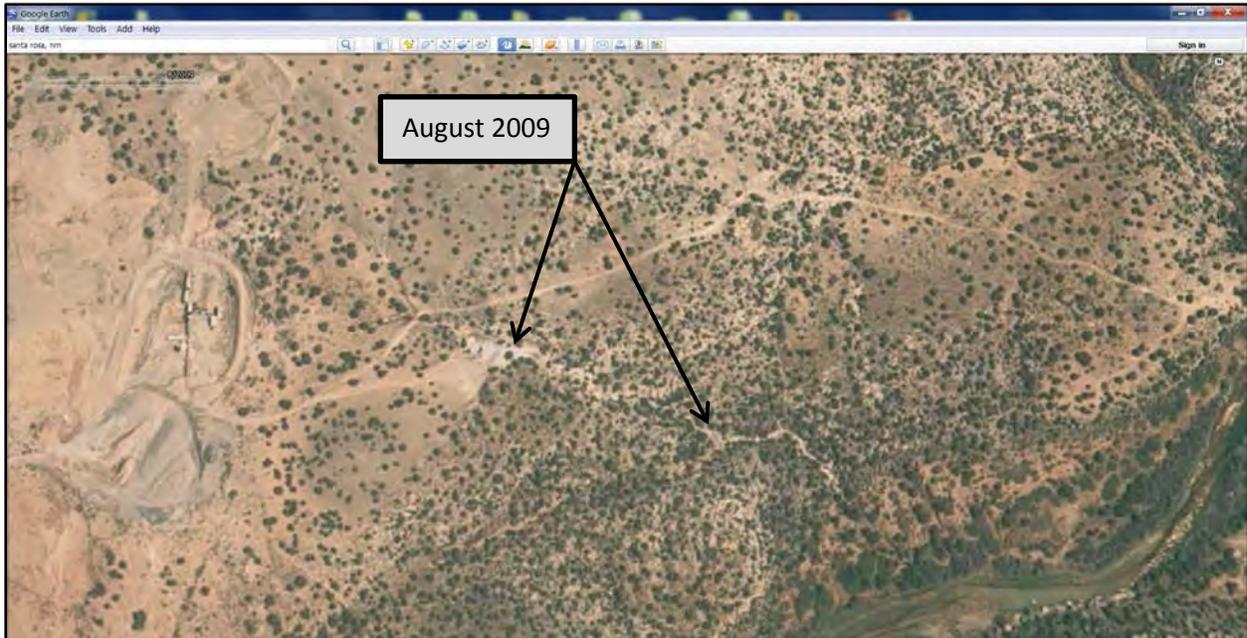
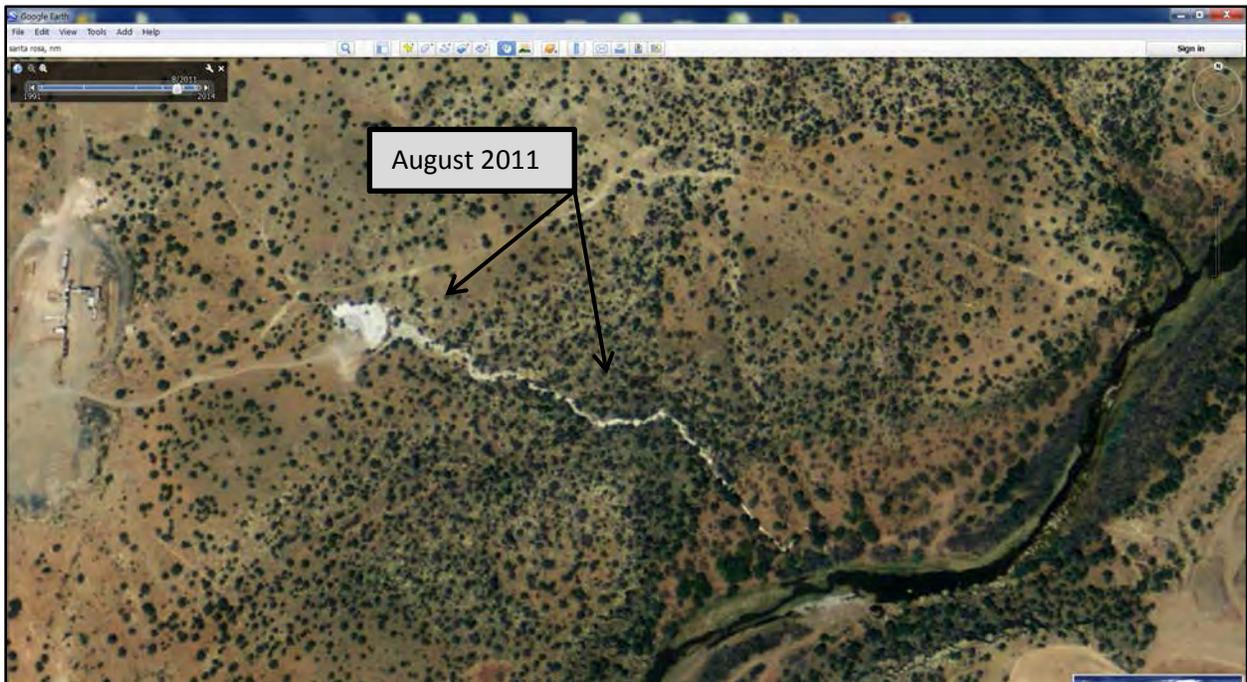
Google Earth Overview 1
N 34° 57' 08.67", W -104° 42' 36.31"

1. Concrete washout area, N 34° 57' 03.58", W 104° 42' 22.90". A road from the asphalt plant goes to an unnamed arroyo which discharges to the Pecos River. This appears to be where cement trucks are discharging unused concrete and wash out water. Google earth was used to determine an approximate timeline of the activity occurring at the site. It appears the area was not in use in August 2009 but was by August 2011. See attached Google Earth Overviews.

Subject: Discharge appears to have started sometime between August 2009 and August 2011.

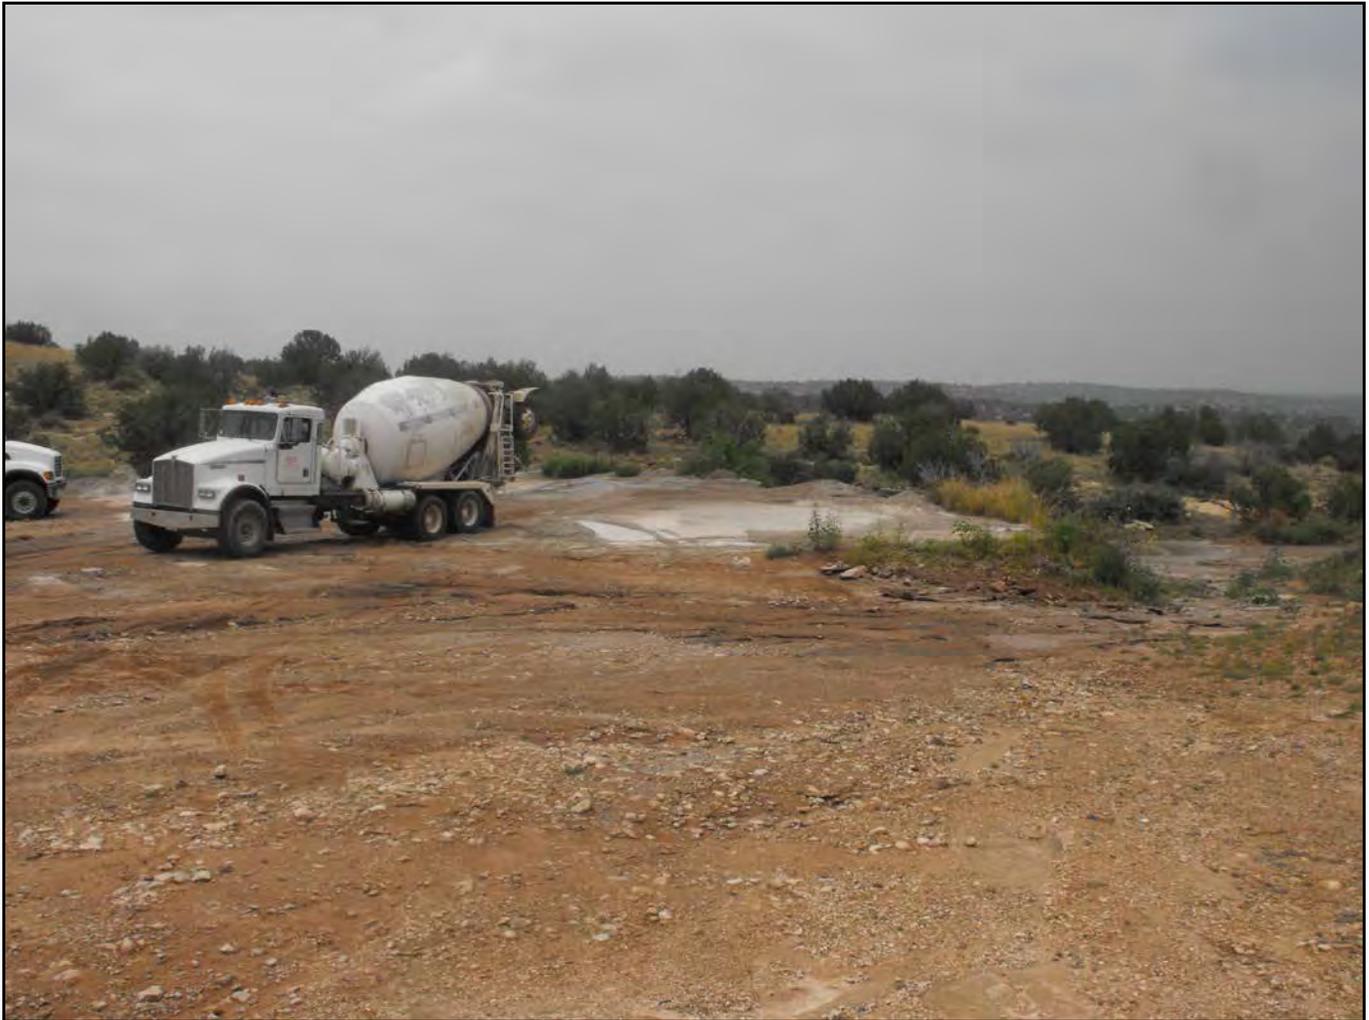
Photo # 2

While the Inspectors were at the site two cement trucks pulled up, one backed in and began to discharge. When the driver saw us taking pictures he made a phone call, stopped discharging and left. The second truck just circled and left. The site was still being used as of the date of this inspection. The Inspector followed the white discharge down the arroyo to the bottom where it drops into sand/gravel along the river. See attached photos detailing the area.

Photographer: Daniel Valenta	Date: 7/7/2015	Time: 1354 hours
City/County: Santa Rosa/ Guadalupe County		
Location: Robert Rivera Construction Inc. 1261Rivera Road, east of the asphalt plant, facing northeast.		
Subject: Cement waste disposal area, truck backing in to discharge into the arroyo.

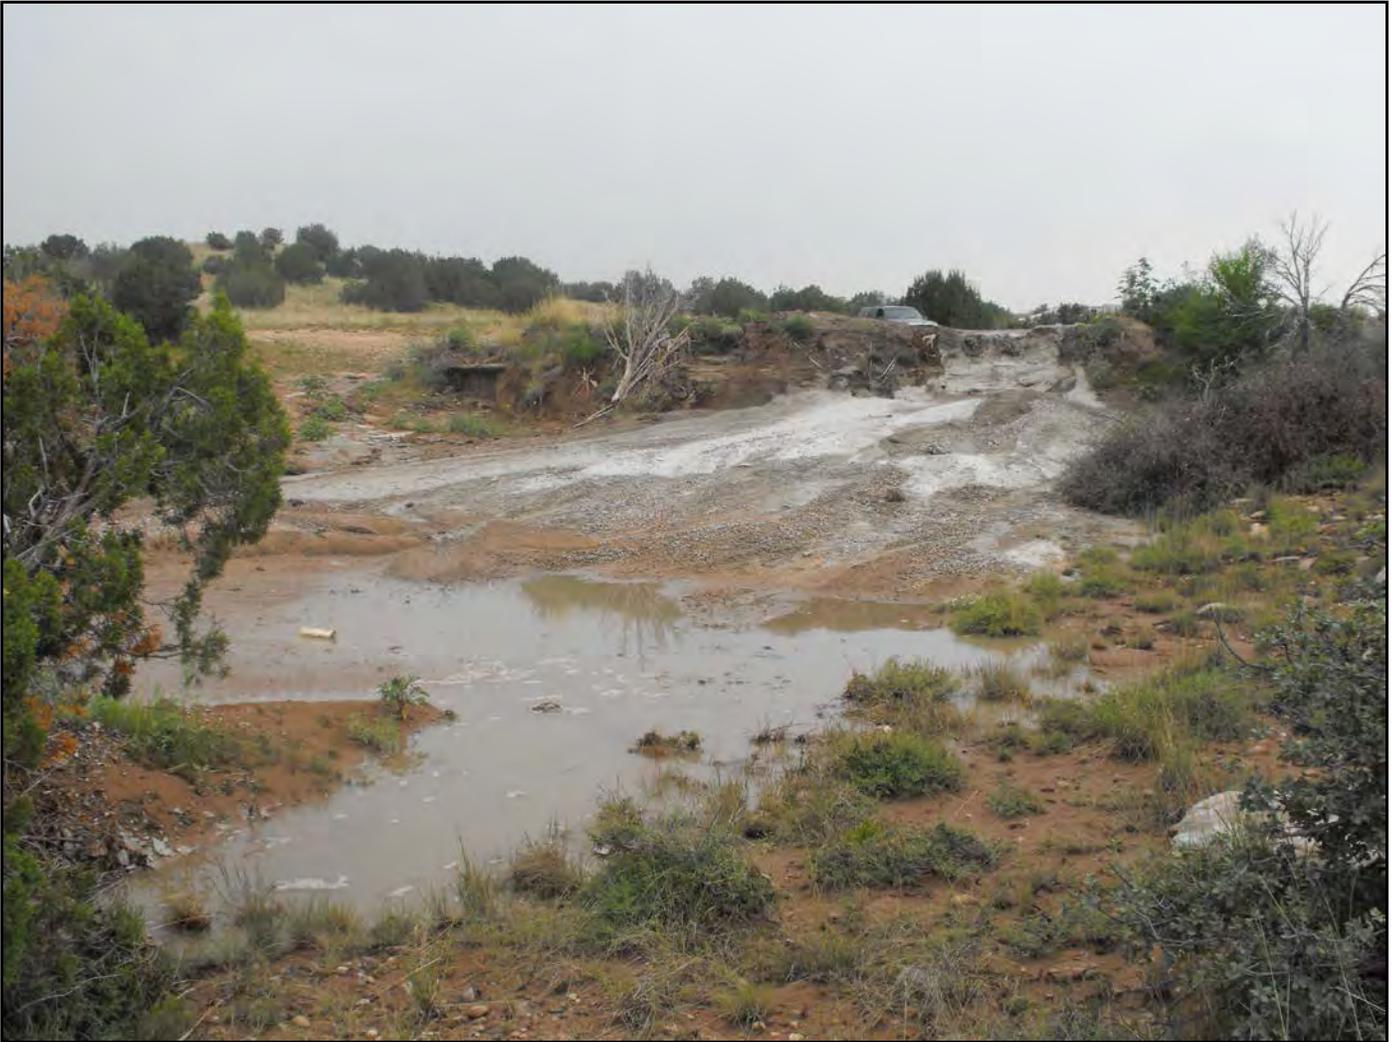
Photo # 3

Photographer: Daniel Valenta	Date: 7/7/2015	Time: 1332 hours
City/County: Santa Rosa/Guadalupe County		
Location: Robert Rivera Construction Inc. 1261Rivera Road, east of the asphalt plant, facing southwest.		
Subject: Cement waste disposal area, waste flows downhill following the arroyo to the river.

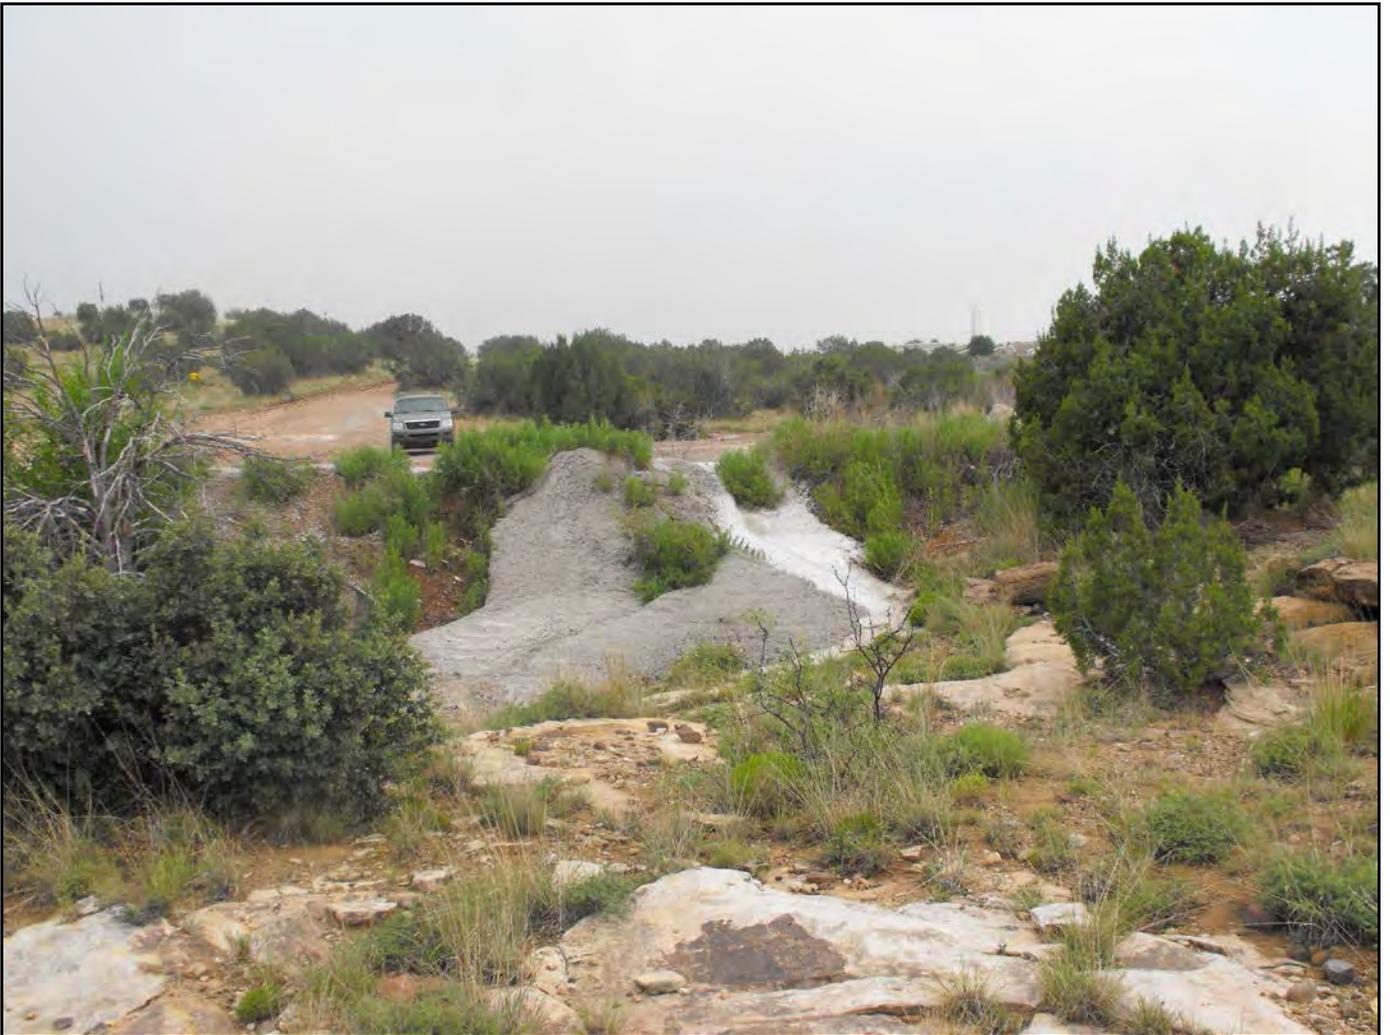
Photo # 4

Photographer: Daniel Valenta	Date: 7/7/2015	Time: 1331 hours
City/County: Santa Rosa/Guadalupe County		
Location: Robert Rivera Construction Inc. 1261 Rivera Road, east of the asphalt plant, facing southwest.		
Subject: Cement waste disposal area, waste flows downhill following the arroyo to the river.

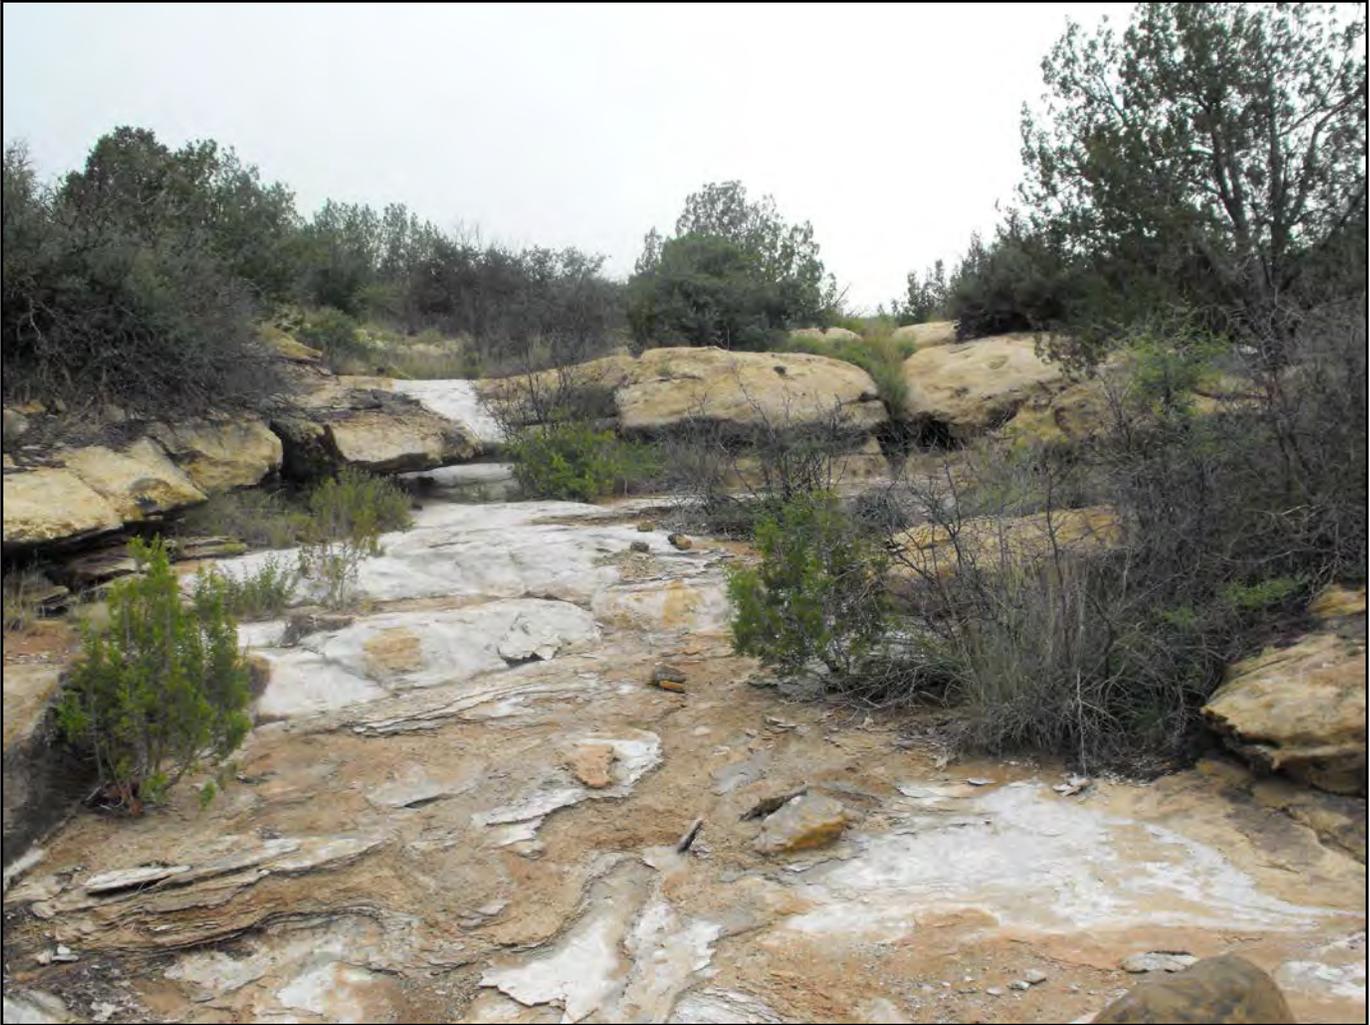
Photo # 5

Photographer: Daniel Valenta	Date: 7/7/2015	Time: 1335 hours
City/County: Santa Rosa/Guadalupe County		
Location: Robert Rivera Construction Inc. 1261Rivera Road, east of the asphalt plant, facing west.		
Subject: Cement waste disposal area, arroyo to the Pecos River.

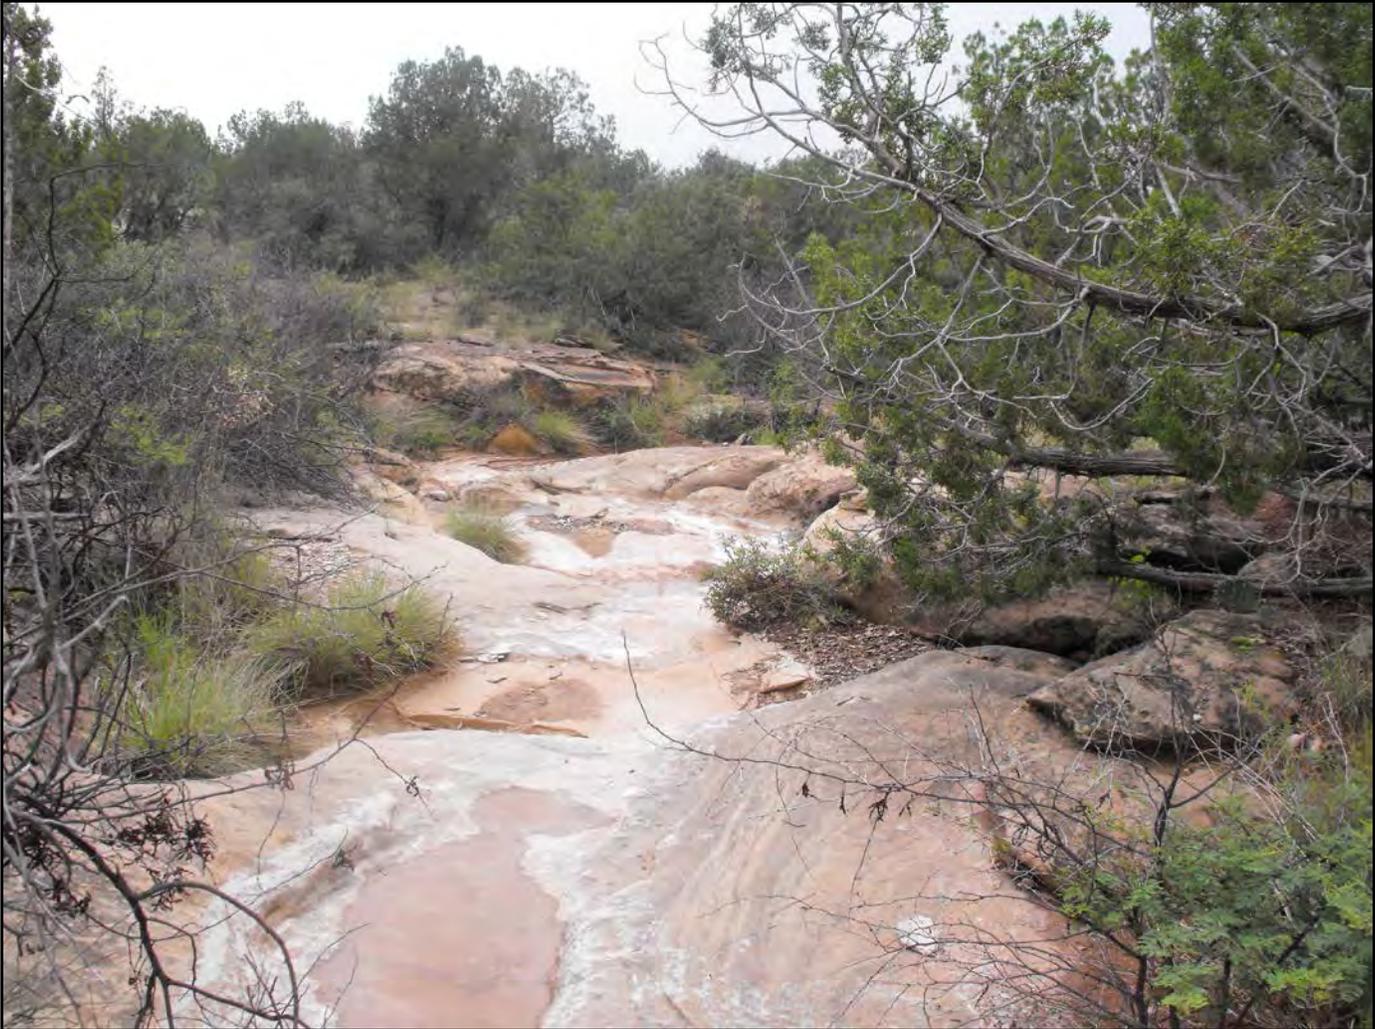
Photo # 6

Photographer: Daniel Valenta	Date: 7/7/2015	Time: 1340 hours
City/County: Santa Rosa/Guadalupe County		
Location: Robert Rivera Construction Inc. 1261Rivera Road, east of the asphalt plant, facing west.		
Subject: Below the cement waste disposal area, arroyo to the Pecos River.

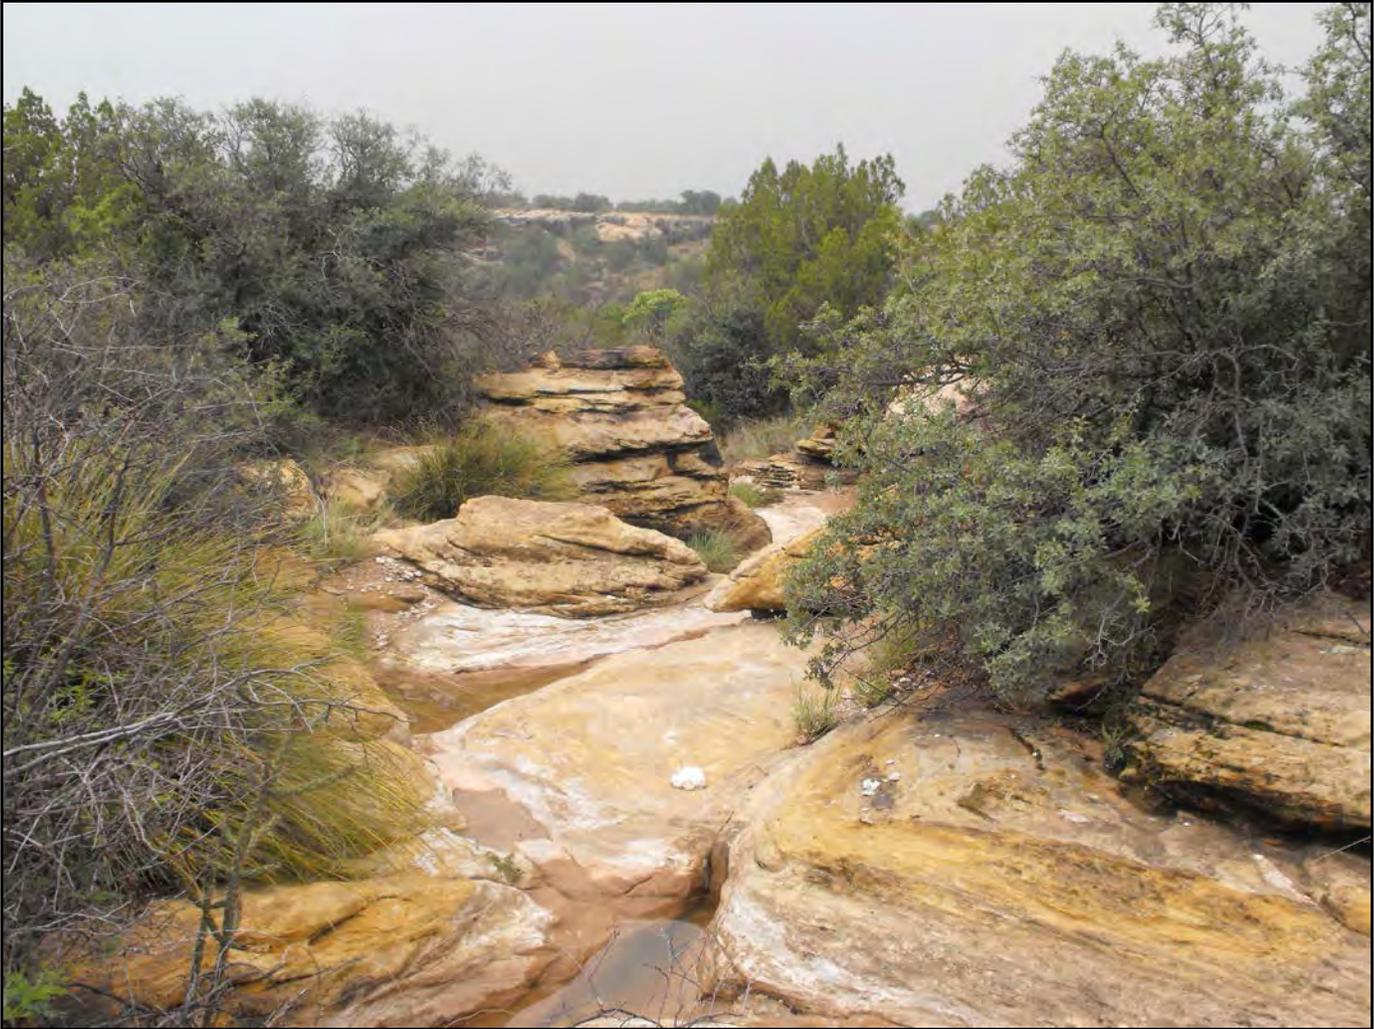
Photo # 7

Photographer: Daniel Valenta	Date: 7/7/2015	Time: 1341 hours
City/County: Santa Rosa/Guadalupe County		
Location: Robert Rivera Construction Inc. 1261Rivera Road, east of the asphalt plant, facing east.		
Subject: Just above the drop off into the Pecos River sand/gravel bank. Note height of stains on the channel rocks.

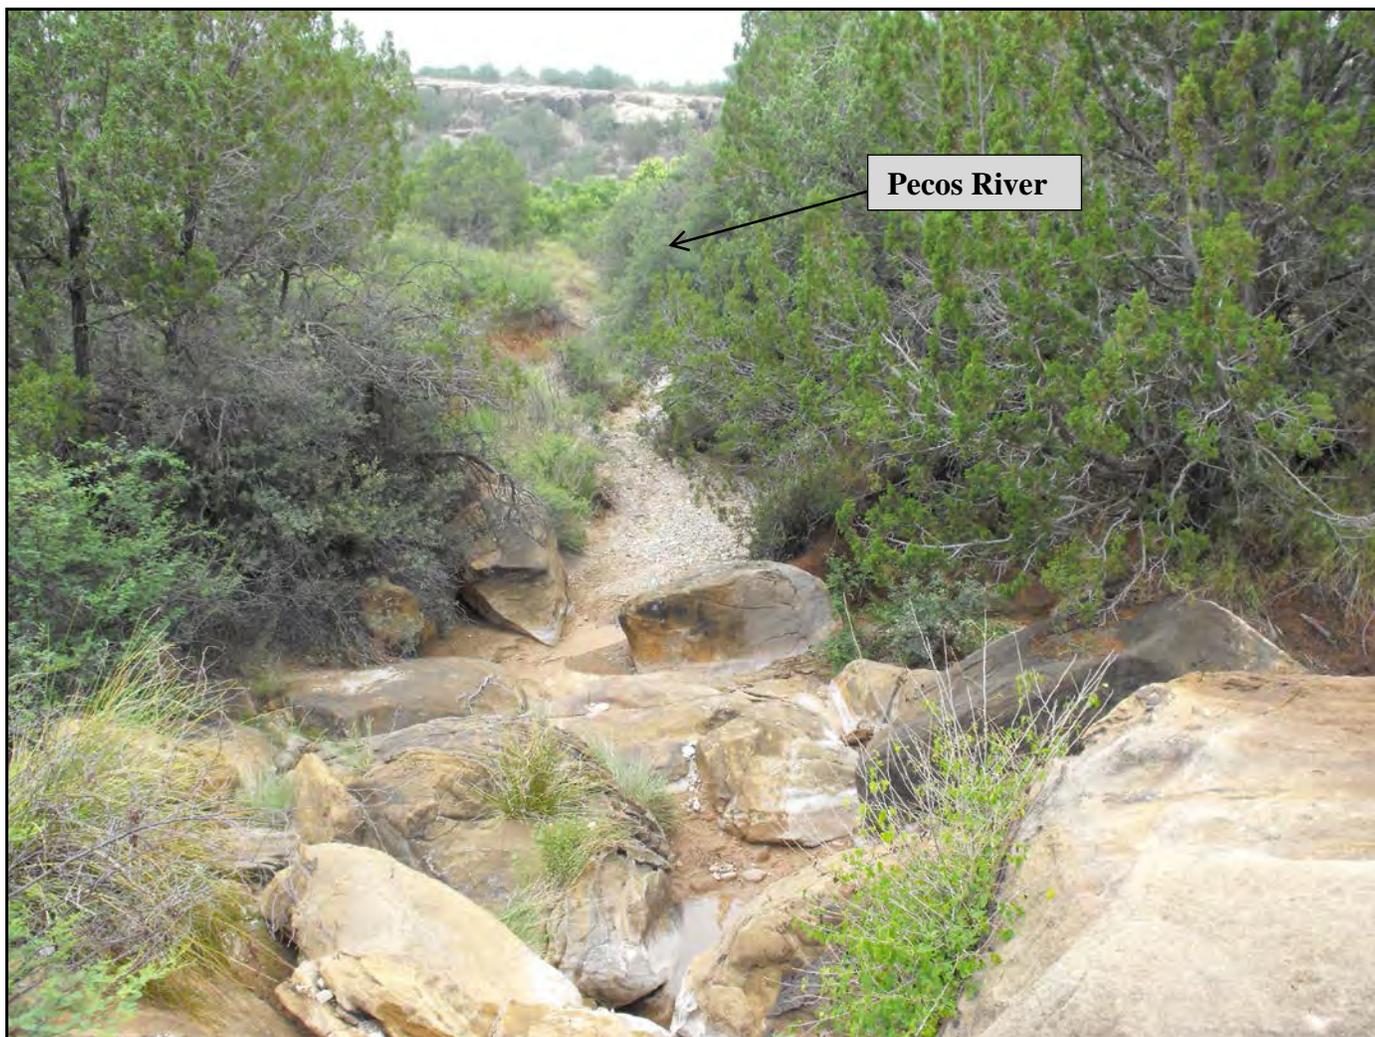
Photo # 8

Photographer: Daniel Valenta	Date: 7/7/2015	Time: 1343 hours
City/County: Santa Rosa/Guadalupe County		
Location: Robert Rivera Construction Inc. 1261Rivera Road, east of the asphalt plant, facing east.		
Subject: Sand/gravel at bottom of arroyo along the river

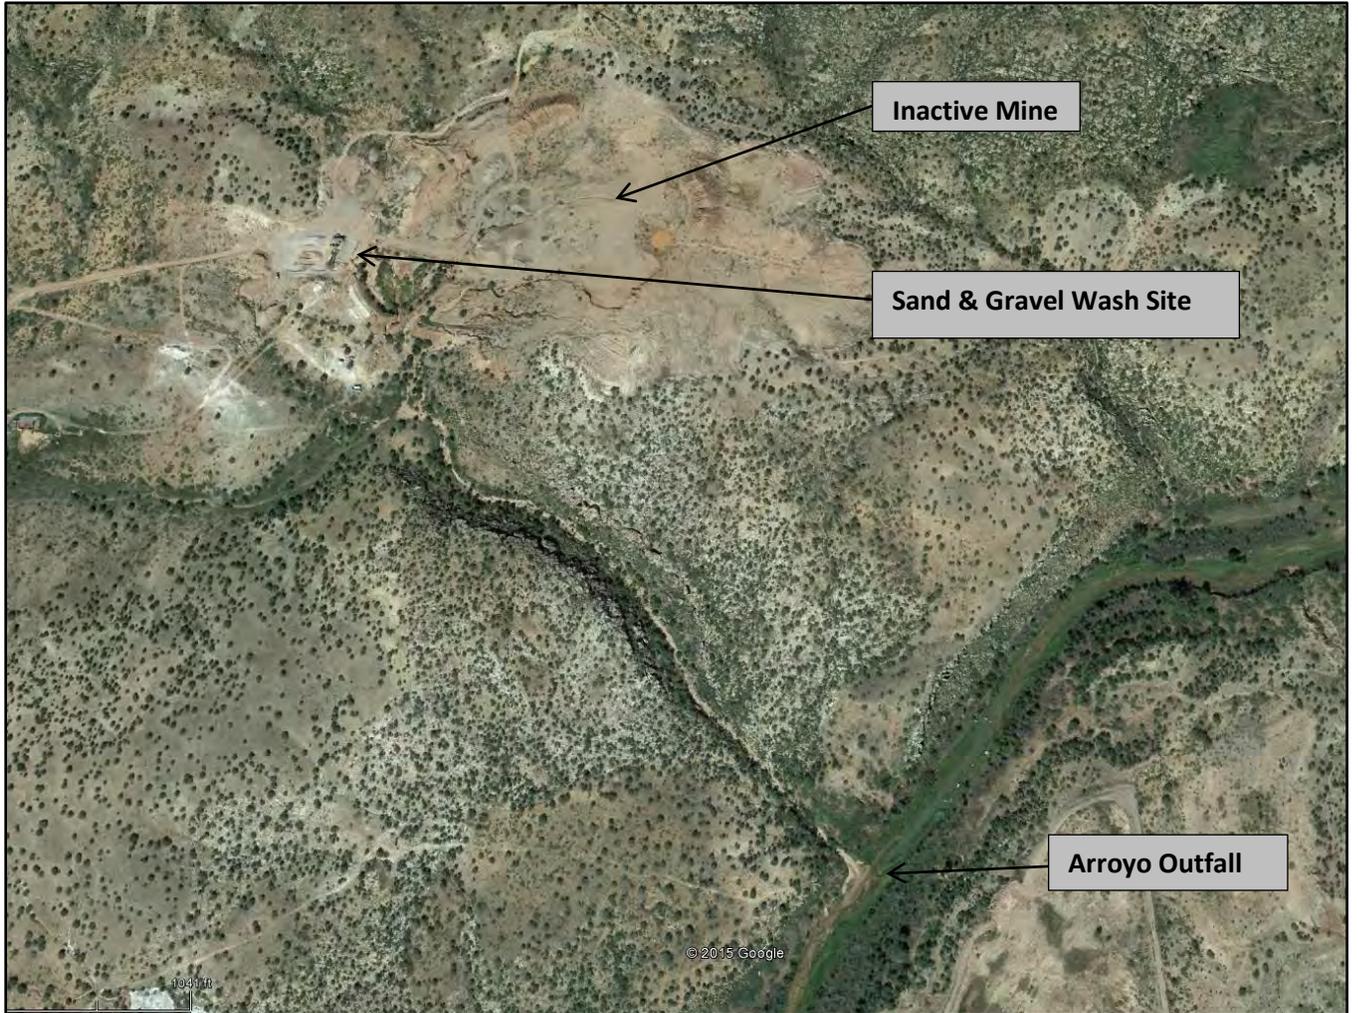
Google Earth Overview 2
N 34° 57' 11.04", W 104° 42' 12.36"

2. Stormwater sediment discharge, N 34° 57' 11.04", W 104° 42' 12.36". The facility has a sand/gravel wash area. Water is sprayed over these materials and flows into a settling area divided up into three interconnected basins. At the site no berms or other BMPs were present to deter or limit stormwater discharges to the arroyo. See Google Overview and Photos 9-11. At this time there is an inactive sand/gravel quarry next to the washing operation. This property does not belong to Mr. Rivera. The area did not appear to have any BMPs in place.

Subject: Rivera sand/gravel wash area and surrounding features, 09/30/2014. It is approximately 0.5 miles from the wash area to the river.

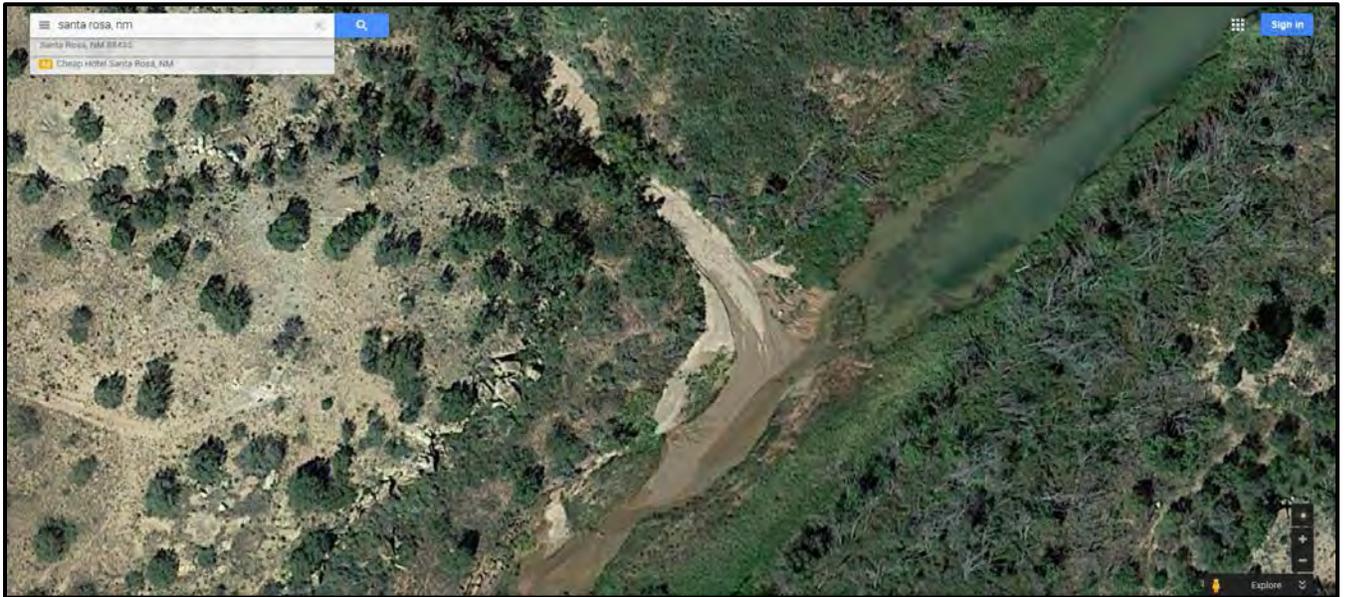
Google Earth Overview 3
N 34° 57' 11.04", W 104° 42' 12.36"

Subject: Arroyo outfall to the Pecos River, 09/30/2014

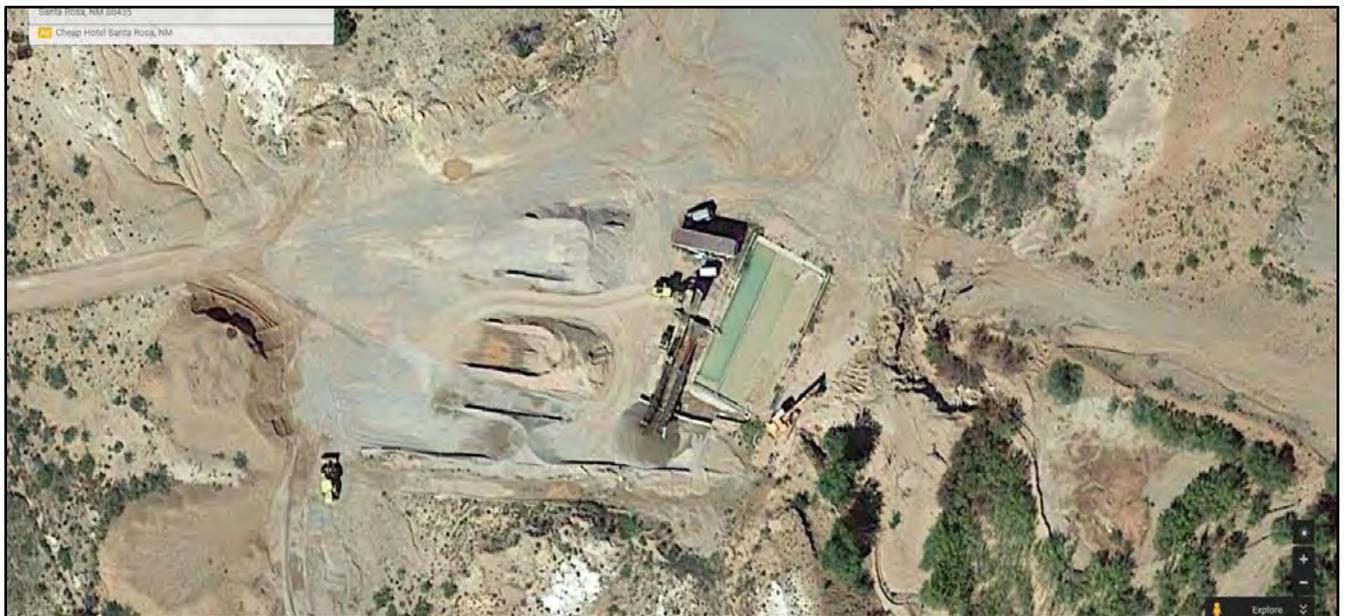
Google Earth Overview 4
N 34° 57' 31.45", W 104° 42' 29.86"

Subject: Rivera sand/gravel wash area, 09/30/2014

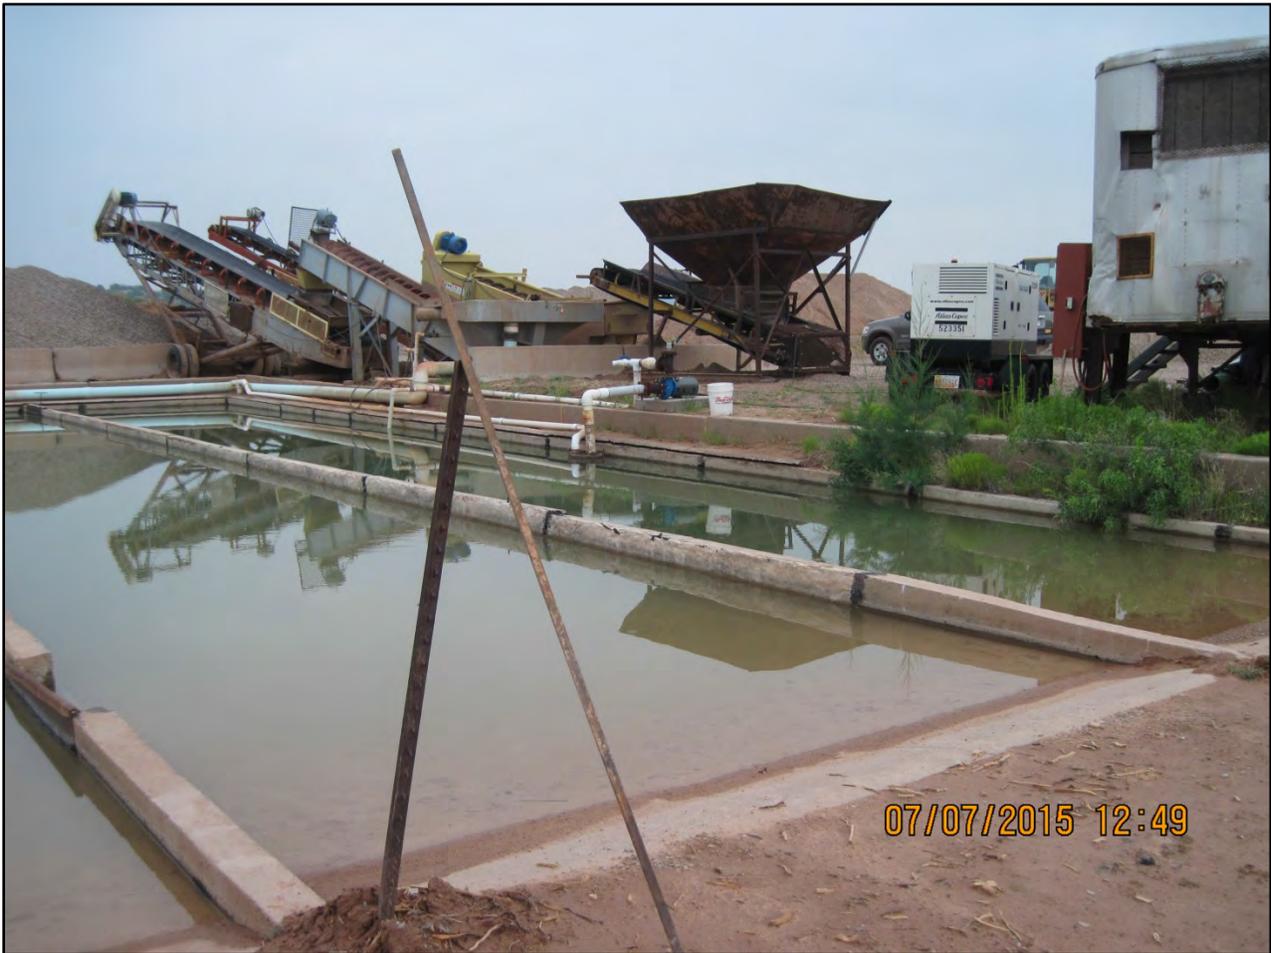
Photo # 9

Photographer: Erin Trujillo	Date: 7/7/2015	Time: 1249 hours
City/County: Santa Rosa/ Guadalupe County		
Location: Sand & gravel wash facility, Robert Rivera Construction Inc. facing southeast.		
Subject: Sediment settling basins.

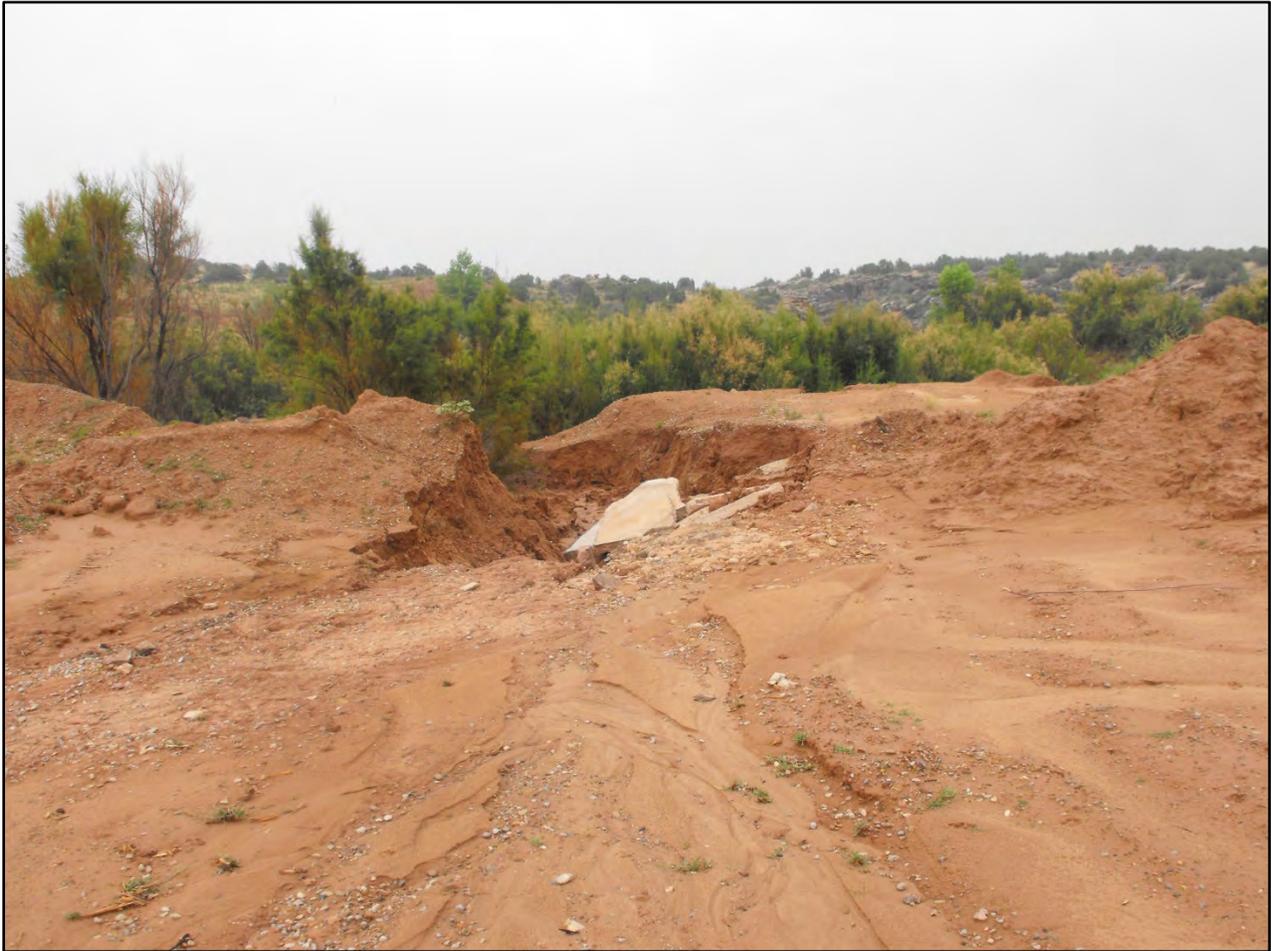
Photo # 10

Photographer: Daniel Valenta	Date: 7/7/2015	Time: 1233 hours
City/County: Santa Rosa/ Guadalupe County		
Location: Sand & gravel wash facility, Robert Rivera Construction Inc. facing northeast.		
Subject: Stormwater erosion next to the sand/gravel wash basins.

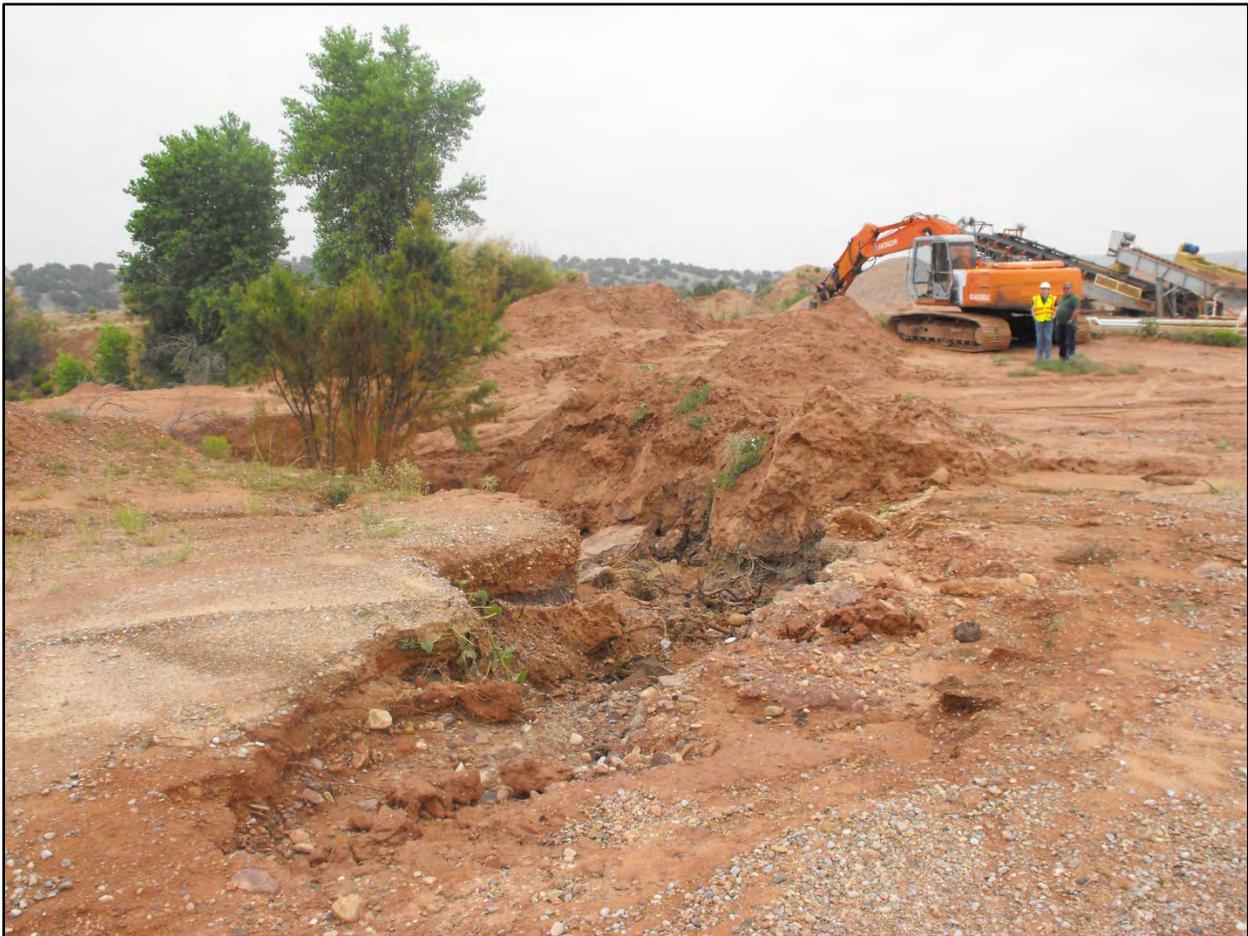
Photo # 11

Photographer: Erin Trujillo	Date: 7/7/2015	Time: 1249 hours
City/County: Santa Rosa/ Guadalupe County		
Location: Sand & gravel wash facility, Robert Rivera Construction Inc.		
Subject: Stormwater erosion next to the sand/gravel wash basins.

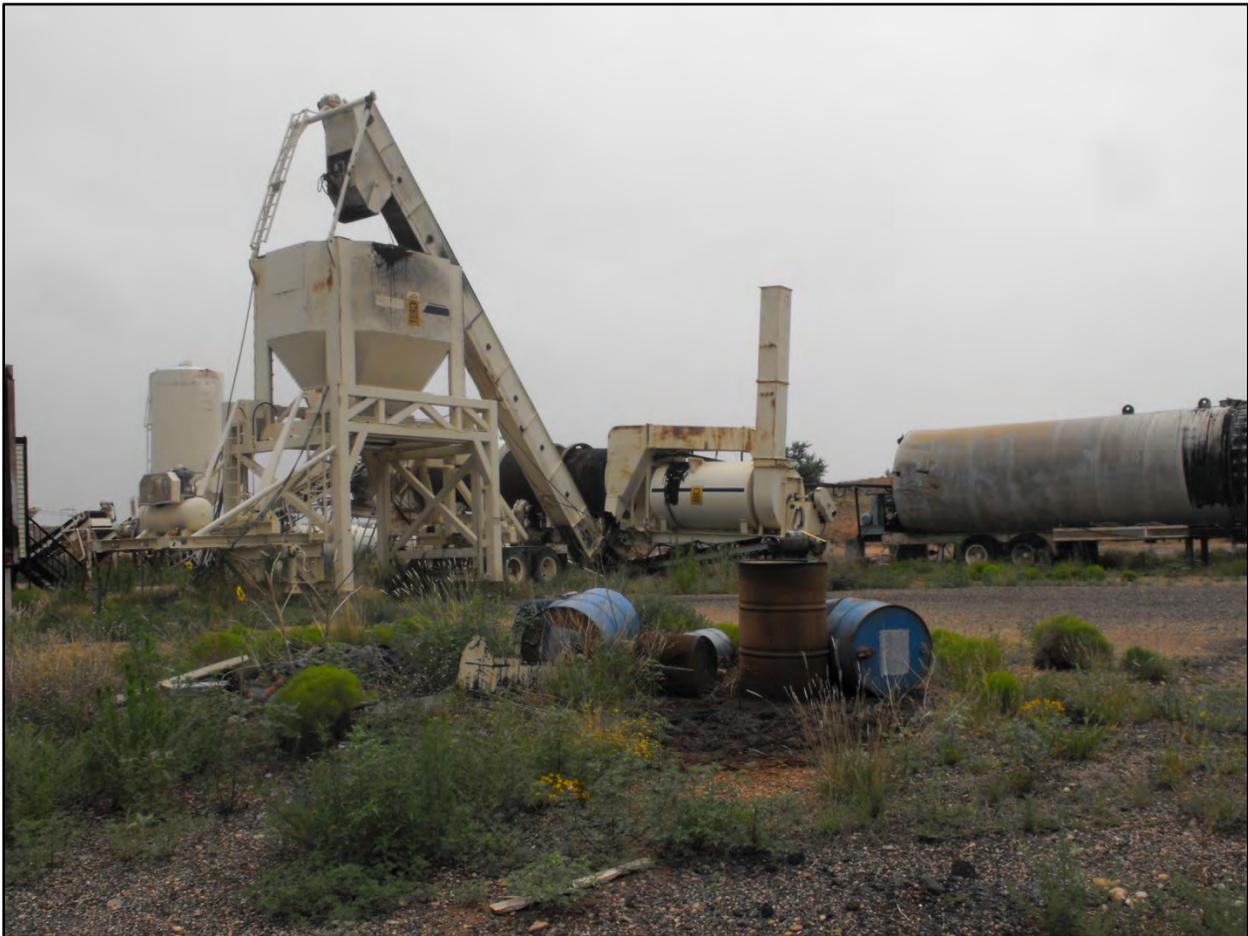
Photo # 12

The inspection primarily focused on what appeared to be two sites where discharges had and were occurring to unnamed arroyos that discharge into the Pecos River. It appears at the time of the inspection that both of these areas are potentially ongoing sources of stream pollution. The site also contained an inactive asphalt plant, (see photo 12).

Photographer: Erin Trujillo	Date: 7/7/2015	Time: 1404 hours
City/County: Santa Rosa/ Guadalupe County		
Location: Sand & gravel wash facility, Robert Rivera Construction Inc.		
Subject: Inactive asphalt plant, west of the concrete waste dump, (see Google Overview 1).
