RE: Robert Rivera Construction Company; Industrial Permit; SIC 1442 & 1373; NPDES Compliance Evaluation Inspection; NPDES NMU001897; July 7, 2015

**Multi-Sector General Permit
Compliance Evaluation Inspection
NPDES Permit NMU001897
Inspection Date: July 7, 2015**

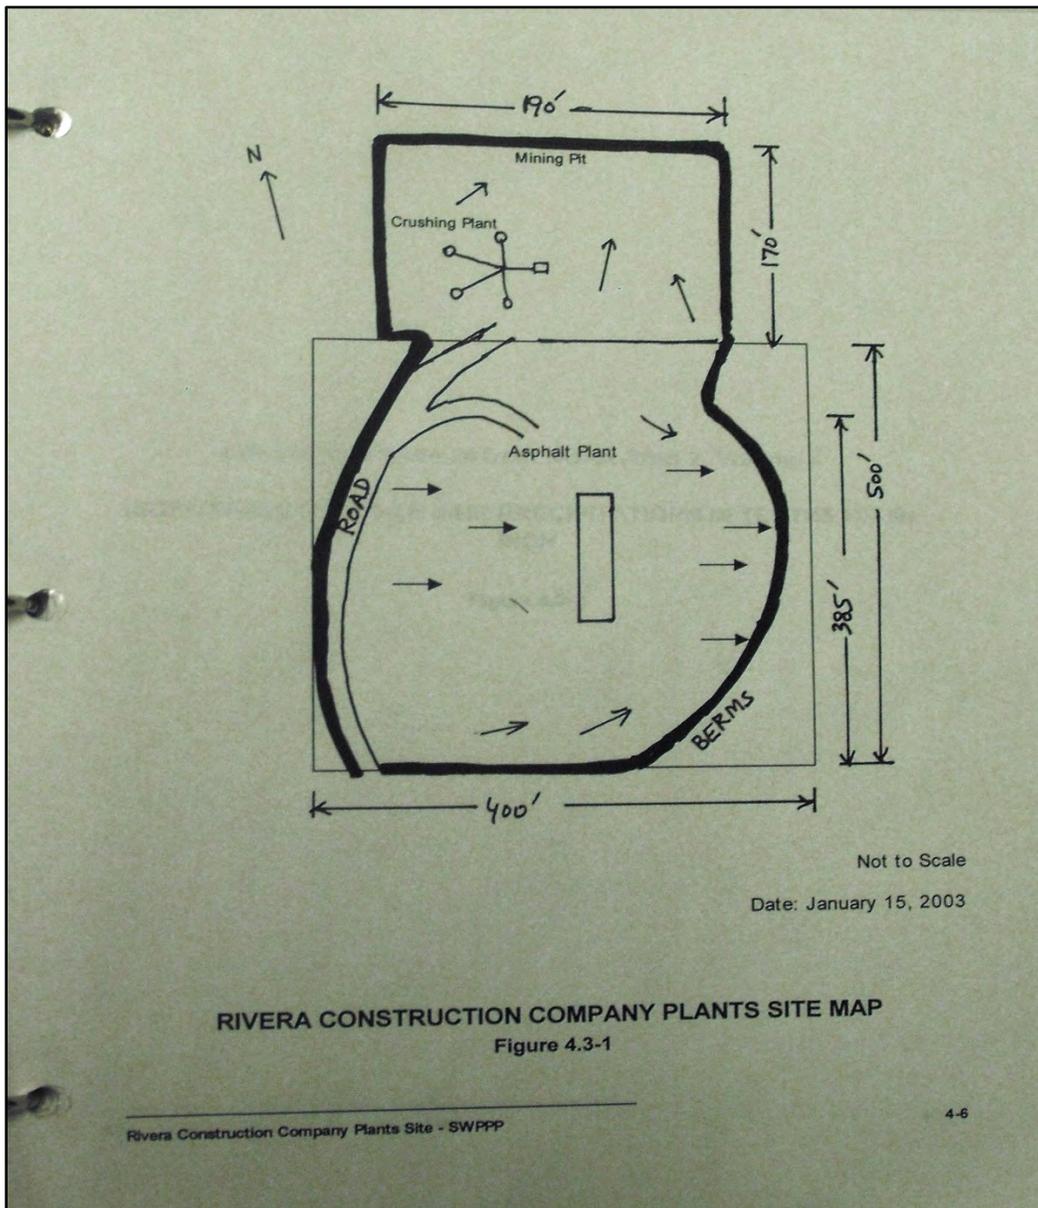
Photo # 13

Photographer: Erin Trujillo	Date: 7/7/2015	Time: 1152 hours
City/County: Santa Rosa/ Guadalupe County		
Location: Sand & gravel wash facility, Robert Rivera Construction Inc.		
Subject: Map of site from the 2003 SWPPP. SWPPP did not reflect current conditions.
