Re: Next Generation Contracting Inc.; Casas Bonitas Subdivision, Santa Fe, Unpermitted Construction Stormwater; SIC 1521; NPDES Compliance Evaluation Inspection; NPDES NMU001923; September 21, 2016

NPDES Compliance Inspection Report

Casas Bonitas Subdivision, Santa Fe, New Mexico
Next Generation Contracting Inc. (NPDES Tracking No. NMU001923)
Compliance Evaluation Inspection
September 21, 2016

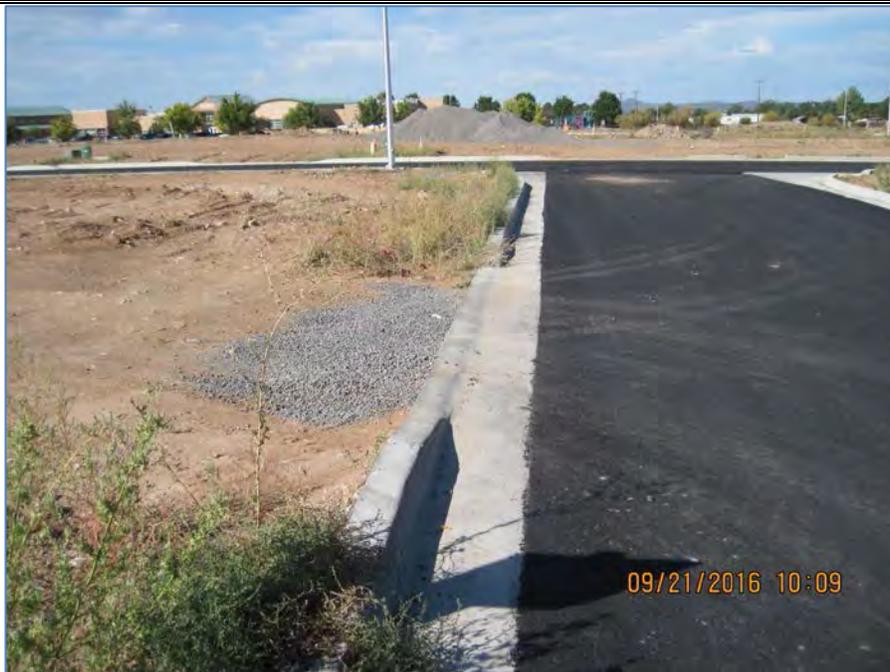
**NMED/SWQB
Official Photograph Log
Photo # 1**

Subject: Looking west from eastern entrance of subdivision, small rock was located at one curb cut of disturbed lot.

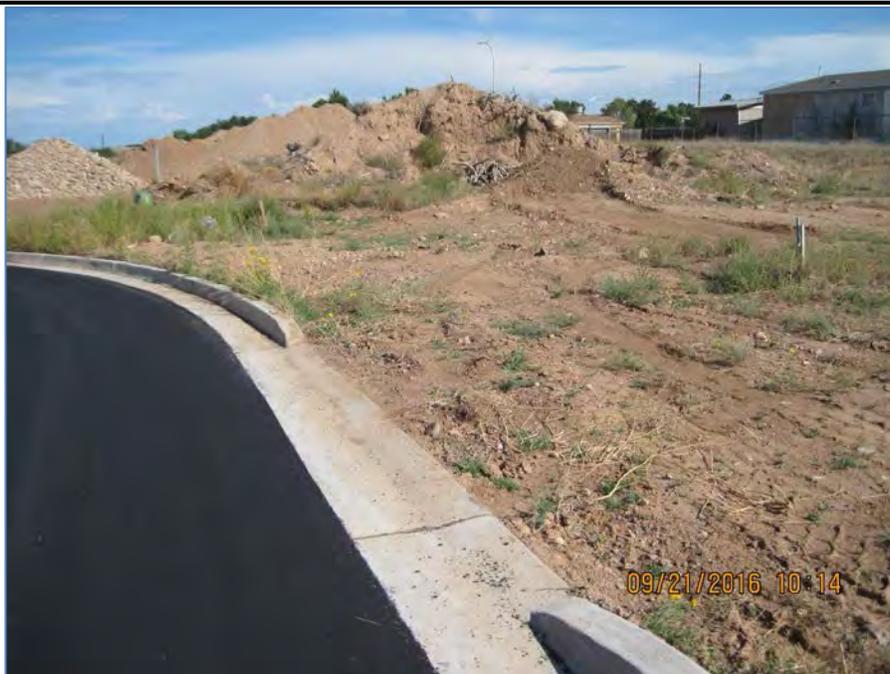
**NMED/SWQB
Official Photograph Log
Photo # 2**

Subject: Disturbed areas and material stockpiles in northeast corner of site. Example where no vehicle trackout control measures were observed for curb cut.

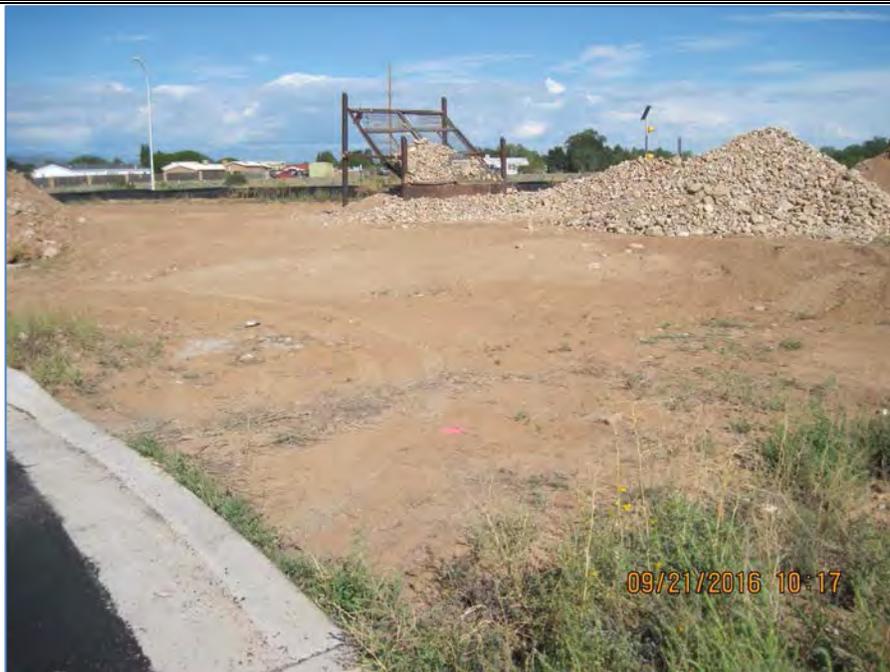
NMED/SWQB
Official Photograph Log
Photo # 3

Subject: Disturbed areas and rock sorting was in northeast corner of site. Example where no vehicle trackout control measures were observed for curb cut.

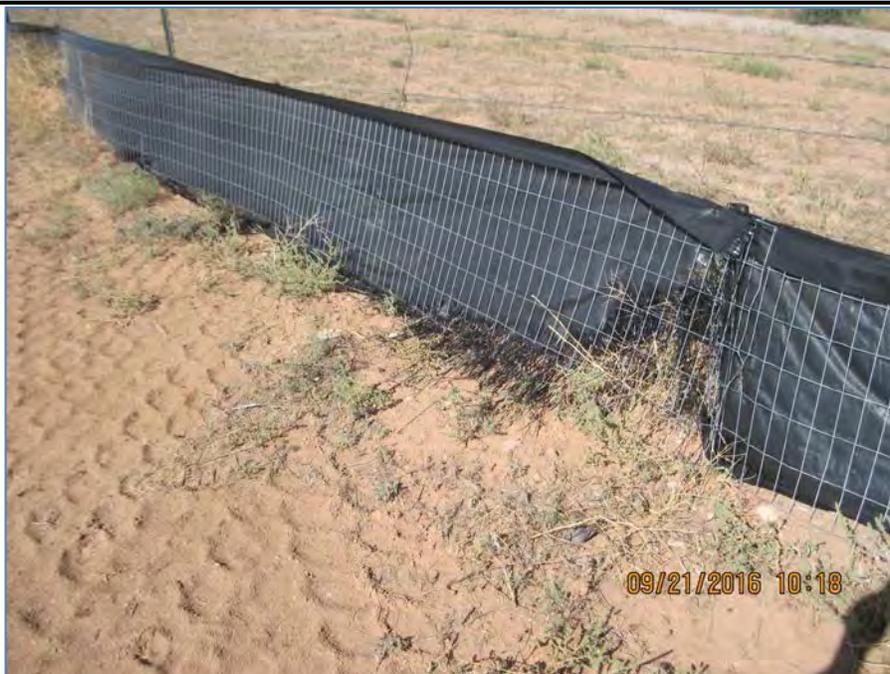
NMED/SWQB
Official Photograph Log
Photo # 4

Subject: Area where silt fence was damaged (no longer trenched) at northern property boundary of site.

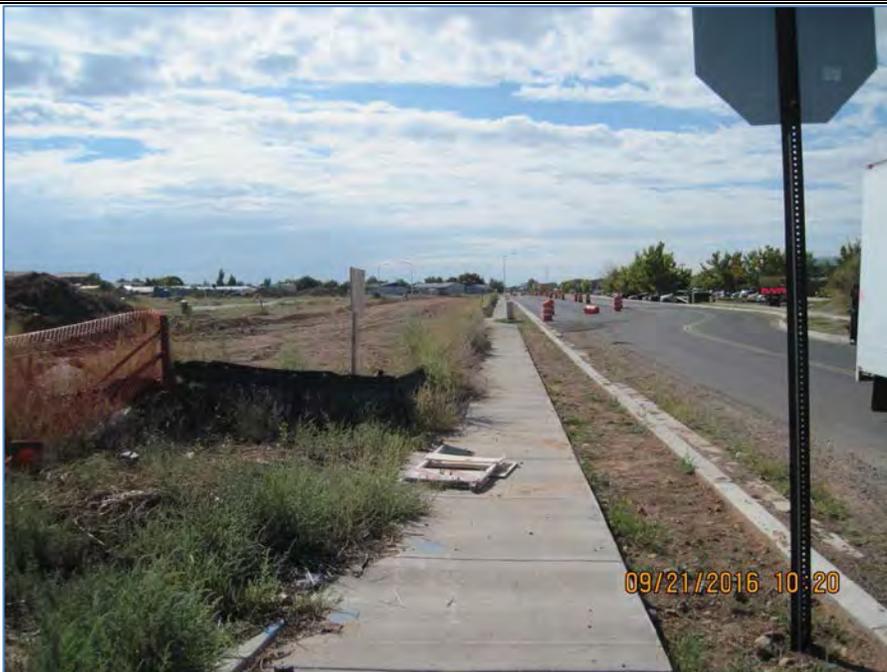
NMED/SWQB
Official Photograph Log
Photo # 5

Subject Looking south from northwest corner of site, example of weed vegetation in previously disturbed areas.

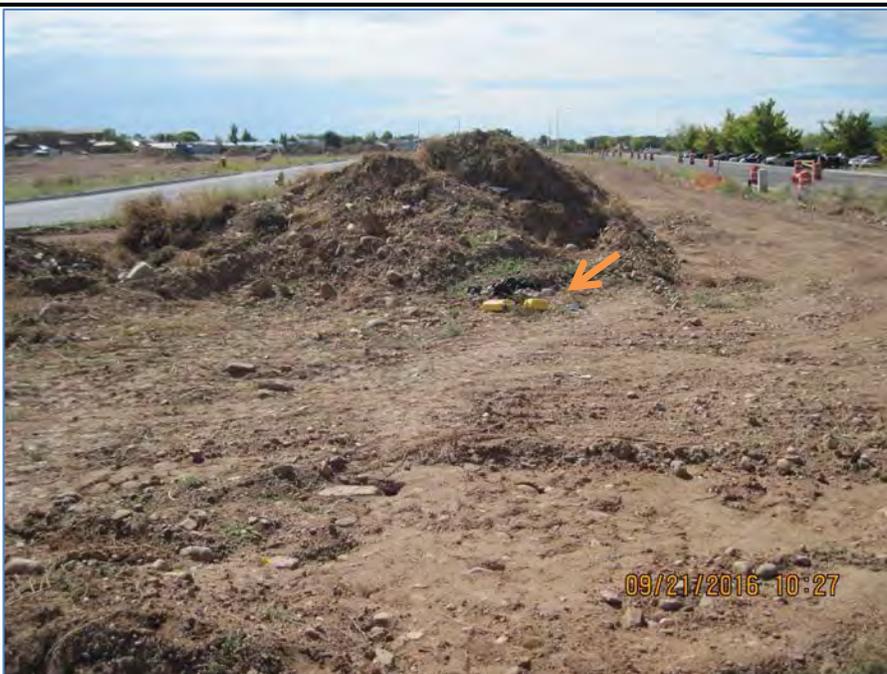
NMED/SWQB
Official Photograph Log
Photo # 6

Subject: Disturbed area and material stockpile near northwest corner of site. Arrow points to trash (e.g., plastic containers, plastic, paper).

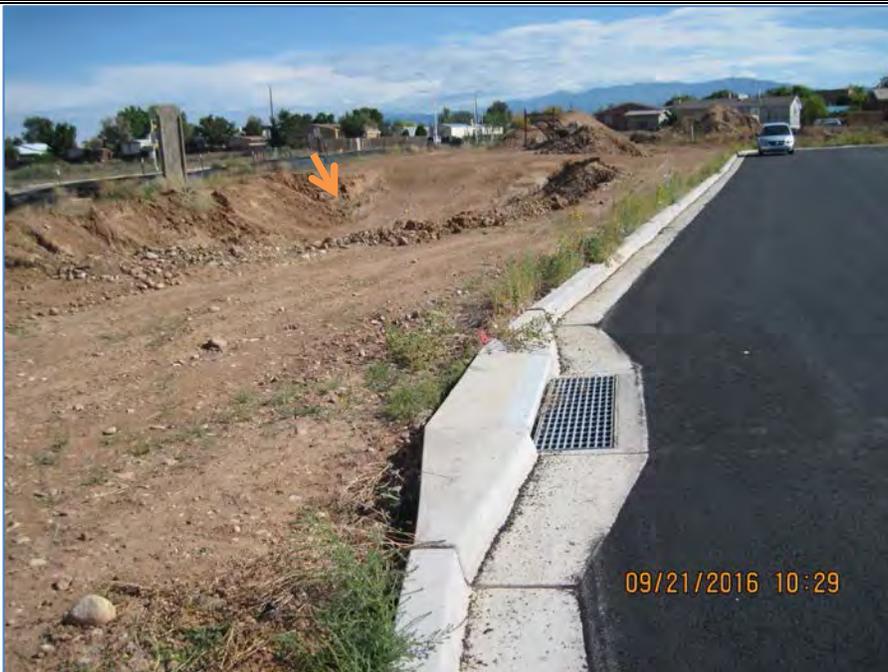
NMED/SWQB
Official Photograph Log
Photo # 7

Subject: Arrow points to excavated area described as sediment pond. Bonitas Loop within subdivision was paved, and had curb & gutter and stormwater sewer drop inlets.

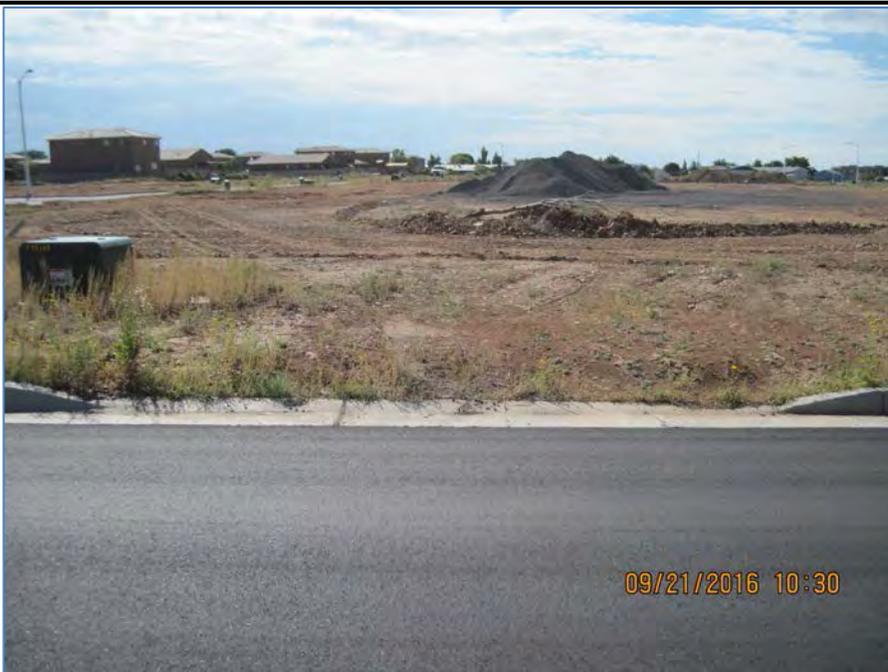
NMED/SWQB
Official Photograph Log
Photo # 8

Subject: Disturbed area and stockpile in center of subdivision. Some vegetation, but no structural controls were observed to prevent trackout or access at curb cut.

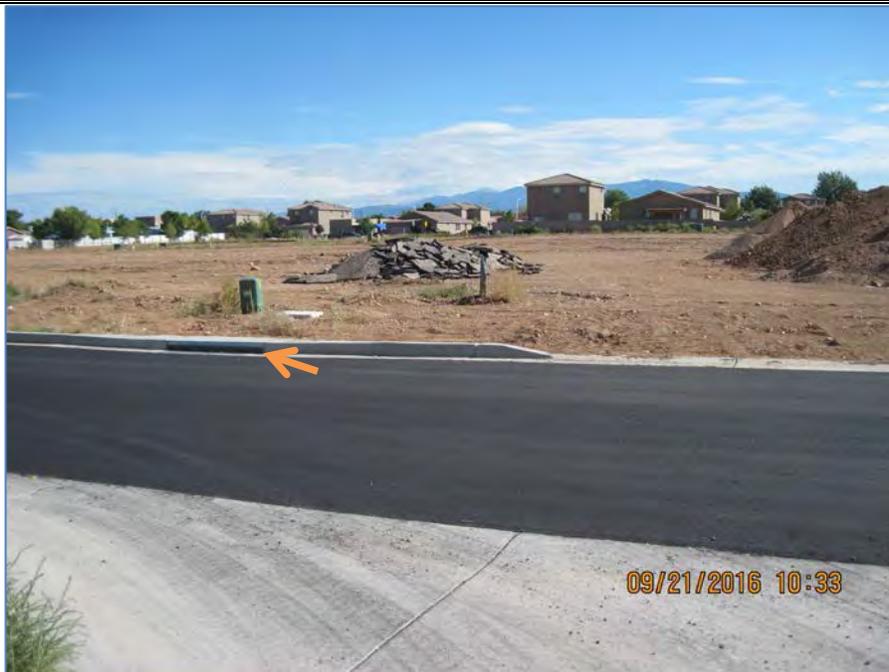
NMED/SWQB
Official Photograph Log
Photo # 9

Subject: Looking east, more asphalt and material stockpiles were in center of subdivision. No vehicle trackout controls were observed for curb cut. Arrow points to inlet.

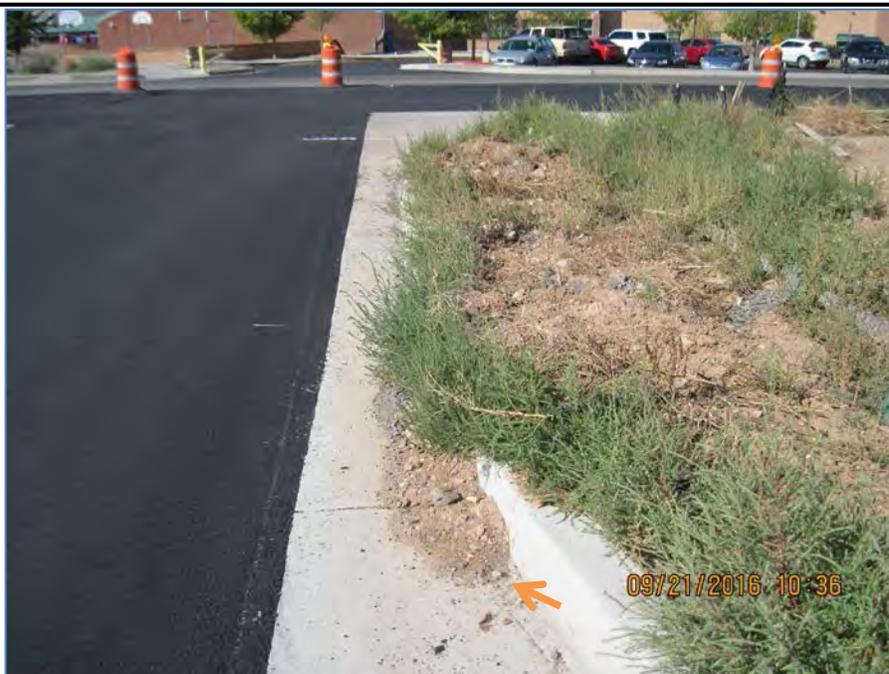
NMED/SWQB
Official Photograph Log
Photo # 10

Subject: Accumulated sediment and concrete material solids were observed along street's curb and gutter at western entrance to subdivision.

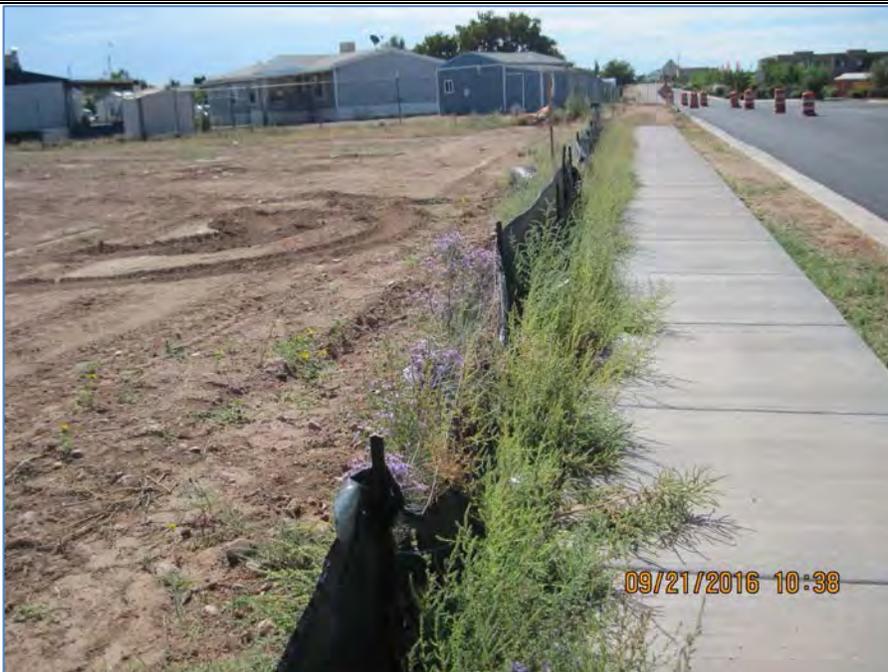
NMED/SWQB
Official Photograph Log
Photo # 11

Subject: Looking south, disturbed areas in southwest portion of site. Portions of sit fence were damaged and/or missing.

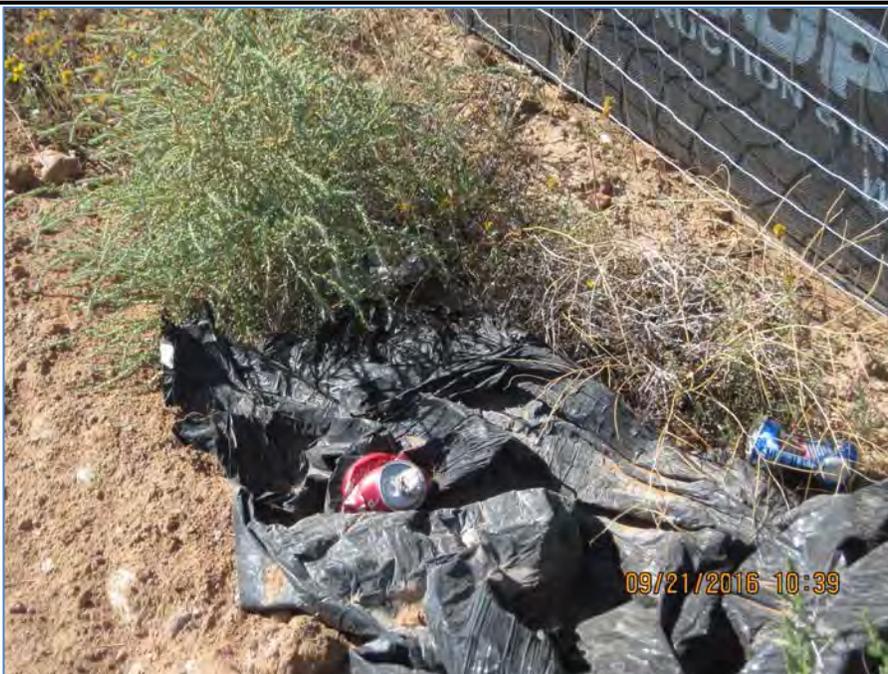
NMED/SWQB
Official Photograph Log
Photo # 12

Subject: Plastic and aluminum can trash on site.

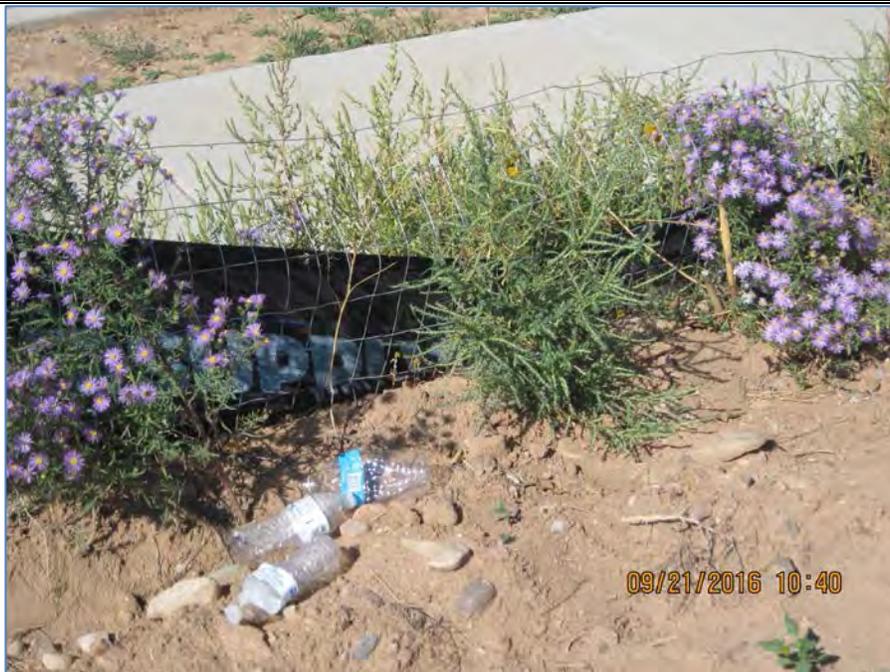
NMED/SWQB
Official Photograph Log
Photo # 13

Subject: Plastic bottle trash on site.

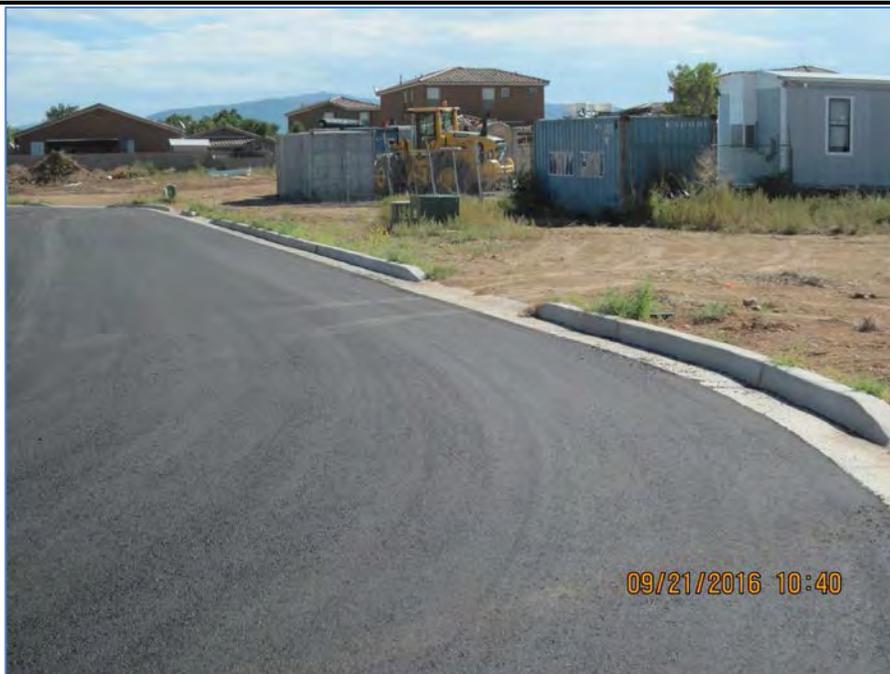
NMED/SWQB
Official Photograph Log
Photo # 14

Subject: Contractor support area (e.g., heavy equipment, mobile home, shipping containers, fuel storage, and material storage) was located in southeast portion of site.

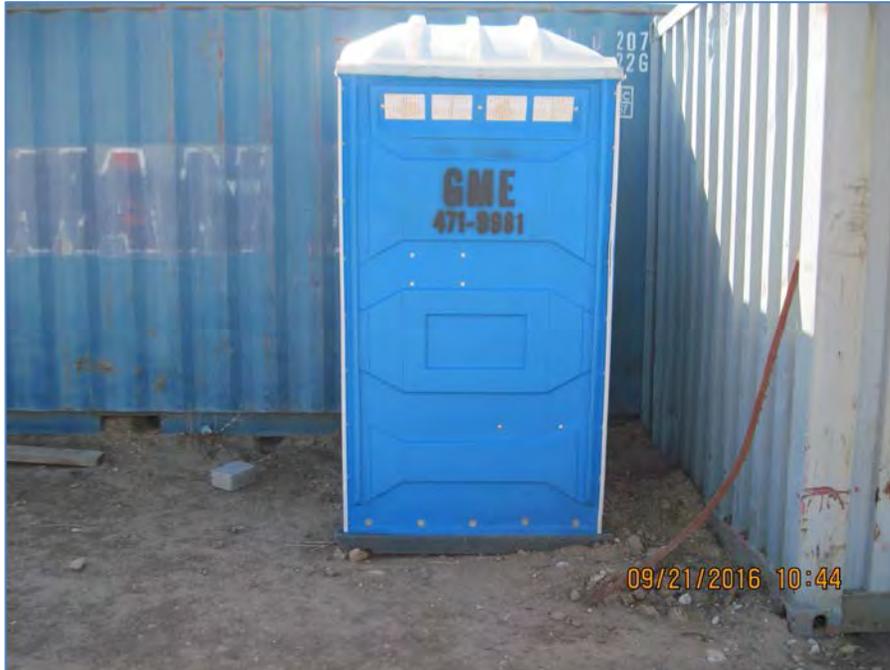
NMED/SWQB
Official Photograph Log
Photo # 15

Subject: Portable toilet at contractor support area appeared to be protected from vehicle traffic.

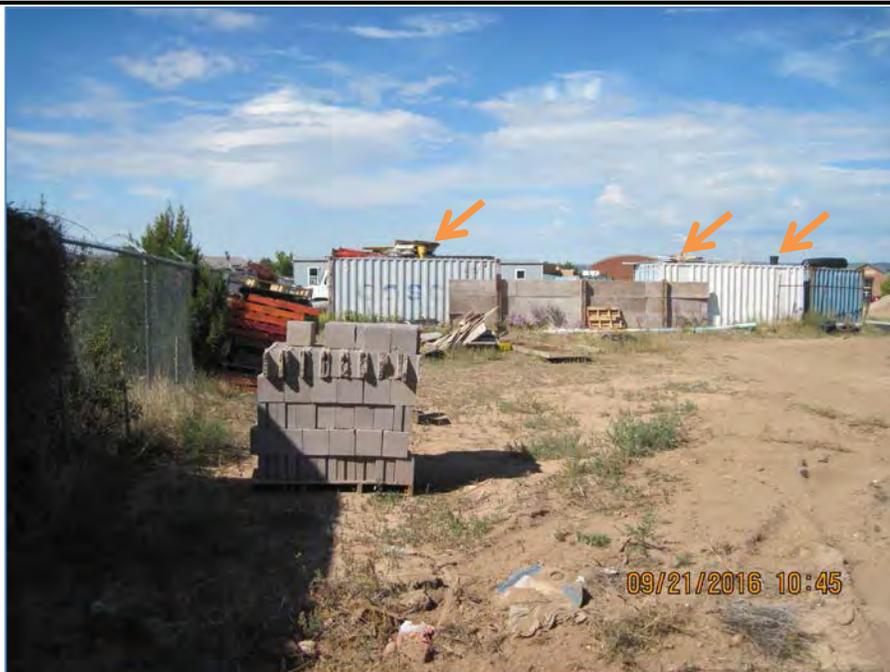
NMED/SWQB
Official Photograph Log
Photo # 16

Subject: Looking west from southeast corner of site, material were stored above shipping/storage containers were exposed to precipitation (see arrows).

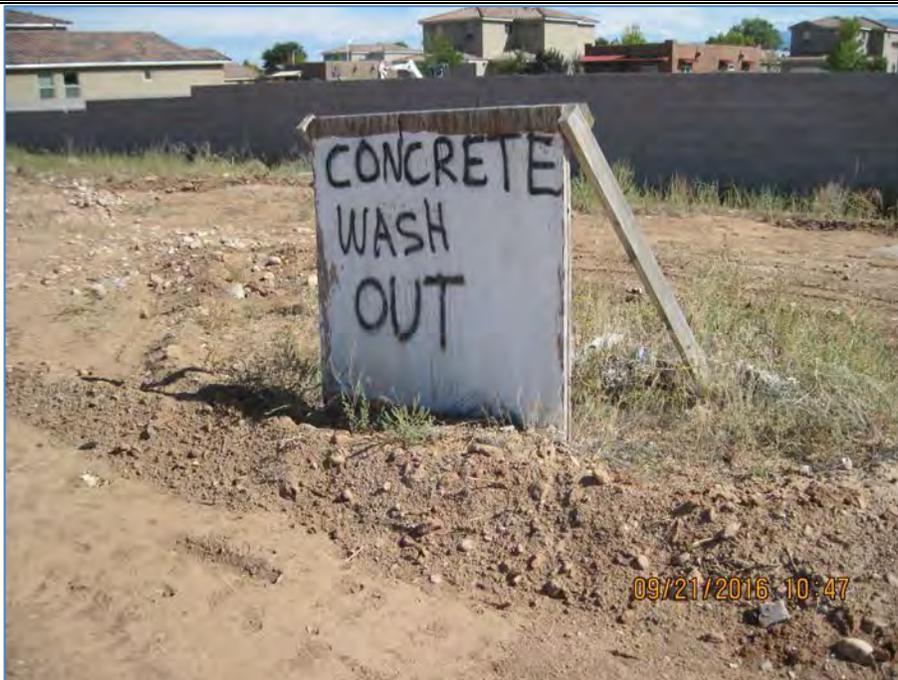
NMED/SWQB
Official Photograph Log
Photo # 17

Subject: No structural pollutant control measures (e.g., excavated pit) were observed at area where sign indicated concrete washout.

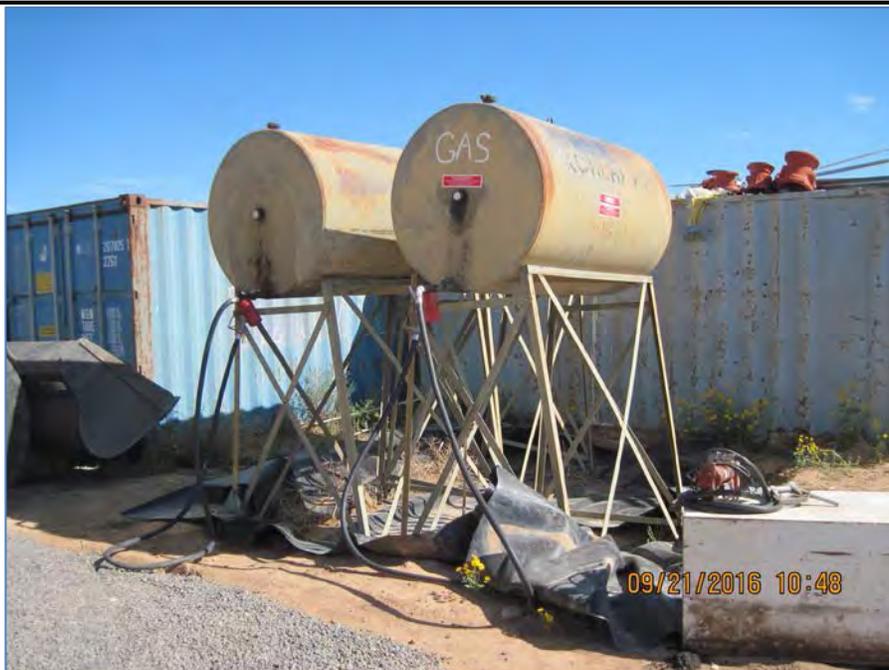
NMED/SWQB
Official Photograph Log
Photo # 18

Subject: Arrow points to excavated area below/near fuel storage. Liner below tanks was not in good condition and may not allow any spills from entering containment.
