**Re: Major-Municipal, SIC 4952, NPDES Compliance Evaluation SSO Inspection, Rio Rancho WWTP #2, NM0027987, August 24 & 25, 2010**

**Rio Rancho #2 WWTP NPDES Permit No. NM0027987**  
**Montoyas Arroyo Sanitary Sewer Overflow**  
**Spill dates: August 24-25, 2010**  
**NMED Site Inspection: August 25 & 26, 2010**  
**NMED-SWQB Inspector: Sarah Holcomb**

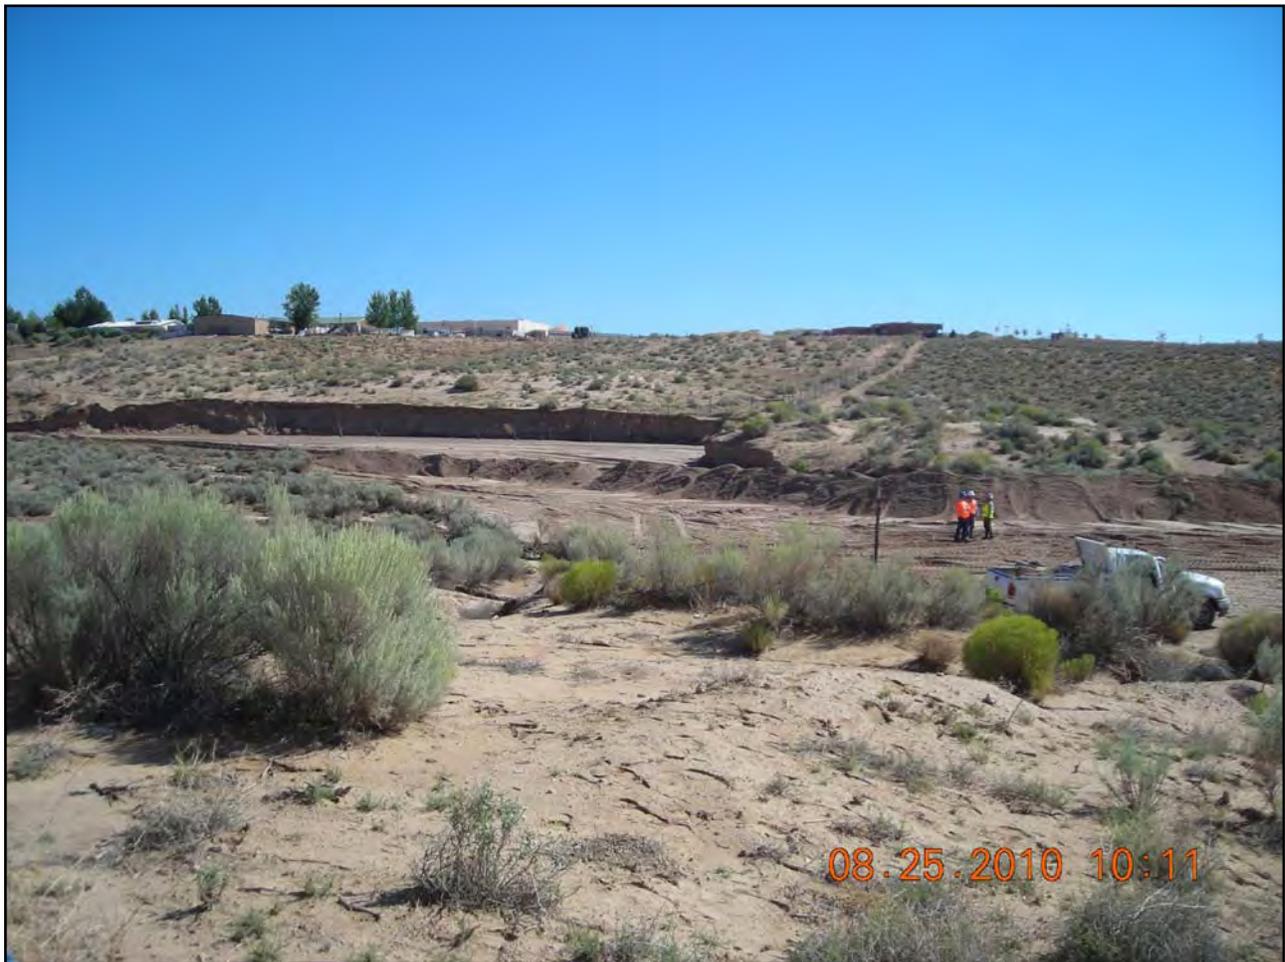
Photo # 1

Cause of the Overflow: Rio Rancho experienced a large rain event (>2 inches) Monday evening. The resulting water flow through the Montoyas Arroyo (estimated at about 3000 cfs) created severe erosion problems – Please see Picture #1. The erosion created a large swale on the west side of the arroyo, where the sewer line was located, and the force of the water washed away the manhole located there. The force of the water also broke the line further down the arroyo, just above the sports complex on High Resort Blvd.

Photographer: Sarah Holcomb	Date: 8-25-2010	Time: 1011 hours
City/County: Rio Rancho/Sandoval		
Location: Montoyas Arroyo (near the intersection of High Resort and Broadmoor)		
Subject: The area to the top left of the arroyo had been eroded by the flood waters. The same flood waters created another swale to the bottom right (outside the frame of the picture) where the manhole was washed out.

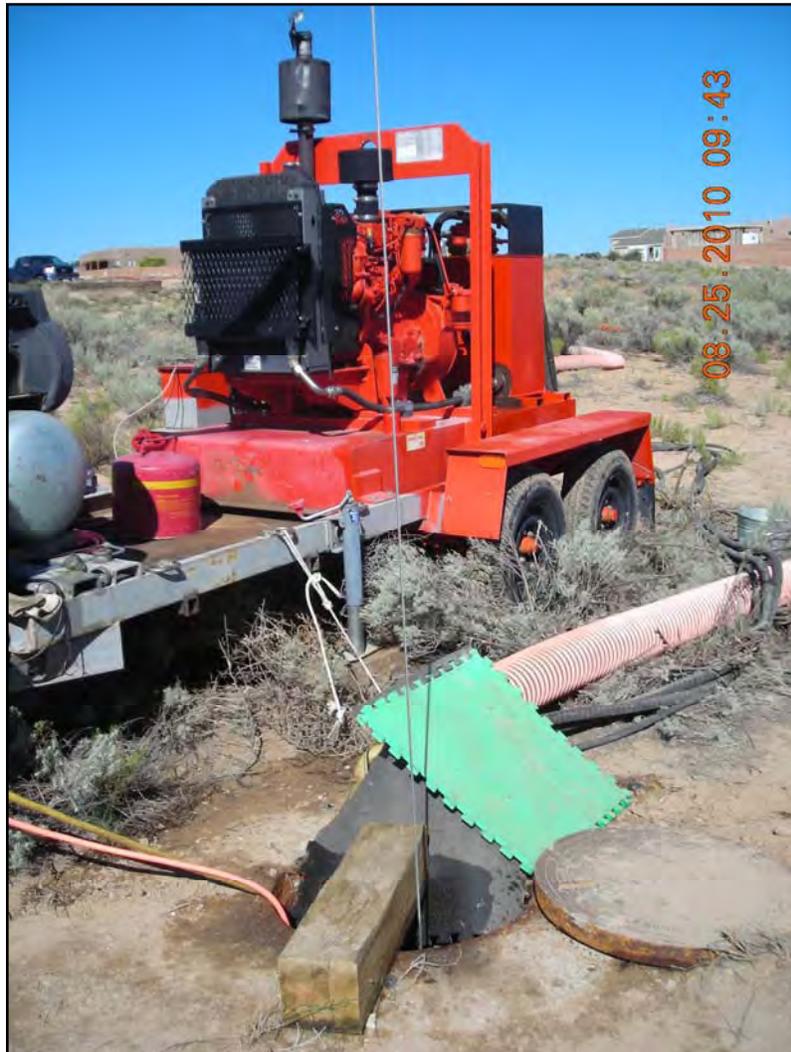
Photo # 2

Photographer: Sarah Holcomb	Date: 8-25-2010	Time: 0943 hours
City/County: Rio Rancho/Sandoval		
Location: Montoyas Arroyo (near the intersection of High Resort and Broadmoor)		
Subject: Raw wastewater pump at broken 15" line.

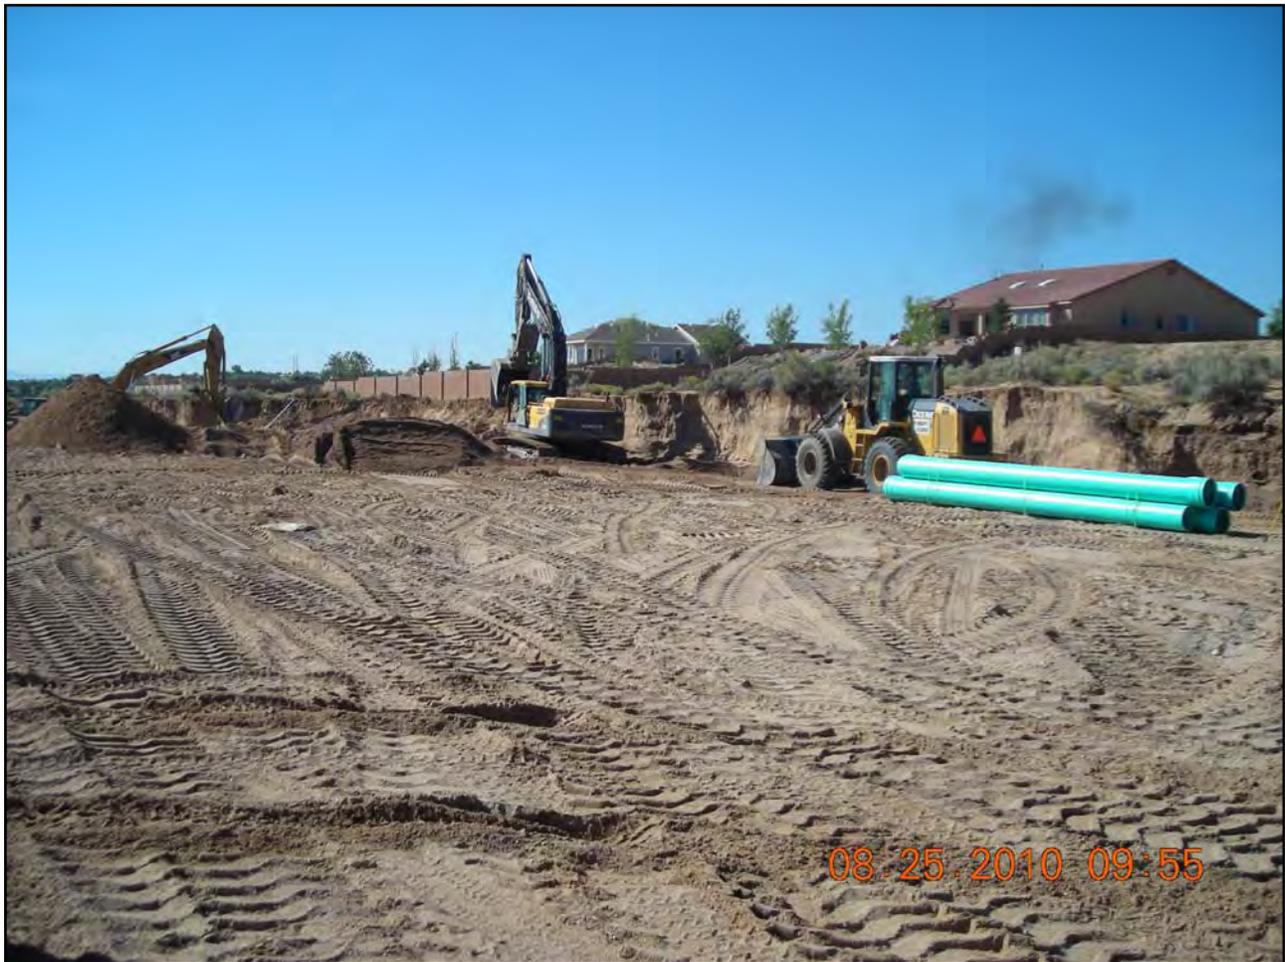
Photo # 3

Ms. Sarah Holcomb (NMED SWQB) arrived onsite at 0920 hours on Wednesday August 25, 2010 (along with Mr. Robert George and Mr. Russell Isaac of the NMED/GWQB) and met with Mr. Larry Webb (Utilities Division Manager, City of Rio Rancho) and Mr. Cliff Leeper (Project Manager, CH2M Hill/OMI). Mr. Webb and Mr. Leeper escorted the inspectors on a tour of the line breaks and the repairs currently underway. The area of the first line break had been mitigated by plugging the original 15” line and pumping the raw wastewater into an 8” line in an adjacent street (Chessman Rd.). [Please see Photo #2.] Some HTH had been applied for disinfection. Mr. Leeper indicated that the flood waters had eroded about 75 cubic yards of sand from the banks of the arroyo in that area. Crews were currently working to dig another trench to reinstall a new 15” line. [Please see Photo #3.]

Photographer: Sarah Holcomb	Date: 8-25-2010	Time: 0955 hours
City/County: Rio Rancho/Sandoval		
Location: Montoyas Arroyo (near the intersection of High Resort and Broadmoor)		
Subject: Work underway to construct replacement 15" line on east side of Montoyas.

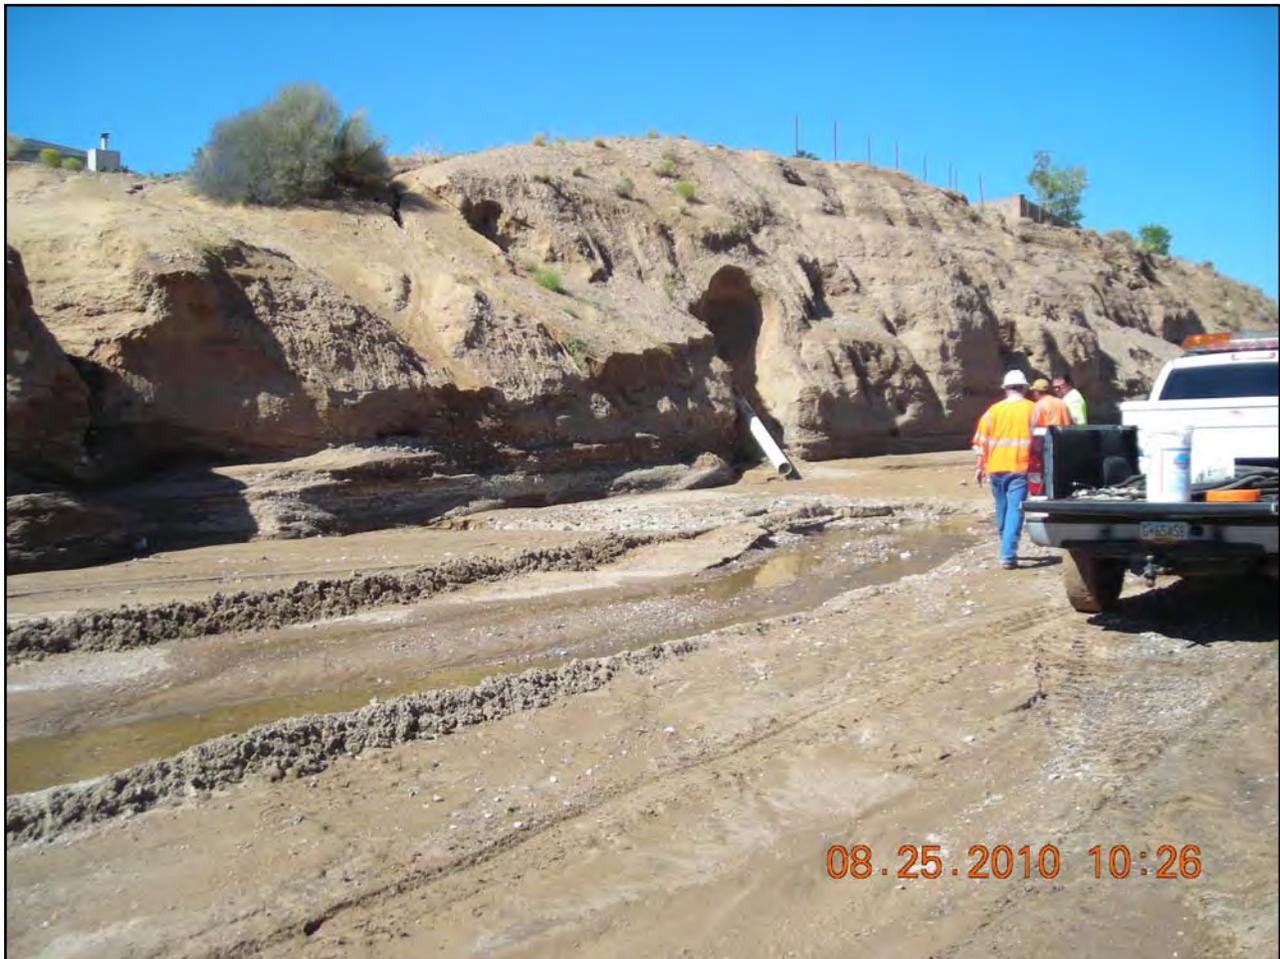
Photo # 4

The second line break occurred above the city’s sports complex area. The trunk line was located in the bottom of the arroyo, and a feeder line was located in the bank of the arroyo. The erosion that occurred here tore the feeder line away from the trunk line. The feeder line was still flowing (just a trickle) but the trunk line was leaking substantially. [Please see Photo #4.] The raw wastewater was flowing up from beneath the floor of the arroyo and flowing downstream. City utility staff was spreading HTH along the floor of the arroyo to disinfect the wastewater. [Please see Photo #5.] The city staff were also trying to assess where the nearest upstream manhole was, but it appeared that it had been covered up with construction debris. The city staff had constructed a berm just east of the sports complex area in order to contain any of the flows from the second break. [Please see Photo #6.] The inspector indicated that the city should keep track of how much HTH was being applied and should also take chlorine residuals at the berm located downstream.

Photographer: Sarah Holcomb	Date: 8-25-2010	Time: 1026 hours
City/County: Rio Rancho/Sandoval		
Location: Montoyas Arroyo (near the intersection of High Resort and Broadmoor)		
Subject: Second line break above city sports complex.

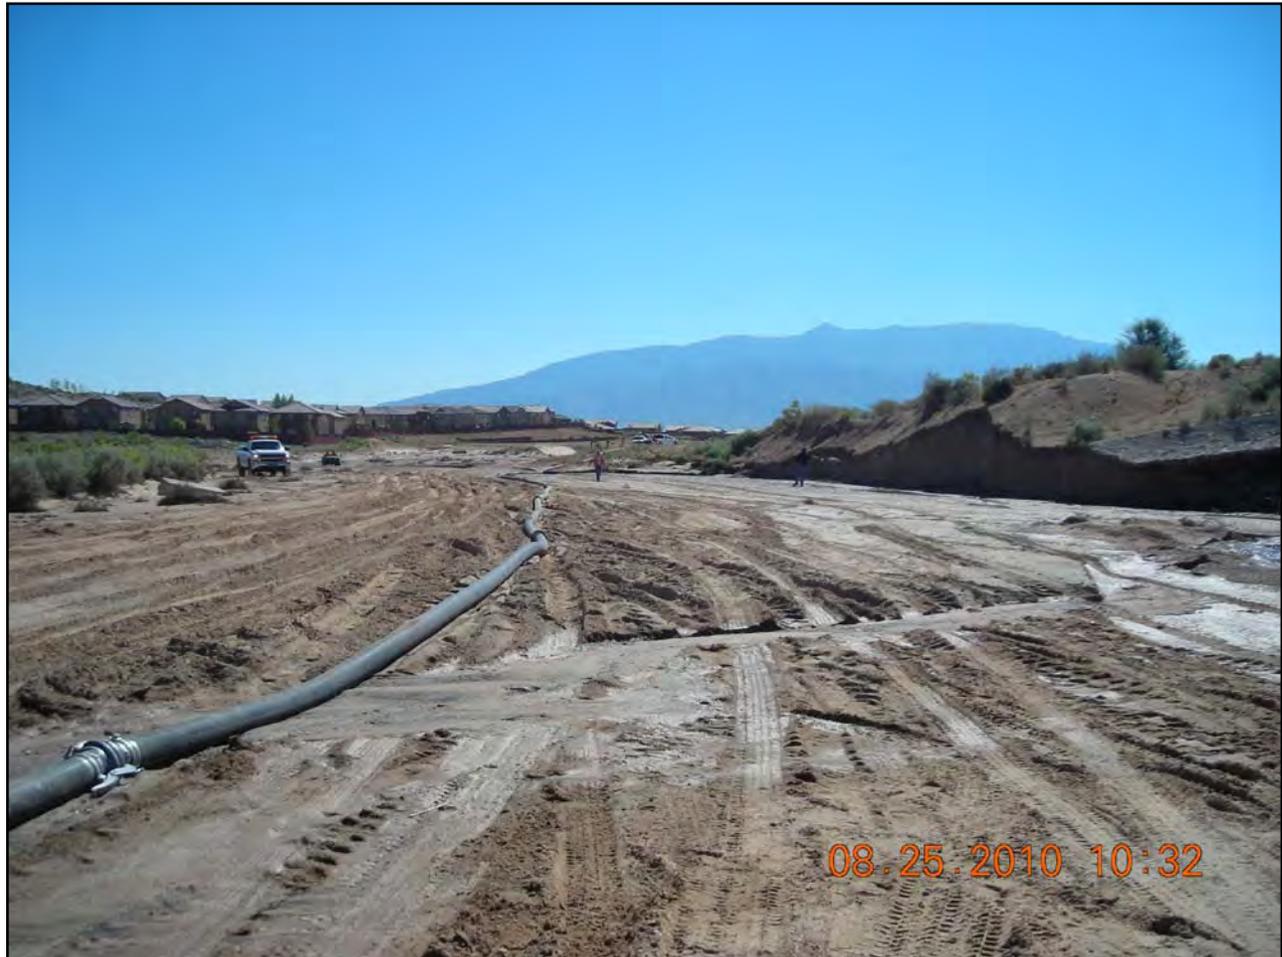
Photo # 5

The line downstream of the first line break was completely plugged with sediment and gravel. The inspectors estimated that approximately 3000’ of line would need to be cleared. The city had been searching for vacor trucks to assist in jetting the line. Raw wastewater above the sediment plug was being directed through 1500’ of hose into a manhole downstream of the second line break.

Photographer: Sarah Holcomb	Date: 8-25-2010	Time: 1032 hours
City/County: Rio Rancho/Sandoval		
Location: Montoyas Arroyo (near the intersection of High Resort and Broadmoor)		
Subject: Section of 1500' length of hose diverting flow from above sediment plug to manhole below. City staff are also pictured applying HTH to arroyo.

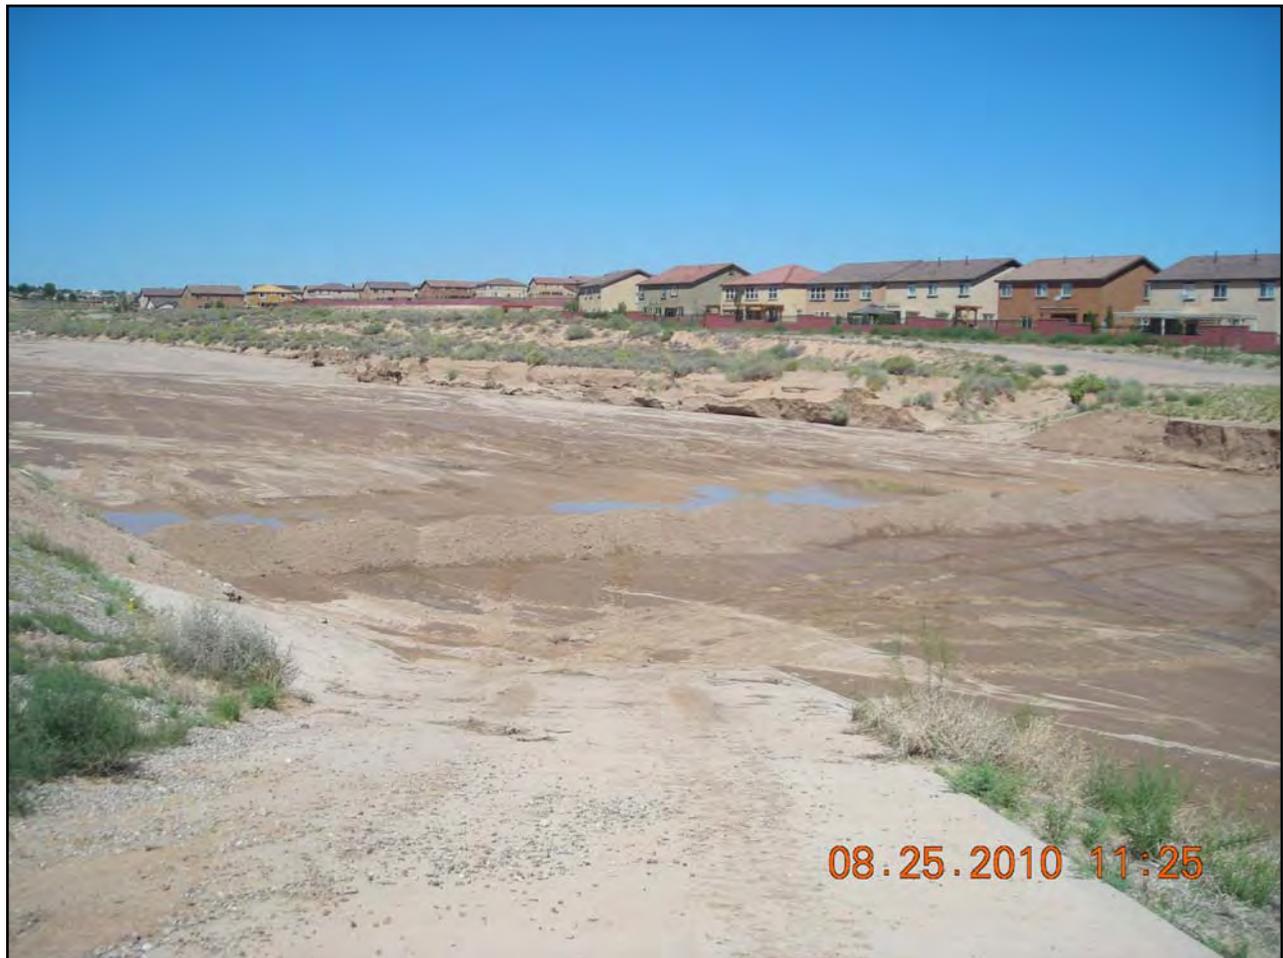
Photo # 6

Photographer: Sarah Holcomb	Date: 8-25-2010	Time: 1125 hours
City/County: Rio Rancho/Sandoval		
Location: Montoyas Arroyo (near the intersection of High Resort and Broadmoor)		
Subject: Berm constructed downstream of city sports complex to contain wastewater from second break.

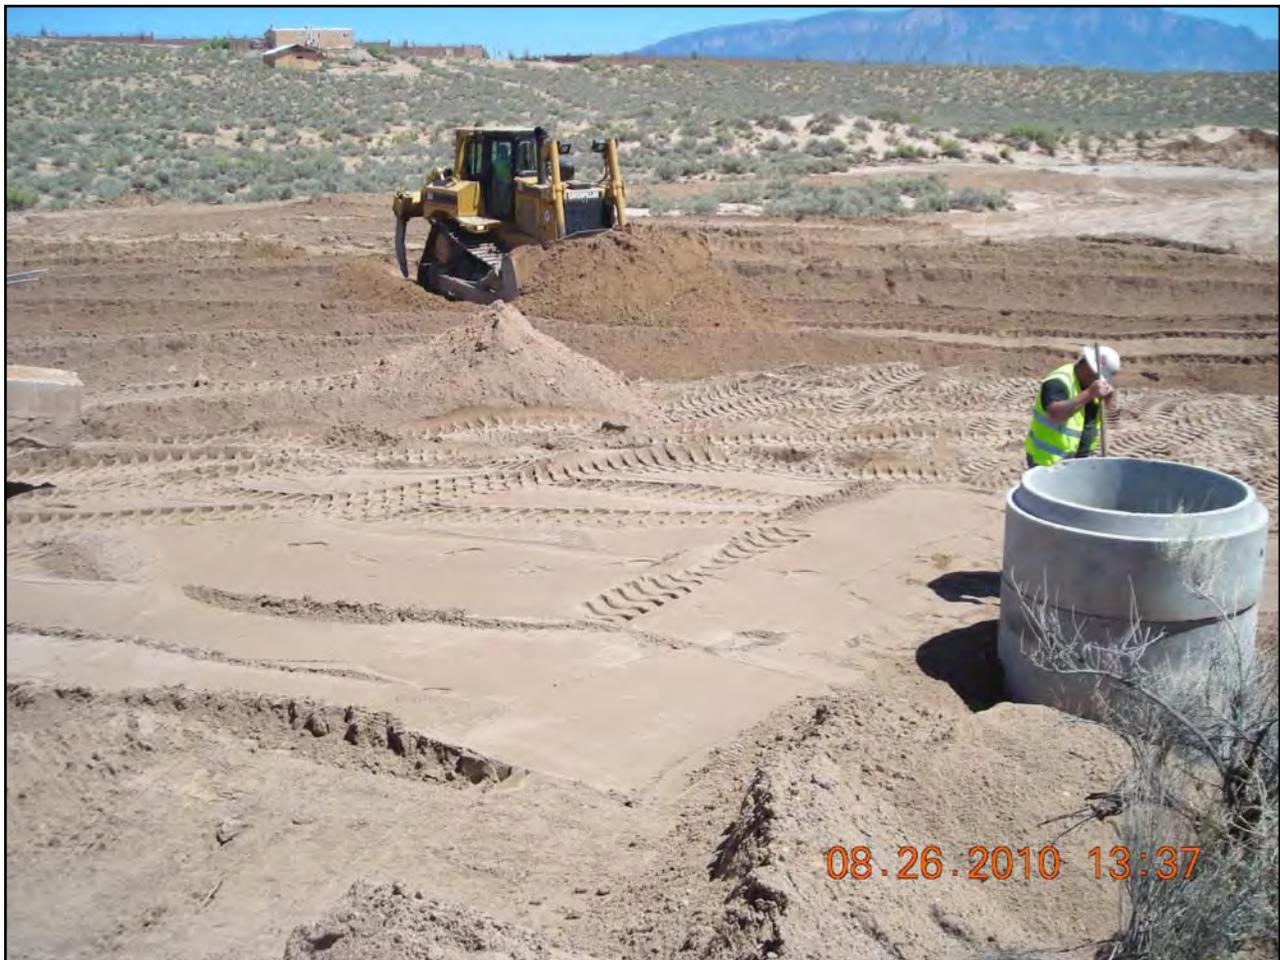
Photo # 7

Photographer: Sarah Holcomb	Date: 8-26-2010	Time: 1337 hours
City/County: Rio Rancho/Sandoval		
Location: Montoyas Arroyo (near the intersection of High Resort and Broadmoor)		
Subject: New manhole installed at break site #1. Crews were backfilling the dirt into the trench and building up the side of the arroyo.

Ms. Holcomb visited the site with Mr. Cliff Leeper and Mr. David Sohns on August 26, 2010 to confirm the fixes. At break site #1, crews had reinstalled 15” line and a new manhole, and were in the process of backfilling the bank of the arroyo. At break site #2, a pipeline fix was underway and crews were integrating the applied HTH into the soil of the arroyo to avoid the next storm flows carrying the chlorine down to the Rio Grande.

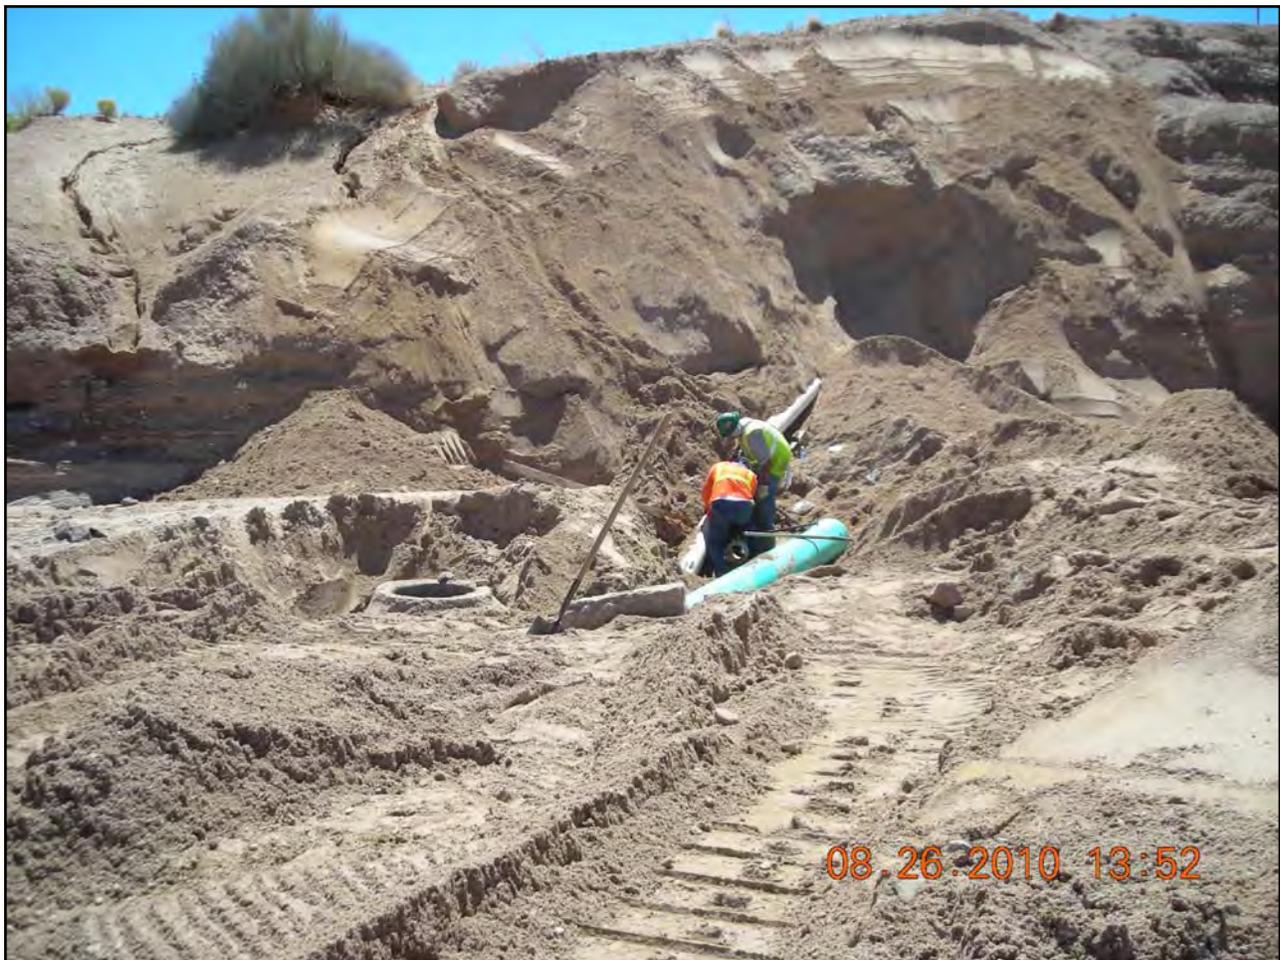
Photo # 8

Photographer: Sarah Holcomb	Date: 8-26-2010	Time: 1352 hours
City/County: Rio Rancho/Sandoval		
Location: Montoyas Arroyo (near the intersection of High Resort and Loma Vista)		
Subject: Pipe repair and new raised manhole underway at break site #2.
