RE: Major Non-municipal, SIC 9711, NPDES Compliance Evaluation Inspection, Los Alamos National Laboratory / Sanitary Effluent Reclamation Facility, NM0028355, March 12, 2013

NPDES Compliance Inspection Report

Los Alamos National Laboratory / Sanitary Effluent Reclamation Facility
NPDES Permit No NM0028355
Compliance Evaluation Inspection
March 12, 2013

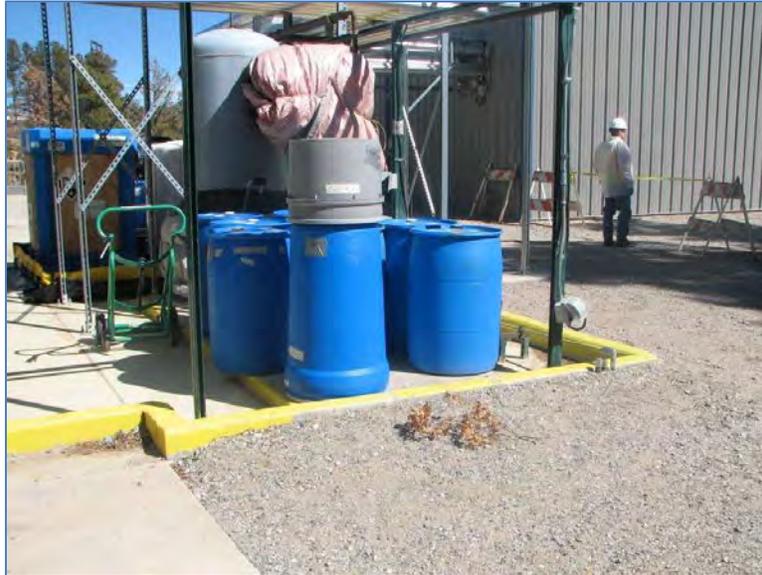
**NMED/SWQB
Official Photograph Log
Photo # 1**

Photographer: G.Herrera, SERF Operator as directed by Erin Trujillo	Date: 03/12/2013	Time: 1155 hours
City/County: Los Alamos County	State: New Mexico	
Location: Los Alamos National Laboratory / Sanitary Effluent Reclamation Facility (SERF) / NM0028355		
Subject: Looking north, container storage at south end of concrete pad with raised berm painted yellow.

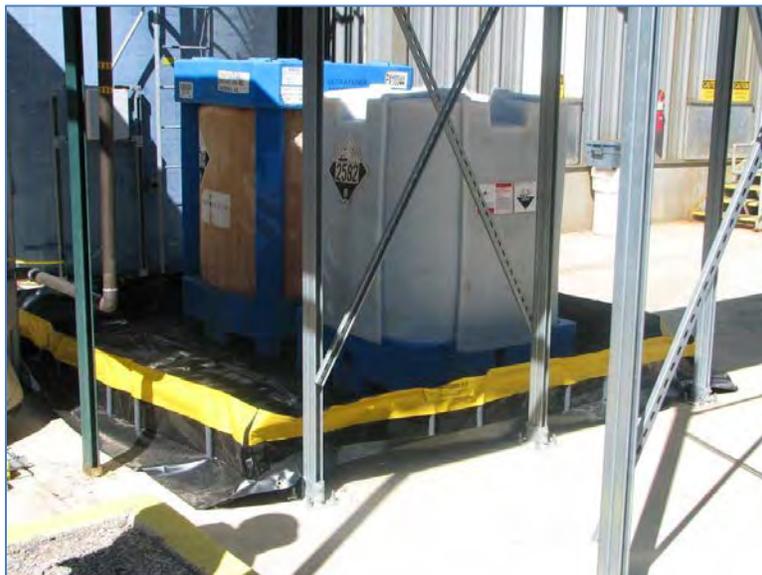
**NMED/SWQB
Official Photograph Log
Photo # 2**

Photographer: G.Herrera, SERF Operator as directed by Erin Trujillo	Date: 03/12/2013	Time: 1159 hours
City/County: Los Alamos County	State: New Mexico	
Location: Los Alamos National Laboratory / Sanitary Effluent Reclamation Facility (SERF) / NM0028355		
Subject: Chemical storage inside portable spill containment.

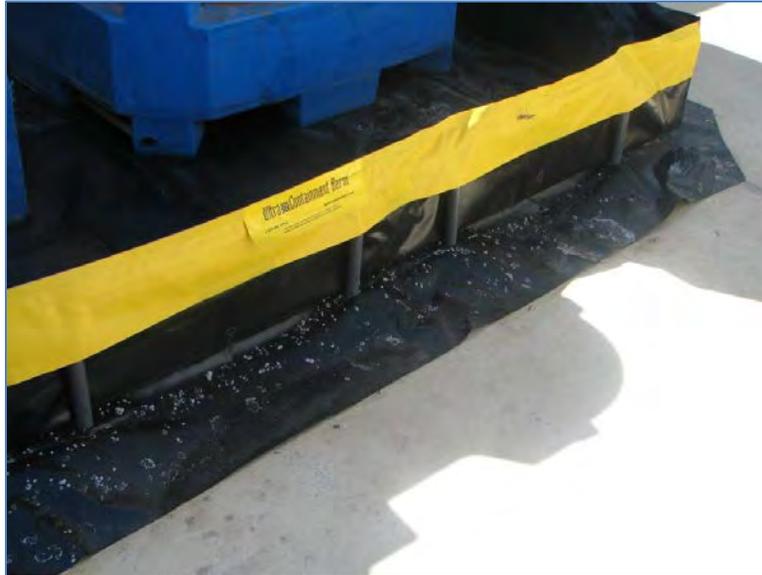
**NMED/SWQB
Official Photograph Log
Photo # 3**

Photographer: G.Herrera, SERF Operator as directed by Erin Trujillo	Date: 03/12/2013	Time: 1201 hours
City/County: Los Alamos County		State: New Mexico
Location: Los Alamos National Laboratory / Sanitary Effluent Reclamation Facility (SERF) / NM0028355		
Subject: White residue or spots on portable spill containment.

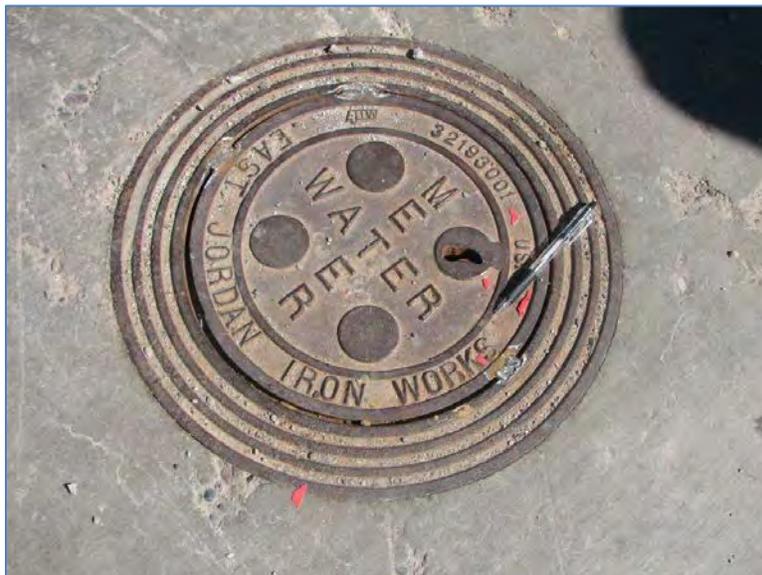
**NMED/SWQB
Official Photograph Log
Photo # 4**

Note: As described below and shown in Photos #4 and 8, the valve vault cover was observed to be tacked welded and the pipe plugged.

Photographer: G.Herrera, SERF Operator as directed by Erin Trujillo	Date: 03/12/2013	Time: 1207 hours
City/County: Los Alamos County		State: New Mexico
Location: Los Alamos National Laboratory / Sanitary Effluent Reclamation Facility (SERF) / NM0028355		
Subject: Tack-welded valve vault cover. The valve was used to release flow to pipe outlet above Sandia Canyon.

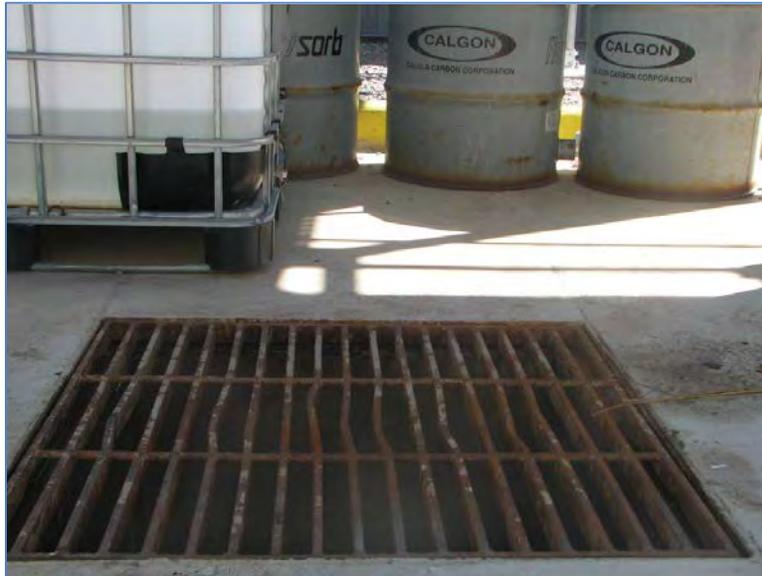
**NMED/SWQB
Official Photograph Log
Photo # 5**

Photographer: G.Herrera, SERF Operator as directed by Erin Trujillo	Date: 03/12/2013	Time: 1210 hours
City/County: Los Alamos County		State: New Mexico
Location: Los Alamos National Laboratory / Sanitary Effluent Reclamation Facility (SERF) / NM0028355		
Subject: Open grate above outside open sump. Exterior chemical pipes in this area shade, but do not provide shelter area from precipitation. Chemical containers (metal caged container) and drums stored on concrete pad.

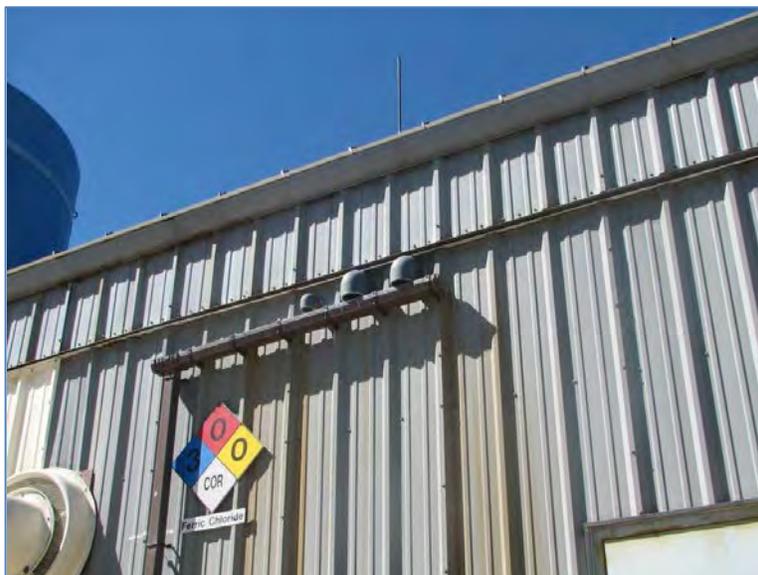
**NMED/SWQB
Official Photograph Log
Photo # 6**

Photographer: G.Herrera, SERF Operator as directed by Erin Trujillo	Date: 03/12/2013	Time: 1211 hours
City/County: Los Alamos County		State: New Mexico
Location: Los Alamos National Laboratory / Sanitary Effluent Reclamation Facility (SERF) / NM0028355		
Subject: Vents for chemical storage tanks. Tanks are inside TA-33-1398 (not shown).

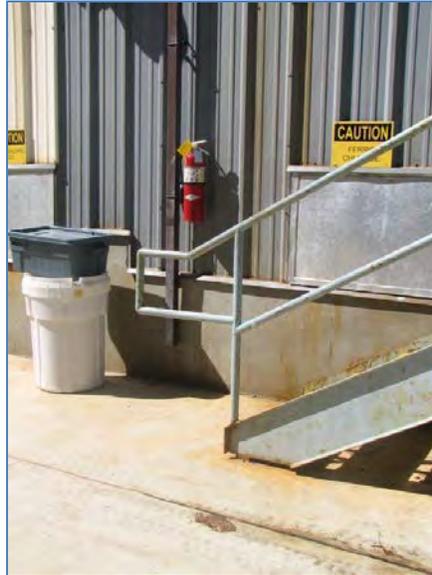
**NMED/SWQB
Official Photograph Log
Photo # 7**

Photographer: G.Herrera, SERF Operator as directed by Erin Trujillo	Date: 03/12/2013	Time: 1212 hours
City/County: Los Alamos County	State: New Mexico	
Location: Los Alamos National Laboratory / Sanitary Effluent Reclamation Facility (SERF) / NM0028355		
Subject: Drain from vents shown in previous photo has downspout on concrete pad. Example of spill kit also shown in photo

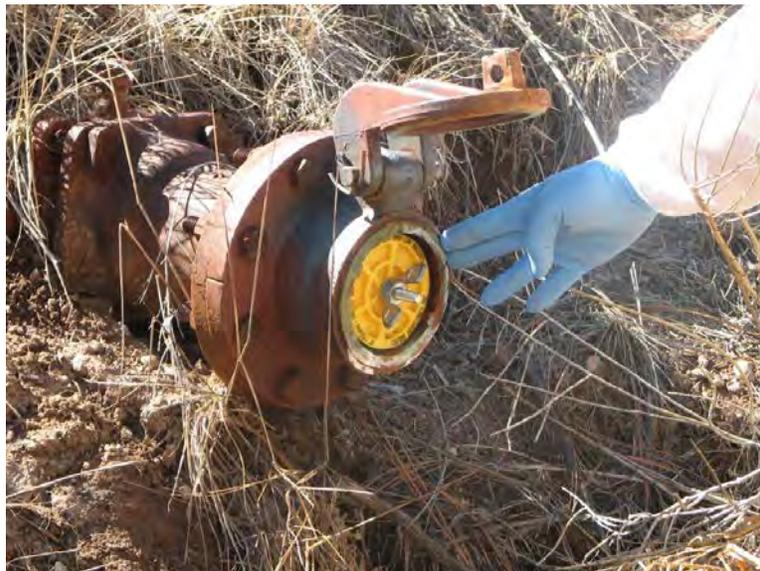
**NMED/SWQB
Official Photograph Log
Photo # 8**

Photographer: G.Herrera, SERF Operator as directed by Erin Trujillo	Date: 03/12/2013	Time: 1213 hours
City/County: Los Alamos County	State: New Mexico	
Location: Los Alamos National Laboratory / Sanitary Effluent Reclamation Facility (SERF) / NM0028355		
Subject: Plug installed in pipe from sump

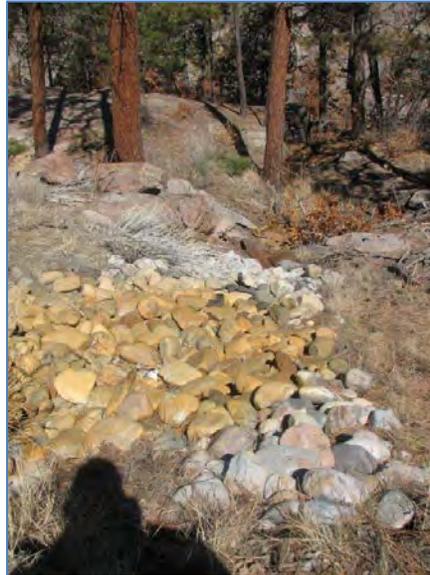
**NMED/SWQB
Official Photograph Log
Photo # 9**

A brown stain was observed on the rock on the slope and channel below the outlet pipe. Water in the channel and at the bedrock outcrop may have been from recent snow melt. Wattle had been installed at and below the bedrock outcrop above Sandia Canyon.

Photographer: G.Herrera, SERF Operator as directed by Erin Trujillo	Date: 03/12/2013	Time: 1214 hours
City/County: Los Alamos County		State: New Mexico
Location: Los Alamos National Laboratory / Sanitary Effluent Reclamation Facility (SERF) / NM0028355		
Subject: A brown staining was observed on the rock on the slope and channel below the outlet pipe shown in previous photo.

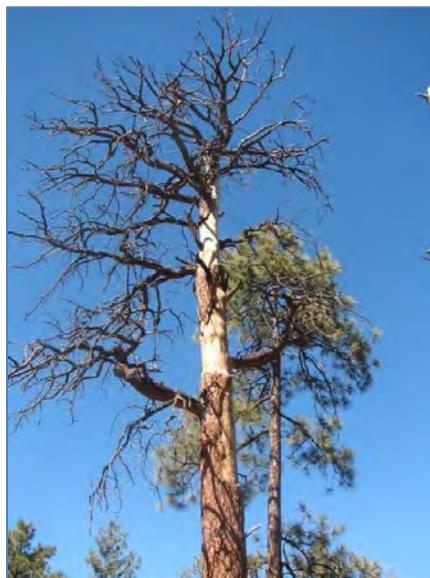
**NMED/SWQB
Official Photograph Log
Photo # 10**

Photographer: G.Herrera, SERF Operator as directed by Erin Trujillo	Date: 03/12/2013	Time: 1216 hours
City/County: Los Alamos County		State: New Mexico
Location: Los Alamos National Laboratory / Sanitary Effluent Reclamation Facility (SERF) / NM0028355		
Subject: Ponderosa Pine (approximately 50 feet north of plugged pipe). On-site representatives noted that this pine was drought stricken.

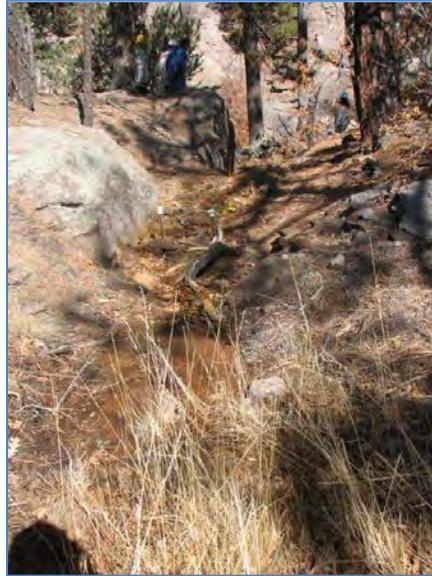
**NMED/SWQB
Official Photograph Log
Photo # 11**

Photographer: G.Herrera, SERF Operator as directed by Erin Trujillo	Date: 03/12/2013	Time: 1218 hours
City/County: Los Alamos County		State: New Mexico
Location: Los Alamos National Laboratory / Sanitary Effluent Reclamation Facility (SERF) / NM0028355		
Subject: Wet channel below plugged pipe. Some staining observed. Water in channel and at bedrock outcrop may have been from recent snow melt.

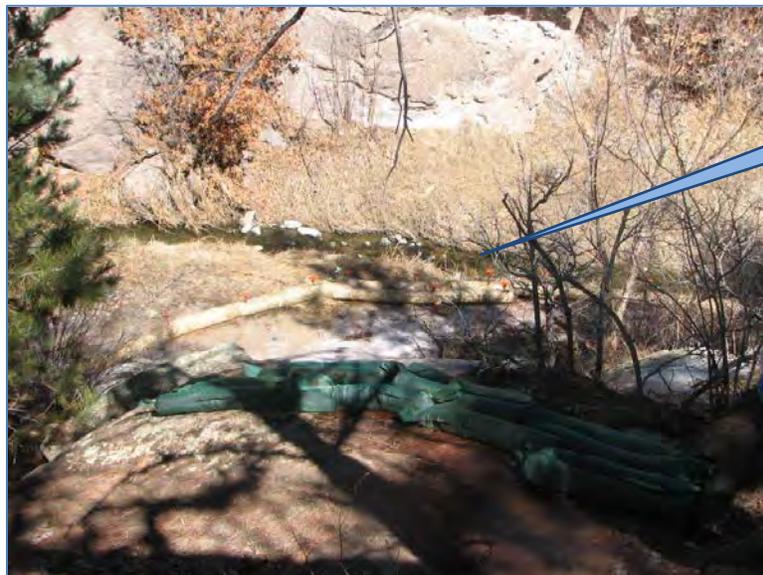
**NMED/SWQB
Official Photograph Log
Photo # 12**

Photographer: G.Herrera, SERF Operator as directed by Erin Trujillo	Date: 03/12/2013	Time: 1221 hours
City/County: Los Alamos County		State: New Mexico
Location: Los Alamos National Laboratory / Sanitary Effluent Reclamation Facility (SERF) / NM0028355		
Subject: Wattle had been installed at and below the bedrock outcrop above Sandia Canyon. Water in bedrock outcrop may have been from recent snow melt. Sandia Canyon is approximately 125 feet north of plugged pipe.

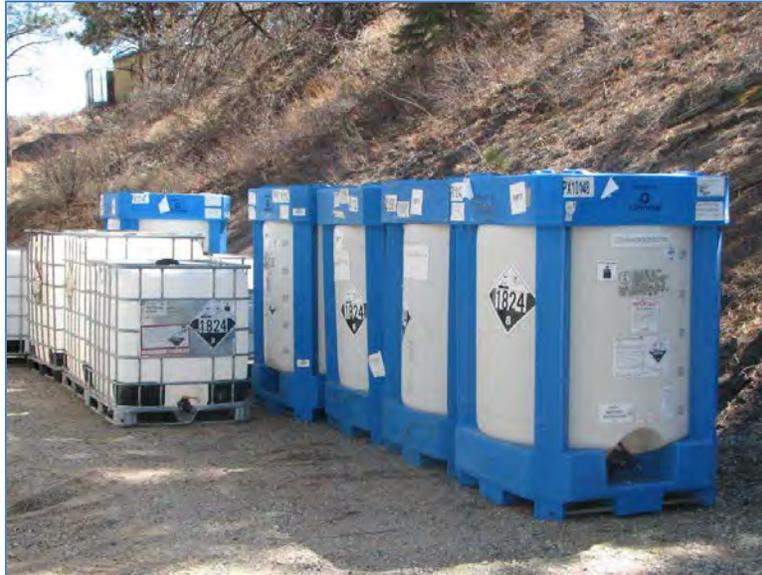
**NMED/SWQB
Official Photograph Log
Photo # 13**

Photographer: G.Herrera, SERF Operator as directed by Erin Trujillo	Date: 03/12/2013	Time: 1228 hours
City/County: Los Alamos County		State: New Mexico
Location: Los Alamos National Laboratory / Sanitary Effluent Reclamation Facility (SERF) / NM0028355		
Subject: Empty bulk storage containers were stored on gravel behind (south side) of TA-3-3093.

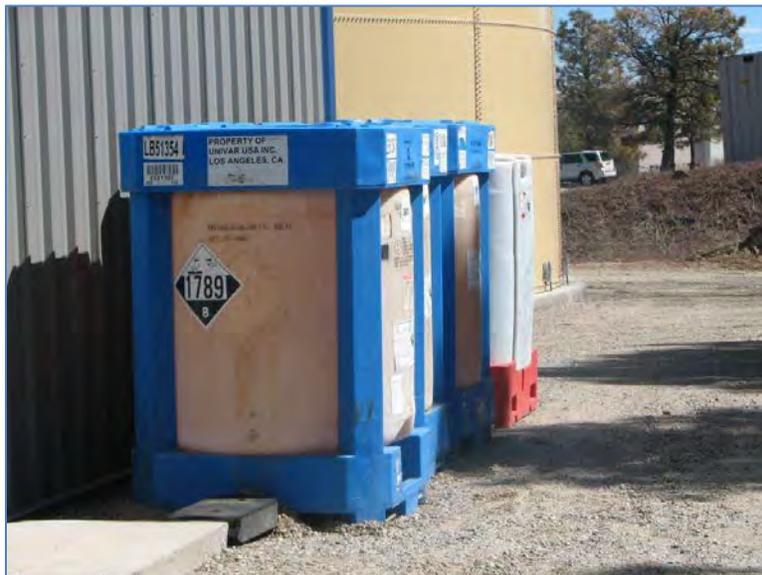
**NMED/SWQB
Official Photograph Log
Photo # 14**

Photographer: G.Herrera, SERF Operator as directed by Erin Trujillo	Date: 03/12/2013	Time: 1228 hours
City/County: Los Alamos County		State: New Mexico
Location: Los Alamos National Laboratory / Sanitary Effluent Reclamation Facility (SERF) / NM0028355		
Subject: Empty bulk storage containers were stored on gravel behind (south side) of TA-3-3093.
