Re: **Minor Non-Municipal; SIC 4952; NPDES Compliance Evaluation Inspection; Harper Valley Homeowners Association; NM0029025; May 23, 2012**

Compliance Evaluation Inspection
Harper Valley Home Owners Association Wastewater Treatment Facility
NPDES Permit No. NM0029025
May 23, 2012

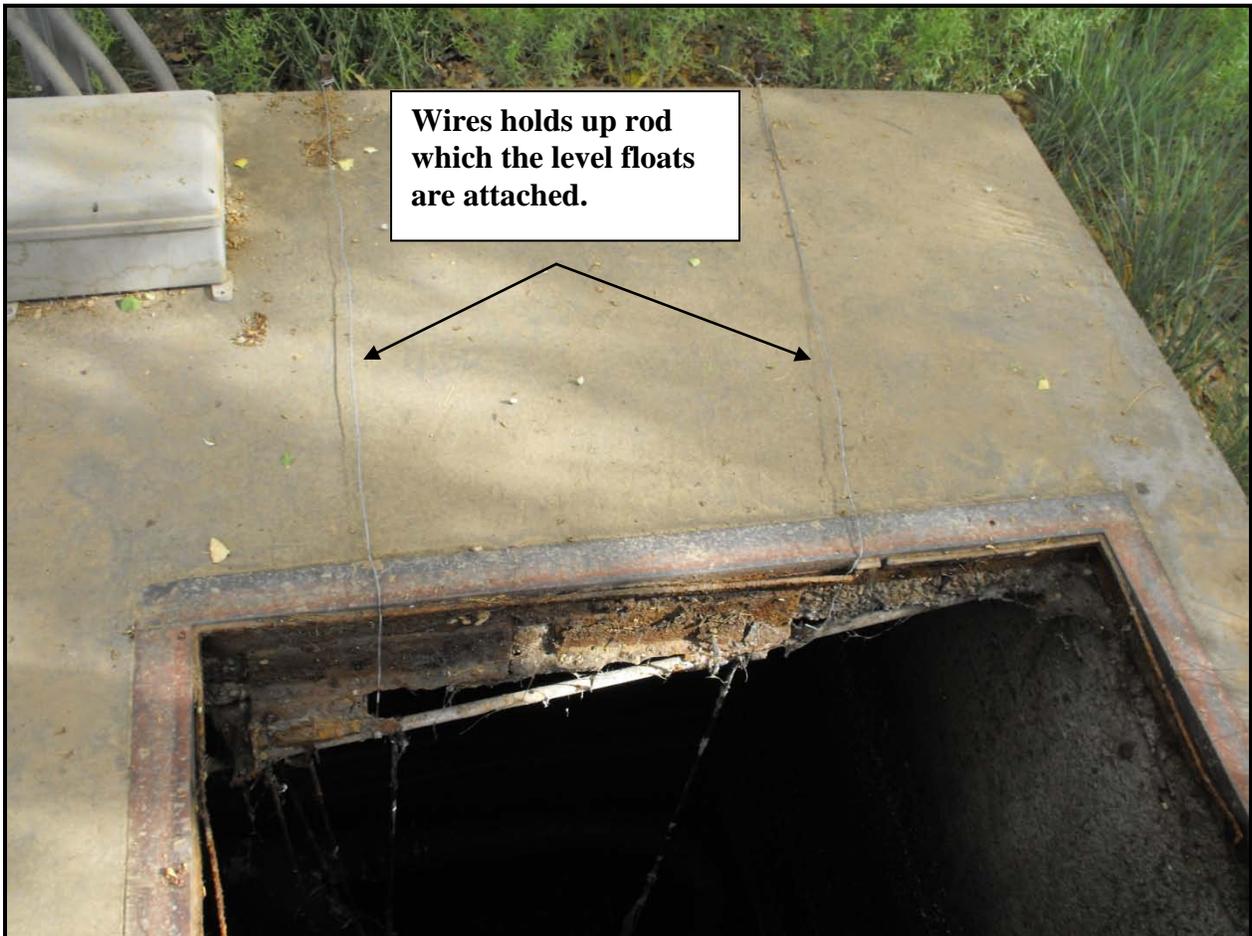
Photo # 1

Raw wastewater flows by gravity to a lift station located up gradient of the WWTP. This WWTP services a small housing development of less than 163 homes. The lift station consists of two pumps and has a holding capacity of 12 hours should the pumps become inoperable. An alarm light is situated on top of the lift control panel and is monitored by Mr. Hathaway when in the area. In the event of a mechanical or power failure, a local septage hauler would be contacted and employed to pump out the wastewater and deliver it to the Farmington WWTP. The lift station has no fence around it and the door has no lock to prevent anyone from opening it. All metal items show heavy corrosion with wire being used to help support level probes, (see photo 1).

- The lift station has no fence around it; the metal door covering the lift station has no lock to keep it from being opened. The floats in the well which trigger the pumps are attached to a bar at the top of the lift station; this bar is held in place on one side by a wire. The other side of the bar is also attached to a wire which helps support it. The wires are connected to the ground outside the lift station, (see photo 1). If the bar fails, the established pumping level and on/off cycles may be non-operational. The lift station is located next to the river.

Photographer: Daniel Valenta	Date: 5/23/2012	Time: 1745
City/County: Community of Harper Valley, Farmington /San Juan County		
Location: Lift station at the south end of Road 6050, Community of Harper Valley, facing south.		
Subject: Entrance to lift station.

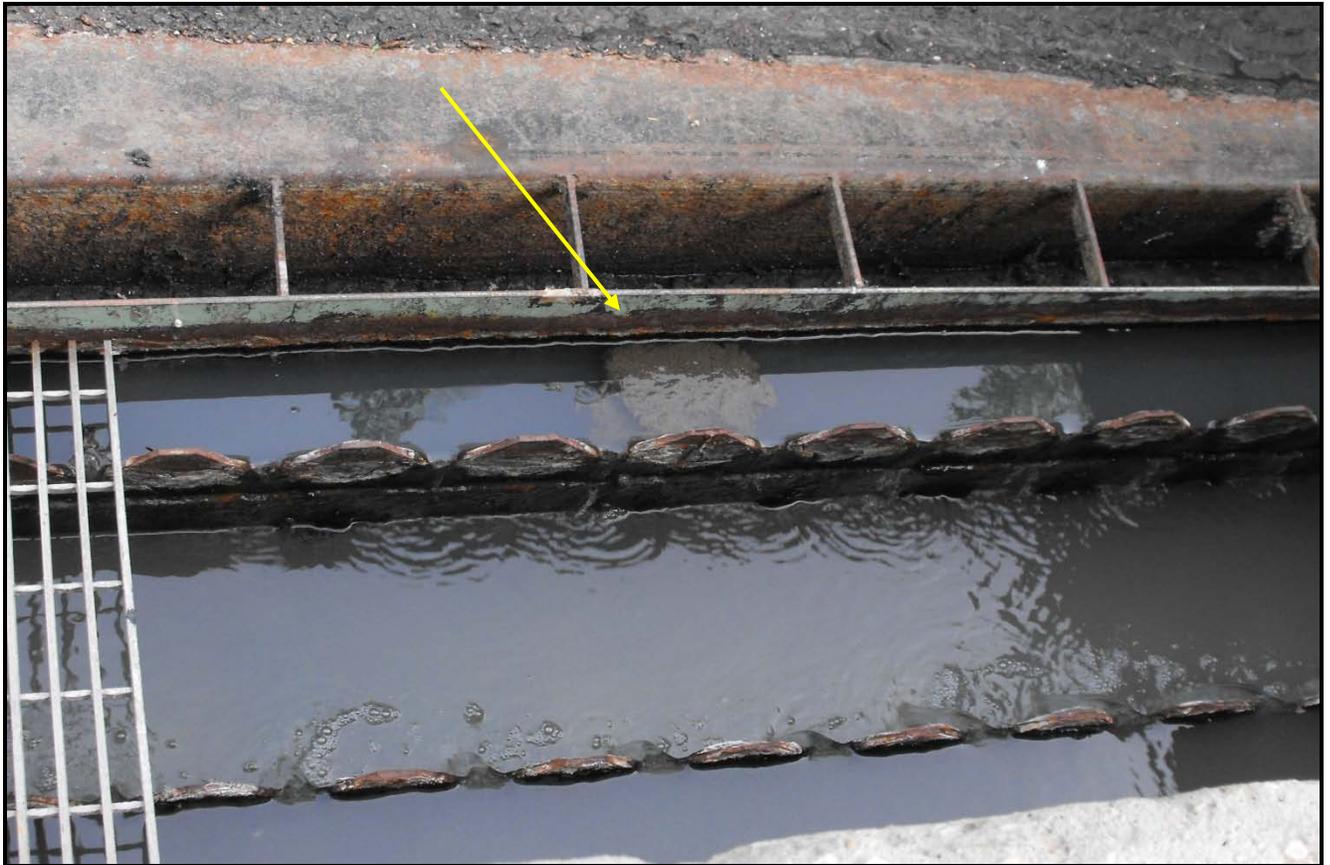
Photo # 2

A set of V-weirs decants wastewater from the aeration basin into a rectangular basin where it flows to the clarifier. At the time of the inspection, the aeration basin weirs were partially clogged with algal growth, brownish scum, and other solids. The aging weir structure showed signs of metal deterioration such as worn notches. The aeration unit discharges to the clarifier when the water level reaches the level of the weir. When the fixed surface aerator is operating water does not flow smoothly through the notched weir but surges and bounces across the teeth carrying solids with it (see photo 2).

Photographer: Daniel Valenta	Date: 5/23/2012	Time: 1833
City/County: Community of Harper Valley, Farmington /San Juan County		
Location: Harper Valley WWTP at the end of road 6070, Community of Harper Valley, looking south.		
Subject: Solids get through the aeration basin weir.

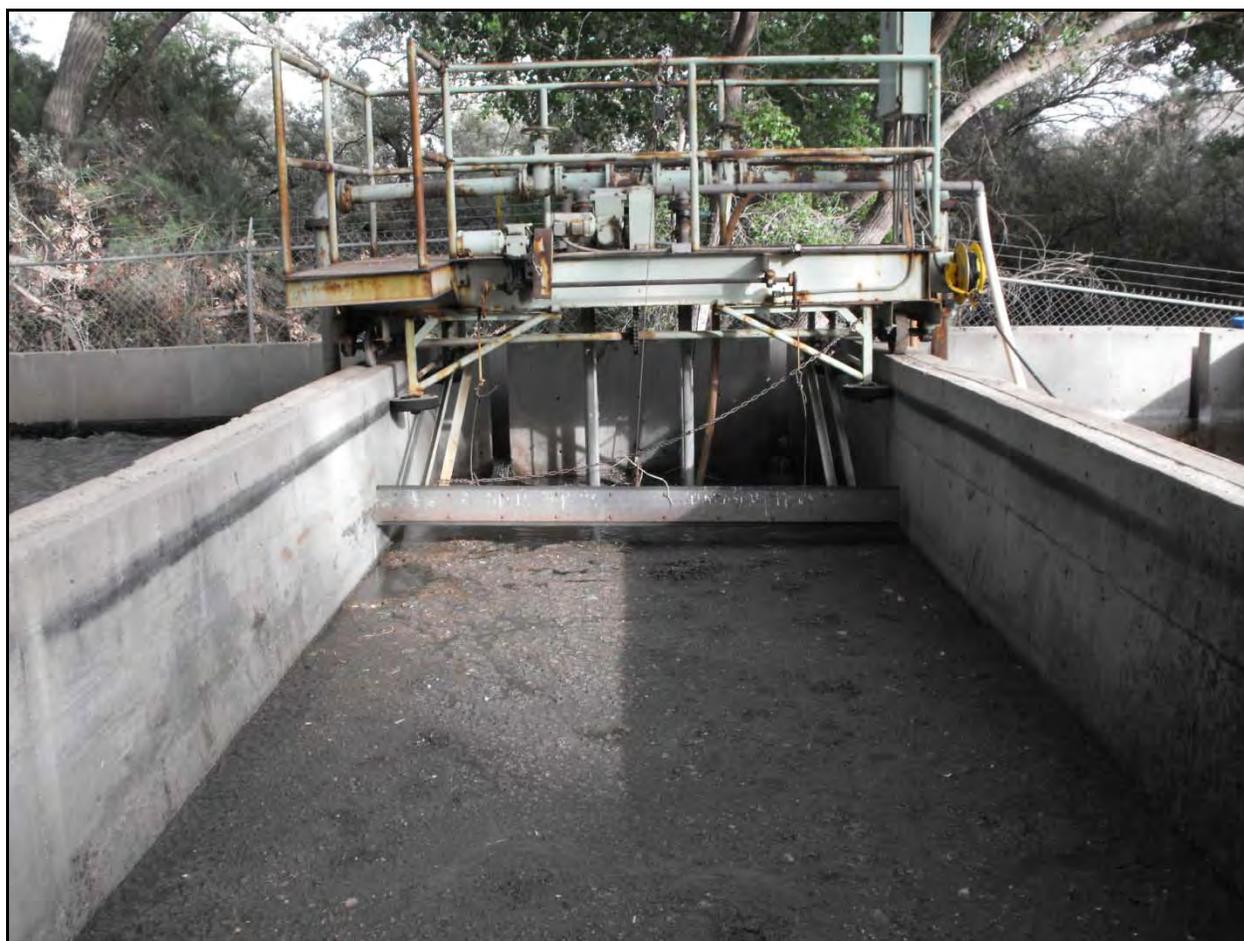
Photo # 3

Clarified effluent flows to the serpentine chlorine contact chamber where calcium hypochlorite tablets in water are set on a continuous drip dosing system. The tablets at times fail to completely dissolve and at times clog the chlorine injector. The effluent had a gray cloudy appearance, solids/grease/scum was floating in the chlorine contact chamber (see photo 3 & 4).

Photographer: Daniel Valenta	Date: 5/23/2012	Time: 1834
City/County: Community of Harper Valley, Farmington /San Juan County		
Location: Harper Valley WWTP at the end of road 6070, Community of Harper Valley, looking south.		
Subject: Clarifier chamber, oil/grease balls floating in the scum blanket, a sludge depth measurement was unavailable.

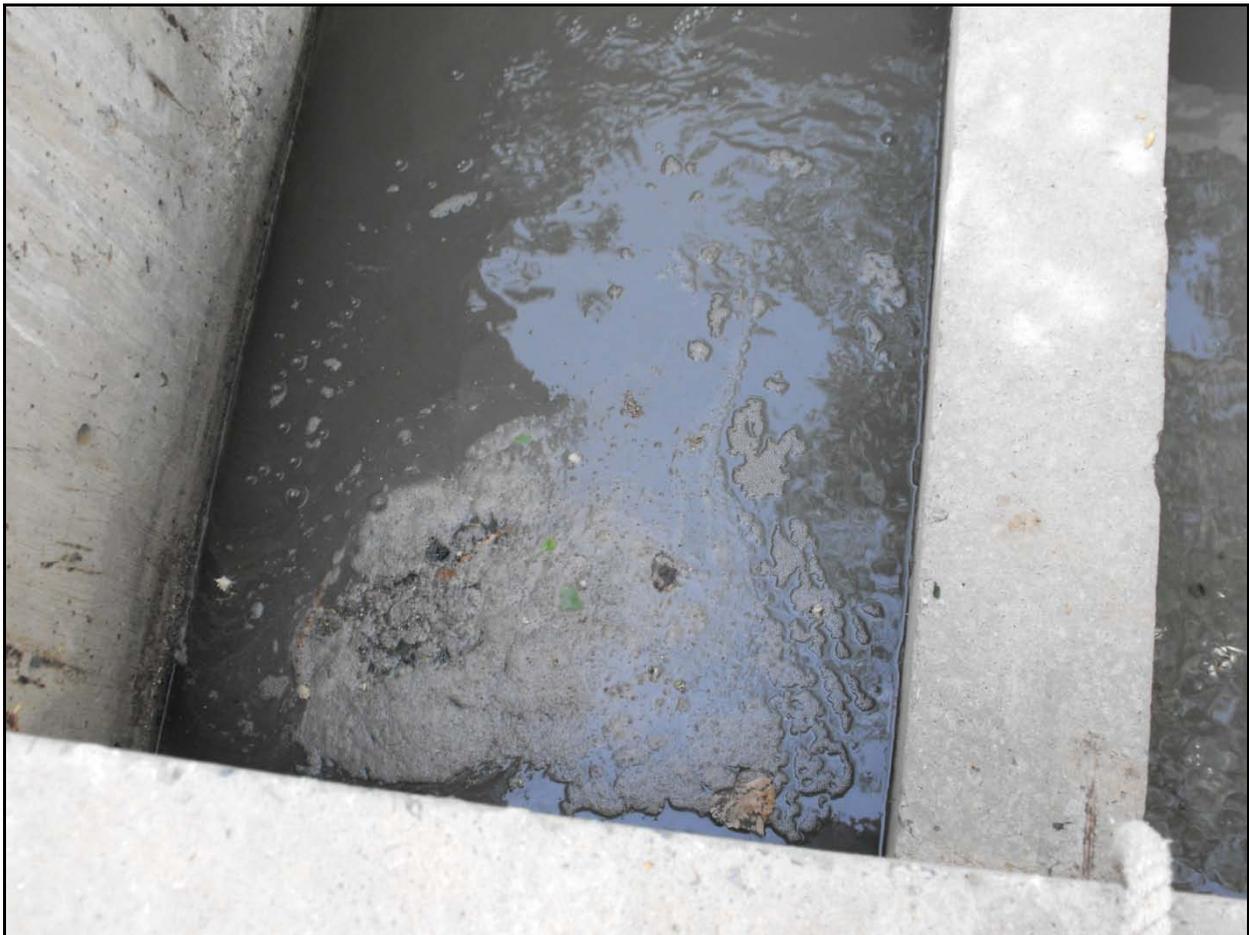
Log Photo # 4

Solids could be seen discharging from the chlorine contact chamber into the pipe flowing into the San Juan River (see photos 4 & 5).

Photographer: Daniel Valenta	Date: 5/23/2012	Time: 1840
City/County: Community of Harper Valley, Farmington /San Juan County		
Location: Harper Valley WWTP at the end of road 6070, Community of Harper Valley, looking west.		
Subject: Scum floating on top of the chlorine contact chamber, a sludge depth measurement was unavailable.

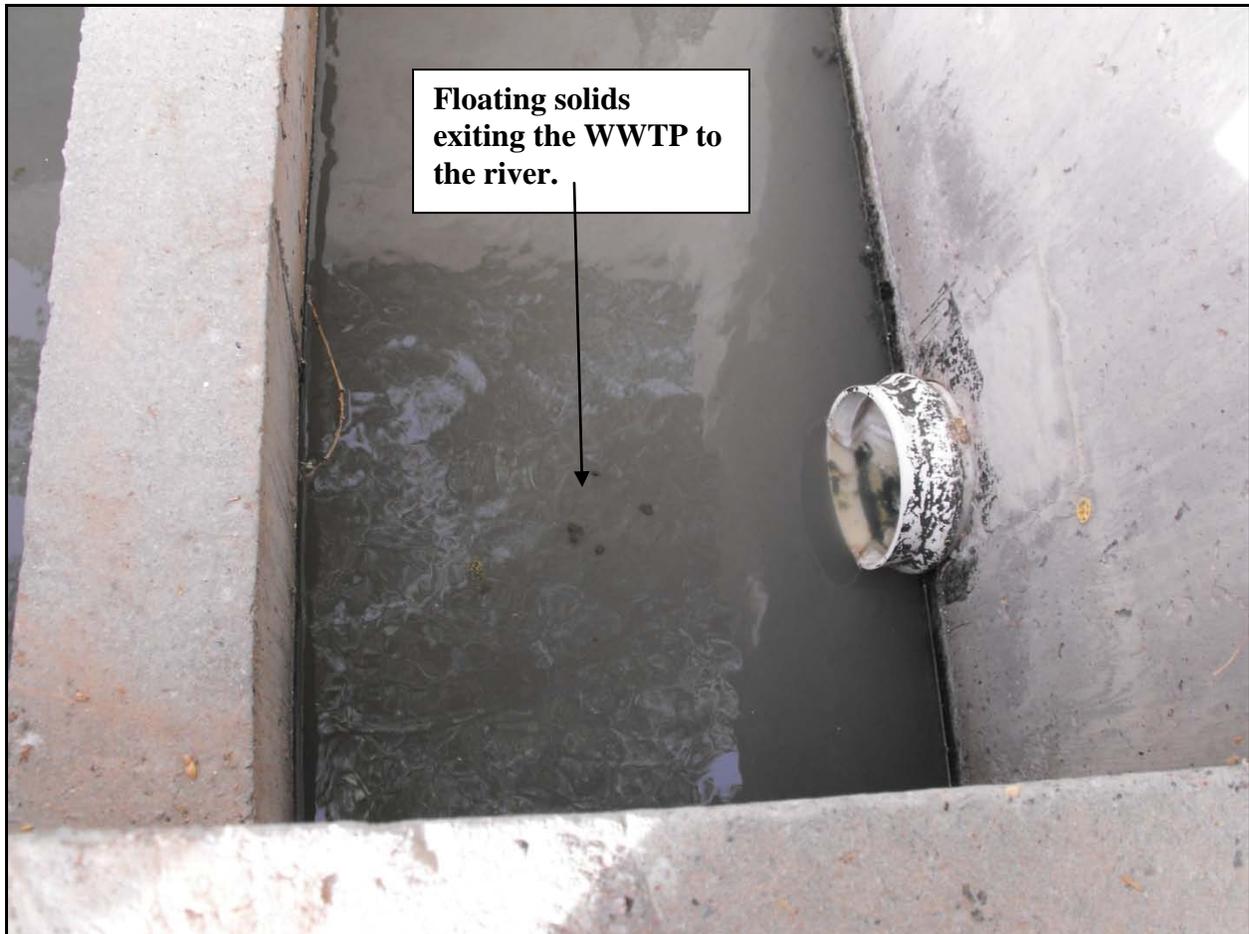
Log Photo # 5

Photographer: Daniel Valenta	Date: 5/23/2012	Time: 1842
City/County: Community of Harper Valley, Farmington /San Juan County		
Location: Harper Valley WWTP at the end of road 6070, Community of Harper Valley, looking west.		
Subject: Discharge pipe from the chlorine contact chamber to the river.

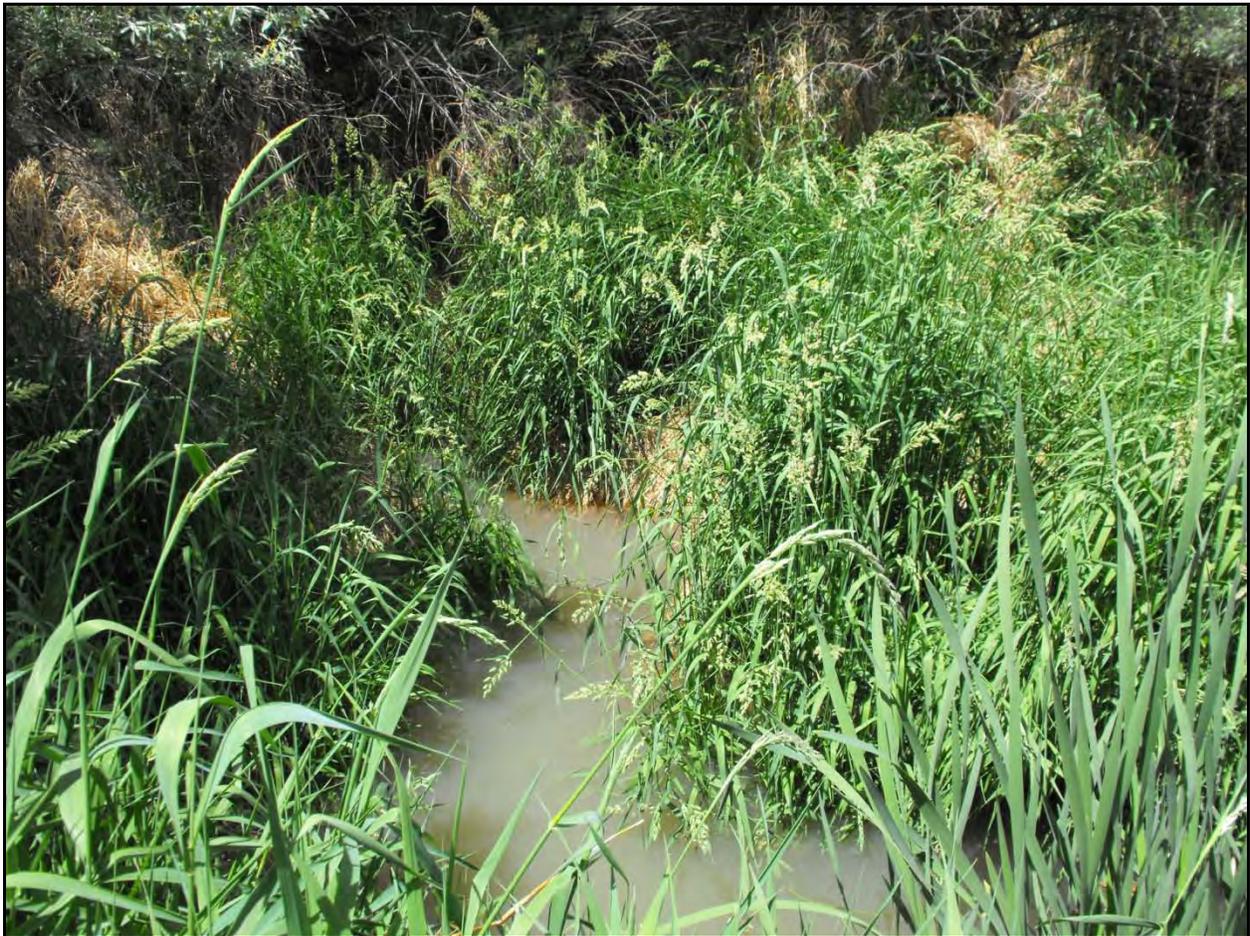
Log Photo # 6

Photographer: Daniel Valenta	Date: 5/23/2012	Time: 1418
City/County: Community of Harper Valley, Farmington /San Juan County		
Location: Harper Valley WWTP at the end of road 6070, Community of Harper Valley, looking northwest.		
Subject: Discharge from Outfall 001, Harper Valley WWTP, as it flows into the San Juan River.
