**NEW MEXICO
ENVIRONMENT DEPARTMENT**

RE: Minor Non-Municipal; SIC 4952; NPDES Compliance Evaluation Inspection; Ranchland Utilities; NM0030368; May 8, 2012

**Compliance Evaluation Inspection
Ranchland Utilities Water Reclamation Facility
NPDES Permit No. NM0030368
May 8, 2012**

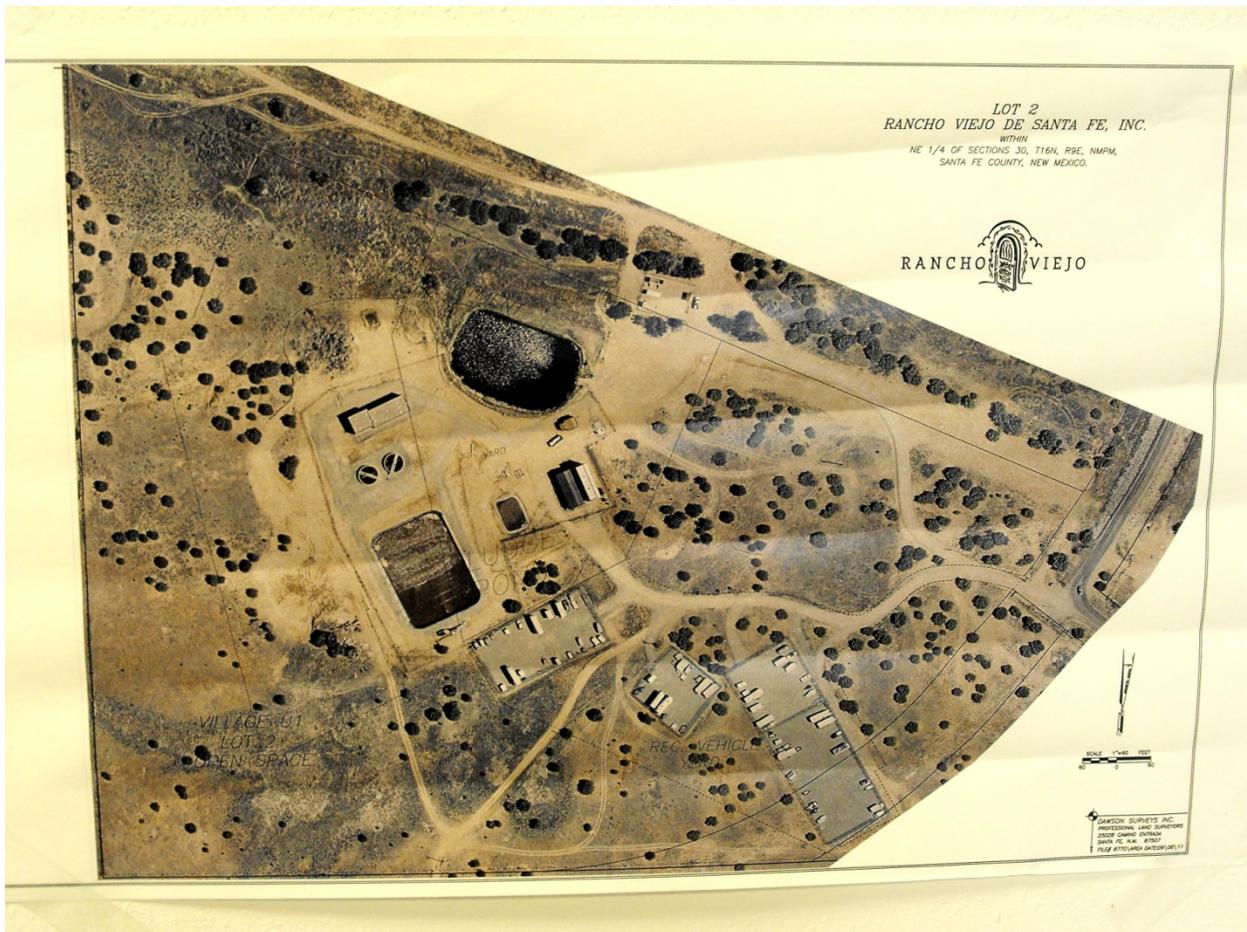
**NMED/SWQB
Official Photograph Log
Photo # 1**

Photographer: Daniel Valenta	Date: May 8, 2012	Time: N/A
City/County: Santa Fe / Santa Fe	State: New Mexico	
Location: Ranchland Utilities		
Subject: Overview of Ranchland Utilities Treatment Plant

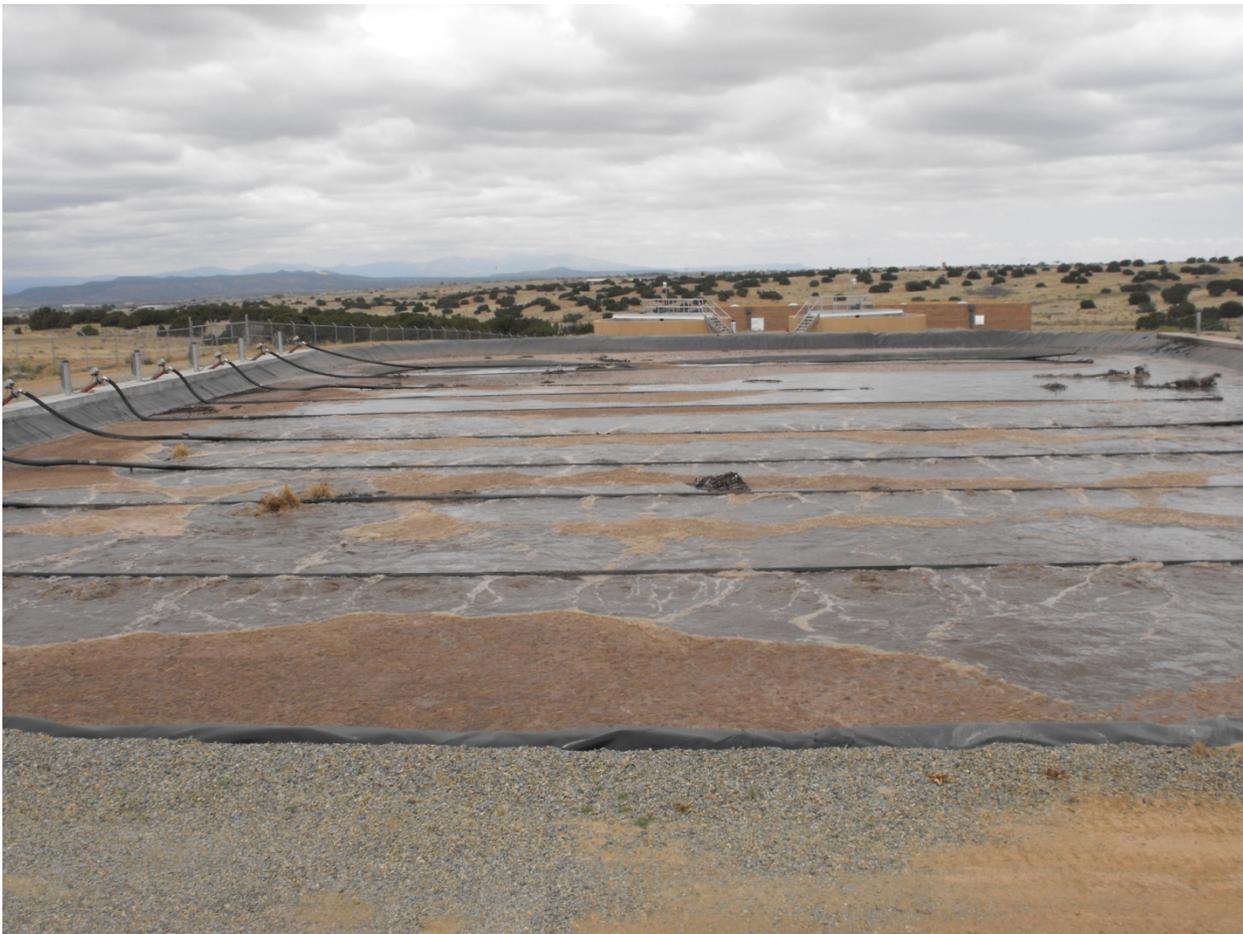
NMED/SWQB
Official Photograph Log
Photo # 2

The biolac system has floating solids as well as noticeable grease. Some of the fine bubble diffusers were malfunctioning. The permittee purchased a boat to enable the operator to get into the biolac pond, however, there is no ramp to allow for the boat to enter the pond. Therefore, the operator has no way of accessing the pond to clean it out and maintain the diffusers.

Photographer: Daniel Valenta	Date: May 8, 2012	Time: 1052 Hours
City/County: Santa Fe / Santa Fe		State: New Mexico
Location: Ranchland Utilities		
Subject: Looking north – biolac basin.

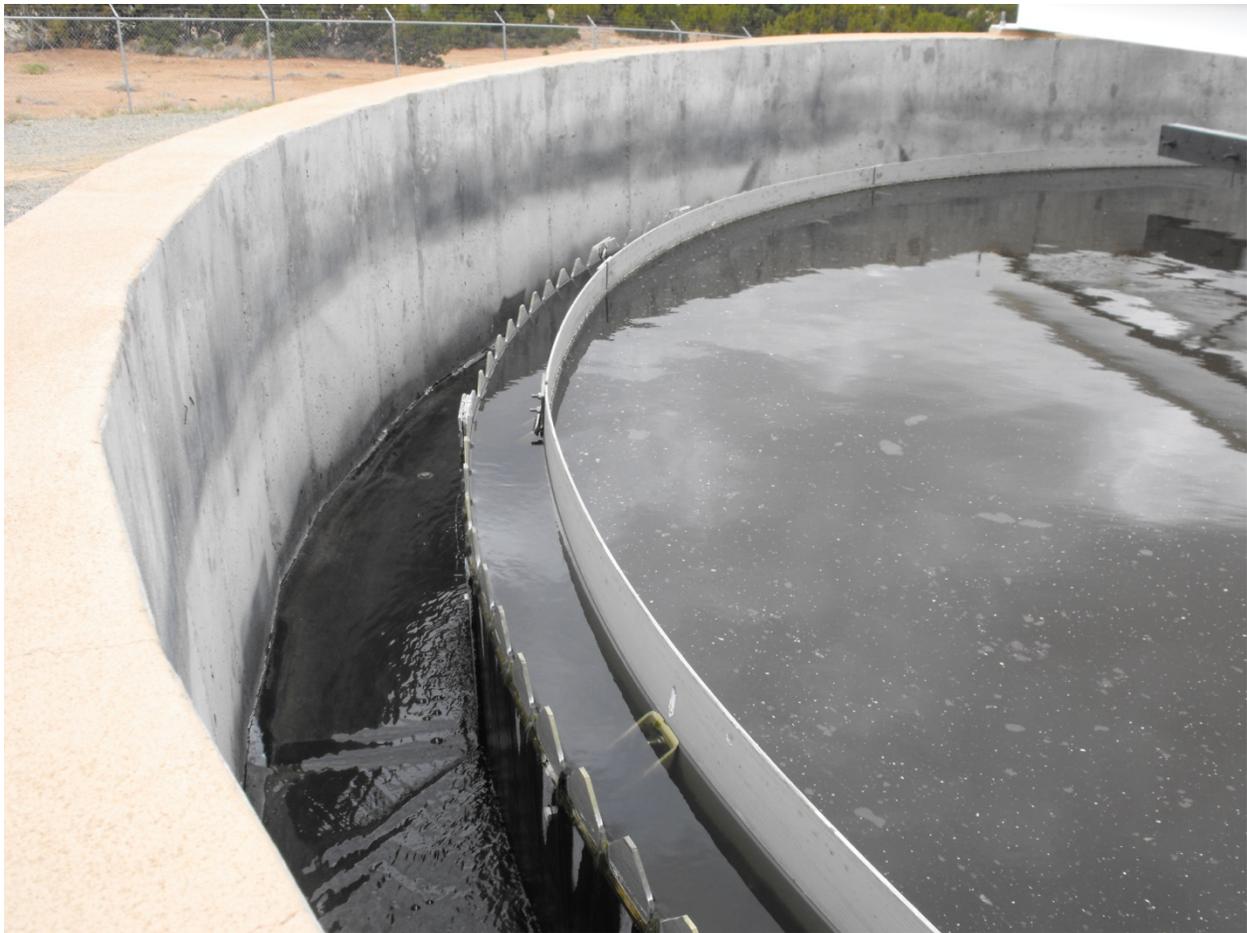
NMED/SWQB
Official Photograph Log
Photo # 3

Photographer: Daniel Valenta	Date: May 8, 2012	Hours: 1058
City/County: Santa Fe / Santa Fe		State: New Mexico
Location: Ranchland Utilities		
Subject: West Clarifier

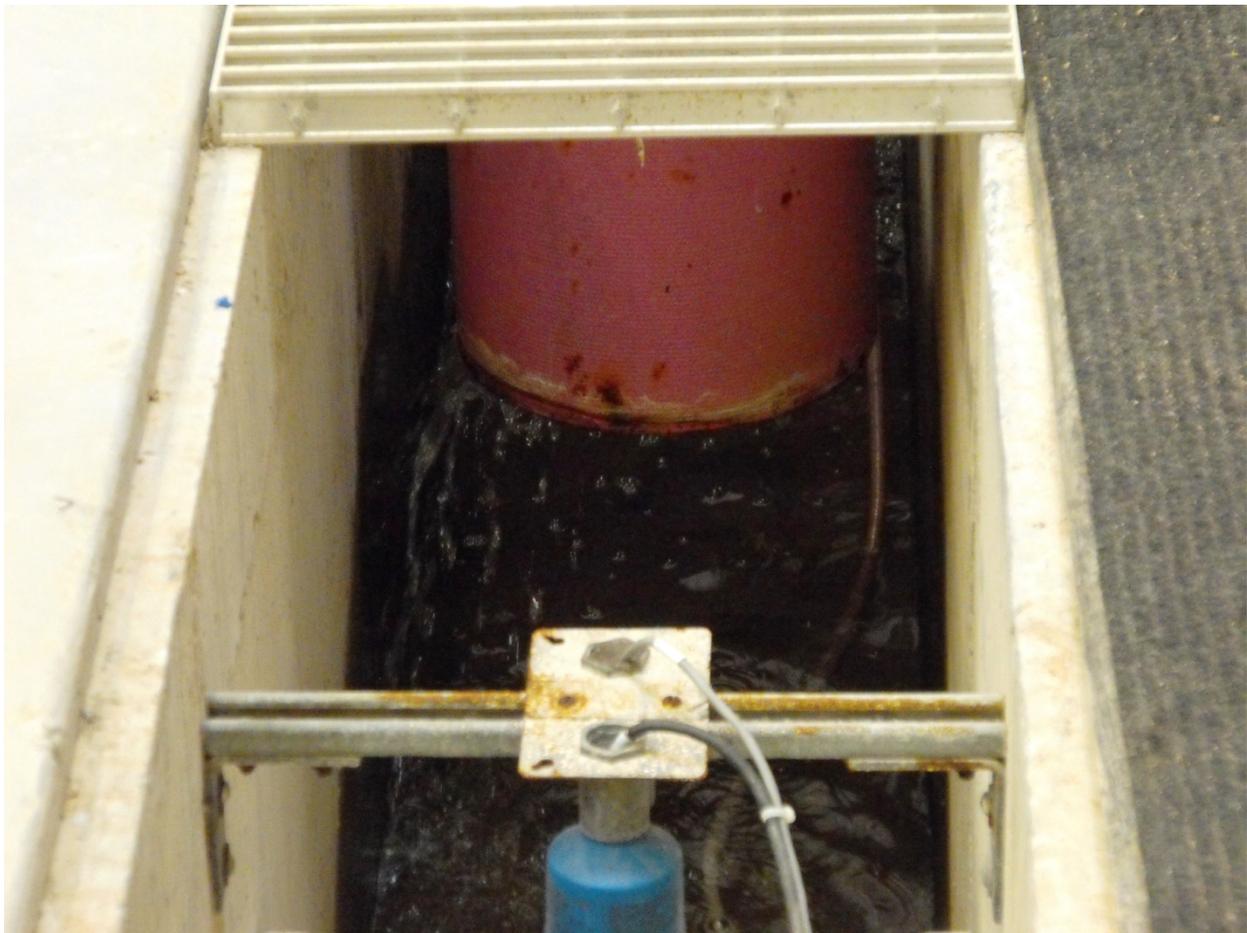
NMED/SWQB
Official Photograph Log
Photo # 4

The permittee has two channels of ultraviolet lights for disinfection. The operator can switch weekly from each channel for disinfection. However, on this date, it was noted that the non-functioning ultraviolet channel had some flow going through it, which indicates that there is a faulty valve that is not closing completely. This effluent is leaving the facility without proper disinfection.

Photographer: Daniel Valenta	Date: May 8, 2012	Hours: 1107
City/County: Santa Fe / Santa Fe		State: New Mexico
Location: Ranchland Utilities		
Subject: South effluent pipes which were discharging, however, no UV disinfection was occurring from this side. There is an apparent faulty valve which does not close completely and allows undisinfectated effluent to leave treatment plant.

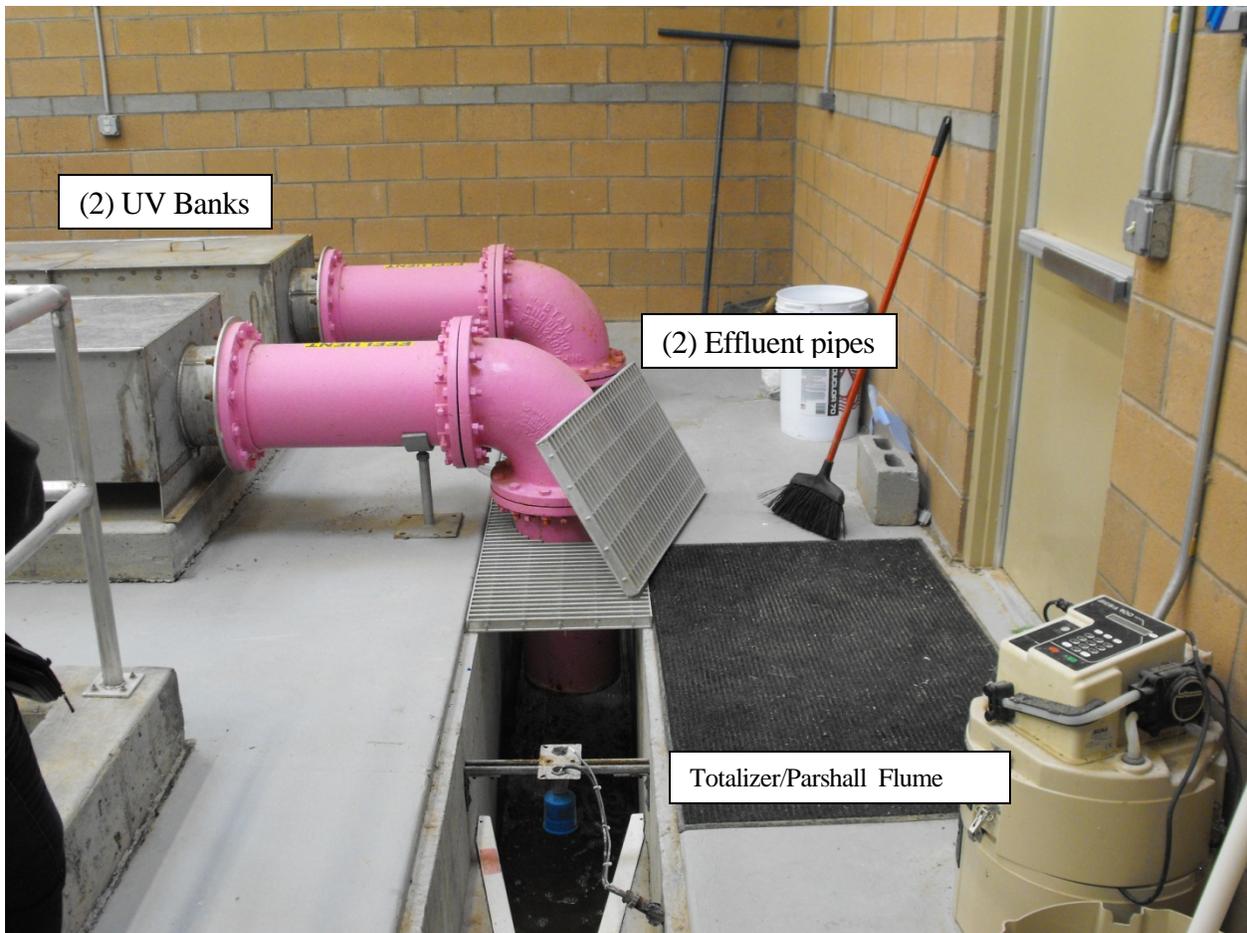
NMED/SWQB
Official Photograph Log
Photo # 5

Photographer: Daniel Valenta	Date: May 8, 2012	Hours: 1107
City/County: Santa Fe / Santa Fe		State: New Mexico
Location: Ranchland Utilities		
Subject: Overview of UV banks (North UV bank was on-line, south UV bank discharging as well – see previous picture)

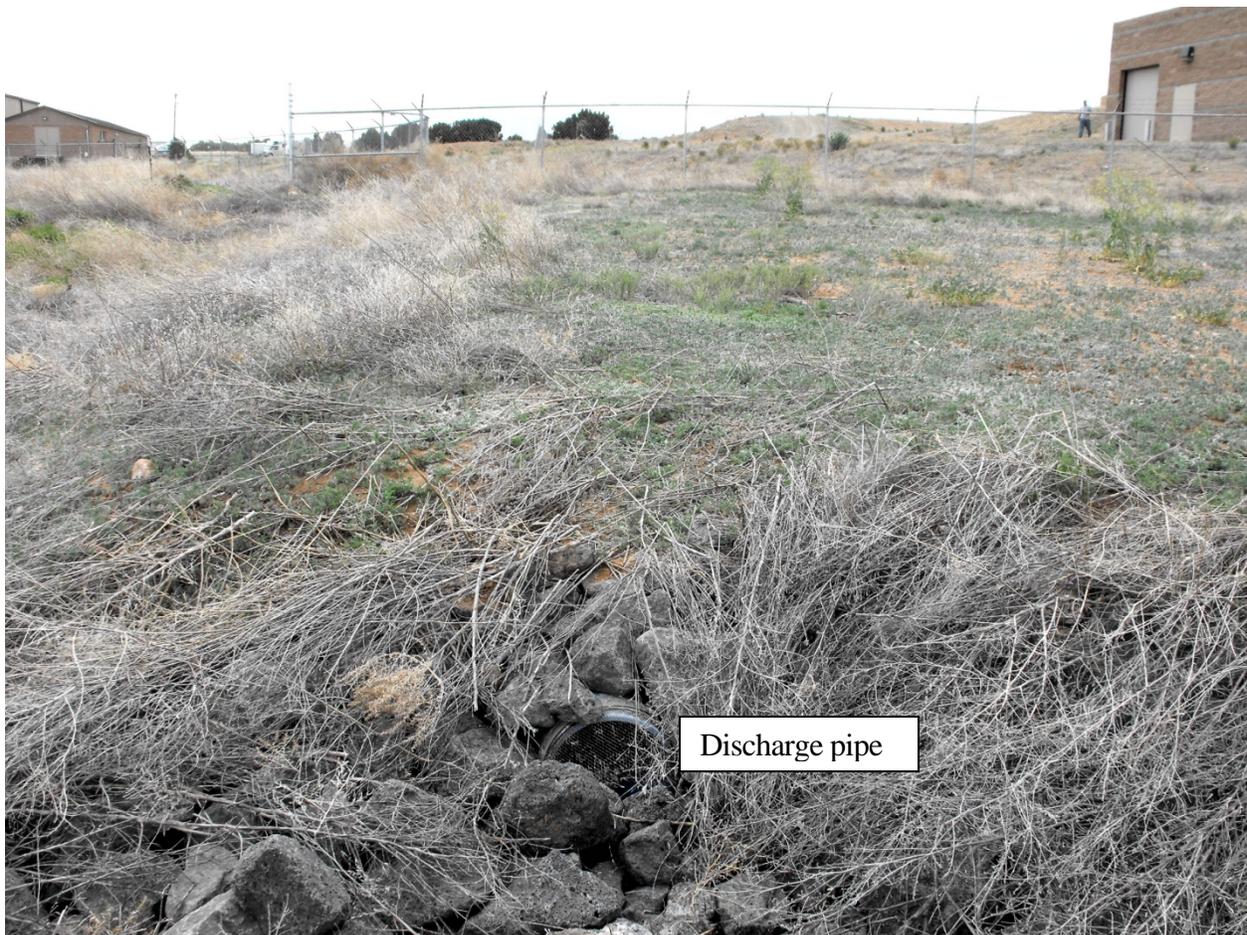
NMED/SWQB
Official Photograph Log
Photo # 6

When the inspectors and the operator went to the discharge pipe at this facility, it was noted that the pipe was discharging and the area around the pipe had green vegetation. This may be an indication of prolonged discharge. The effluent was apparently supposed to be discharging only to the retention pond. However, it was also noted that the bank of the pond had been breached and effluent was entering the discharge channel from the pond as well. The operator stated that he would fix the embankment of the pond as soon as possible and was going to try and replace the valve which apparently was not shutting all the way to the discharge pipe. It is unclear how long this discharge has been occurring. No sampling has been occurring on the months that the operator has stated "no discharge" on their DMRs.

The permittee has submitted DMRs with “No Discharge” checked on the box. However, as noted during this inspection, the permittee is discharging effluent to Canada Del Rancho rather than having all effluent enter the retaining pond for irrigation purposes. The permittee should replace the faulty valve as soon as possible. It is unclear how long the permittee has been discharging and checking the “no discharge” box on their DMRs. The permittee has not checked their discharge location in a number of months prior to this inspection.

Photographer: Daniel Valenta	Date: May 8, 2012	Hours: 1217
City/County: Santa Fe / Santa Fe		State: New Mexico
Location: Ranchland Utilities		
Subject: Discharge location at Ranchland Utilities. Upon inspection, the permittee stated that all effluent was being discharged to the retention pond, however, there was effluent leaving the discharge point as well. No sampling has occurred.

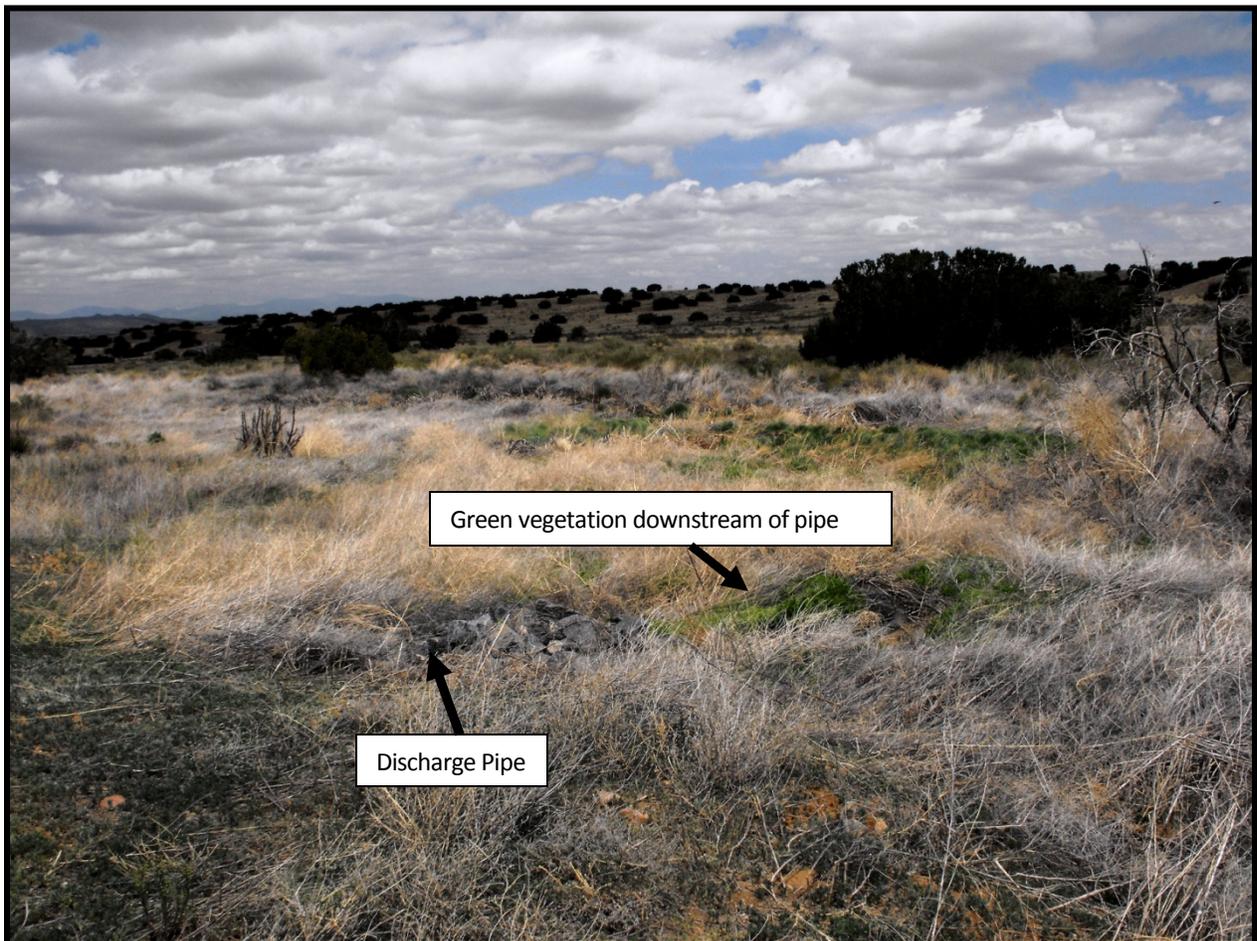
NMED/SWQB
Official Photograph Log
Photo # 7

Photographer: Daniel Valenta	Date: May 8, 2012	Hours: 1218
City/County: Santa Fe / Santa Fe		State: New Mexico
Location: Ranchland Utilities		
Subject: Discharge location at Ranchland Utilities. Upon inspection, the permittee stated that all effluent was being discharged to the retention pond, however, there was effluent leaving the discharge point as well. No sampling has occurred.

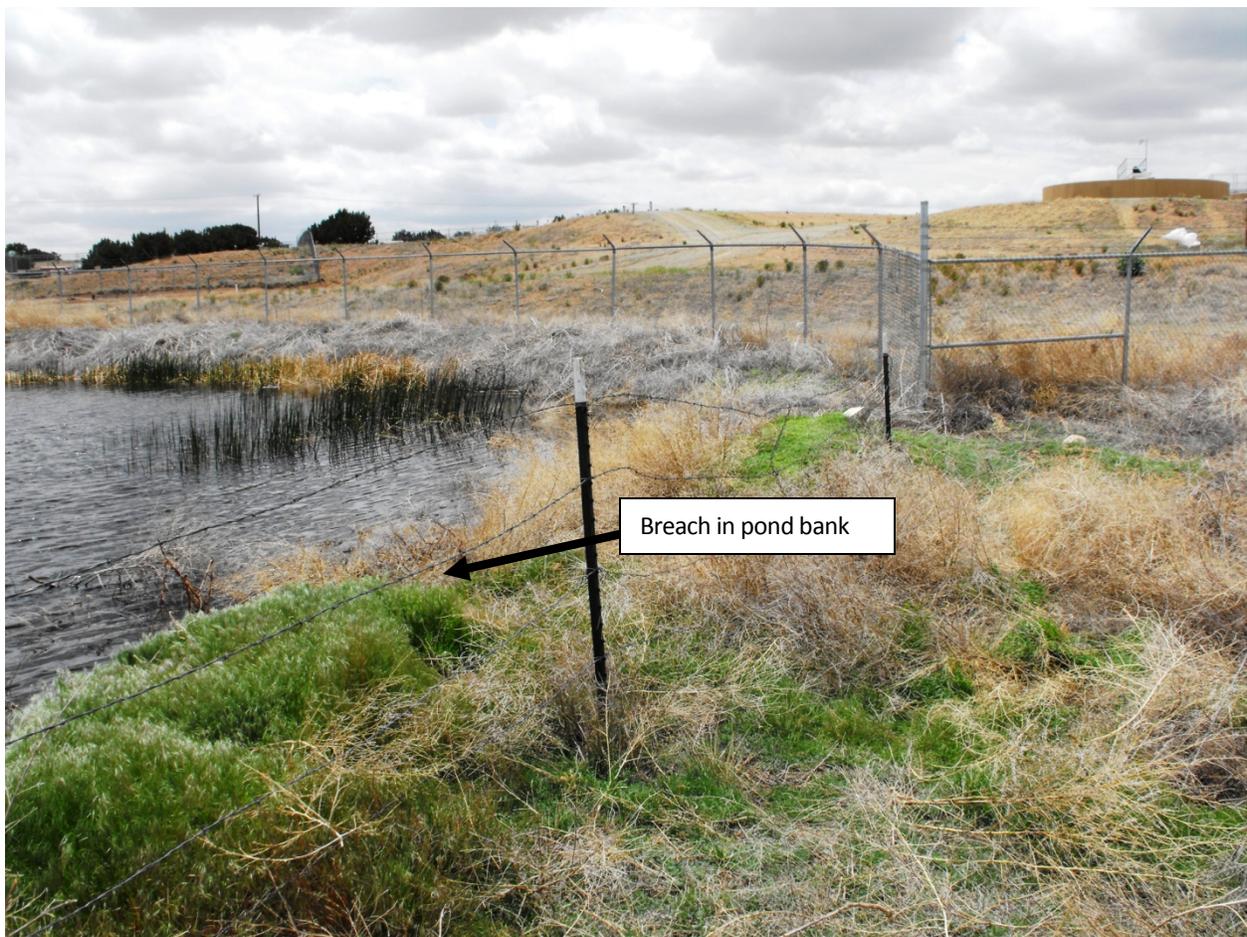
NMED/SWQB
Official Photograph Log
Photo # 8

Photographer: Daniel Valenta	Date: May 8, 2012	Hours: 1217
City/County: Santa Fe / Santa Fe		State: New Mexico
Location: Ranchland Utilities		
Subject: Retention pond
