NEW MEXICO
ENVIRONMENT DEPARTMENT

RE: Industrial Storm Water, SIC 4911, NPDES Compliance Evaluation Inspection, City of Farmington, Electric Utility System, Animas Power Plant, NMR05B19, October 14, 2010

**City of Farmington, Electric Utility System, Animas Power Plant
Industrial Storm Water Compliance Evaluation Inspection
NPDES Tracking Number NMR05B19
October 14, 2010**

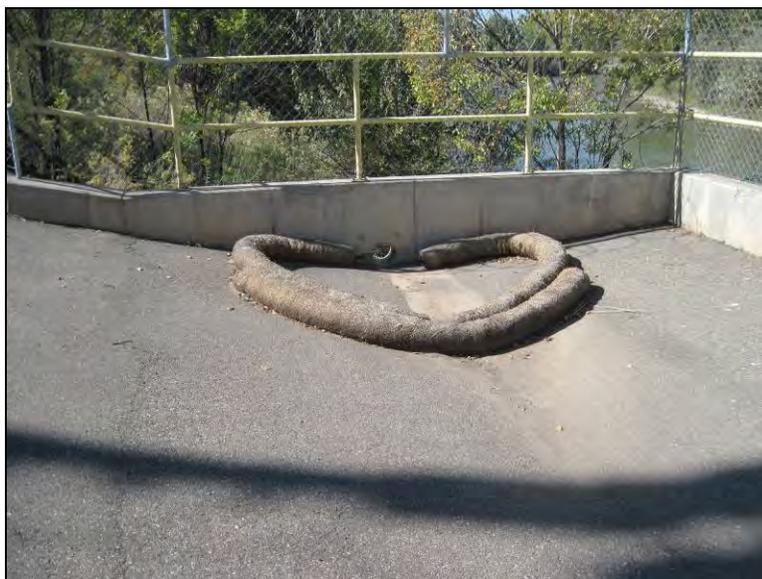
**NMED/SWQB
Official Photograph Log
Photo # 1**

However, straw wattles were not properly installed to overlap along the eastern property boundary (see Photo #3). Also, the storm drain near the Hydro Power Plant had accumulated sediment inside the inlet protection that needed to be removed (see Photo #1). As previously discussed, erosion was observed at the northern site boundary in Area II (see Photo #4 and #5). Additional corrective action to manage runoff appears needed along the northern property boundary (e.g., detention ponds, flow attenuation, velocity dissipation, etc.).

Photographer: Erin S. Trujillo	Date: 10/14/2010	Time: 1134 hours
City/County: Farmington / San Juan County	State: New Mexico	
Location: Farmington Animas Power Plant		
Subject: Accumulated sediment at storm drain inlet to outfall near Hydro Power Plant. Animas River is in background.

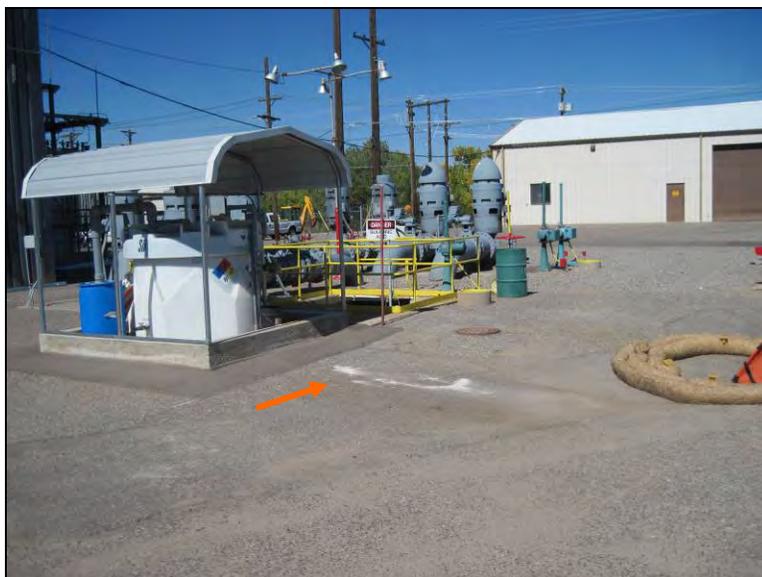
**NMED/SWQB
Official Photograph Log
Photo # 2**

Generally, housekeeping at the site appeared orderly and well maintained with little to no accumulated windblown trash. However, accumulated solids near the above-ground sulfuric acid tank and storm drain inlet were observed (see Photo #2). The on-site representative did not know the source of the solids. Identification of the solids, removal and proper disposal is needed to prevent the solids from becoming a pollutant to storm water discharges.

Photographer: Erin S. Trujillo	Date: 10/14/2010	Time: 1145 hours
City/County: Farmington / San Juan County	State: New Mexico	
Location: Farmington Animas Power Plant		
Subject: Arrow points to white solids on pavement near above-ground sulfuric acid tank.

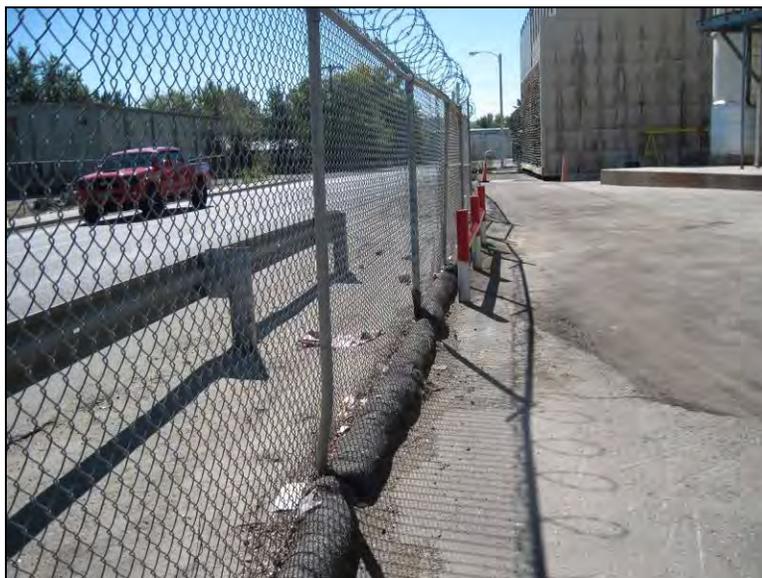
**NMED/SWQB
Official Photograph Log
Photo # 3**

Photographer: Erin S. Trujillo	Date: 10/14/2010	Time: 1159 hours
City/County: Farmington / San Juan County		State: New Mexico
Location: Farmington Animas Power Plant		
Subject: Example of straw wattle that does not overlap along eastern property boundary.

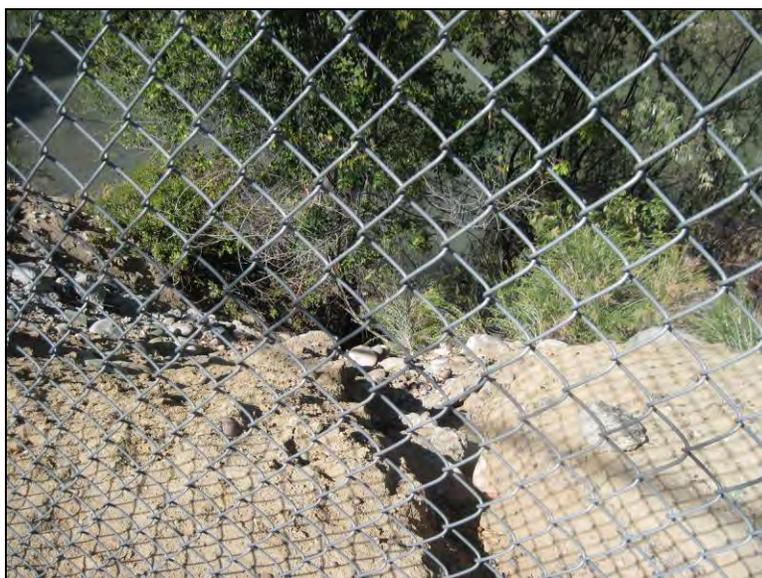
**NMED/SWQB
Official Photograph Log
Photo # 4**

Photographer: Erin S. Trujillo	Date: 10/14/2010	Time: 1233 hours
City/County: Farmington / San Juan County		State: New Mexico
Location: Farmington Animas Power Plant		
Subject: Erosion along northern property boundary. Animas River is in background.

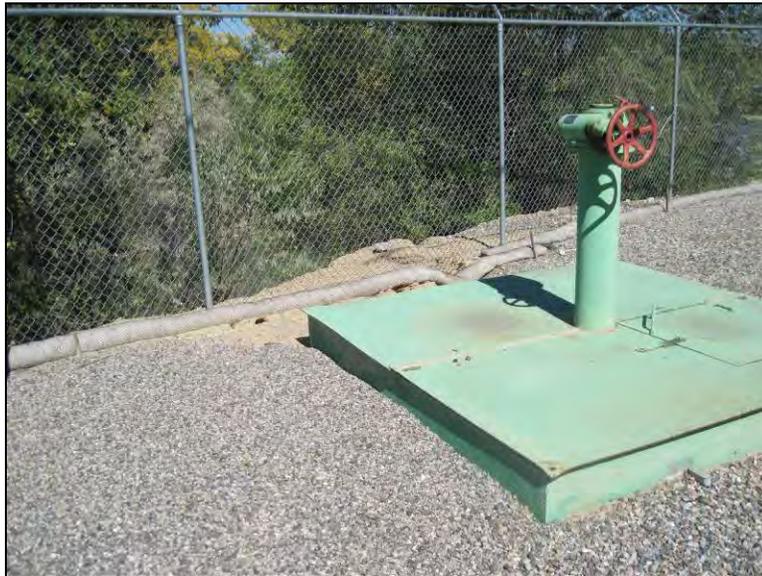
**NMED/SWQB
Official Photograph Log
Photo # 5**

Photographer: Erin S. Trujillo	Date: 10/14/2010	Time: 1133 hours
City/County: Farmington / San Juan County		State: New Mexico
Location: Farmington Animas Power Plant		
Subject: Erosion along northern property shown in previous photo.

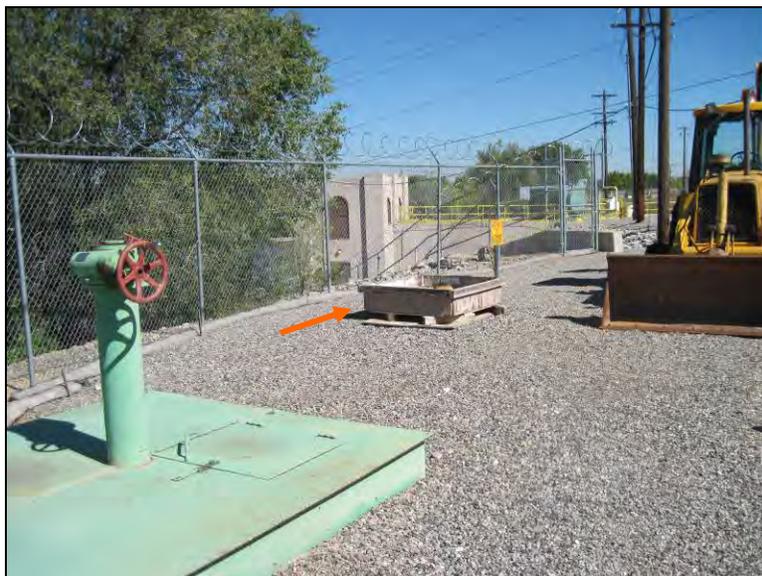
**NMED/SWQB
Official Photograph Log
Photo # 6**

- directions of storm water flow (e.g., use arrows to show which way storm water will flow);
- locations used for the treatment, storage or disposal of wastes, in this case, locations of paint activities or sources which would be exposed to precipitation/surface runoff (see Photo #6); and
- locations of stormwater outfalls and an approximate outline of the area draining to each outfall.

Photographer: Erin S. Trujillo	Date: 10/14/2010	Time: 1133 hours
City/County: Farmington / San Juan County		State: New Mexico
Location: Farmington Animas Power Plant		
Subject: Arrow points to location of box not shown on site map used to allow paint waste to dry before disposal.
