NEW MEXICO
ENVIRONMENT DEPARTMENT
Surface Water Quality Bureau

RE: Industrial Storm Water, SIC 1499, NPDES Compliance Evaluation Inspection, Morningstar Minerals Corporation / Humate Mill and Manufacturing Facility, Farmington, NMR05HG37, May 3, 2012

Morningstar Minerals Corporation
Humate Mill and Manufacturing Facility
NMR05HG37
Compliance Evaluation Inspection – Industrial Stormwater
May 3, 2012

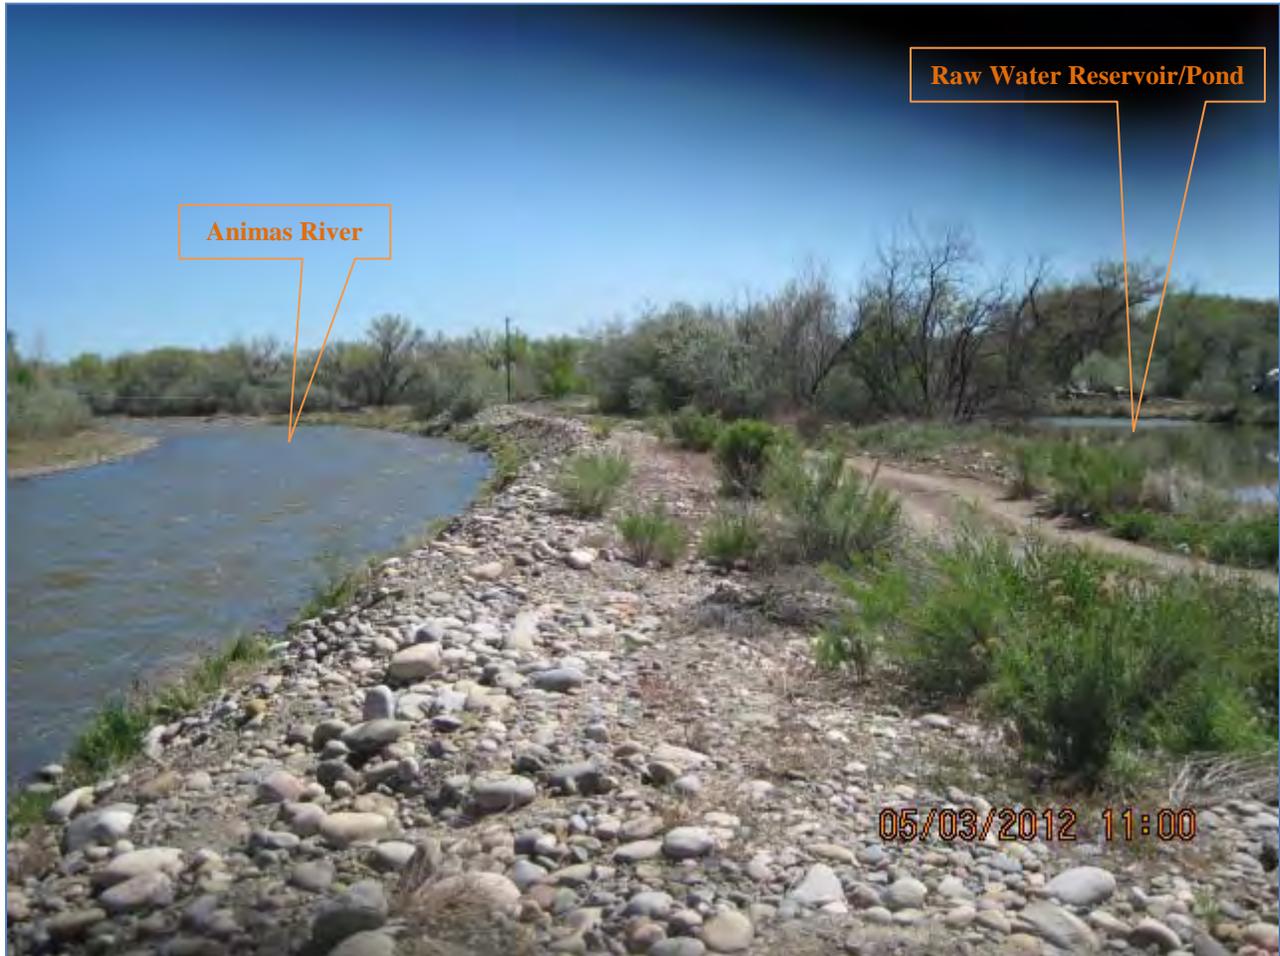
NMED/SWQB
Official Photograph Log
Photo # 1

Photographer: Erin S. Trujillo	Date: 05/03/2012	Time: 1100 hours
City/County: Near Farmington / San Juan	State: New Mexico	
Location: Morningstar Minerals Corporation Mill and Manufacturing Facility		
Subject: Looking generally east (upstream) from the bank of the Animas River at cobble along bank, adjacent access road, vegetation and Animas Valley Land & Water Co., LLC raw water reservoir or pond between the Morningstar operation and the river.

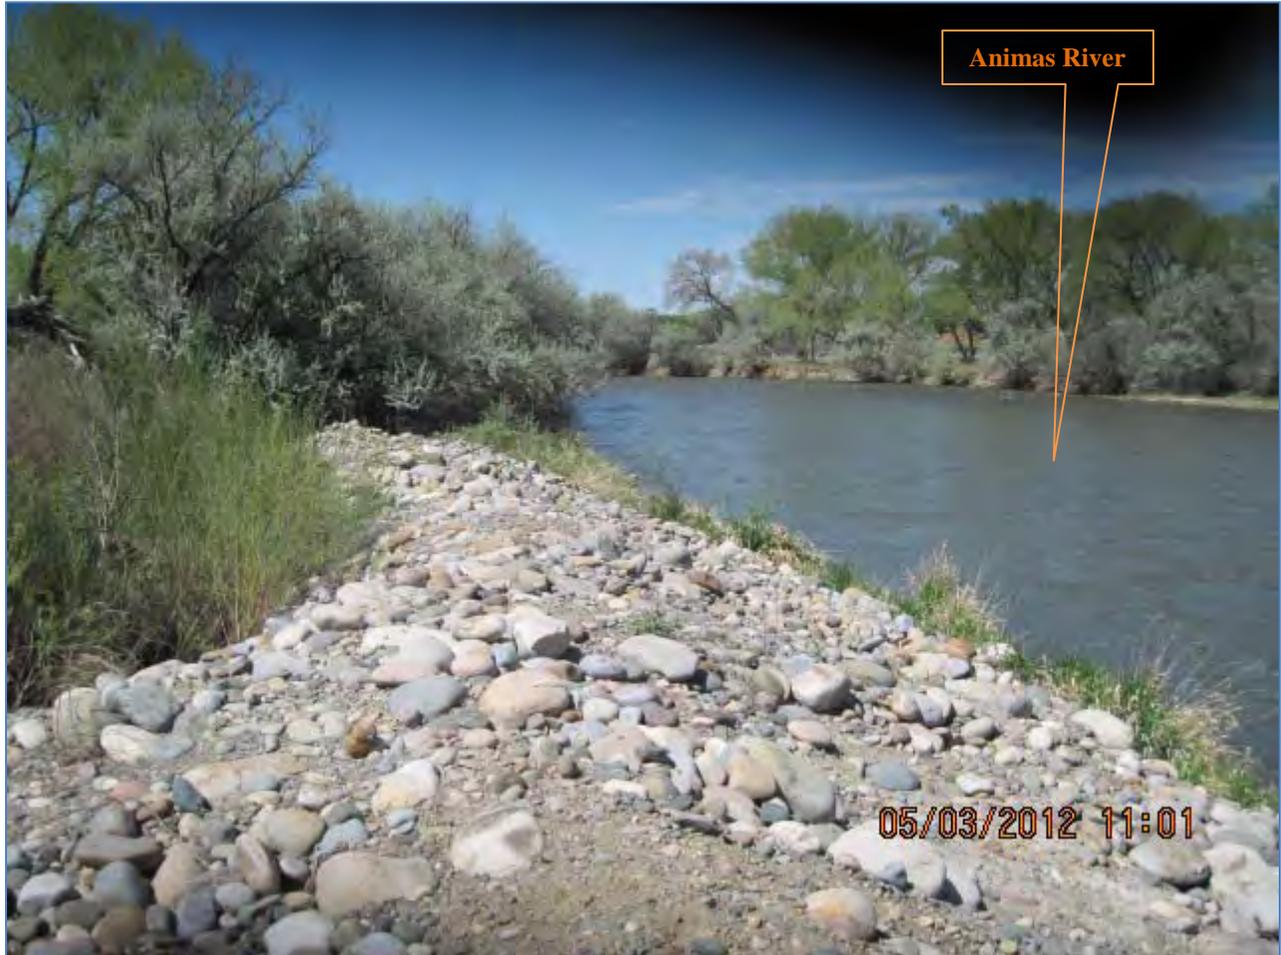
NMED/SWQB
Official Photograph Log
Photo # 2

Photographer: Erin S. Trujillo	Date: 05/03/2012	Time: 1101 hours
City/County: Near Farmington / San Juan	State: New Mexico	
Location: Morningstar Minerals Corporation Mill and Manufacturing Facility		
Subject: Looking generally southwest (downstream) from same location as previous photo at cobble and vegetation along the bank of the Animas River.

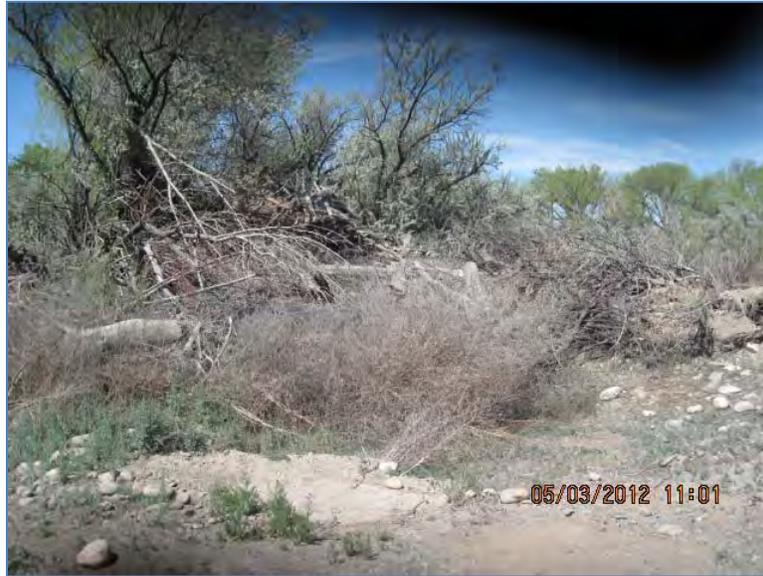
**NMED/SWQB
Official Photograph Log
Photo # 3**

Photographer: Erin S. Trujillo	Date: 05/03/2012	Time: 1101 hours
City/County: Near Farmington / San Juan		State: New Mexico
Location: Morningstar Minerals Corporation Mill and Manufacturing Facility		
Subject: Looking generally west at brush pile between Morningstar's berm (see Photo 12) and the Animas River.

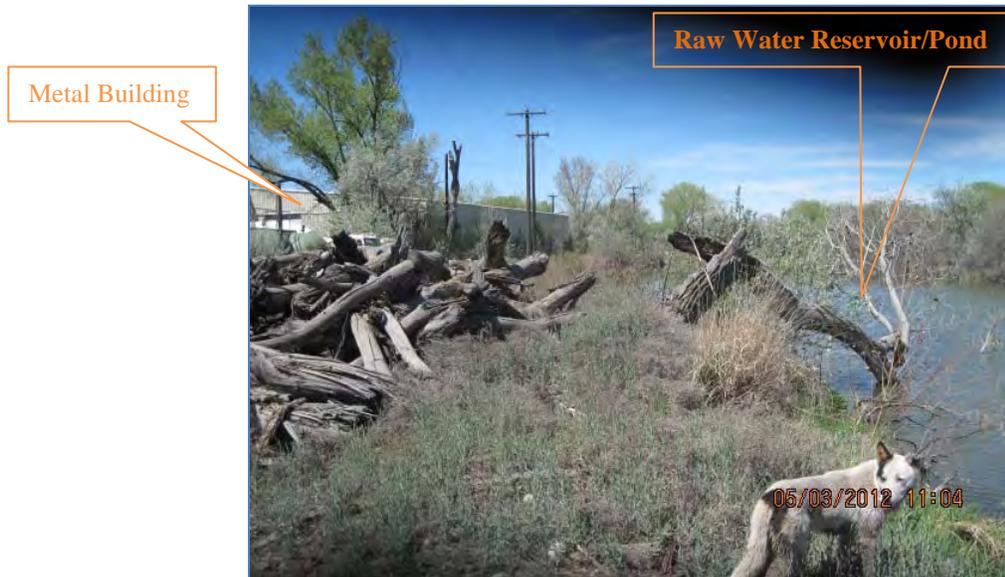
**NMED/SWQB
Official Photograph Log
Photo # 4**

Photographer: Erin S. Trujillo	Date: 05/03/2012	Time: 1104 hours
City/County: Near Farmington / San Juan		State: New Mexico
Location: Morningstar Minerals Corporation Mill and Manufacturing Facility		
Subject: East and north of disturbed area shown in Figure 5, looking generally west at metal building on site and vegetation south of the pond.

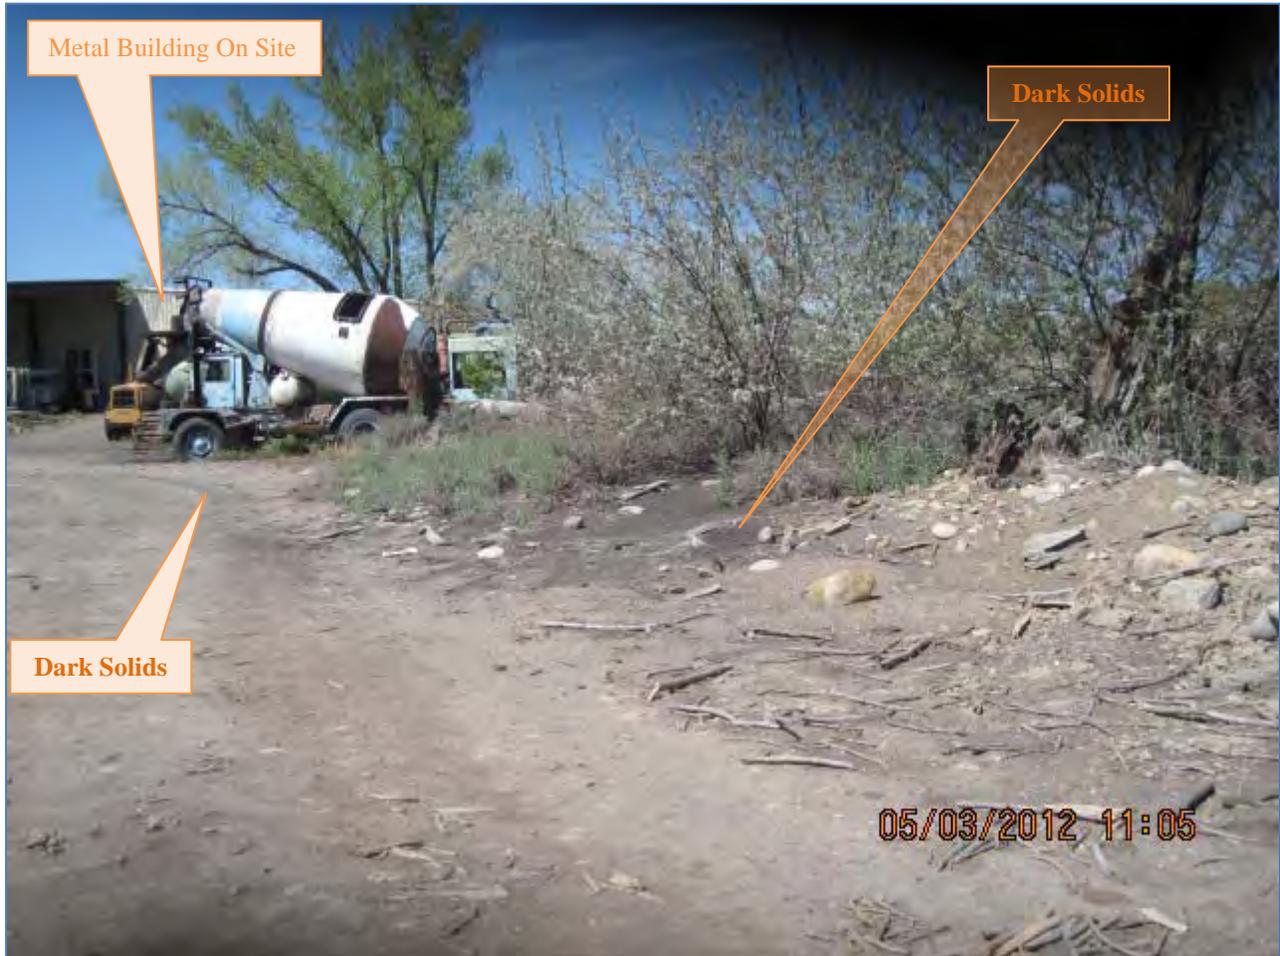
NMED/SWQB
Official Photograph Log
Photo # 5

Photographer: Erin S. Trujillo	Date: 05/03/2012	Time: 1105 hours
City/County: Near Farmington / San Juan	State: New Mexico	
Location: Morningstar Minerals Corporation Mill and Manufacturing Facility		
Subject: South of previous photo, looking generally west toward metal building on site. Mr. Wharton stated that the heavy equipment shown in photo was not part of the Morningstar operation. Dark soils are outside the disturbed area shown in Figure 5. Called out dark solids appear to be humate from mill and manufacturing facility.

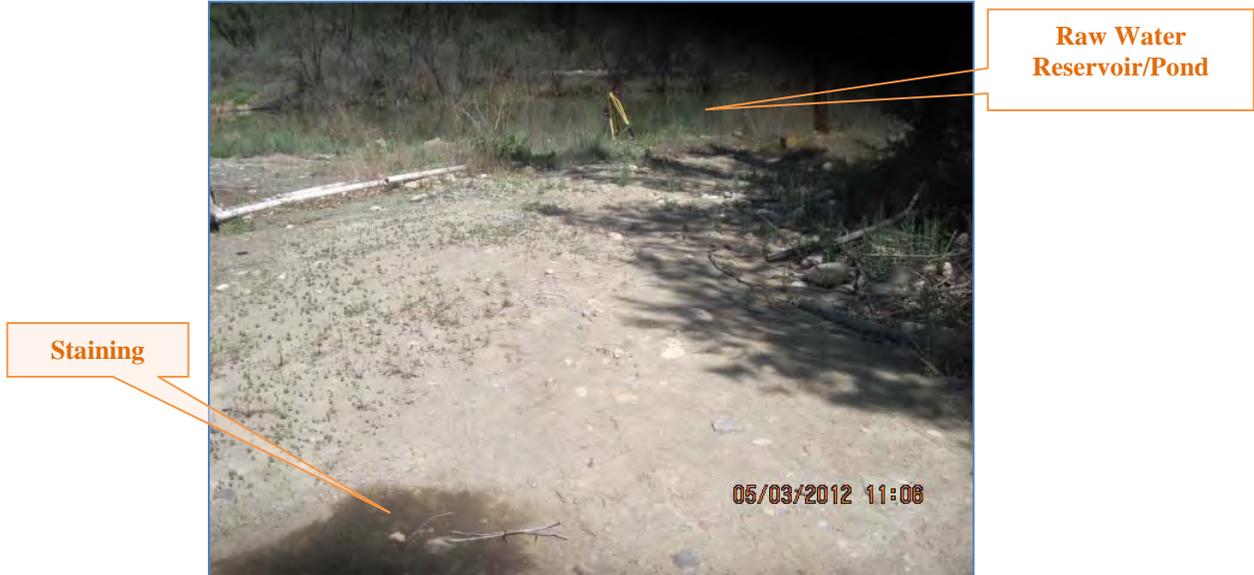
**NMED/SWQB
Official Photograph Log
Photo # 6**

Photographer: Erin S. Trujillo	Date: 05/03/2012	Time: 1106 hours
City/County: Near Farmington / San Juan		State: New Mexico
Location: Morningstar Minerals Corporation Mill and Manufacturing Facility		
Subject: Looking generally north near the northeast corner of the metal building on site at staining on ground.

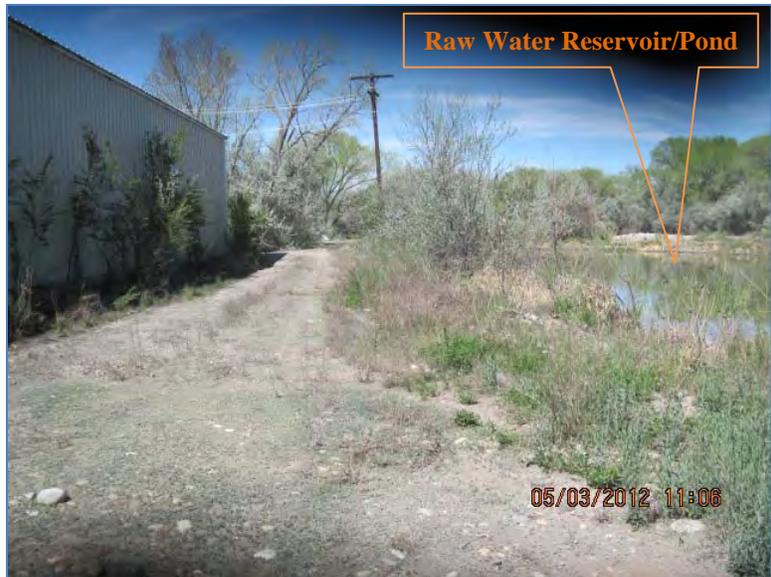
**NMED/SWQB
Official Photograph Log
Photo # 7**

Photographer: Erin S. Trujillo	Date: 05/03/2012	Time: 1106 hours
City/County: Near Farmington / San Juan		State: New Mexico
Location: Morningstar Minerals Corporation Mill and Manufacturing Facility		
Subject: Looking generally west at access road and vegetation between metal building on site and pond.

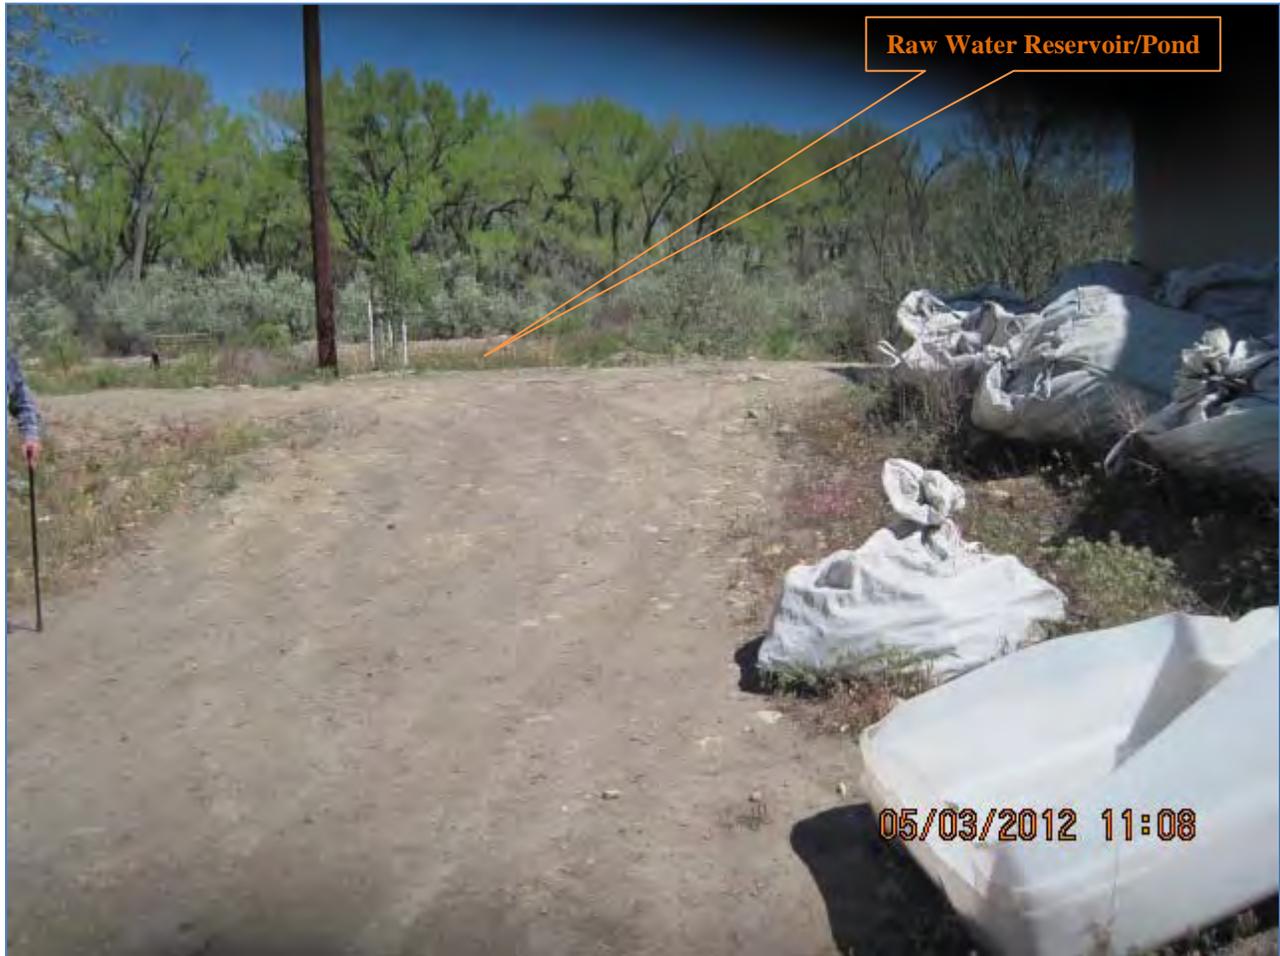
NMED/SWQB
Official Photograph Log
Photo # 8

Photographer: Erin S. Trujillo	Date: 05/03/2012	Time: 1108 hours
City/County: Near Farmington / San Juan	State: New Mexico	
Location: Morningstar Minerals Corporation Mill and Manufacturing Facility		
Subject: Looking generally north from west side of metal building on site at access road/constructed berm. Photo was taken standing at a lower elevation than the top of the berm/access road. Called out pond is not visible in this photo.

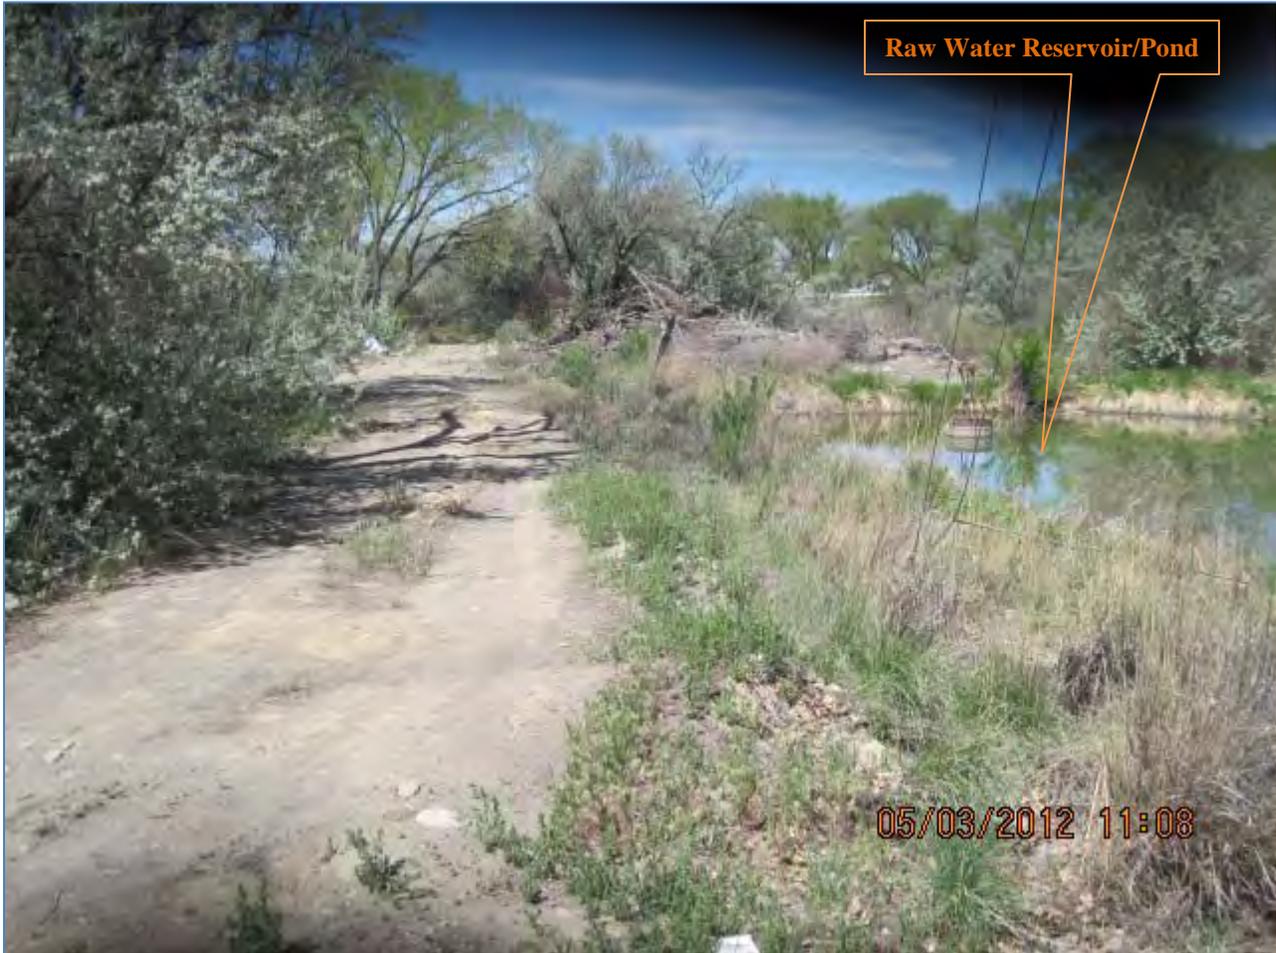
NMED/SWQB
Official Photograph Log
Photo # 9

Photographer: Erin S. Trujillo	Date: 05/03/2012	Time: 1108 hours
City/County: Near Farmington / San Juan	State: New Mexico	
Location: Morningstar Minerals Corporation Mill and Manufacturing Facility		
Subject: Looking generally west at vegetation and access road/constructed berm between Morningstar operation and pond.

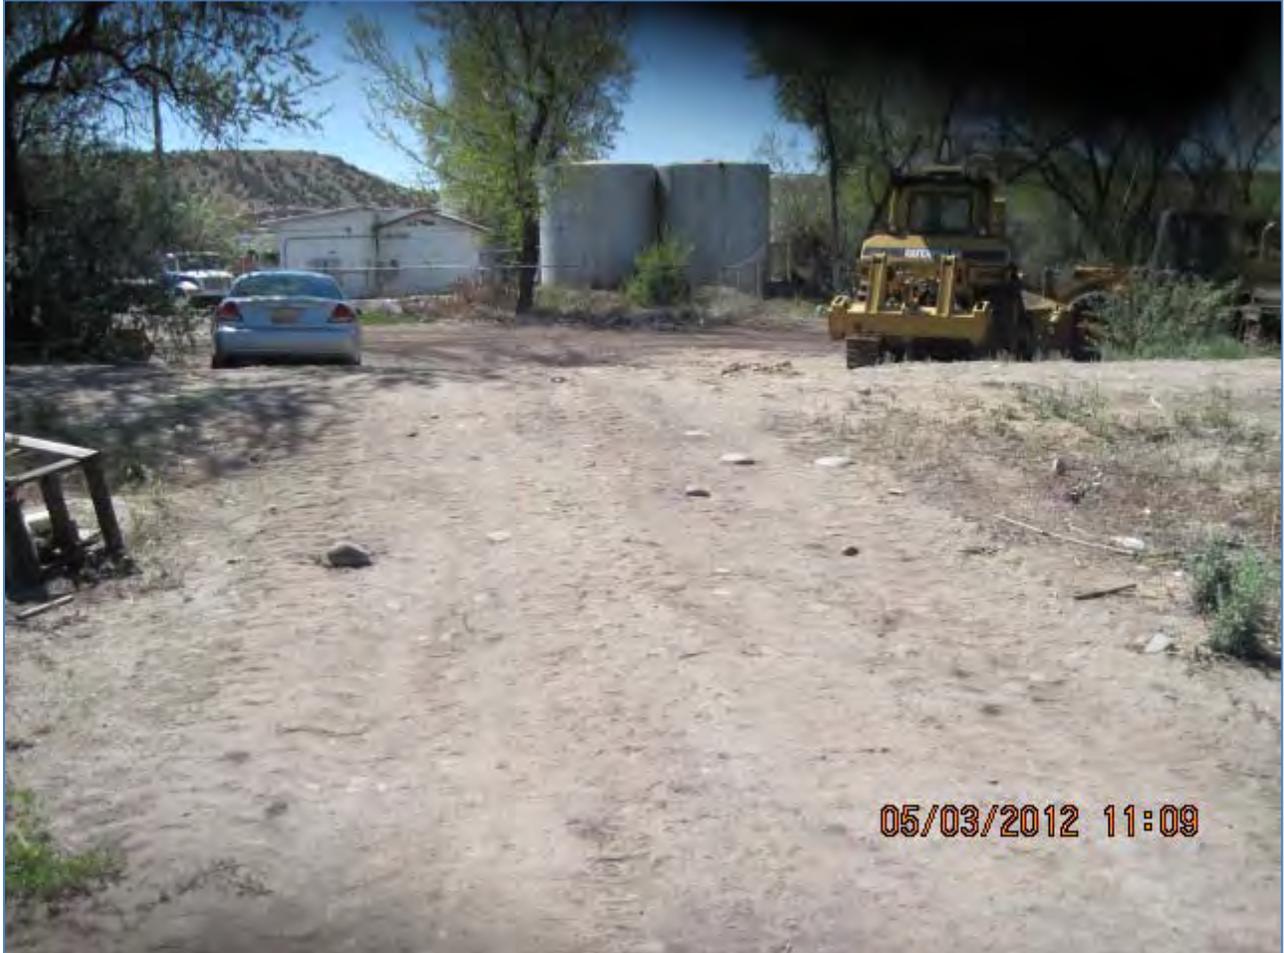
NMED/SWQB
Official Photograph Log
Photo # 10

Photographer: Erin S. Trujillo	Date: 05/03/2012	Time: 1109 hours
City/County: Near Farmington / San Juan	State: New Mexico	
Location: Morningstar Minerals Corporation Mill and Manufacturing Facility		
Subject: Looking generally south at constructed berm from access road west of pond. Building and tanks in background of this photo are associated with the Animas Valley Land & Water Co., LLC water treatment plant.

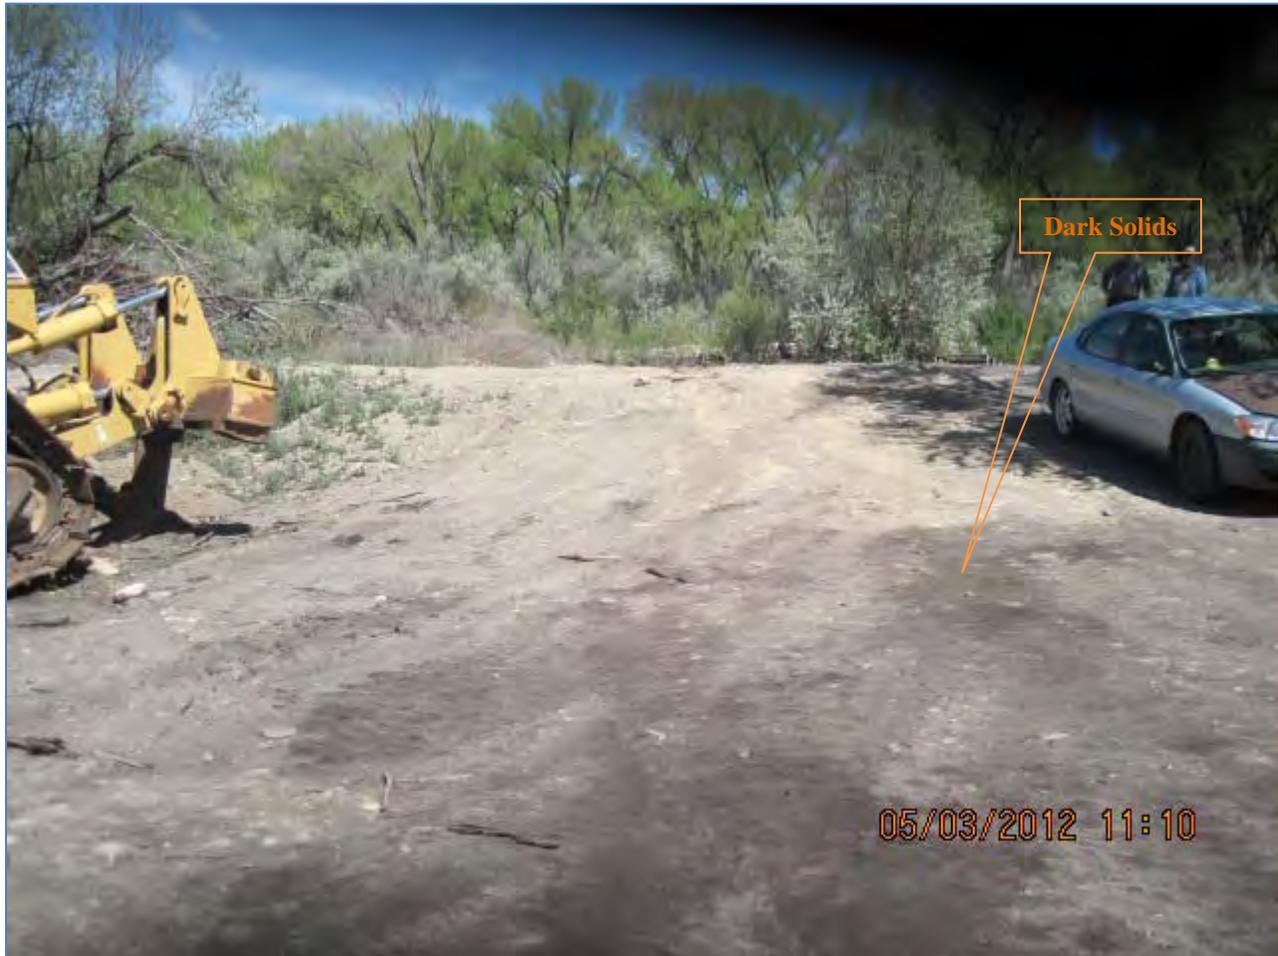
NMED/SWQB
Official Photograph Log
Photo # 11

Photographer: Erin S. Trujillo	Date: 05/03/2012	Time: 1110 hours
City/County: Near Farmington / San Juan	State: New Mexico	
Location: Morningstar Minerals Corporation Mill and Manufacturing Facility		
Subject: Looking generally north from humate storage area shown in photo #12 at constructed berm. Photo was taken standing at a lower elevation than the top of the berm. Called out dark solids appear within the disturbed area shown in Figure 5.

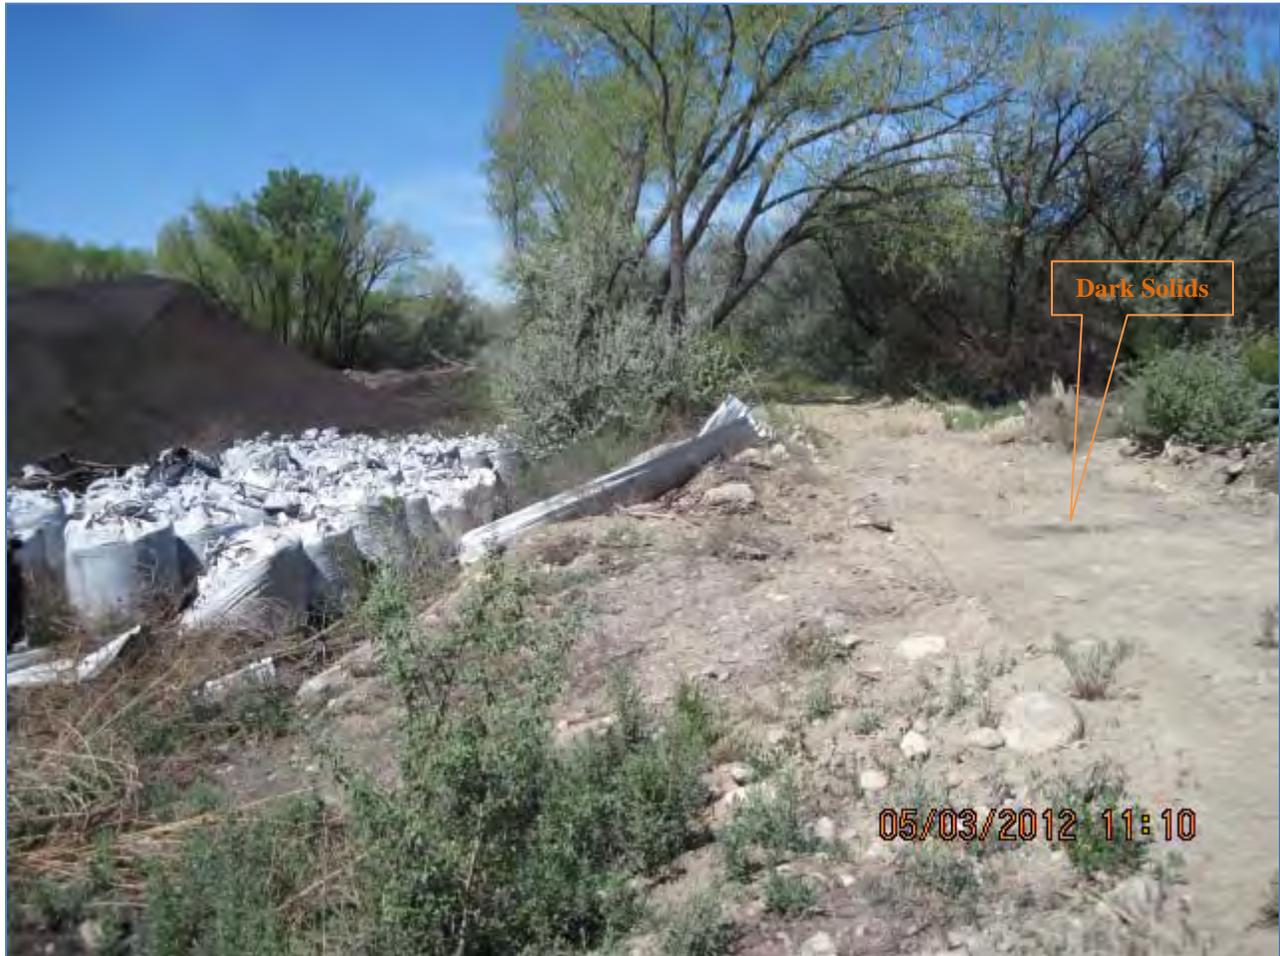
NMED/SWQB
Official Photograph Log
Photo # 12

Photos 8 thru 12 show a constructed berm west of the metal building on site continuing north of the humate storage area shown in Photo 12. Photos 12 and 13 show dark solids on the berm and north of the berm. The dark solids appeared to be humate from the mill and manufacturing facility. In the area of the humate storage area shown in Photo 12, the aerial photograph measured distance between the berm and the Animas River varies from approximately 50 to 75 feet.

Photographer: Erin S. Trujillo	Date: 05/03/2012	Time: 1110 hours
City/County: Near Farmington / San Juan	State: New Mexico	
Location: Morningstar Minerals Corporation Mill and Manufacturing Facility		
Subject: Looking generally west-southwest at humate stockpile. Bags contain humate according to permittee on-site representatives. Base of humate storage area on left side of photo is lower than the top of the berm. Called out dark solids on top of berm appear to be humate from mill and manufacturing facility.

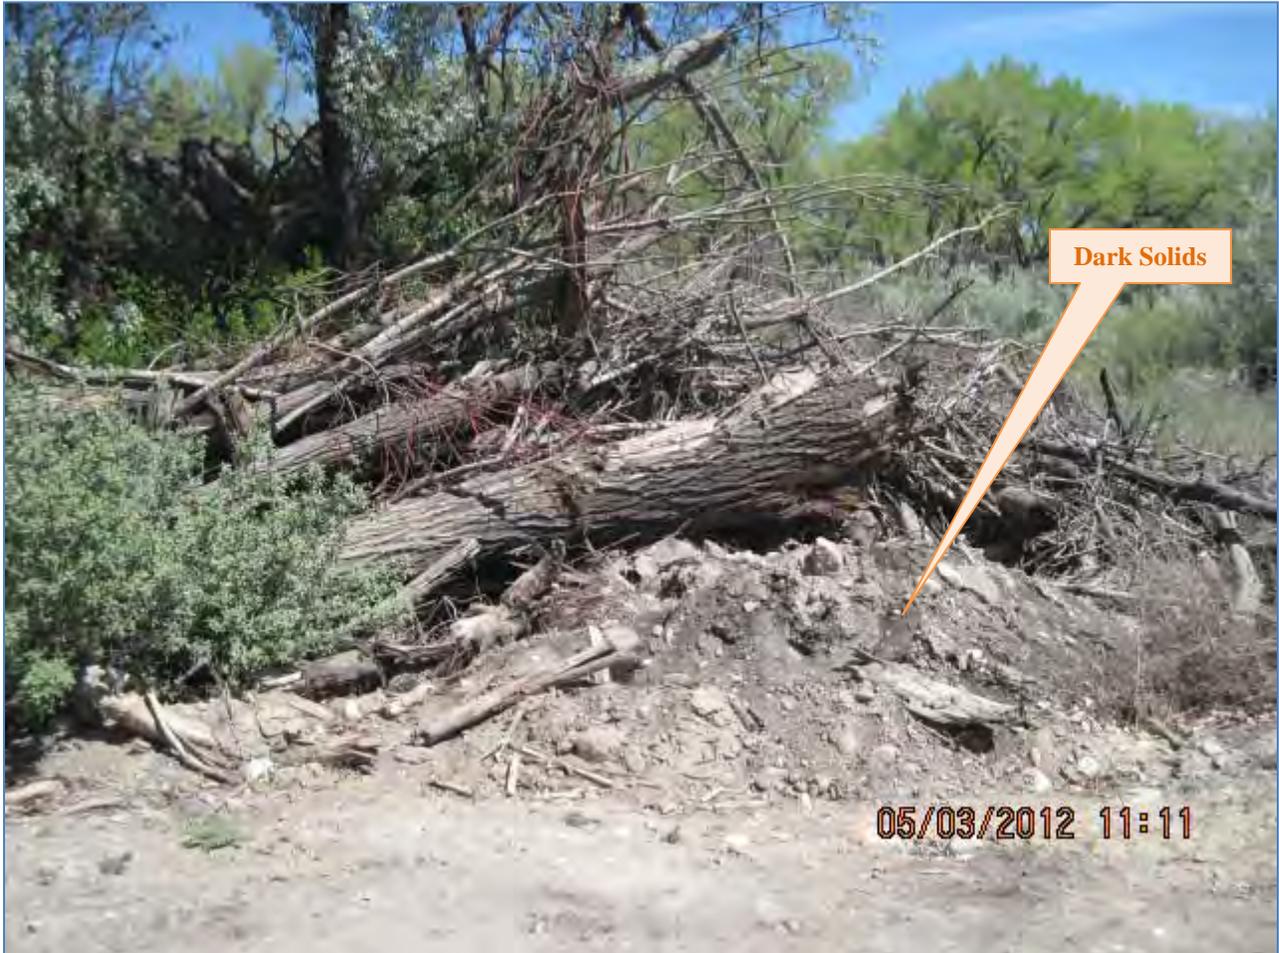
NMED/SWQB
Official Photograph Log
Photo # 13

Photographer: Erin S. Trujillo	Date: 05/03/2012	Time: 1111 hours
City/County: Near Farmington / San Juan	State: New Mexico	
Location: Morningstar Minerals Corporation Mill and Manufacturing Facility		
Subject: Looking generally north (standing on berm near location of previous photo) at brush pile and solids between berm and Animas River. Called out dark solids appear to be humate from mill and manufacturing facility.

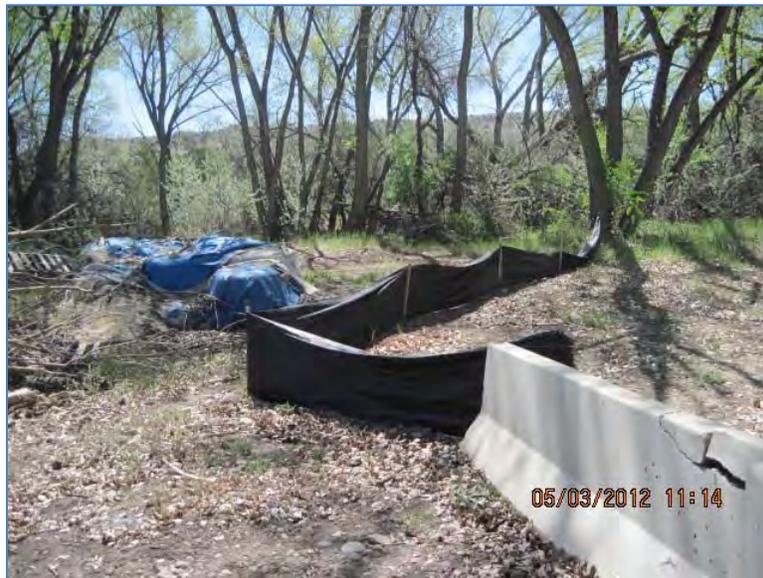
**NMED/SWQB
Official Photograph Log
Photo # 14**

Photographer: Erin S. Trujillo	Date: 05/03/2012	Time: 1114 hours
City/County: Near Farmington / San Juan		State: New Mexico
Location: Morningstar Minerals Corporation Mill and Manufacturing Facility		
Subject: West of humate storage area shown in Photo #12, looking generally south at concrete barriers and silt fence. Silt fence was not trenched. This northern cleared area is visible in the aerial photograph dated 06/10/2011 (Figure 11).

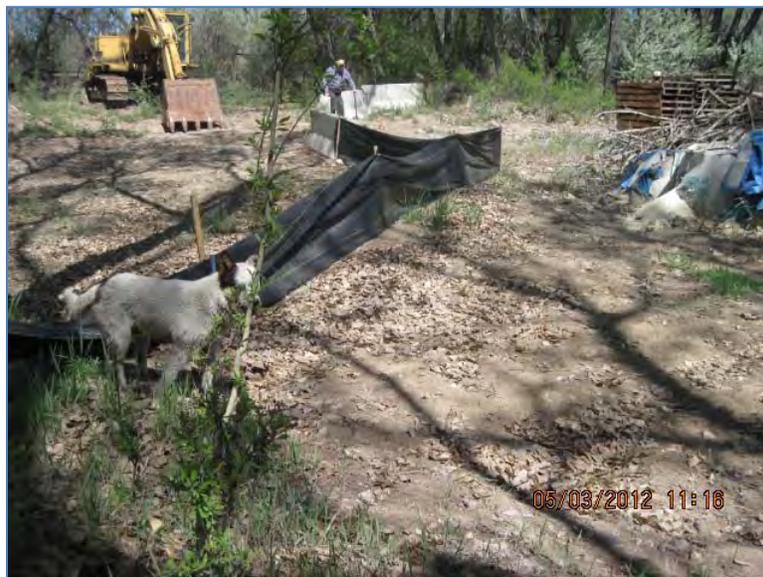
**NMED/SWQB
Official Photograph Log
Photo # 15**

Photographer: Erin S. Trujillo	Date: 05/03/2012	Time: 1116 hours
City/County: Near Farmington / San Juan		State: New Mexico
Location: Morningstar Minerals Corporation Mill and Manufacturing Facility		
Subject: West of humate storage area shown in Photo #12, looking generally north at concrete barriers and silt fence. Heavy equipment is west of silt fence and concrete barrier.

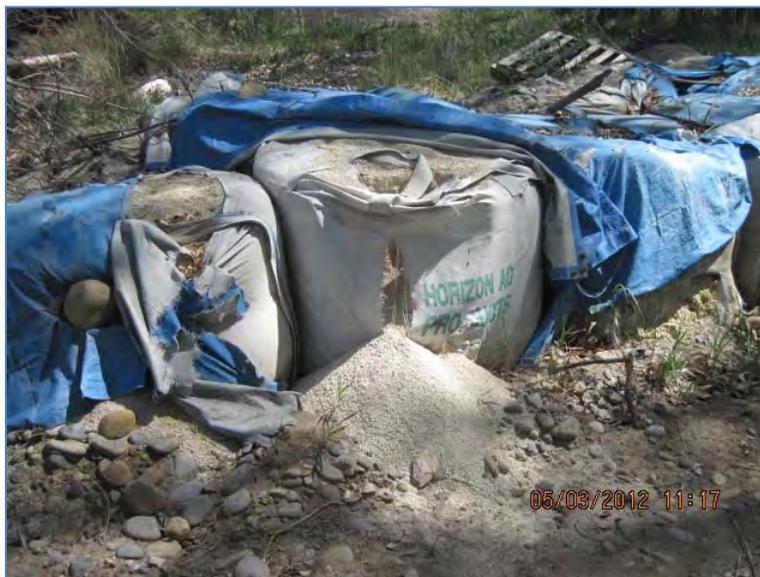
**NMED/SWQB
Official Photograph Log
Photo # 16**

Photographer: Erin S. Trujillo	Date: 05/03/2012	Time: 1117 hours
City/County: Near Farmington / San Juan		State: New Mexico
Location: Morningstar Minerals Corporation Mill and Manufacturing Facility		
Subject: Tarp does not cover torn bags labeled Horizon AG products. Bags contain potash according to Mr. Wharton and Mr. McMahon. Mr. Wharton stated that potash is not used in Morningstar operations.

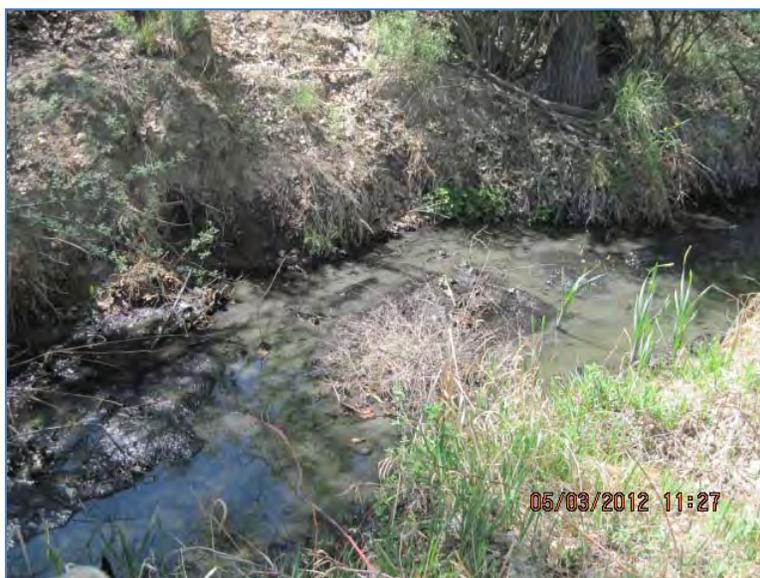
**NMED/SWQB
Official Photograph Log
Photo # 17**

Photographer: Erin S. Trujillo	Date: 05/03/2012	Time: 1127 hours
City/County: Near Farmington / San Juan		State: New Mexico
Location: Morningstar Minerals Corporation Mill and Manufacturing Facility		
Subject: Water in trench south of humate storage area shown in Photo 12 that flows to the west.

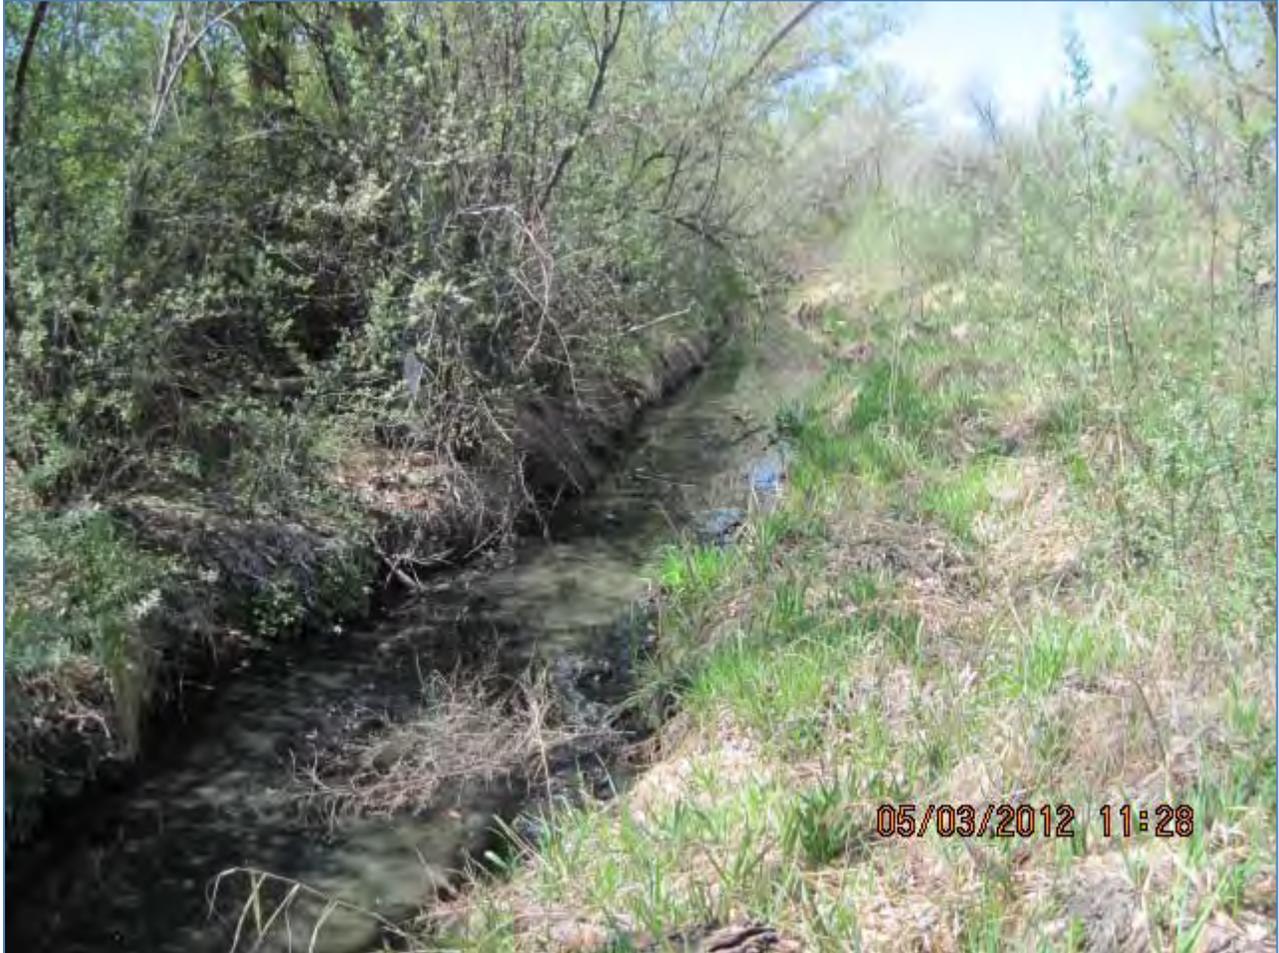
NMED/SWQB
Official Photograph Log
Photo # 18

Photographer: Erin S. Trujillo	Date: 05/03/2012	Time: 1128 hours
City/County: Near Farmington / San Juan	State: New Mexico	
Location: Morningstar Minerals Corporation Mill and Manufacturing Facility		
Subject: Looking generally west, water exists in trench that continues west of humate storage area shown in Photo 12.

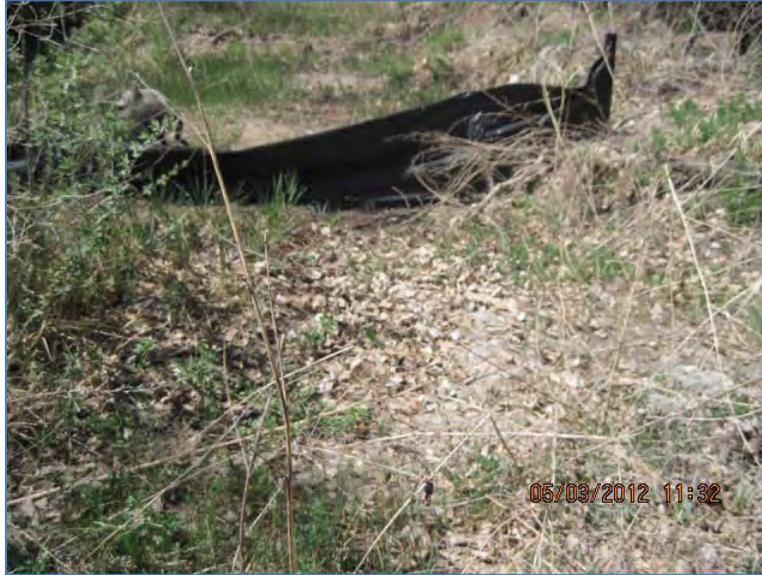
NMED/SWQB
Official Photograph Log
Photo # 19

Photos 19 and 20 show a silt fence and dark solids on the upland area along this trench. The upland or cleared area is visible in the 06/10/2011 aerial photograph (Figure 11). The silt fence was not trenched. A pile of dark solids which appeared to be humate from the mill and manufacturing facility were west of the silt fence outside disturbed areas shown in Figure 5.

Photographer: Erin S. Trujillo	Date: 05/03/2012	Time: 1132 hours
City/County: Near Farmington / San Juan	State: New Mexico	
Location: Morningstar Minerals Corporation Mill and Manufacturing Facility		
Subject: Looking generally west, silt fence west of humate storage area shown in Photo 12. Silt fence was not trenched.

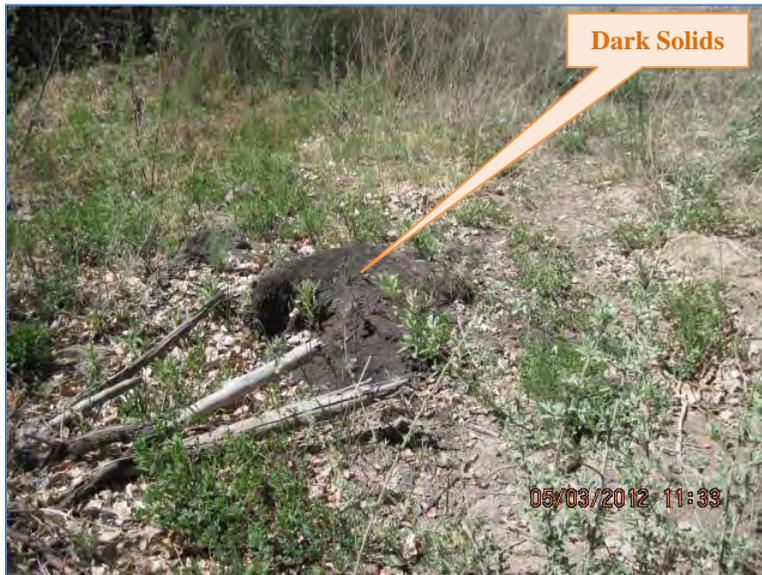
NMED/SWQB
Official Photograph Log
Photo # 20

Photographer: Erin S. Trujillo	Date: 05/03/2012	Time: 1139 hours
City/County: Near Farmington / San Juan	State: New Mexico	
Location: Morningstar Minerals Corporation Mill and Manufacturing Facility		
Subject: West of silt fence shown in previous photo, called out dark solids appear to be humate from mill and manufacturing facility.

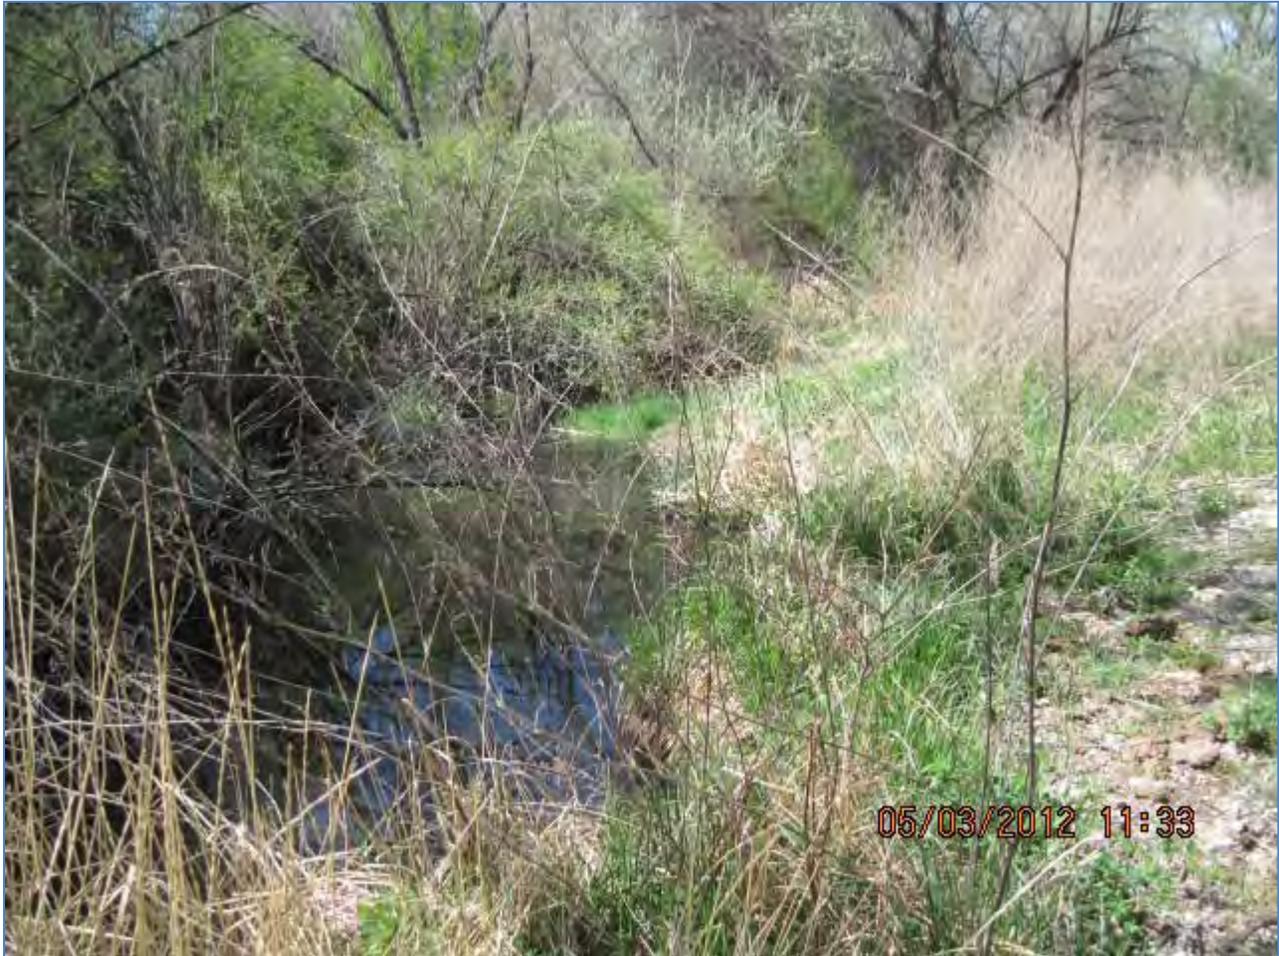
NMED/SWQB
Official Photograph Log
Photo # 21

Photographer: Erin S. Trujillo	Date: 05/03/2012	Time: 1133hours
City/County: Near Farmington / San Juan	State: New Mexico	
Location: Morningstar Minerals Corporation Mill and Manufacturing Facility		
Subject: Looking generally west at water in the west end of the trench shown in Photos 17, 18, and 32 thru 36.

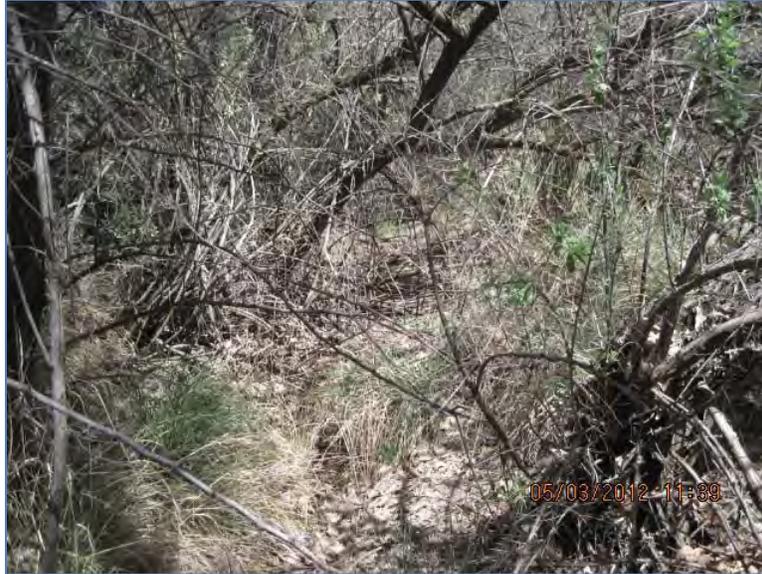
NMED/SWQB
Official Photograph Log
Photo # 22

Photographer: Erin S. Trujillo	Date: 05/03/2012	Time: 1139 hours
City/County: Near Farmington / San Juan	State: New Mexico	
Location: Morningstar Minerals Corporation Mill and Manufacturing Facility		
Subject: Vegetation and leaf litter in ditch that existed toward Andrea Corporation western property boundary.

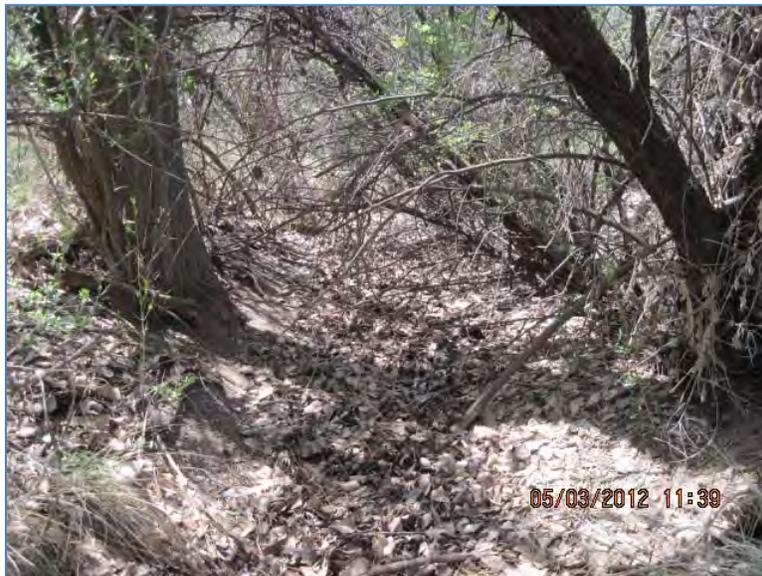
NMED/SWQB
Official Photograph Log
Photo # 23

Photographer: Erin S. Trujillo	Date: 05/03/2012	Time: 1139 hours
City/County: Near Farmington / San Juan	State: New Mexico	
Location: Morningstar Minerals Corporation Mill and Manufacturing Facility		
Subject: Leaf litter in ditch that existed toward Andrea Corporation western property boundary.
