NEW MEXICO
ENVIRONMENT DEPARTMENT
Surface Water Quality Bureau

RE: Industrial Storm Water, SIC 1499, NPDES Compliance Evaluation Inspection, Morningstar Minerals Corporation / Humate Mill and Manufacturing Facility, Farmington, NMR05HG37, May 3, 2012

Morningstar Minerals Corporation
Humate Mill and Manufacturing Facility
NMR05HG37
Compliance Evaluation Inspection – Industrial Stormwater
May 3, 2012

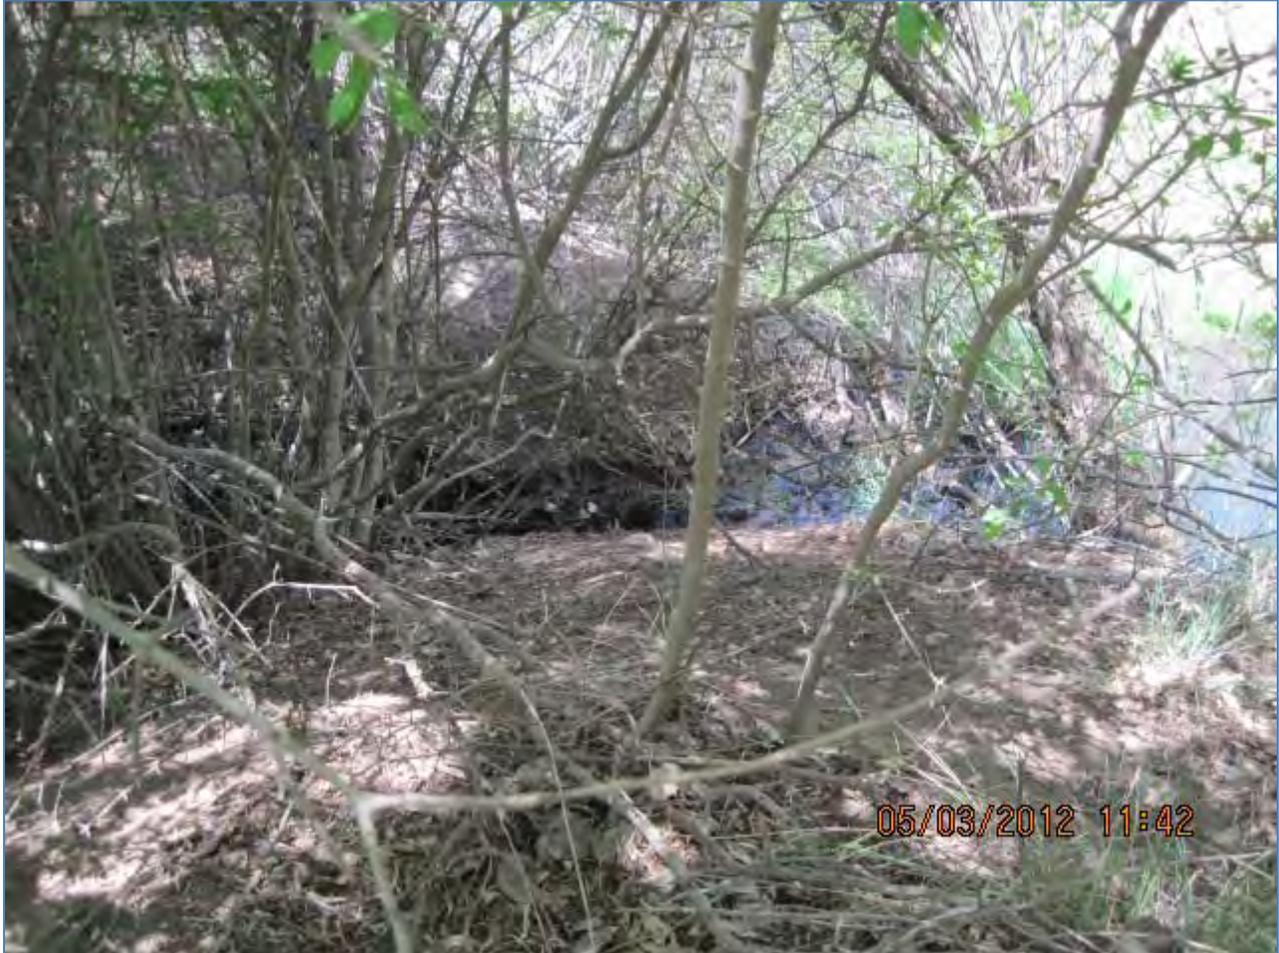
NMED/SWQB
Official Photograph Log
Photo # 24

Photographer: Erin S. Trujillo	Date: 05/03/2012	Time: 1142 hours
City/County: Near Farmington / San Juan	State: New Mexico	
Location: Morningstar Minerals Corporation Mill and Manufacturing Facility		
Subject: Outlet of water from trench shown in Photo 21 to ditch shown in Photos 22 and 23.

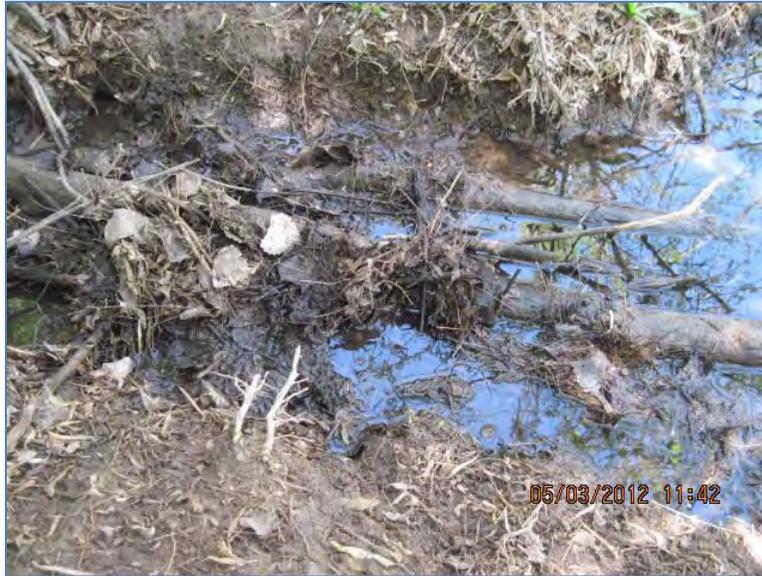
NMED/SWQB
Official Photograph Log
Photo # 25

Photographer: Erin S. Trujillo	Date: 05/03/2012	Time: 1142 hours
City/County: Near Farmington / San Juan	State: New Mexico	
Location: Morningstar Minerals Corporation Mill and Manufacturing Facility		
Subject: Close up of water in outlet shown in previous photo.

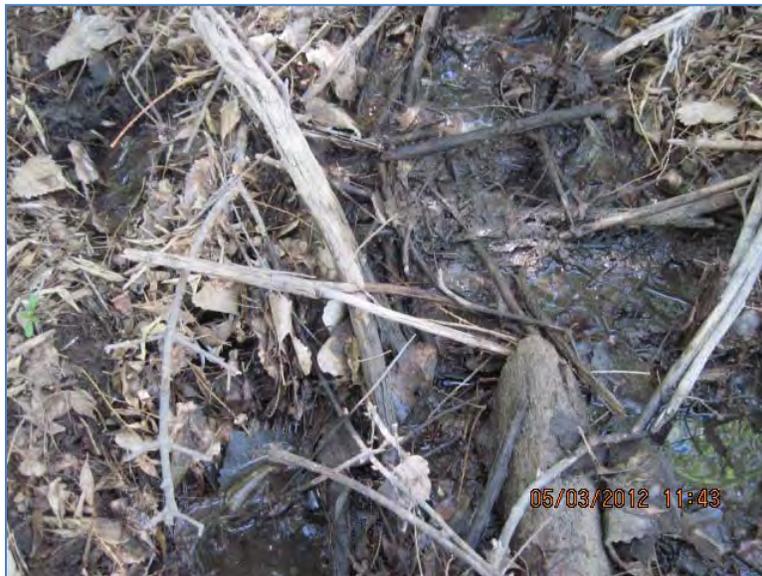
NMED/SWQB
Official Photograph Log
Photo # 26

Photographer: Erin S. Trujillo	Date: 05/03/2012	Time: 1143 hours
City/County: Near Farmington / San Juan	State: New Mexico	
Location: Morningstar Minerals Corporation Mill and Manufacturing Facility		
Subject: Looking generally west, close up of water in ditch.

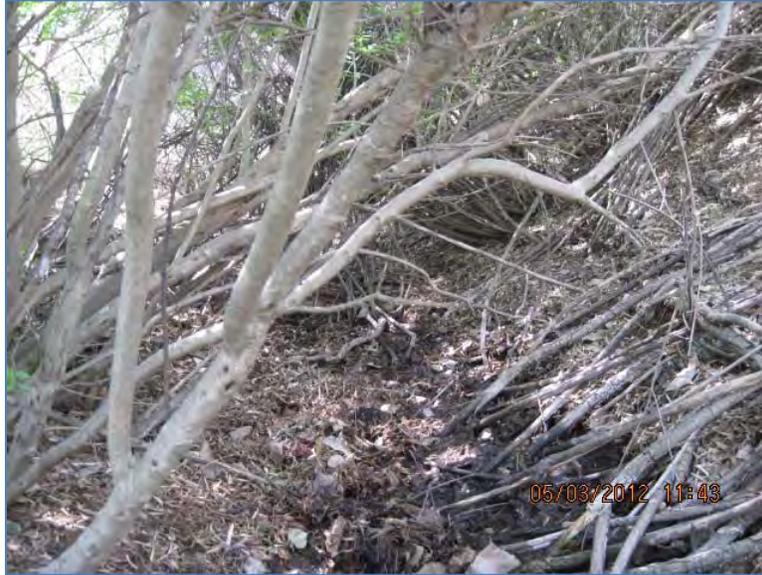
**NMED/SWQB
Official Photograph Log
Photo # 27**

Photographer: Erin S. Trujillo	Date: 05/03/2012	Time: 1143 hours
City/County: Near Farmington / San Juan	State: New Mexico	
Location: Morningstar Minerals Corporation Mill and Manufacturing Facility		
Subject: Looking generally west from same location as previous photo at wet soils in ditch. Ditch continues to location shown in Photos #21 and #22.

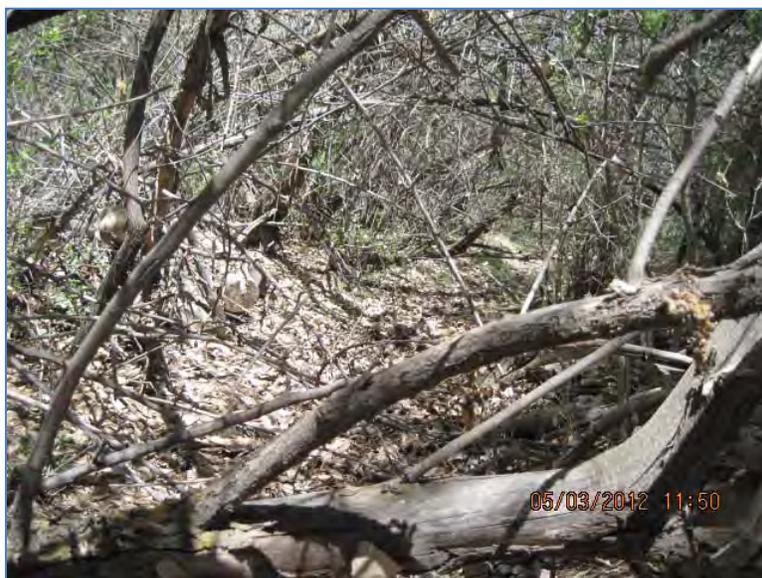
**NMED/SWQB
Official Photograph Log
Photo # 28**

Photographer: Erin S. Trujillo	Date: 05/03/2012	Time: 1150 hours
City/County: Near Farmington / San Juan	State: New Mexico	
Location: Morningstar Minerals Corporation Mill and Manufacturing Facility		
Subject: Ditch shown in Photos #21 and #22 continues toward the Woodard parcel.

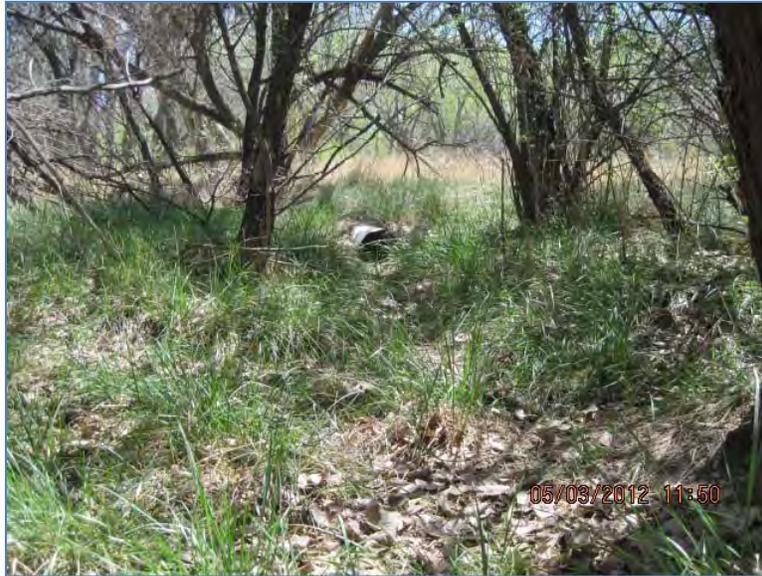
NMED/SWQB
Official Photograph Log
Photo # 29

Photographer: Erin S. Trujillo	Date: 05/03/2012	Time: 1150 hours
City/County: Near Farmington / San Juan	State: New Mexico	
Location: Morningstar Minerals Corporation Mill and Manufacturing Facility		
Subject: Culvert in shallow vegetated ditch. This ditch enters ditch shown in previous photo.

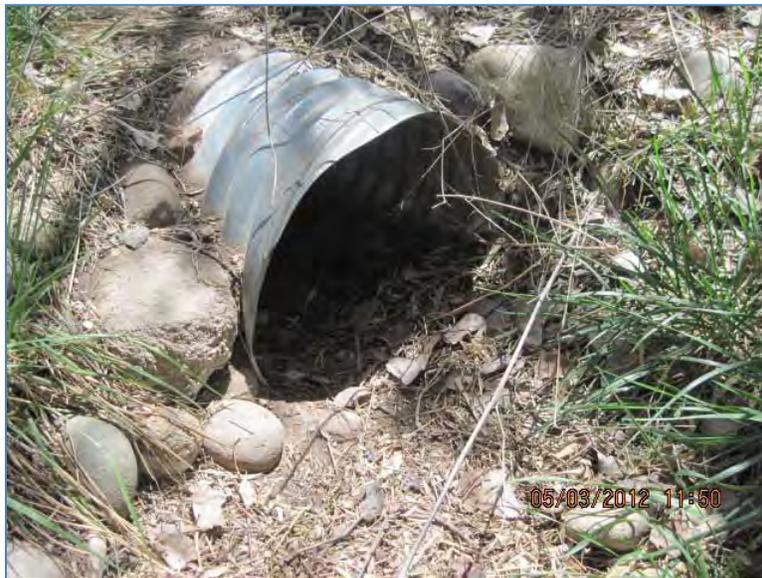
NMED/SWQB
Official Photograph Log
Photo # 30

Photographer: Erin S. Trujillo	Date: 05/03/2012	Time: 1150 hours
City/County: Near Farmington / San Juan	State: New Mexico	
Location: Morningstar Minerals Corporation Mill and Manufacturing Facility		
Subject: Culvert shown in previous photo.

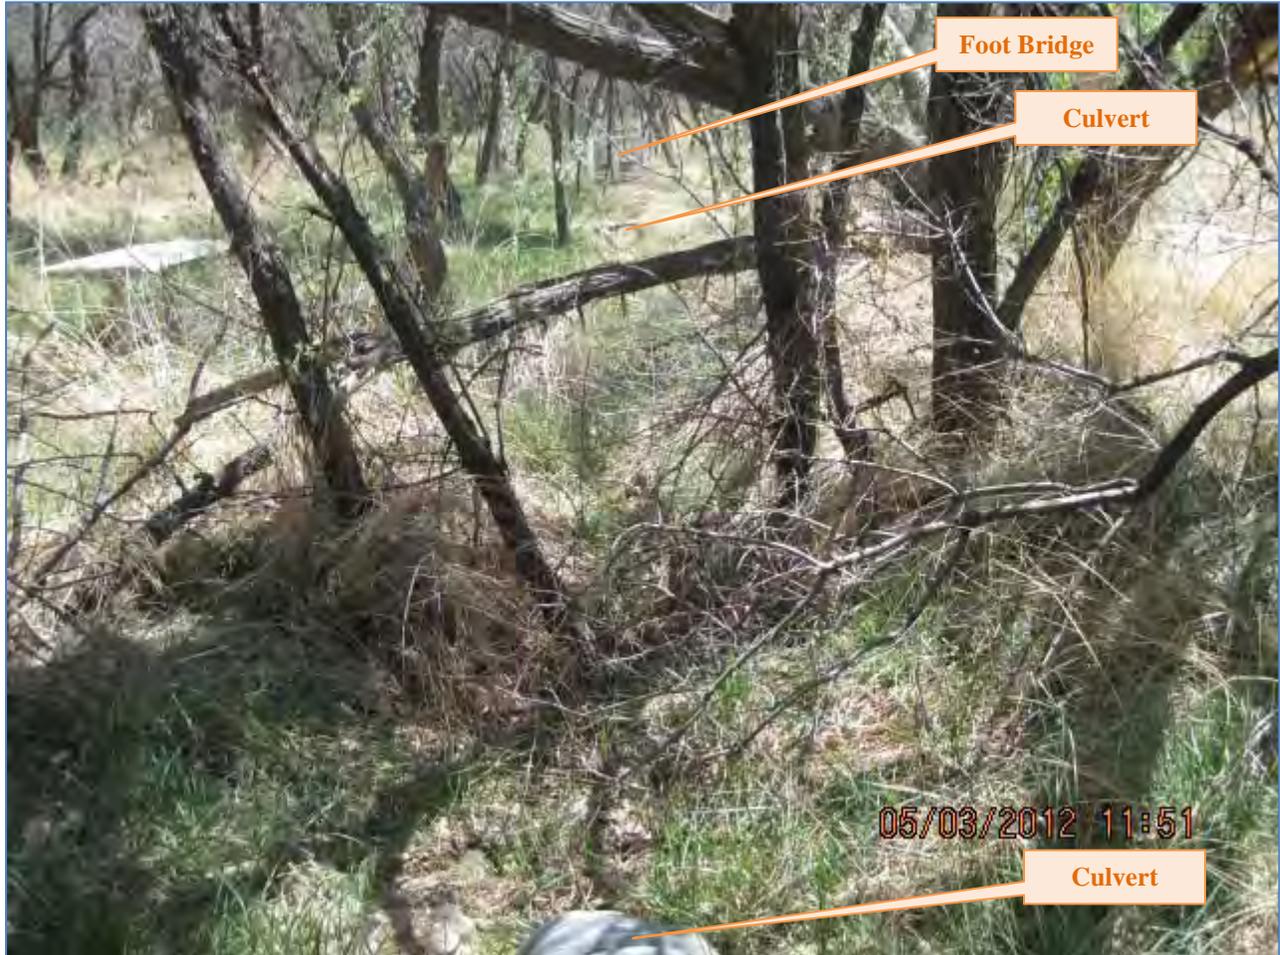
NMED/SWQB
Official Photograph Log
Photo # 31

Photographer: Erin S. Trujillo	Date: 05/03/2012	Time: 1151 hours
City/County: Near Farmington / San Juan	State: New Mexico	
Location: Morningstar Minerals Corporation Mill and Manufacturing Facility		
Subject: Looking generally east from culvert shown in previous photo. This ditch continues to CR 3957 south of the Morningstar entrance.

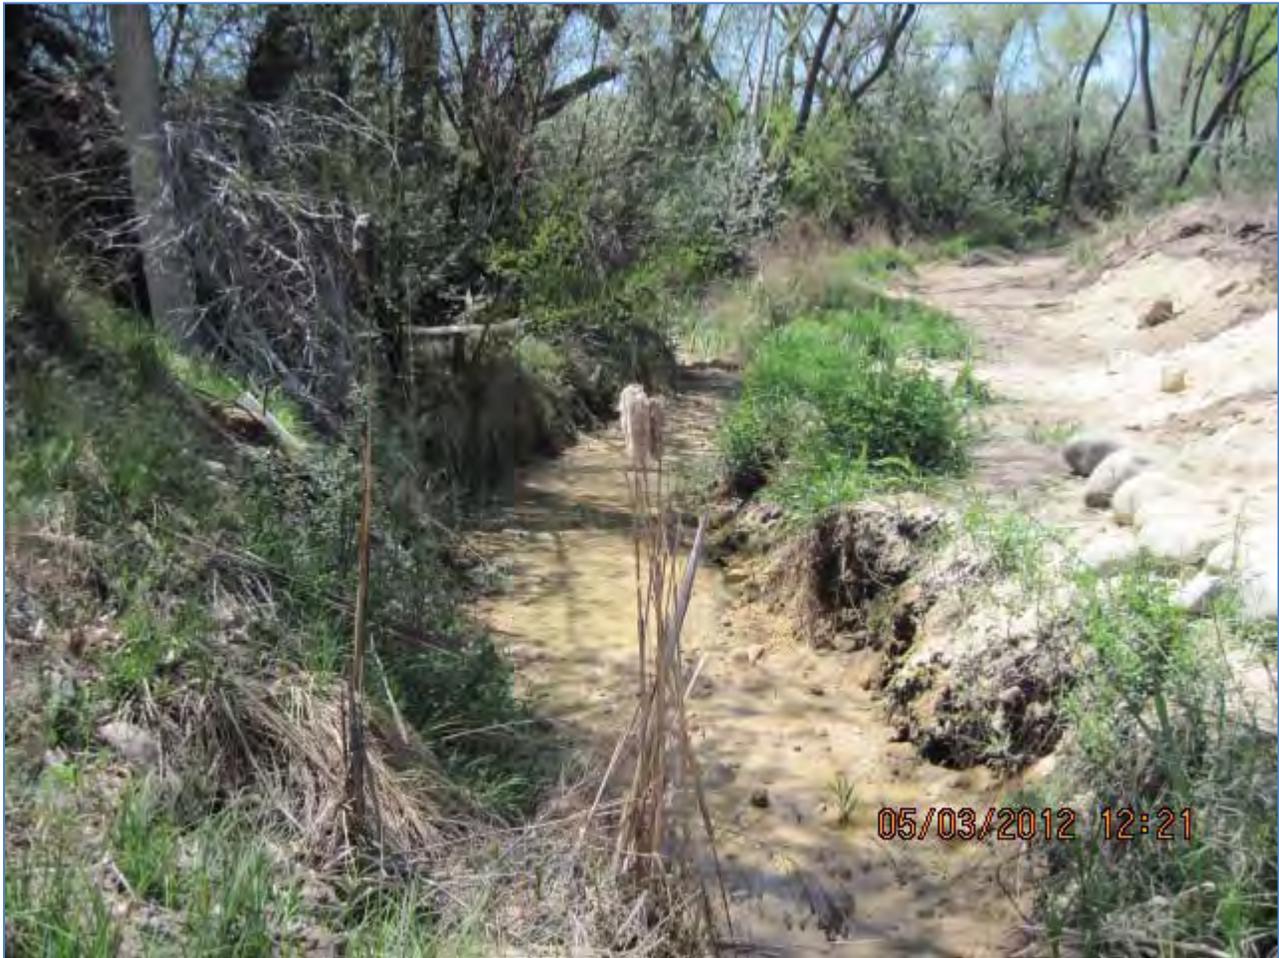
NMED/SWQB
Official Photograph Log
Photo # 32

Photos 32 thru 36 show the eastern end of a trench shown in Photos 17, 18 and 21 south of the humate storage area. The trench south of the humate storage area continues west toward the Andrea Corporation western parcel boundary. Mr. Wharton described how the water level in the trench fluctuates depending upon irrigation and level of the Animas River. Filter backwash flows from the adjacent Animas Valley Land & Water Co., LLC Water Treatment Plant and reverse osmosis backwash from the Morningstar operation enters this trench. No backwash flows into this trench were observed during this inspection, but the water flow in the trench was to the west. Photos 32, 33 and 37 show an exposed material berm between the trench and the humate storage area. The materials in the berm included light-colored fine and sand-size grained material and dark solids. The dark solids appeared to be humate from the mill and

Photographer: Erin S. Trujillo	Date: 05/03/2012	Time: 1221 hours
City/County: Near Farmington / San Juan	State: New Mexico	
Location: Morningstar Minerals Corporation Mill and Manufacturing Facility		
Subject: Looking generally west, eastern end of channel shown in Photos 17, 18 and 21.

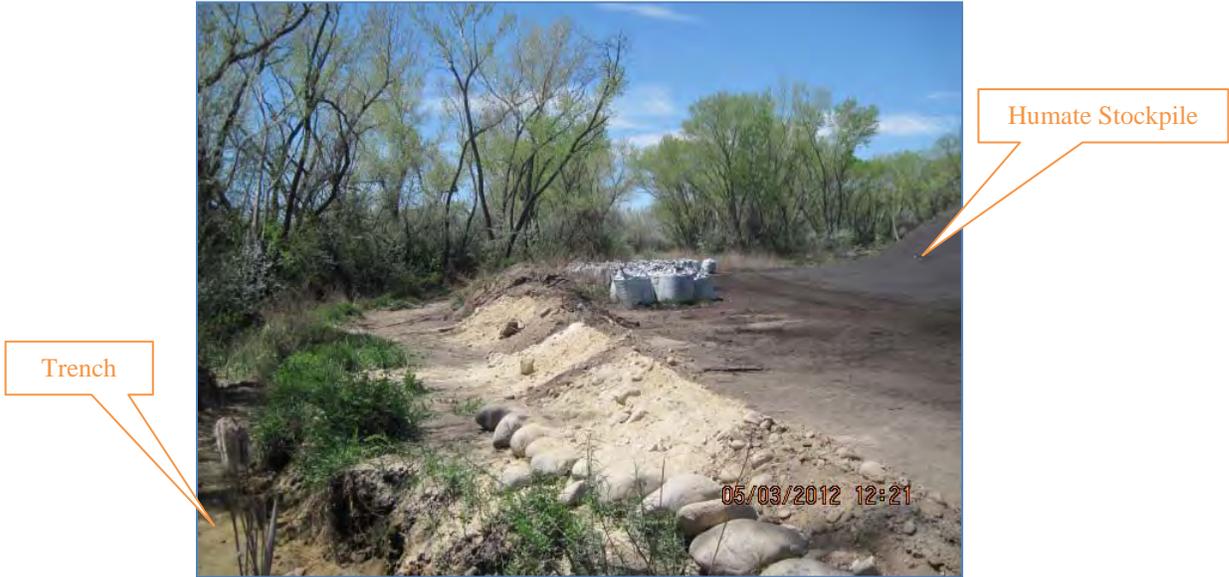
**NMED/SWQB
Official Photograph Log
Photo # 33**

Photographer: Erin S. Trujillo	Date: 05/03/2012	Time: 1221 hours
City/County: Near Farmington / San Juan		State: New Mexico
Location: Morningstar Minerals Corporation Mill and Manufacturing Facility		
Subject: Looking generally west at unstablized berm between humate stockpile on right side and trench on left side of photo. Berm contained mix of fine and coarse sized material.

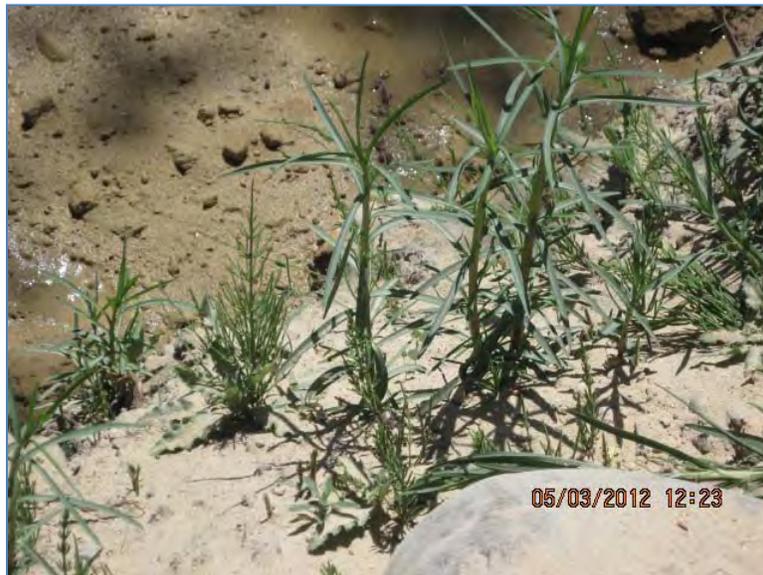
**NMED/SWQB
Official Photograph Log
Photo # 34**

manufacturing facility. The berm was not stabilized. Light-colored fine and sand-size grained material existed on the ground from the berm to the trench (Photo 34). The bed of the trench was also light in color (Photos 34 thru 36). Humate was observed in the trench (Photos 35 and 36).

Photographer: Erin S. Trujillo	Date: 05/03/2012	Time: 1223 hours
City/County: Near Farmington / San Juan		State: New Mexico
Location: Morningstar Minerals Corporation Mill and Manufacturing Facility		
Subject: Lighter colored material similar to material used in berm shown in previous photo appears on bank and trench.

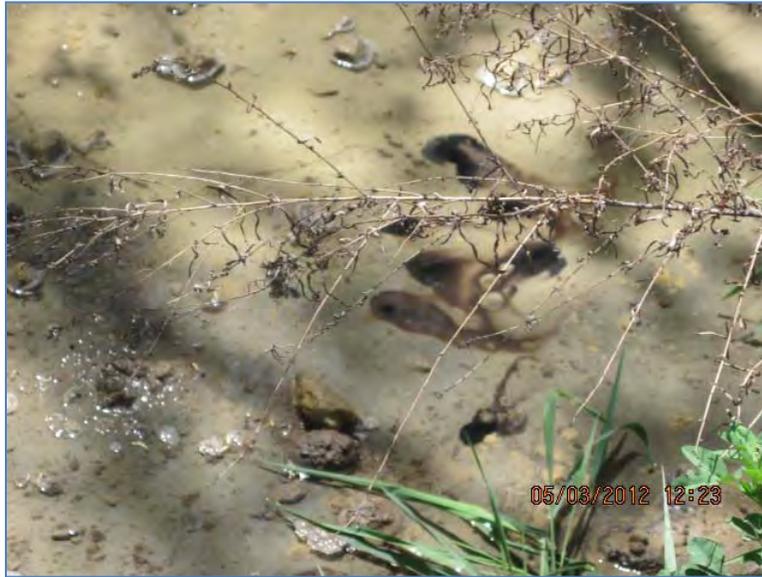
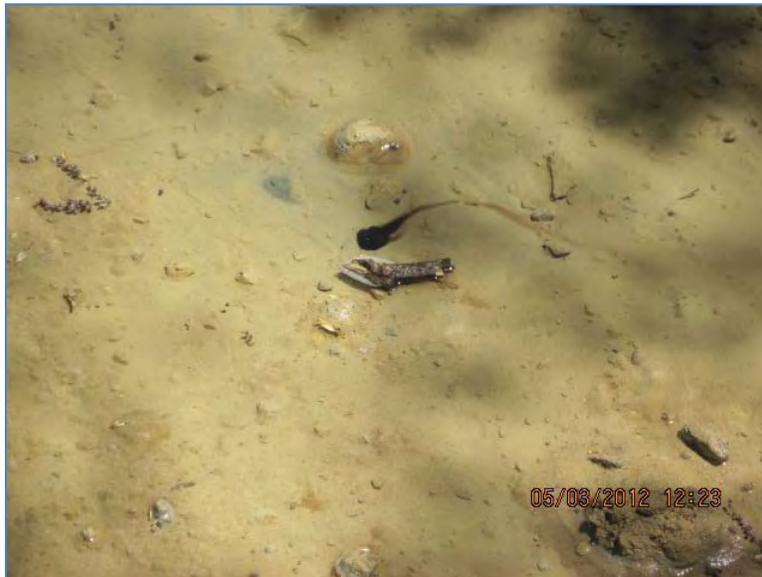
NMED/SWQB
Official Photograph Log
Photo # 35 and 36

Photographer: Erin S. Trujillo	Date: 05/03/2012	Time: 1223 hours
City/County: Near Farmington / San Juan	State: New Mexico	
Location: Morningstar Minerals Corporation Mill and Manufacturing Facility		
Subject: Dark solids (humate) in channel. Lighter colored material similar to material used in berm appears in bed of trench.

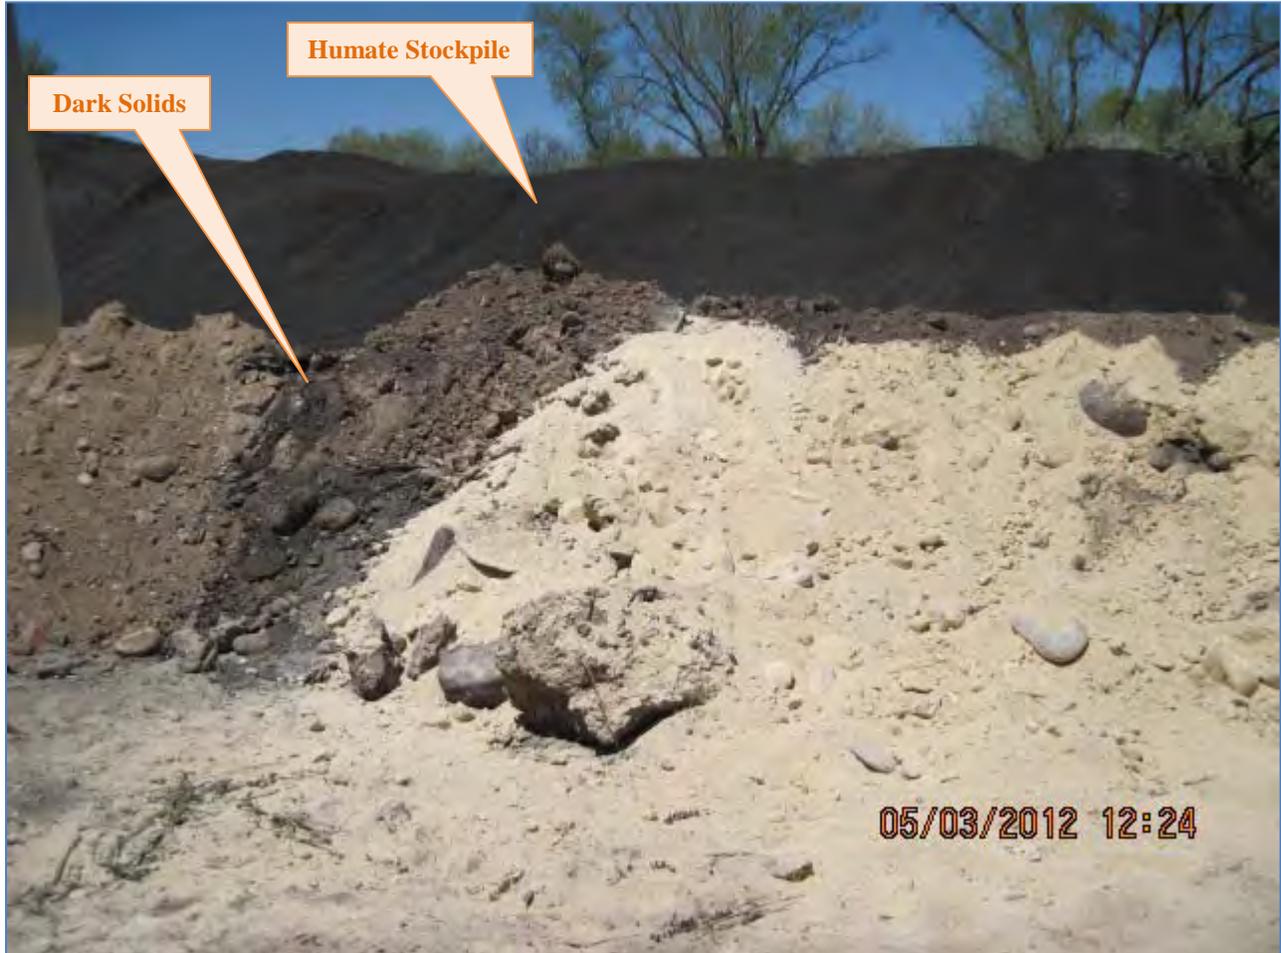
NMED/SWQB
Official Photograph Log
Photo # 37

Photographer: Erin S. Trujillo	Date: 05/03/2012	Time: 1224 hours
City/County: Near Farmington / San Juan	State: New Mexico	
Location: Morningstar Minerals Corporation Mill and Manufacturing Facility		
Subject: Called out dark solids in berm shown in Photos 32 and 33 appear to be humate from mill and manufacturing facility.

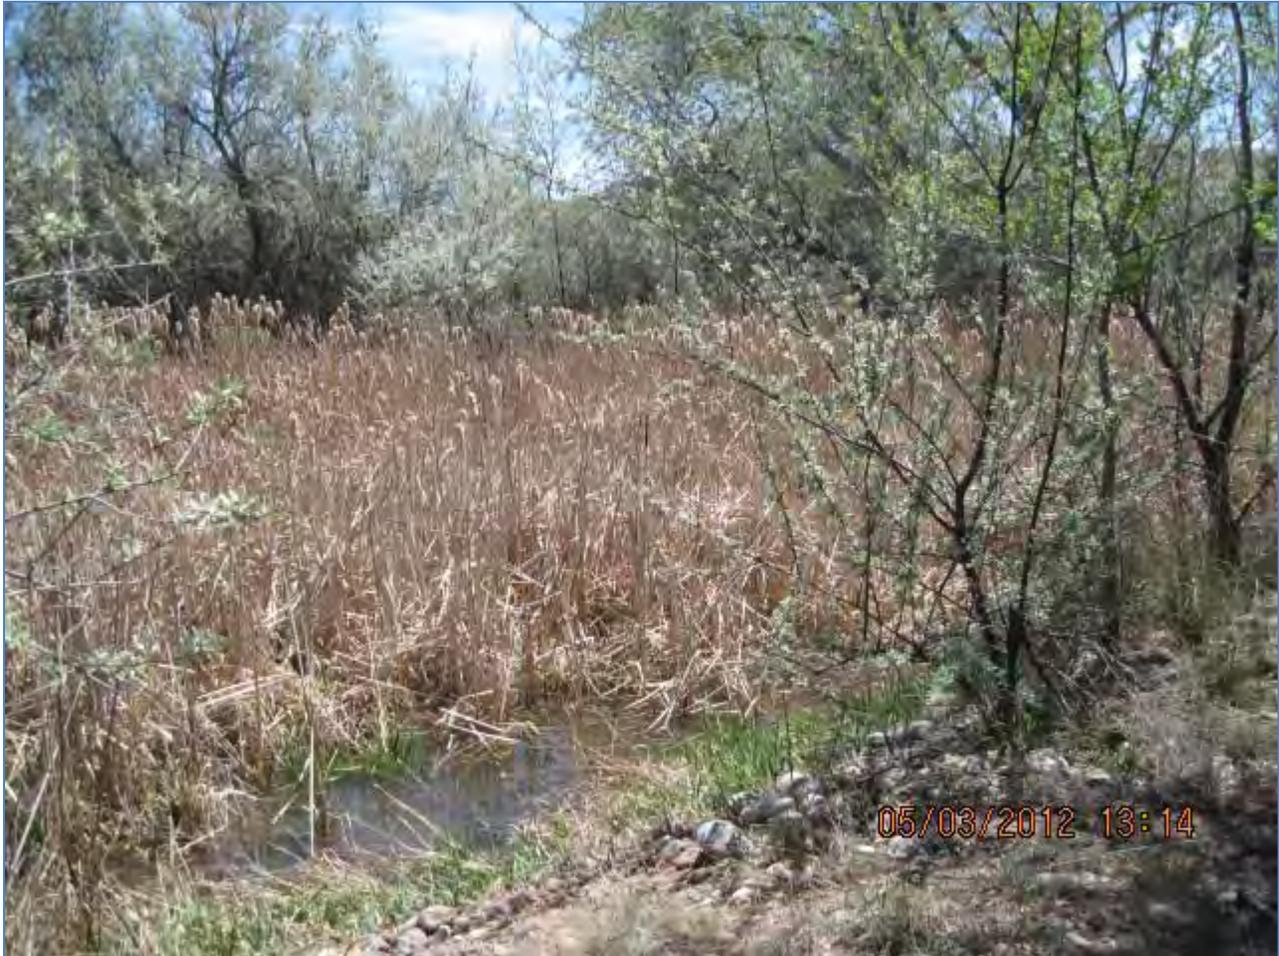
NMED/SWQB
Official Photograph Log
Photo # 38

Photographer: Erin S. Trujillo	Date: 05/03/2012	Time: 1314 hours
City/County: Near Farmington / San Juan	State: New Mexico	
Location: Morningstar Minerals Corporation Mill and Manufacturing Facility		
Subject: Cattail pond in northeast corner of the Chitwood parcel along Animas River.

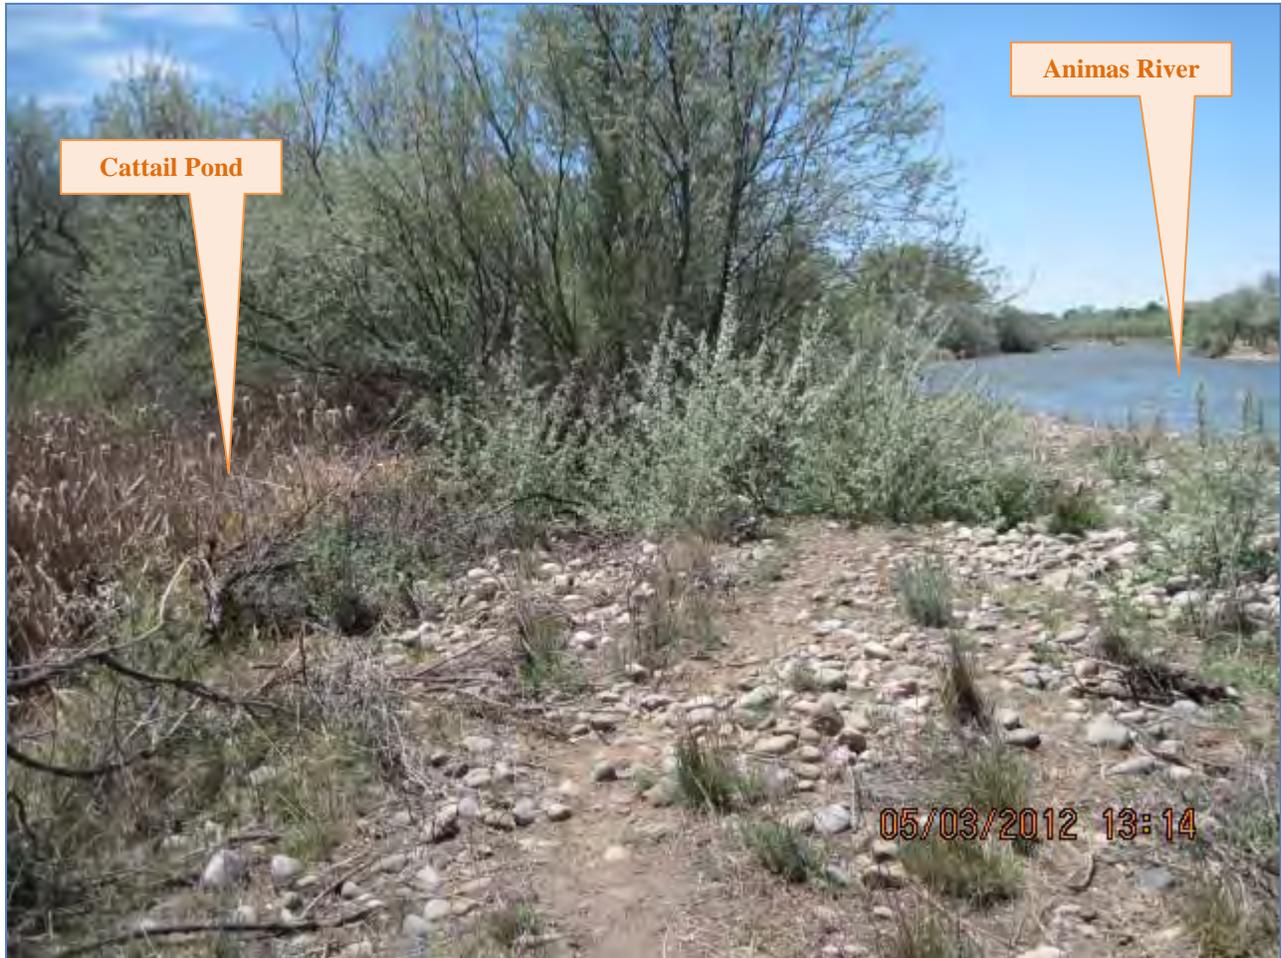
NMED/SWQB
Official Photograph Log
Photo # 39

Photographer: Erin S. Trujillo	Date: 05/03/2012	Time: 1314 hours
City/County: Near Farmington / San Juan	State: New Mexico	
Location: Morningstar Minerals Corporation Mill and Manufacturing Facility		
Subject: Cattails in pond on Chitwood Property near Animas River

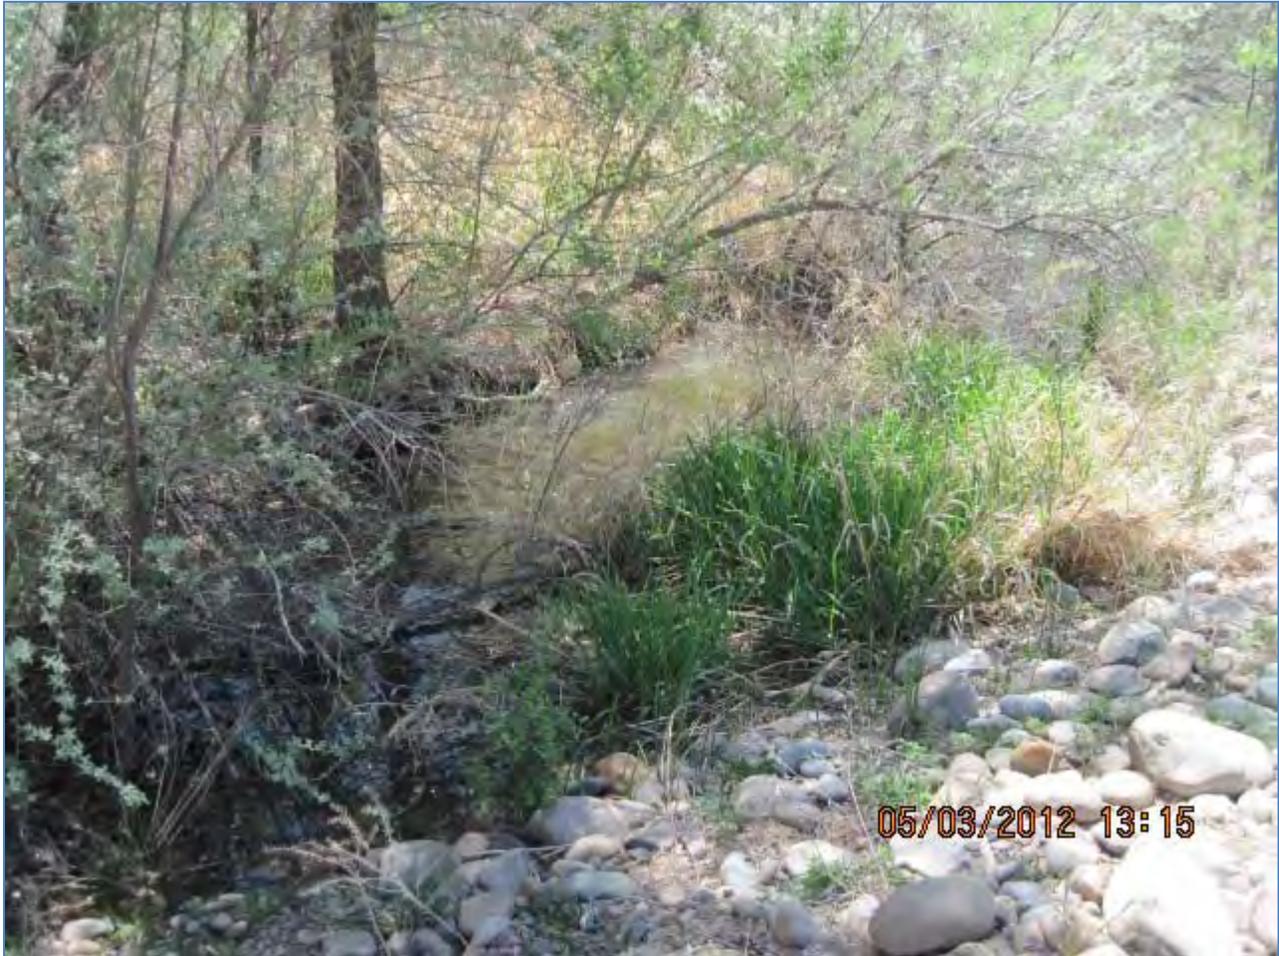
NMED/SWQB
Official Photograph Log
Photo # 40

Photographer: Erin S. Trujillo	Date: 05/03/2012	Time: 1315 hours
City/County: Near Farmington / San Juan	State: New Mexico	
Location: Morningstar Minerals Corporation Mill and Manufacturing Facility		
Subject: Surface water and/or seepage south-southwest from cattail pond shown in previous photos.

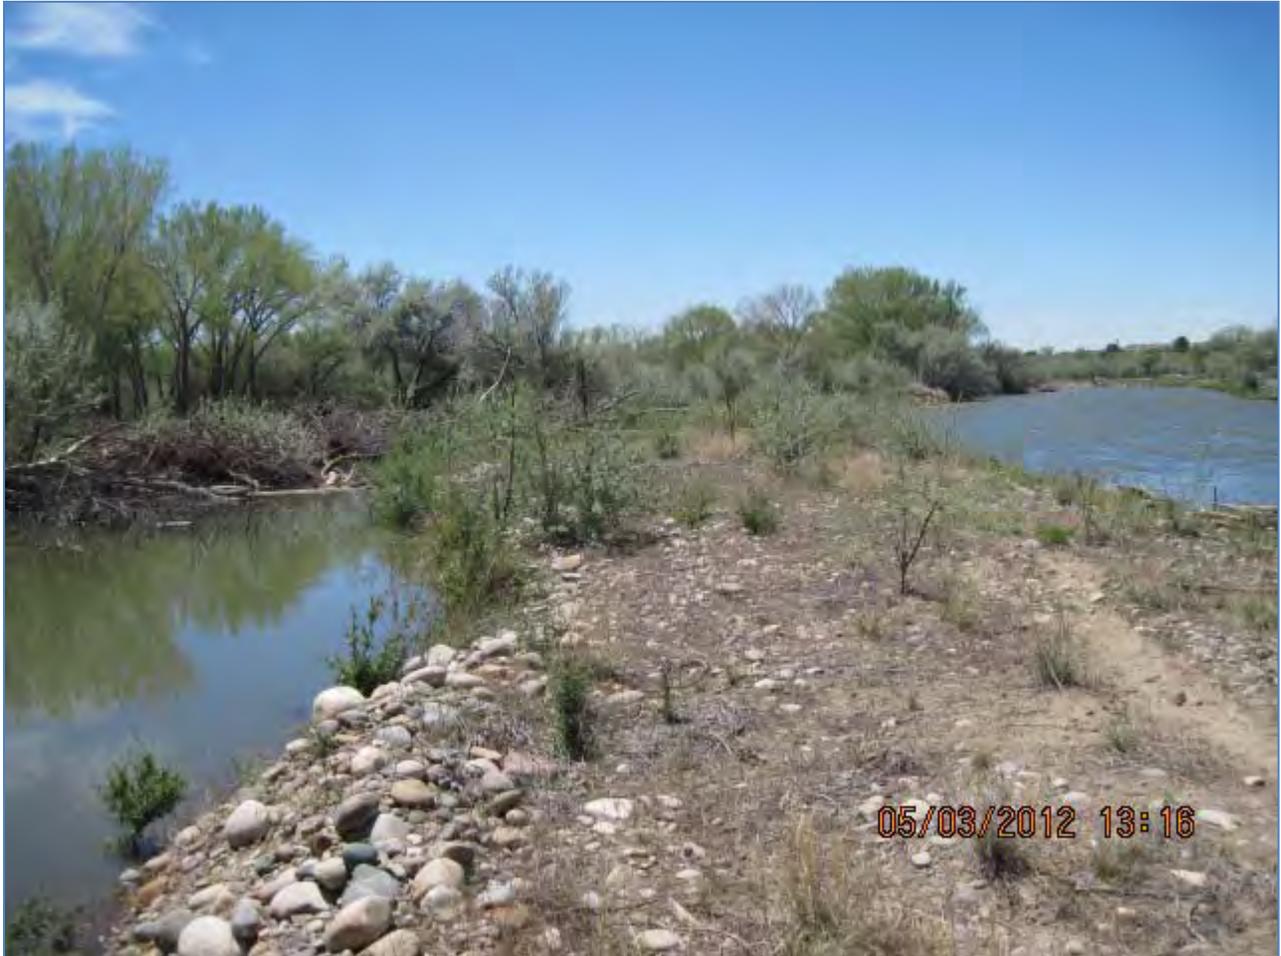
NMED/SWQB
Official Photograph Log
Photo # 41

Photographer: Erin S. Trujillo	Date: 05/03/2012	Time: 1316 hours
City/County: Near Farmington / San Juan	State: New Mexico	
Location: Morningstar Minerals Corporation Mill and Manufacturing Facility		
Subject: Connected to previous photo, surface water and/or seepage south-southwest from cattail pond.

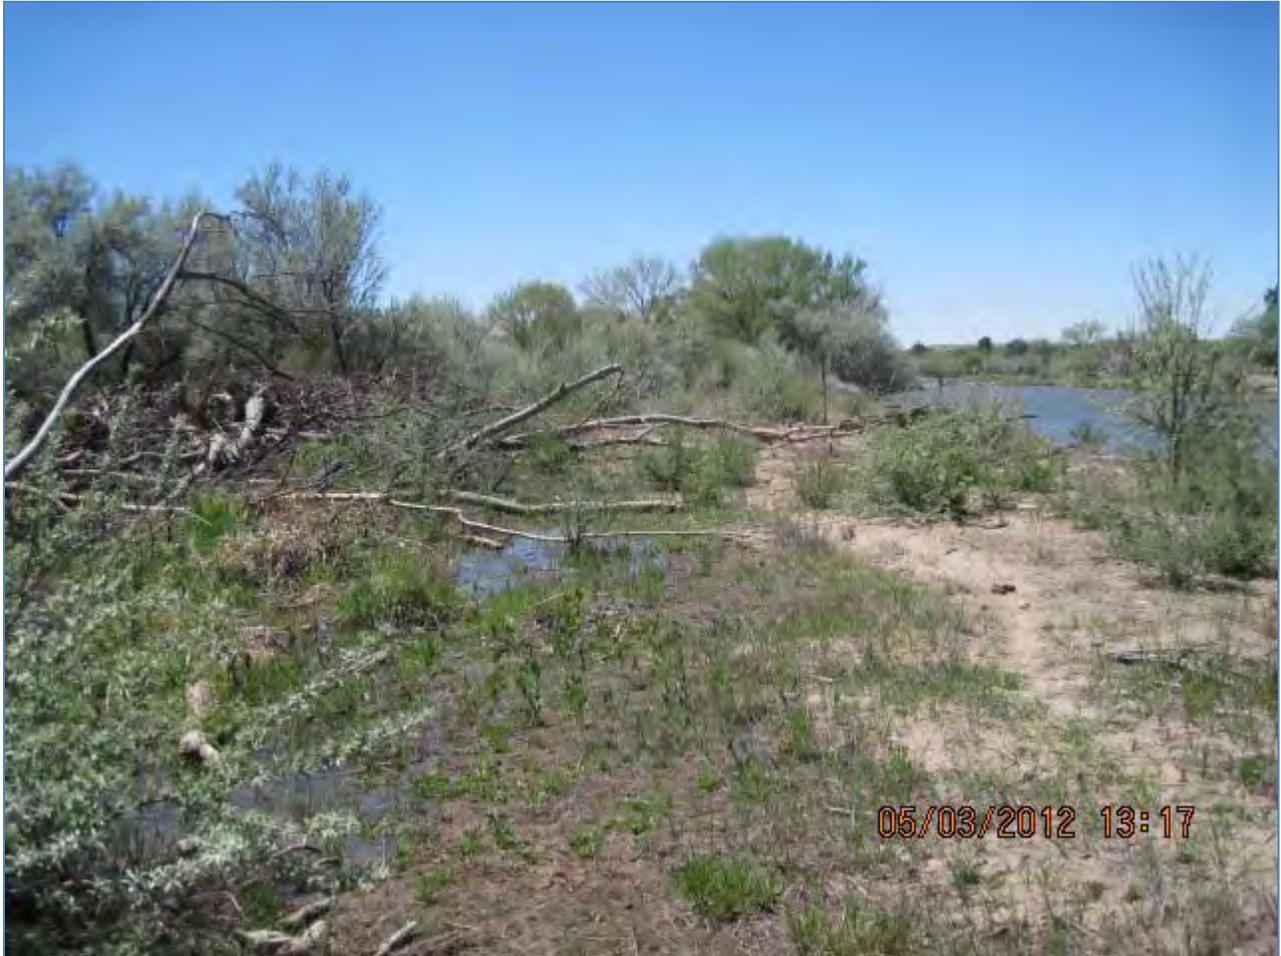
NMED/SWQB
Official Photograph Log
Photo # 42

Photographer: Erin S. Trujillo	Date: 05/03/2012	Time: 1317 hours
City/County: Near Farmington / San Juan	State: New Mexico	
Location: Morningstar Minerals Corporation Mill and Manufacturing Facility		
Subject: Connected to previous photo, surface water and/or seepage south-southwest from cattail pond.

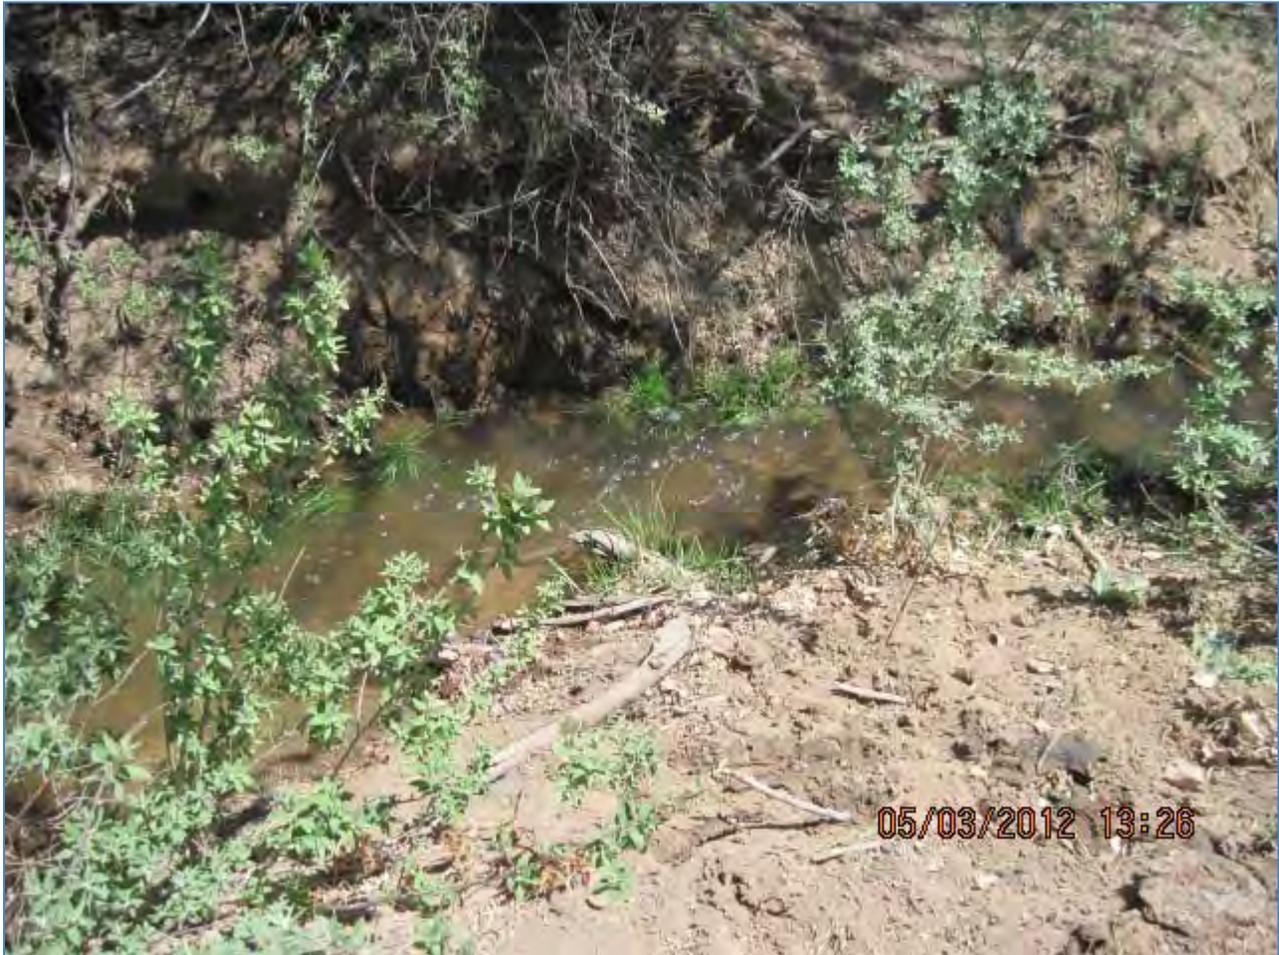
NMED/SWQB
Official Photograph Log
Photo # 43

Photographer: Erin S. Trujillo	Date: 05/03/2012	Time: 1326 hours
City/County: Near Farmington / San Juan	State: New Mexico	
Location: Morningstar Minerals Corporation Mill and Manufacturing Facility		
Subject: Irrigation flow in ditch on the Chitwood parcel. This irrigation ditch enters cattail pond shown in Photo 38.

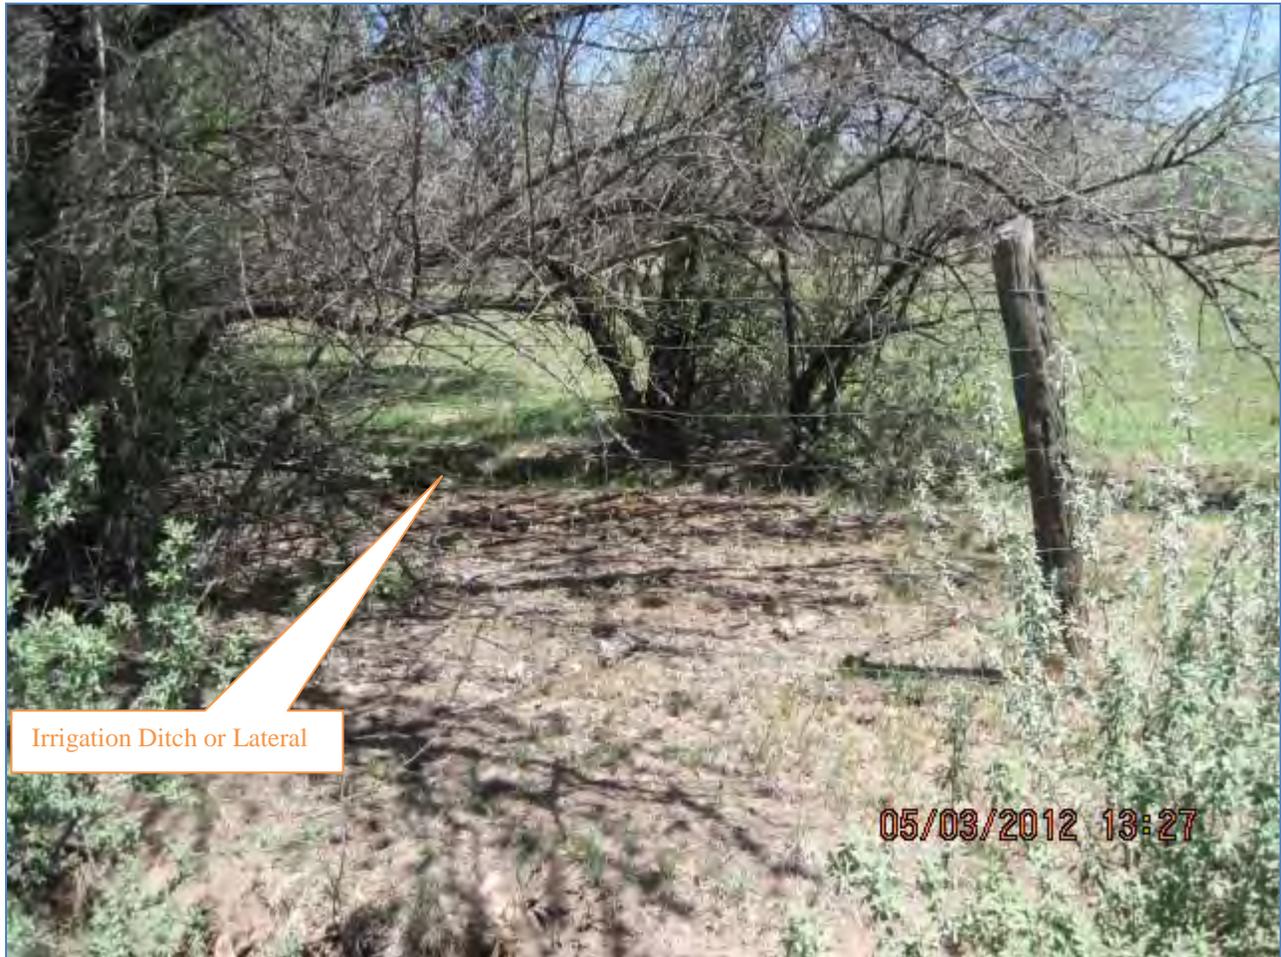
NMED/SWQB
Official Photograph Log
Photo # 44

Photographer: Erin S. Trujillo	Date: 05/03/2012	Time: 1327 hours
City/County: Near Farmington / San Juan	State: New Mexico	
Location: Morningstar Minerals Corporation Mill and Manufacturing Facility		
Subject: Irrigation ditch on the Hamilton-Kasselmann parcel. Trench appeared to continue east along northern limit of pasture.

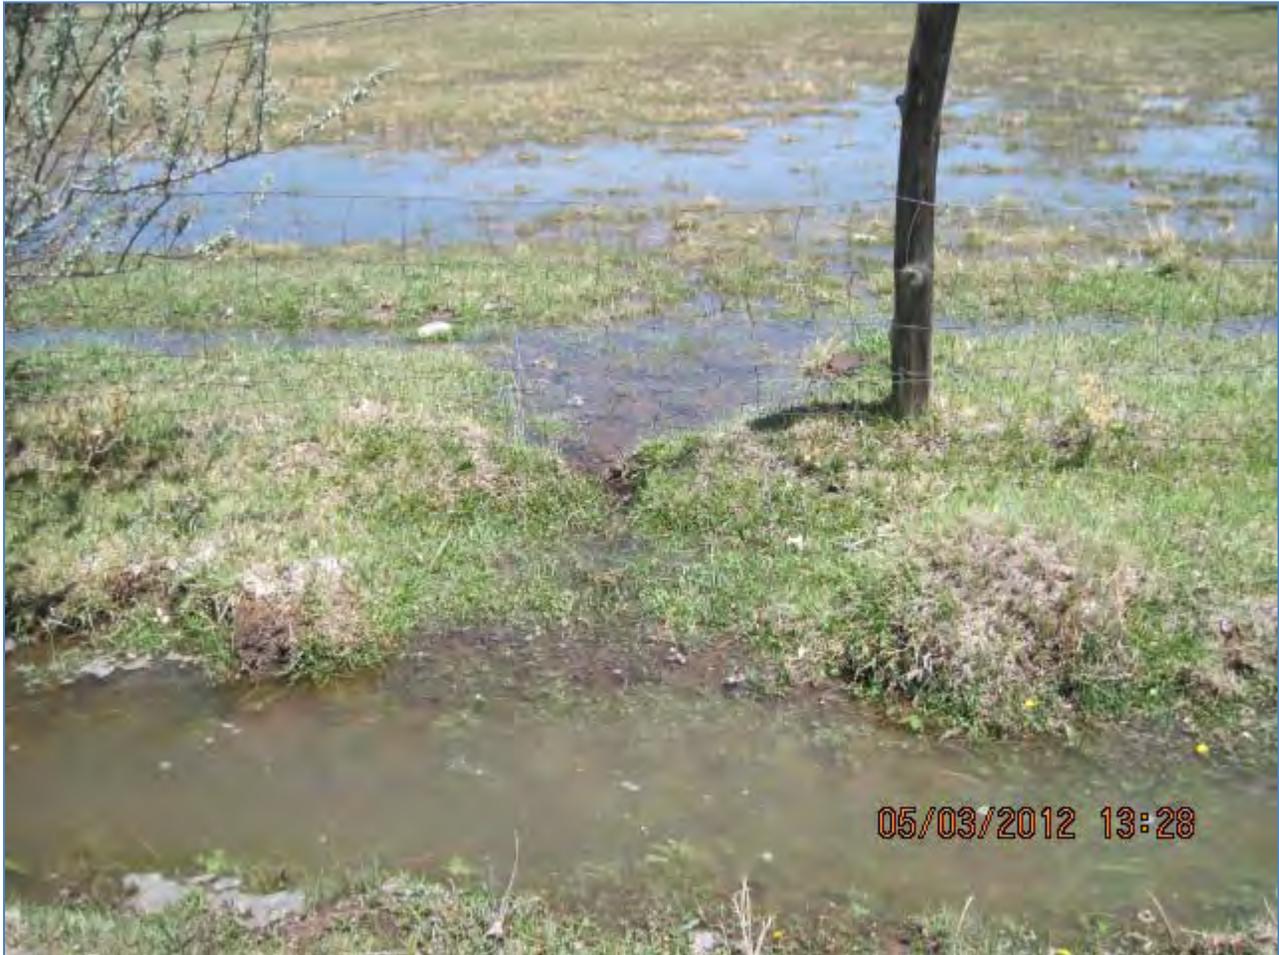
NMED/SWQB
Official Photograph Log
Photo # 45

Photographer: Erin S. Trujillo	Date: 05/03/2012	Time: 1328 hours
City/County: Near Farmington / San Juan	State: New Mexico	
Location: Morningstar Minerals Corporation Mill and Manufacturing Facility		
Subject: Flood irrigation flow on the Hamilton-Kasselmann parcel (background) flowing west into irrigation ditch on the Chitwood parcel (foreground).
