**RE:** Construction Storm Water, SIC 1522, NPDES Compliance Evaluation Inspection, Pavilion Construction, LLC / Villa Alegre, NMR10GX08, November 3, 2010

### NPDES Compliance Inspection Report

**NPDES Construction Storm Water Compliance Evaluation Inspection**  
**Pavilion Construction LLC / Villa Alegre**  
**NPDES Tracking # NMR10GX08**  
**November 3, 2010**

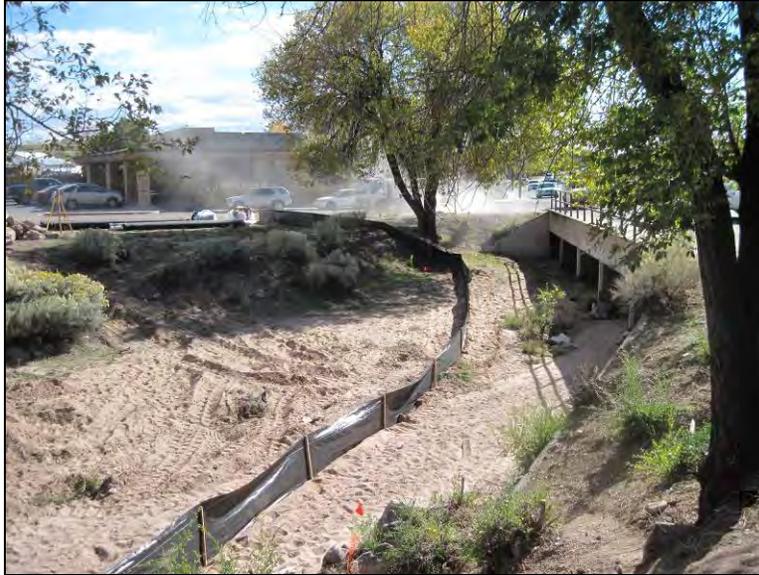
<b>NMED/SWQB Official Photograph Log Photo # 1</b>		
Photographer: Erin Trujillo	Date: 11/03/2010	Time: 1420 hours
City/County: Santa Fe / Santa Fe County		State: New Mexico
Location: Villa Alegre		
Subject: Silt fence crossing Arroyo Mascaras stream bed and bank. Dust visible in background of photo was generated by street sweeper operating on Las Mascaras Street.

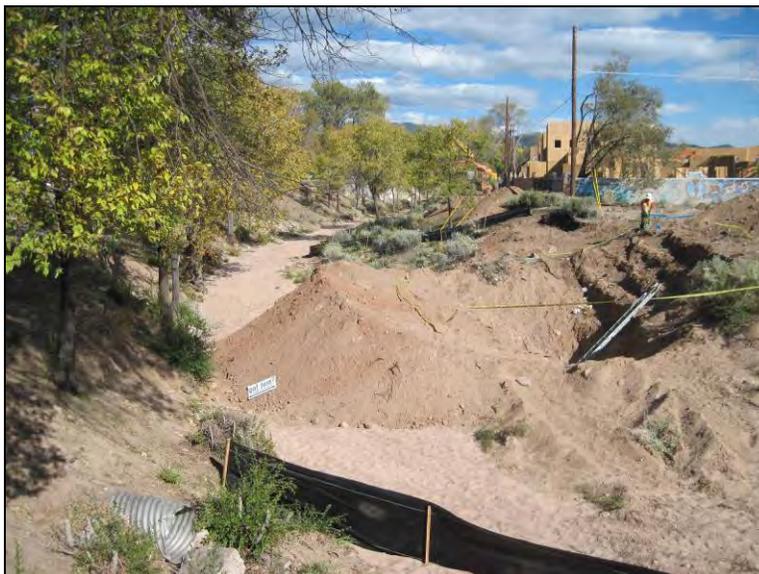
<b>NMED/SWQB Official Photograph Log Photo # 2</b>		
Photographer: Erin Trujillo	Date: 11/03/2010	Time: 1420 hours
City/County: Santa Fe / Santa Fe County		State: New Mexico
Location: Villa Alegre		
Subject: Material from trench excavation sidecast/stockpiled spans Arroyo Mascaras stream bed.

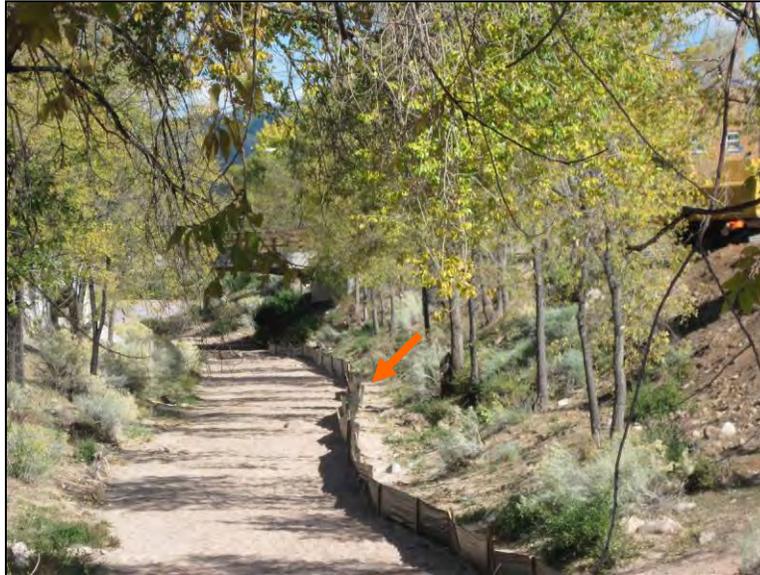
<b>NMED/SWQB Official Photograph Log Photo # 3</b>		
Photographer: Erin Trujillo	Date: 11/03/2010	Time: 1421 hours
City/County: Santa Fe / Santa Fe County		State: New Mexico
Location: Villa Alegre		
Subject: Looking upstream, arrow points to silt fence installed in the stream bed of Arroyo Mascaras that would not protect the stream from construction debris or sediment from disturbance on bank and floodplain (right side of photo).

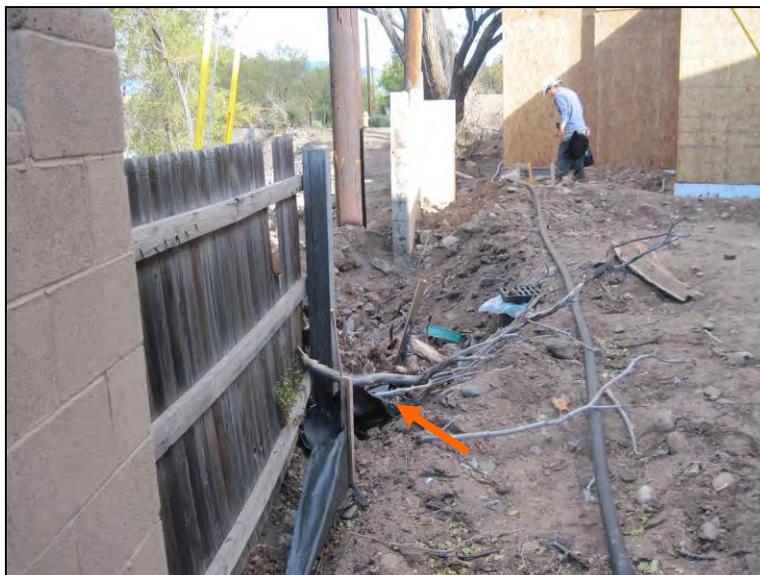
<b>NMED/SWQB Official Photograph Log Photo # 4</b>		
Photographer: Erin Trujillo	Date: 11/03/2010	Time: 1440 hours
City/County: Santa Fe / Santa Fe County		State: New Mexico
Location: Villa Alegre		
Subject: Arrow points to example of damaged silt fence that had been removed according to the permittee on-site representative from a gap along north boundary of Phase 1 and 2 adjacent to floodplain of Arroyo Mascaras.

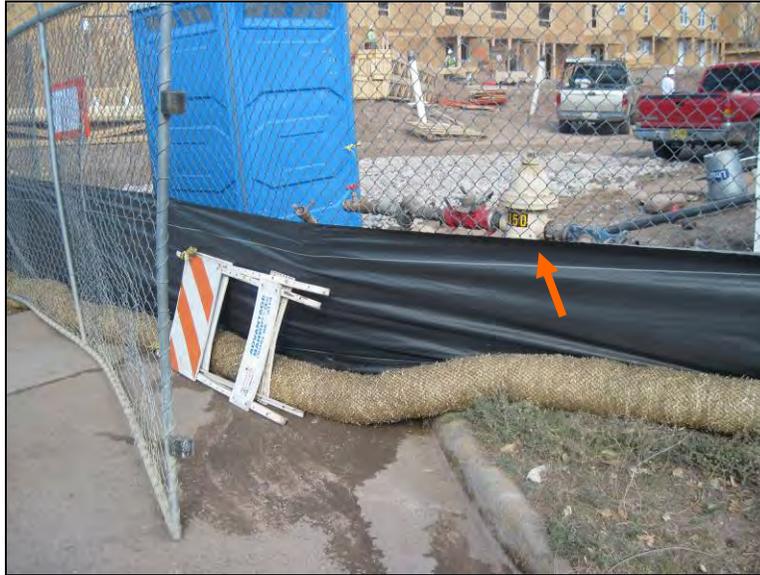
<b>NMED/SWQB Official Photograph Log Photo # 5</b>		
Photographer: Erin Trujillo	Date: 11/03/2010	Time: 1449 hours
City/County: Santa Fe / Santa Fe County		State: New Mexico
Location: Villa Alegre		
Subject: Sediment in Las Crucitas Street in northwest corner of Phase 1 and 2. Arrow points to fire hydrant with water line connection used to obtain water for drilling operations.

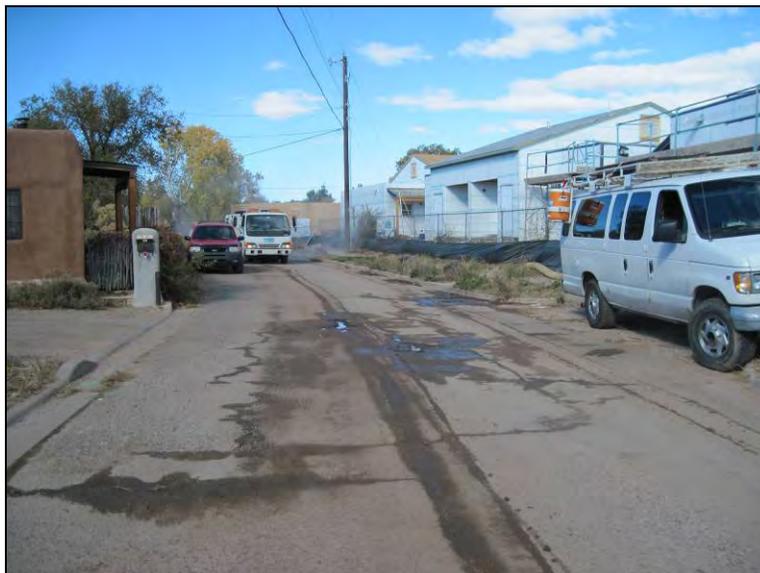
<b>NMED/SWQB Official Photograph Log Photo # 6</b>		
Photographer: Erin Trujillo	Date: 11/03/2010	Time: 1445 hours
City/County: Santa Fe / Santa Fe County		State: New Mexico
Location: Villa Alegre		
Subject: Wet pavement and water accumulated in Las Crucitas Street. It is unknown how much of the water is from the hydrant connections shown in previous photo or operation of street sweeper shown in background of the photo.

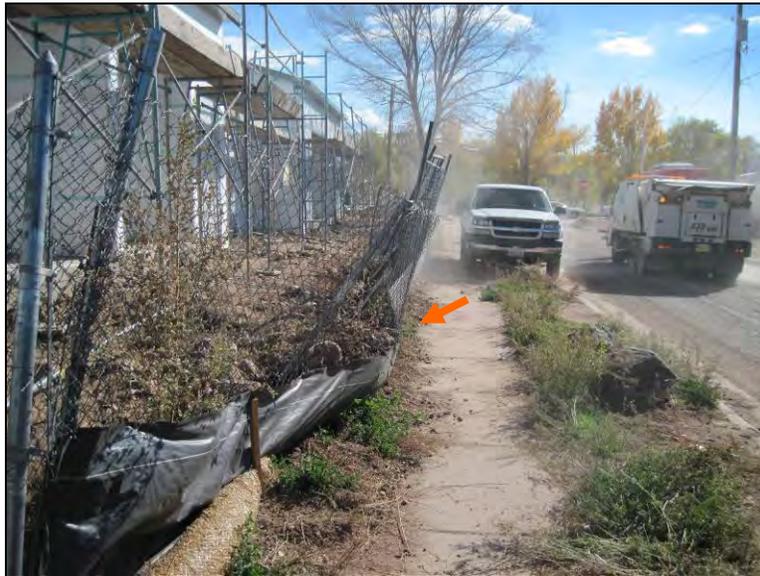
<b>NMED/SWQB Official Photograph Log Photo # 7</b>		
Photographer: Erin Trujillo	Date: 11/03/2010	Time: 1447 hours
City/County: Santa Fe / Santa Fe County		State: New Mexico
Location: Villa Alegre		
Subject: Arrow points to trapped sediment/fill reaching and overtopping the silt fence height and sediment on sidewalk along Las Crucitas Street. Photo also shows street sweeper generating dust while operating.

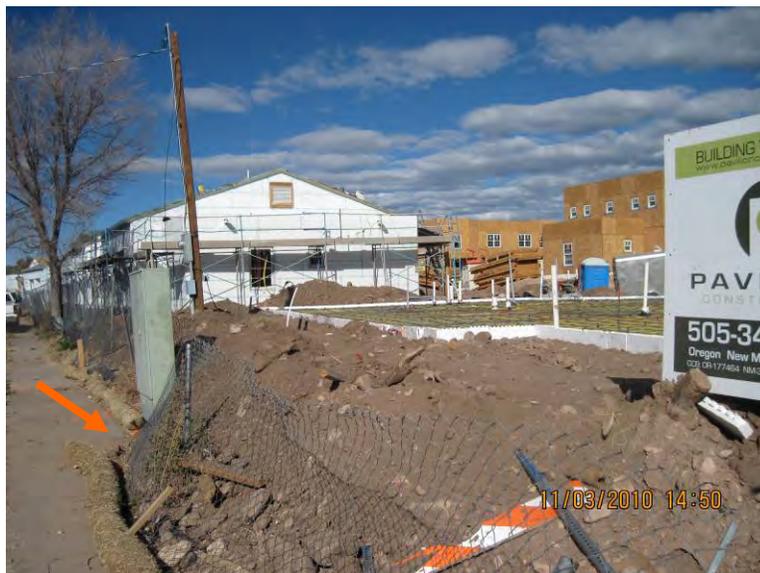
<b>NMED/SWQB Official Photograph Log Photo # 8</b>		
Photographer: Erin Trujillo	Date: 11/03/2010	Time: 1450 hours
City/County: Santa Fe / Santa Fe County		State: New Mexico
Location: Villa Alegre		
Subject: Example of gap and unstaked straw wattle placed on sidewalk at base of sediment/fill material at corner of Las Crucitas Street and West Alameda Street.

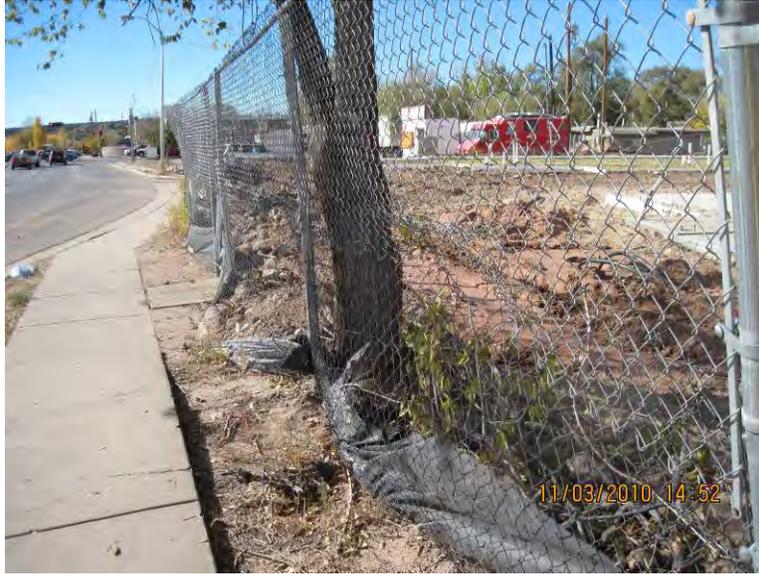
<b>NMED/SWQB Official Photograph Log Photo # 9</b>		
Photographer: Erin Trujillo	Date: 11/03/2010	Time: 1452 hours
City/County: Santa Fe / Santa Fe County		State: New Mexico
Location: Villa Alegre		
Subject: Example of damaged and gaps in silt fence on southern perimeter along West Alameda Street.

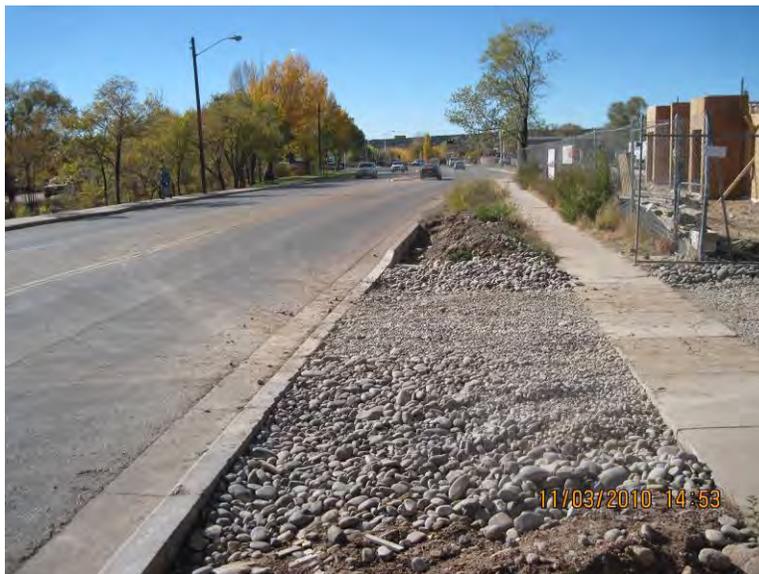
<b>NMED/SWQB Official Photograph Log Photo # 10</b>		
Photographer: Erin Trujillo	Date: 11/03/2010	Time: 1453 hours
City/County: Santa Fe / Santa Fe County		State: New Mexico
Location: Villa Alegre		
Subject: Example of accumulated sediment and vehicle tracking on West Alameda. This entrance had rock track out control measure with accumulated sediment. Because of the off-site tracking additional maintenance or measures appears needed.

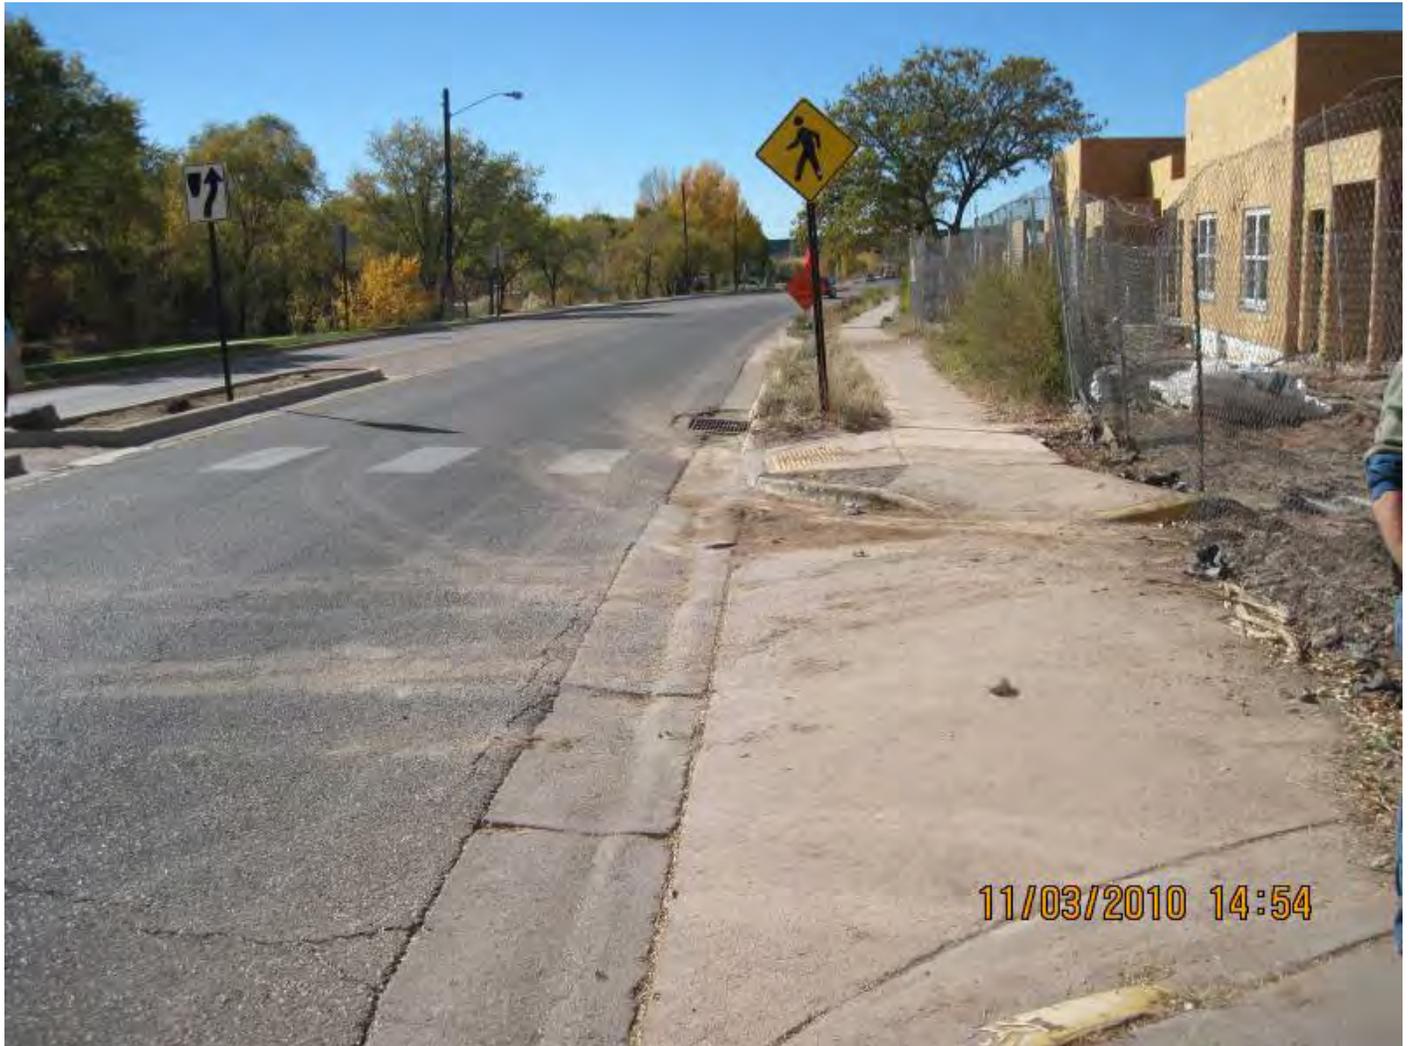
NMED/SWQB Official Photograph Log Photo # 11		
Photographer: Erin Trujillo	Date: 11/03/2010	Time: 1454 hours
City/County: Santa Fe / Santa Fe County		State: New Mexico
Location: Villa Alegre		
Subject: Example of accumulated sediment and vehicle tracking on West Alameda and sidewalk near storm drain inlet. There was no rock track out and perimeter sediment control measures were damaged or missing. Not all sediment appears to be from vehicle tracking, but may be from stormwater discharge, drilling operations or other use of water on-site.

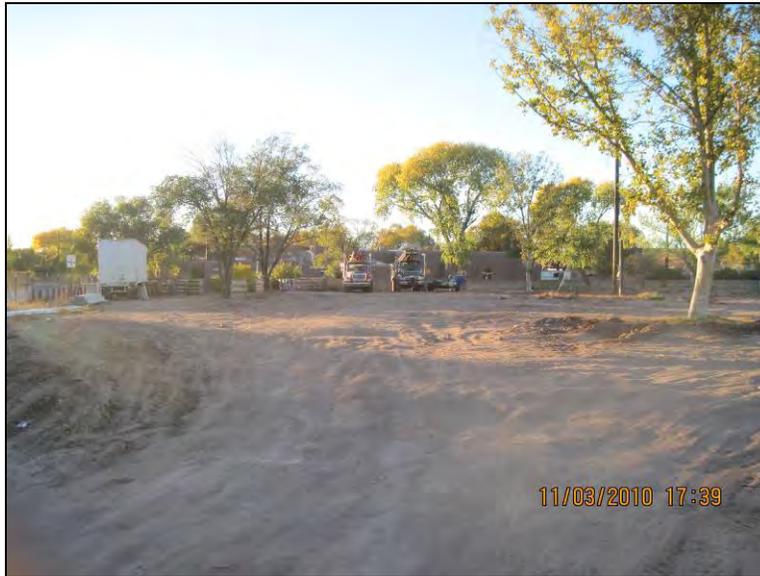
<b>NMED/SWQB Official Photograph Log Photo # 12</b>		
Photographer: Erin Trujillo	Date: 11/03/2010	Time: 1739 hours
City/County: Santa Fe / Santa Fe County		State: New Mexico
Location: Villa Alegre		
Subject: Example of disturbed area in portion of Phase 3 used as support activity area. This photo shows approximately half of the approximately 1.5 acre track/lot used for equipment staging (drill rigs), material storage and parking.

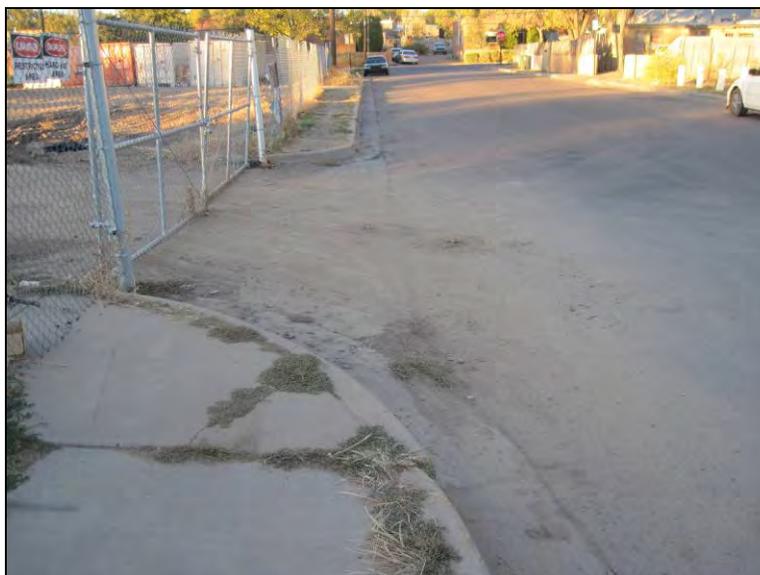
<b>NMED/SWQB Official Photograph Log Photo # 13</b>		
Photographer: Erin Trujillo	Date: 11/03/2010	Time: 1743 hours
City/County: Santa Fe / Santa Fe County		State: New Mexico
Location: Villa Alegre		
Subject: Accumulated sediment in Camino Del Campo Street at entrance to support activity area.
