NEW MEXICO
ENVIRONMENT DEPARTMENT
Surface Water Quality Bureau

RE: Construction Storm Water, SIC 1611, NPDES Compliance Evaluation Inspection, Enviroworks, LLC / Las Soleras and Beckner Road Extension, NMR10HC47, August 24, 2011

Enviroworks, LLC
Los Soleras and Beckner Road Extension
NPDES Tracking No. NMR10HC47
August 24, 2011

NPDES Industrial Storm Water Worksheet (Construction)

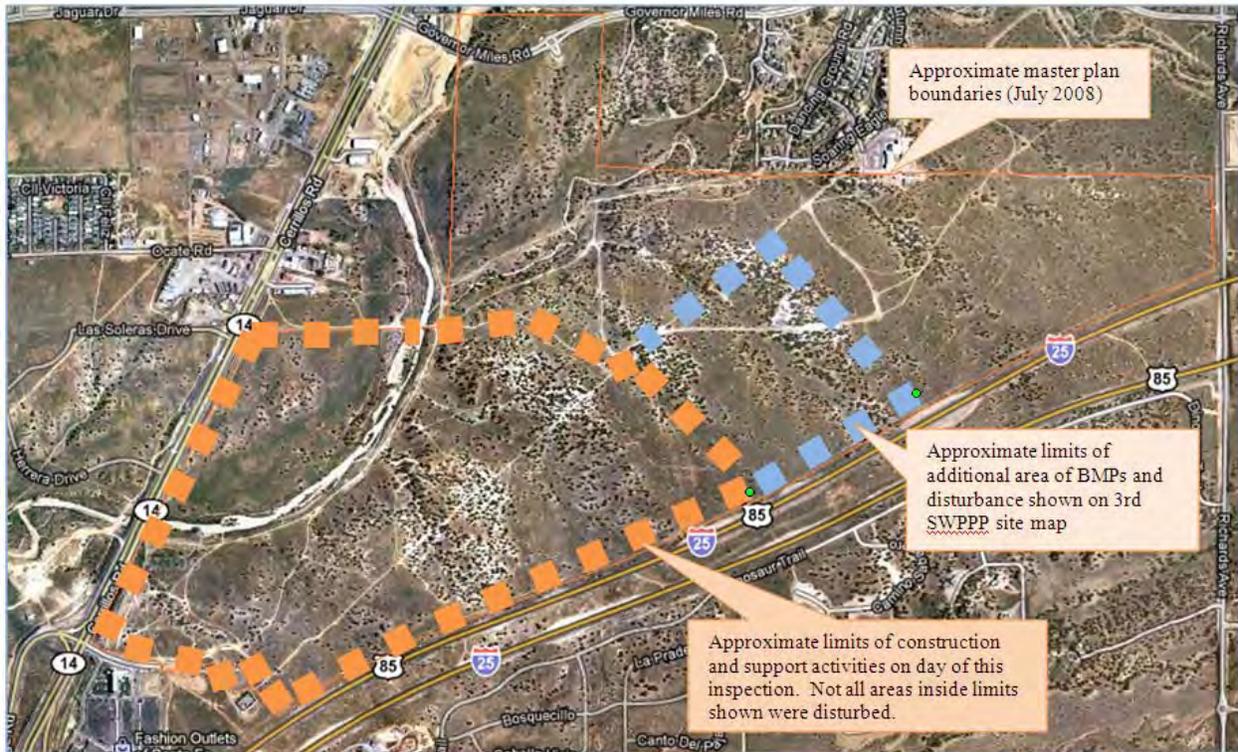
Figure 1 Las Soleras

Notes: Approximate Las Soleras master plan boundaries shown below is based on a James W. Siebert and Associates, Inc. aerial photo plan sheet dated July 2008 provided by the operator/permittee on-site representative during this inspection. The approximate limits of the Las Soleras construction and support activities on the day of this inspection is shown below for information purposes. The limits were not surveyed by the inspector, but are based on information provided by the permittee representative, SWPPP Site Maps, and observed disturbance.

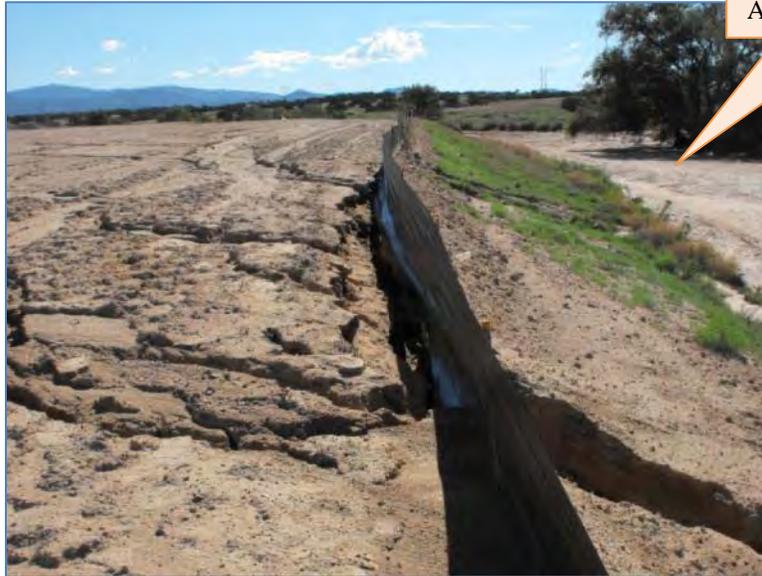
NMED/SWQB Official Photograph Log Photo # 5		
Photographer: Daniel Valenta	Date: 08/24/2011	Time: 0955 hours
City/County: Santa Fe / Santa Fe		State: New Mexico
Location: Las Soleras and Beckner Road Extension		
Subject: Erosion from fill area along silt fence and undercutting silt fence (same area shown in Photo #4).

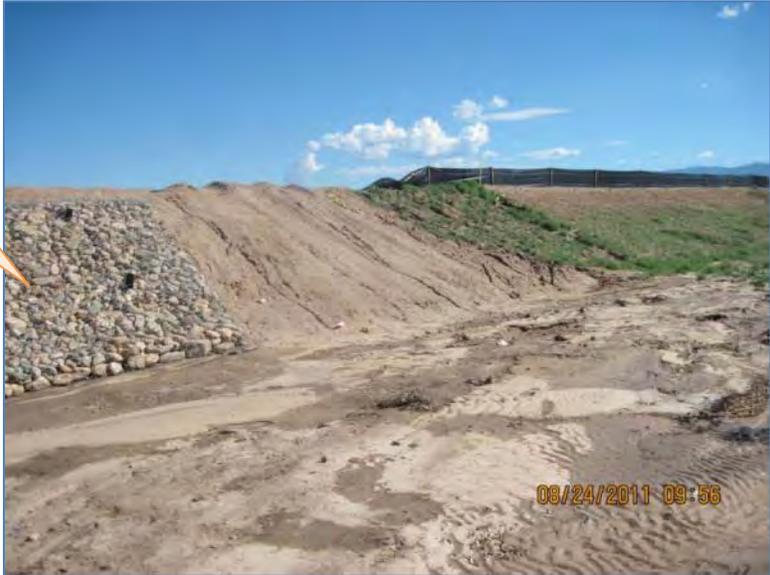
NMED/SWQB Official Photograph Log Photo # 8		
Photographer: Erin S. Trujillo	Date: 08/24/2011	Time: 0956 hours
City/County: Santa Fe / Santa Fe		State: New Mexico
Location: Las Soleras and Beckner Road Extension		
Subject: Upstream of previous photos, example of erosion rills along constructed fill/slope at gap and damaged silt fence as observed from floodplain of Arroyo de los Chamisos. Previous flows had risen above the banks of the stream in this area. Additional gap in silt fence and undercutting was observed upstream (not shown in photo).

Short segment of rip rap had been installed at buried utility line according to on-site representatives.

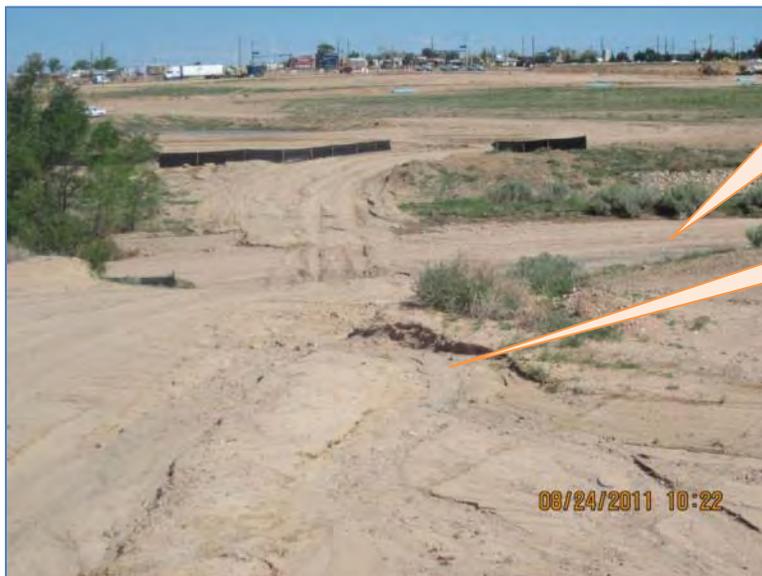
NMED/SWQB Official Photograph Log Photo # 11		
Photographer: Erin S. Trujillo	Date: 08/24/2011	Time: 1022 hours
City/County: Santa Fe / Santa Fe	State: New Mexico	
Location: Las Soleras and Beckner Road Extension		
Subject: Looking north from grading for Crossing at Chamisos. Erosion from disturbed areas flows toward low water crossing. Flow along graded road was not diverted.

Erosion rill toward graded road and stream

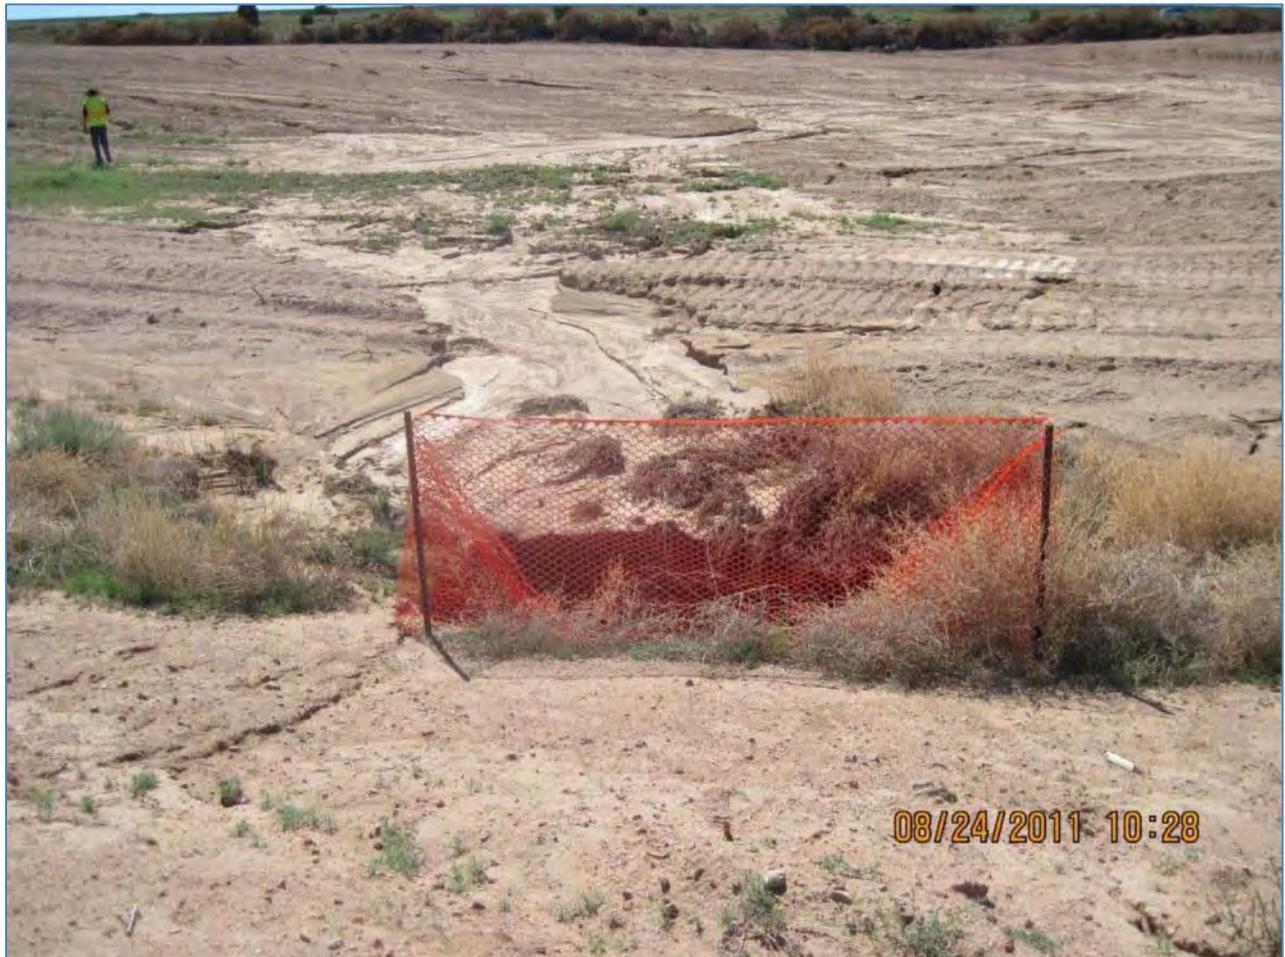
NMED/SWQB
Official Photograph Log
Photo # 12

Subject: Looking south from graded Beckner Road Extension, erosion in disturbed area. Tackifier was recorded to have been used in this area. Because the temporary riser pipe (planned drop inlet) for the Beckner Road Extension is missing, flow from this area discharge directly from the outfall (shown in previous photo) into Arroyo de los Chamisos. Repair of the riser is needed to prevent discharge into Arroyo de los Chamisos from this area. Re-application of tackifier and/or other control measures appears needed.

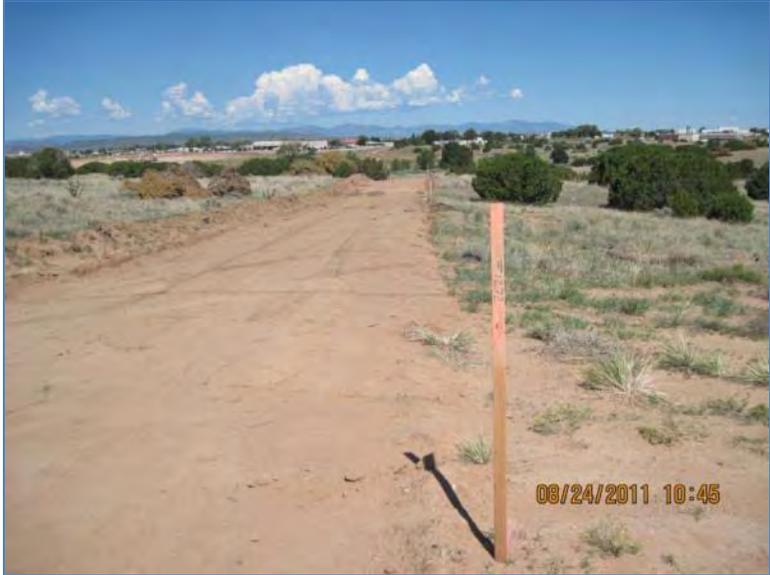
NMED/SWQB Official Photograph Log Photo # 15		
Photographer: Erin S. Trujillo	Date: 08/24/2011	Time: 1045 hours
City/County: Santa Fe / Santa Fe		State: New Mexico
Location: Las Soleras and Beckner Road Extension		
Subject: Looking north, graded and staked road approximately 3,000 feet east of construction site entrance that was not shown on Site Maps to be disturbed.

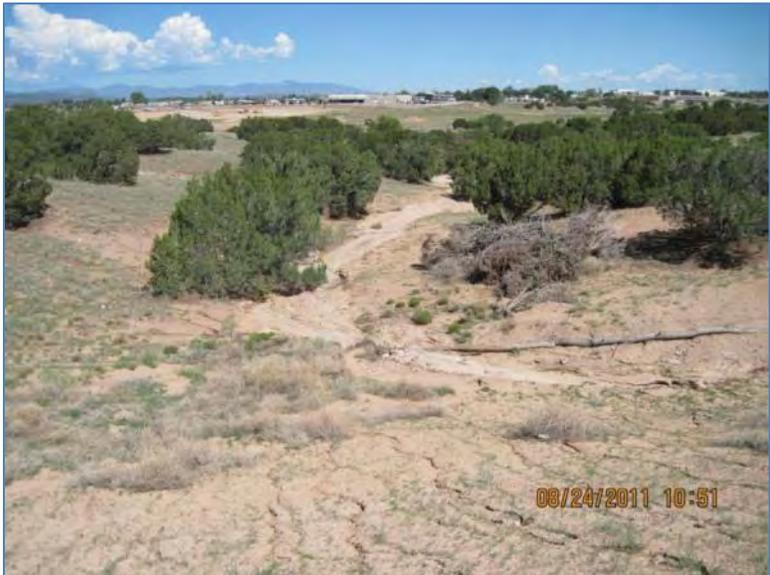
NMED/SWQB Official Photograph Log Photo # 16		
Photographer: Erin S. Trujillo	Date: 08/24/2011	Time: 1051 hours
City/County: Santa Fe / Santa Fe		State: New Mexico
Location: Las Soleras and Beckner Road Extension		
Subject: Erosion rills from Beckner Road fill slope leading toward tributary. Wattles crossing tributary do not provide erosion/sediment control measures from fill slopes.

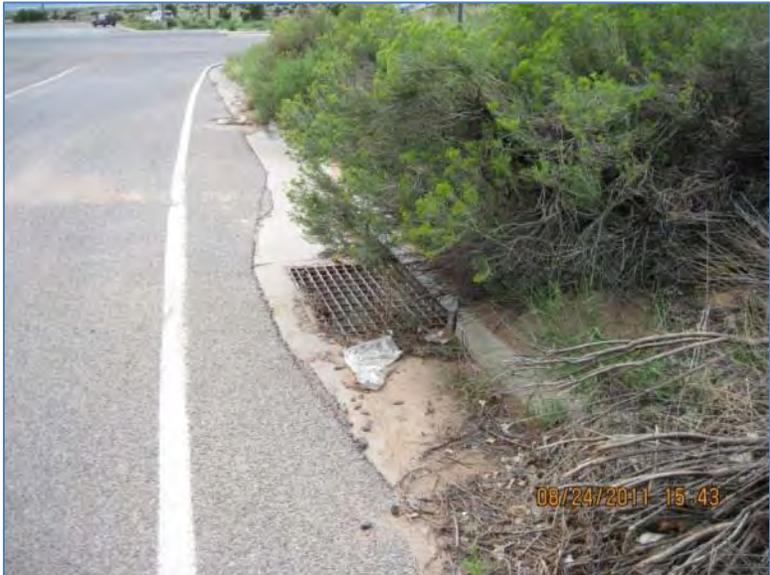
NMED/SWQB Official Photograph Log Photo # 26		
Photographer: Erin S. Trujillo	Date: 08/24/2011	Time: 1543 hours
City/County: Santa Fe / Santa Fe		State: New Mexico
Location: Las Soleras and Beckner Road Extension		
Subject: Not all off-site accumulated sediment or trash shown can be attributed to Las Soleras construction activities. Additional measures as discussed in previous photo appear needed.
