NEW MEXICO
ENVIRONMENT DEPARTMENT
Surface Water Quality Bureau

RE: Construction Storm Water, SIC 1622, NPDES Compliance Evaluation, New Mexico Department of Transportation / CN 3673 NM 120 Canadian River Bridge Replacement, NMR10HC66, April 2, 2012

NPDES Compliance Inspection Report

NPDES Industrial Storm Water Worksheet (Construction)

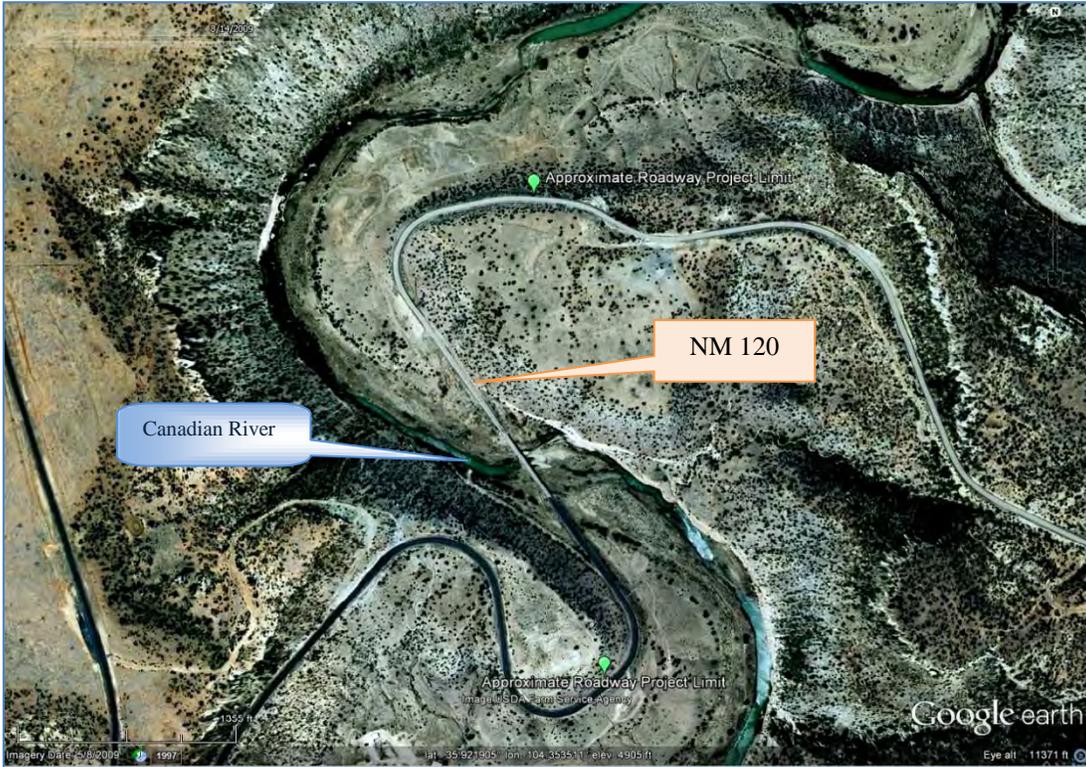
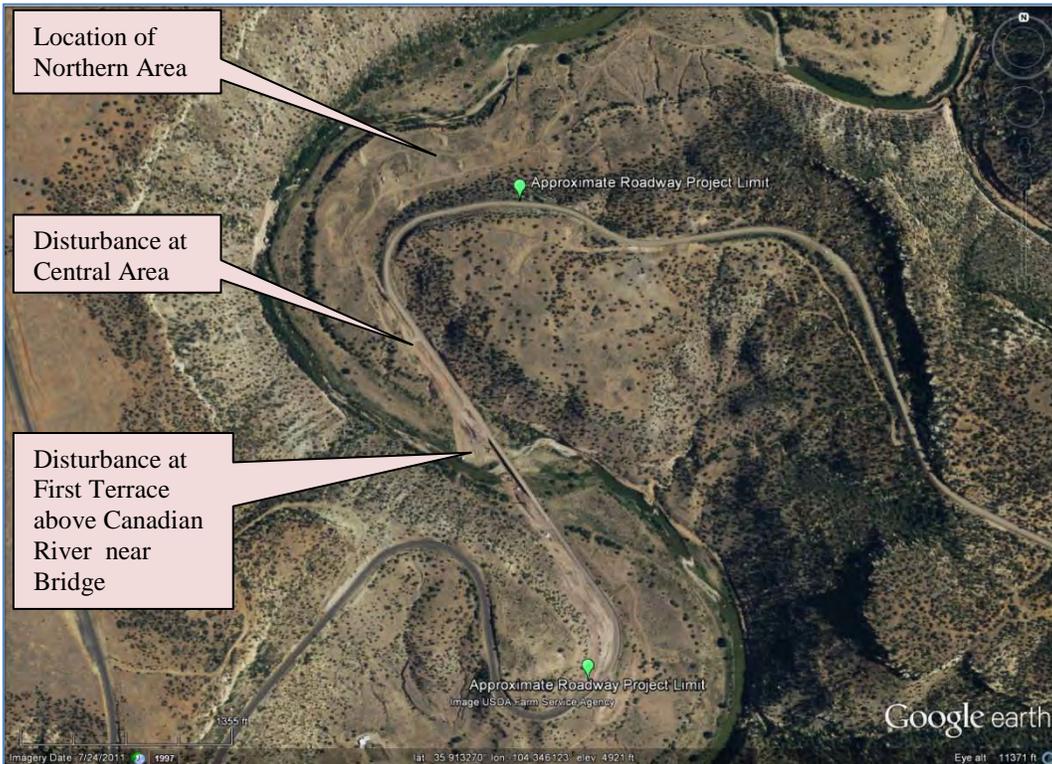
| NMED/SWQB Aerial Photography (Prior and During Construction) | | |
|---|--|---|
| Subject: Top imagery date is 5/8/2009 prior this construction project (CN 3673 NM 120 Canadian River Bridge Replacement). Lower imagery date is 7/24/2011 during construction. Location of support activity areas discussed in this report are called out in lower image. | | |

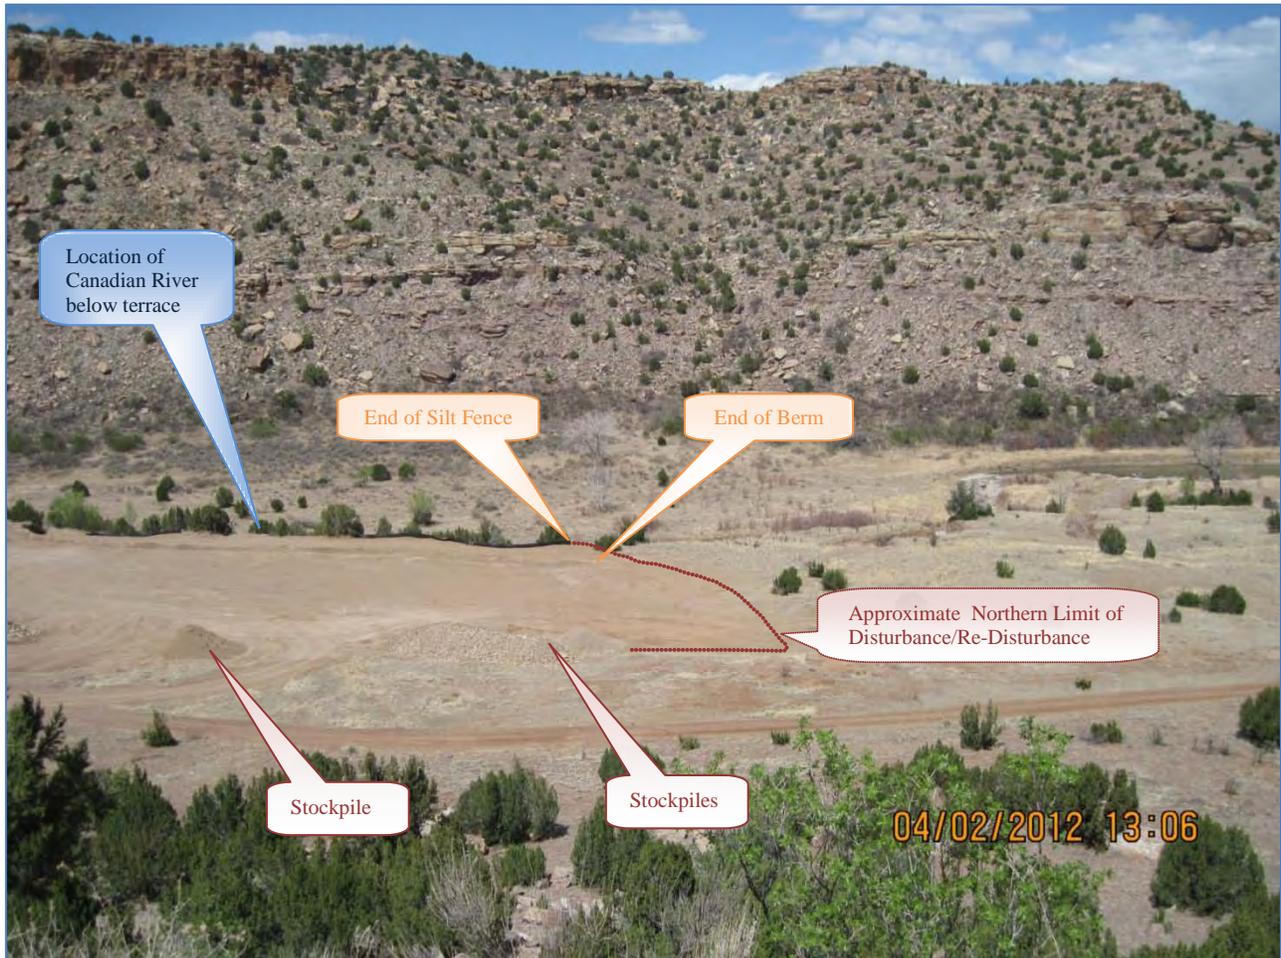
NMED/SWQB
Official Photograph Log
Photo # 1

Subject: From NM 120 looking at northern limit of disturbance (northern support activity area) on terrace above the Canadian River. Silt fence along terrace edge and berm did not extend to northern limit of disturbance. Approximate northern limit of disturbance is indicated by dashed line.

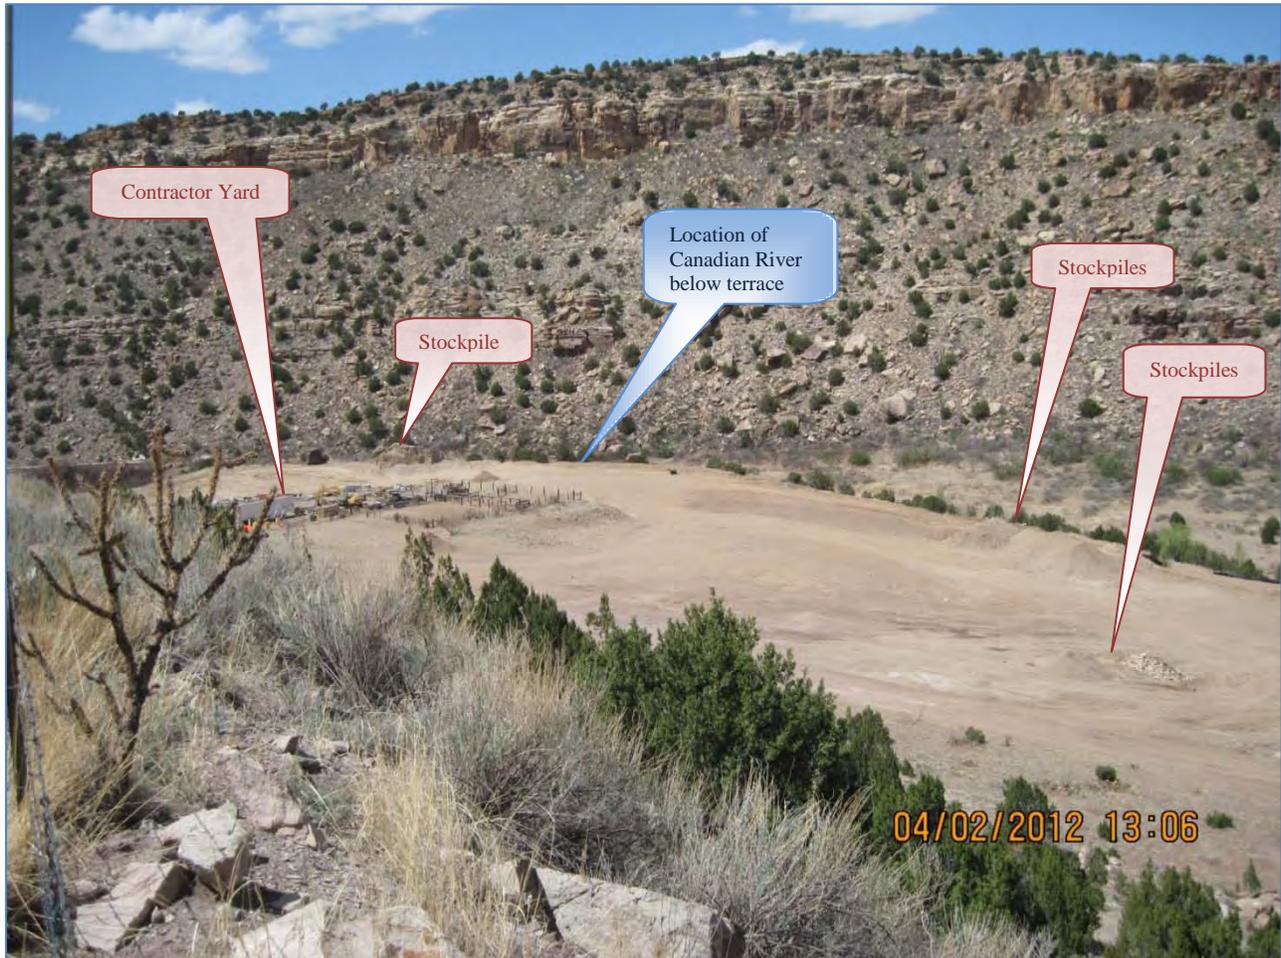
NMED/SWQB
Official Photograph Log
Photo # 2

Subject: From NM 120 looking at yard with equipment and material storage, including stockpiles, in northern support activity area.

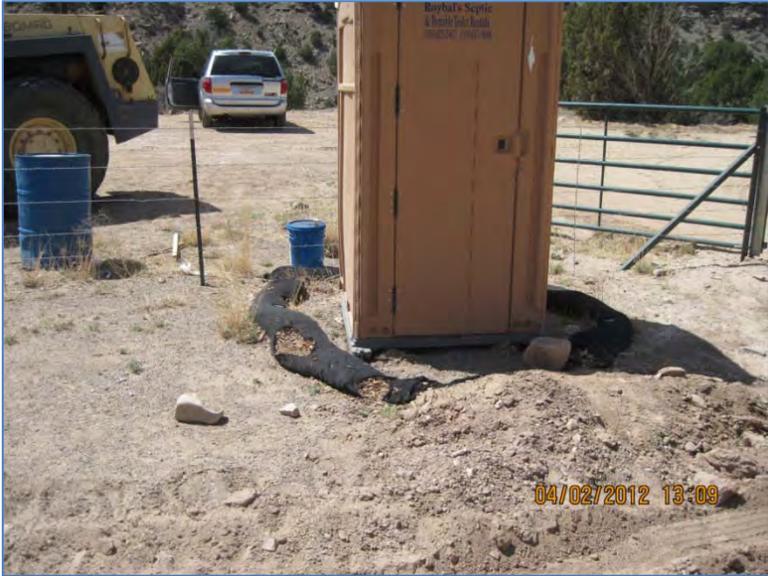
| NMED/SWQB Official Photograph Log Photo # 3 | | |

| NMED/SWQB Official Photograph Log Photo # 3 | | |
|---|---|---|
| Subject: Photo shows damaged wattle sock at portable toilet. Location of toilet; and engine and equipment fluid containers (drum and bucket) at central support activity area was not shown on site maps. Fluid containers do not appear protected from vehicle traffic by barrier. | | |

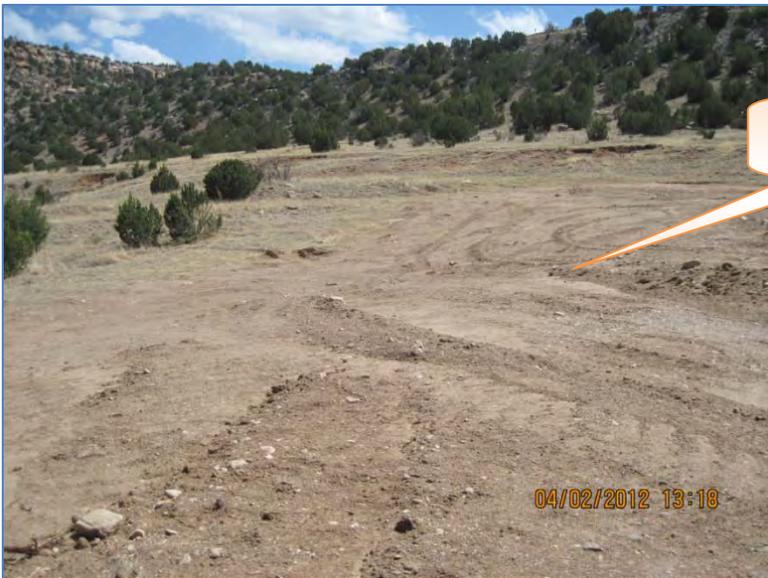
| NMED/SWQB Official Photograph Log Photo # 4 | | |

| NMED/SWQB Official Photograph Log Photo # 4 | | |
|--|---|---|
| Subject: Northern limit of disturbance called out in Photo 1. Disturbance/Re-disturbance and vehicle tire tracks existed past end of berm. | | |

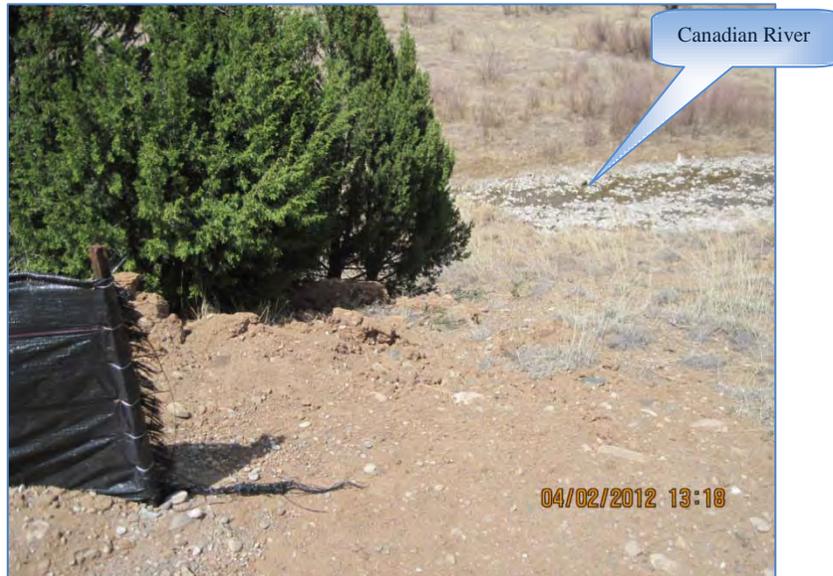
| NMED/SWQB Official Photograph Log Photo # 5 | | |

| NMED/SWQB Official Photograph Log Photo # 5 | | |
|---|---|---|
| Subject: End of silt fence along terrace edge above Canadian River called out in Photo 1. Sediment observed on slope was past silt fence/edge of terrace. | | |

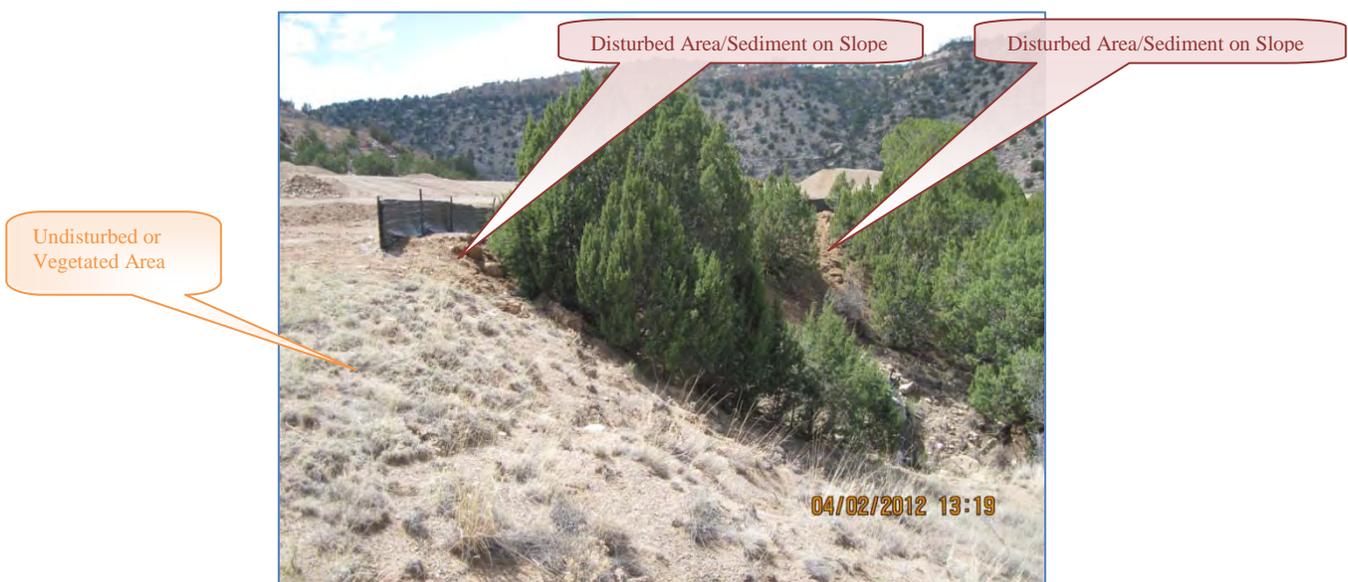
| NMED/SWQB Official Photograph Log Photo # 6 | | |

| NMED/SWQB Official Photograph Log Photo # 6 | | |
|---|---|---|
| Subject: Same end of silt fence shown in previous photo. Sediment observed on slope below silt fence/edge of terrace. No vegetation existed in disturbed areas compared to un-disturbed area called out in photo. | | |

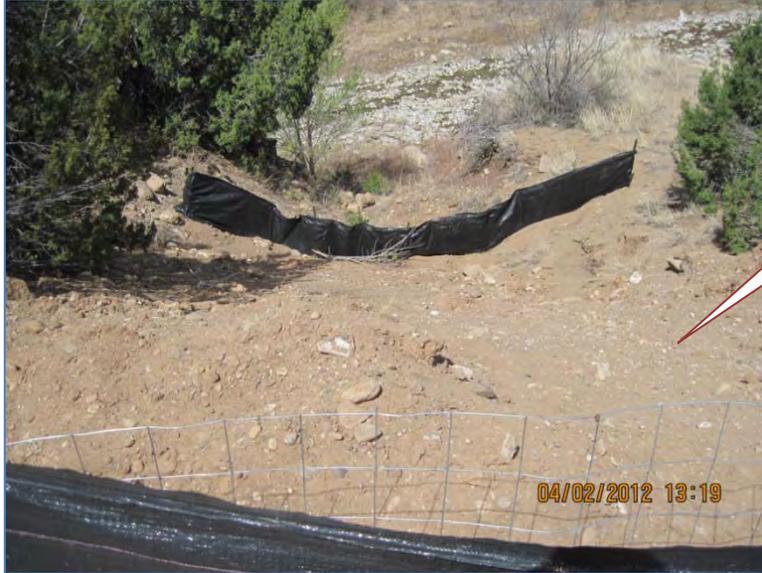
| NMED/SWQB Official Photograph Log Photo # 7 | | |

| NMED/SWQB Official Photograph Log Photo # 7 | | |
|--|---|---|
| Subject: Disturbed area/sediment on slope and additional silt fence below terrace edge above Canadian River at northern support activity area. | | |

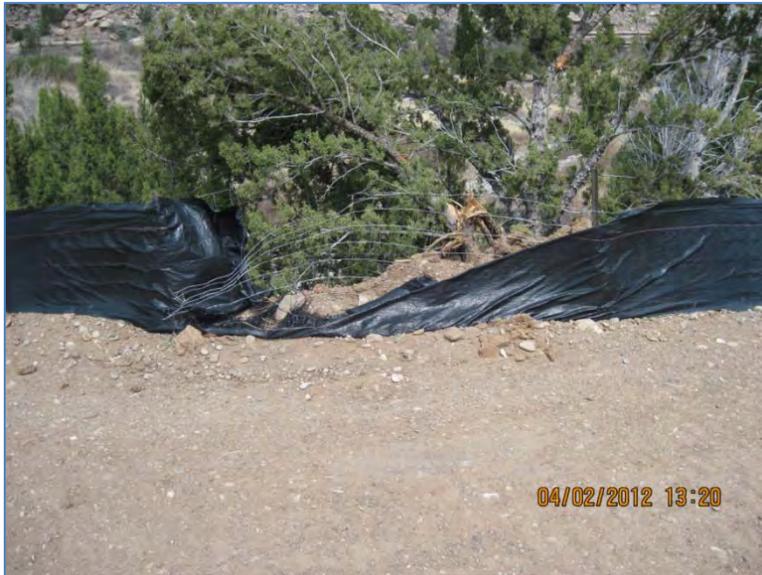
| NMED/SWQB Official Photograph Log Photo # 8 | | |

| NMED/SWQB Official Photograph Log Photo # 8 | | |
|--|---|---|
| Subject: Broken limbs on vegetation below damaged silt fence along edge of terrace above the Canadian River at northern support activity area. | | |

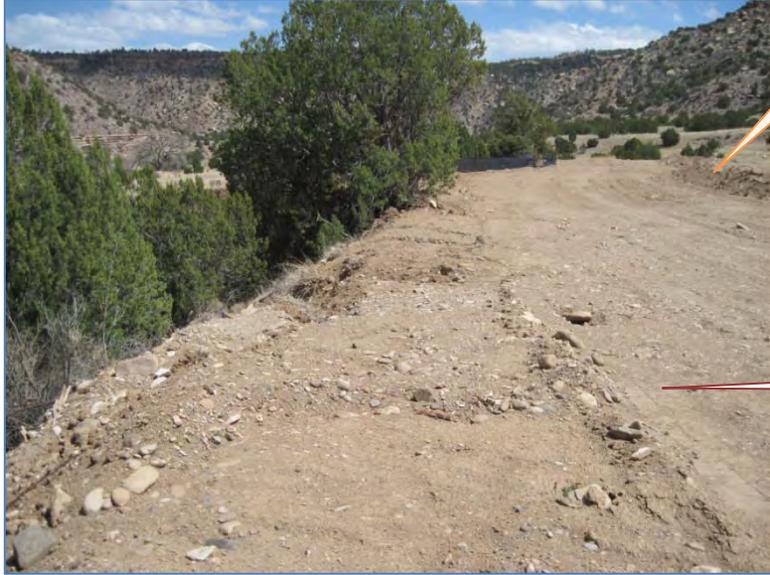
| NMED/SWQB Official Photograph Log Photo # 9 | | |

| NMED/SWQB Official Photograph Log Photo # 9 | | |
|---|---|---|
| Subject: No structural control measures observed for disturbed area between berm and edge of terrace. | | |

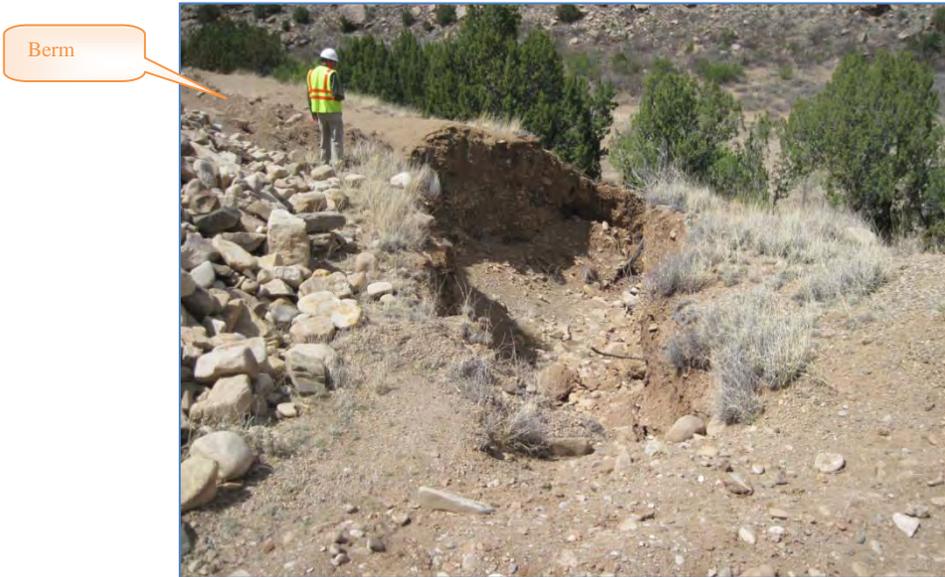
| NMED/SWQB Official Photograph Log Photo # 10 | | |

| NMED/SWQB Official Photograph Log Photo # 10 | | |
|---|---|---|
| Subject: Looking north, gully erosion at edge of terrace above Canadian River. This gully appears to have existed prior to construction based on readily available on-line and NMED SWQB GIS aerial photography imagery. Berm near this gully was not shown on site maps. | | |

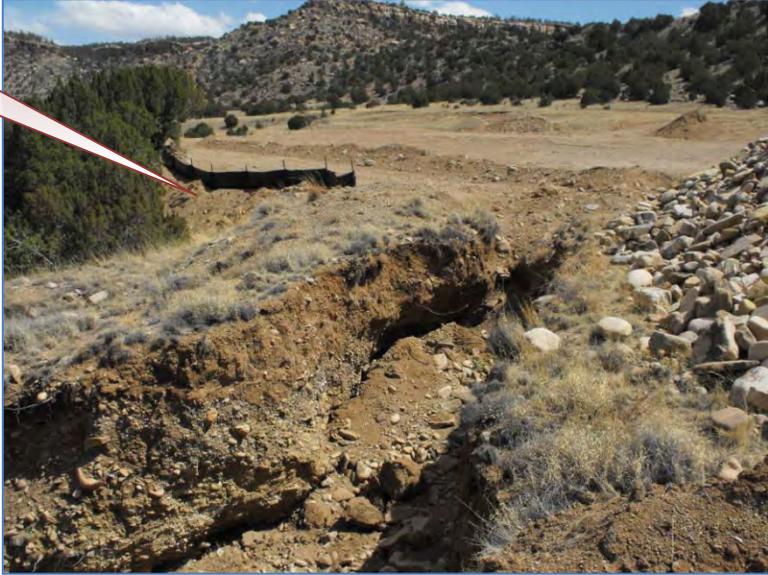
| NMED/SWQB Official Photograph Log Photo # 11 | | |

| NMED/SWQB Official Photograph Log Photo # 11 | | |
|--|---|---|
| Subject: Looking southeast, gully erosion shown in previous photo. Silt fence, berm, cobble material storage near this gully was not shown on site maps. | | |

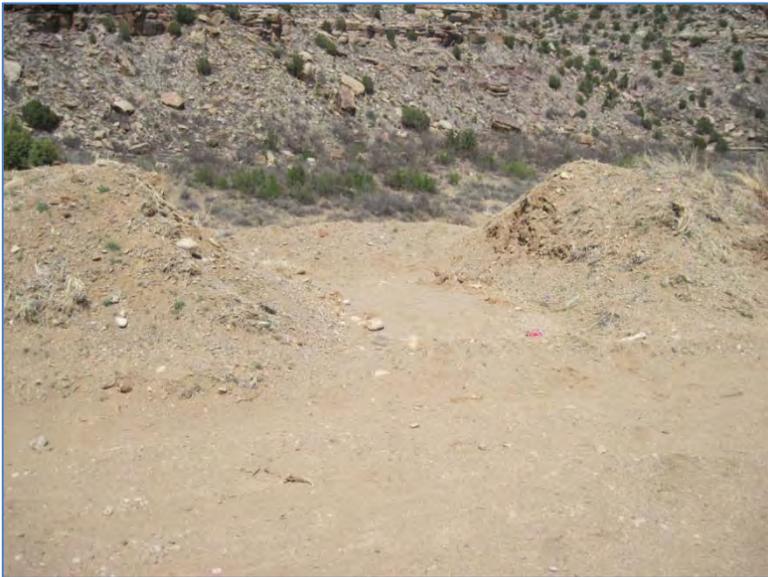
| NMED/SWQB Official Photograph Log Photo # 12 | | |

| NMED/SWQB Official Photograph Log Photo # 12 | | |
|---|---|---|
| Subject: Break in higher berm with sparse vegetation along edge of terrace above Canadian River. A lower un-vegetated berm exists at break. See next photo. | | |

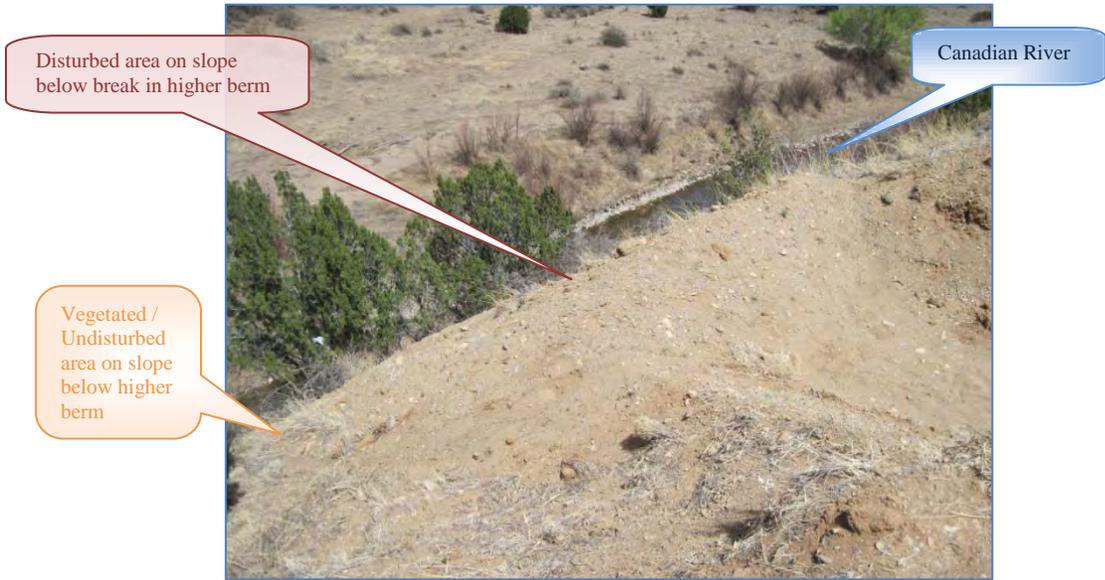
| NMED/SWQB Official Photograph Log Photo # 13 | | |

| NMED/SWQB Official Photograph Log Photo # 13 | | |
|---|---|---|
| Subject: Disturbance below break shown in previous photo on slope above Canadian River. No vegetation existed in disturbed area compared to undisturbed area below higher berm. | | |

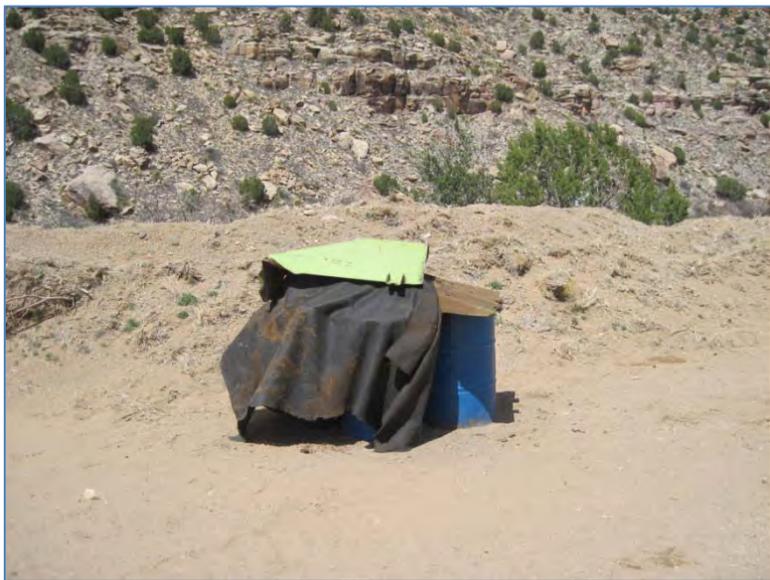
| NMED/SWQB Official Photograph Log Photo # 14 | | |

| NMED/SWQB Official Photograph Log Photo # 14 | | |
|---|---|---|
| Subject: Covered containers not shown on site maps/hand drawn sketches. | | |

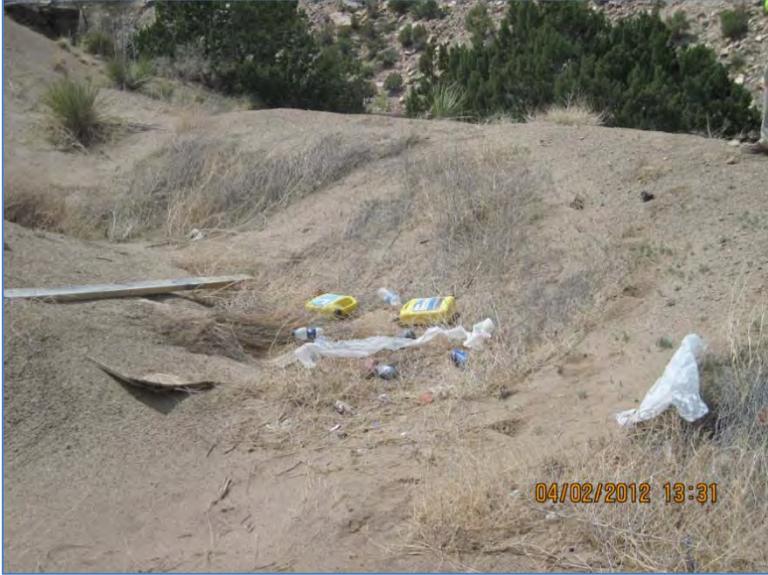
| NMED/SWQB Official Photograph Log Photo # 15 | | |

| Subject: Trash observed in northern support activity area. | | |

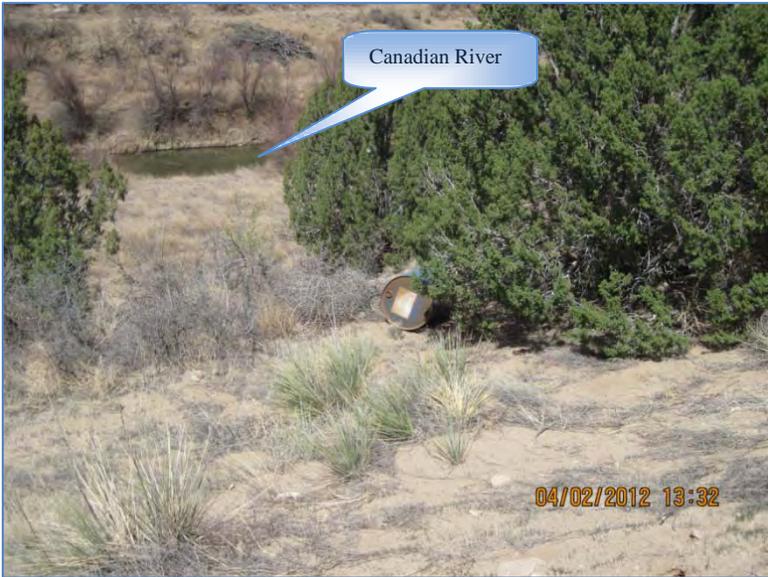
| NMED/SWQB Official Photograph Log Photo # 16 | | |

| Subject: Drum on slope below terrace at northern support activity area. | | |

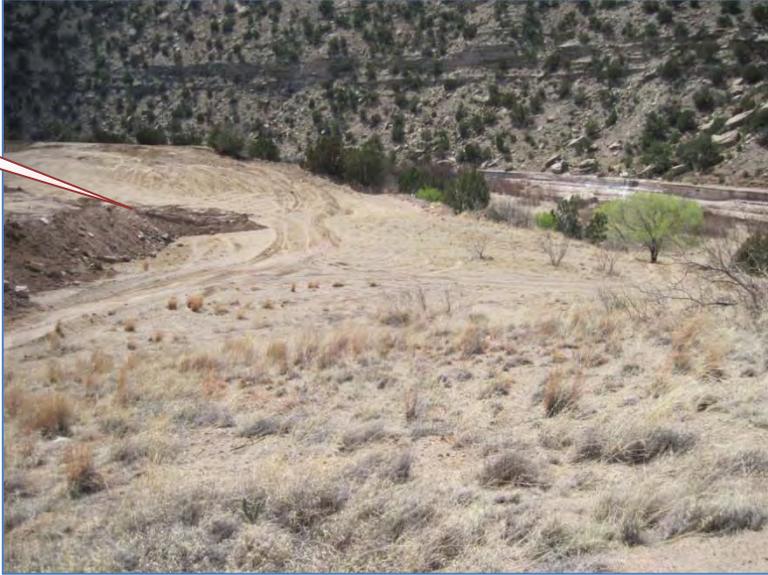
| NMED/SWQB Official Photograph Log Photo # 17 | | |

| Subject: Disturbance/fill areas in northern support activity area. Limits of disturbance and berm not shown on site maps. | | |

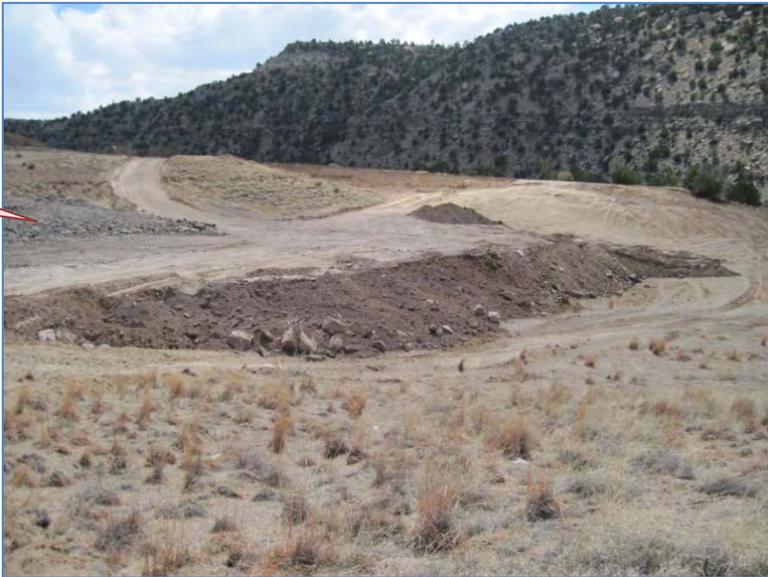
| NMED/SWQB Official Photograph Log Photo # 18 | | |

| Subject: Concrete disposal/fill areas (same area shown in previous area) was not shown on site maps. | | |

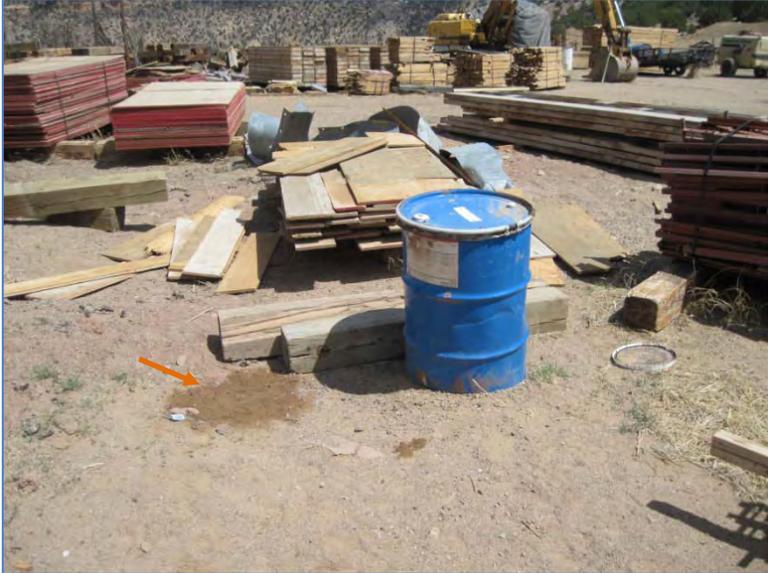
| NMED/SWQB Official Photograph Log Photo # 19 | | |

| Subject: Arrow points to staining at yard in northern support activity area. | | |

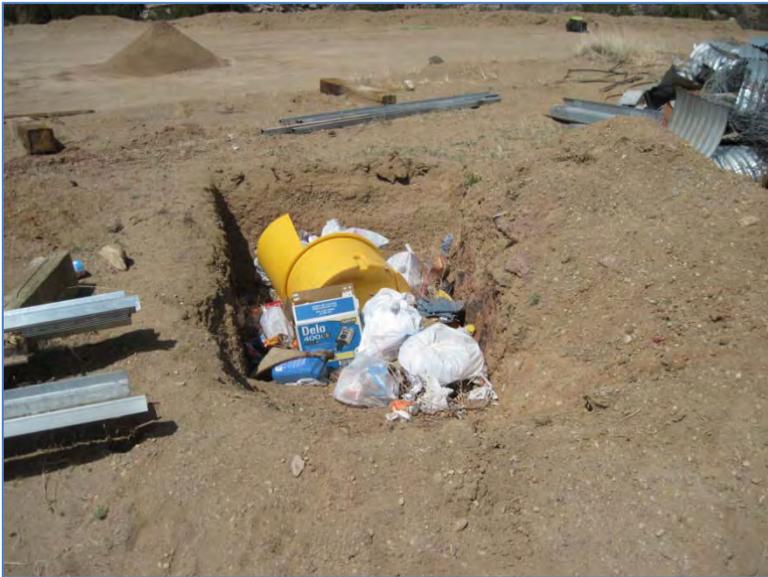
| NMED/SWQB Official Photograph Log Photo # 20 | | |

| Subject: Unlined and uncovered trash pit at yard in northern support activity area. | | |

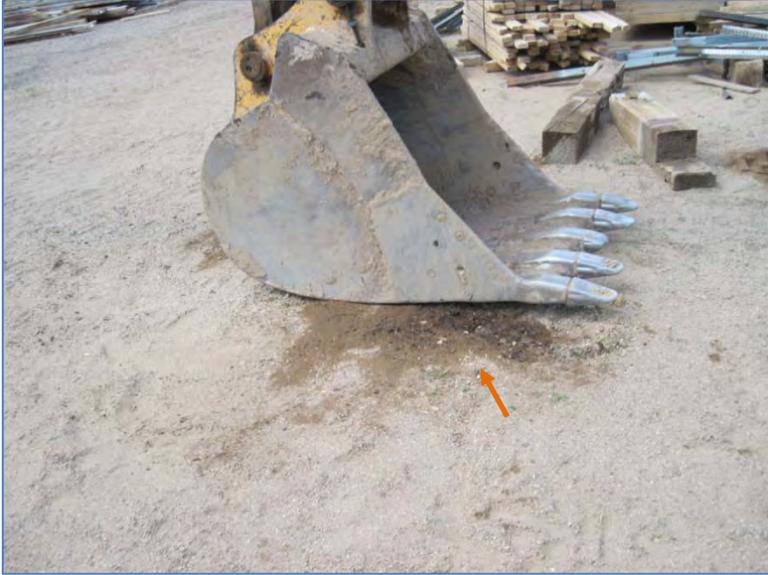
| NMED/SWQB Official Photograph Log Photo # 21 | | |

| Subject: Arrow points to soil staining below equipment at yard in northern support activity area. | | |

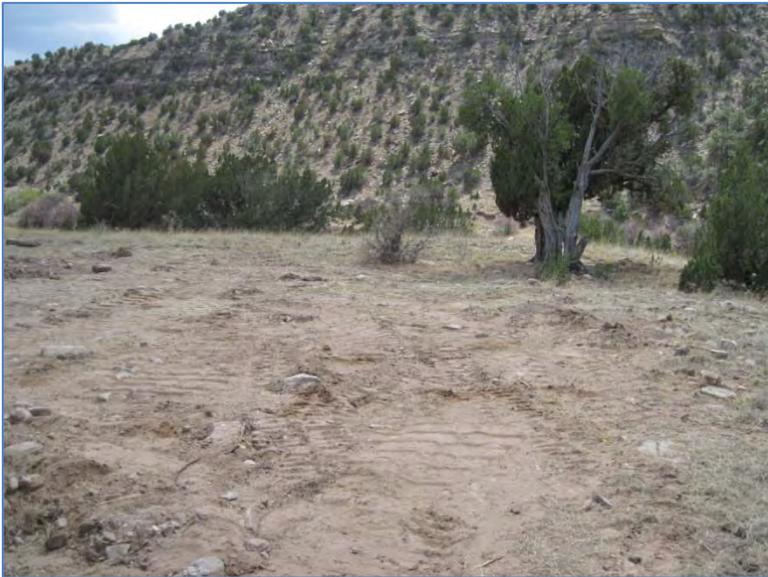
| NMED/SWQB Official Photograph Log Photo # 22 | | |

| Subject: Limits of disturbance from vehicle tracks in central support activity area not shown on site maps. No structural control measures observed. | | |

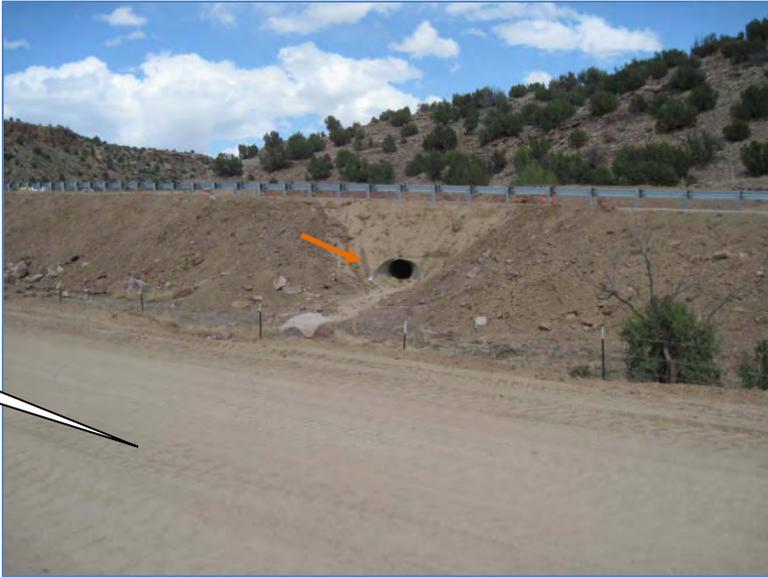
| NMED/SWQB Official Photograph Log Photo # 23 | | |

| NMED/SWQB Official Photograph Log Photo # 23 | | |
|---|---|---|
| Subject: Arrow points to culvert outlet. Mulch sock at slope limits shown on site map was not observed in this area. Disturbance/re-disturbance associated with access road to northern support activity area also not shown on maps. See next photo. | | |

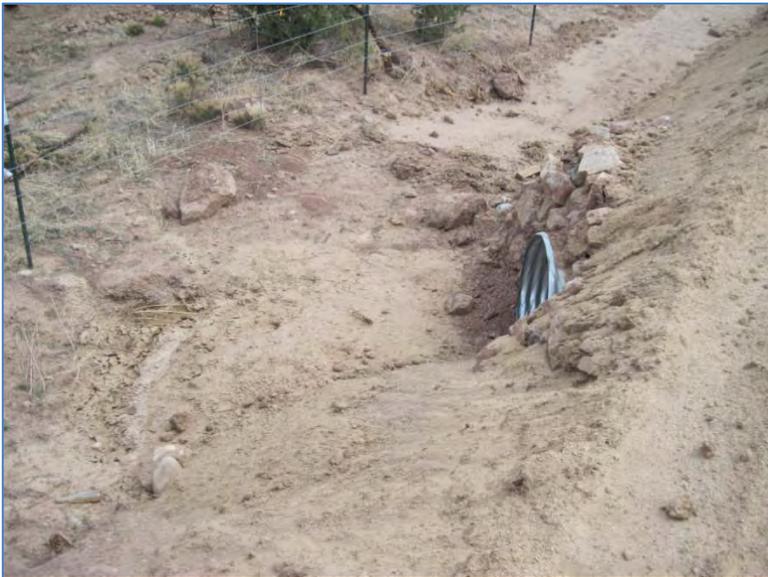
| NMED/SWQB Official Photograph Log Photo # 24 | | |

| NMED/SWQB Official Photograph Log Photo # 24 | | |
|---|---|---|
| Subject: Culvert outlet beneath access road shown in previous photo. Additional limits of disturbance and culvert outlet not shown on site maps. No control measure (e.g., outlet protection, mulch sock) shown on site maps for disturbance along access road to northern support activity area. | | |

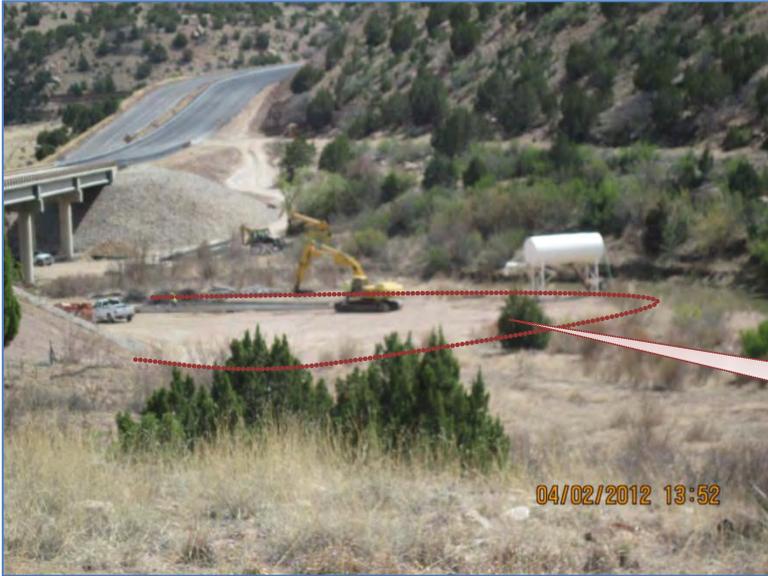
| NMED/SWQB Official Photograph Log Photo # 25 | | |

| NMED/SWQB Official Photograph Log Photo # 25 | | |
|--|---|---|
| Subject: Support activity area on first terrace above Canadian River. Additional disturbance and control measures, in this case, mulch sock on Canadian River bank was not shown on site maps, including CWA Compliance Work Plan maps contained in SWPPP. | | |

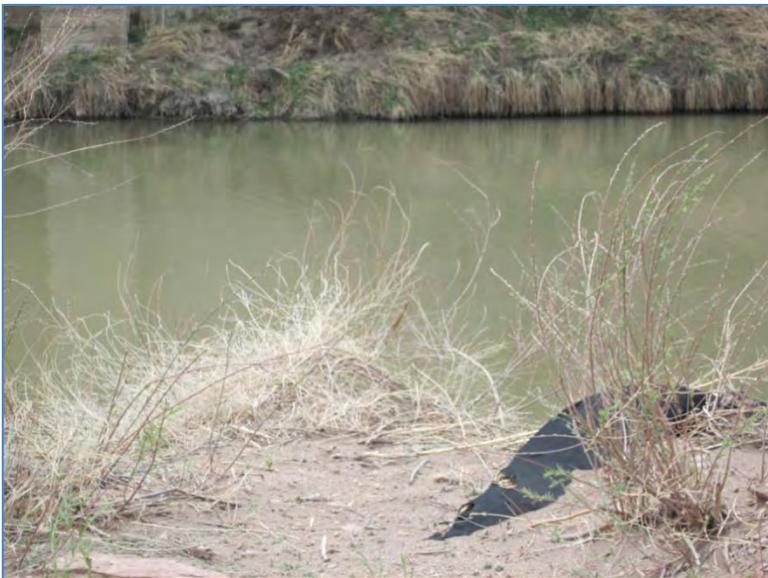
| NMED/SWQB Official Photograph Log Photo # 26 | | |

| NMED/SWQB Official Photograph Log Photo # 26 | | |
|--|---|---|
| Subject: Damaged, missing or buried control measure (mulch sock) along bank of Canadian River in support activity area shown in Photo #25. | | |

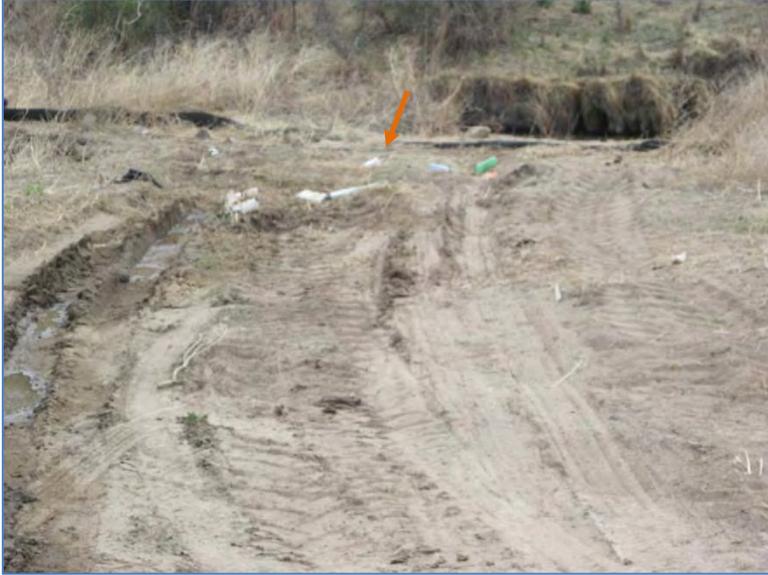
| NMED/SWQB Official Photograph Log Photo # 27 | | |

| NMED/SWQB Official Photograph Log Photo # 27 | | |
|---|---|---|
| Subject: Arrow points to trash on first terrace above Canadian River in support activity area shown in Photo #25. | | |

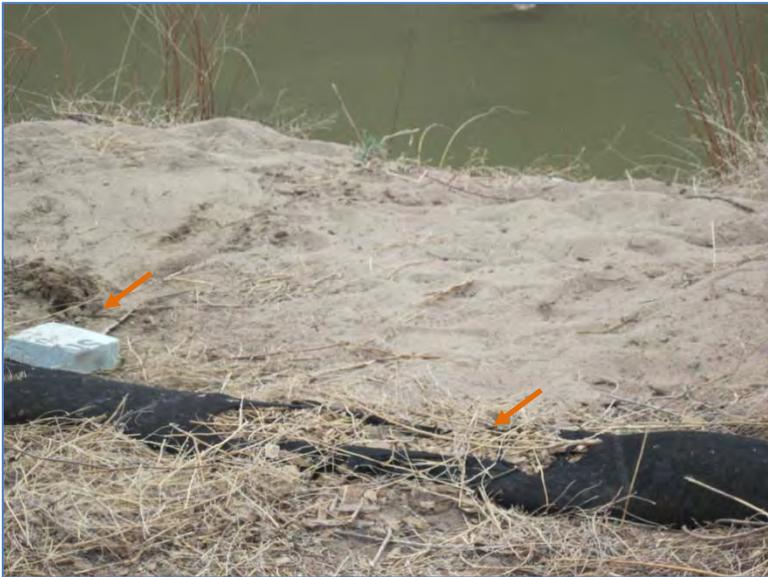
| NMED/SWQB Official Photograph Log Photo # 28 | | |

| NMED/SWQB Official Photograph Log Photo # 28 | | |
|---|---|---|
| Subject: Arrows point to damaged mulch sock along bank of Canadian River and trash in support activity area shown in Photo #25. | | |

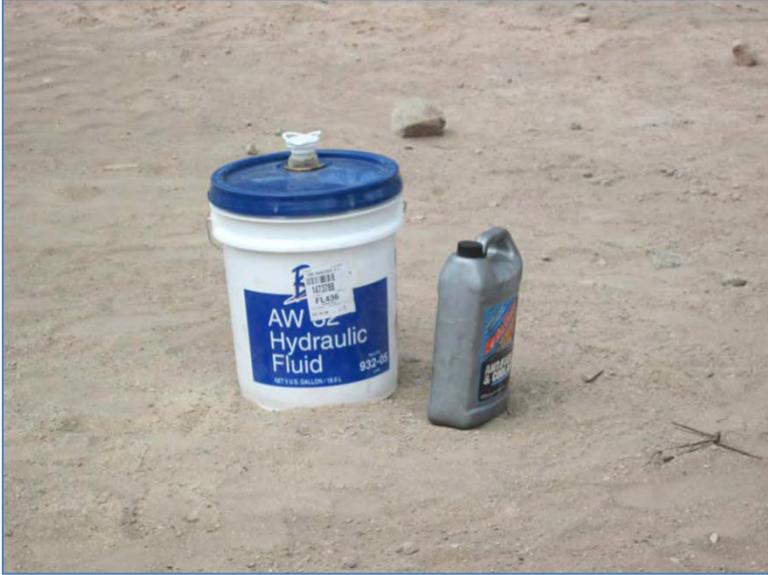
| NMED/SWQB Official Photograph Log Photo # 29 | | |

| Subject: Equipment fluid containers in support activity area shown in Photo #25. Containers not protected from vehicle traffic. | | |

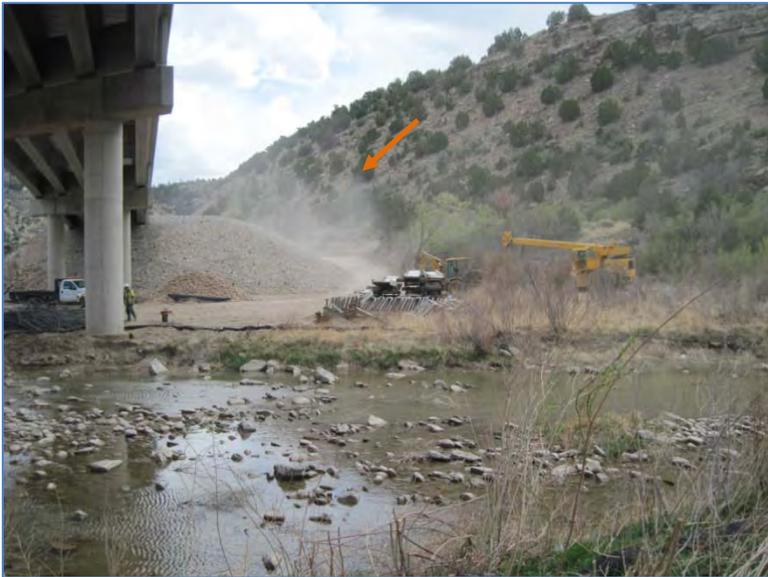
| NMED/SWQB Official Photograph Log Photo # 30 | | |

| Subject: Example of dust observed during this inspection. Dust control (watering/operation of water truck) was not observed during this inspection. | | |

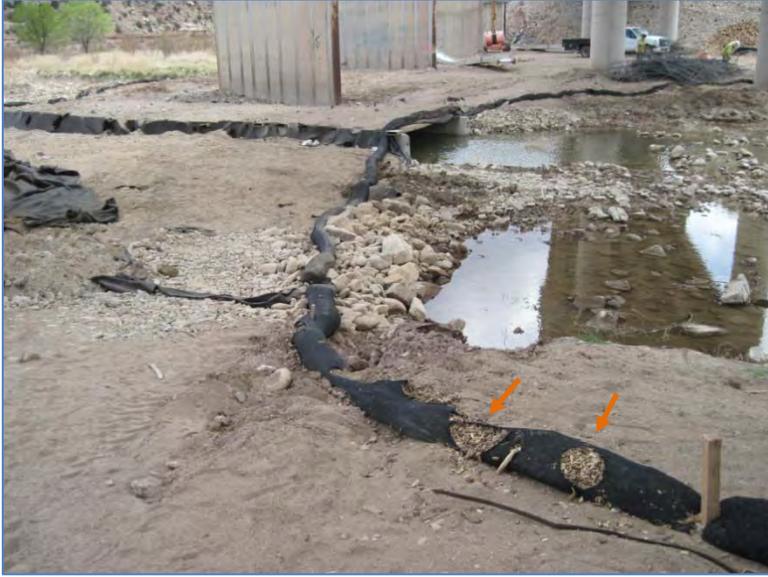
| NMED/SWQB Official Photograph Log Photo # 31 | | |

| NMED/SWQB Official Photograph Log Photo # 31 | | |
|--|---|---|
| Subject: Arrows show location of damaged sock along bank of Canadian River. Temporary fill materials in Canadian River would be regulated under CWA Section 404. | | |

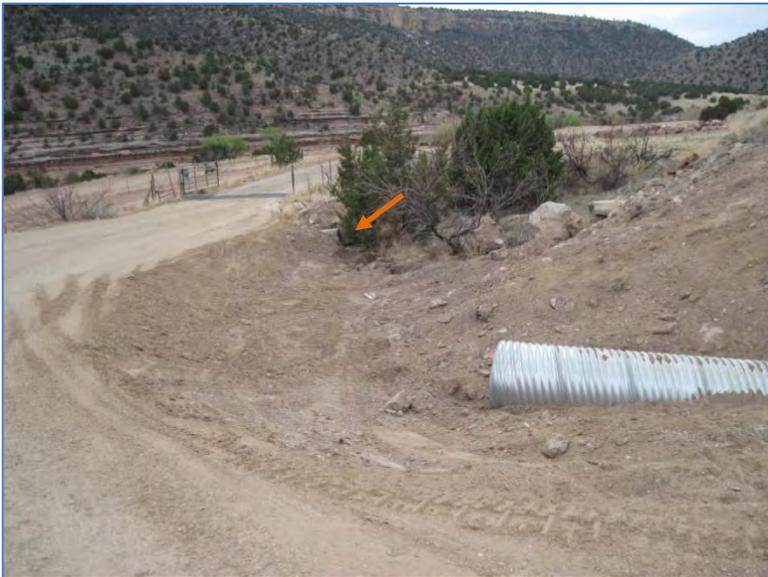
| NMED/SWQB Official Photograph Log Photo # 32 | | |

| NMED/SWQB Official Photograph Log Photo # 32 | | |
|---|---|---|
| Subject: No temporary control measure (e.g., mulch sock) shown on site map for this disturbed location. Arrow points to offsite culvert for adjacent private road. The culvert on private property road has an outlet shown on site map above the Canadian River. | | |

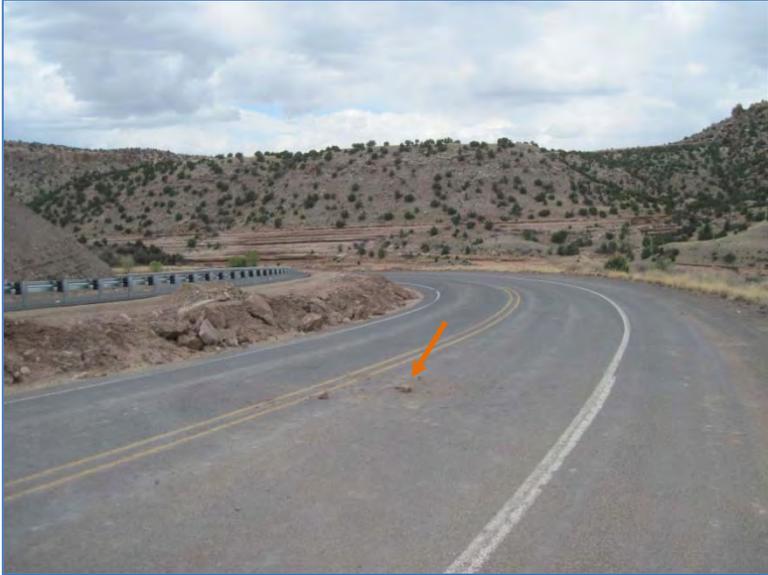
| NMED/SWQB Official Photograph Log Photo # 33 | | |

| Subject: Arrow points to some accumulated sediment on old paved roadway alignment. | | |

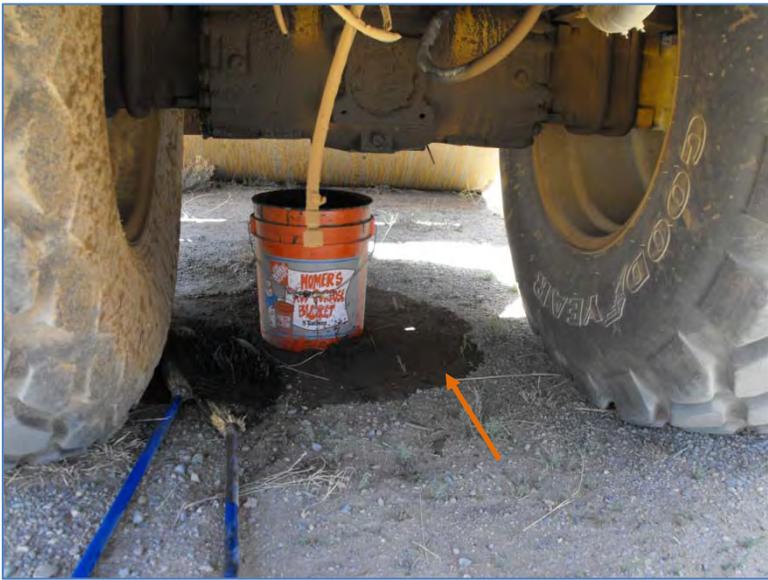
| NMED/SWQB Official Photograph Log Photo # 34 | | |

| Subject: Bucket and staining below heavy equipment parked at central support activity area. | | |
