**RE: NPDES Construction Storm Water, SIC 1629, Compliance Evaluation Inspection, Ojo Caliente Holdings, Inc. / Ojo Caliente Mineral Springs Resort & Spa, Taos County, NMU001715, February 17, 2011**

**Ojo Caliente Holdings, Inc. / Ojo Caliente Mineral Springs Resort & Spa**  
**NPDES Tracking No. NMU001715**  
**Compliance Evaluation Inspection - Construction Storm Water**  
**February 17, 2011**

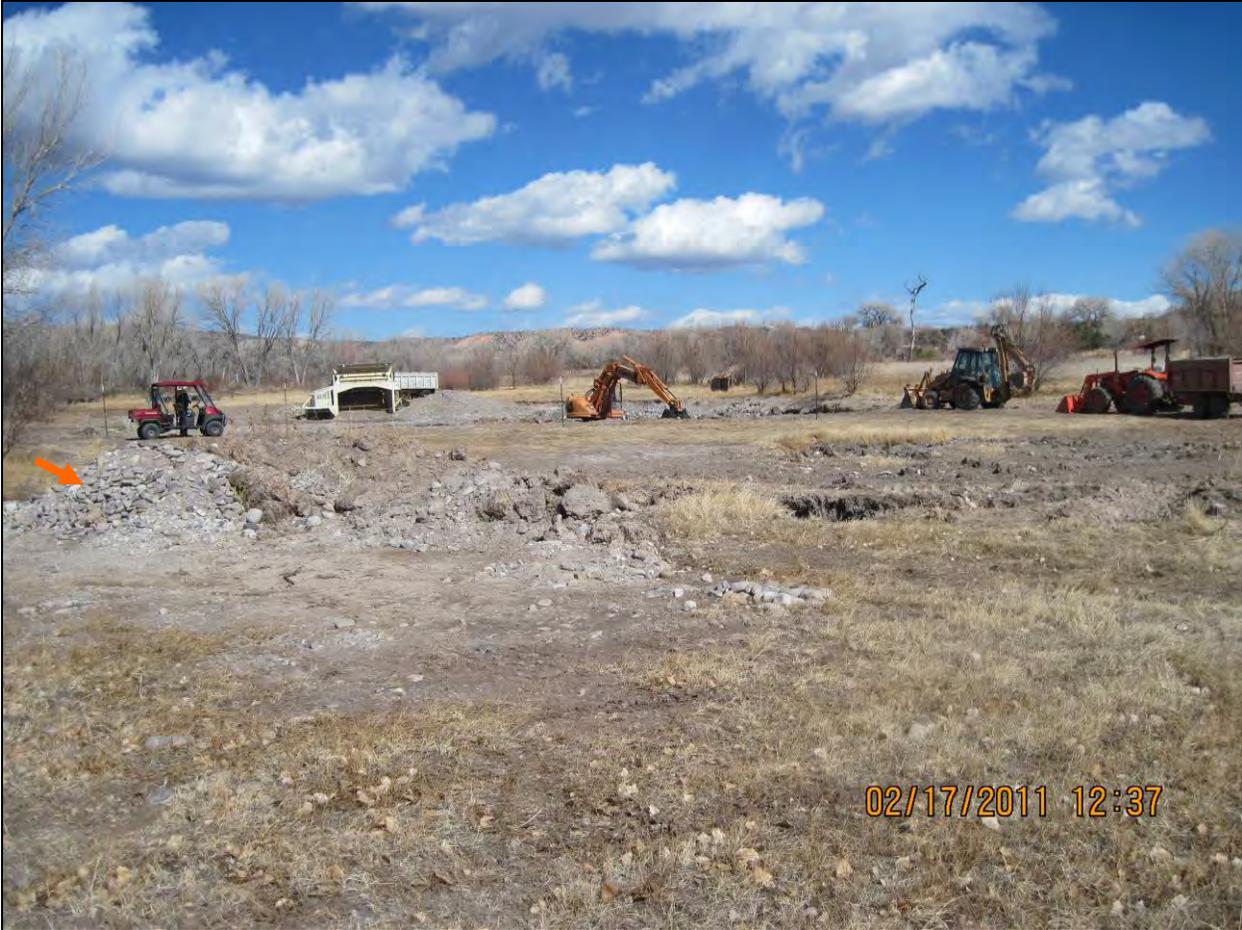
<b>NMED/SWQB</b> <b>Official Photograph Log</b> <b>Photo # 1</b>		
Photographer: Erin Trujillo	Date: 02/17/2011	Time: 1237 hours
City/County: North of Ojo Caliente / Ojo Caliente		State: New Mexico
Location: Ojo Caliente Mineral Springs Resort & Spa		
Subject: Southern limits of disturbance associated with pond and dewatering trench excavation. Except for ATV cart, various heavy construction equipment, including "Grizzle" and another sand and gravel sorter, was stored at the approximately one acre pond location. Arrow points to example of excavated material stockpiles along dewatering trench shown in next photo. Spills or leaks from heavy equipment were not observed, but can be a source of pollutants.

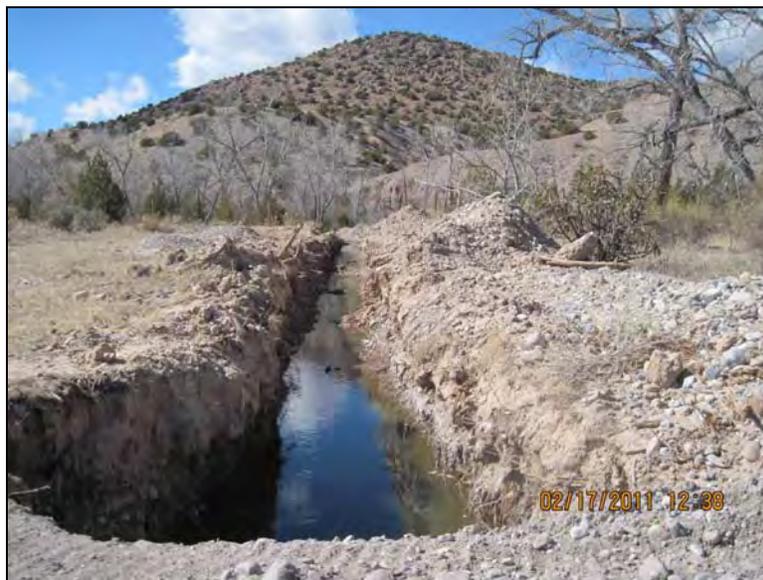
<b>NMED/SWQB Official Photograph Log Photo # 2</b>		
Photographer: Erin Trujillo	Date: 02/17/2011	Time: 1238 hours
City/County: North of Ojo Caliente / Ojo Caliente		State: New Mexico
Location: Ojo Caliente Mineral Springs Resort & Spa		
Subject: Disturbance and excavated material stockpiles along banks of dewatering trench. The dewatering trench continues south-southwest from the pond, but does not enter the Rio Ojo Caliente. This area has no erosion or sediment controls for disturbance or stockpiles.

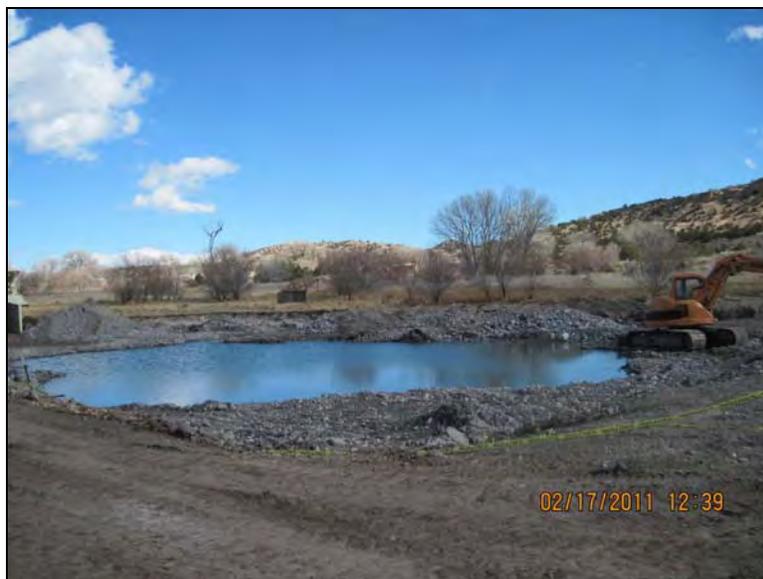
<b>NMED/SWQB Official Photograph Log Photo # 3</b>		
Photographer: Erin Trujillo	Date: 02/17/2011	Time: 1239 hours
City/County: North of Ojo Caliente / Ojo Caliente		State: New Mexico
Location: Ojo Caliente Mineral Springs Resort & Spa		
Subject: Disturbed areas associated with path/road (foreground) and excavation for pond. As previously discussed, spills or leaks from heavy equipment can be a source of pollutants.

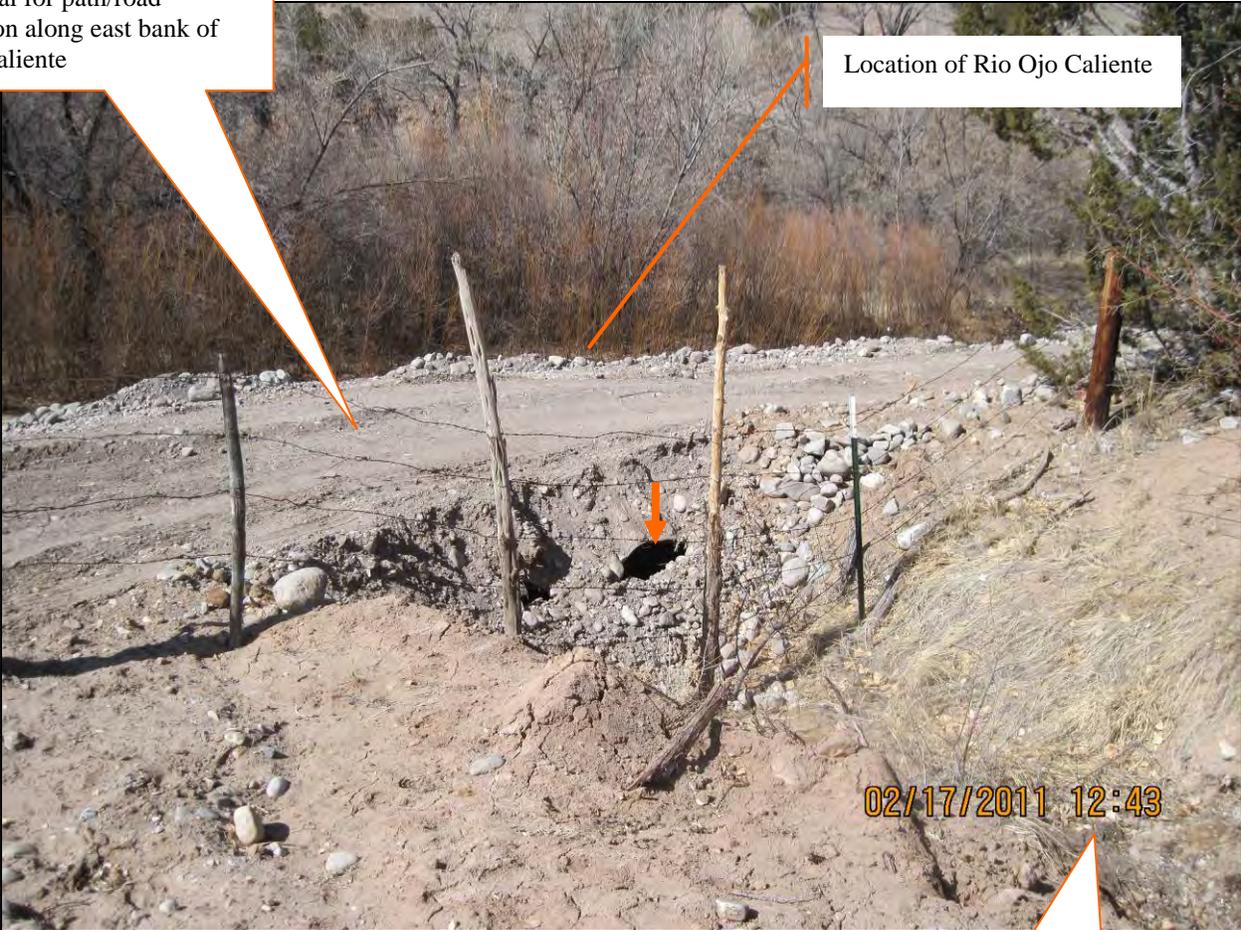
<b>NMED/SWQB</b> <b>Official Photograph Log</b> <b>Photo # 4</b>		
Photographer: Erin Trujillo	Date: 02/17/2011	Time: 1243 hours
City/County: North of Ojo Caliente / Ojo Caliente		State: New Mexico
Location: Ojo Caliente Mineral Springs Resort & Spa		
Subject: Example of disturbed areas and fill material used for path/road construction. Arrow points to partially buried inlet at a culvert crossing installed for the path/road. The outlet of culvert (not shown) is directly above the Rio Ojo Caliente. The fill materials in and disturbed soils along this vegetative drainage channel are sources of sediment pollution until stabilized.

Fill material for path/road construction along east bank of Rio Ojo Caliente

Location of Rio Ojo Caliente

Vegetated drainage channel (easement) from US 285 to Rio Ojo Caliente

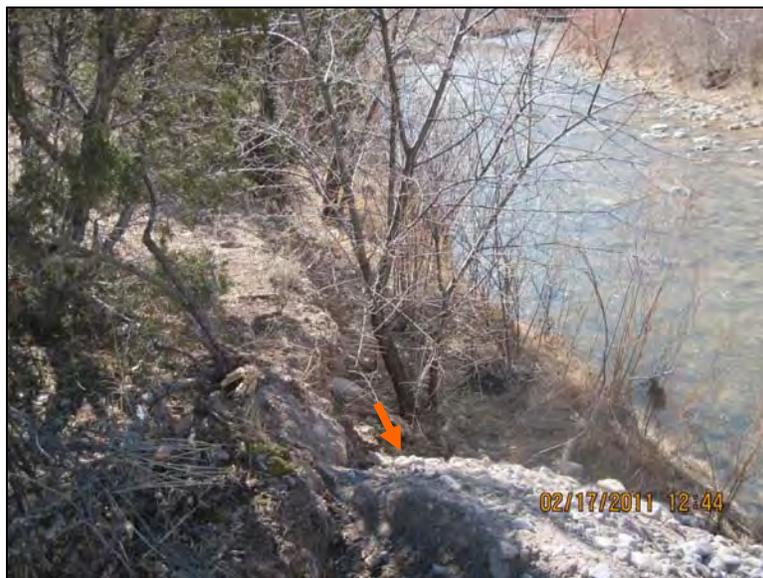
<b>NMED/SWQB Official Photograph Log Photo # 5</b>		
Photographer: Erin Trujillo	Date: 02/17/2011	Time: 1244 hours
City/County: North of Ojo Caliente / Ojo Caliente		State: New Mexico
Location: Ojo Caliente Mineral Springs Resort & Spa		
Subject: Looking downstream, arrow points to fill material used for bank stabilization on east bank of Rio Ojo Caliente near location shown in Photo #4.

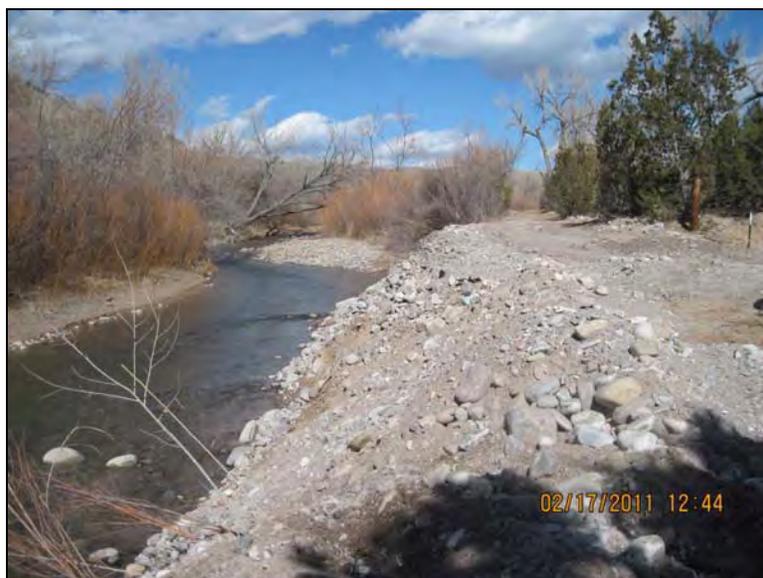
<b>NMED/SWQB Official Photograph Log Photo # 6</b>		
Photographer: Erin Trujillo	Date: 02/17/2011	Time: 1244 hours
City/County: North of Ojo Caliente / Ojo Caliente		State: New Mexico
Location: Ojo Caliente Mineral Springs Resort & Spa		
Subject: Looking upstream, fill material used for bank stabilization and path/road construction on east bank of Rio Ojo Caliente near location shown in Photo #4.

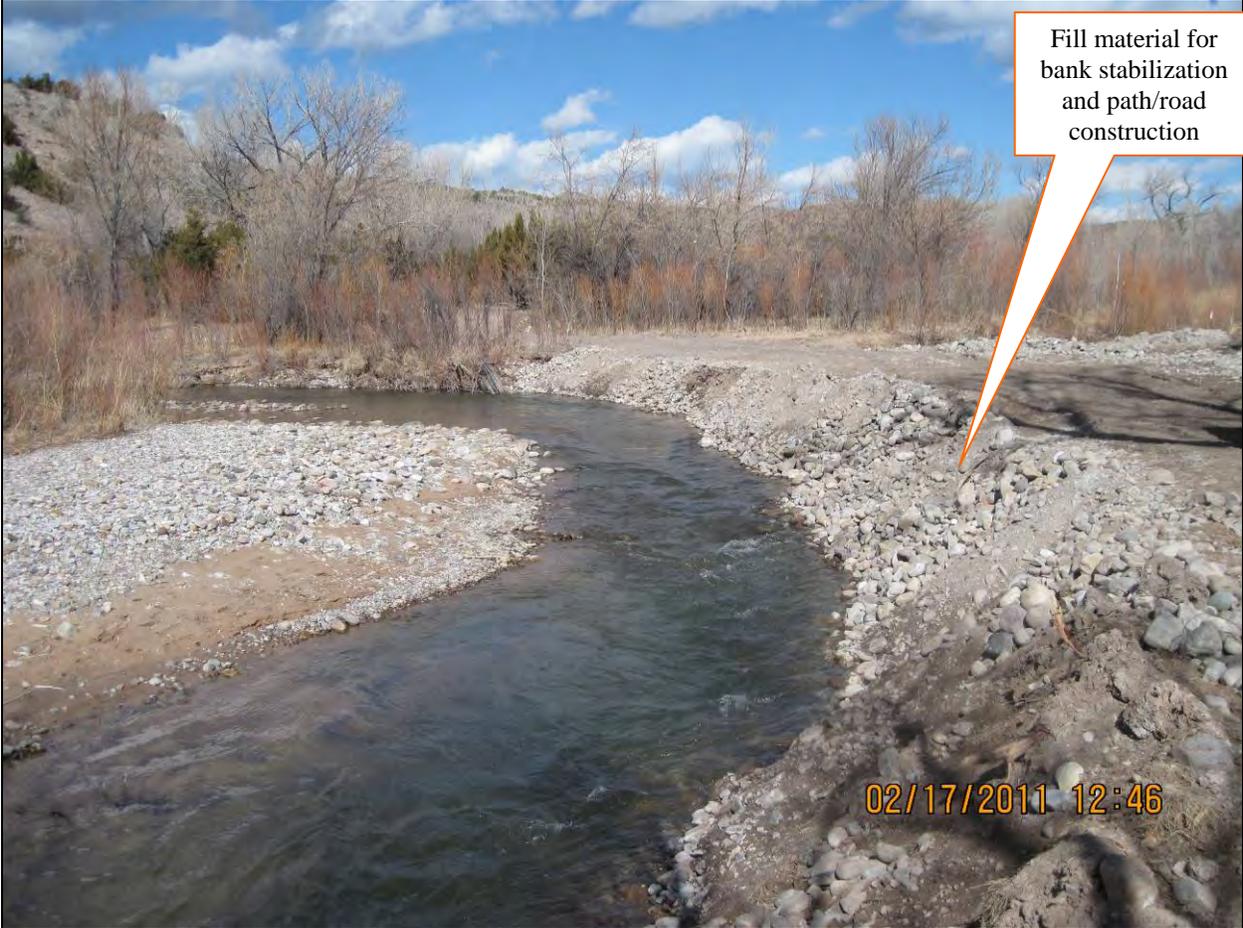
<b>NMED/SWQB</b> <b>Official Photograph Log</b> <b>Photo # 7</b>		
Photographer: Erin Trujillo	Date: 02/17/2011	Time: 1246 hours
City/County: North of Ojo Caliente / Ojo Caliente		State: New Mexico
Location: Ojo Caliente Mineral Springs Resort & Spa		
Subject: Further upstream of previous photo, fill material used for bank stabilization and path/road on east bank of Rio Ojo Caliente.

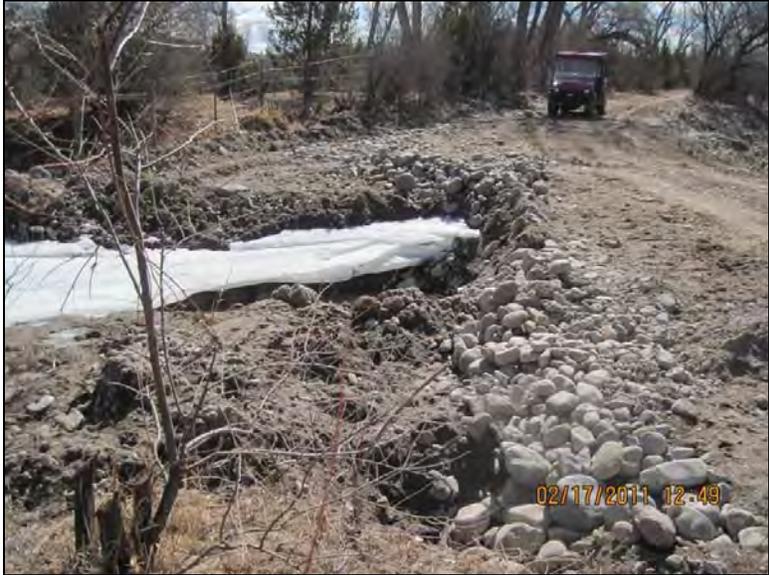
<b>NMED/SWQB</b> <b>Official Photograph Log</b> <b>Photo #8 and #9</b>		
Photographer: Erin Trujillo	Date: 02/17/2011	Time: 1249 hours
City/County: North of Ojo Caliente / Ojo Caliente		State: New Mexico
Location: Ojo Caliente Mineral Springs Resort & Spa		
Subject: Disturbed area, fill material and culvert pipe for path/road on east bank of Rio Ojo Caliente shown in previous photo. Culvert pipe is shown in Photo #9 (bottom photo).

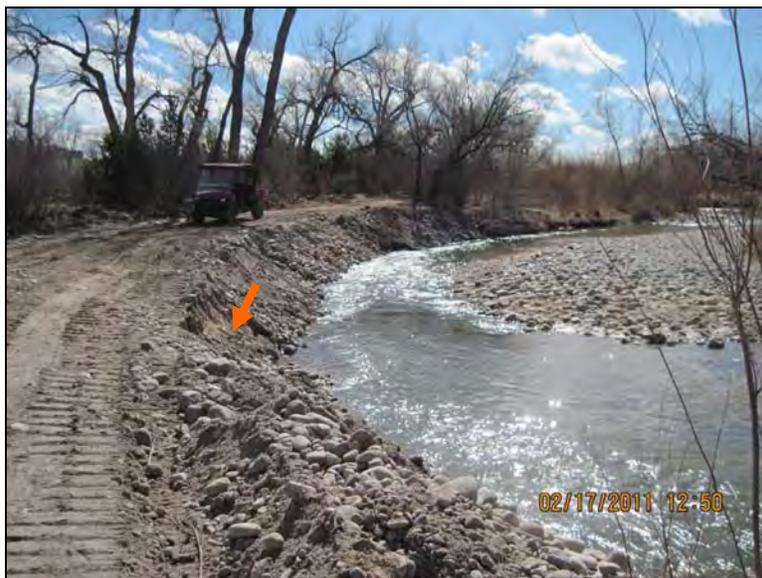
<b>NMED/SWQB          Official Photograph Log          Photo # 10</b>		
Photographer: Erin Trujillo	Date: 02/17/2011	Time: 1250 hours
City/County: North of Ojo Caliente / Ojo Caliente		State: New Mexico
Location: Ojo Caliente Mineral Springs Resort & Spa		
Subject: Arrow points to location of outlet above Rio Ojo Caliente of culvert inlet shown in previous photo. No additional outfall protection provided along bank for outfall.

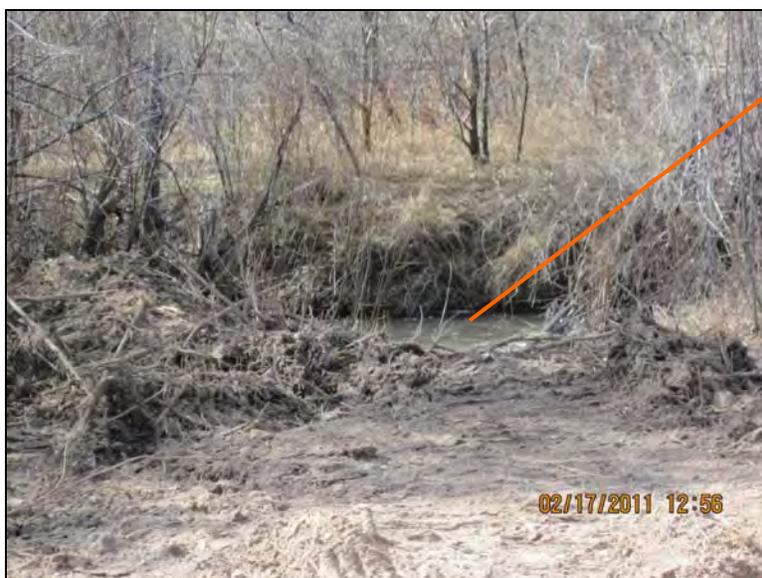
<b>NMED/SWQB          Official Photograph Log          Photo # 11</b>		
Photographer: Erin Trujillo	Date: 02/17/2011	Time: 1256 hours
City/County: North of Ojo Caliente / Ojo Caliente		State: New Mexico
Location: Ojo Caliente Mineral Springs Resort & Spa		
Subject: Further upstream of previous photo, disturbed area from clearing and grubbing and vehicle access associated with path/road pull out immediately adjacent to Rio Ojo Caliente. No erosion or sediment controls provided. Also, construction material (culvert) stored in this area is shown in Photo #12.

Rio Ojo Caliente

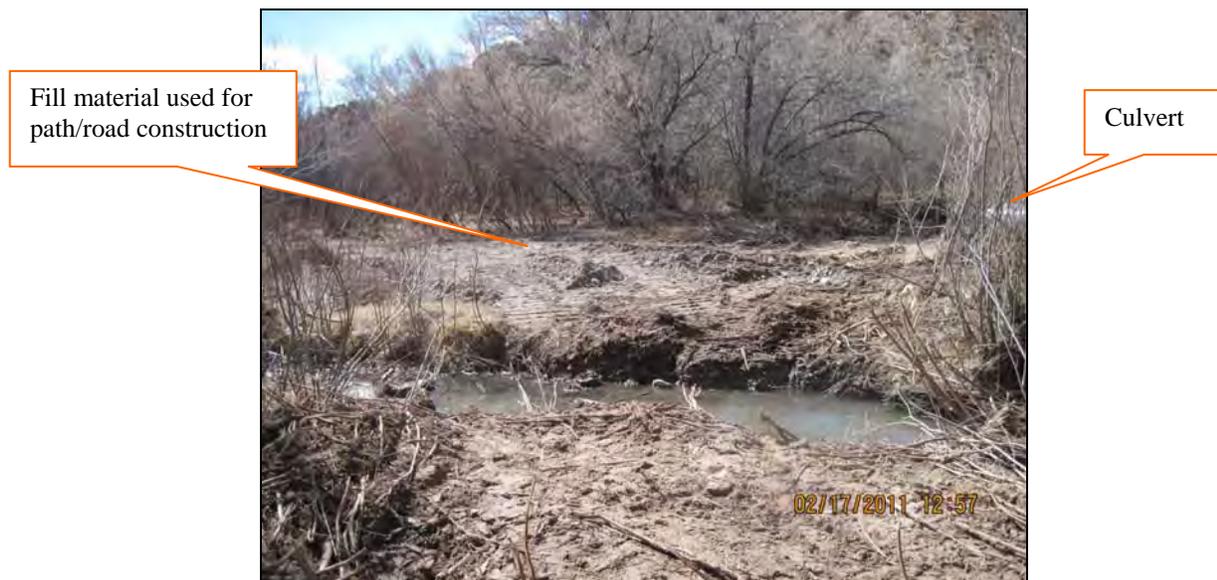
<b>NMED/SWQB Official Photograph Log Photo # 12</b>		
Photographer: Erin Trujillo	Date: 02/17/2011	Time: 1257 hours
City/County: North of Ojo Caliente / Ojo Caliente		State: New Mexico
Location: Ojo Caliente Mineral Springs Resort & Spa		
Subject: Immediately north of previous photo and pullout, example of disturbance and fill material for path/road at proposed culvert location.

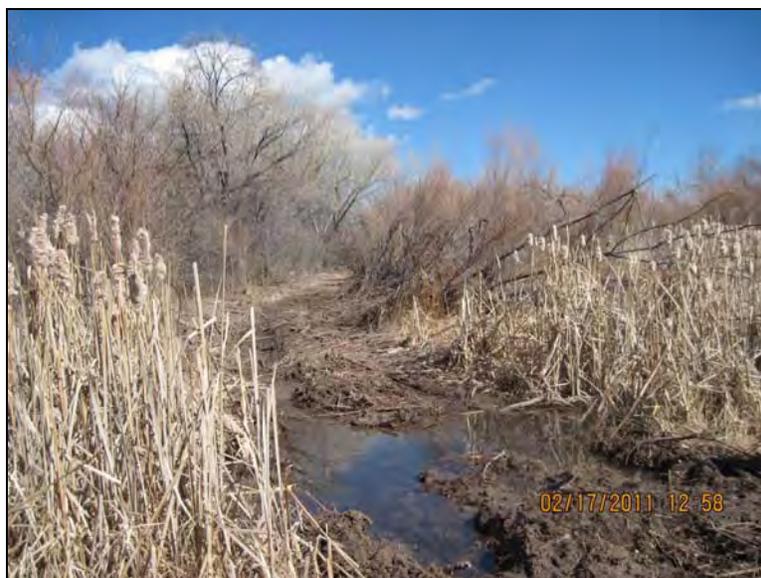
<b>NMED/SWQB Official Photograph Log Photo # 13</b>		
Photographer: Erin Trujillo	Date: 02/17/2011	Time: 1258 hours
City/County: North of Ojo Caliente / Ojo Caliente		State: New Mexico
Location: Ojo Caliente Mineral Springs Resort & Spa		
Subject: Further north of previous photo, example of disturbance from heavy equipment access and clearing and grubbing for the path/road. A culvert is proposed in this area.

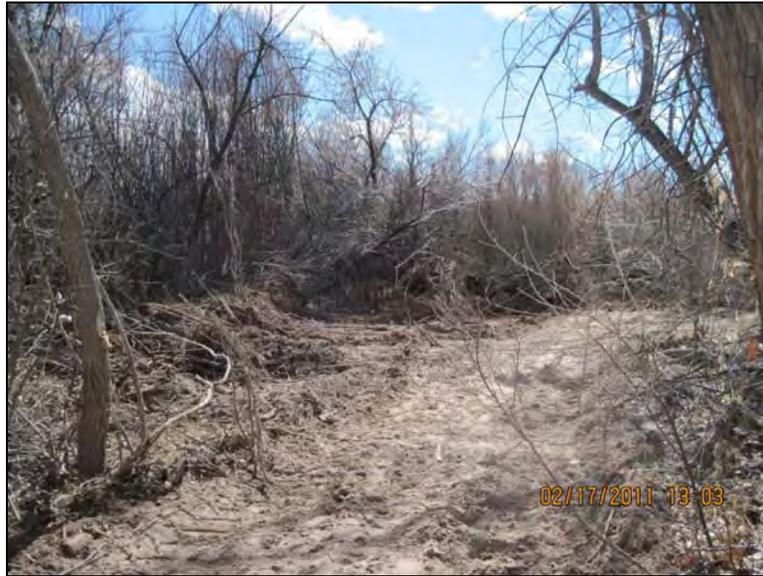
<b>NMED/SWQB Official Photograph Log Photo # 14</b>		
Photographer: Erin Trujillo	Date: 02/17/2011	Time: 1303 hours
City/County: North of Ojo Caliente / Ojo Caliente		State: New Mexico
Location: Ojo Caliente Mineral Springs Resort & Spa		
Subject: Further north of previous photo, example of clearing and grubbing for and adjacent to path/road.

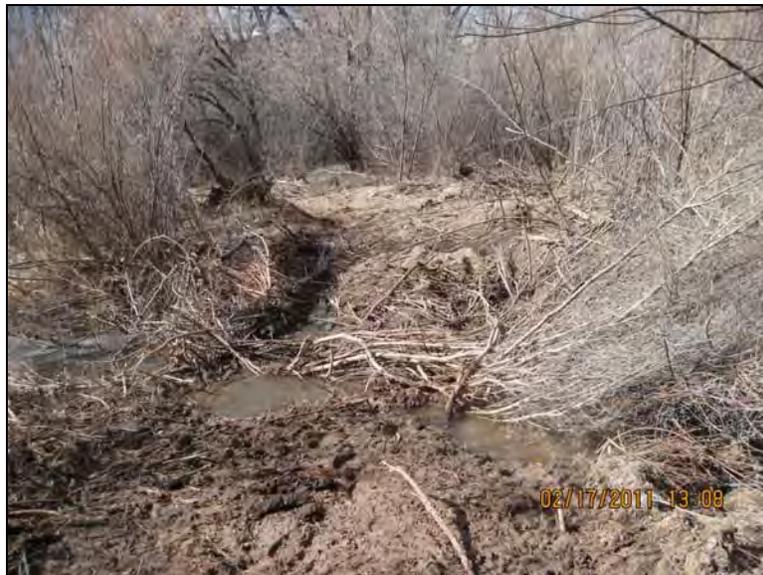
<b>NMED/SWQB Official Photograph Log Photo # 15</b>		
Photographer: Erin Trujillo	Date: 02/17/2011	Time: 1308 hours
City/County: North of Ojo Caliente / Ojo Caliente		State: New Mexico
Location: Ojo Caliente Mineral Springs Resort & Spa		
Subject: Further north of previous photo, example of clearing and grubbing at channel downstream of beaver dam. A culvert is proposed in this area near the southwest corner of Tract 3.
