NEW MEXICO  
ENVIRONMENT DEPARTMENT

RE: Industrial Stormwater; SIC 2421; NPDES Compliance Evaluation Inspection; W. H. Moore Cash Lumber, LLC; NPDES Permit No. NMU001731; September 21, 2011

**Multi-Sector General Permit  
Compliance Evaluation Inspection  
W H Moore CASH Lumber, LLC  
NPDES Permit No. NMU001731  
Inspection Date: September 21, 2011**

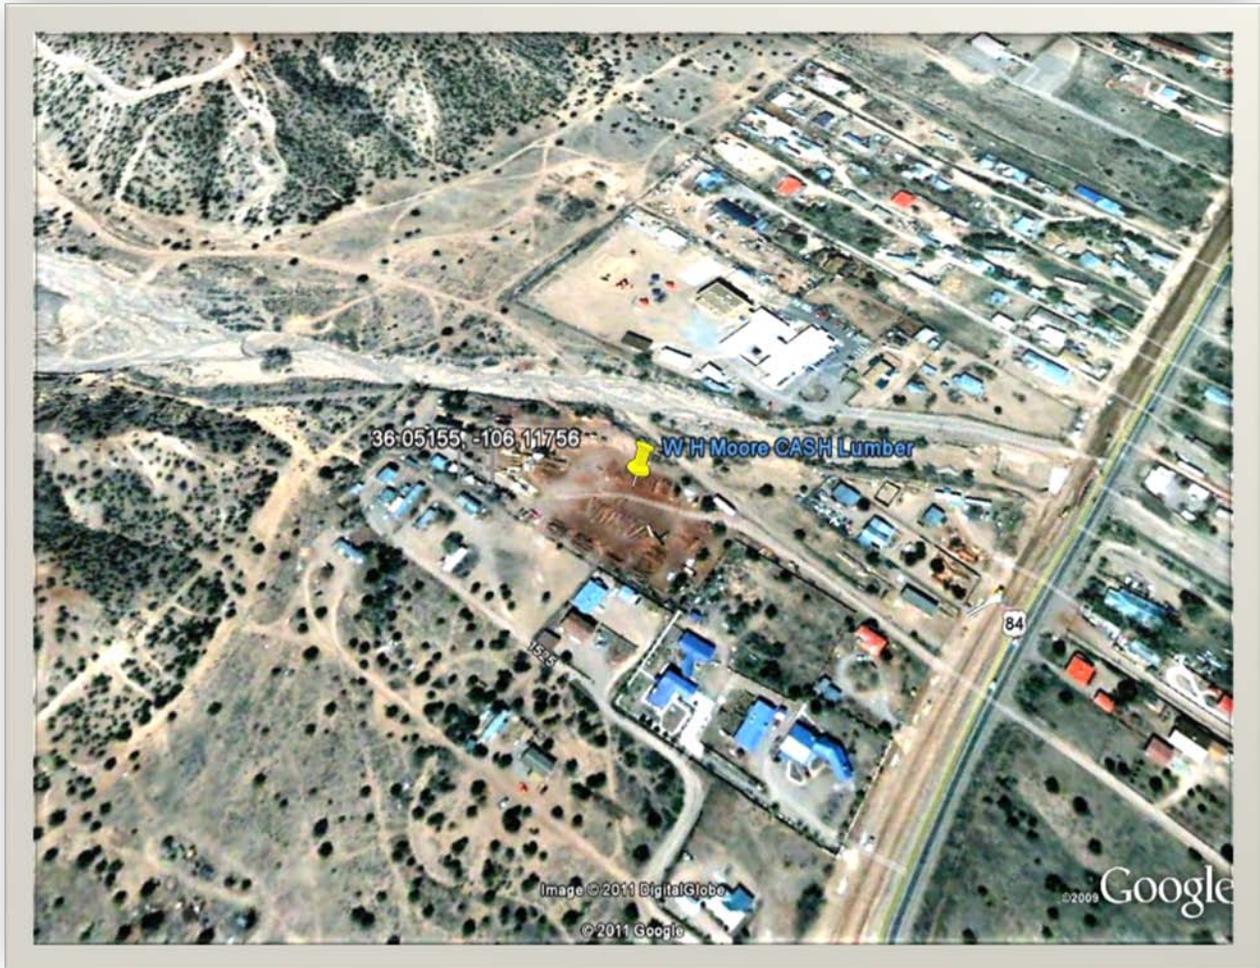
**NMED/SWQB**  
**Official Photograph Log**  
**Photo # 1**

Photographer: Google Earth	Date: 2005	
City/County: Hernandez/Rio Arriba		State: New Mexico
Location: WH Moore CASH Lumber, LLC		
Subject: Overview of site from Google Earth

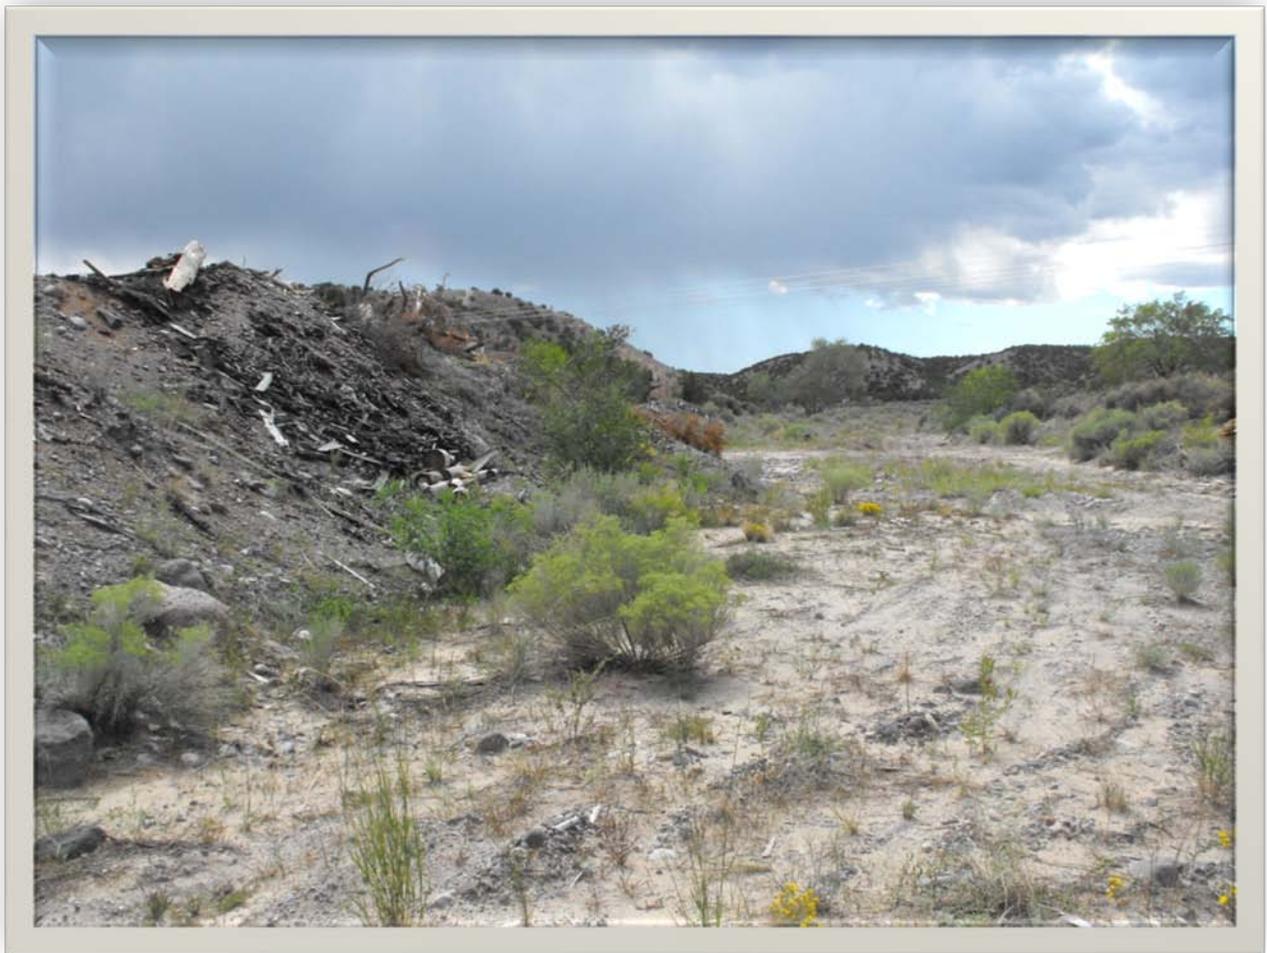
**NMED/SWQB**  
**Official Photograph Log**  
**Photo # 2**

Photographer: Daniel Valenta	Date: September 21, 2011	Time: 1327 Hours
City/County: Hernandez / Rio Arriba		State: New Mexico
Location: W H Moore CASH Lumber, LLC		
Subject: View of West side of property along arroyo.

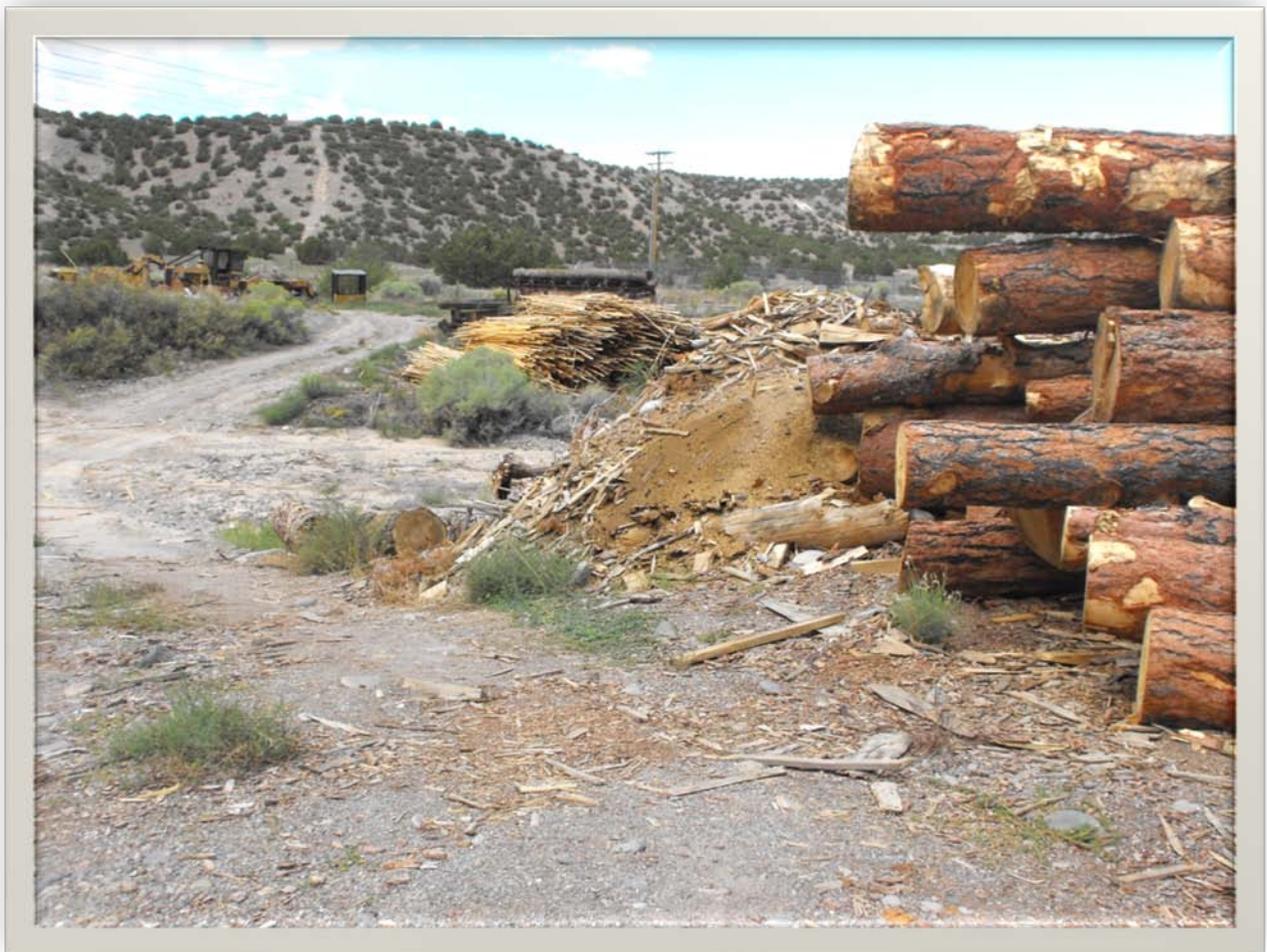
**NMED/SWQB**  
**Official Photograph Log**  
**Photo # 3**

Photographer: Daniel Valenta	Date: September 21, 2011	Time: 1329 Hours
City/County: Hernandez / Rio Arriba		State: New Mexico
Location: W H Moore CASH Lumber, LLC		
Subject: Raw lumber, used metal parts from equipment, along with saw dust piled on both sides of arroyo.
