NEW MEXICO
ENVIRONMENT DEPARTMENT
Surface Water Quality Bureau

RE: Minor Industrial, NPDES Reconnaissance Inspection, City of Grants / Riverwalk Park Fountain and Ponds, NMU001732, May 23, 2011

NPDES Compliance Inspection Report

City of Grants Riverwalk Park Fountain and Ponds
NPDES Tracking No. NMU001732
Reconnaissance Inspection
May 23, 2011

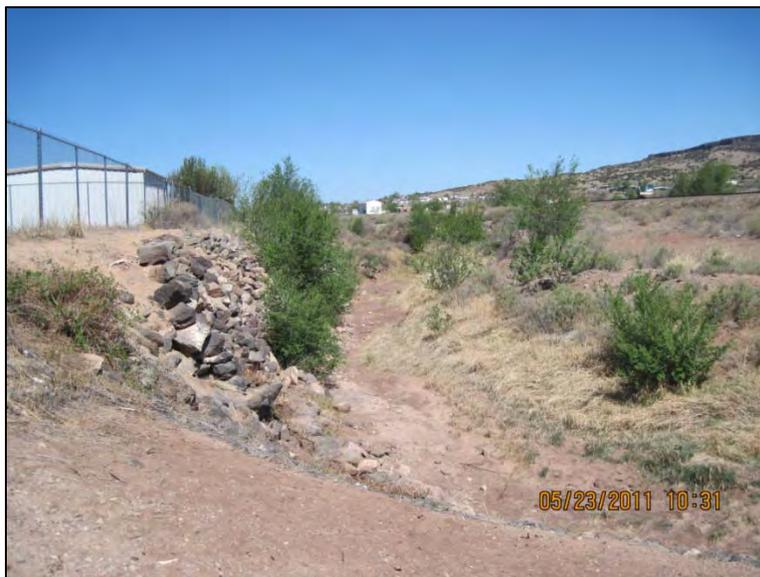
**NMED/SWQB
Official Photograph Log
Photo # 1**

Photographer: Erin S. Trujillo	Date: 05/23/2011	Time: 1031 hours
City/County: Grants / Cibola		State: New Mexico
Location: Rio San Jose		
Subject: Stream channel upstream from railroad underpass and City of Grants Riverwalk Park

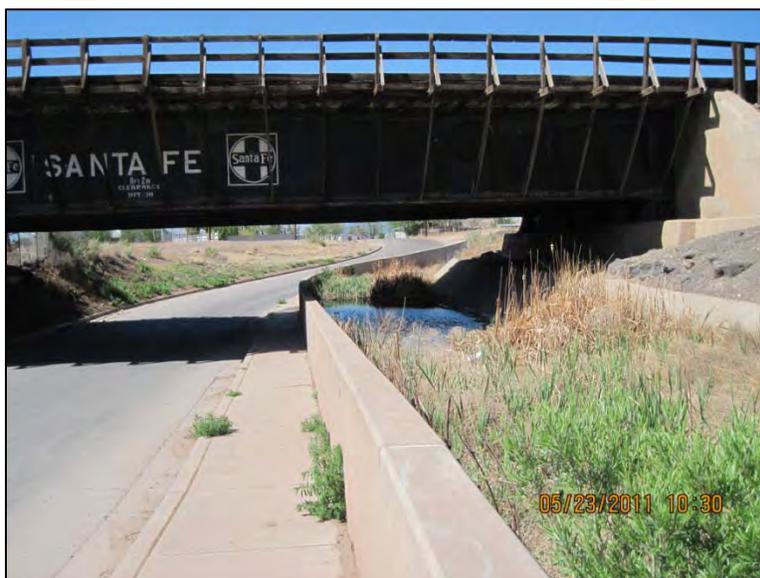
**NMED/SWQB
Official Photograph Log
Photo # 2**

Photographer: Erin S. Trujillo	Date: 05/23/2011	Time: 1030 hours
City/County: Grants / Cibola		State: New Mexico
Location: Rio San Jose		
Subject: Standing water in Rio San Jose under railroad underpass south of the fountain overflow at Riverwalk Park.

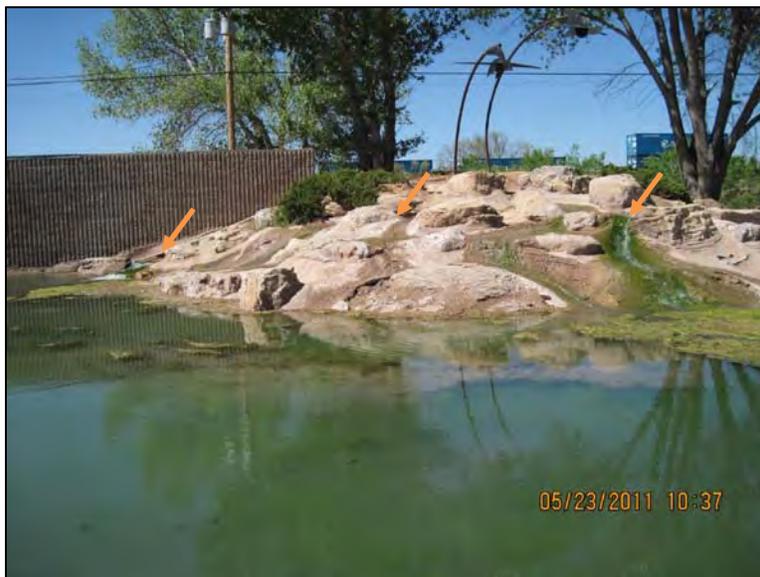
NMED/SWQB
Official Photograph Log
Photo # 3

It was noted that flow from two of the observed pipes in the fountain felt cool, while one felt warm on the day of the inspection. The City's representatives stated that flow from the groundwater well directly into the fountain was generally warmer than the re-circulated groundwater water from the stream.

Photographer: Erin S. Trujillo	Date: 05/23/2011	Time: 1037 hours
City/County: Grants / Cibola	State: New Mexico	
Location: Riverwalk Park		
Subject: Algal growth in fountain. Arrows point to location of pipes in fountain with flow.

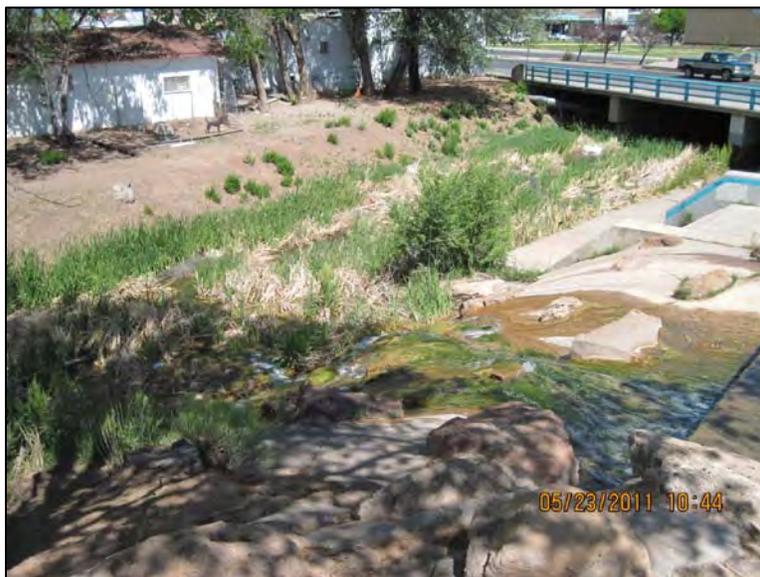
NMED/SWQB
Official Photograph Log
Photo # 4

Groundwater is pumped to an on-site building that contains a water meter. The locked building with the meter and distribution pipes could not be opened by the operator's on-site representative on the day of the inspection. From this building, flow enters PVC pipes with outlets on a manmade rock structure fountain. The fountain has a spillway and flow from the fountain directly entered the Rio San Jose on the day of this inspection.

An NPDES permit has not been obtained for the discharge of groundwater and occasionally chemically treated groundwater water (dyes) from a fountain and ponds that overflow into the Rio San Jose. Based on conversations with the City Manager, the City was unaware of the need for a permit. Contact information for USEPA Region 6 NPDES Permit Coordinator for New Mexico was provided to Mr. Martinez on May 24, 2011.

Photographer: Erin S. Trujillo	Date: 05/23/2011	Time: 1044 hours
City/County: Grants / Cibola	State: New Mexico	
Location: Rio San Jose at Southern end of Riverwalk Park		
Subject: Overflow from fountain into Rio San Jose.

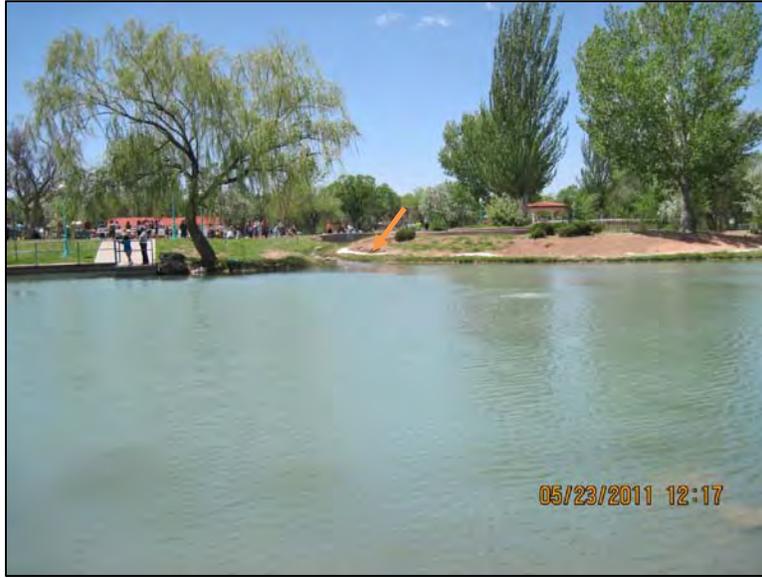
NMED/SWQB
Official Photograph Log
Photo # 5

Photographer: Erin S. Trujillo	Date: 05/23/2011	Time: 1217 hours
City/County: Grants / Cibola	State: New Mexico	
Location: Riverwalk Park		
Subject: Second pond. Arrow points to channel from first pond with flow entering second pond.

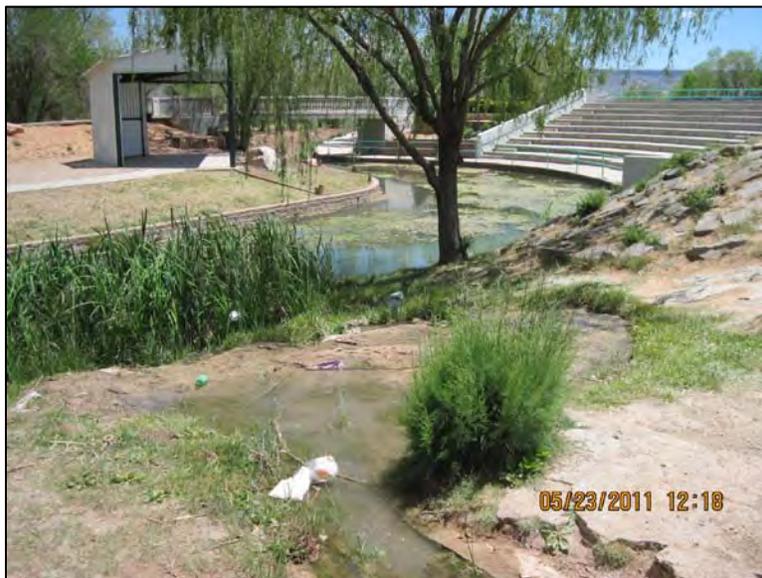
NMED/SWQB
Official Photograph Log
Photo # 6

Trash was observed at the second pond overflow location. There was no velocity dissipation or other structures to minimize erosion at the second pond overflow.

Photographer: Erin S. Trujillo	Date: 05/23/2011	Time: 1218 hours
City/County: Grants / Cibola	State: New Mexico	
Location: Riverwalk Park		
Subject: Overflow from second pond into Rio San Jose. Trash and some erosion was observed at this location.

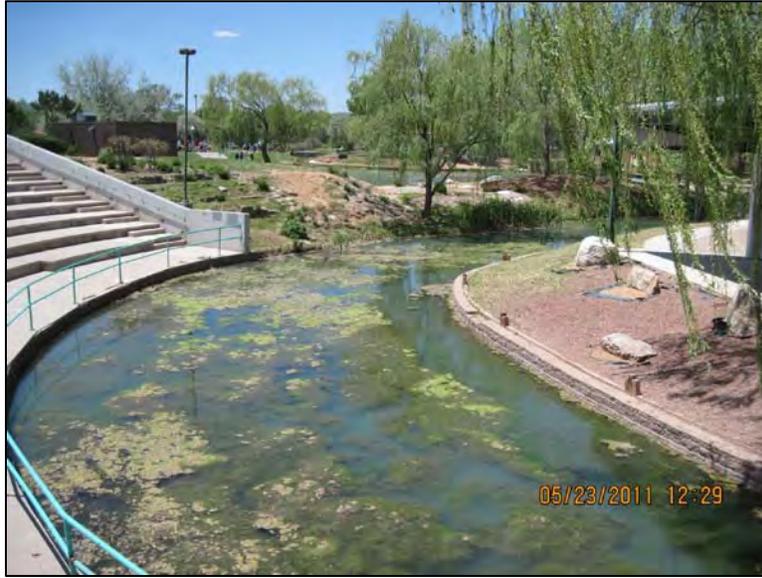
**NMED/SWQB
Official Photograph Log
Photo # 7**

Excessive algal growth was observed in the Rio San Jose downstream of the overflows which may indicate high nutrient levels in the stream. Nutrient analytical results of water quality samples collected from the Rio San Jose at the park on May 17, 2011 by NMED MAS are not available at the writing of this report. City of Grants has not tested the groundwater from Well B00039. Sources of nutrients in streams can be from nonpoint (dispersed, both human and natural sources) and point-source discharges.

Photographer: Erin S. Trujillo	Date: 05/23/2011	Time: 1229 hours
City/County: Grants / Cibola	State: New Mexico	
Location: Rio San Jose at Northern End of Riverwalk Park		
Subject: Excessive algal growth in stream at southern end of park. Banks of stream have been stabilized.

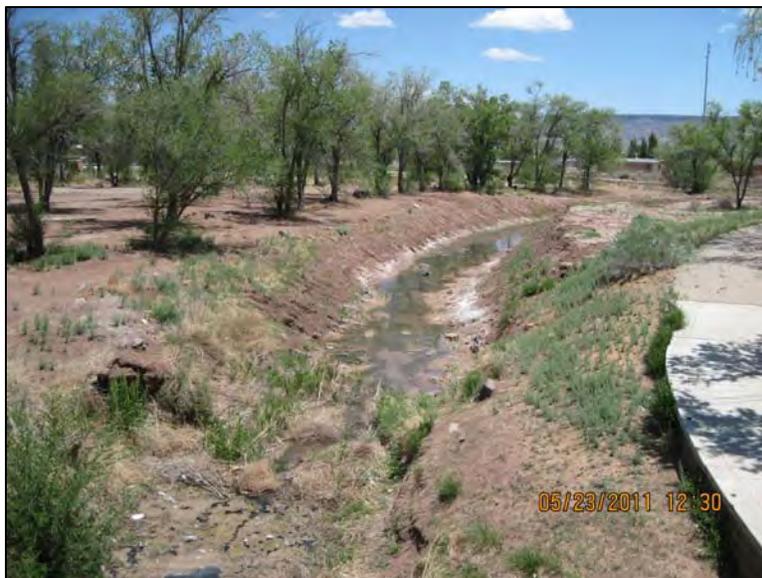
**NMED/SWQB
Official Photograph Log
Photo # 8**

Photographer: Erin S. Trujillo	Date: 05/23/2011	Time: 1230 hours
City/County: Grants / Cibola	State: New Mexico	
Location: Rio San Jose		
Subject: Flow in stream channel downstream from City of Grants Riverwalk Park. Channel banks and bed had recently been cleared of vegetation by the City.
