RE: Minor Non-Municipal, SIC 1711, NPDES Reconnaissance Inspection, New Mexico Highlands University / Student Union Geothermal Well Drilling, NMU001737, June 9, 2011

NPDES Compliance Inspection Report

**New Mexico Highlands University - Student Union
Geothermal Well Drilling Area
NPDES Tracking No NMU001737
Reconnaissance Inspection
June 9, 2011**

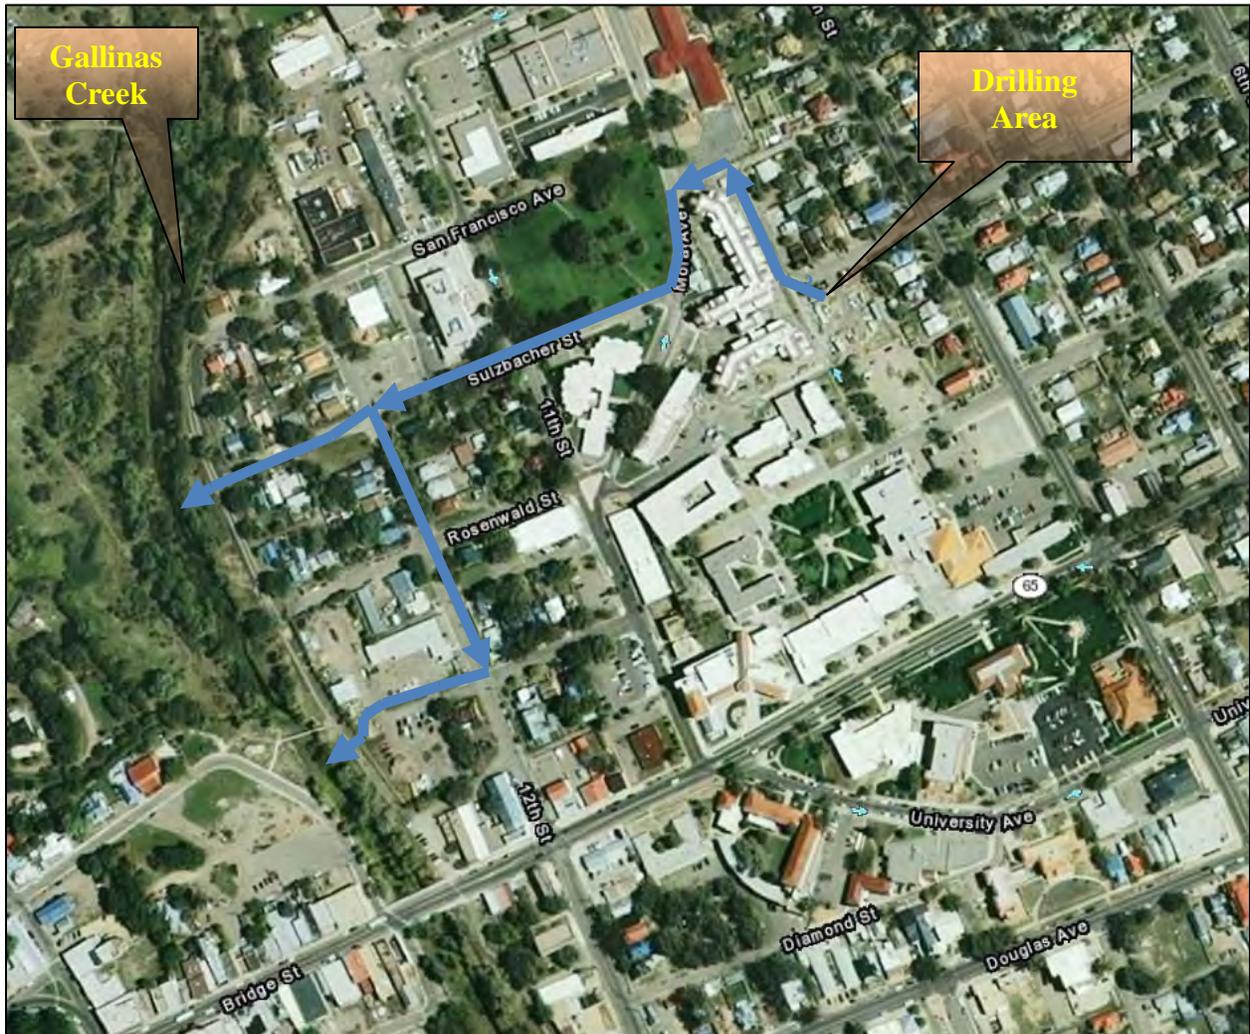
NMED/SWQB
Site Map

Created by: Erin S. Trujillo		
City/County: Las Vegas / San Miguel	State: New Mexico	
Location: New Mexico Highlands University Student Union Geothermal Well Drilling Area		
Subject: Approximate flow path of discharge to Gallinas Creek.

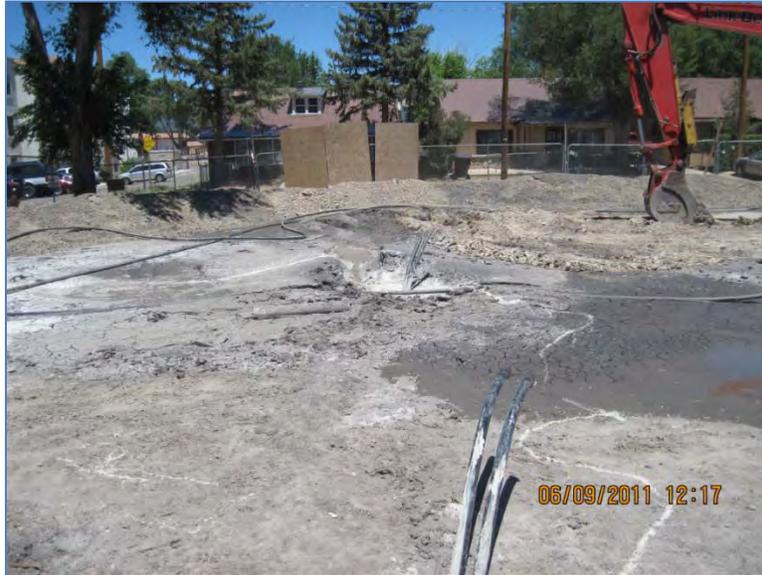
**NMED/SWQB
Official Photograph Log
Photo # 1**

On the day of this inspection, pulverized cuttings including shale, remaining standing water, grout and sand were on the surface at the drilling area. The course gravel berm, hale bales and wattle were not sufficient to contain the process water onsite and prevent pulverized cuttings and other possible pollutants from flowing offsite.

Photographer: Erin S. Trujillo	Date: 06/09/2011	Time: 1217 hours
City/County: Las Vegas / San Miguel	State: New Mexico	
Location: New Mexico Highlands University Student Union Geothermal Well Drilling Area		
Subject: Standing water, pulverized cuttings, grout & sand at the drilling area. Coarse gravel berm installed along site perimeter. Boards were installed along fence to catch cutting fragments during drilling.

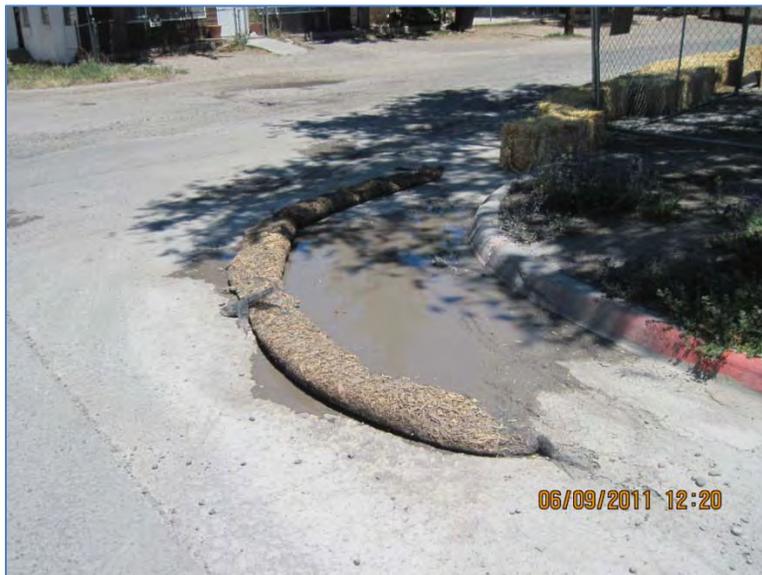
**NMED/SWQB
Official Photograph Log
Photo # 2**

Photographer: Erin S. Trujillo	Date: 06/09/2011	Time: 1220 hours
City/County: Las Vegas / San Miguel	State: New Mexico	
Location: New Mexico Highlands University Student Union Geothermal Well Drilling Area		
Subject: Example of the remaining standing water in street, straw wattle and hay bales at drilling area.

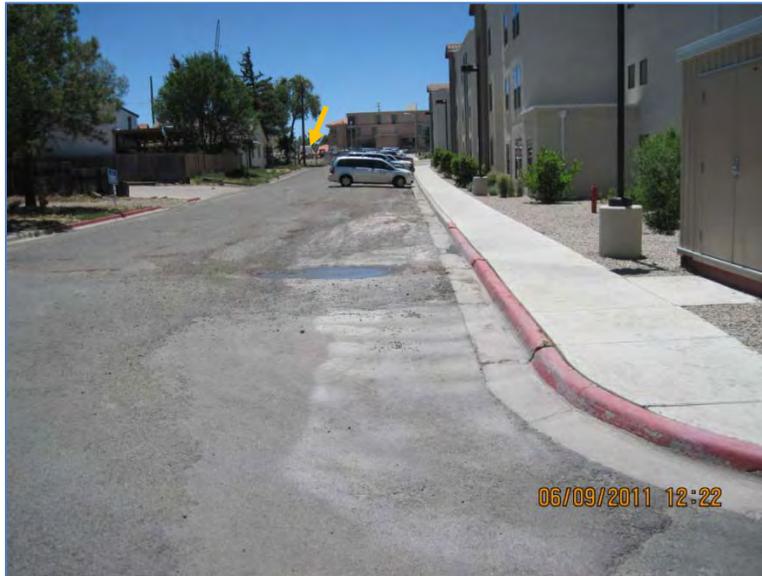
**NMED/SWQB
Official Photograph Log
Photo # 3**

Photographer: Daniel Valenta	Date: 06/09/2011	Time: 1222 hours
City/County: Las Vegas / San Miguel	State: New Mexico	
Location: New Mexico Highlands University Discharge Flow Path		
Subject: Example of remaining standing water and accumulated solids on Ninth Street. Arrow points to drilling area.

Additional information received from NMHU on June 14, 2011 states, “...June 10, 2011, NMHU mobilized maintenance personnel with brooms and shovels as well as a mechanized street sweeper to pick up any sediment deposits left on the city streets as a result of the discharge.”

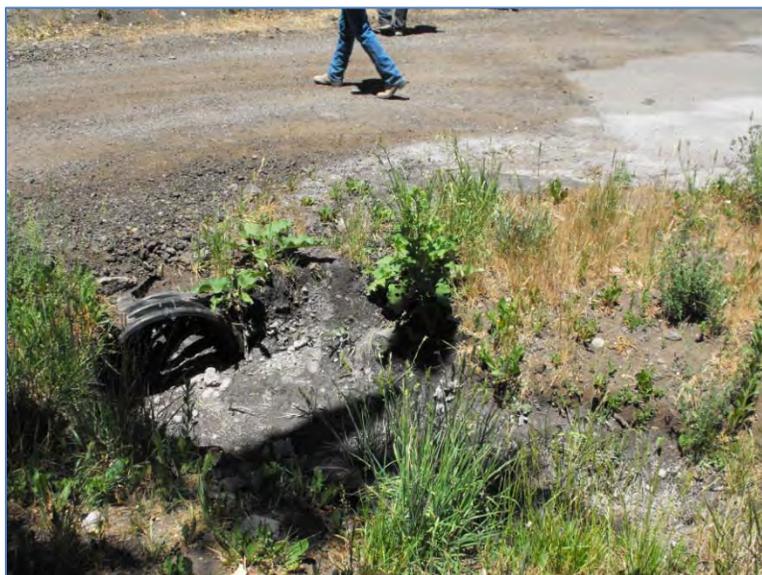
**NMED/SWQB
Official Photograph Log
Photo # 4**

On the day of this inspection, accumulated solids or other discoloration from the discharge was not observed in and along Gallinas Creek. Jeffery Mills, District II and Chris Cudia, SWQB at NMED Las Vegas offices stated that they observed the discharge on June 8 from the drilling operations at two locations into the Gallinas Creek. The discharge had a visual contrast compared to surface water flowing upstream of the two discharge points.

Photographer: Daniel Valenta	Date: 06/09/2011	Time: 1234 hours
City/County: Las Vegas / San Miguel	State: New Mexico	
Location: Unnamed Road along Gallinas Creek at Sulzbacher Street		
Subject: One of the two off-site drainage ditches where discharge entered culvert pipe with an outlet above Gallinas Creek.
