NEW MEXICO  
ENVIRONMENT DEPARTMENT  
*Surface Water Quality Bureau*

**RE: Minor Non-Municipal, SIC 1499, NPDES Compliance Evaluation Inspection, Morningstar Minerals Corporation / Humate Mill and Manufacturing Facility, Farmington, NMU001743, June 28, 2011**

### NPDES Compliance Inspection Report

**Morningstar Minerals Corporation**  
**Humate Mill and Manufacturing Facility**  
**NMU001743**  
**Compliance Evaluation Inspection**  
**June 28, 2011**

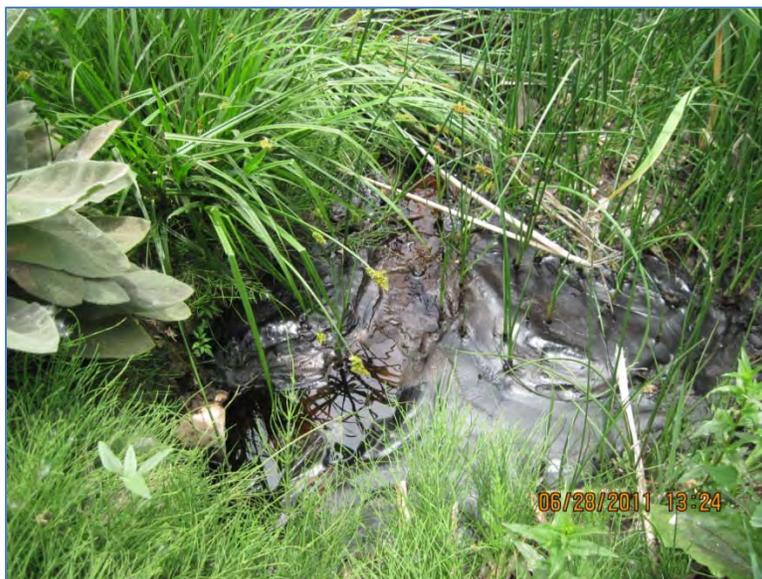
NMED/SWQB  
Official Photograph Log  
Photo # 1

In the process of manufacturing supplements, chlorinated drinking water is used in the facility's reverse osmosis (RO) water treatment system. Filter backwash from the RO system is piped to an excavated pit/pond at the adjacent drinking water treatment plant (Photo 1). Peroxide is occasionally used to clean filters, but no cleaning or conditioning chemicals (e.g., acids, bases, phosphates) are used during the RO treatment system backwash according to the operator's on-site representative. The operator's on-site representative estimated that the amount of backwash from the RO treatment system is approximately 35 gallons once a week. A culvert (Photo 4) from the excavated pit/pond allows flow from the pit/pond to enter a man-made ditch or excavated trench (Photo 2) between the drinking water treatment plant and humate mill storage area. The operator's on-site representative stated that this culvert and flow was from the pit/pond. A portion of the trench continued south-southwest off-site and standing water was observed at the Andrea Corporation property boundary (Photo 5 and 6).

Photographer: Erin S. Trujillo	Date: 06/28/2011	Time: 1324 hours
City/County: Farmington / San Juan County	State: New Mexico	
Location: Morningstar Minerals Corporation Mill and Manufacturing Facility		
Subject: Pipe with process water backwash from RO at pit/pond at adjacent water treatment plant. Black solids in pond is humate from mill operations runoff/dust.

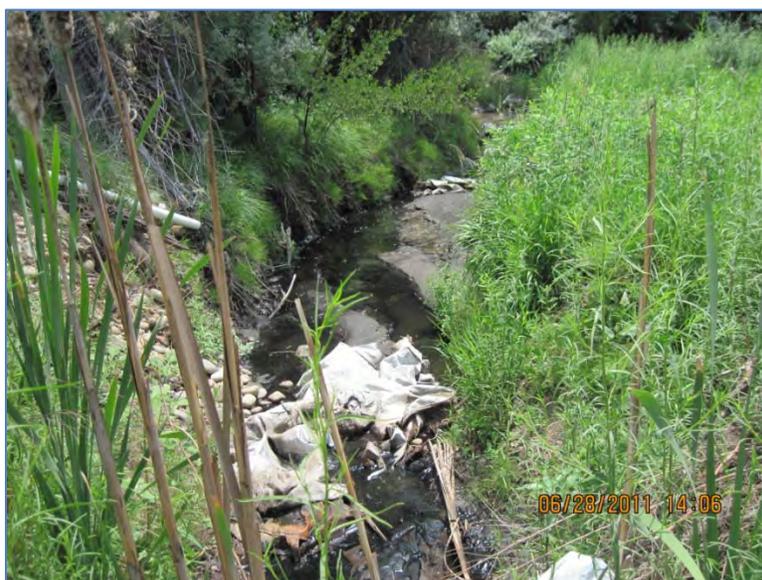
NMED/SWQB  
Official Photograph Log  
Photo # 2

Photographer: Erin S. Trujillo	Date: 06/28/2011	Time: 1406 hours
City/County: Farmington / San Juan County	State: New Mexico	
Location: Morningstar Minerals Corporation Mill and Manufacturing Facility		
Subject: Trench along water treatment plant/mill boundaries. Black solids in trench is humate.

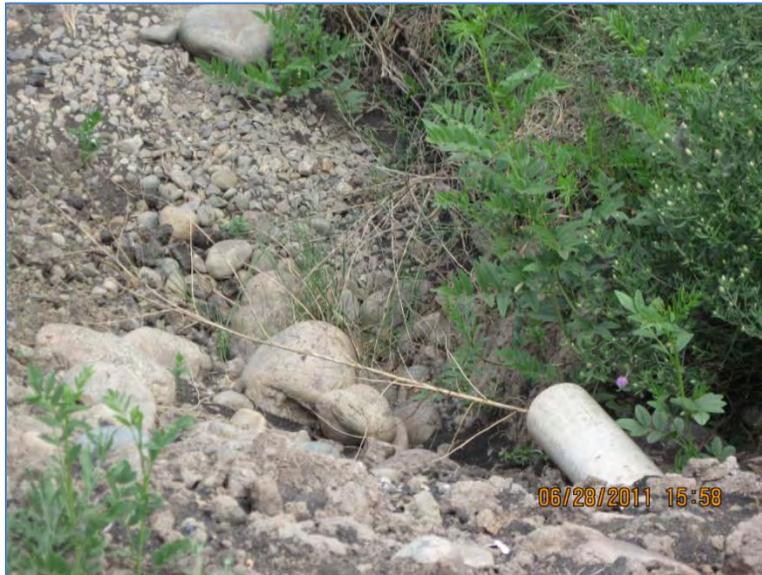
**NMED/SWQB  
Official Photograph Log  
Photo # 3**

During the facility tour, the operator's on-site representative indicated that testing waters were discharged to an irrigation lateral in the eastern portion of the site. Plastic pipe from the facility's processing areas to the irrigation lateral was observed, but testing process water was not flowing to the lateral on the day of this inspection (Photo 3). As part of this on-site testing, water from the Animas River intake/gallery is pumped to an evaporative cooling/heat exchanger. The operator's on-site representative estimated that approximately 4,000 gallons of cooling water per day for ten days in the last six months was piped to the lateral. No conditioning chemicals were used to control algae or corrosion according to the operator's on-site representative; but, additional testing and/or use of the heat exchanger may be needed in the future. Also, the operator's on-site representative stated that chemicals to control algae and/or corrosion may also be needed.

Photographer: Erin S. Trujillo	Date: 06/28/2011	Time: 1558 hours
City/County: Farmington / San Juan County		State: New Mexico
Location: Morningstar Minerals Corporation Mill and Manufacturing Facility		
Subject: Pipe at irrigation lateral at east portion of site. No cooling water flow observed on day of this inspection.

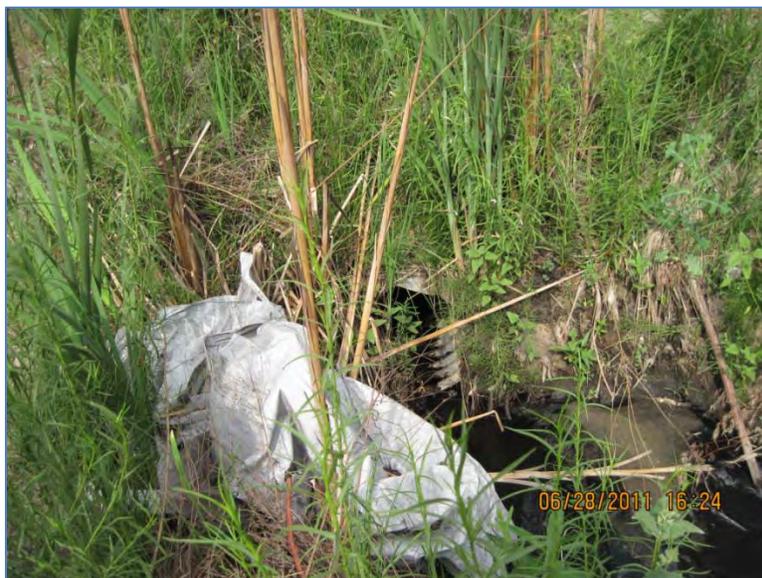
**NMED/SWQB  
Official Photograph Log  
Photo # 4**

Photographer: Erin S. Trujillo	Date: 06/28/2011	Time: 1624 hours
City/County: Farmington / San Juan County		State: New Mexico
Location: Morningstar Minerals Corporation Mill and Manufacturing Facility		
Subject: Culvert from pond shown in Photo 1 w/flow entering trench. Black solids in culvert and trench is humate.

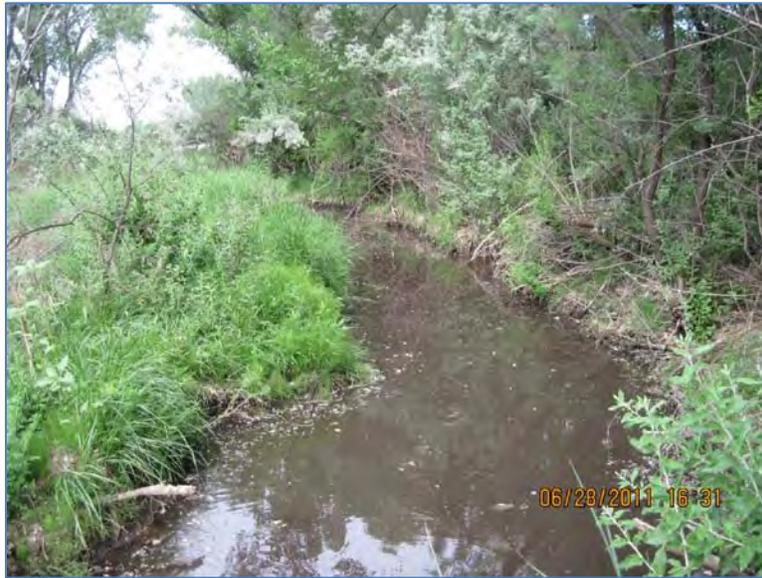
NMED/SWQB  
Official Photograph Log  
Photo # 5

Photographer: Erin S. Trujillo	Date: 06/28/2011	Time: 1631 hours
City/County: Farmington / San Juan County	State: New Mexico	
Location: Morningstar Minerals Corporation Mill and Manufacturing Facility		
Subject: Looking east at slow moving and/or standing water in trench.

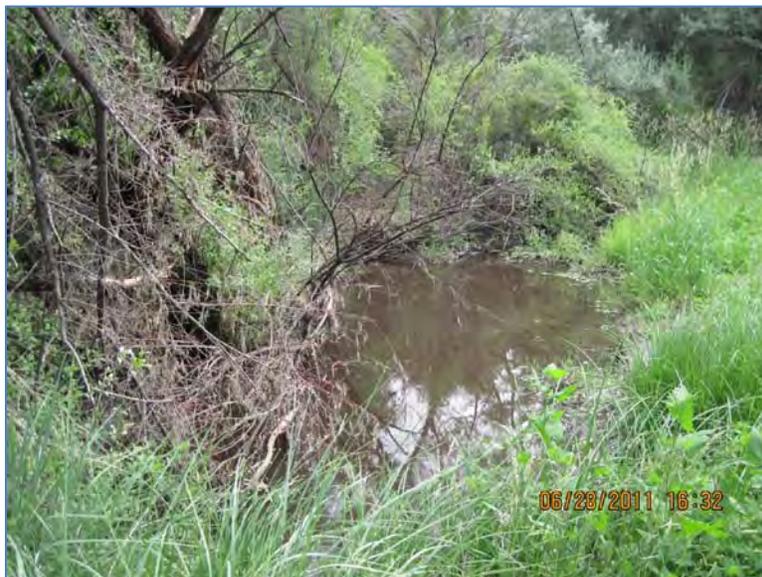
NMED/SWQB  
Official Photograph Log  
Photo # 6

Photographer: Erin S. Trujillo	Date: 06/28/2011	Time: 1632 hours
City/County: Farmington / San Juan County	State: New Mexico	
Location: Morningstar Minerals Corporation Mill and Manufacturing Facility		
Subject: Looking west/southwest at standing water in trench at property boundary.
