RE: Industrial Stormwater; SIC 1442; NPDES Compliance Evaluation Inspection; Monte Verde Ranch; NPDES Permit No. NMU001759; August 10, 2011

### NPDES Compliance Inspection Report

**Compliance Evaluation Inspection**  
**Monte Verde Ranch**  
**August 10, 2011**  
**NMU001759**

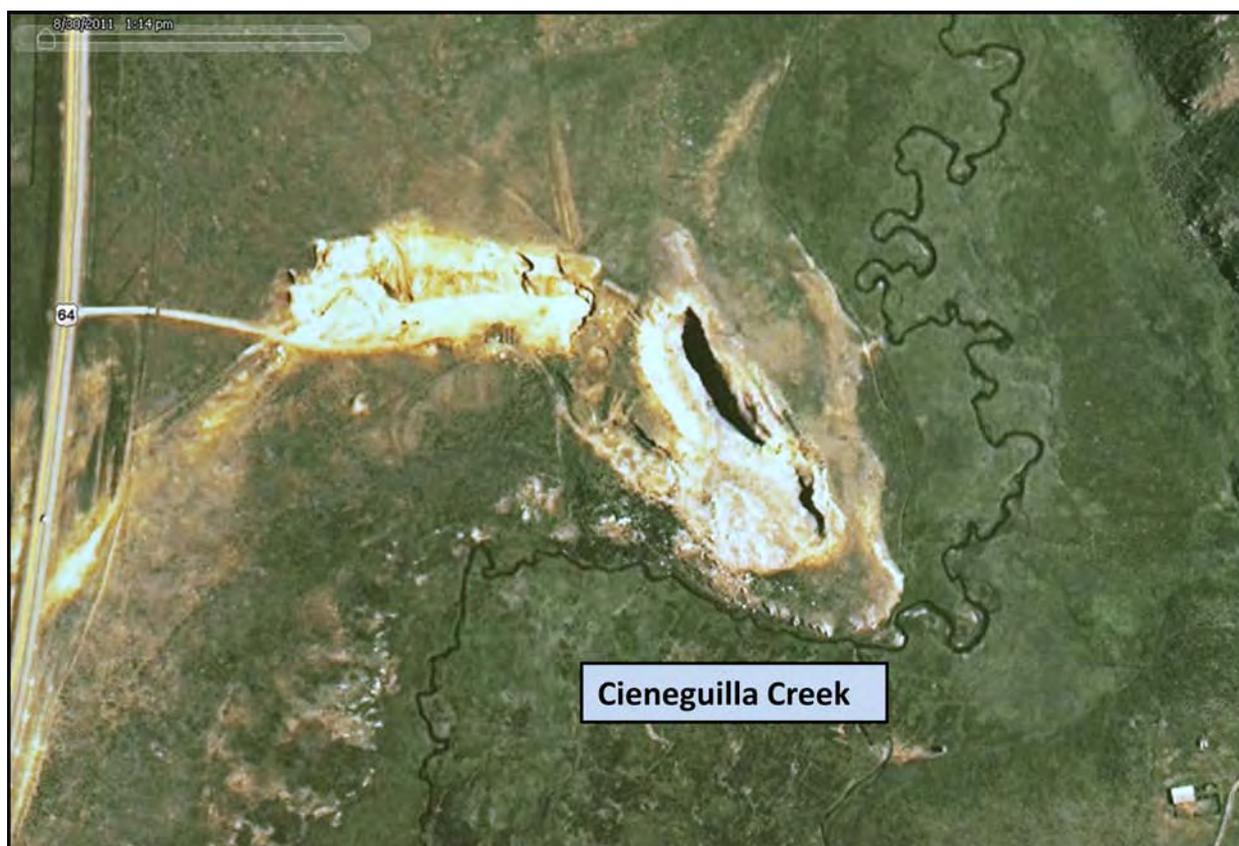
**NMED/SWQB  
Site Overview**

The sand/gravel/rock mine located approximately 7 miles south of Eagle Nest, New Mexico was first mined in 1935. The site is now part of the Monte Verde Ranch owned by Mr. Cliff Teinert. The site can be broken into two areas, (see overview).

1. In reviewing the area with Mr. Teinert, the older part of the mine, close to Cieneguilla creek appears not to be actively mined except in one small area where rock was dug and removed. The sides of the mine leading to Cieneguilla Creek are vegetated with native shrubs along the slopes and with native grasses at the bottom. The site was not disturbed in these areas. Rainwater falling in the older mined area would pond and be retained within the site.

2. The other part of the site which appears lighter in the aerial photograph is being actively mined. No rock separators, grizzlies, or rock crushers were present. But a backhoe and another piece of equipment are at the site. While the site is being mined, the operation appeared to be a small scale operation with no weight scale or office building present. The entrance to the site from Hwy 64 has a locked gate with no signs or marking. While taking pictures of the site from the road, Mr. Nate Kite left the property with a load of sand and gravel. I inquired as to the ownership of the property and his mining at the site. I was directed to the business of Kite Construction, Septic System Services. There I spoke with Mr. Cecil Kite, owner of the business. Mr. Kite said they were given permission to remove sand and gravel from the mine when needed for their jobs. When touring the site with Mr. Teinert, he acknowledged he has given Mr. Kite permission to remove material from the old mine.

City/County: Eagle Nest, New Mexico /Colfax County	
Location: 7 miles south of Eagle Nest, NM on Hwy 64	
Subject: Overview of mine on Monte Verde Ranch along Cieneguilla Creek, taken 7/1/2005.

It does not appear at this time there has been established a business primarily engaged in operating a sand and gravel operation. If the mine is being used commercially the operator needs to apply for and acquire a Multi-Sector General Permit (MSGP). Best Management Practices (BMP's) need to be installed and a Storm Water Pollution Prevention Plan (SWPPP) needs to be created for the site.

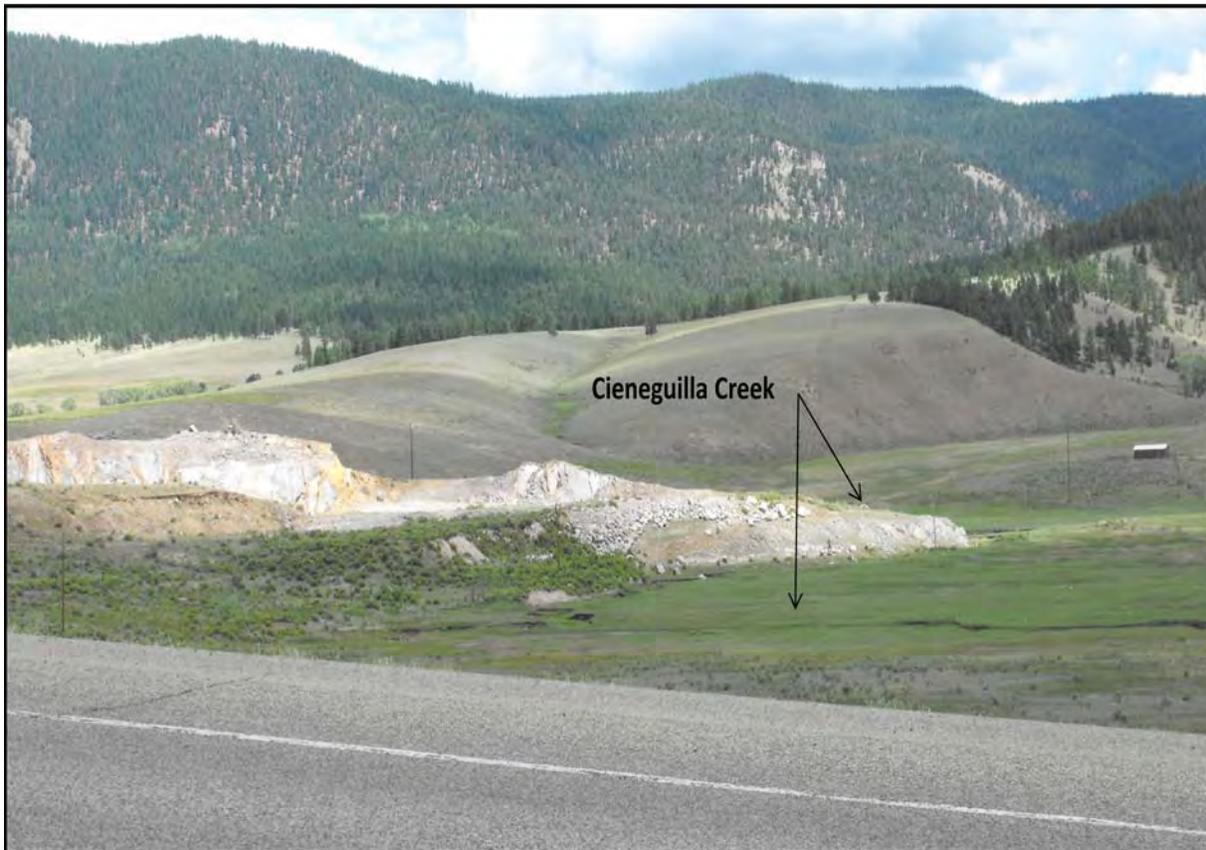
Photo # 1

Photographer: Daniel Valenta	Date: 8/10/2011	Time: 1349 hours
City/County: 7 miles south of Eagle Nest, NM/Colfax County		
Location: 7 miles south of Eagle Nest, NM on Hwy 64 facing north.		
Subject: Sand/Gravel/Rock mine on the Monte Verde Ranch alongside the Cieneguilla Creek.

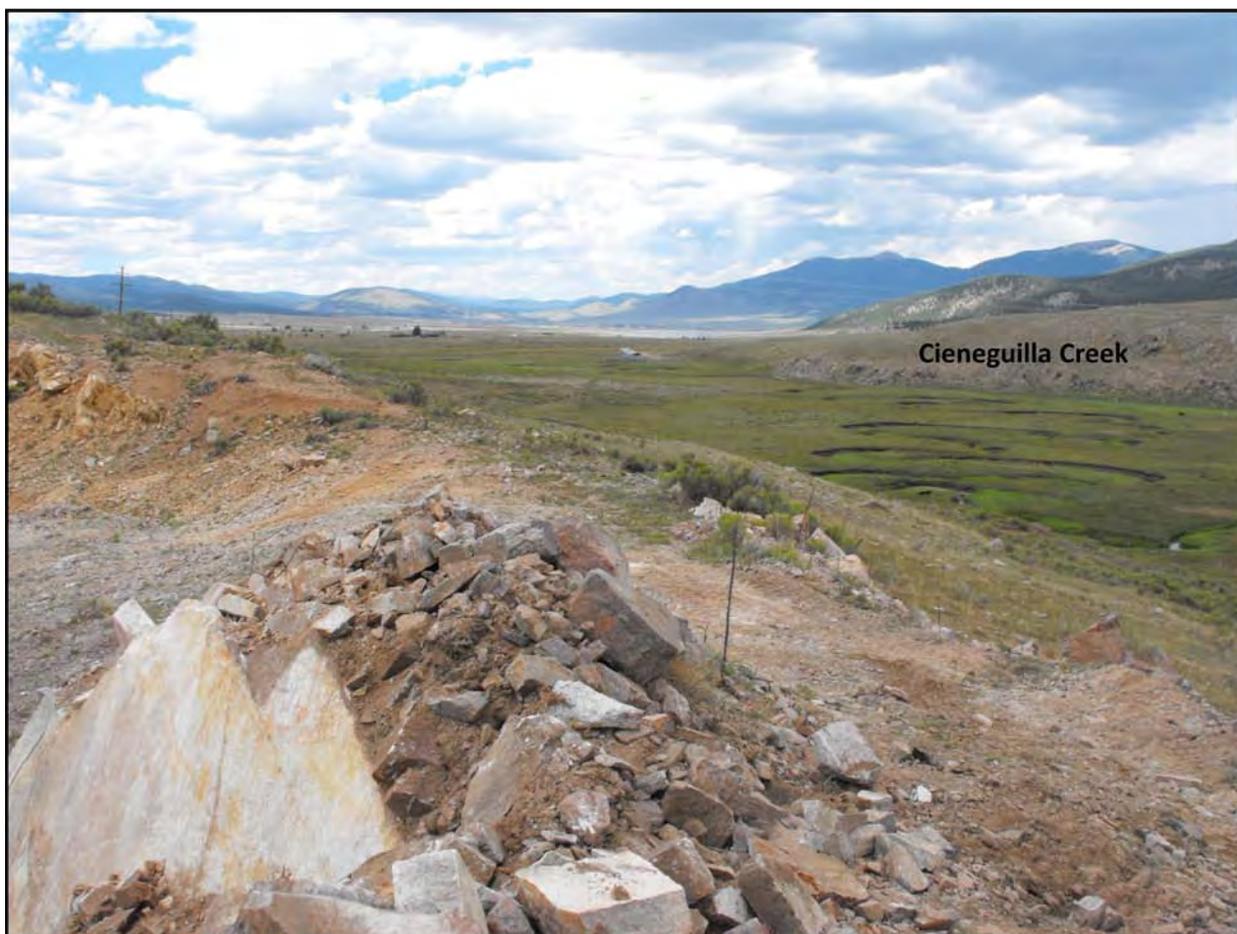
Photo # 2

Photographer: Daniel Valenta	Date: 8/10/2011	Time: 1525 hours
City/County: 7 miles south of Eagle Nest, NM/Colfax County		
Location: East side of the Sand/Gravel/Rock mine on the Monte Verde Ranch, facing northeast.		
Subject: East side of mine, area slopes downward toward the Cieneguilla Creek.
