RE: Industrial Stormwater; SIC 1441; NPDES Compliance Evaluation Inspection; Northern Mountain Constructors, LLC; NPDES Permit No. NMU001761; August 9, 2011

NPDES Compliance Inspection Report

**Compliance Evaluation Inspection
Northern Mountain Constructions
August 9, 2011
NMU001761**

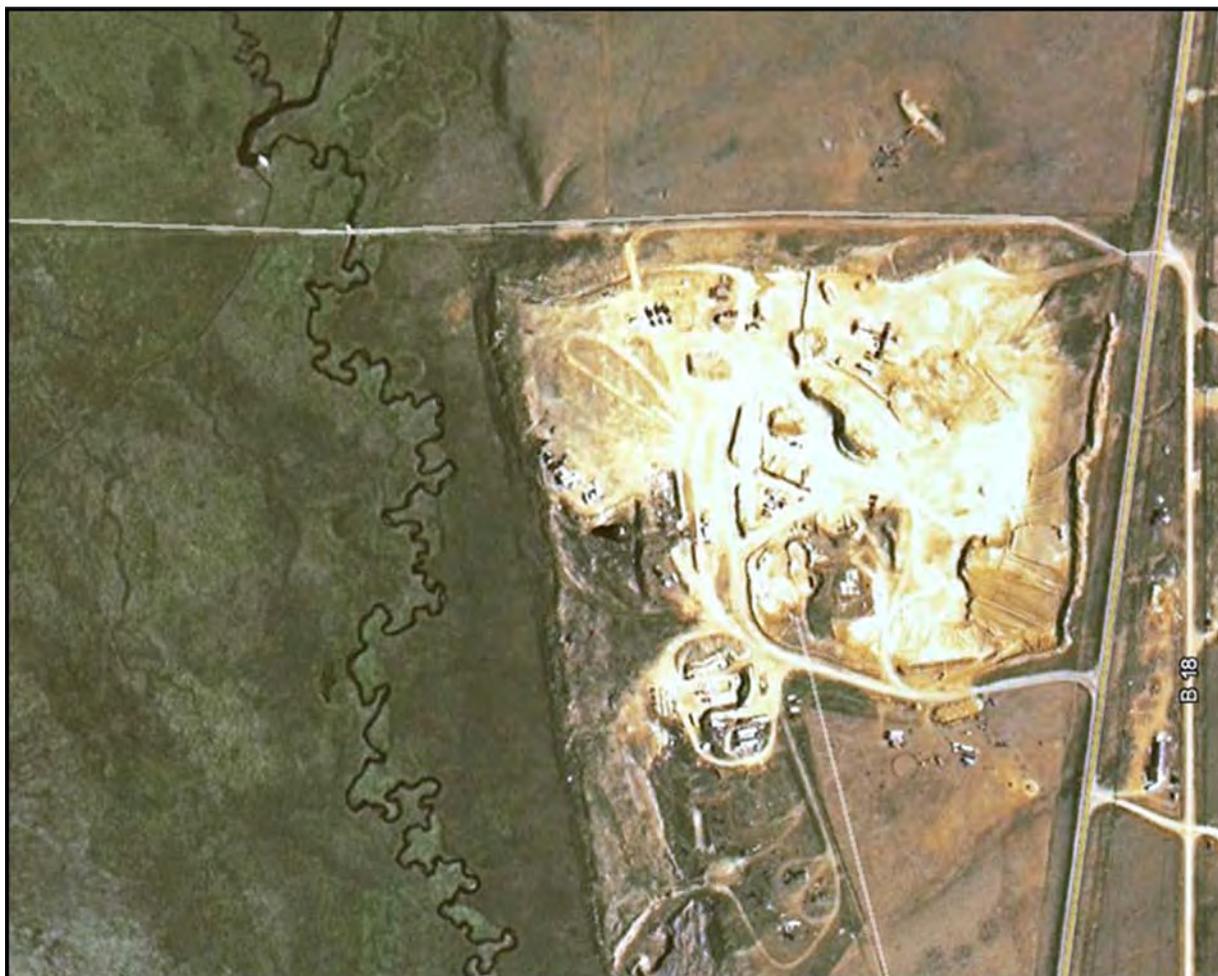
**NMED/SWQB
Site Overview**

City/County: Eagle Nest, New Mexico /Colfax County	
Location: 2845 Hwy 38, Valley Materials Pit, one mile north of Hwy 64.	
Subject: Valley Materials Pit, photo taken July 1, 2005.

Moreno Creek

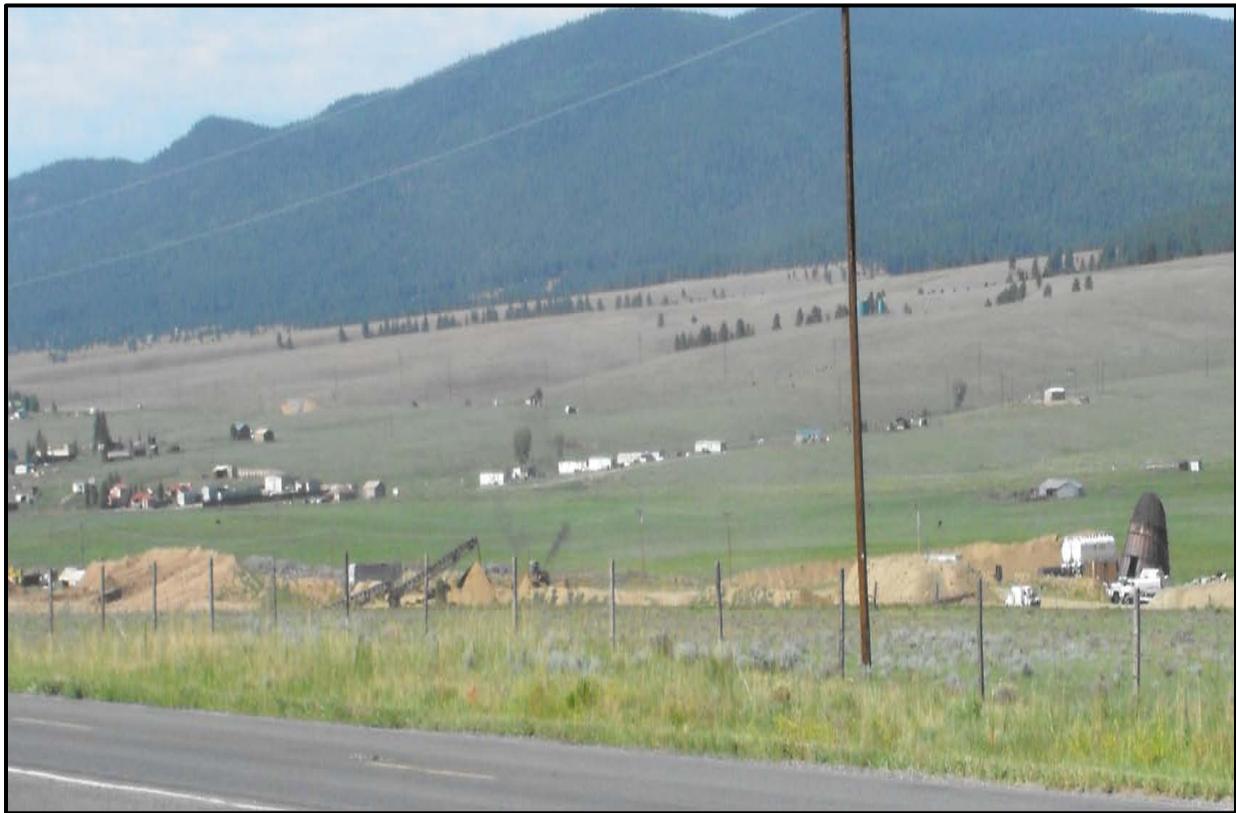
Photo # 1

The active mining and crushing is taking place in the middle of this 90 acre site. Rain water falling on the active mining area would flow into a large depression and be retained and absorbed. However mined sand has been piled on the edge of the site, over twenty feet high, (see photo 1 & 2). An old containment berm can be found around the site, (see overview and photo 2). It was unknown and no documentation present to determine if the containment was still effective or if the present loose soil storage pile would continue to grow or be pushed further toward the unmaintained berm and Moreno Creek.

Photographer: Daniel Valenta	Date: 8/9/2011	Time: 0950 hours
City/County: Eagle Nest, New Mexico /Colfax County		
Location: 2845 Hwy 38, Valley Materials Pit, one mile north of Hwy 64/38. Facing south west.		
Subject: Sand and Gravel mining next to the Moreno creek.

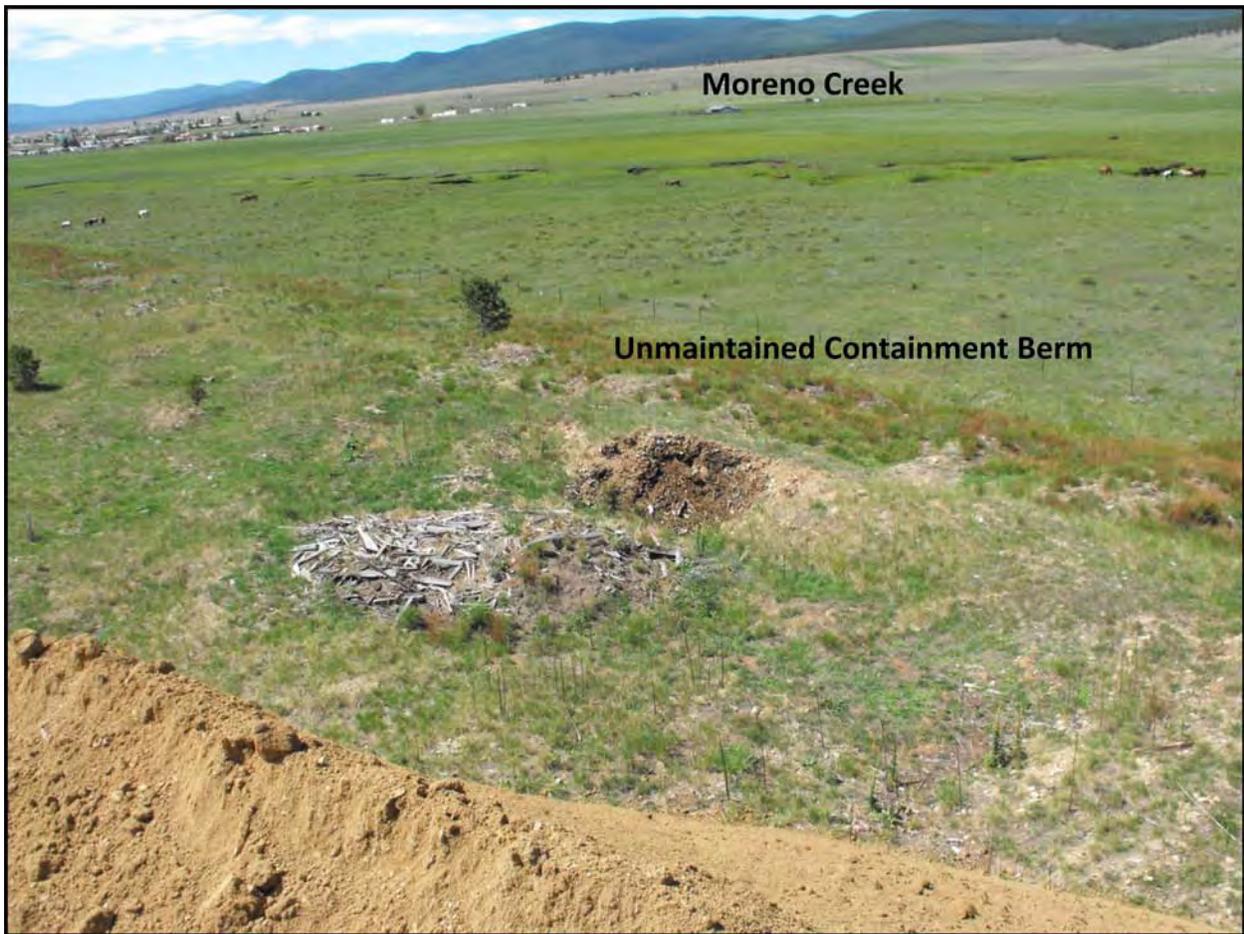
Photo # 2

Photographer: Daniel Valenta	Date: 8/9/2011	Time: 1103 hours
City/County: Eagle Nest, New Mexico /Colfax County		
Location: 2845 Hwy 38, Valley Materials Pit, one mile north of Hwy 64/38, facing west.		
Subject: On top of large material pile next to the containment berm
