RE: Industrial Storm Water; SIC 5093; NPDES Compliance Evaluation Inspection; Valley Scrap Metal, Inc.; NPDES Permit NMU001769; October 12, 2011

NPDES Compliance Inspection Report

Valley Scrap Metal, Inc.
NPDES Tracking No. NMU001769
October 20, 2011

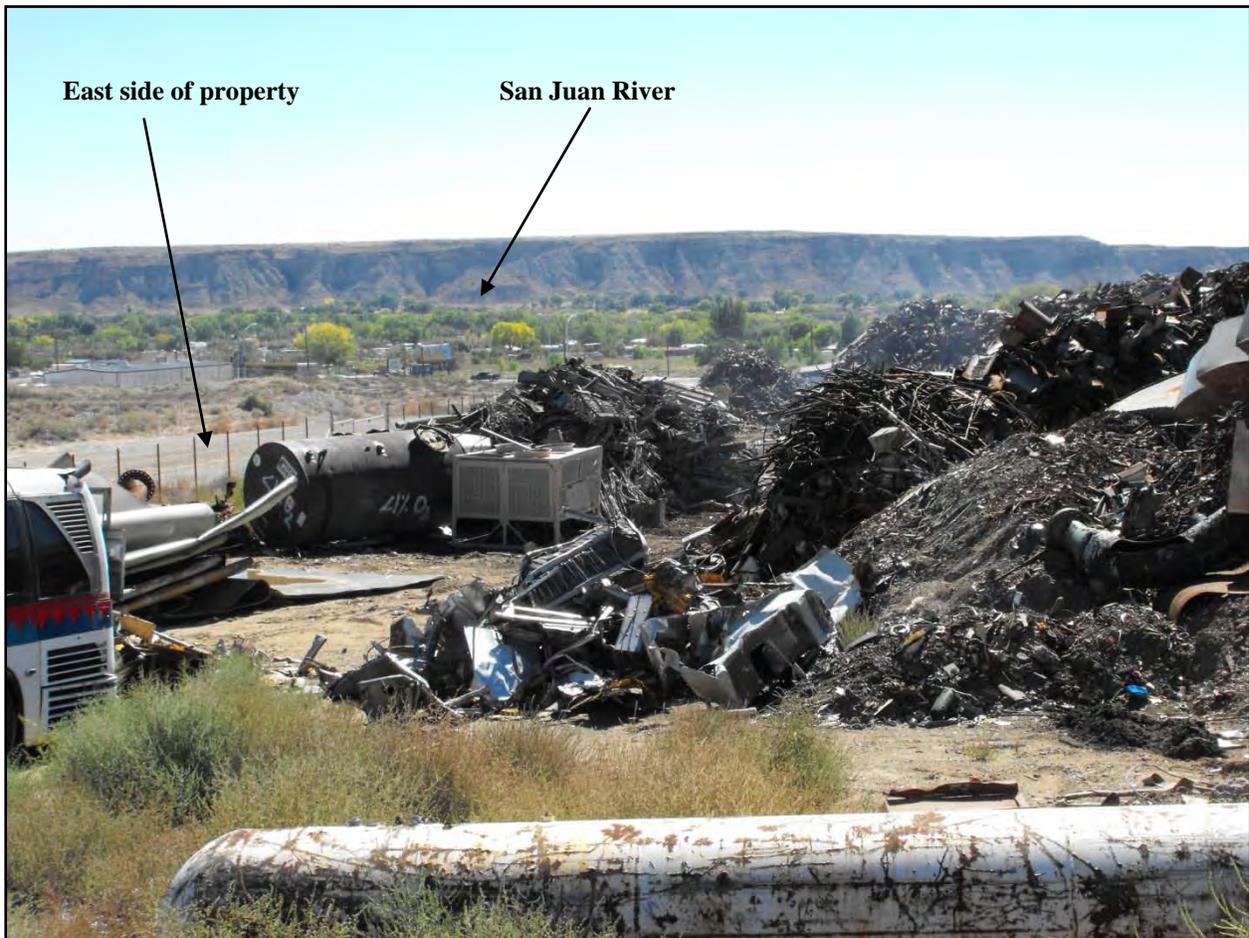
Photo # 1

Photographer: Daniel Valenta	Date: 10/12/2011	Time: 1330 hours
City/County: Kirtland/San Juan		
Location: Valley Scrap Metal, 4346 Hwy 64, Kirtland, New Mexico, facing southeast.		
Subject: Piles of metal scrap at back of property.

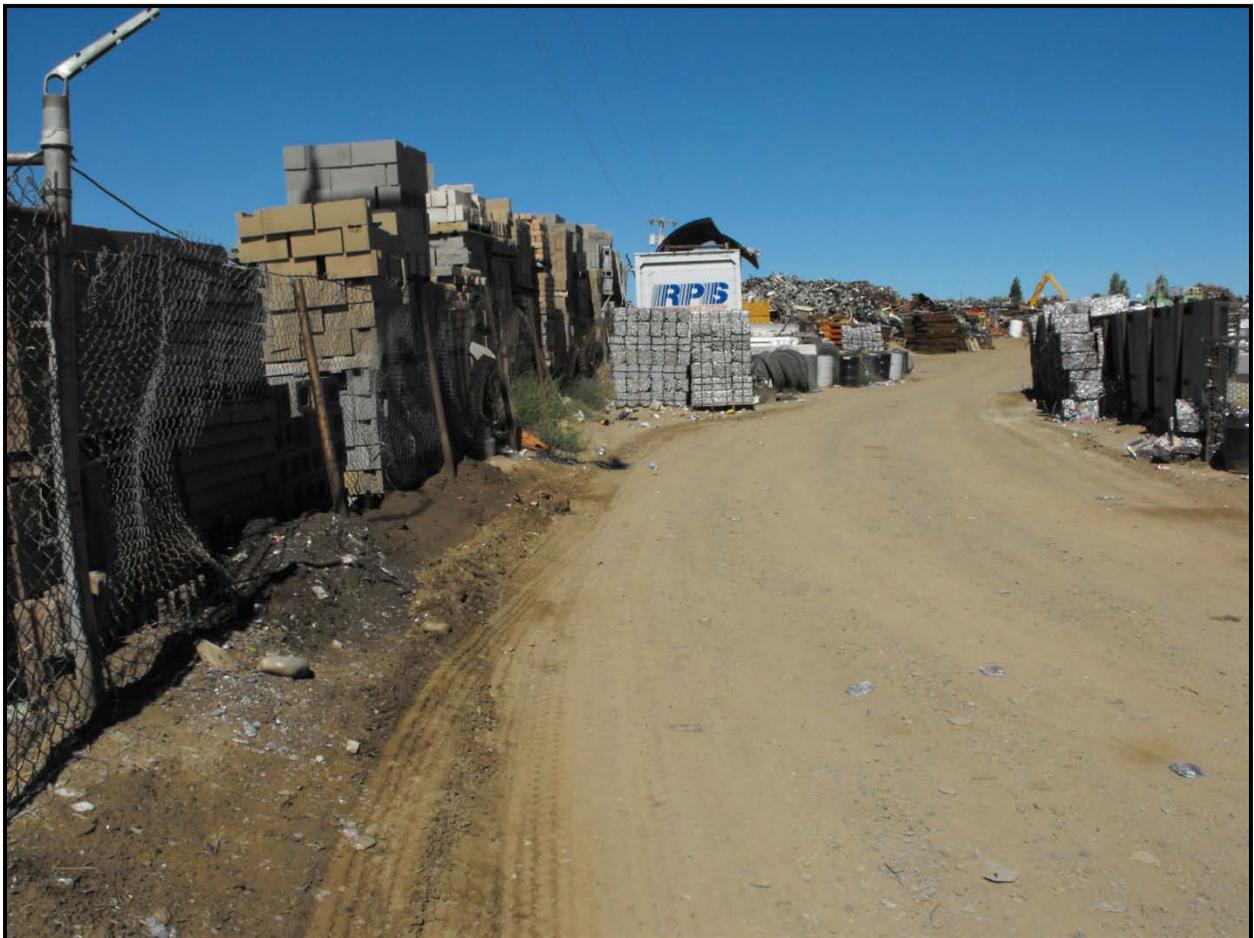
Photo # 2

Photographer: Daniel Valenta	Date: 10/12/2011	Time: 1319 hours
City/County: Kirtland/San Juan		
Location: Valley Scrap Metal, 4346 Hwy 64, Kirtland, New Mexico, facing north.		
Subject: Facing back of property along the west border.

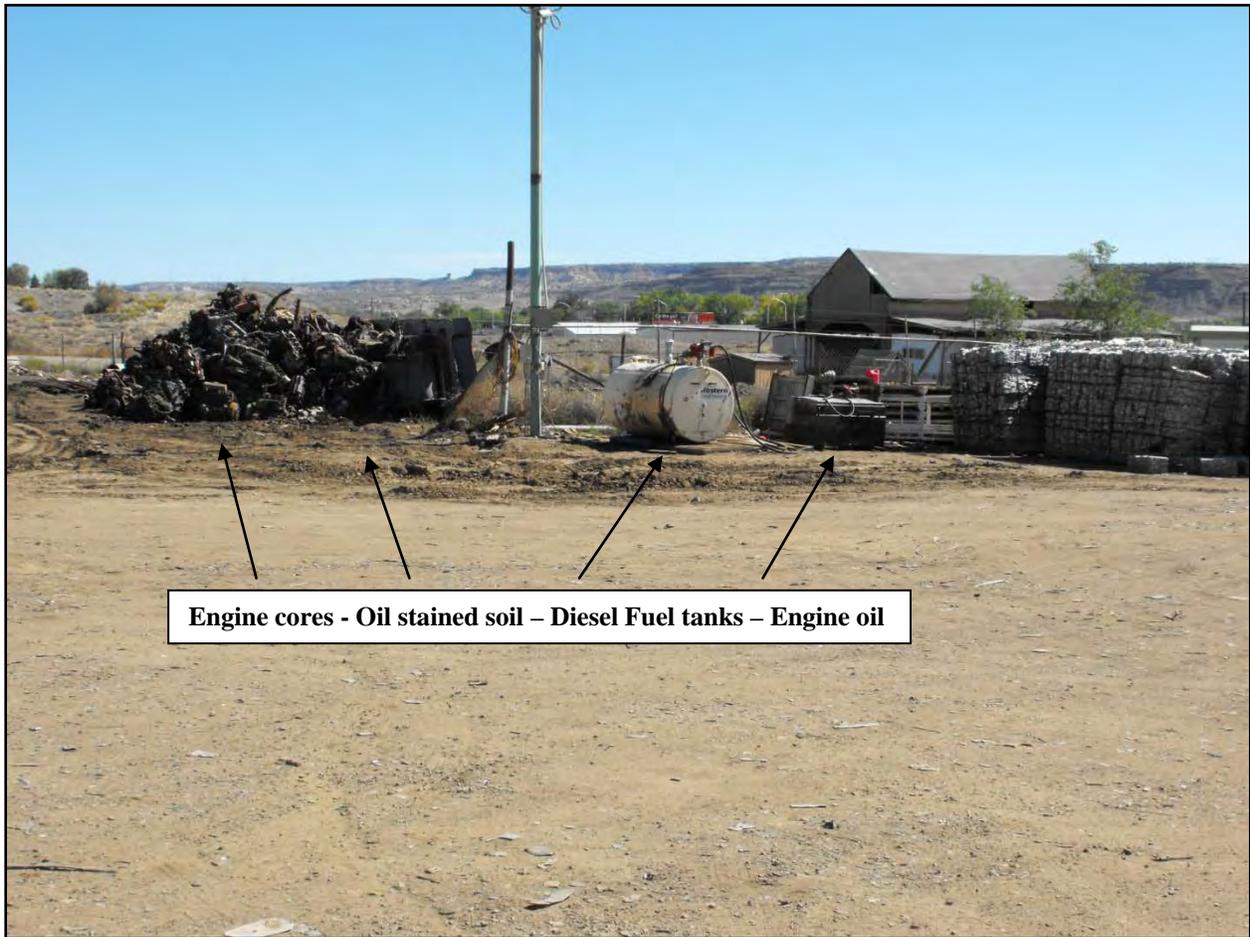
Photo # 3

The back of the site slopes toward the front, south. On half of the east side is just a fence with a road, there is a gate to enter and exit at this point, (see photo 4). The southeast corner of the site is not owned by Mr. Link there are no BMP's in place to prevent runoff from entering this area, (see photo 3). Halfway along the west side is a berm between the salvage yard and the cement brick yard. There are no other BMP's in place to prevent stormwater from leaving the site.

Photographer: Daniel Valenta	Date: 10/12/2011	Time: 1322 hours
City/County: Kirtland/San Juan		
Location: Valley Scrap Metal, 4346 Hwy 64, Kirtland, New Mexico, facing east.		
Subject: Southeast corner of property.

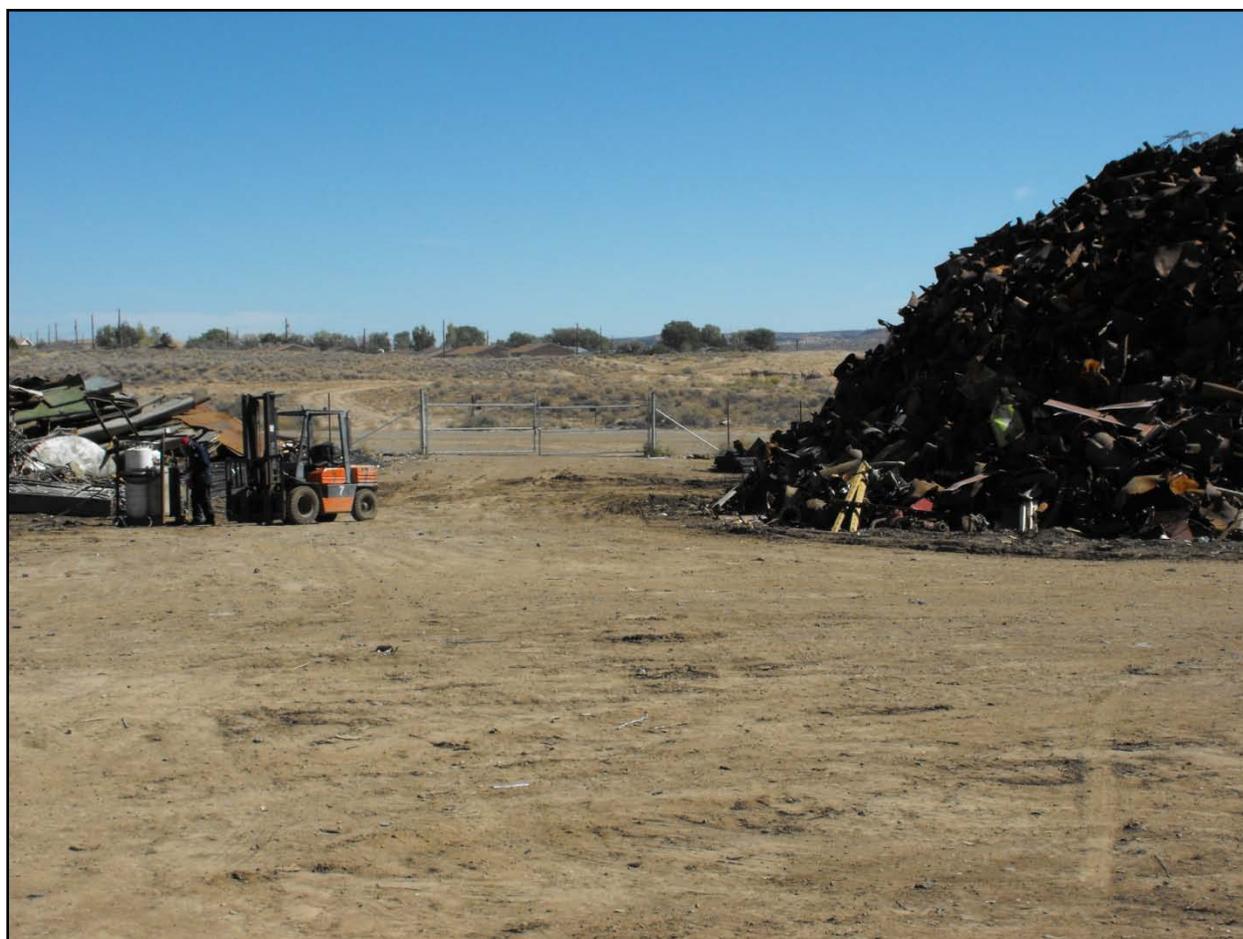
Photo # 4

Photographer: Daniel Valenta	Date: 10/12/2011	Time: 1324 hours
City/County: Kirtland/San Juan		
Location: Valley Scrap Metal, 4346 Hwy 64, Kirtland, New Mexico, facing east.		
Subject: Gate along the east side of property.

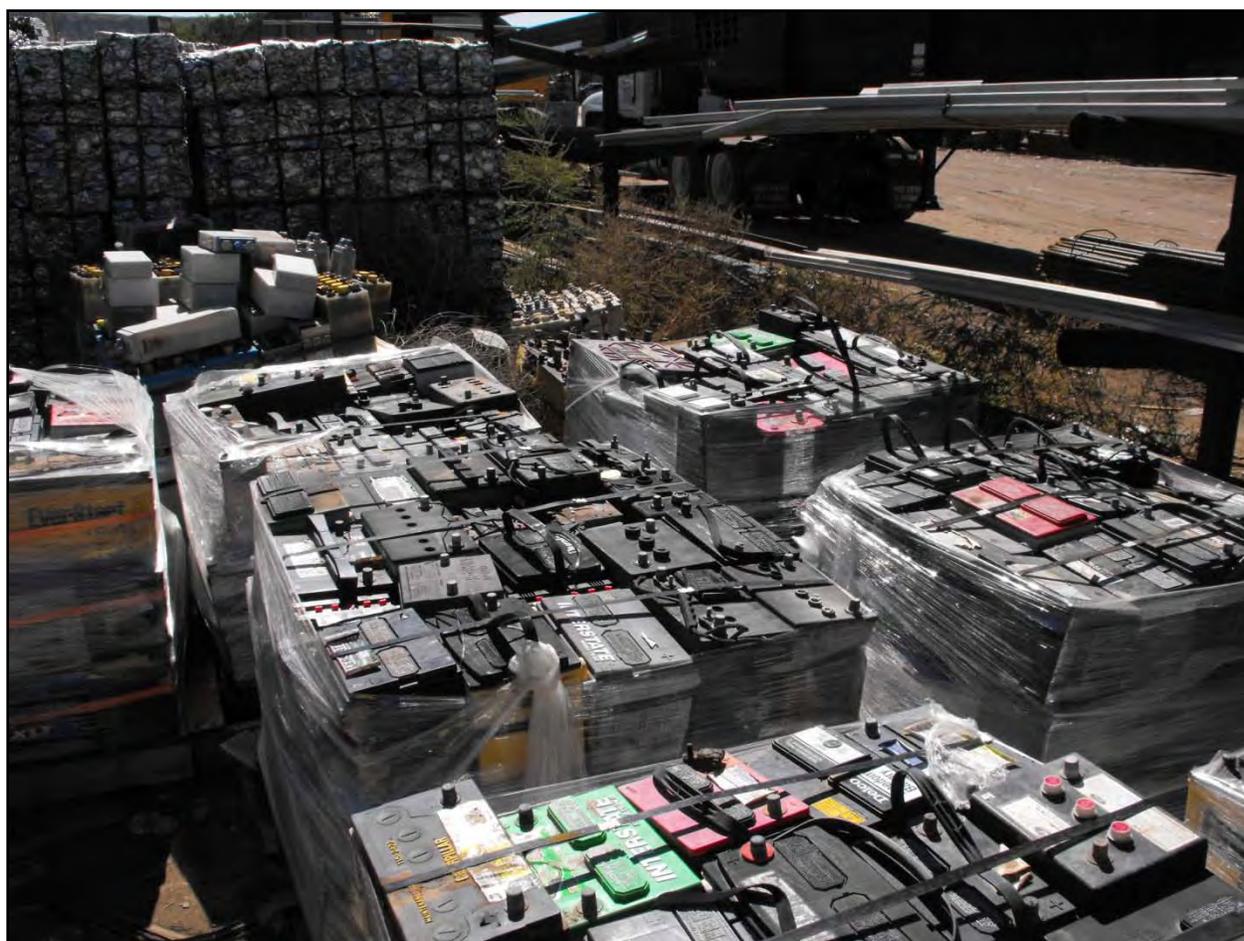
Photo # 5

Photographer: Daniel Valenta	Date: 10/12/2011	Time: 1340 hours
City/County: Kirtland/San Juan		
Location: Valley Scrap Metal, 4346 Hwy 64, Kirtland, New Mexico, facing southwest.		
Subject: Pallets loaded with batteries.
