**NEW MEXICO  
ENVIRONMENT DEPARTMENT**

**RE: Construction Storm Water; SIC 1611; NPDES Compliance Evaluation Inspection; Guzman Construction Solutions LLC; NMU001841; January 16, 2013**

**Guzman Construction Solutions, LLC**  
**January 16, 2013**  
**NMU001841**

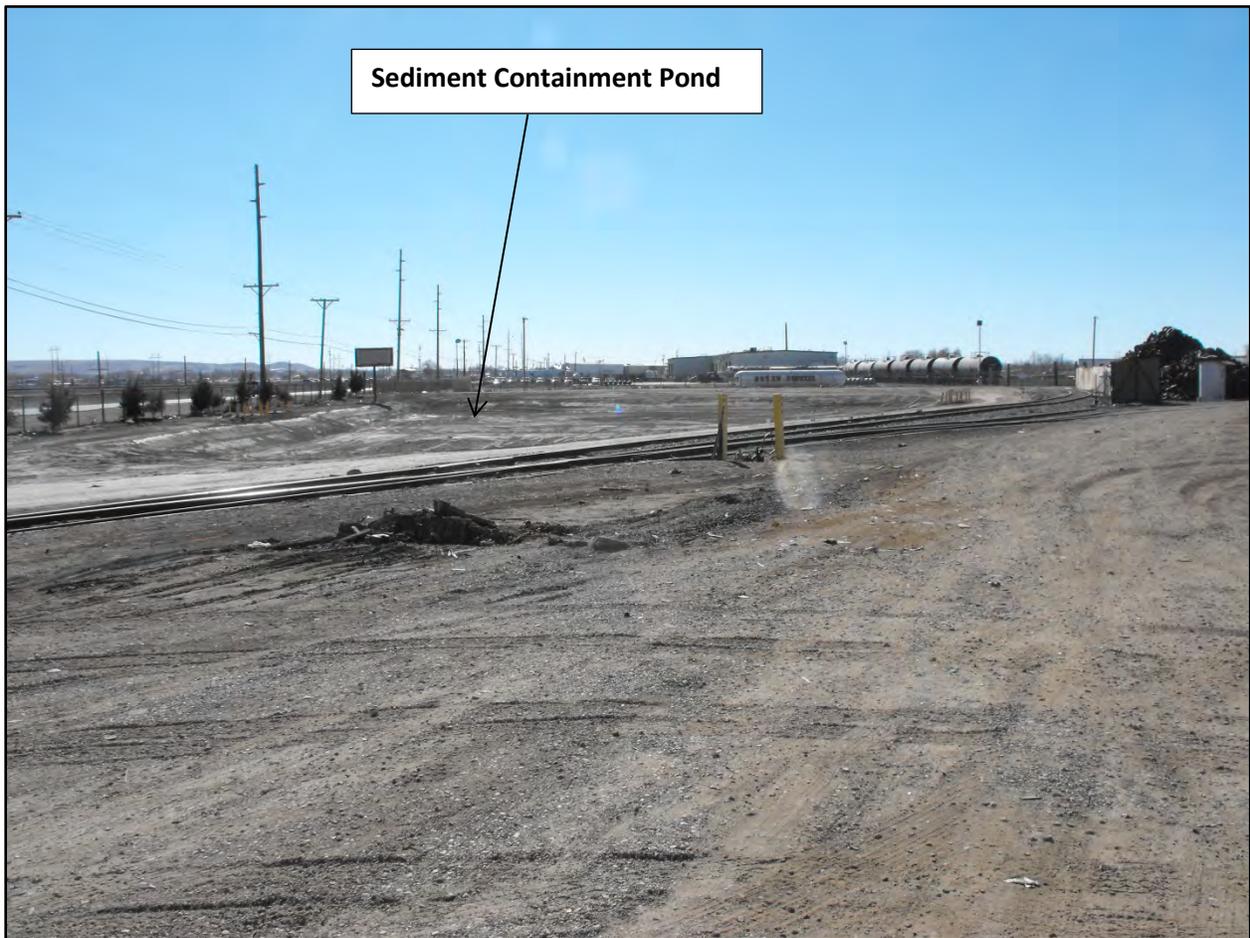
Photo # 1

Photographer: Daniel Valenta	Date: 1/16/2013	Time: 1224 hours
City/County: Albuquerque/Bernalillo		
Location: Albuquerque Metal Recycling, 3339 2 <sup>nd</sup> Street SW, Albuquerque, New Mexico, facing south.		
Subject: One of two sediment containment ponds dug at the site. Soil is stored at the west end of the site.

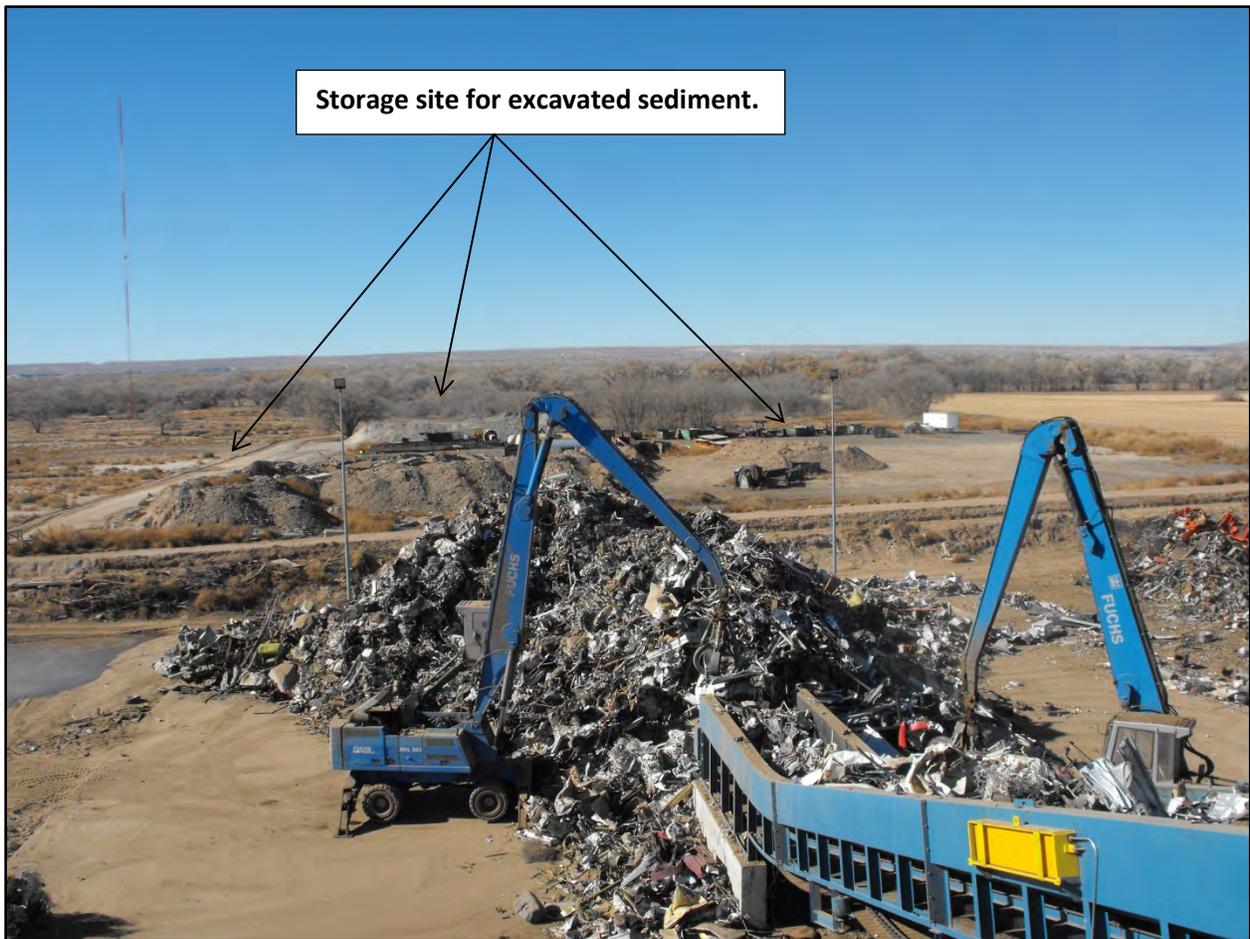
Photo # 2

Construction has been taking place to install new equipment and contour the site to allow better drainage. The grading and drainage plan is designed in connection with the installation of new ferrous and non-ferrous material shredders on the property. A new motor house adjacent to the ferrous shedder will contain the drive motor and control booth. Material excavated from the new containment ponds is being stored on a site west of the irrigation canal. As the site is cleared of material the site will be re-contoured. This material will also be stored in the area west of the facility (see photo 2). This construction project is ongoing.

The facility and contractor does not have the required coverage under the Construction General Permit (CGP) for the disturbance of one acre or more. The footprint of the disturbance includes the storage site for sediment removed in the construction of the detainment pond and the re-contouring of the facility. A recycling facility has been in operation at this site since 1960. As the top layers of sediment are removed from the site they are being stored on a property west of the site. No Best Management Practices (BMP's) have been installed to contain any run off from this area, (see photos 2-5).

Photographer: Daniel Valenta	Date: 1/16/2013	Time: 1245 hours
City/County: Albuquerque/Bernalillo		
Location: Albuquerque Metal Recycling, 3339 2 <sup>nd</sup> Street SW, Albuquerque, New Mexico, facing west.		
Subject: Storage yard on west side of facility.

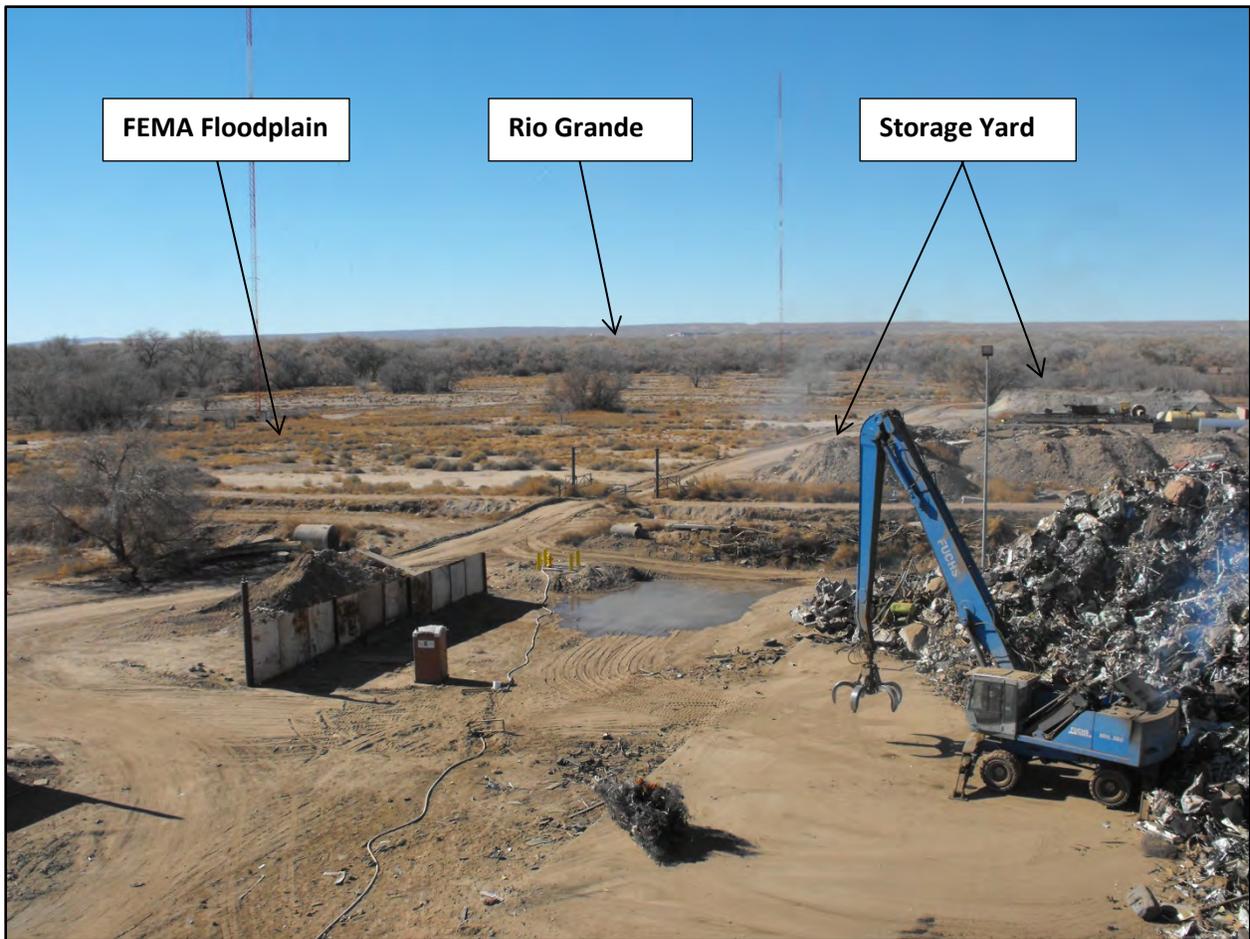
Photo # 3

Photographer: Daniel Valenta	Date: 1/16/2013	Time: 1246 hours
City/County: Albuquerque/Bernalillo		
Location: Albuquerque Metal Recycling, 3339 2 <sup>nd</sup> Street SW, Albuquerque, New Mexico, facing west.		
Subject: Storage yard on west side of facility.

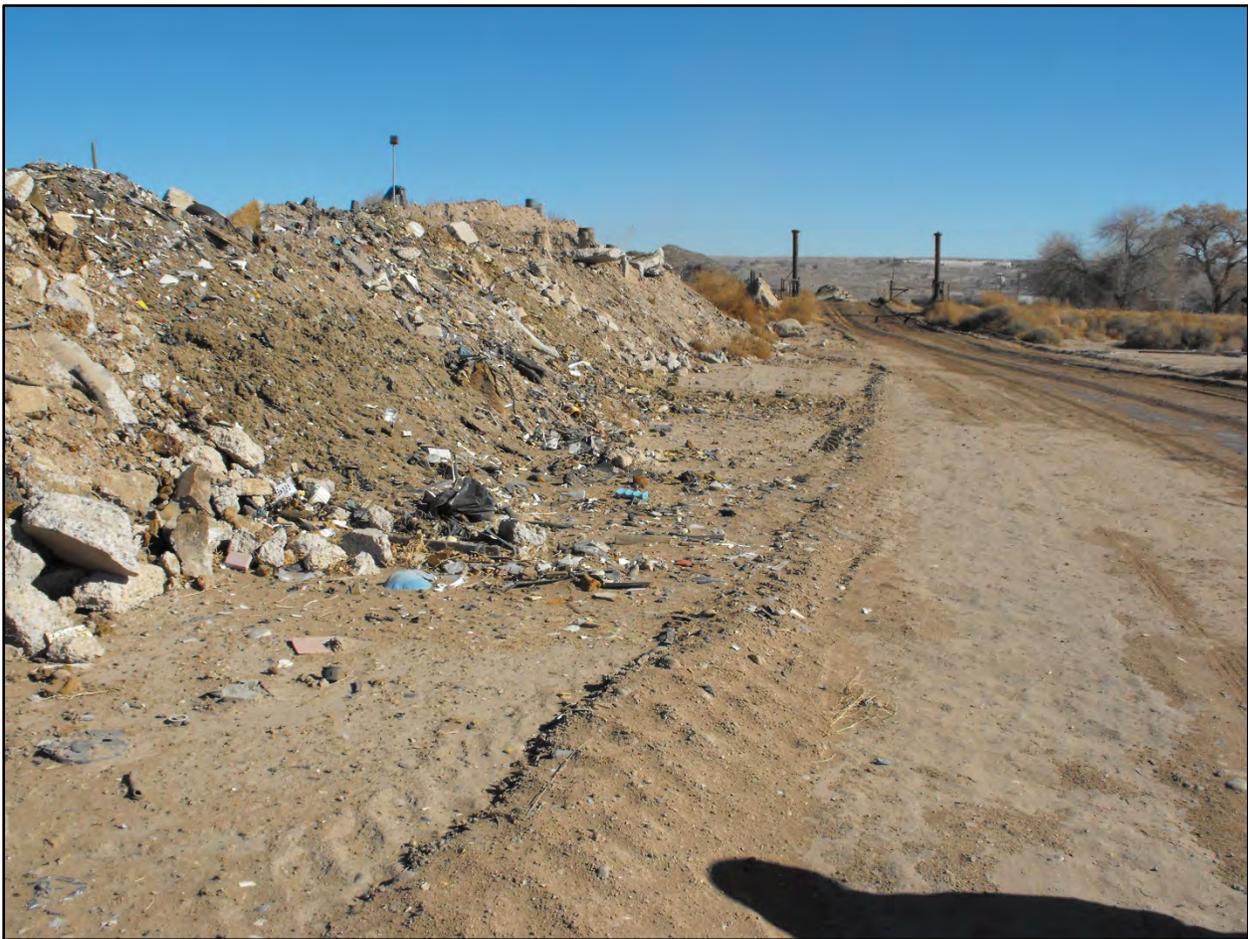
Photo # 4

Photographer: Daniel Valenta	Date: 1/16/2013	Time: 1319 hours
City/County: Albuquerque/Bernalillo		
Location: Albuquerque Metal Recycling, 3339 2 <sup>nd</sup> Street SW, Albuquerque, New Mexico, facing east.		
Subject: One of the uncontained piles of dirt stored at the west side of the facility.

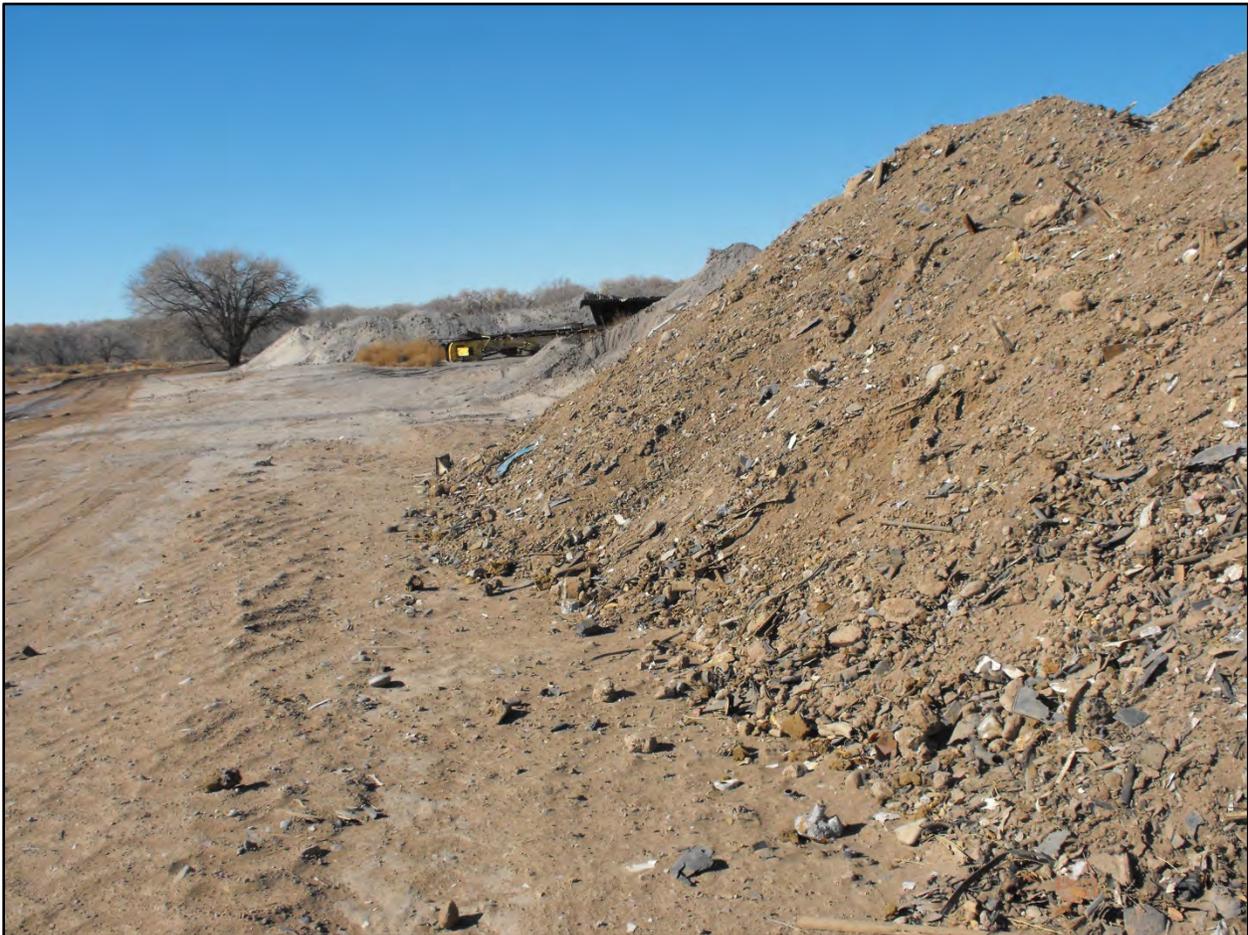
Photo # 5

Photographer: Daniel Valenta	Date: 1/16/2013	Time: 1320 hours
City/County: Albuquerque/Bernalillo		
Location: Albuquerque Metal Recycling, 3339 2 <sup>nd</sup> Street SW, Albuquerque, New Mexico, facing east.		
Subject: Pile of sediment and various materials stored on west side. When the needed equipment arrives this material will be screened and the metal removed.
