SITE ID: 3997

FACILITY ID: 27959

SUBMITTAL DATE: 25-Oct-02

CONCLUSIONS AND RECOMMENDATIONS

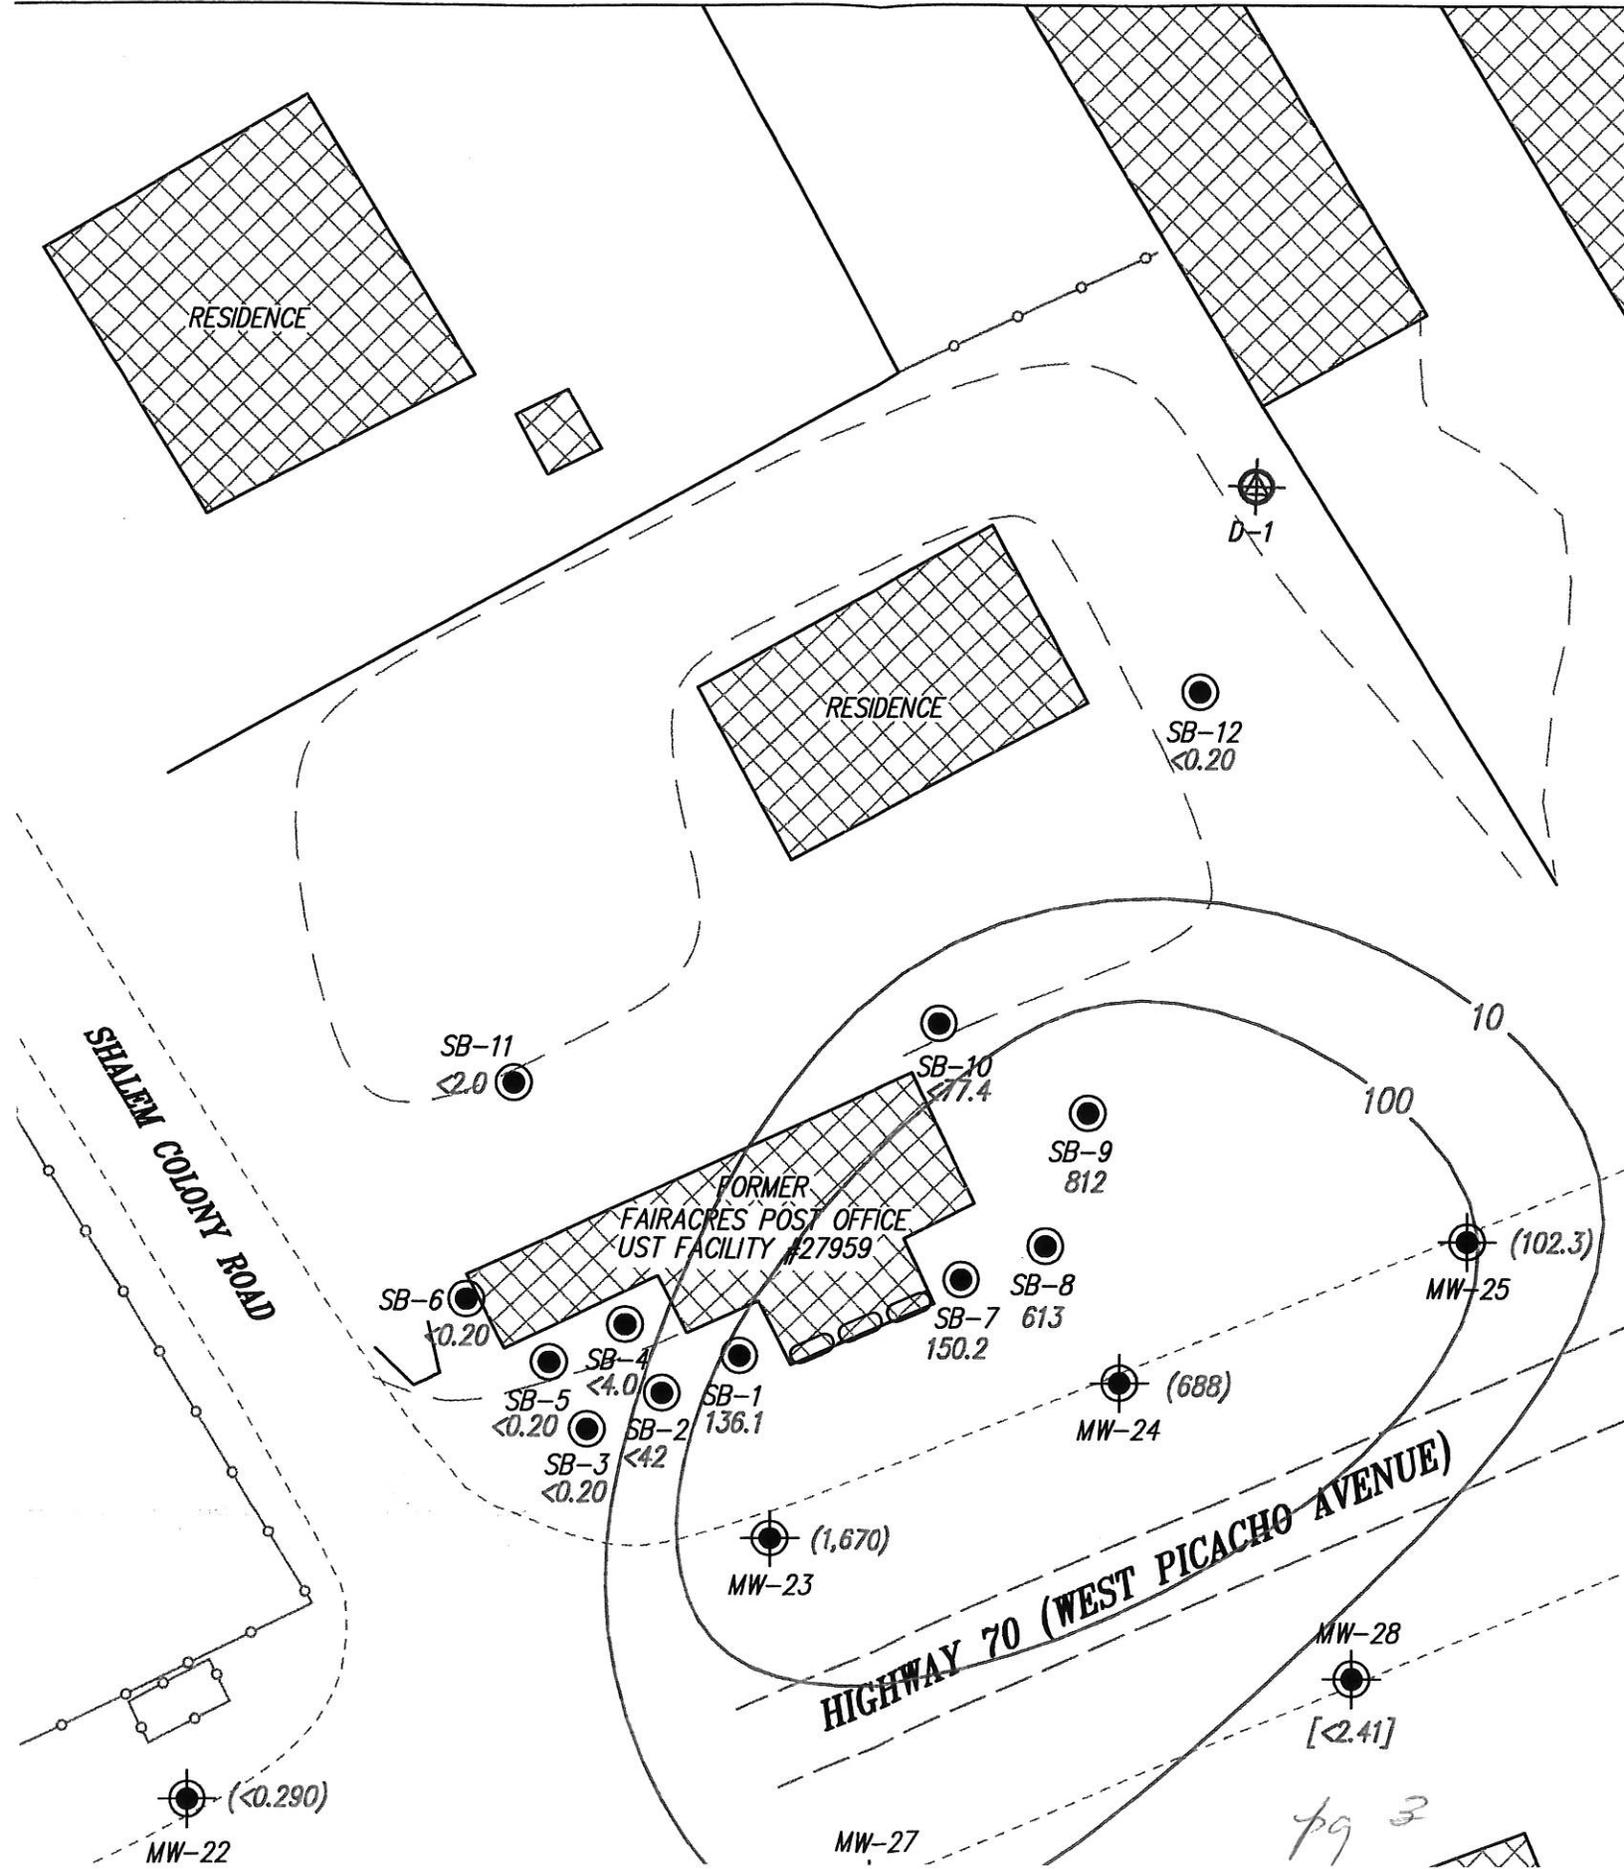
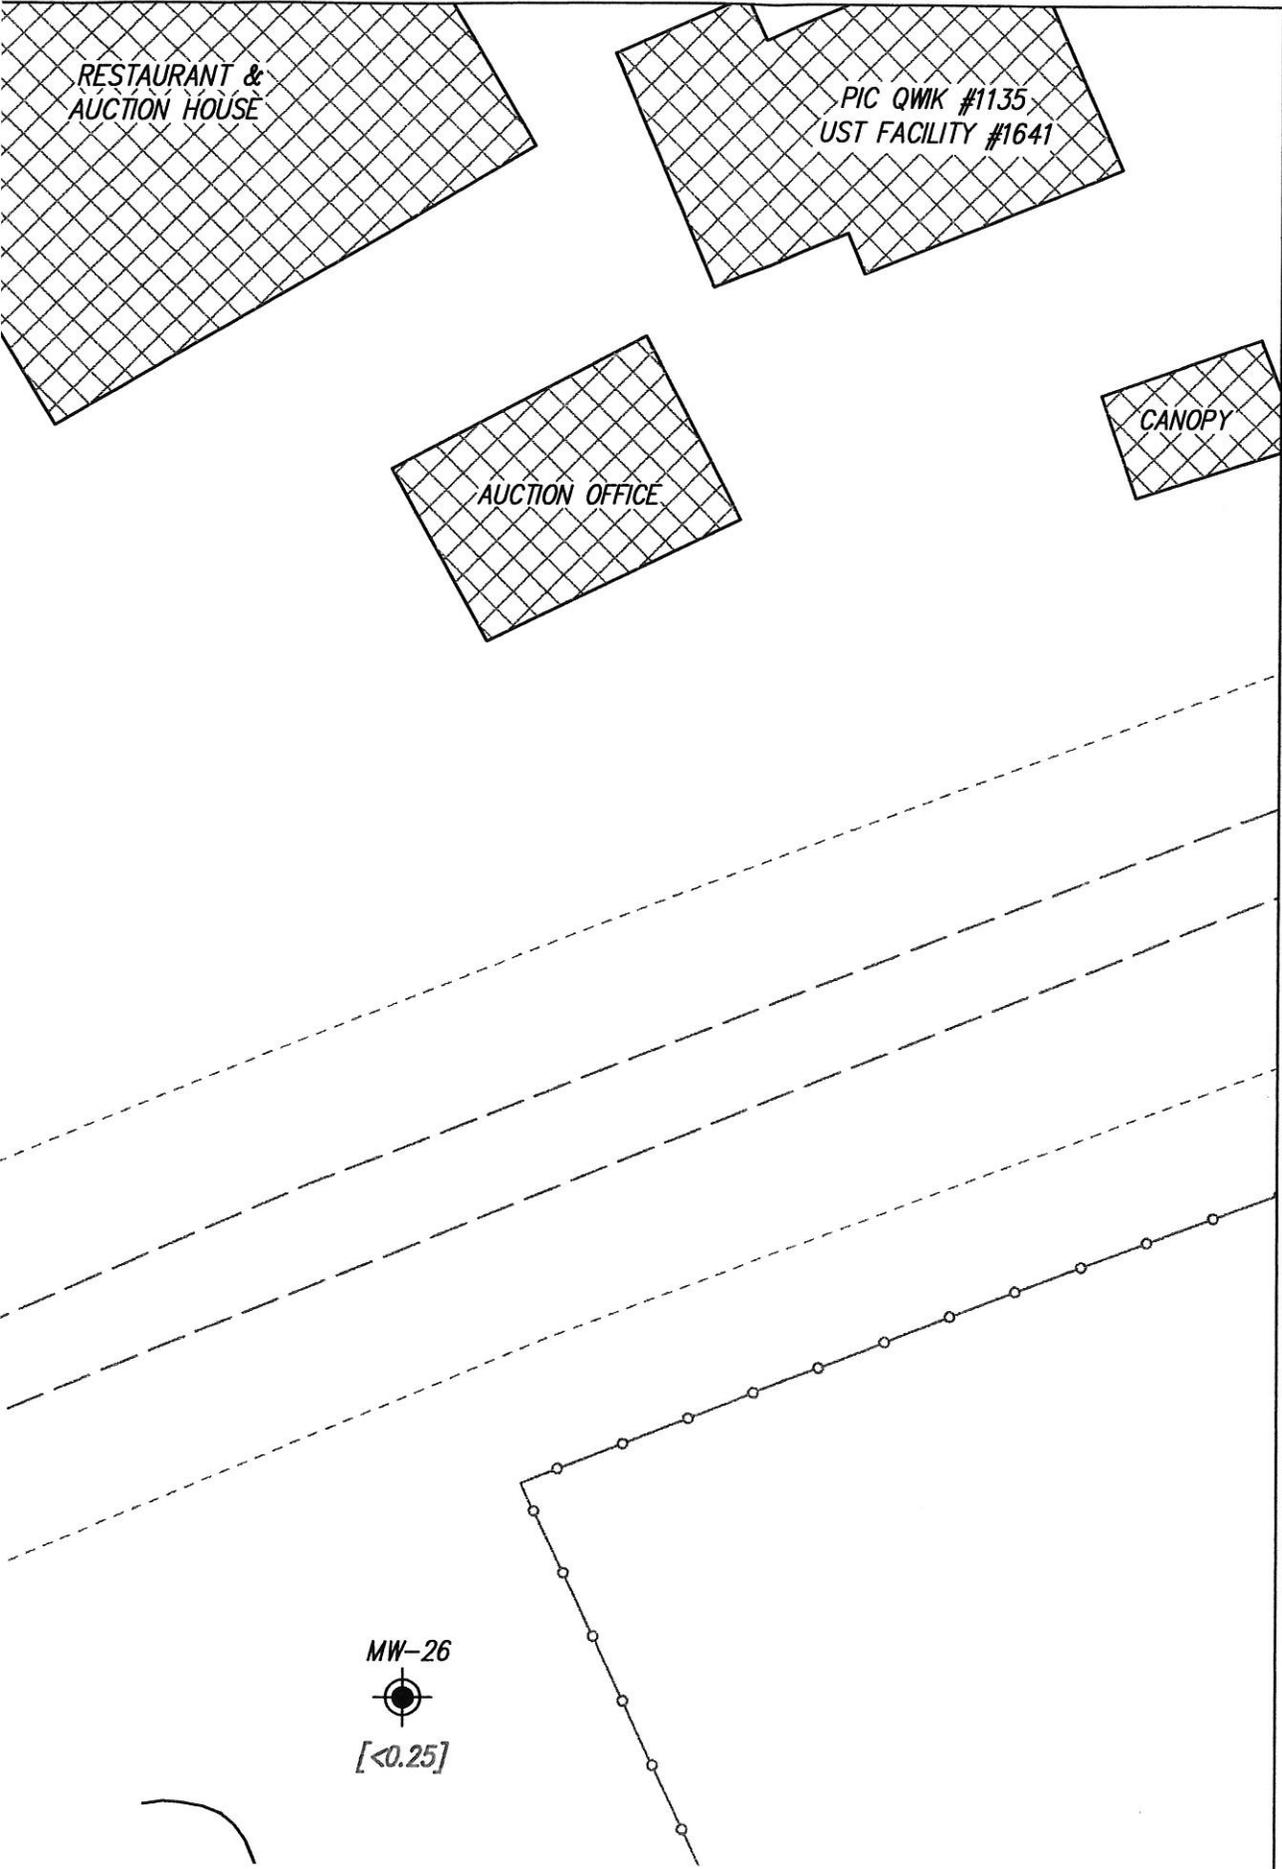
**SOIL CONTAMINANT CONCENTRATION MAP - TOTAL
FORMER FAIRACRES POST OFFICE
FAIRACRES, NEW MEXICO**

10.	<i>Other relevant information</i>
	<i>There is extensive smear zone soil contamination at the site. No near-surface soil contamination was found in the former tank pit or anywhere else. The lack of identified shallow soil contamination as well as the distribution of soil contamination at the site suggests the release point may have been the piping and/or dispensers.</i>

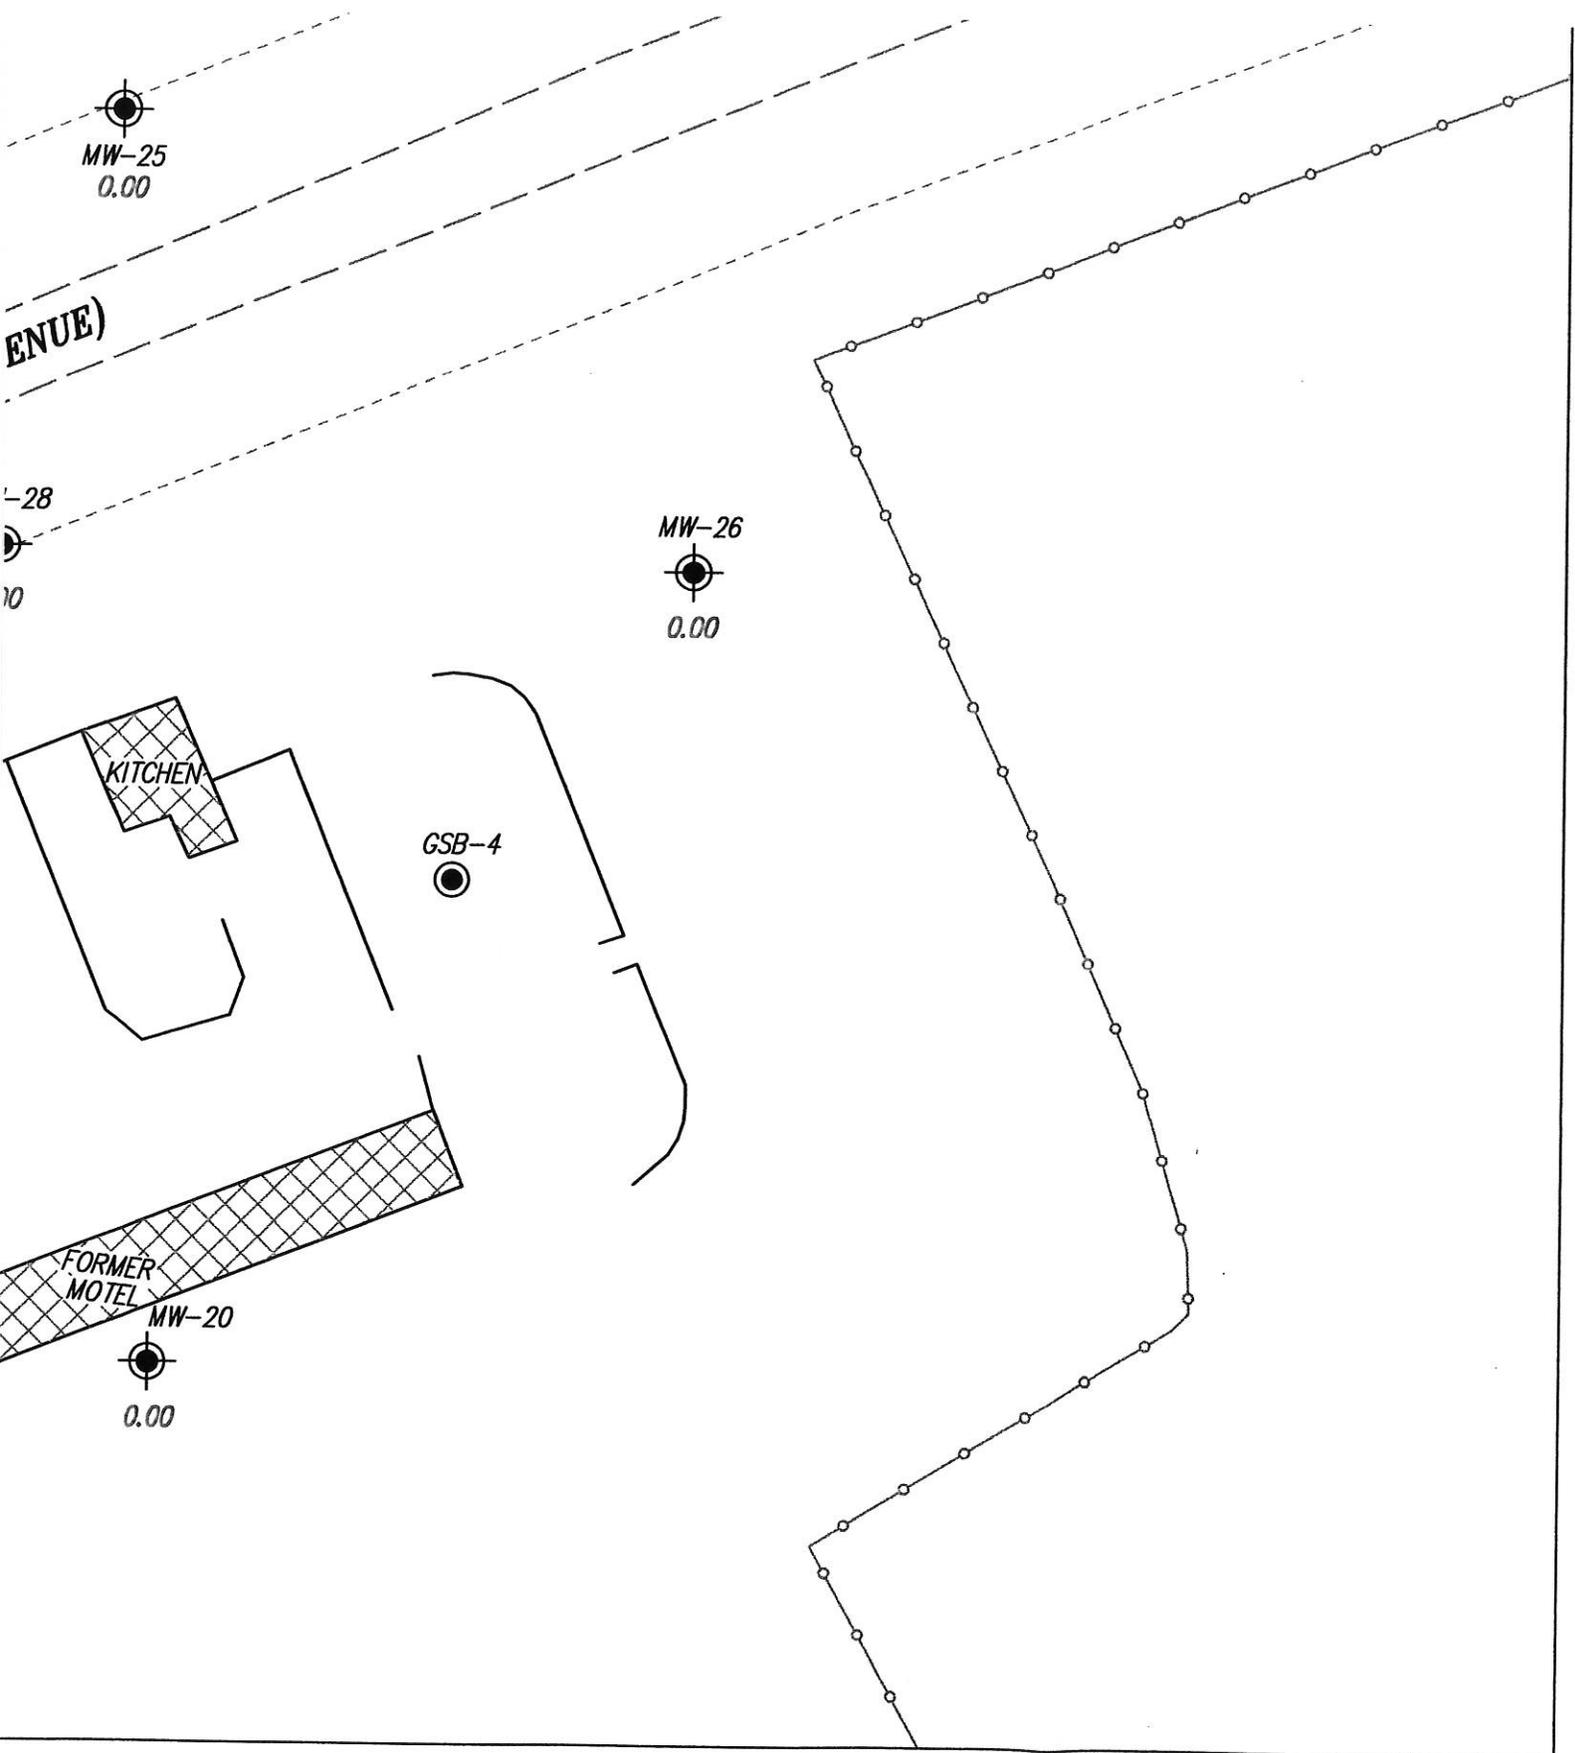
**NAPL THICKNESS CO
 FORMER FAIRACRES 1
 FAIRACRES, NEW**

NAPL has been found in monitoring wells MW-23 and MW-27. Although no NAPL recovery program is in place, NAPL has been recovered from these wells during periodic sampling events and water level measurements associated with a neighboring release site.

12.	<i>Is groundwater monitoring recommended?</i>
	<i>Groundwater monitoring is recommended following definition of the extent of the contaminant plume. In addition, NAPL recovery is recommended given the continued presence of NAPL at the site.</i>

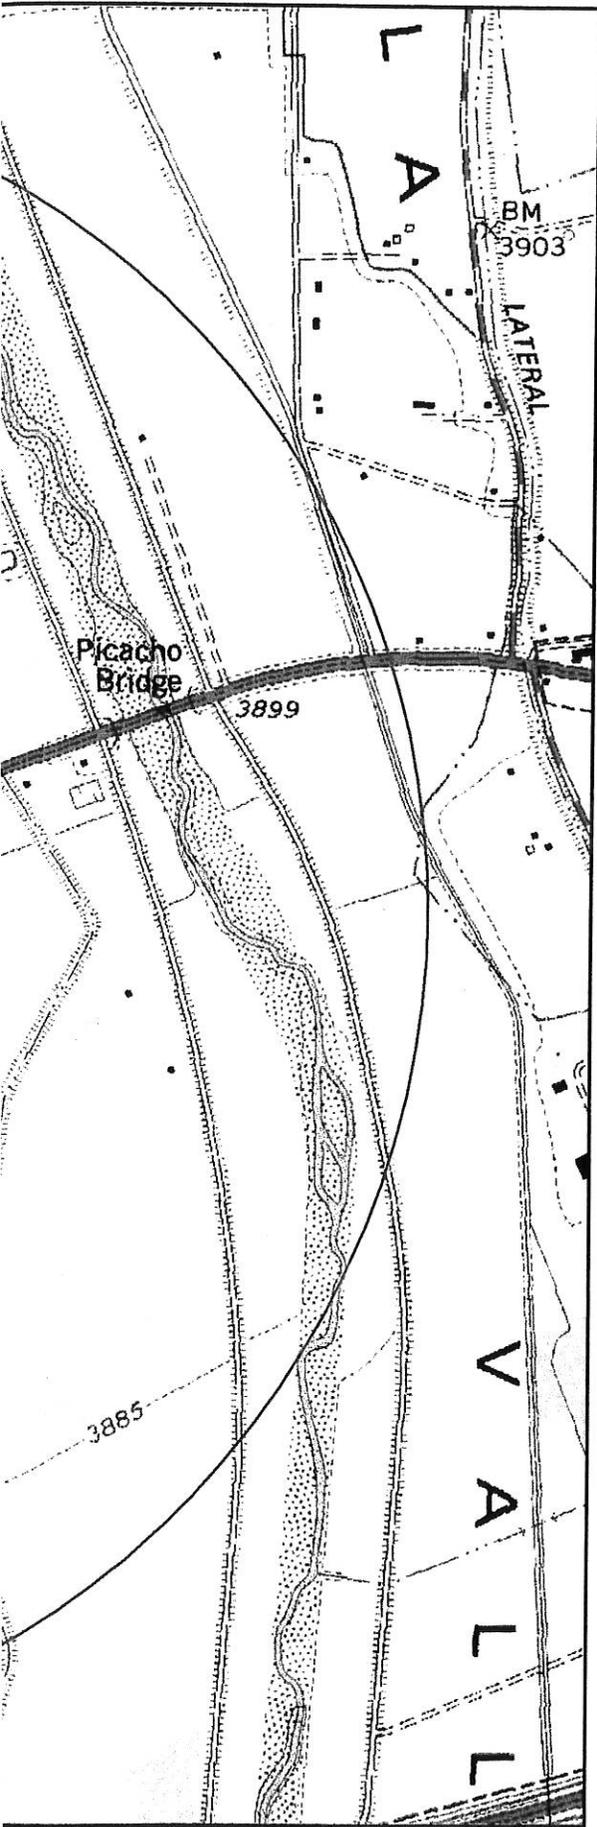
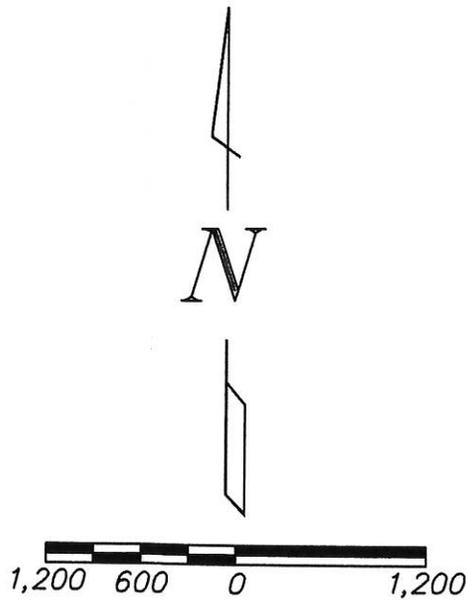
FIGURE 6

13.	<i>Comments on well search results</i>
	<i>Several supply wells are located within the 1,000 foot search radius. In addition to the wells in the NM State Engineers Office (SEO) database, SMA has identified several nearby wells not in the SEO database. The well located at the Guacamole's store is located within the dissolved phase contaminant plume and has been impacted by the contamination. This well has not contained detectable contamination during the most recent sampling events, however, the well owner has used the well less since the contamination was identified. This reduction in use of the well (and therefore drawdown) is likely the cause of the reduced impact of the well.</i>

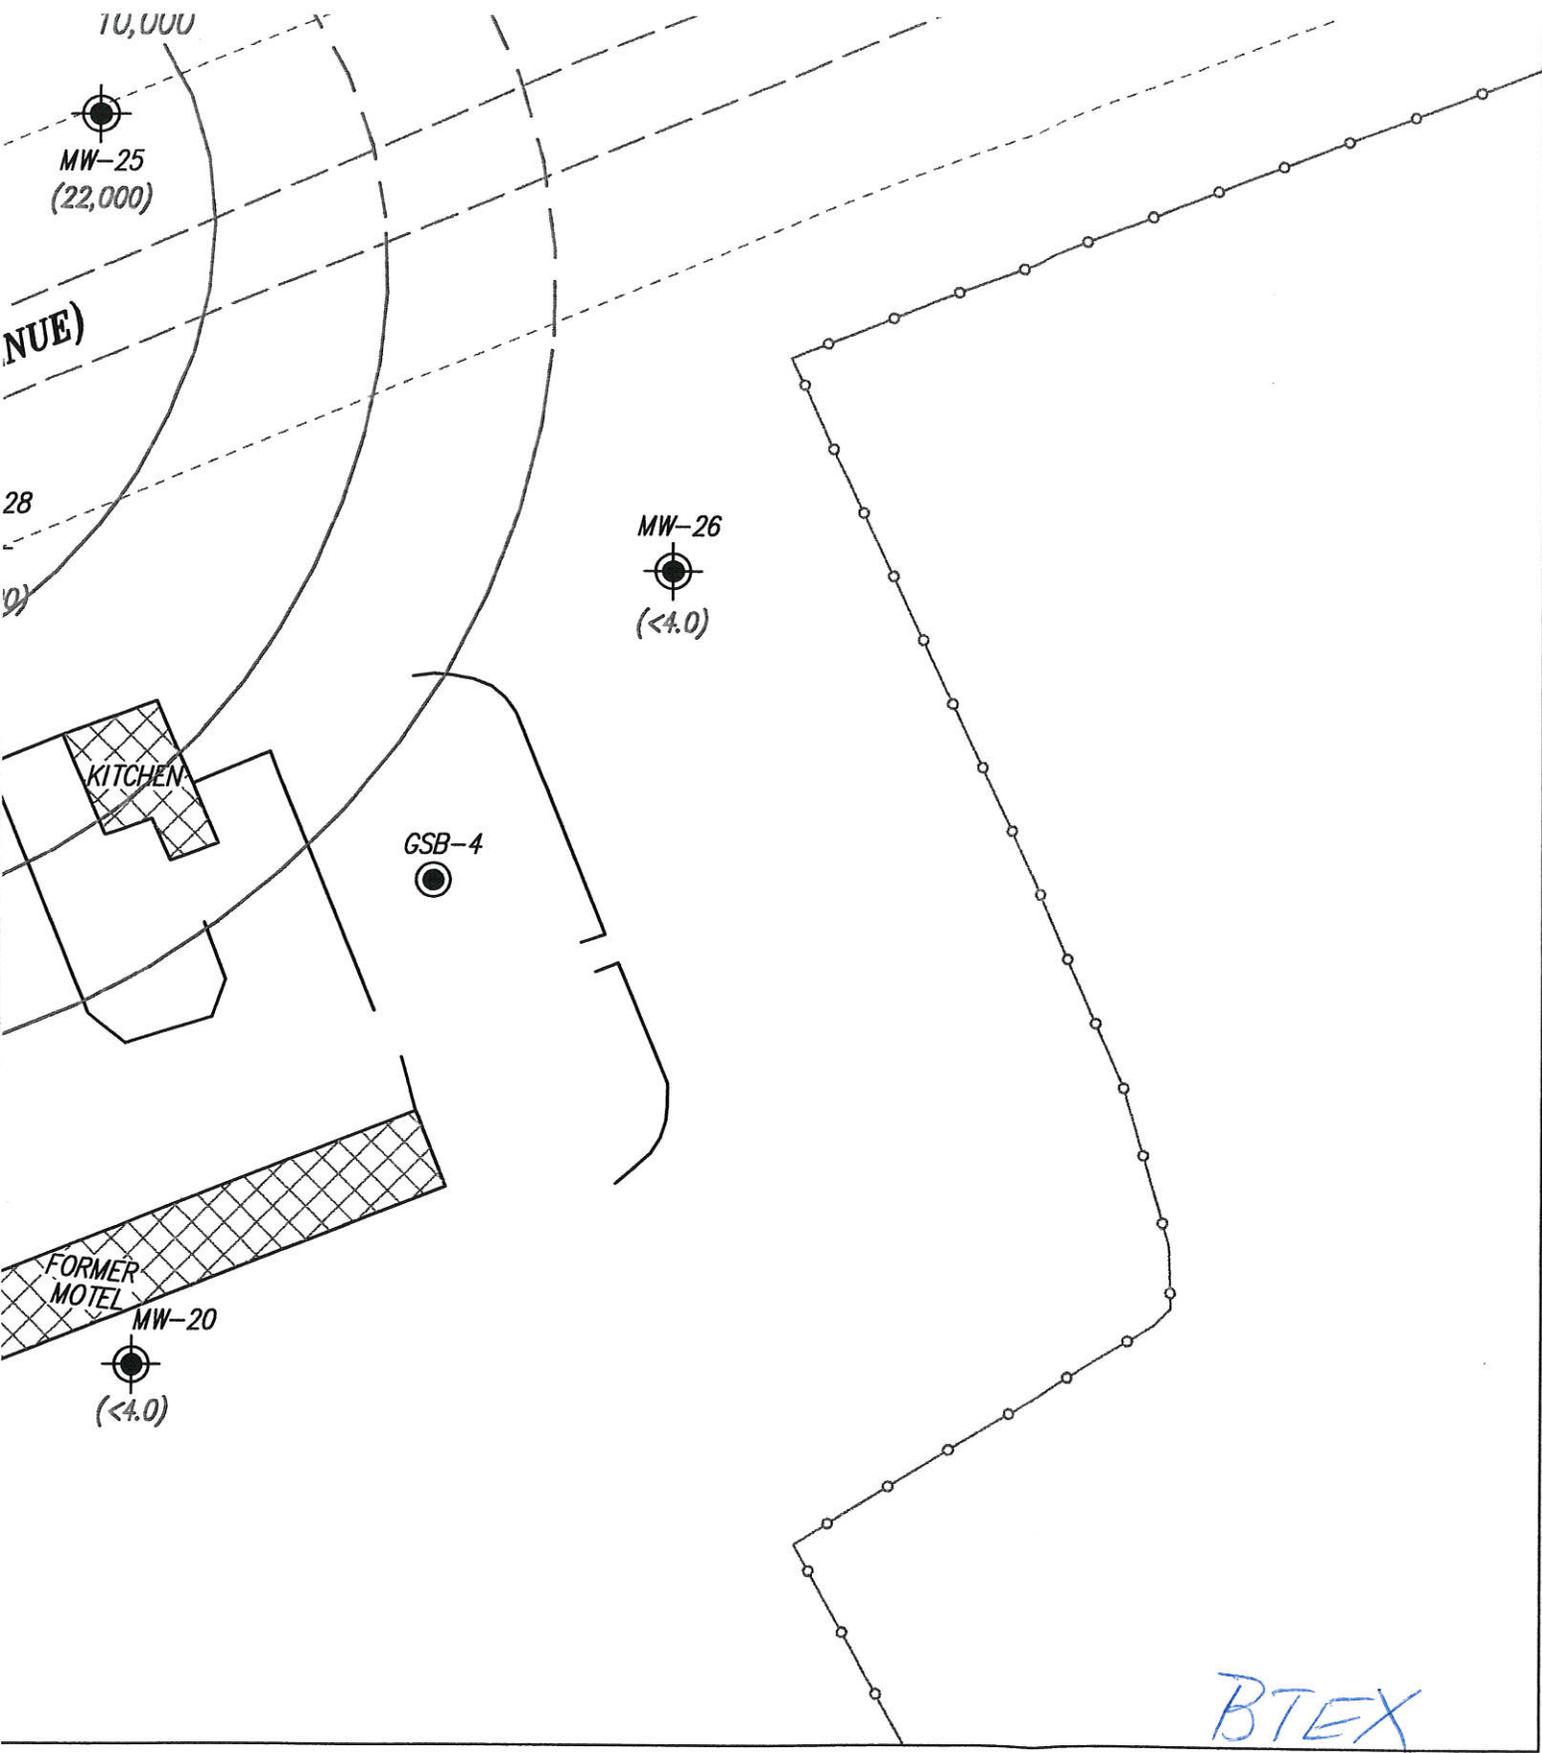
GROUNDWATER CONCENTRATIONS
 FORMER FAIRACRES HOTEL
 FAIRACRES, NEW MEXICO

No. The groundwater contaminant plume is undefined laterally to the east and is also undefined vertically. In addition, no permanent monitoring wells exist to the release area.

8.	<i>Are the groundwater contaminant concentrations in all monitoring wells below the applicable standards for the 8 consecutive quarters (4 consecutive quarters for wells with clear decreasing concentration trends)?</i>
	<i>No. Groundwater contaminant concentrations exceed New Mexico Water Quality Control Commission (NMWQCC) standards in several of the soil borings and monitoring wells.</i>
