***E. coli* and Total Coliform Sampling of Stevens Arroyo, a Tributary to the San Juan River near Kirtland, New Mexico, 2006**

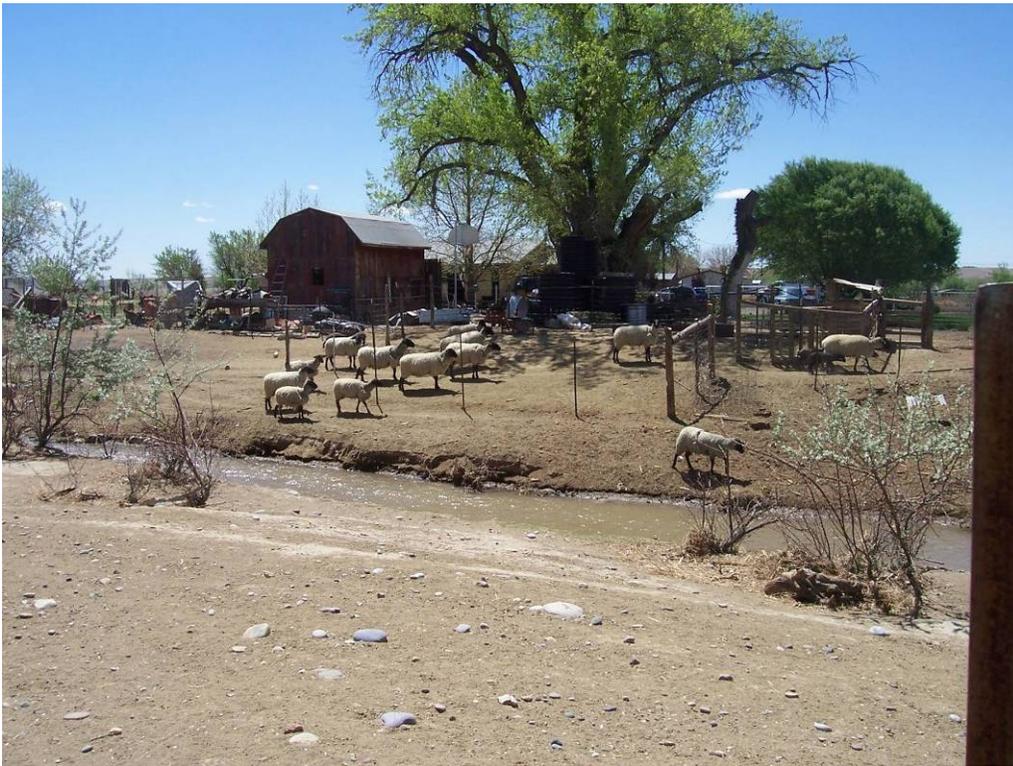
Data from May 12 and June 20, coupled with field observations, strongly suggest that the practice of keeping livestock within the riparian area contributes *E. coli* to Stevens Arroyo. This conclusion is supported by comparing data from Sites 9 and 10 (Table 2 and Table 3), between which livestock were the main potential *E. coli* source observed. The sheep in Figure 5 are the most extreme example observed, but potential livestock sources and heavily grazed riparian areas were observed in other locations as well.

Figure 5: Heavily grazed property and sheep between Sites 8 and 9.

2. With the exception of two irrigation return flows documented on June 20, and undocumented sources that may have been present on the earlier dates, even conspicuous sources like the heavily grazed reach depicted in Figure 5 and the septic inflow produced, at most, only modest increases in *E. coli* concentrations.

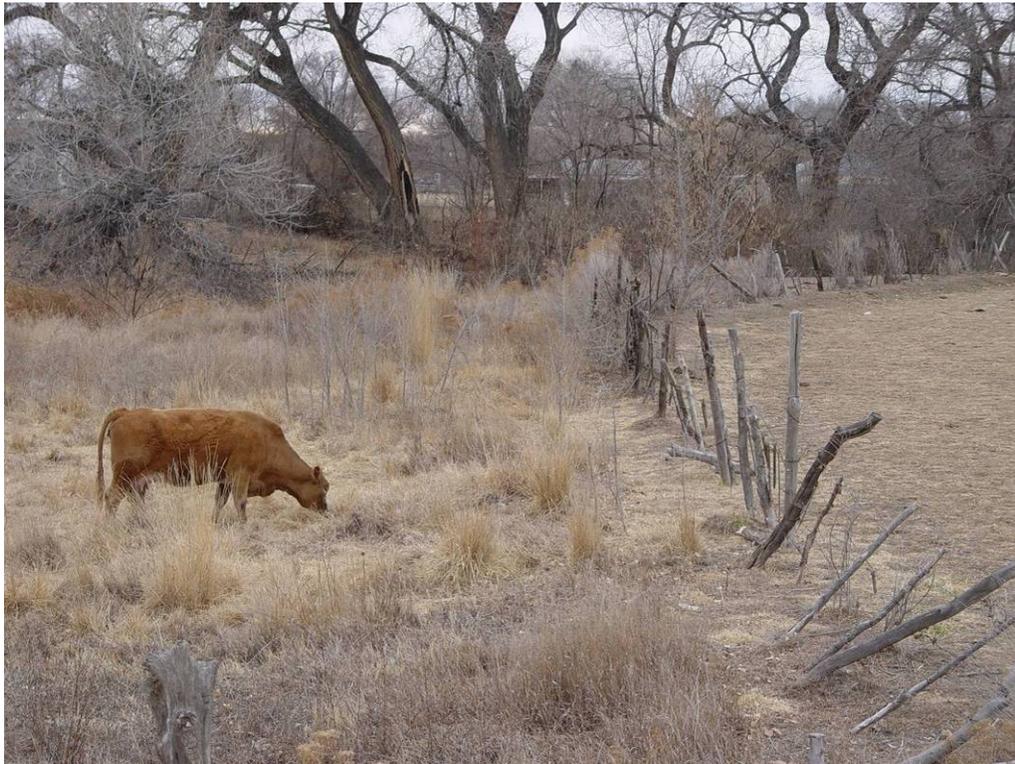
A likely mechanism of *E. coli* loading from irrigation in the Stevens Arroyo watershed is that most fields in the area serve as winter pasture, and manure from grazing livestock is thus present and potentially bears significant amounts of viable *E. coli*, which may run off to Stevens Arroyo when irrigation water is applied during the growing season. If this is the primary mechanism, then it is puzzling that *E. coli* loading from the irrigation return flow at Site 12 was evidently much lower on May 12, a full five weeks earlier in the growing season than June 20. A possible explanation is that while most fields in the area are planted in hay crops, some irrigated pasture exists which may have livestock present at times during the growing season. Factors contributing to variability in *E. coli* from irrigation return flows probably depend on the specifics of each field, and should be determined with the aid of more specialized observation and assistance from irrigators.

Figure 6: March 6 2006 photo of winter pasture with manure load (right), and cow in adjacent lightly grazed riparian area. The photo location is just west (downstream) of CR6675, on the north side of Stevens Arroyo. Stevens Arroyo flows in the background near the large cottonwoods.

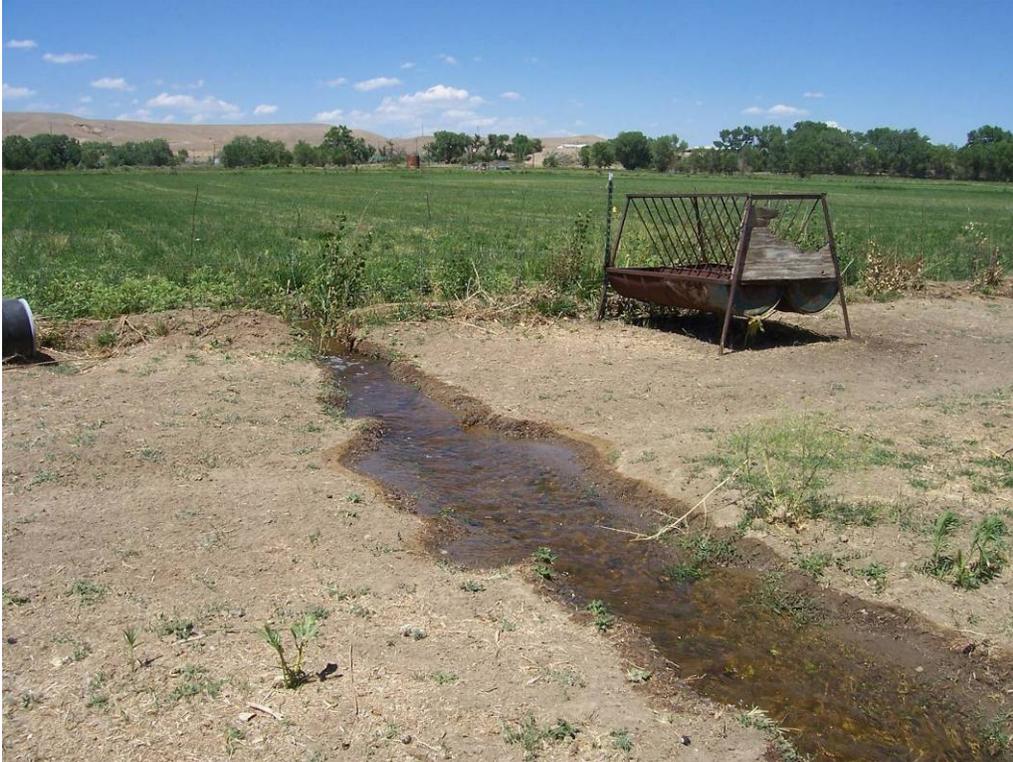
About 140 meters downstream of Site 13, Stevens Arroyo was sampled again (Site 14), just above a second irrigation return flow from the north that was not flowing on May 12. Here the *E. coli* result was back down to close to 1000 CFU/100mL. The irrigation return flow (Site 15) was found to have an *E. coli* level too high to measure without dilution (greater than 2419.6 CFU/100mL), and downstream of there all sites on Stevens Arroyo were also above this maximum measurable level. A third irrigation return flow entering Stevens Arroyo from the north (Site 20), just upstream of County Road 6675, had a relatively low *E. coli* result. The ditch uphill of its return to Stevens Arroyo was observed to be lined with deep grasses such that the water could not easily be seen flowing within. Four horses were grazing in the irrigated pasture adjacent to this ditch. Flow was measured just below this return flow, and increased almost four-fold between County Roads 6675 and 6100 (Table 4). Stevens Arroyo was inspected at one location between the two county roads where access was granted (Site 22), and no obvious *E. coli* sources were noted. Seepage was noted entering Stevens Arroyo from a cut bank at the edge of a field being irrigated south of the stream, but was insufficiently concentrated to collect a sample.

Figure 7: Irrigation return flow at Site 15, observed on June 20.
