Cimarron Watershed-Based Plan

***Prepared by
Joanne Hilton, P.G. in cooperation with
the Cimarron Watershed Alliance
and the Quivira Coalition***

December 2012

Stream Survey of Cieneguilla Creek

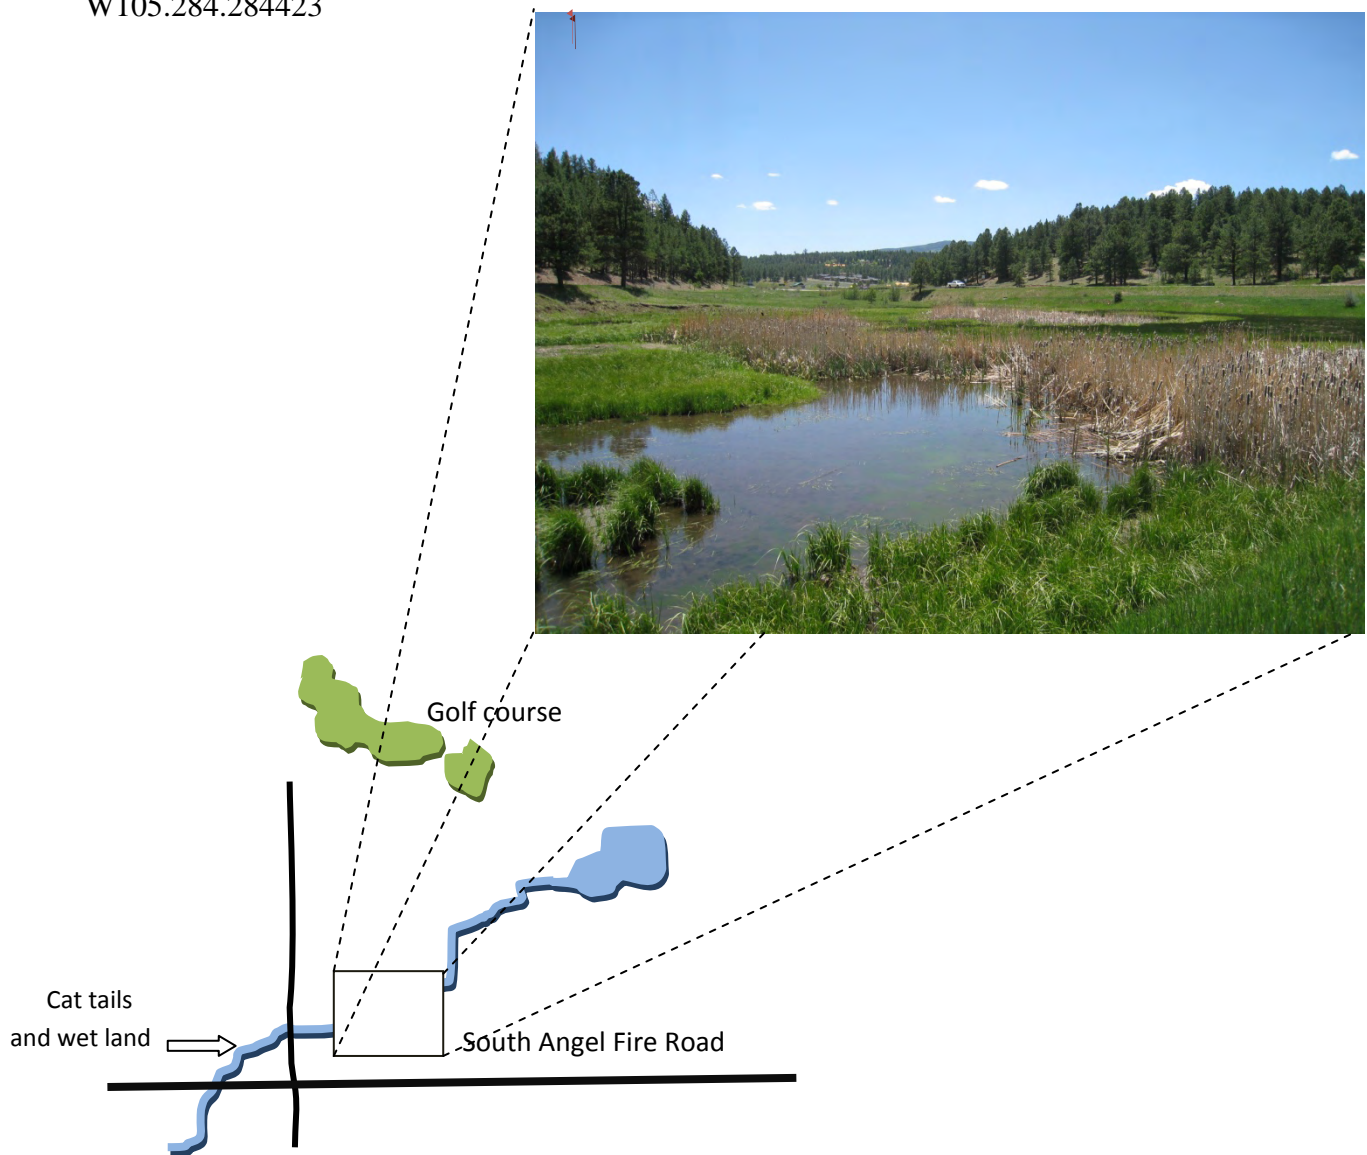
Waypoint 62 N36.38428

There are three culverts that discharge downstream of the road

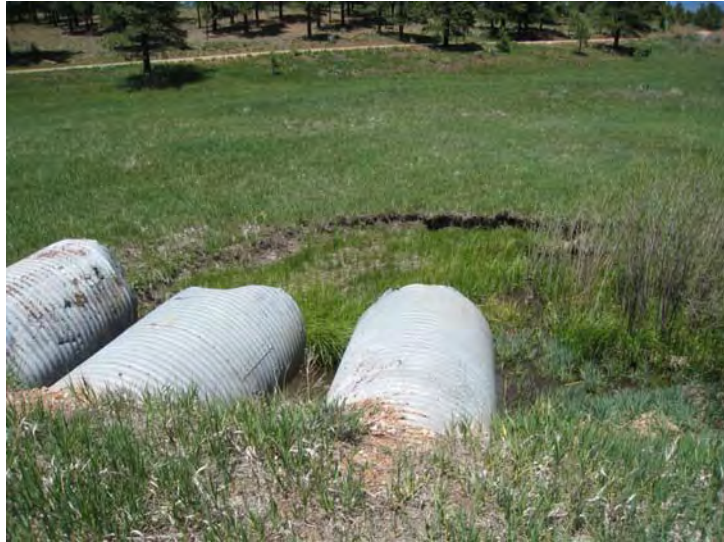
These culverts appear to contribute to stream velocity and should be evaluated for improved placement.

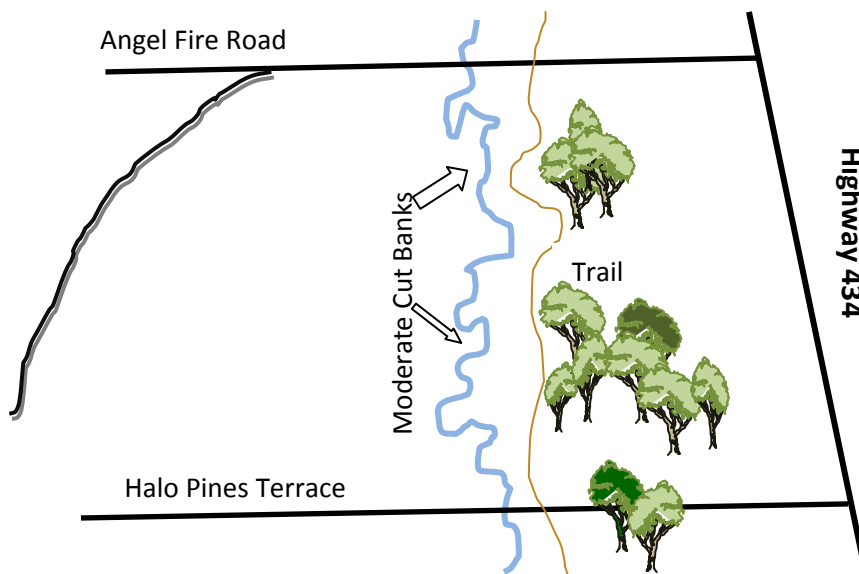
There are 1-2ft cut banks along meanders immediately below the road.

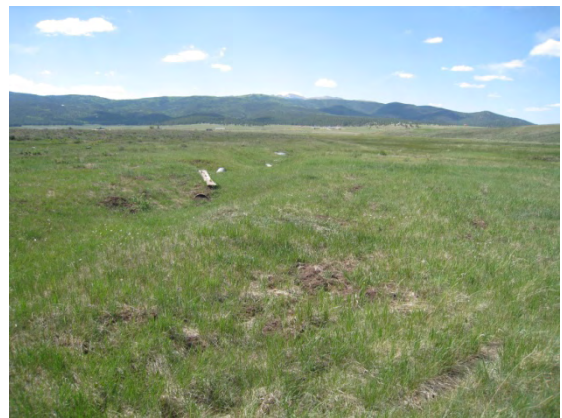
At waypoint 64, N36.42305 W10528458 there is an old road crossing that needs to be removed. The stream is cleaner and less silty with a more stable bottom. This photo shows old meander.

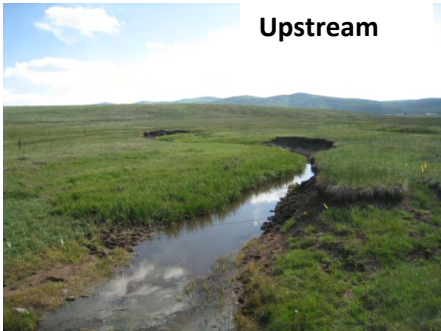
Upstream

5-30 Waypoint 65, N36.44013 W105.27456, is located downstream of the airport going toward

eagle nest on the main road; then on the 1st road to the right just past security building. There is a 3ft culvert at the road crossing.

There are extreme-moderate banks downstream and moderate banks upstream and an electric fence on both

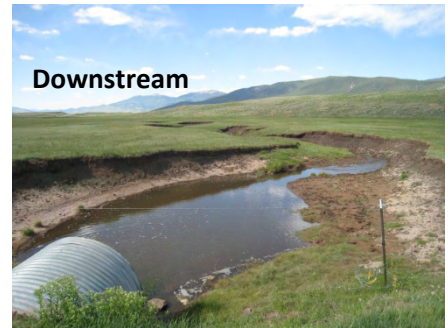
Downstream

sides of the road.

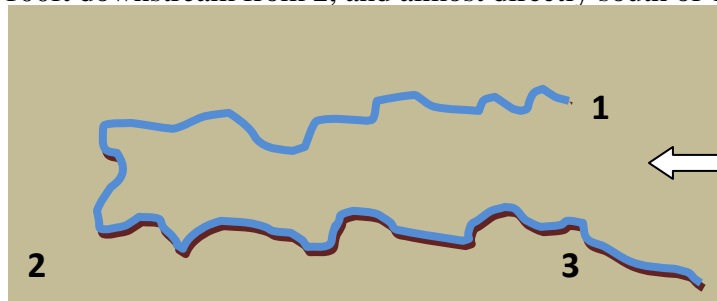
1. 100ft downstream of the road there were culverts. It scored a 24 on BEHI and a moderate on the NBS. Some moderate BEHI banks between points 1 and 2
2. 200ft downstream. Some moderates between 2 and 3
3. 100ft downstream from 2, and almost directly south of 1

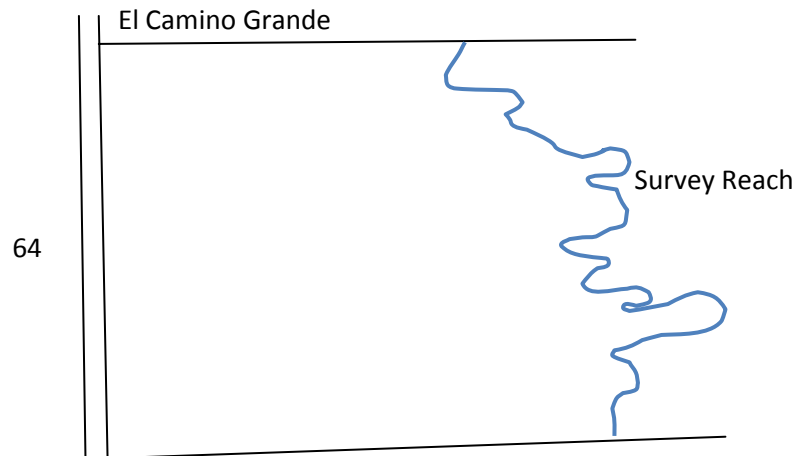
Potential for eventual down cut channel between 1 and 3

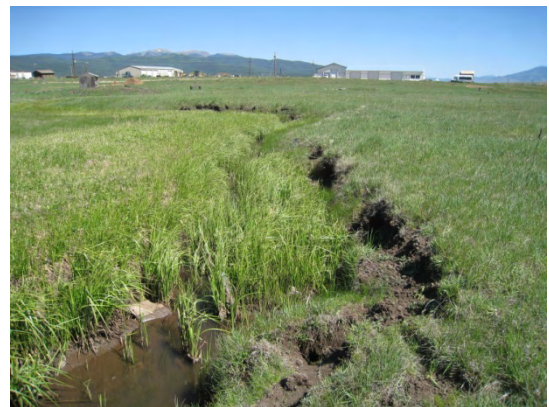
4. There is a large pond with a very silty stream bottom located 50ft downstream of Halo Pines Terrace road crossing/culvert. There is a lot of trash in the stream, and another moderate bank 340ft downstream of the road. All along the stream there is tall grass sometimes growing in the stream slowing down the current. 130ft farther downstream there is a fence going across the stream. 34ft downstream of the fence there is a moderate bank and grass in the stream. 3 inch and smaller fish were observed 30ft farther downstream there is another moderate bank with a grass bench below.

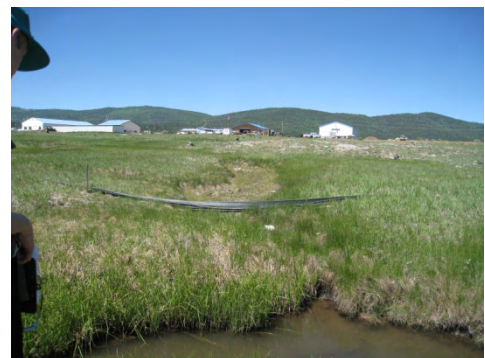
7. Another 230ft downstream there is a small silt fence below an industrial site, located about 500ft away from the stream. There was a small gray rat observed. There are moderate BEHI banks throughout this reach. 230 feet beyond the fence there is a moderate bank with a bench below. 90 feet past that there is a silt fence coming in to the stream.

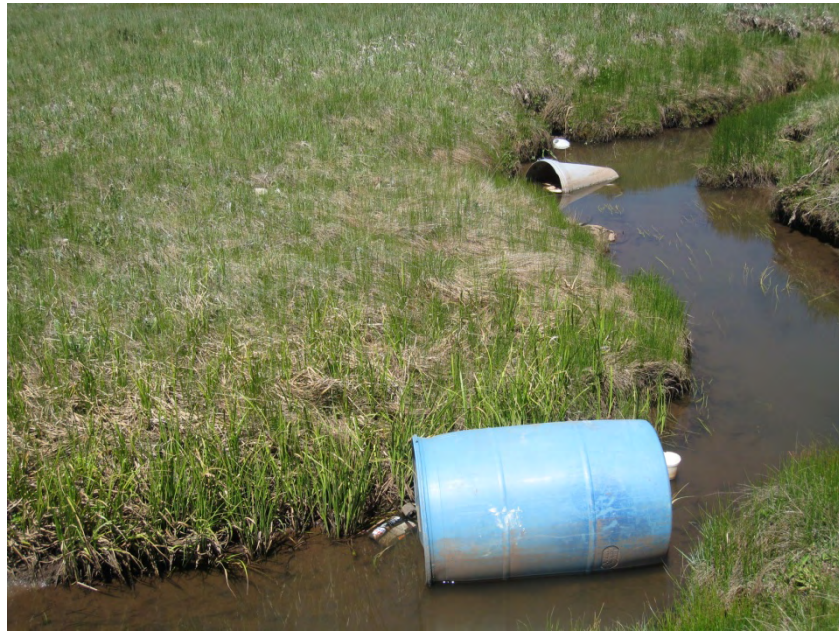
90ft farther downstream there is a blue drum and garbage in the stream.

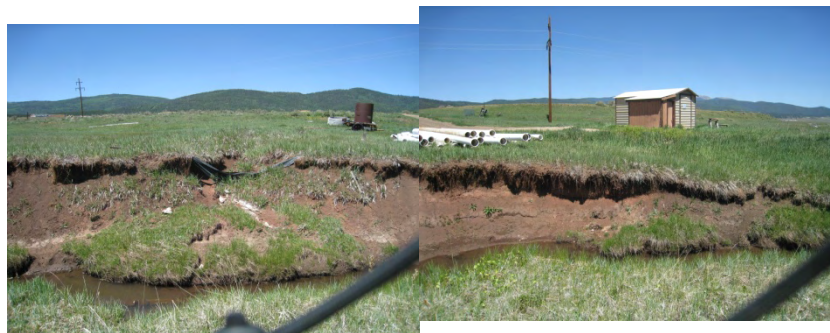
8. Located at N36.40395 and W105.28350 there is 80ft of exposed bank with a BEHI of high to very high. There is a drainage coming in close to the road.

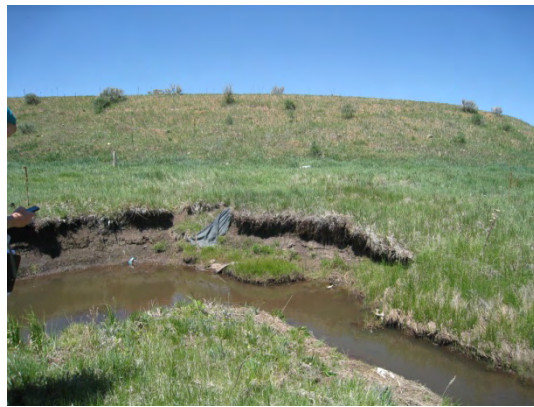
600ft farther down there is a high BEHI bank.

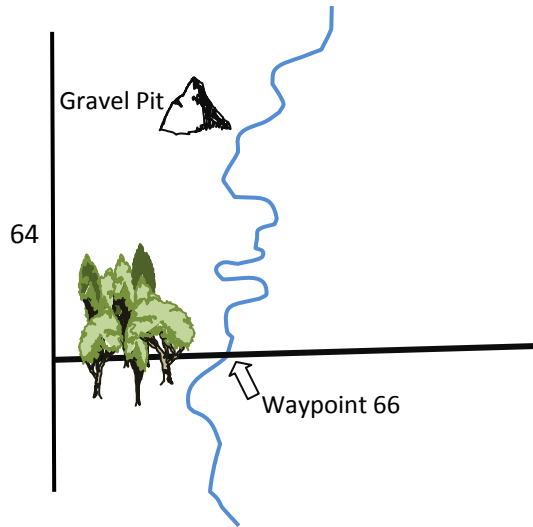
5-30 The next road south is where Waypoint 66 is located, N36.45467 W105.27107. There are many cattle trails and moderate banks in this reach.

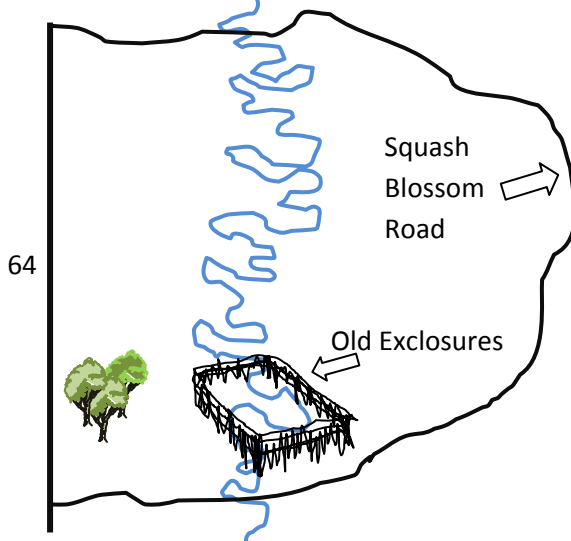
5-30 Waypoint 67. N36.47556 W105.26476, is located on the crossing at Squash Blossom Road. There are three culverts crossing Squash Blossom Road. There is a 50ft long 4.5ft high bank outside meander bend.

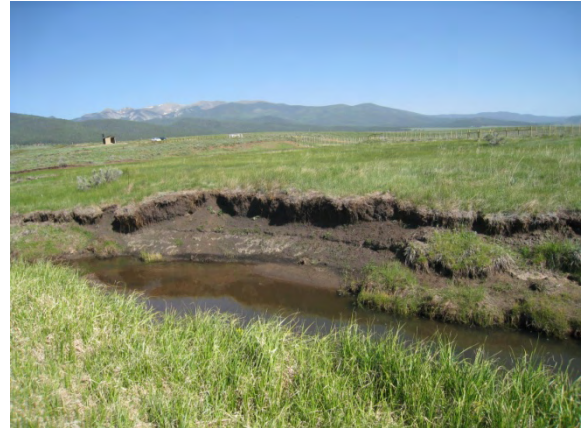
5-31 Waypoint 68, N36.47555 W105.26464, is located off of the first road south of Eagle Nest Lake. Along the Cieneguilla there are a series of exclosures. Upstream there is a fence that has a no trespassing sign. It is south 300ft downstream of the gauging station. The stream is very silty with extreme meanders. Most of the banks are very high to moderate BEHI in both the upstream and downstream direction.

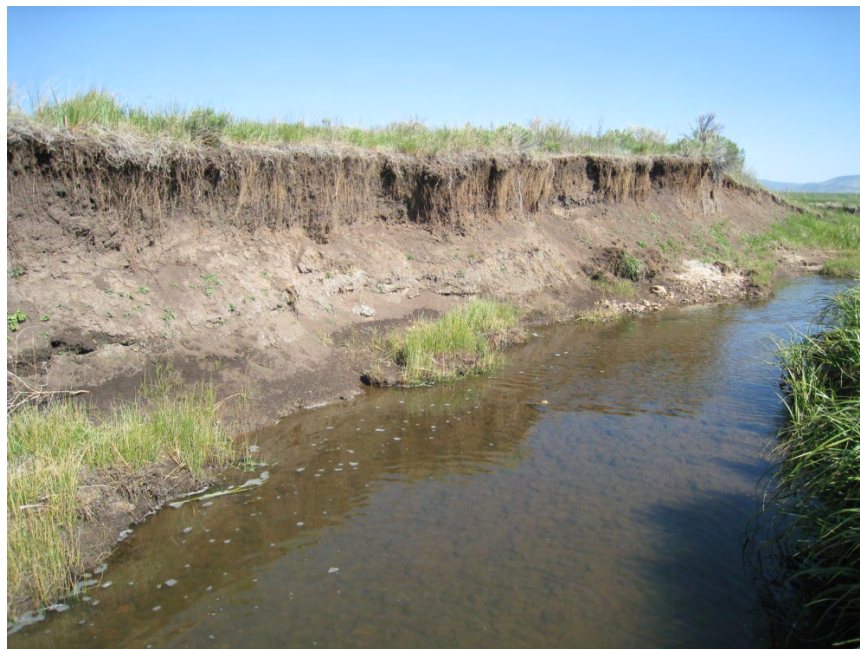
5-31 At Waypoint 69, N36.48659 W105.28814, there is a 100ft long 6ft high bank just North East of the parking lot at the end of the road. That bank has a BEHI of 41: very high erosion potential. 150ft downstream on the Cieneguilla there is a bank with high BEHI, about 100ft long, directly east of the restroom and it borders the exclusion fence.

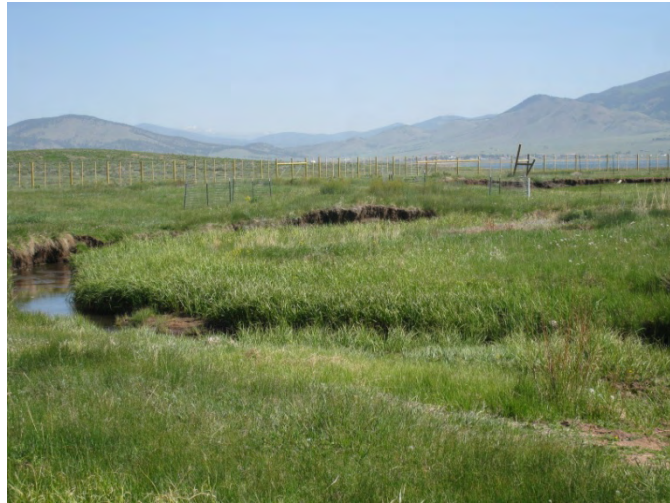
Looking downstream into the exclosure, there are moderate cut banks with some smaller fencing inside as well as small recently planted vegetation.

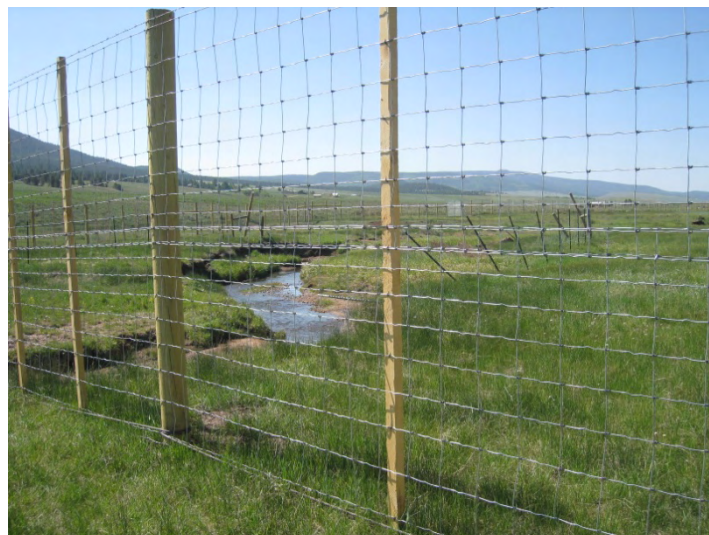
It is possible to walk into the exclosure from the north end. Downstream toward Eagle Nest Lake there are moderate to high banks.

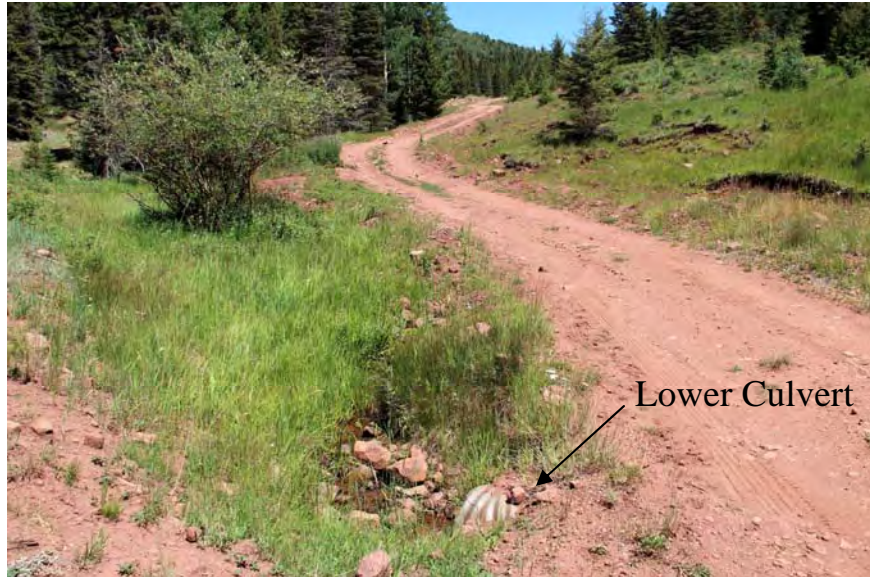
The existing road system crosses West Agua Fria Creek from the north side of the creek over to the south side along the 245 KV powerline right of way and runs east crossing over the creek again and then turns north. Both creek crossings currently have culverts in them. This section of road is approximately 1,600 feet in length.

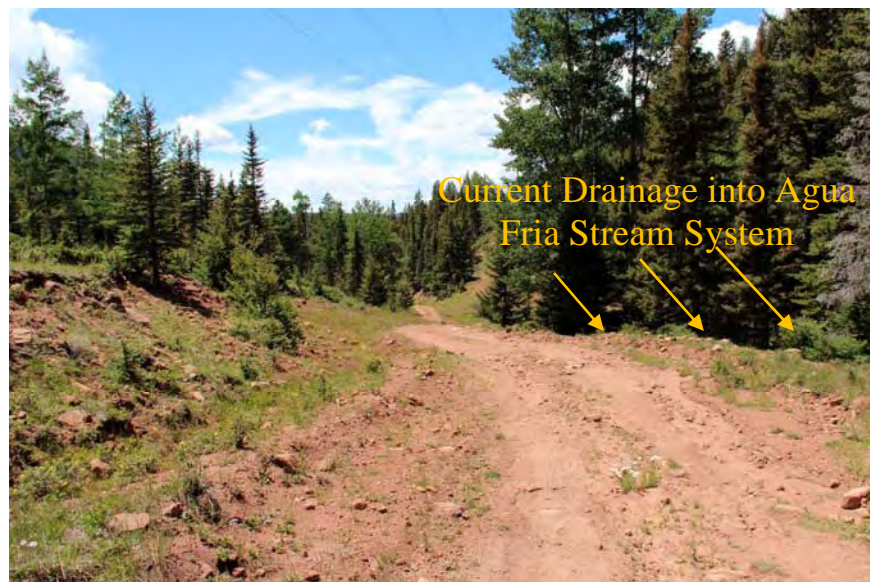
The west section of this road, +/- 750 feet is at a slope of +/- 12% currently drains directly into the creek. The east end of the road, +/- 750 feet also drains directly into the creek at the location of the upper culvert. The soils in this area are fine red clay. This road could be cross drained, however; it is very close to the creek and there are limited buffer areas to filter the runoff water before it enters the stream system.

The proposal to stop the direct sediment contribution into West Agua Fria Creek is to close and drain this section of road and reopen an existing road that is on the north side of the creek.
