GALLINAS WATERSHED THINNING MONITORING Final Report

Prepared by
Surface Water Quality Bureau
New Mexico Environment Department
June 2010

Gallinas Watershed Monitoring Project 2007 - 2009

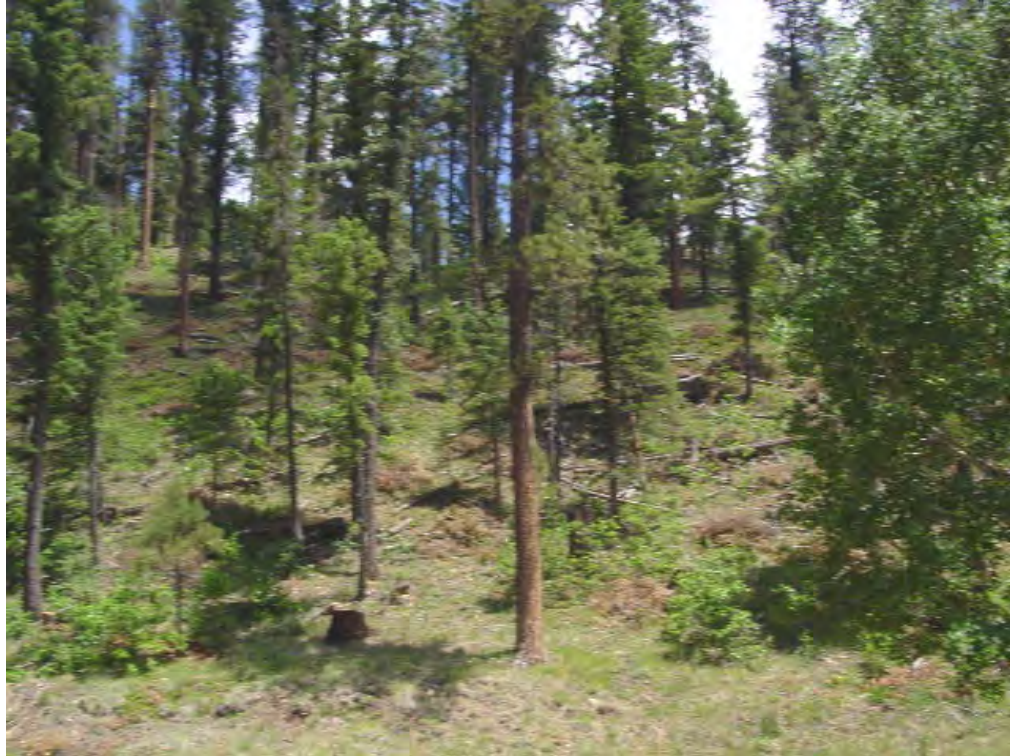
Photo 1. Thinned ponderosa forest above the Gallinas River.

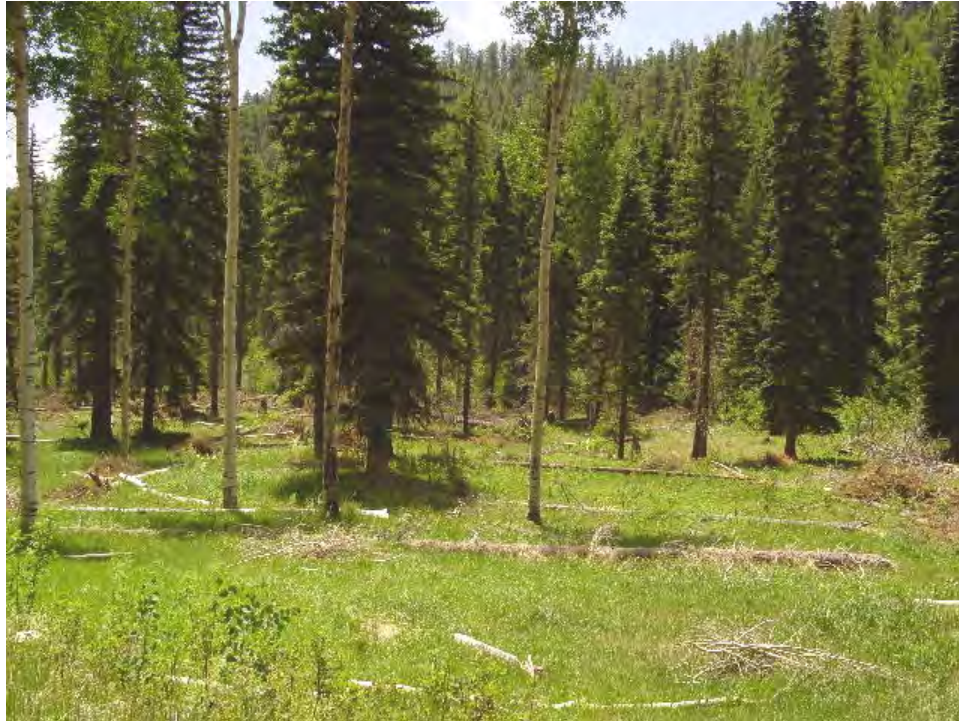
Photo 2. Thinning adjacent to the riparian. A number of spruce trees in this area have apparently drowned, possibly due to rising ground water from downstream beaver activity.

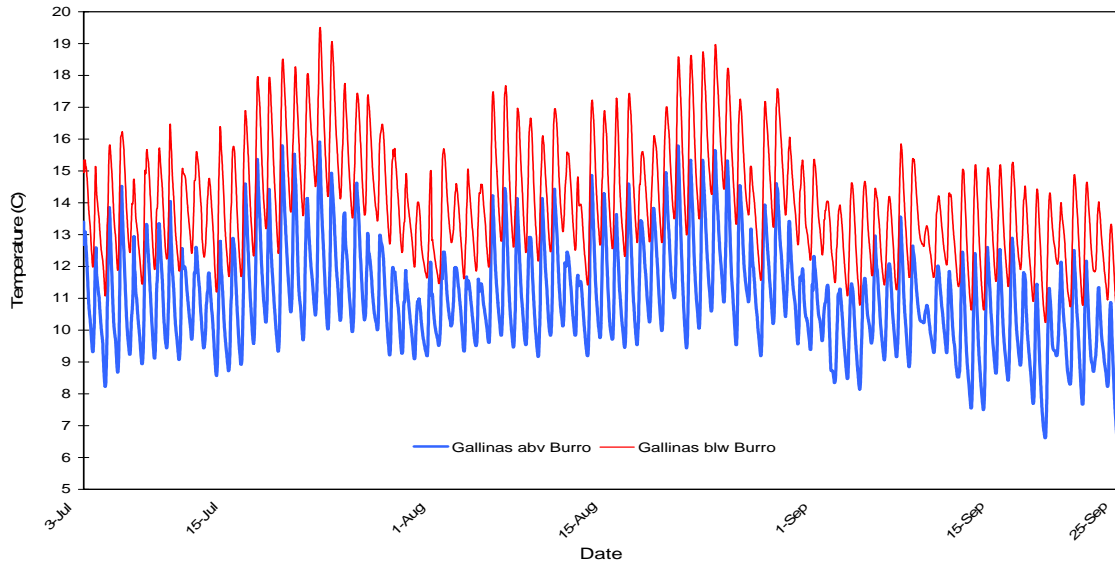
While neither station Gallinas River at end of Forest Road 263 or Gallinas River below Burro Creek exceeded the HQCWAL temperature criterion of 20° C, a noticeable and consistent increase in temperature was observed below Burro Creek (**Figure 3**). These stations are only 1.5 miles apart. This increase was 2.10° C or 14.75% of the average temperature and 3.59° C or 22.60% of the maximum temperature). This increase in temperature is, probably, due to the fact that Burro Creek and the Gallinas River above their confluence both pass through a series of small, shallow impoundments (including those related to a beaver colony on the Gallinas) where long retention times and a lack of shade allows for increased solar heating. The diurnal swing in water temperature from coldest (early morning) to warmest (mid afternoon) at the two stations demonstrates the sensitivity of streams to inputs of solar energy. Excessive thinning of riparian areas could trigger temperature exceedences that would impair the aquatic life use. Re-establishment of woody riparian vegetation in areas where it has been removed and implementation of measures to lower the width / depth ratio, narrowing and deepening the channel, would improve the temperature regime in both watersheds.

Figure 3. Comparison of water temperature in the Gallinas River above and below Burro Creek.
