Lee Ranch Mine Use Attainability Analysis

May 2018

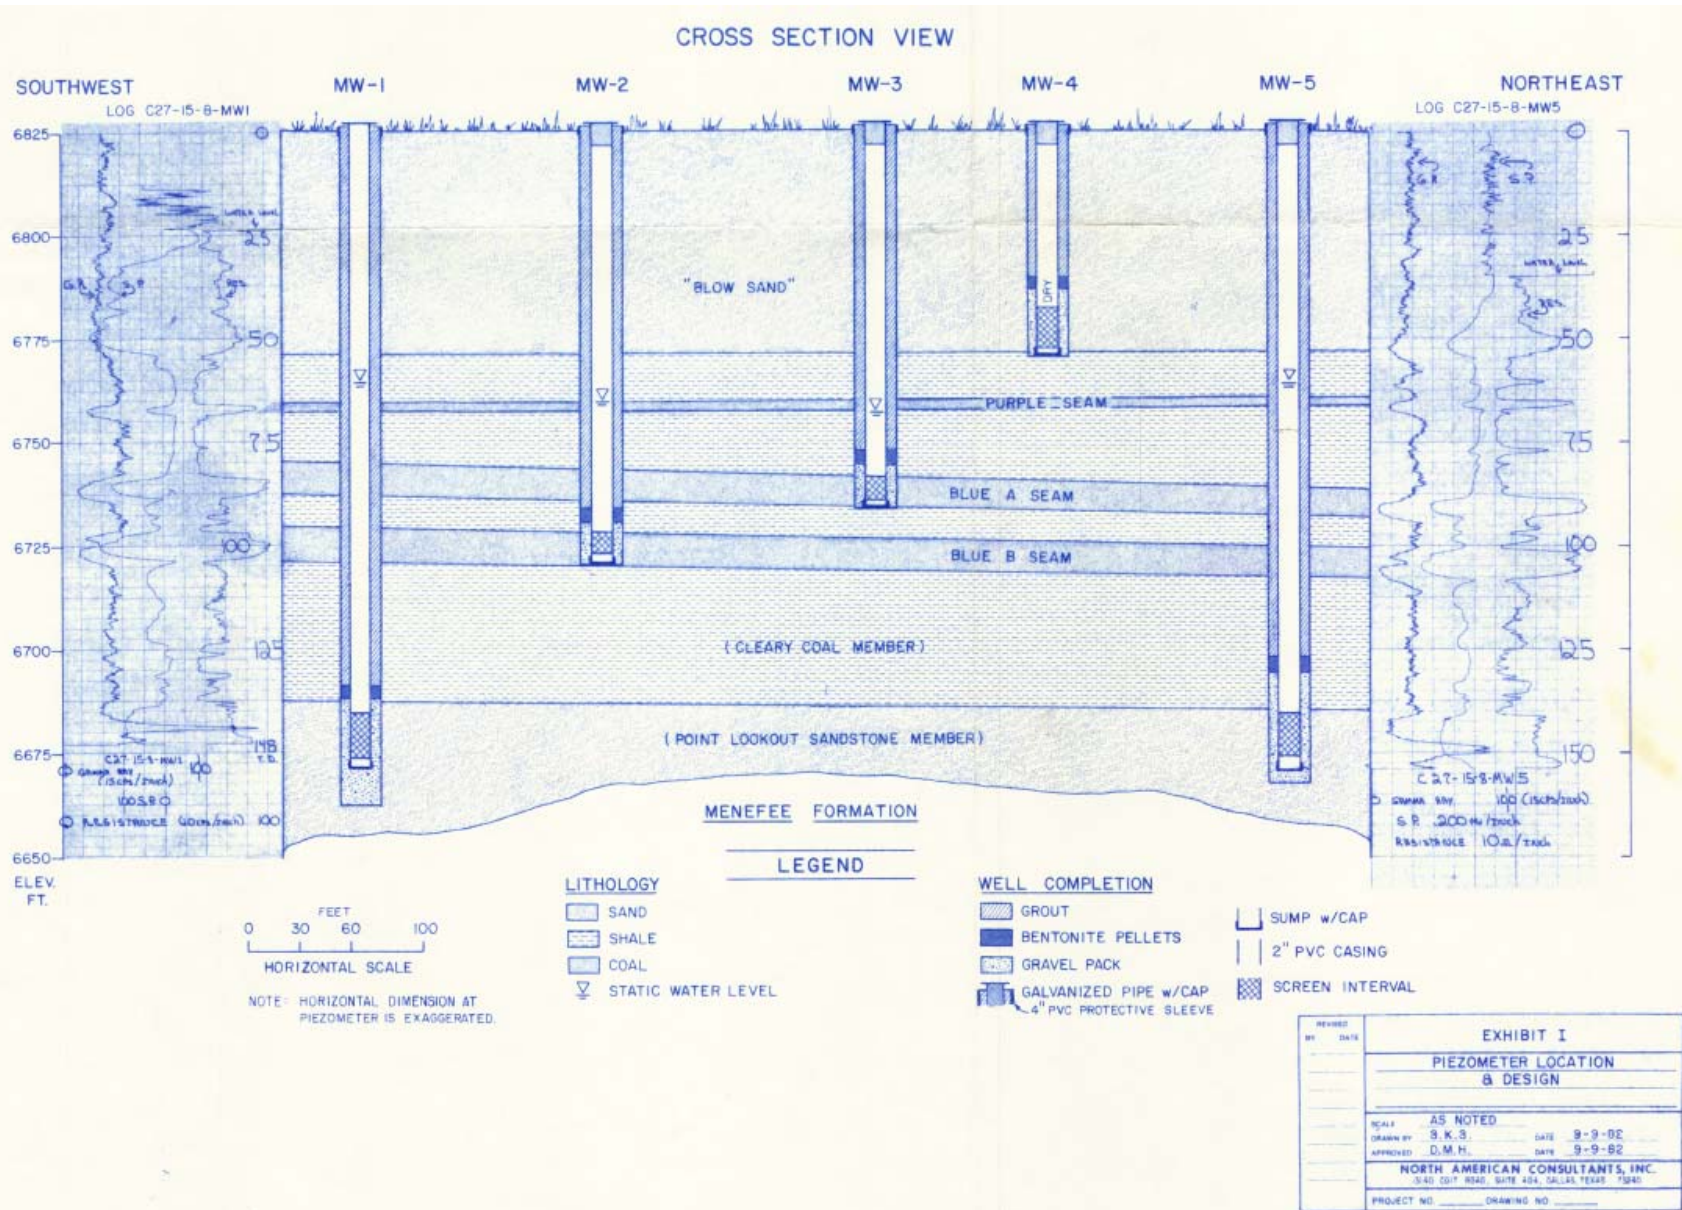
Figure 3. Monitoring well construction diagram for temporary wells MW-1 through MW-5 installed in 1982. Note that unconsolidated well MW-4 is dry.
