PERMIT ATTACHMENT A - FACILITY DESCRIPTION AND HISTORY

PERMIT ATTACHMENT B - INSPECTION REQUIREMENTS

PERMIT ATTACHMENT E – FIGURES

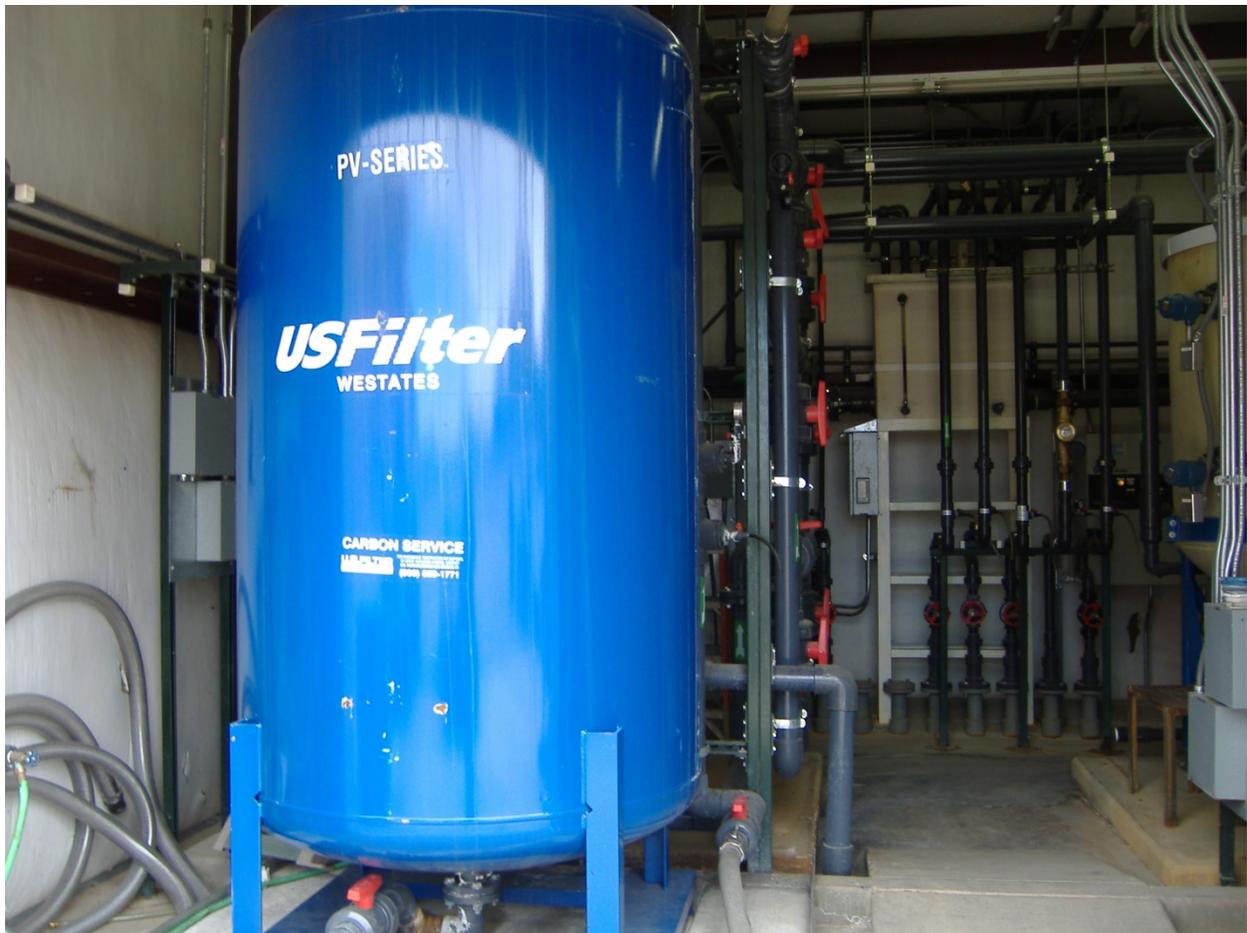
Photo E-11
Groundwater Treatment System, Carbon Unit

The groundwater treatment system (GWTS) (Figures E-5, E-11 and E-12) was installed in 1995. Currently, the GWTS uses activated carbon to treat approximately 61 gpm of groundwater from five groundwater recovery wells. Figure E-7 presents a process flow diagram for the GWTS. Prior to modification of the GWTS in 2002, the primary treatment involved air stripping followed by activated carbon treatment.

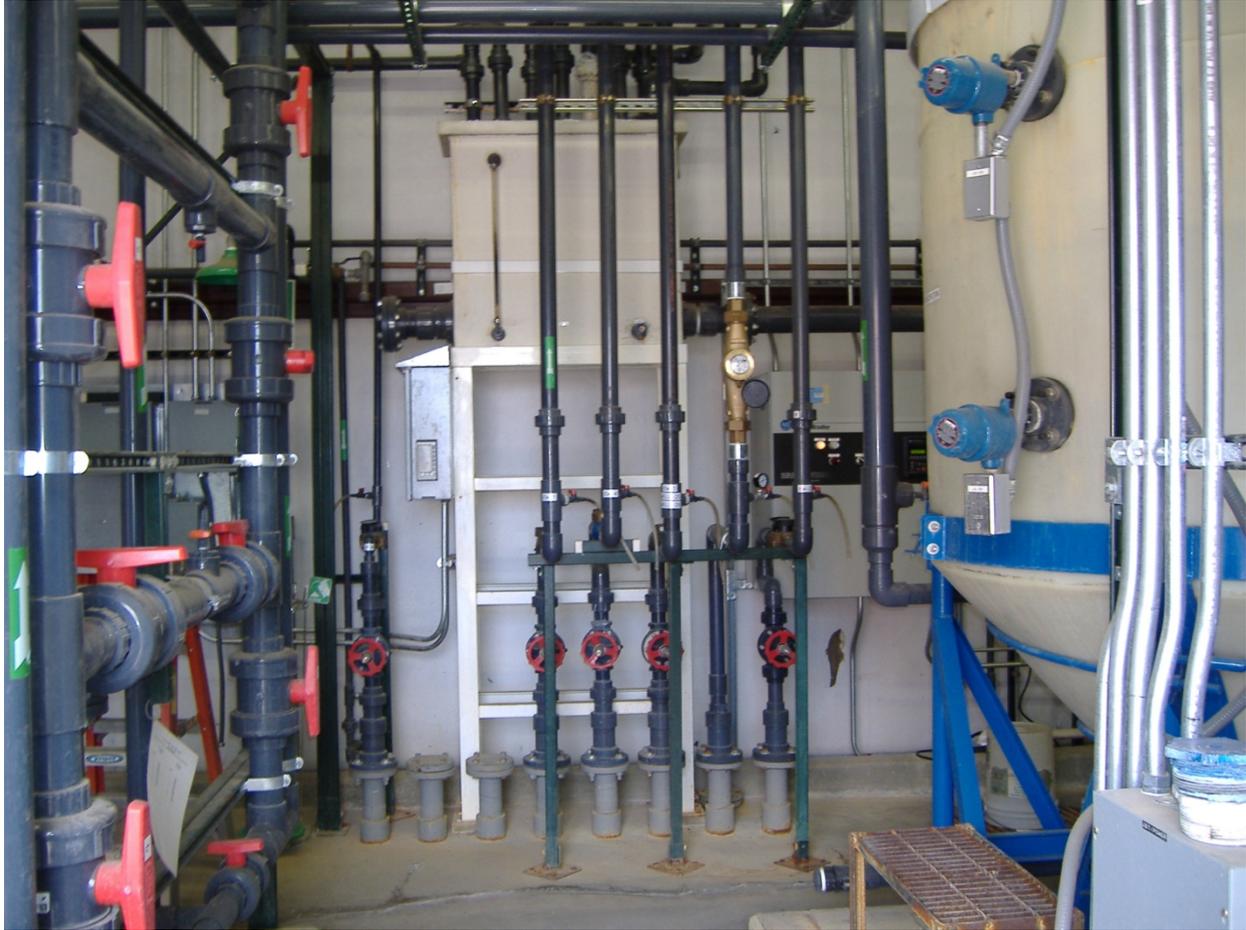
Photo E-12
Groundwater Treatment System, Influent Pipes
