# Kirtland Air Force Base Fuel Spill Cleanup

October 15, 2015

Prepared by  
**Dennis McQuillan, Geologist**  
and  
**Diane Agnew, Hydrogeologist**

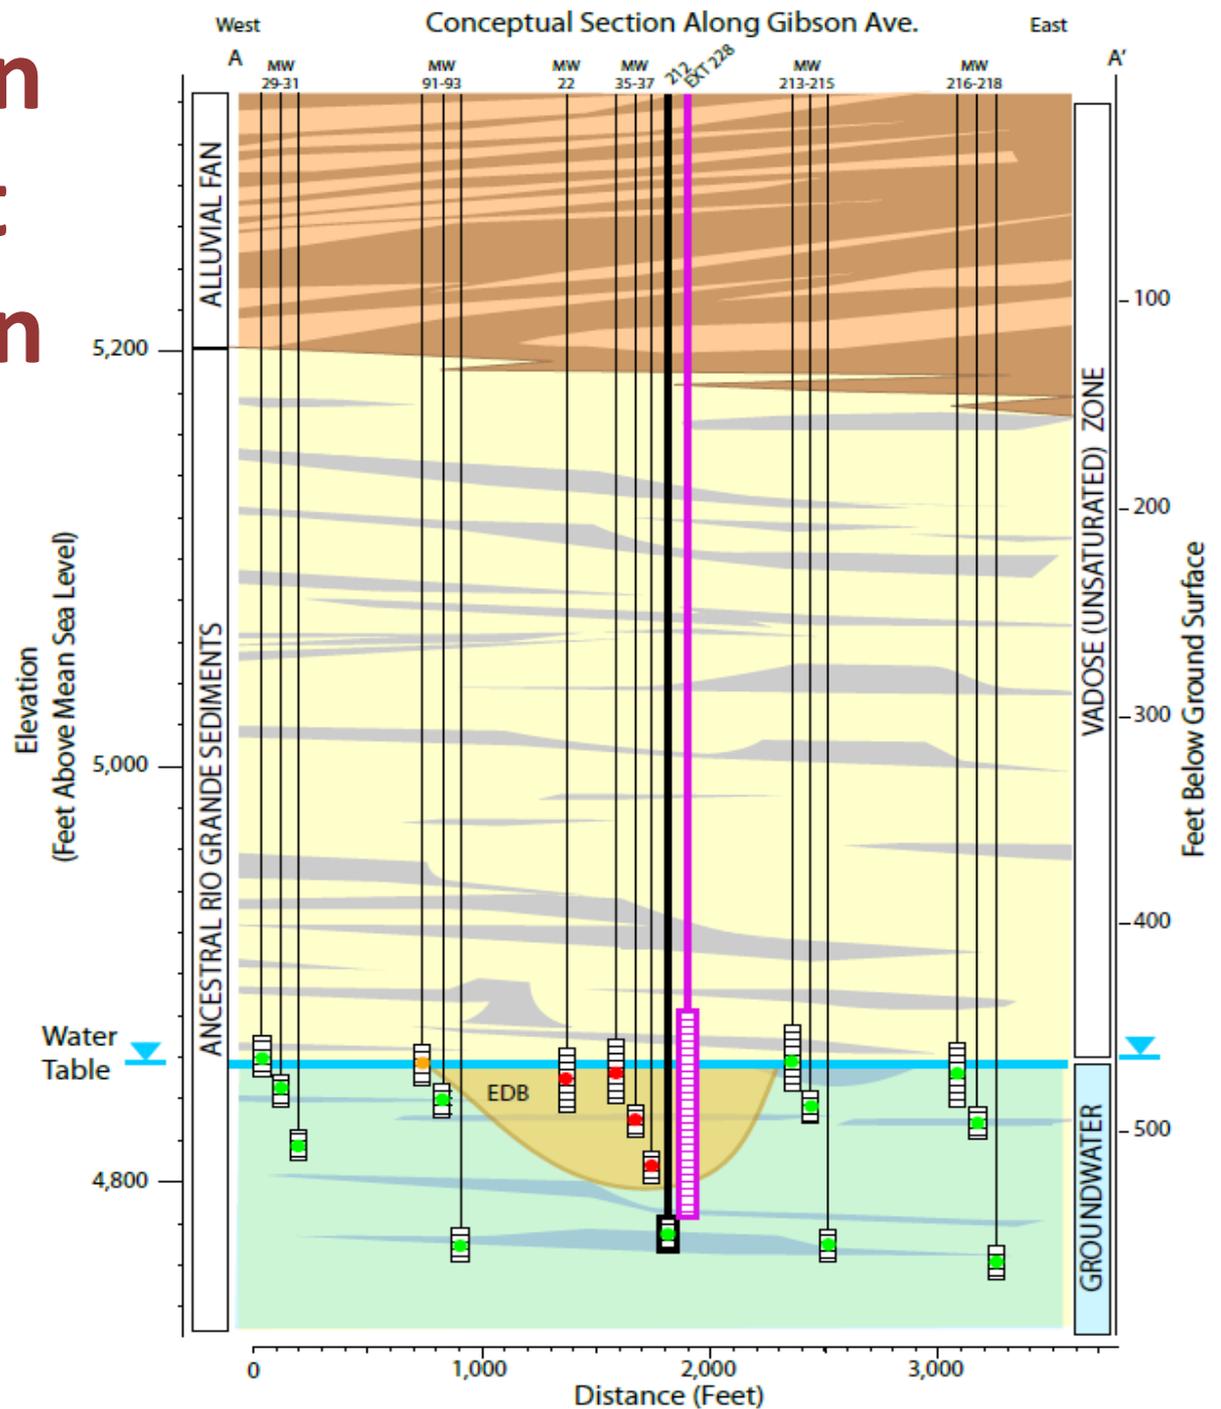
# Cross Section ~ West-East Along Gibson

## Alluvial Fan Sediments

## Ancestral Rio Grande Sediments

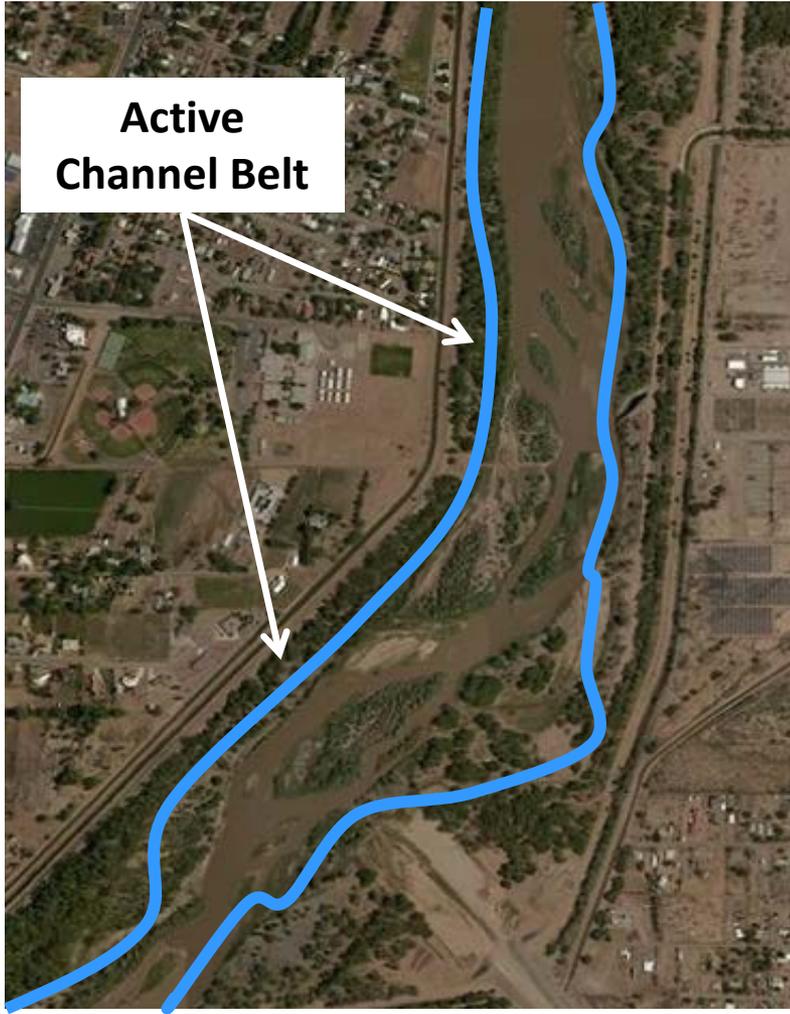
# Rio Grande Braided Stream Channel Belt

Rio Grande Braided Stream  
In Albuquerque South Valley

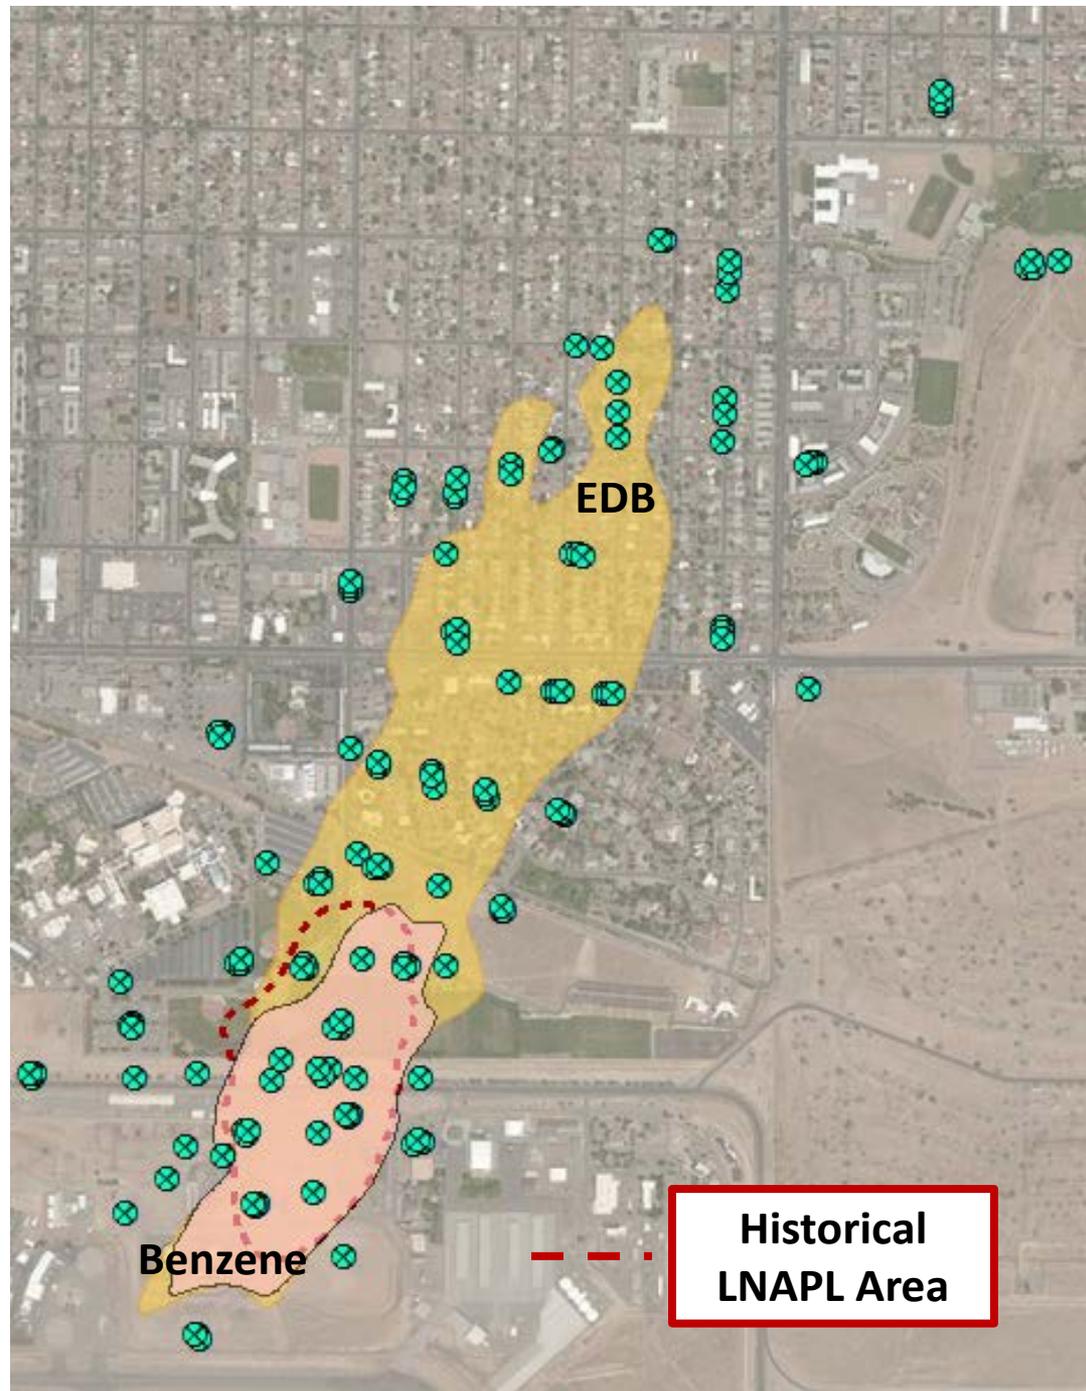
## EDB Plume

Biodegradation only  
in the area with  
dissolved  
hydrocarbons, EDB  
plume footprint is  
much larger than  
benzene footprint

## Benzene Plume

Hydrocarbons are being  
biodegraded by natural  
aquifer bacteria

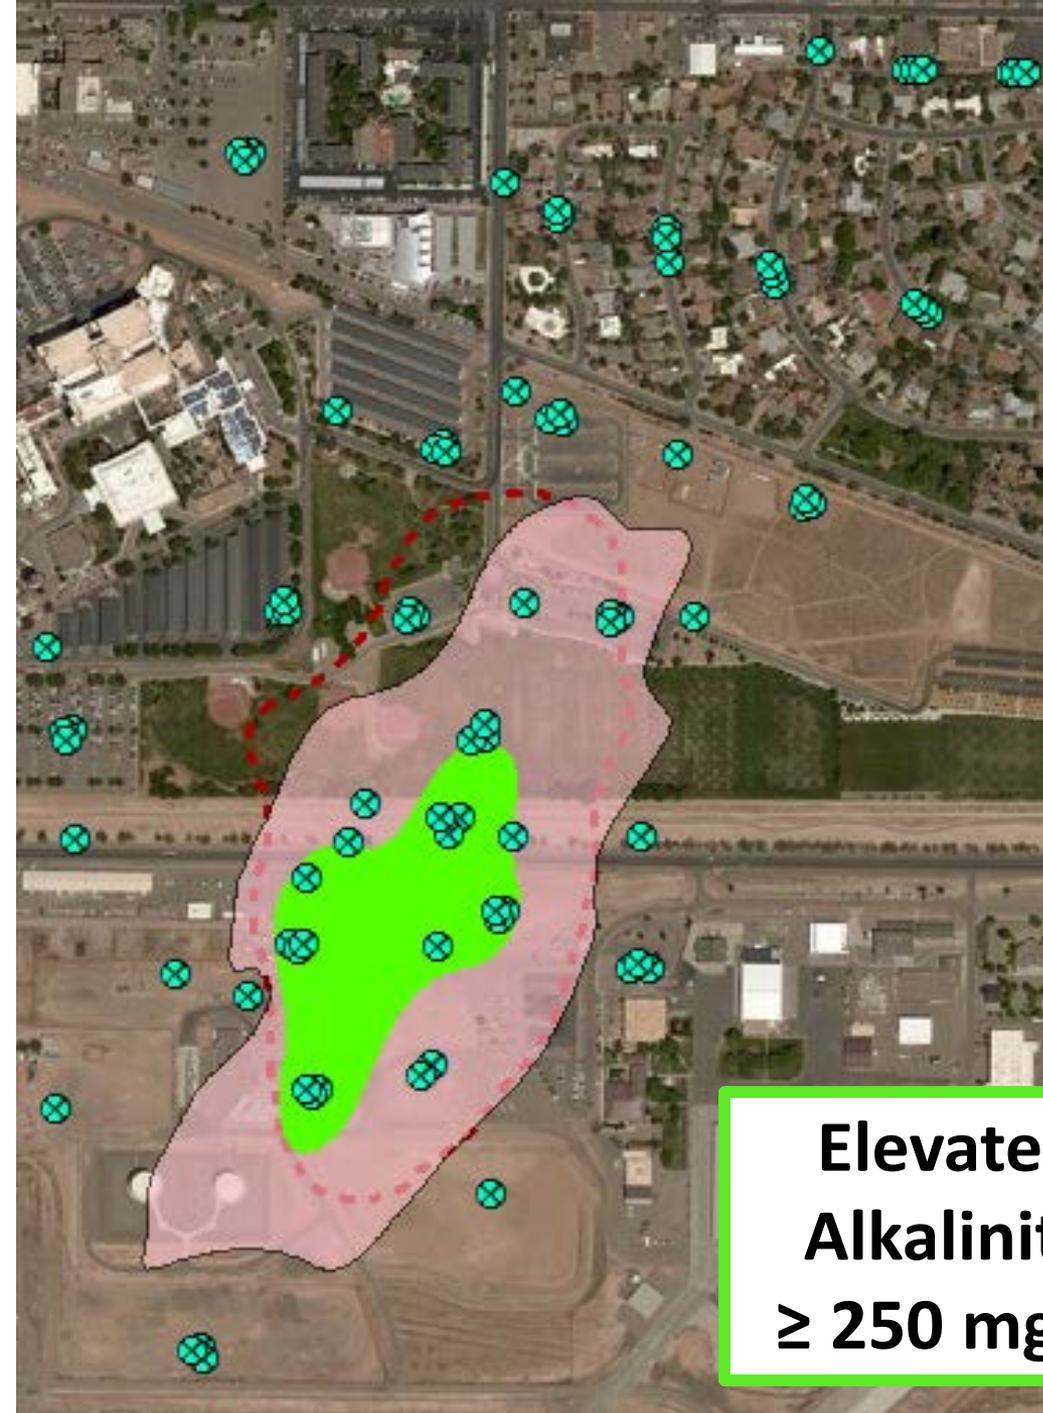
## Benzene Plume

Fuel hydrocarbons  
have undergone  
extensive  
biodegradation  
increasing alkalinity  
in groundwater

**Elevated  
Alkalinity  
≥ 250 mg/L**

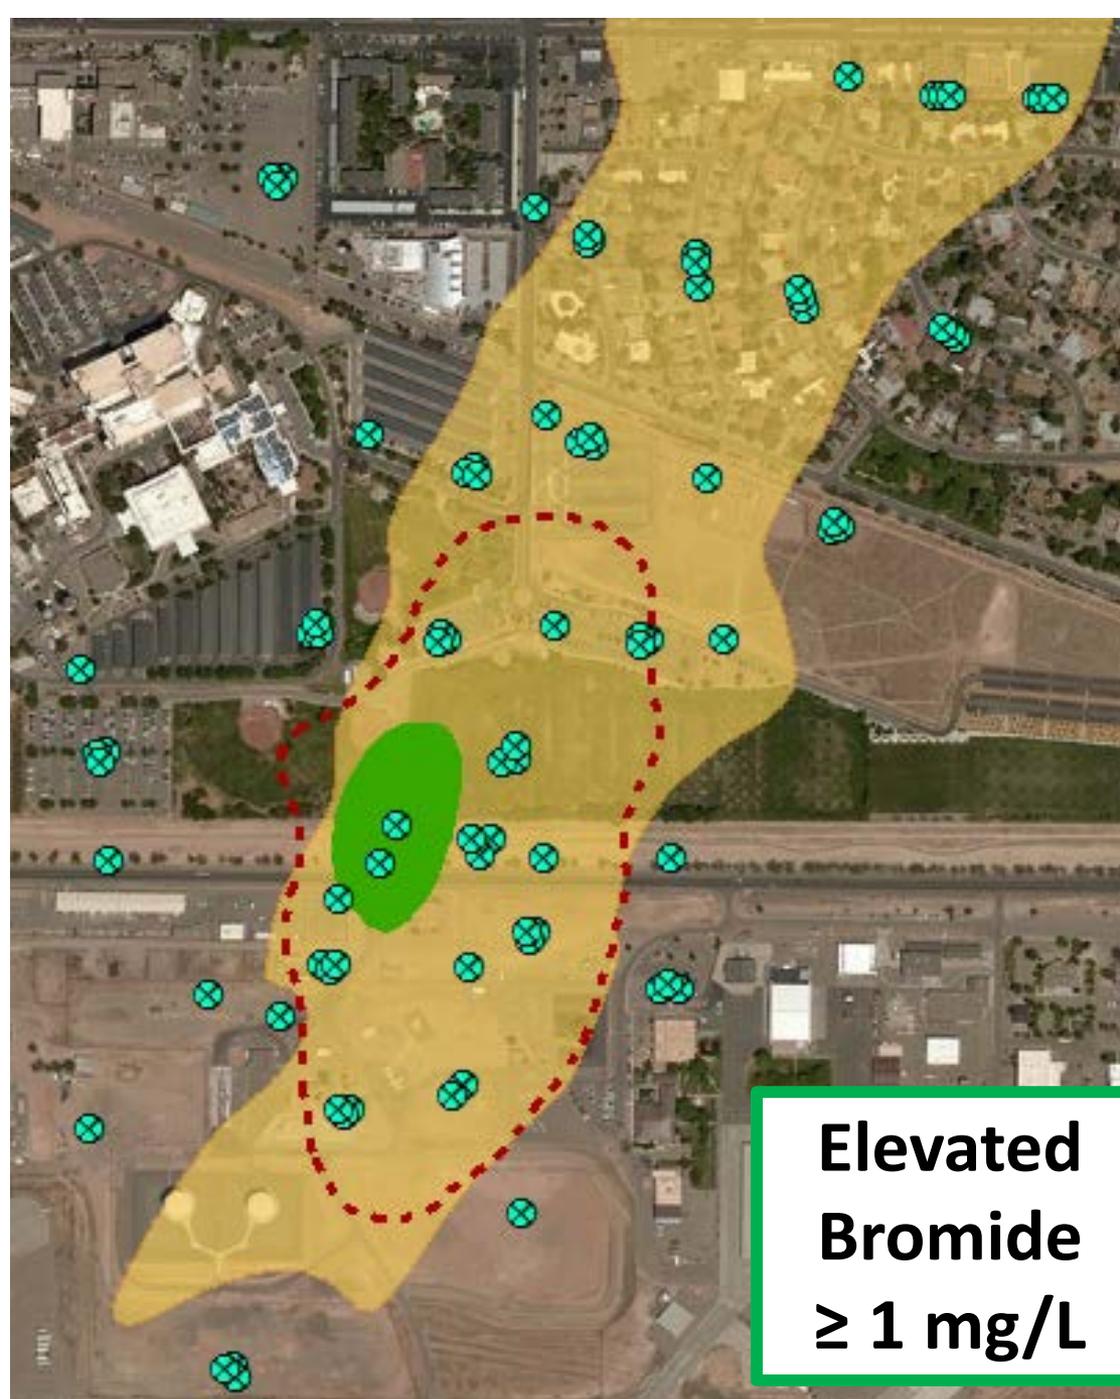
## EDB Plume

EDB has undergone degradation in the anaerobic plume core increasing groundwater bromide

**Elevated  
Bromide  
 $\geq 1$  mg/L**

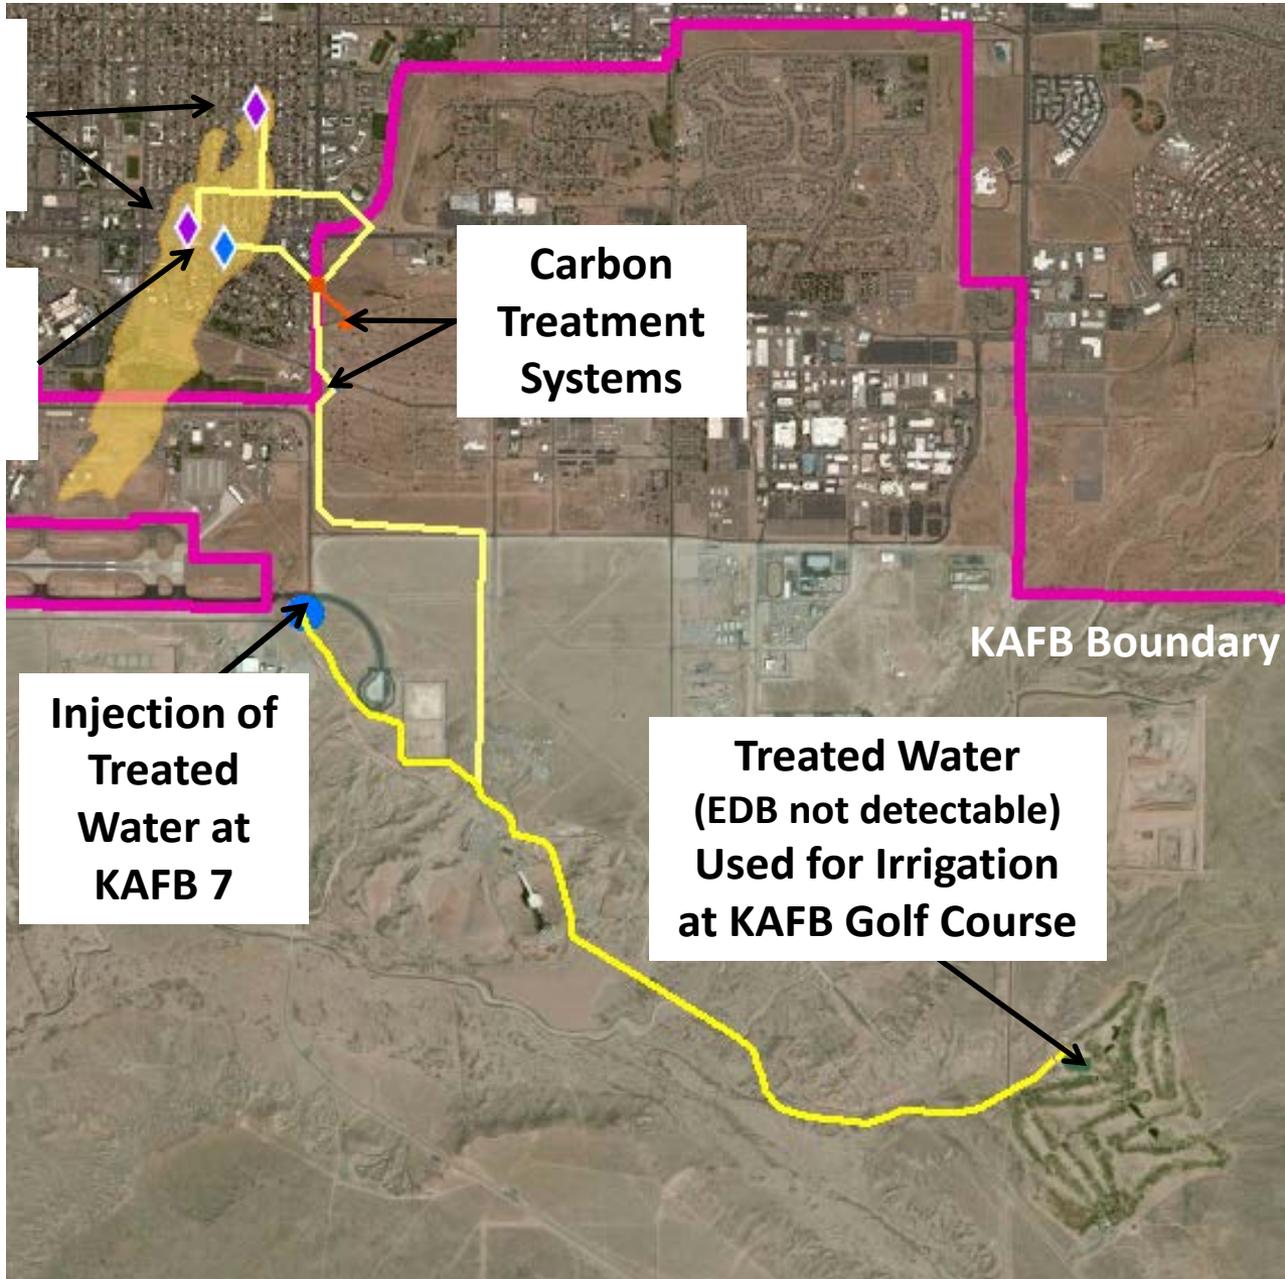
# Collapsing the EDB Plume

2<sup>nd</sup> and 3<sup>rd</sup>  
Extraction  
Wells (2015)

First  
Extraction  
Well

Carbon  
Treatment  
Systems

KAFB Boundary

Injection of  
Treated  
Water at  
KAFB 7

Treated Water  
(EDB not detectable)  
Used for Irrigation  
at KAFB Golf Course

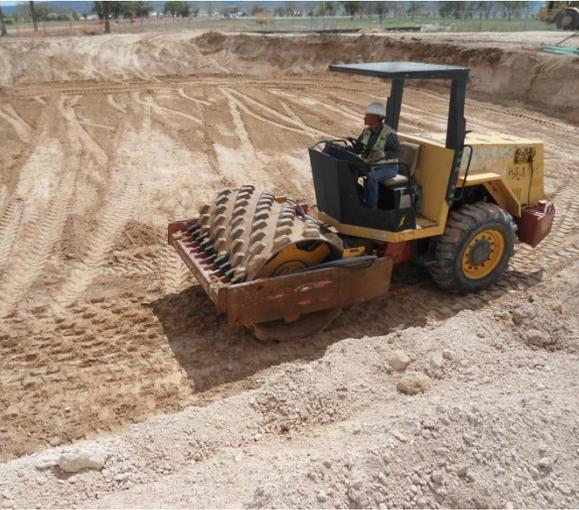
Excavation and leveling of building pad

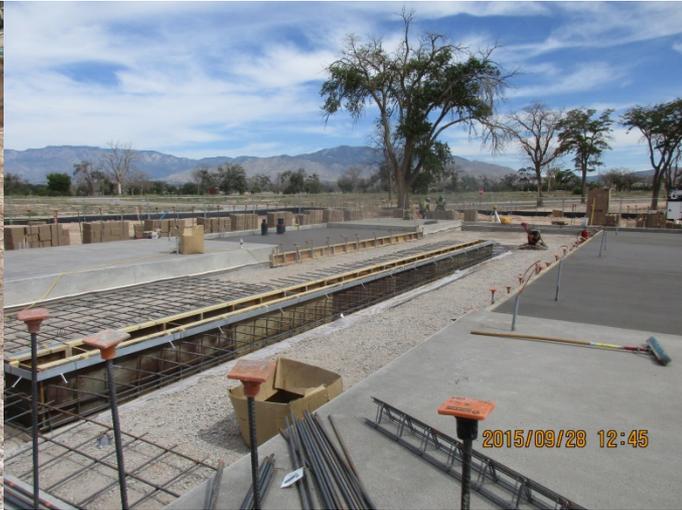
Pouring of floor of building

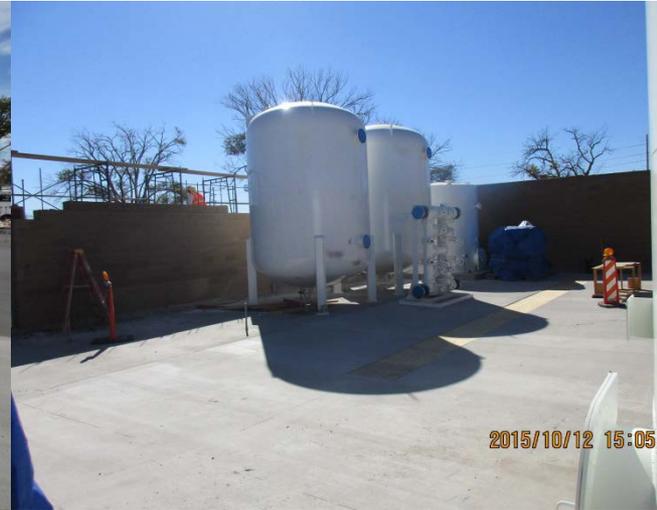
GAC tanks and building walls

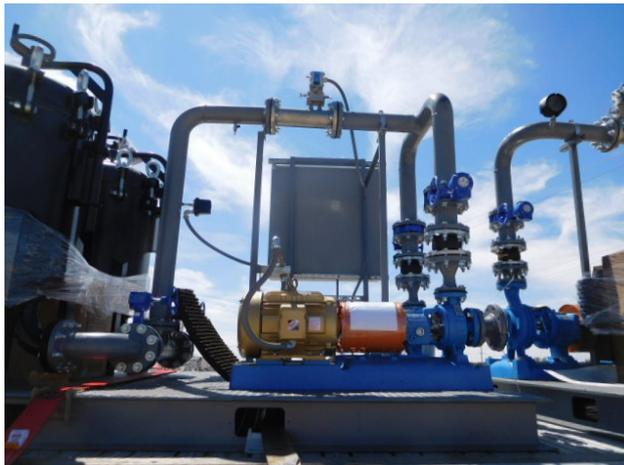
Pump on skid for full-scale treatment system

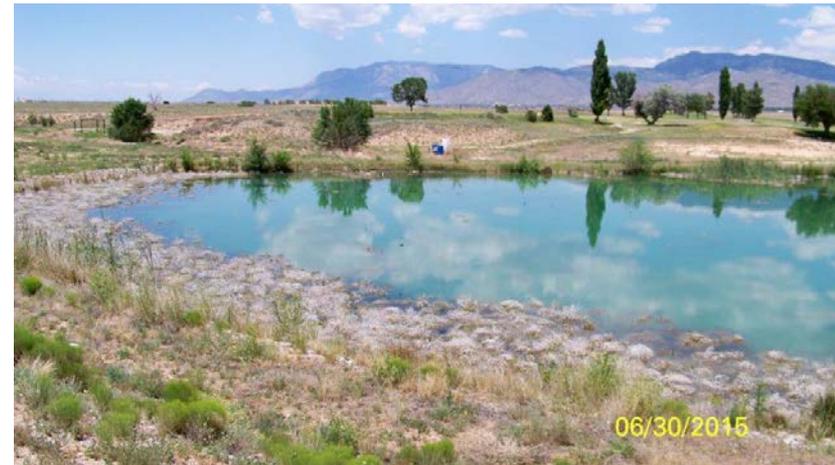
Discharge point at Tijeras Golf Course pond on Kirtland AFB

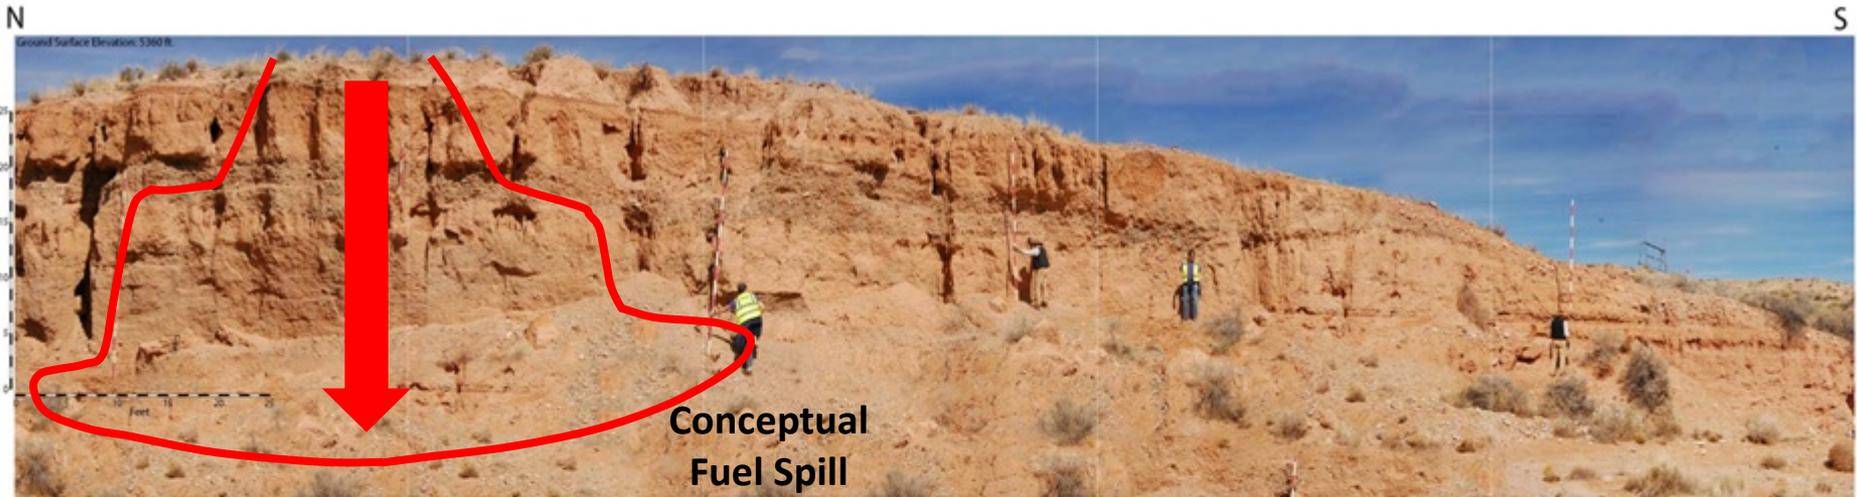
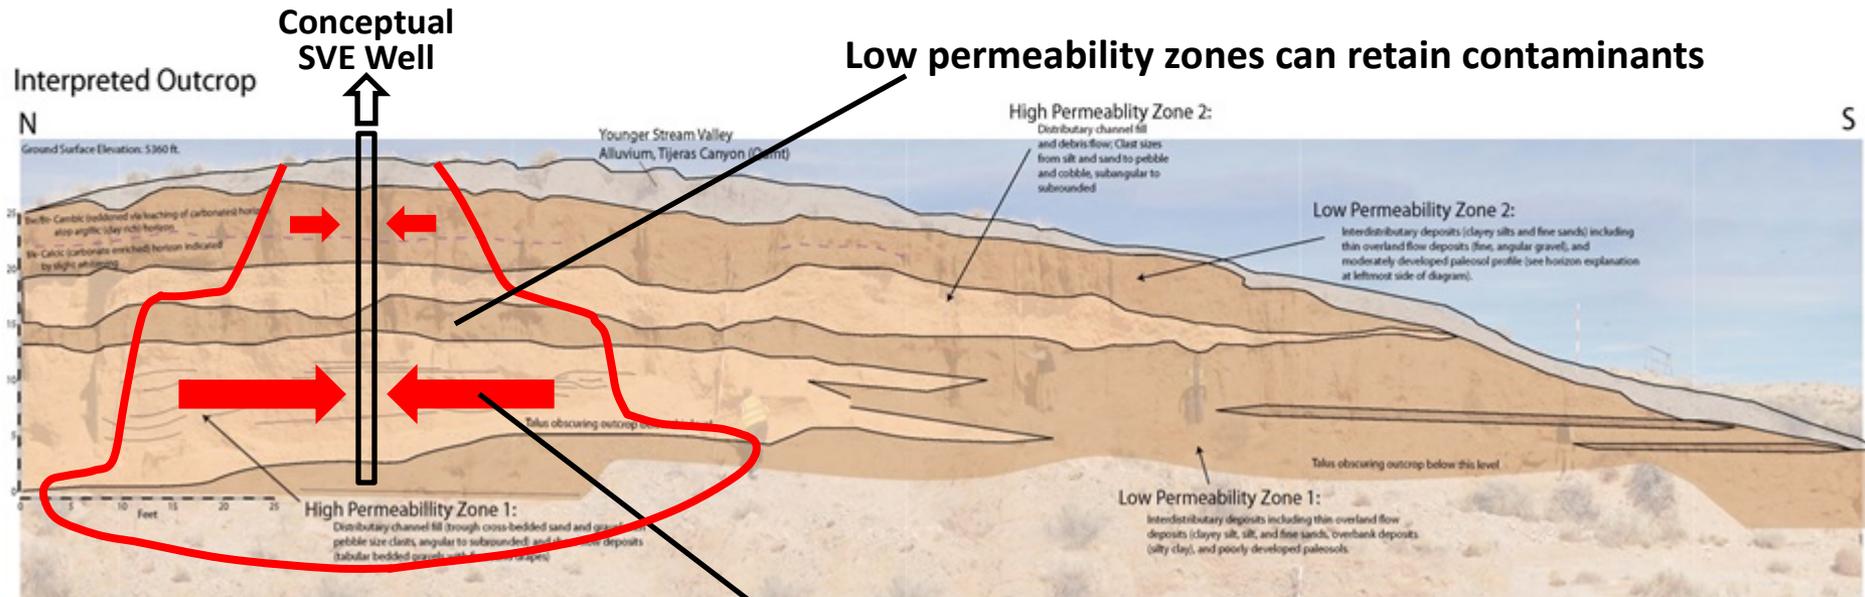
# Alluvial Fan

Permeability differences control the migration of fuel and the recovery of fuel vapor by SVE

SVE vapor flow greater in high permeability zones

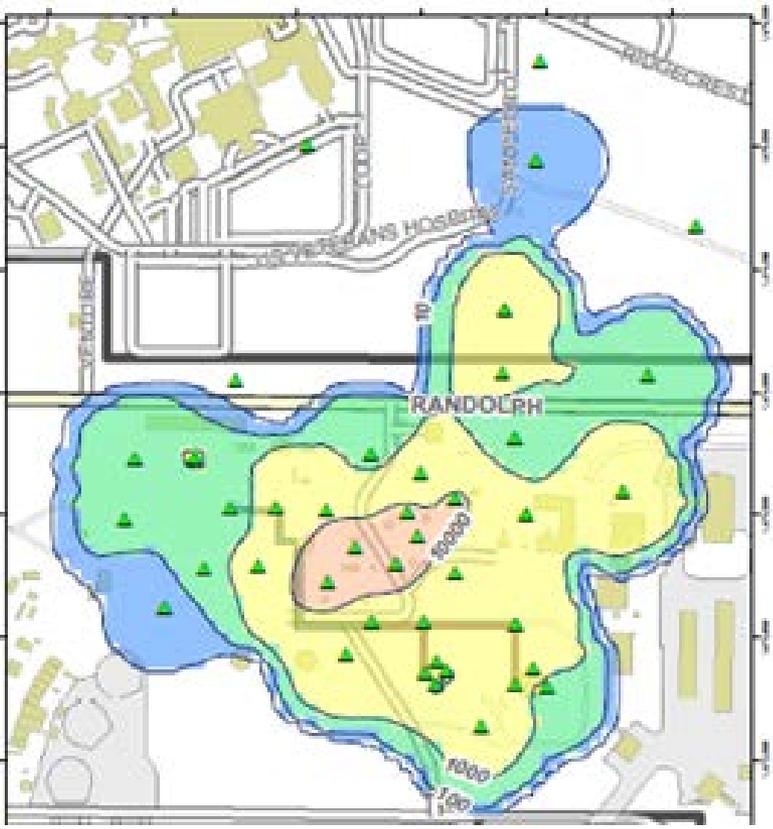
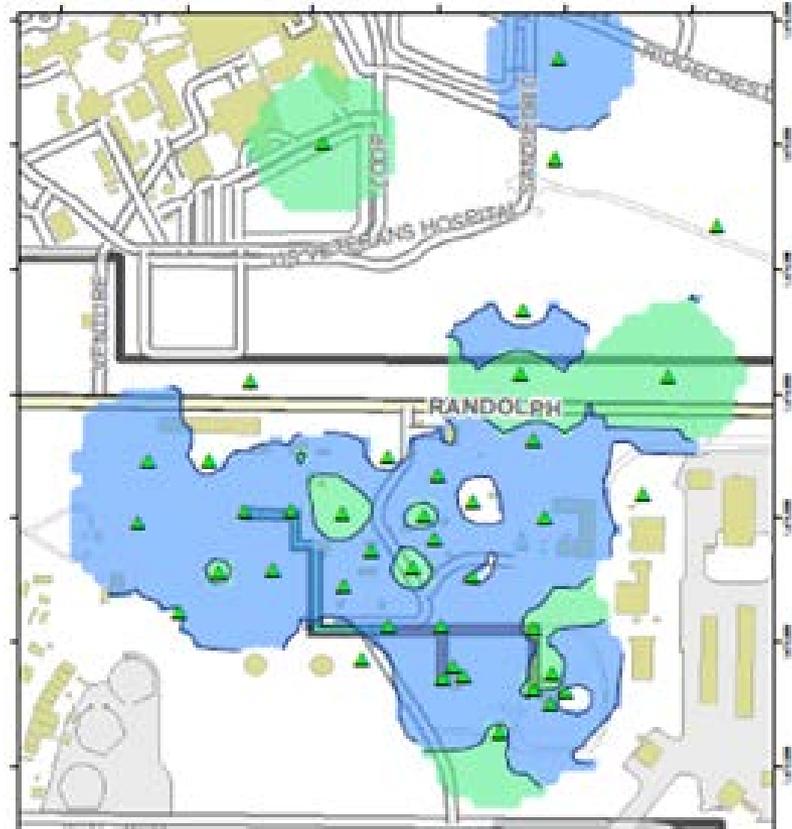
# Reduction in Soil Vapor Contamination

Q4-2011

Q4-2014

450 feet below ground surface

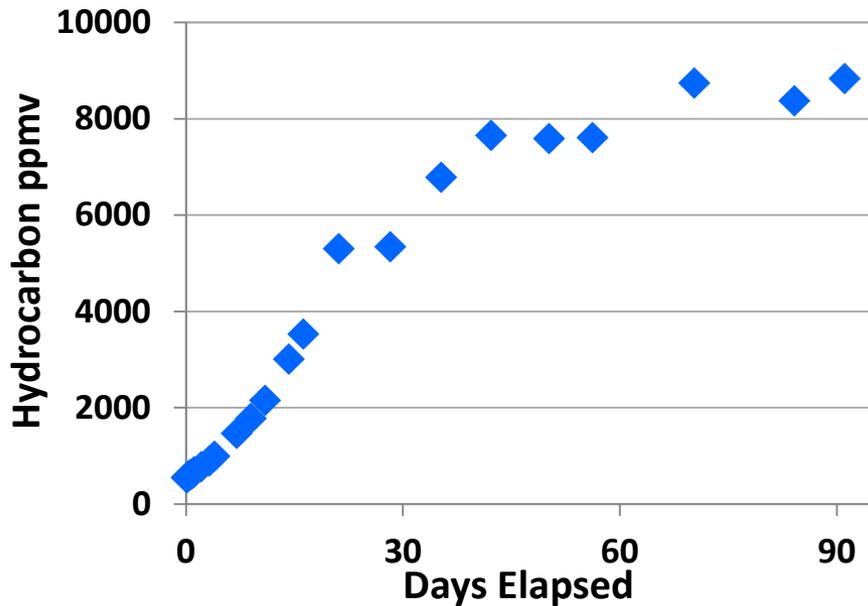
**SVMW-03 at  
250 ft below ground surface**

**Hydrocarbon concentrations  
increased (rebounded)**

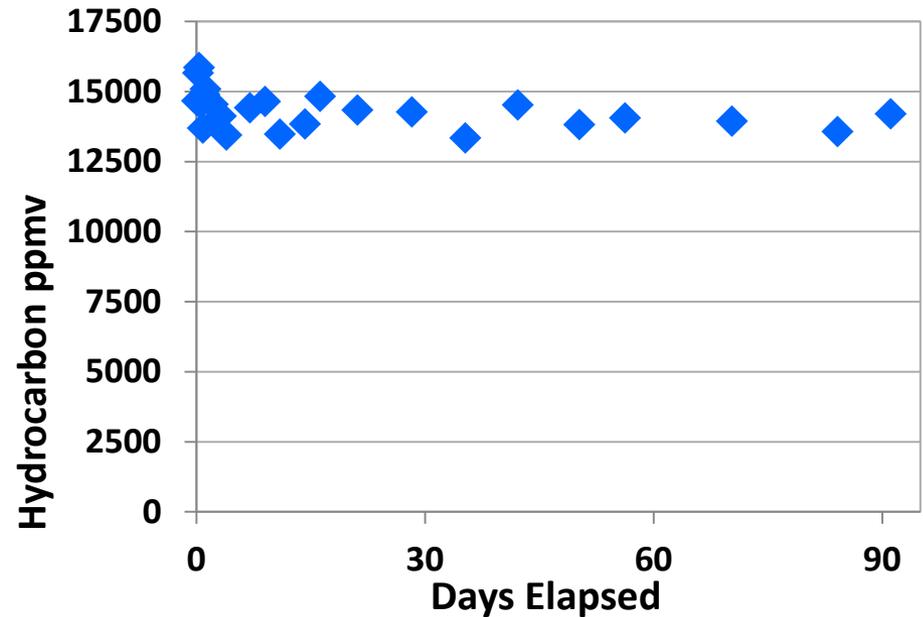
**SVMW-03 at  
300 ft below ground surface**

**Hydrocarbon concentrations  
remained stable**

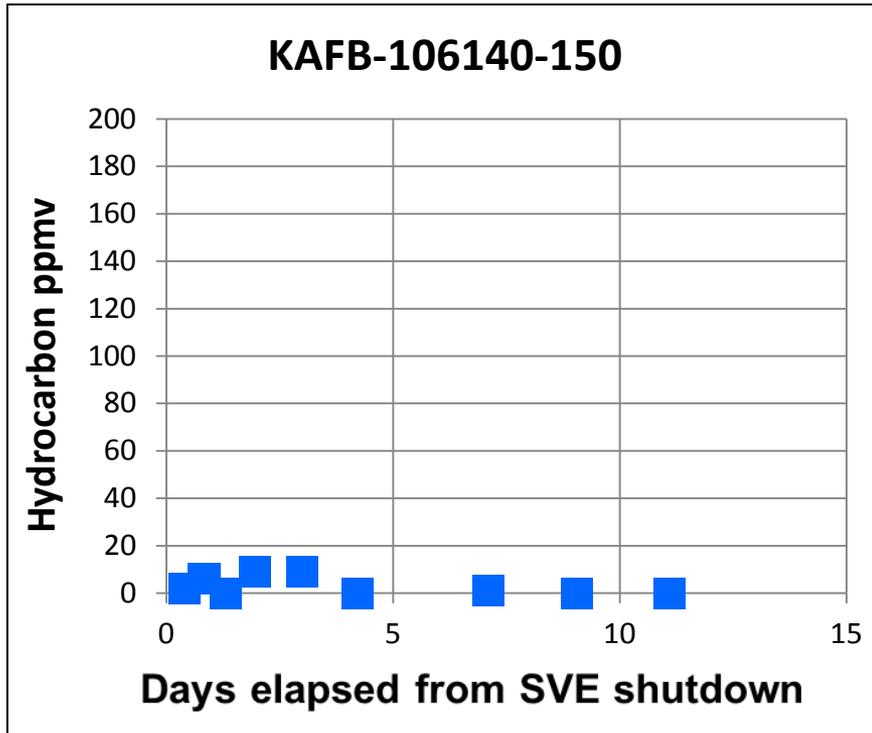
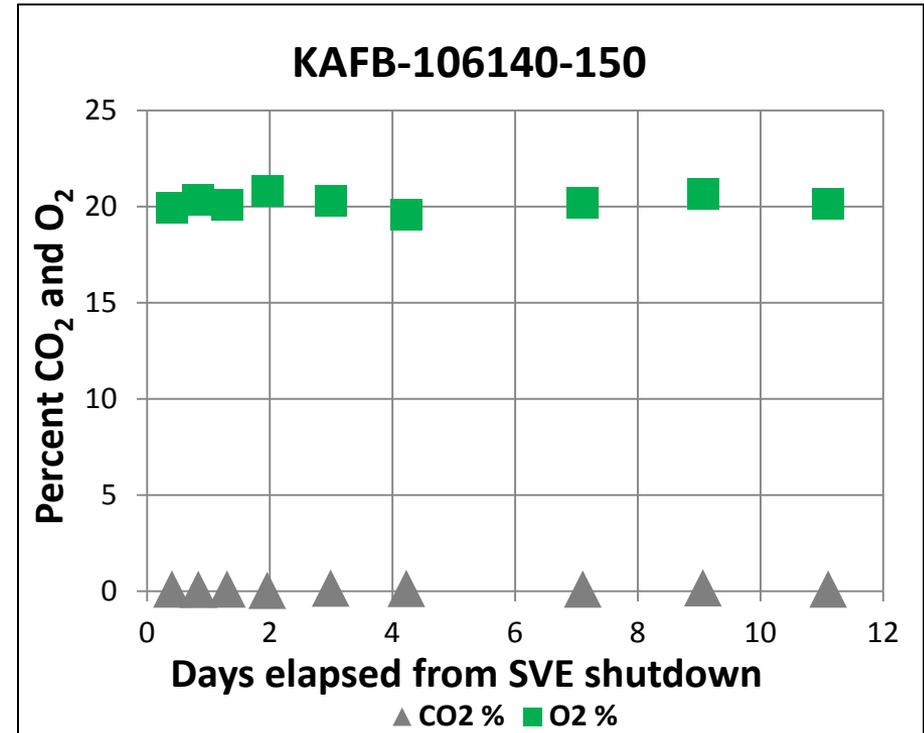
**Background Respiration Example**

- Background SVMPs with little or no hydrocarbon contamination have very low bio-respiration rates
- O<sub>2</sub> and CO<sub>2</sub> signatures at these wells show near atmospheric conditions
- These locations indicate clean vadose zone and require no remediation

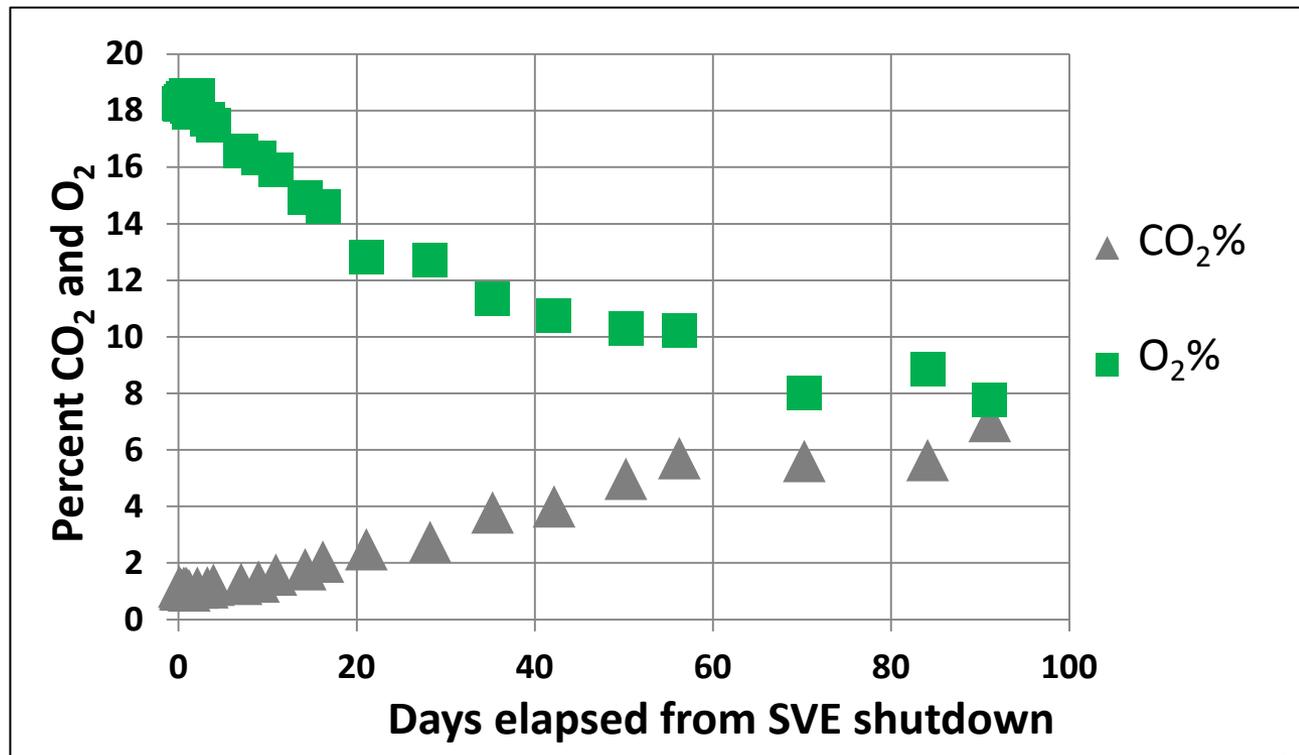
Naturally occurring vadose zone bacteria consume  $O_2$  and produce  $CO_2$  as they biodegrade hydrocarbons

SVMW-03 at 250 ft below ground surface

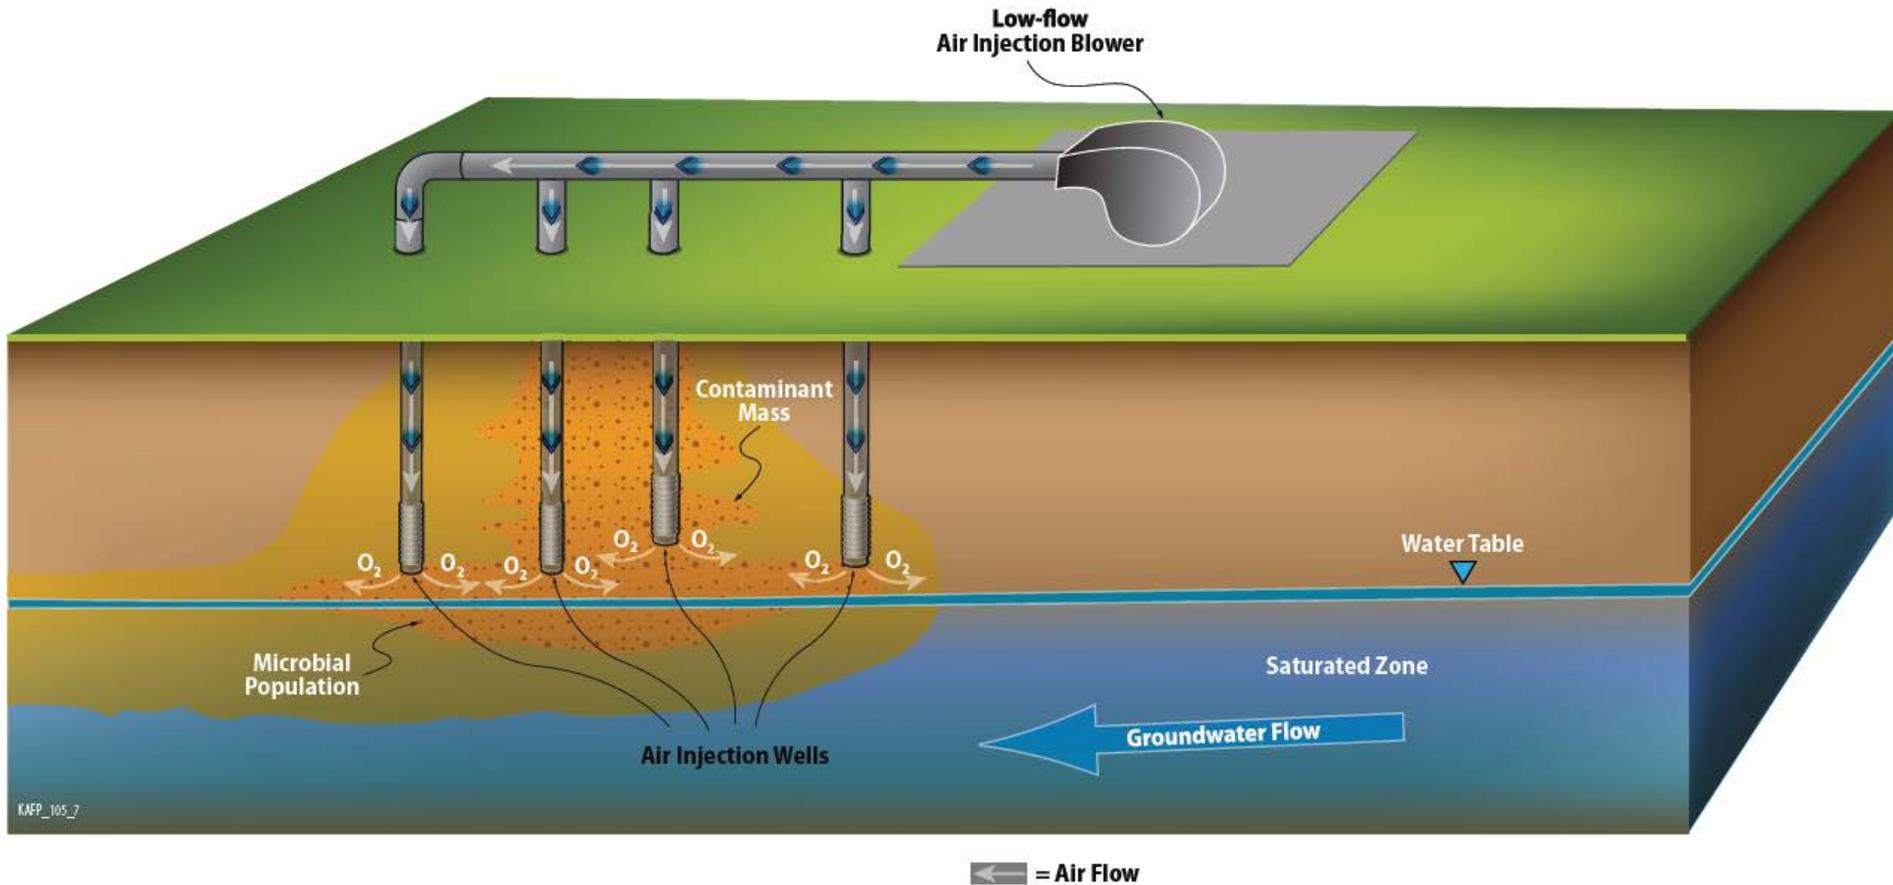
# Bio-Venting

- Air is injected into the vadose zone to deliver oxygen to soil bacteria to help them biodegrade contaminants

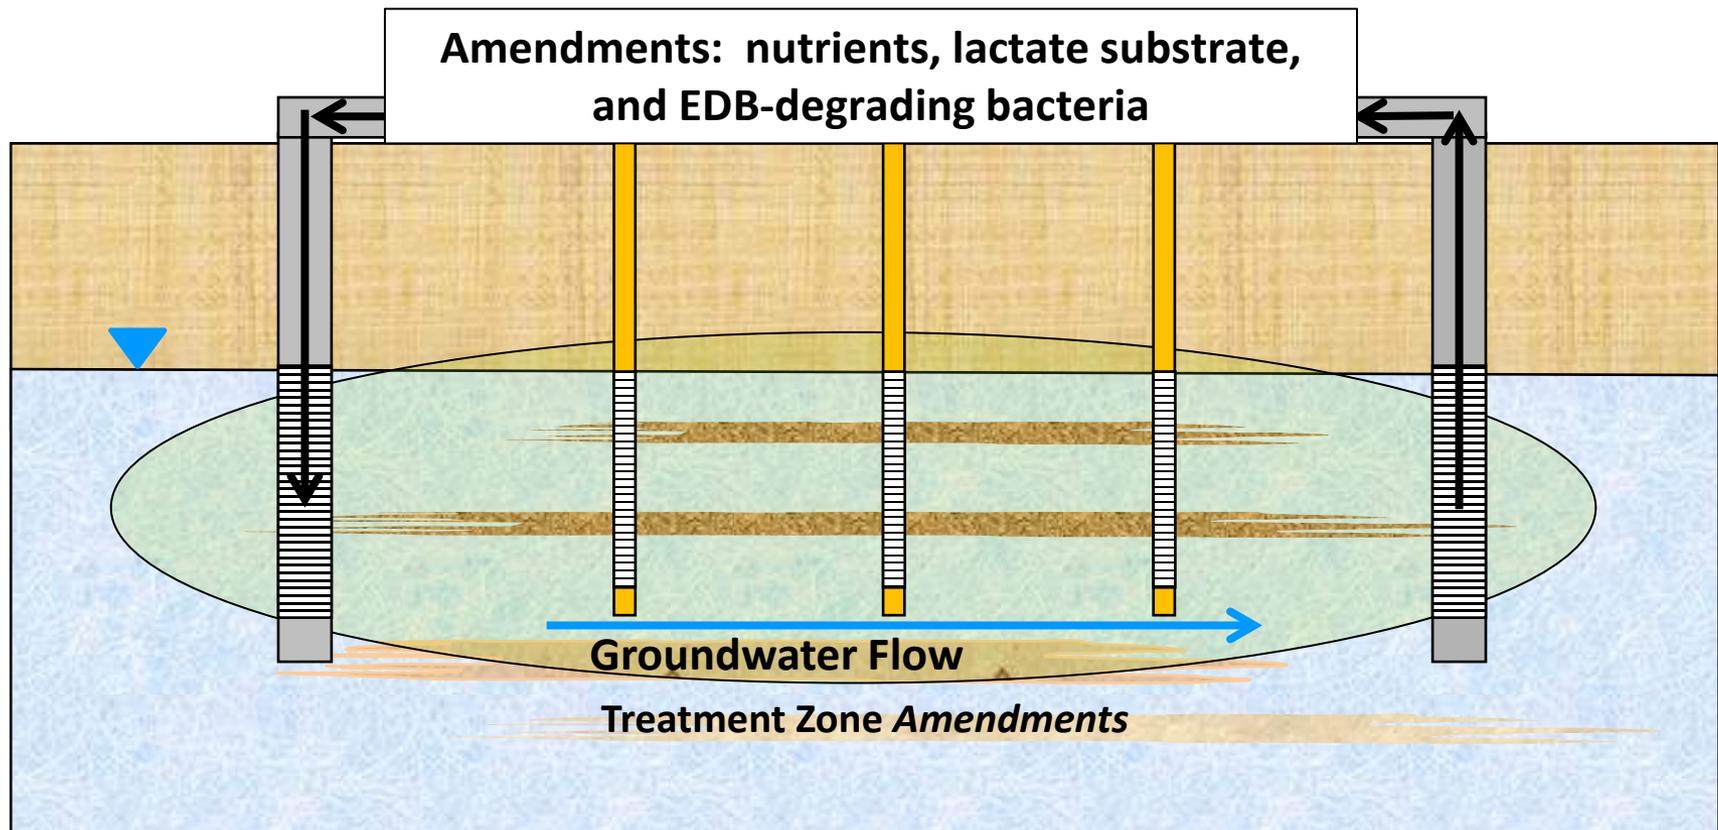
# Anaerobic Biodegradation Pilot Test

## Groundwater Recirculation

- Pump groundwater - Add amendments
- Inject amended water up-gradient to create recirculation cell to support anaerobic biodegradation EDB

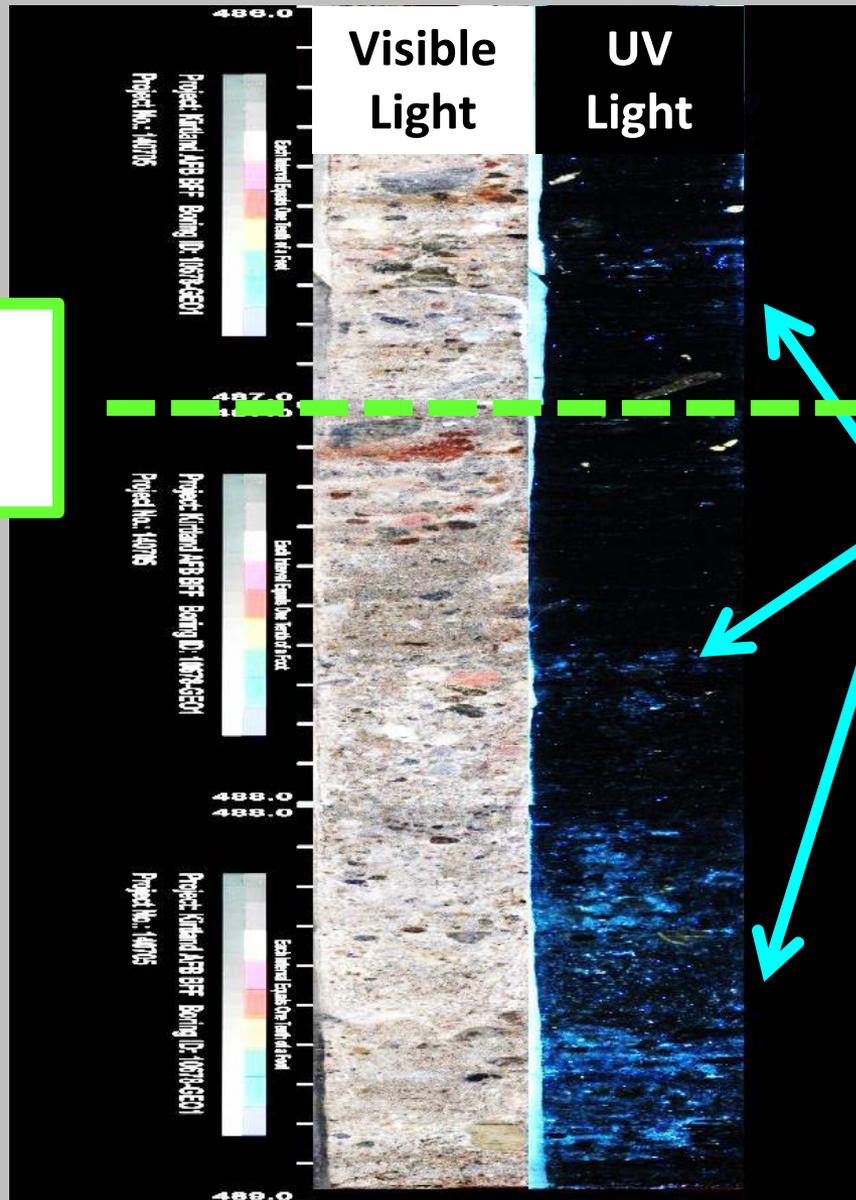
# Drowned LNAPL – Soil Cores

**Groundwater Table**

**LNAPL Under UV Light Fluoresces Blue**
