RE: Surface Soil Sampling, Eagle Springs Wellsite, Sandoval County, New Mexico

Figure 1
 Sample Location Map for Eagle Springs 8 Federal #002M
 Sandoval County, New Mexico

TABLE 1
Laboratory Analytical Results - Soil Samples
 Eagle Springs 8 Federal #002M Wellsite, Sandoval County, New Mexico

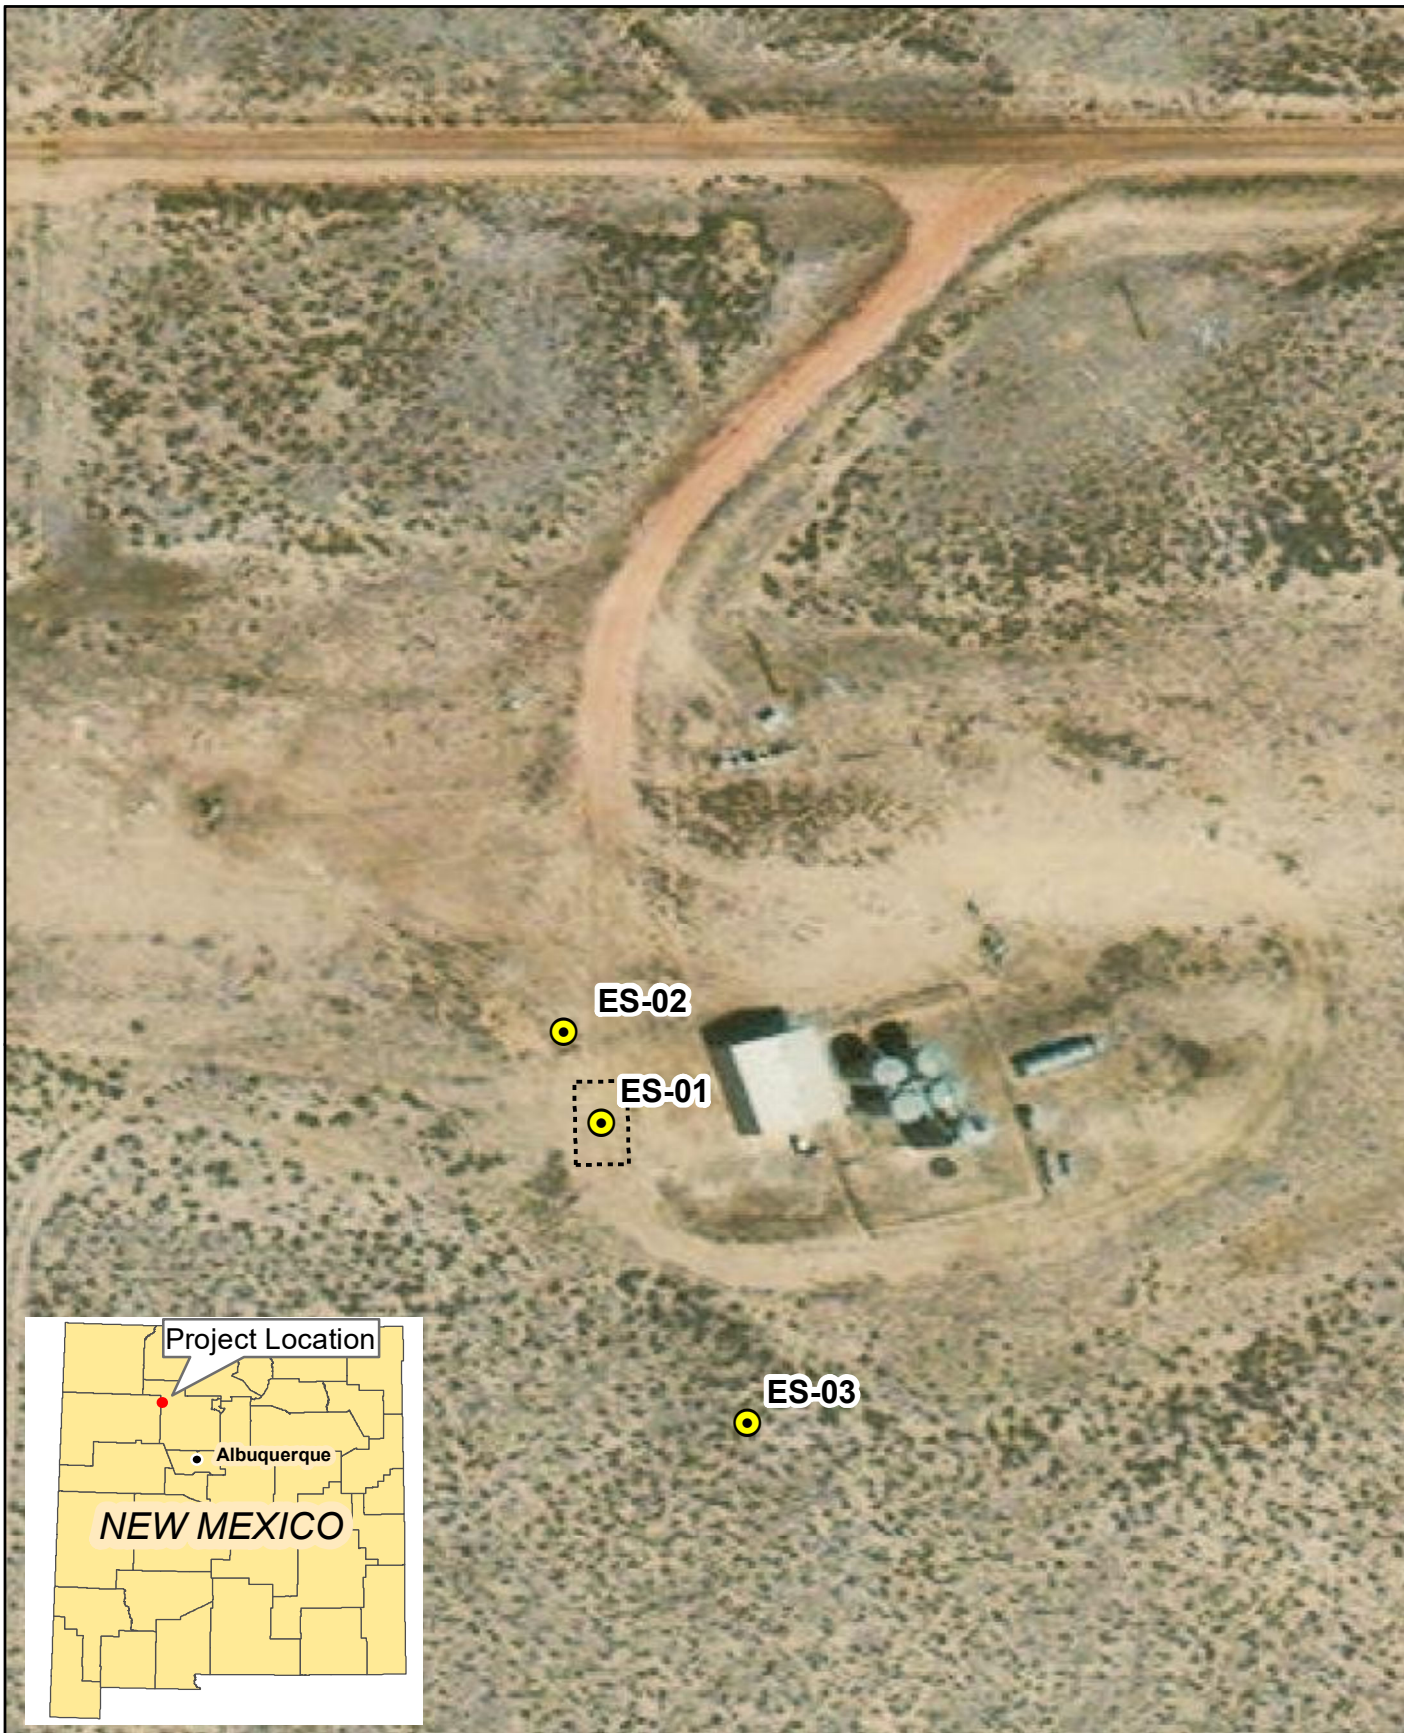
Three (3) soil samples were collected on Site (**Figure 1**) at the surface from 0 to 4" depth including a composite sample from within the fenced in raised bed (ES-01; Photos 1 and 2), a composite sample collected along the drainage channel issuing from the fenced area (ES-02; Photos 3 and 4), and a sample collected in

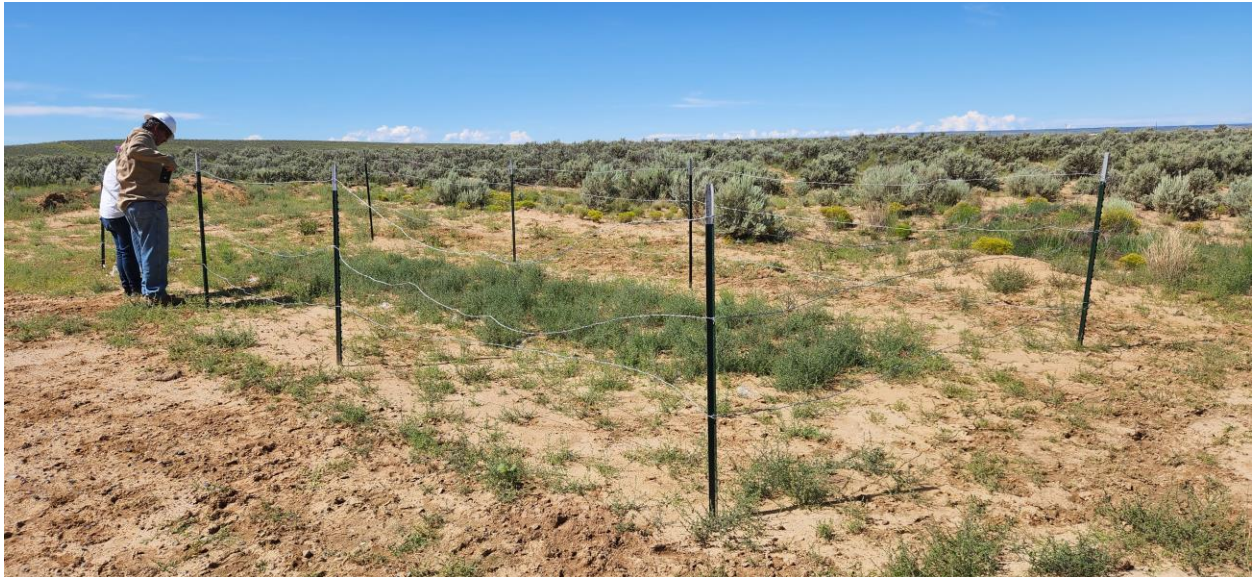
- ES-01 was collected as a 3-point composite sample from 1-3" depth for anion analysis and from 3-4" depth for volatiles analysis. The ES-01 samples for BTEX and TPH analysis were collected using a syringe extraction and methanol preservation method at a slightly deeper interval to get below the surficial material where volatilization would have been the greatest. The ES-01 composite sample consisted of a silty, fine-grained sand material amended with perlite.

Photo 1. Fenced in area of wellsite containing a slightly elevated soil bed with 16 rows approximately 4-ft in length. A 3-point composite sample (ES-01) was collected within the fenced area.

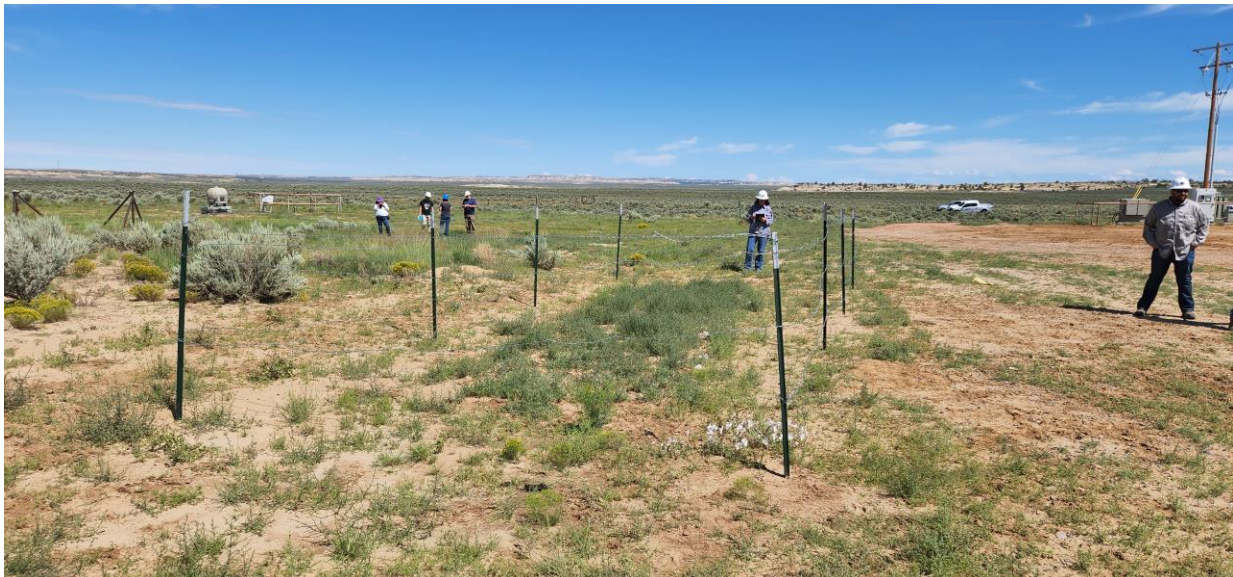
Photo 2. Looking north at fenced area of wellsite with vegetation including various grasses and Russian thistle consistent with surrounding disturbed area vegetation.

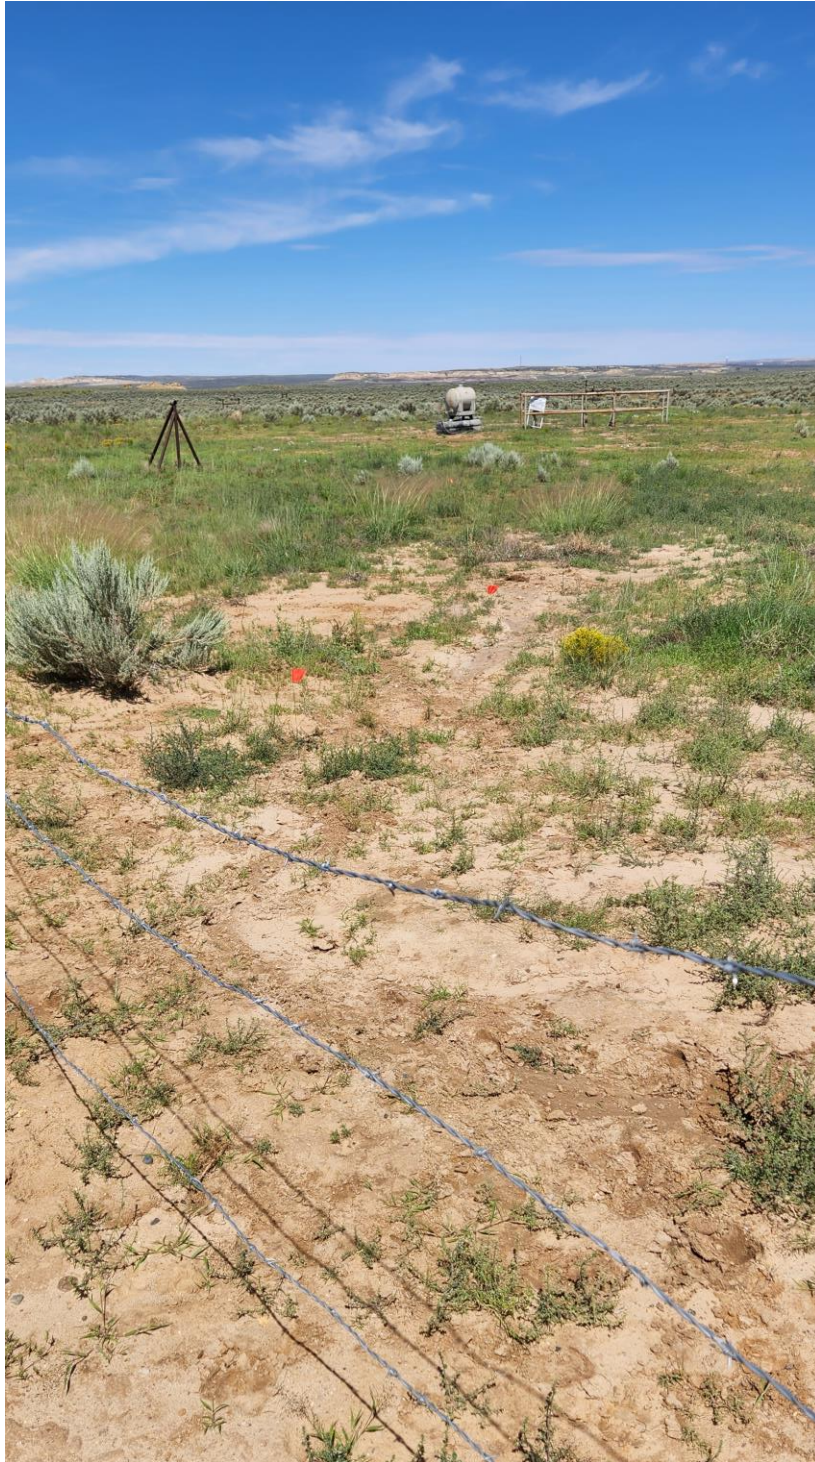
- ES-02 was collected as a 3-point composite sample from 0-3" depth including from the intermittently ponded area at the end of the drainage channel from the raised bed. Algae and recent livestock presence was evident in the ponded area. The ES-02 composite sample consisted of silty, fine to medium-grained sand with a higher moisture content than the other two samples collected.

Photo 3. Looking northwest along small drainage channel from fenced raised bed area at the flagged 3-point composite sample locations for ES-02.

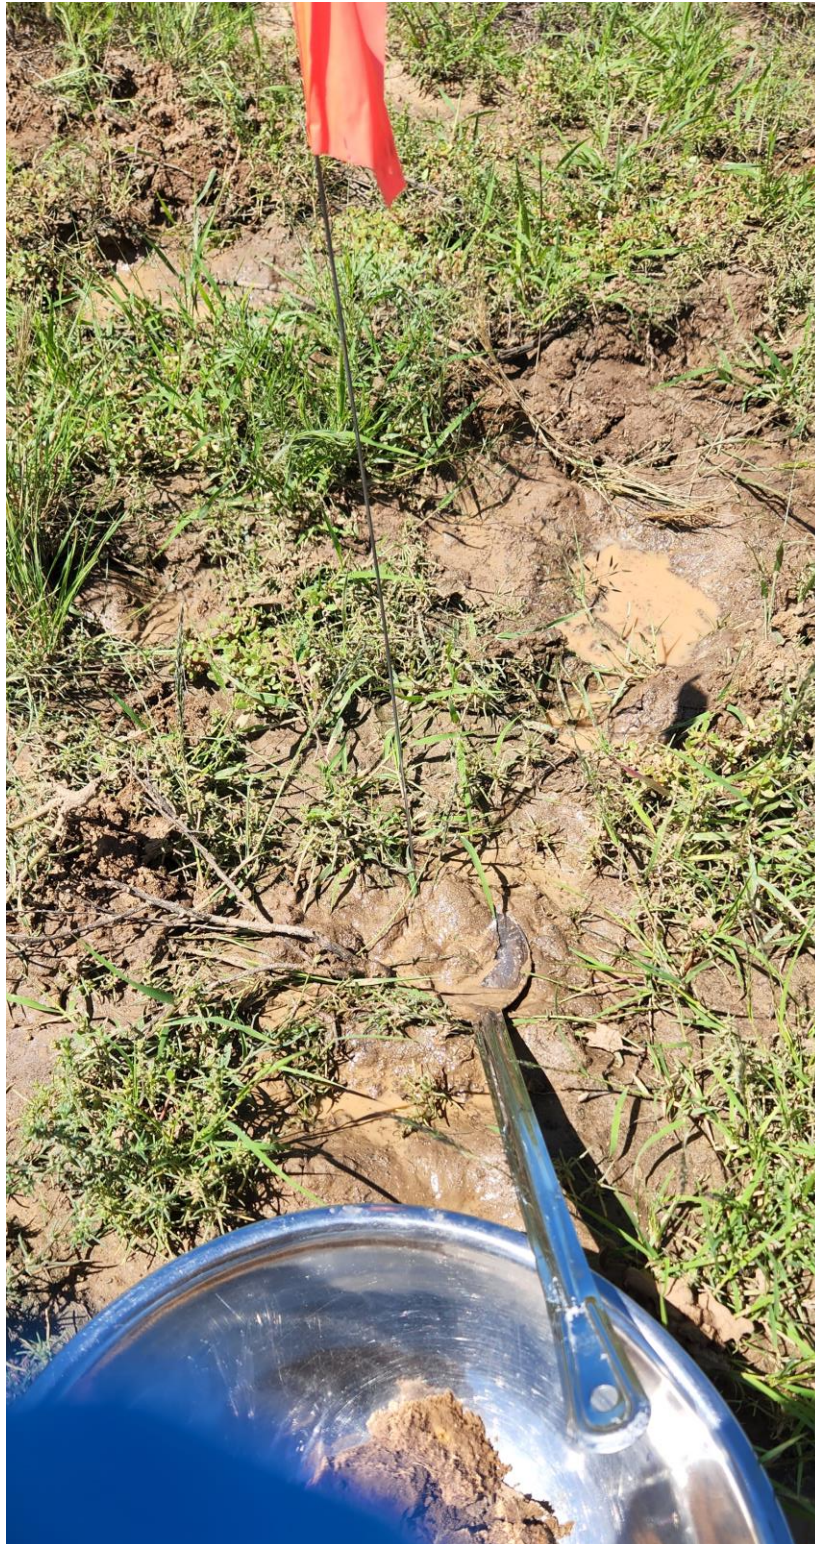
Photo 4. One of the three-point composite sample locations for ES-02 collected from the intermittent ponding area at end of the small drainage channel derived from the fenced in raised bed. This low area contained evidence of recent livestock presence.

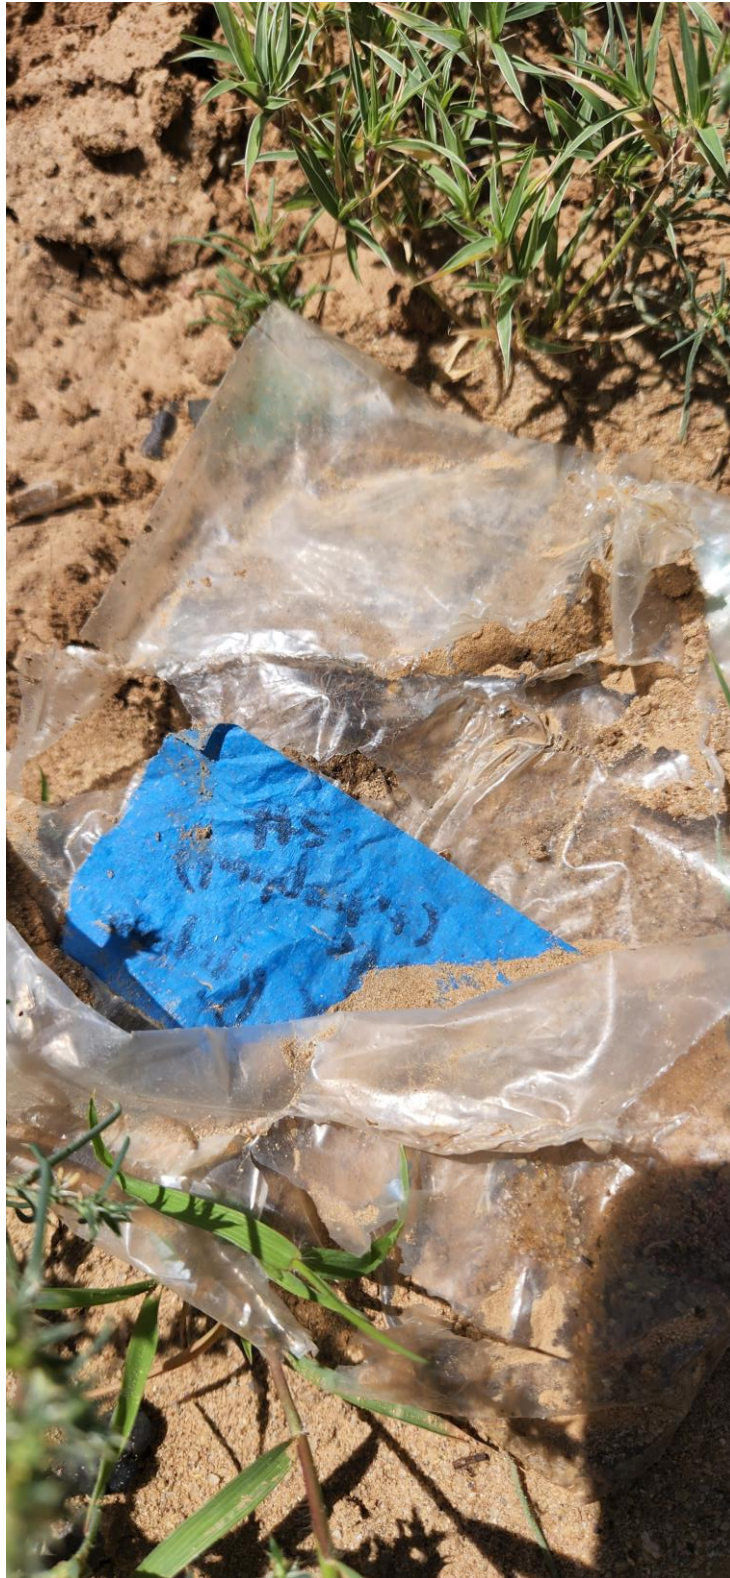
Photo 5. Close-up of one of the 16 soil bed row labels within the fenced area. Labels were written on blue tape and covered in plastic but deemed illegible due to weathering.

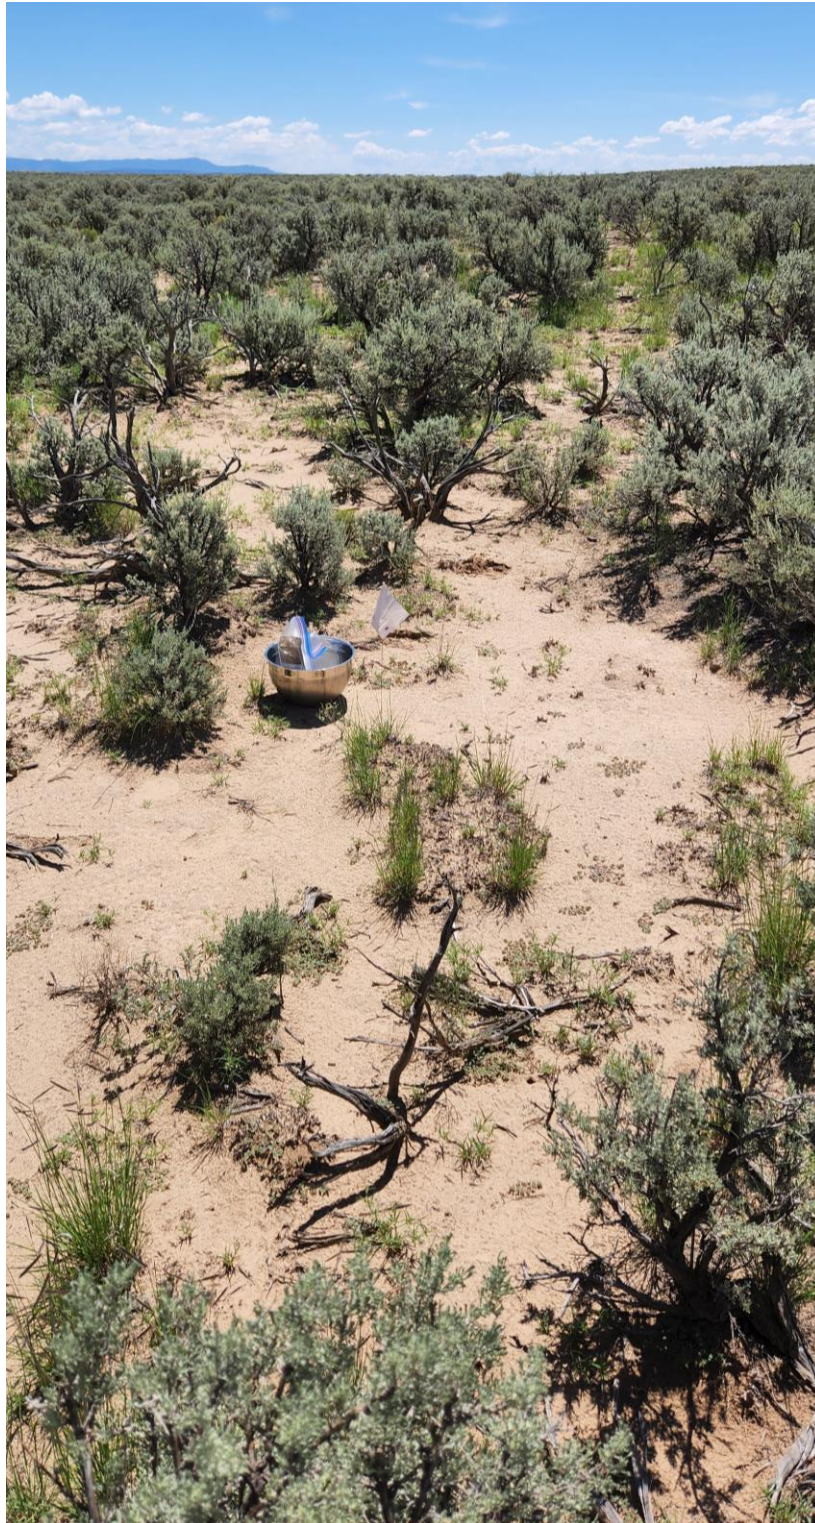
- The ES-03 background sample was collected from 0-3" depth and consisted of silty, fine-grained sand.

Photo 6. Looking south at background sample (ES-03) collection location in undisturbed area south of wellsite.

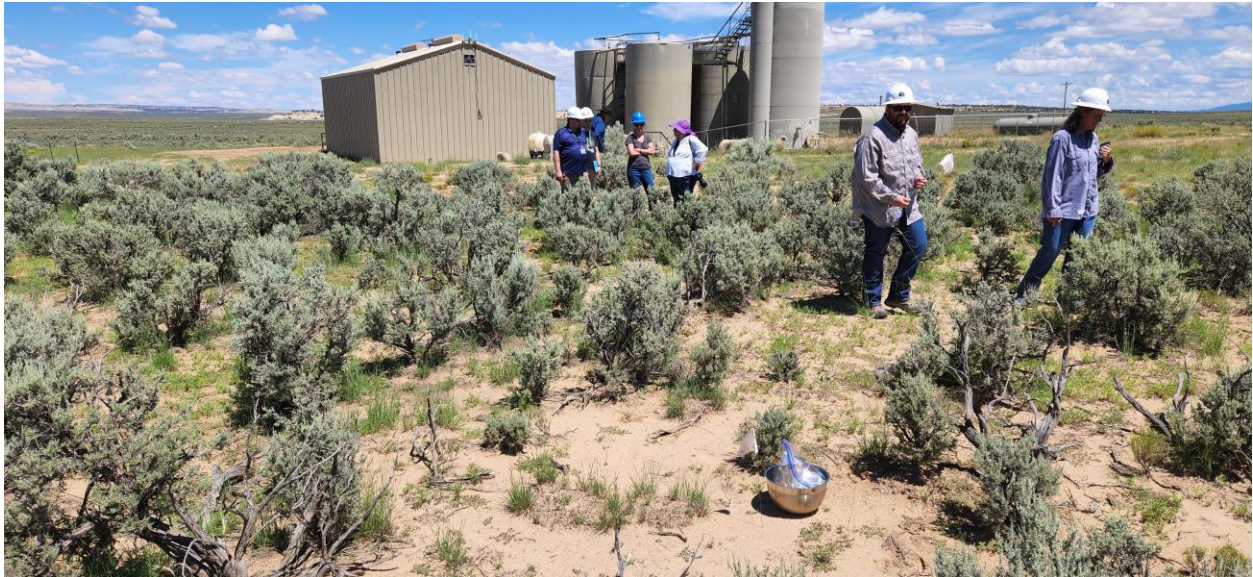
Photo 7. Looking north at background sample (ES-03) collection location in undisturbed area south of wellsite infrastructure. Photo includes members of NMED and NM OCD.
